The following inspection is of the footpath to the western side of Allambie Road starting at the bus stop at the southern end of Section 2, heading in a northerly direction and finishing at the intersection of Arnhem Road, Allambie Heights.

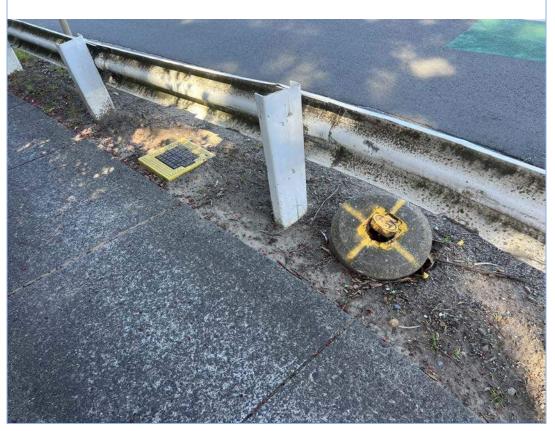
Views of the inspection lid on the south side of Arnhem Road, Allambie Heights.

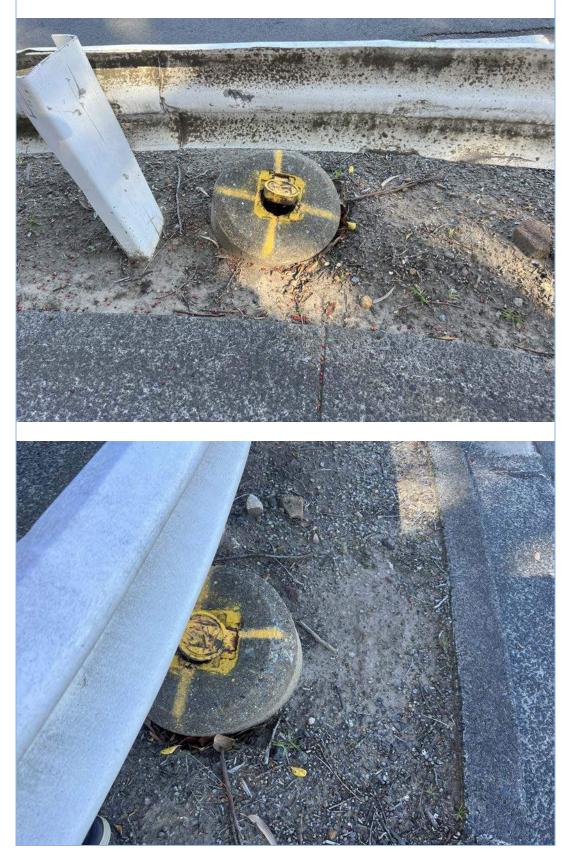
Damage noted to the inspection lid concrete surround on the south side of Arnhem Road, Allambie Heights.

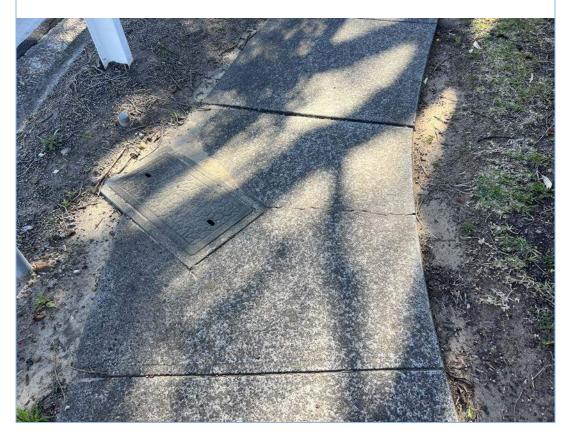
Crack damage to the footpath on the south side of Arnhem Road, Allambie heights.

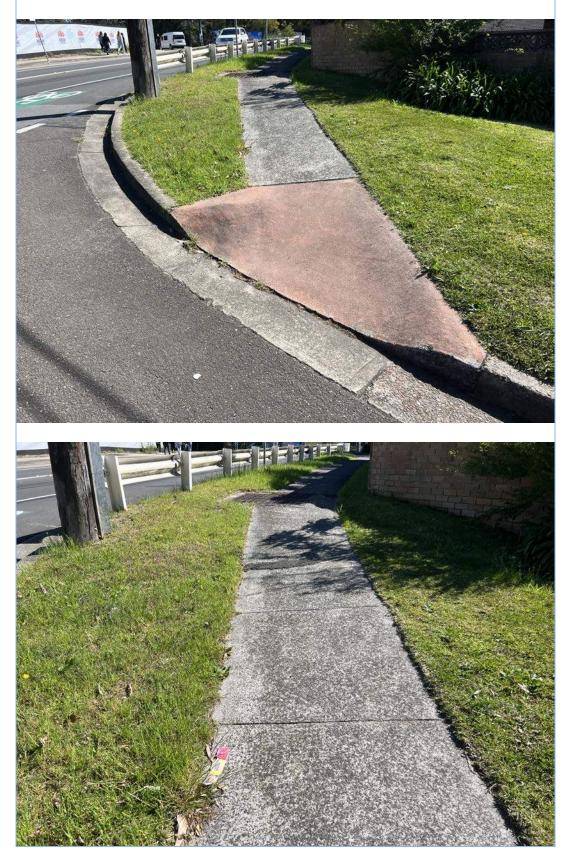
Views of the kerb and footpath on the north side of Arnhem Road, Allambie Heights.

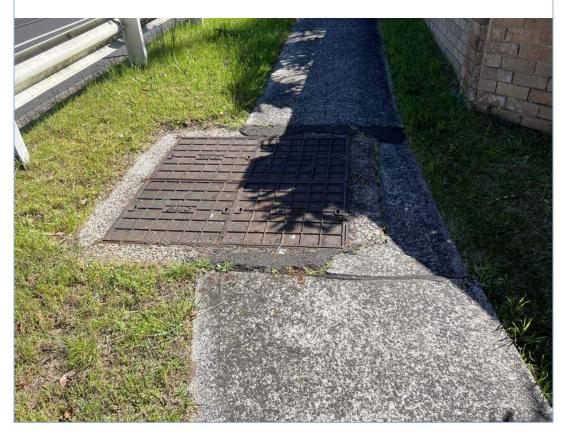
View of the inspection lid on north side of Arnhem Road, Allambie Heights.

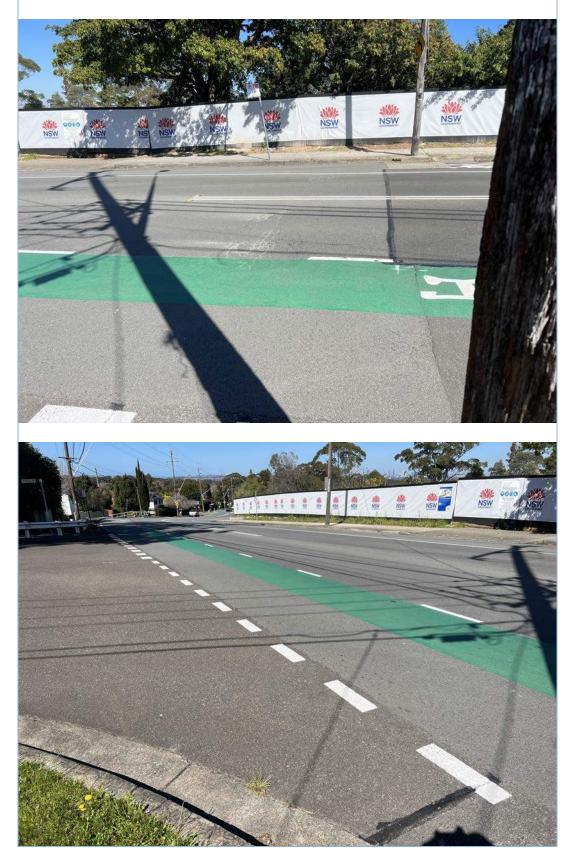
General views of the intersection of Arnhem Road and Allambie Road, looking south.

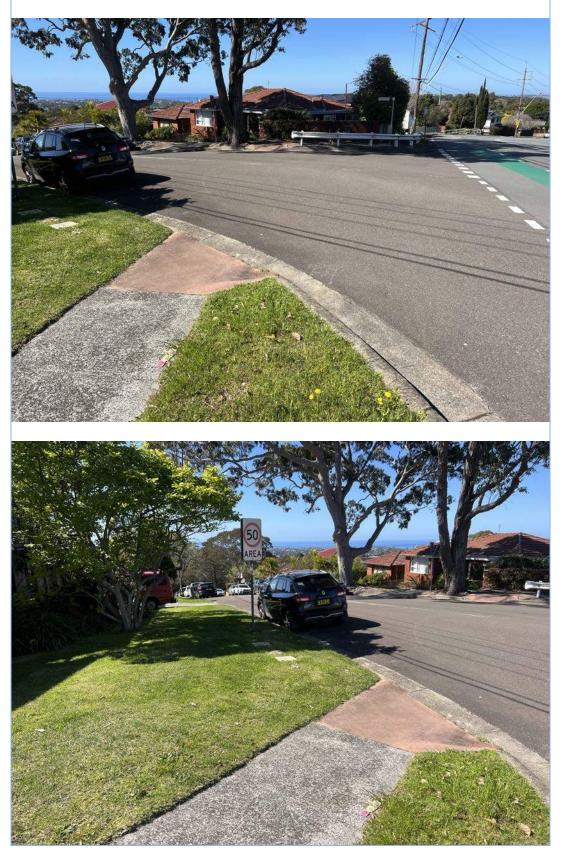
General views of the intersection of Arnhem Road and Allambie Road, looking south.

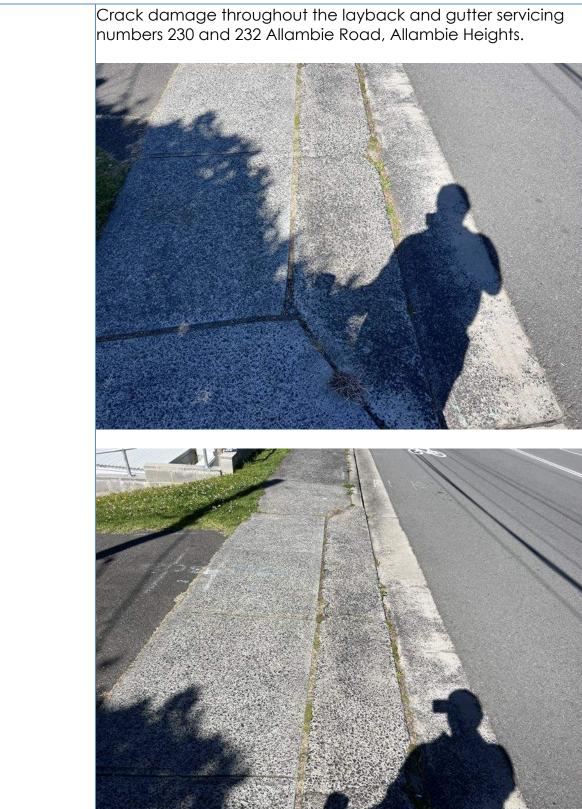
Views of the driveway crossover, layback and gutter servicing
