### Notable Items – Section 3

#### Intersection of Sunlea Place and Allambie Road:

The following inspection is of the public infrastructure at the intersection of Sunlea Place and Allambie Road, Allambie Heights.

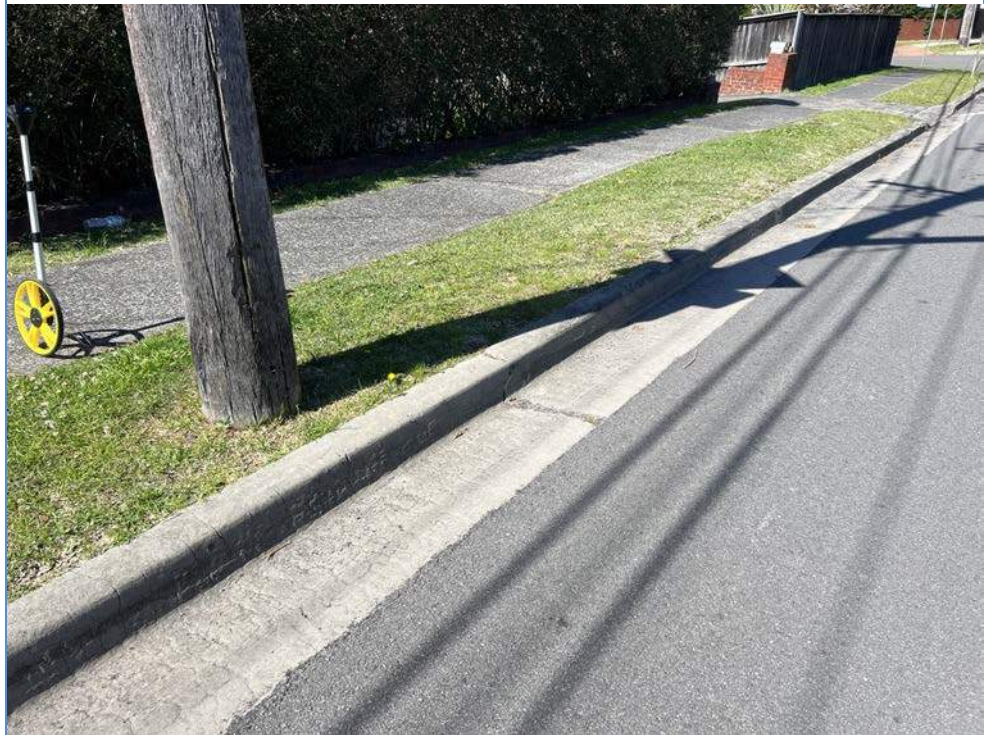
30m

Crack damage to the kerb and gutter.

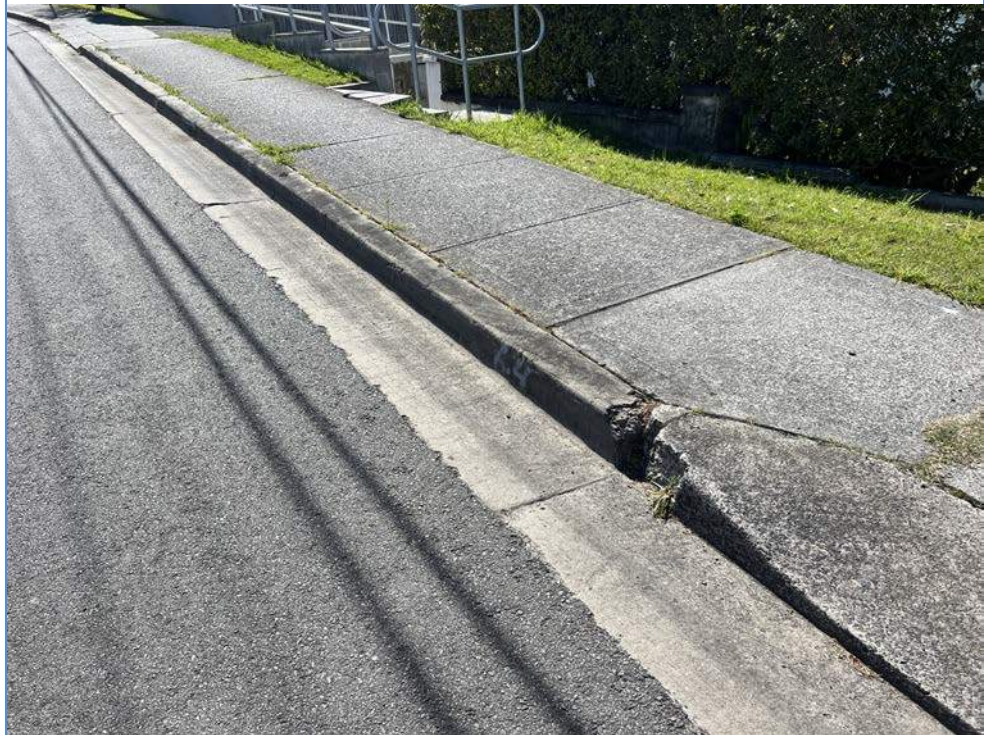
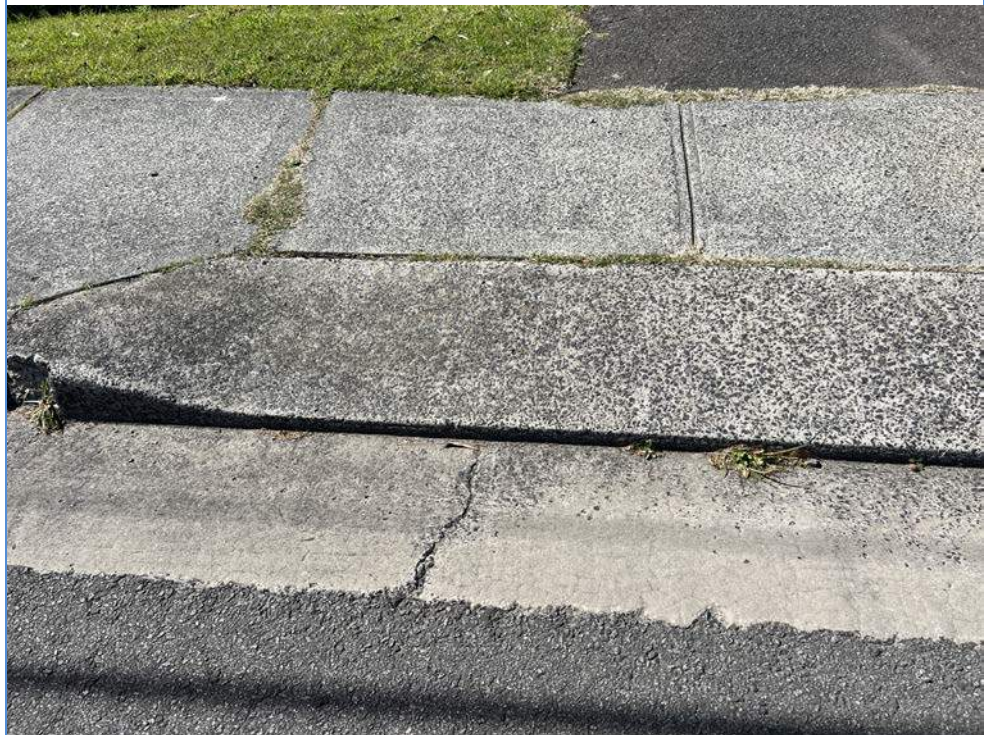
40m

Crack damage to the kerb, layback and gutter.

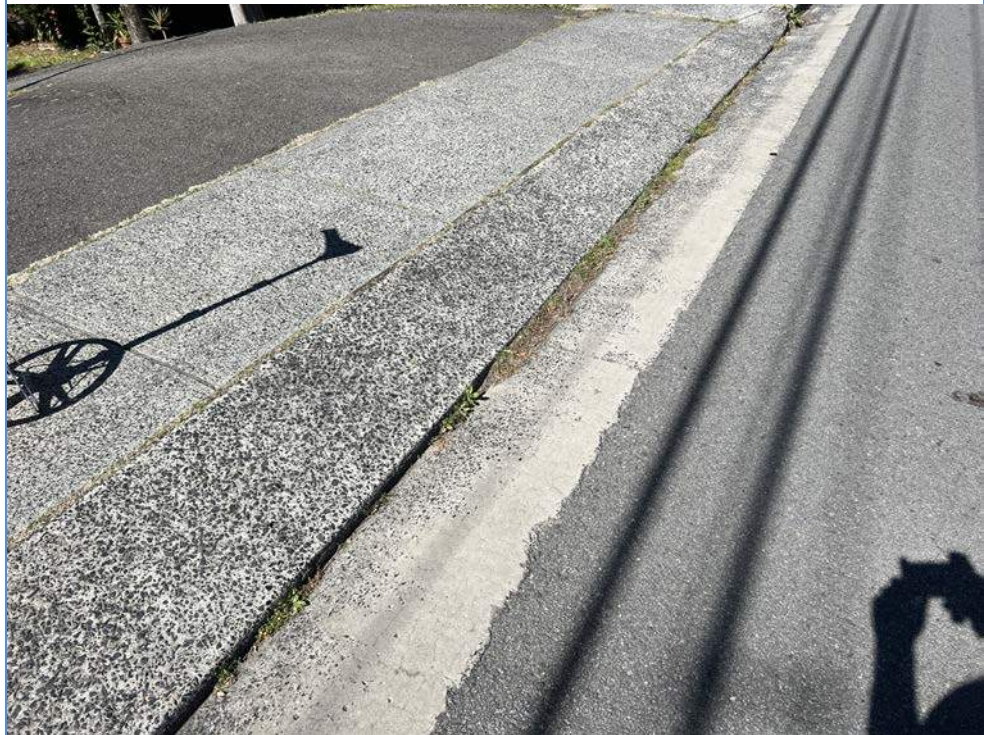
40m

Crack damage to the kerb, layback and gutter.

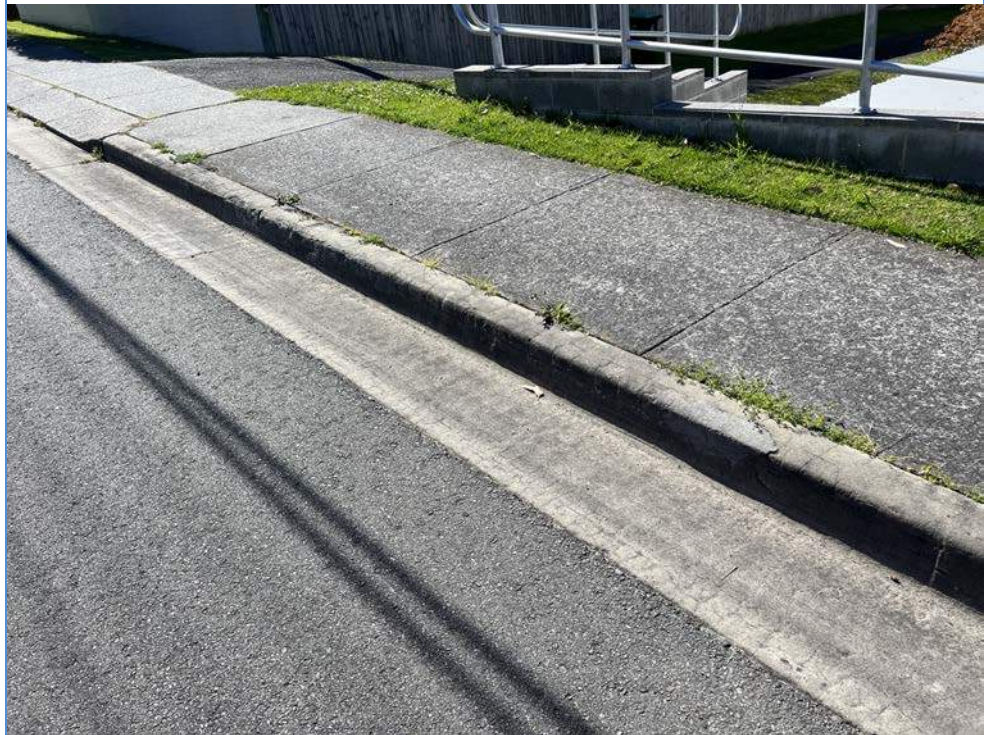
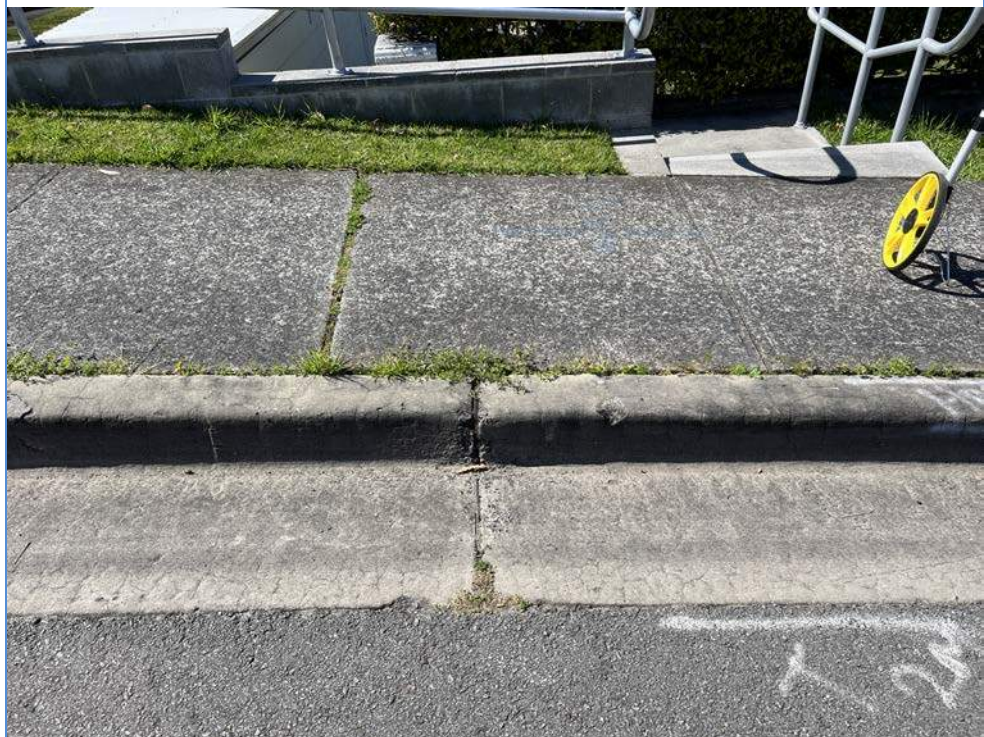
50m

Crack damage throughout the kerb and gutter.

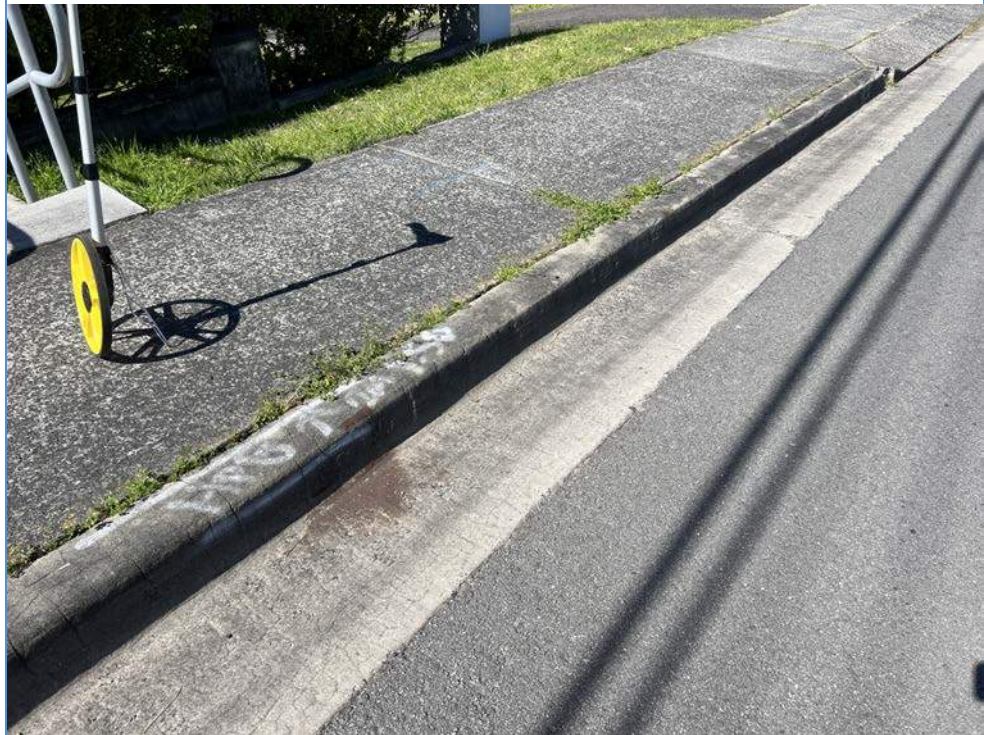
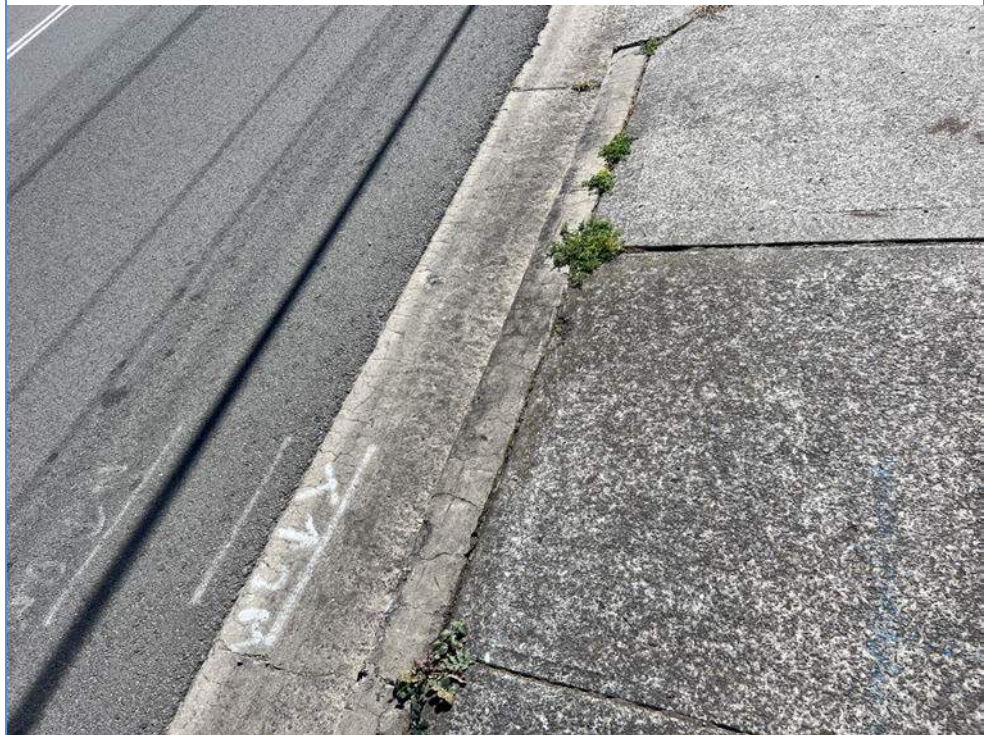
50m

Crack damage throughout the kerb and gutter.

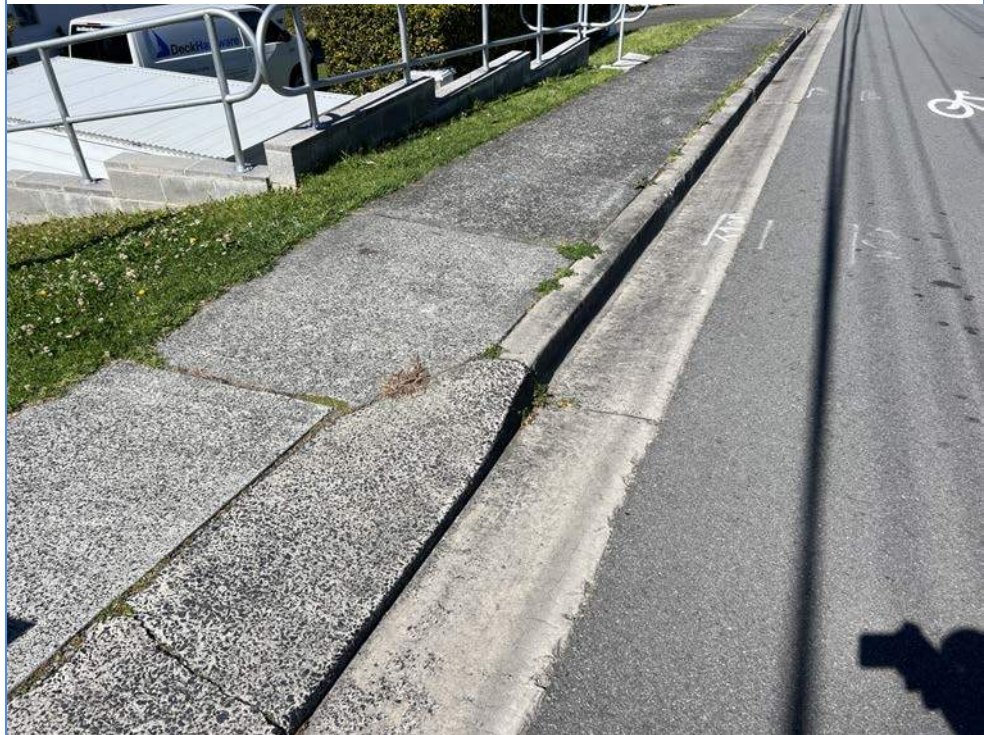
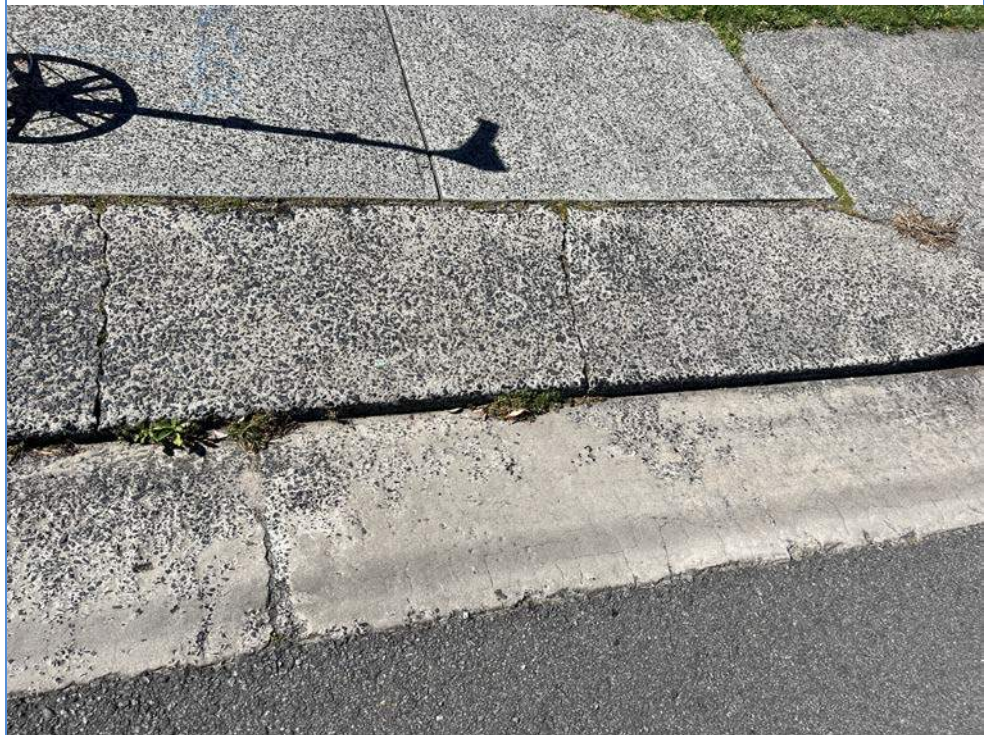
60m

Crack damage throughout the layback, gutter and kerb.

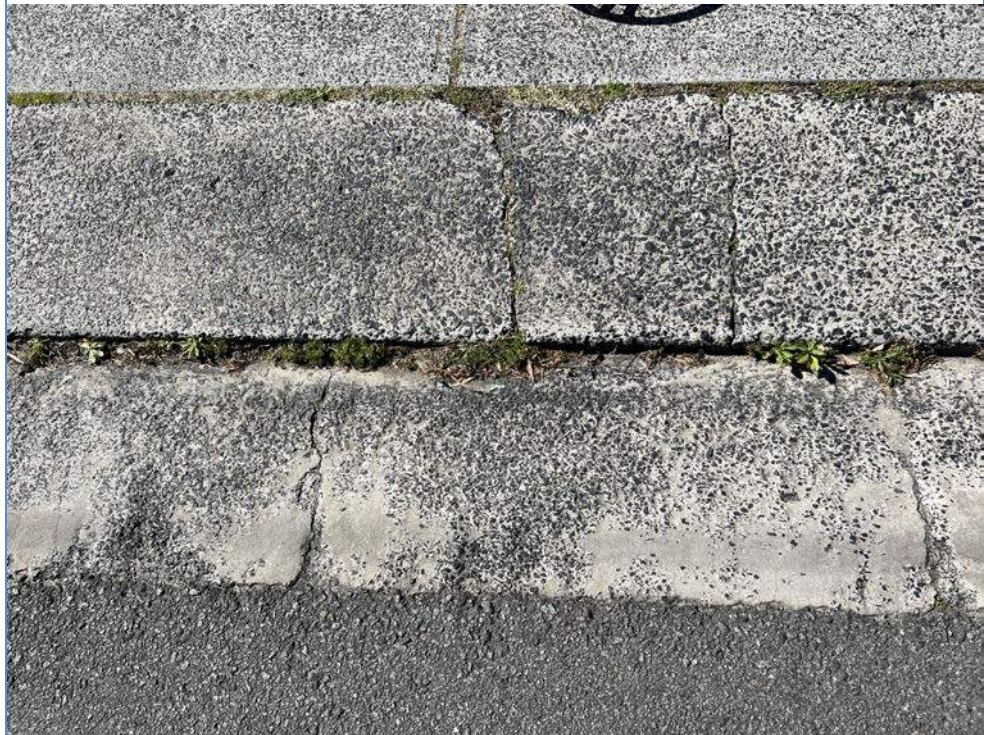
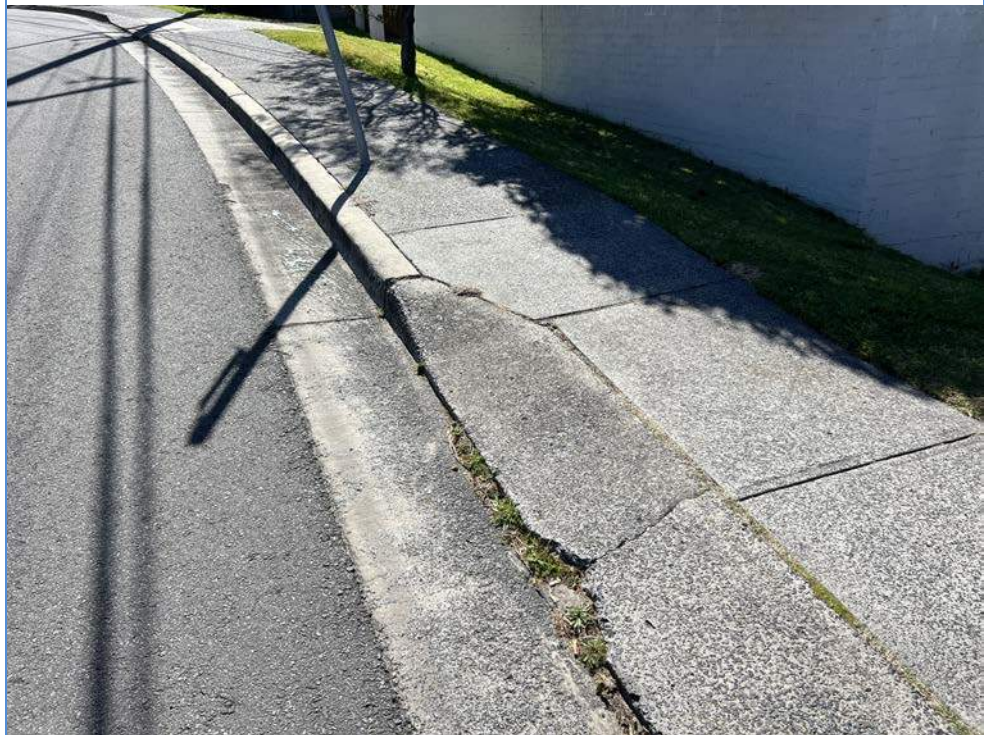
60m

Crack damage throughout the layback, gutter and kerb.

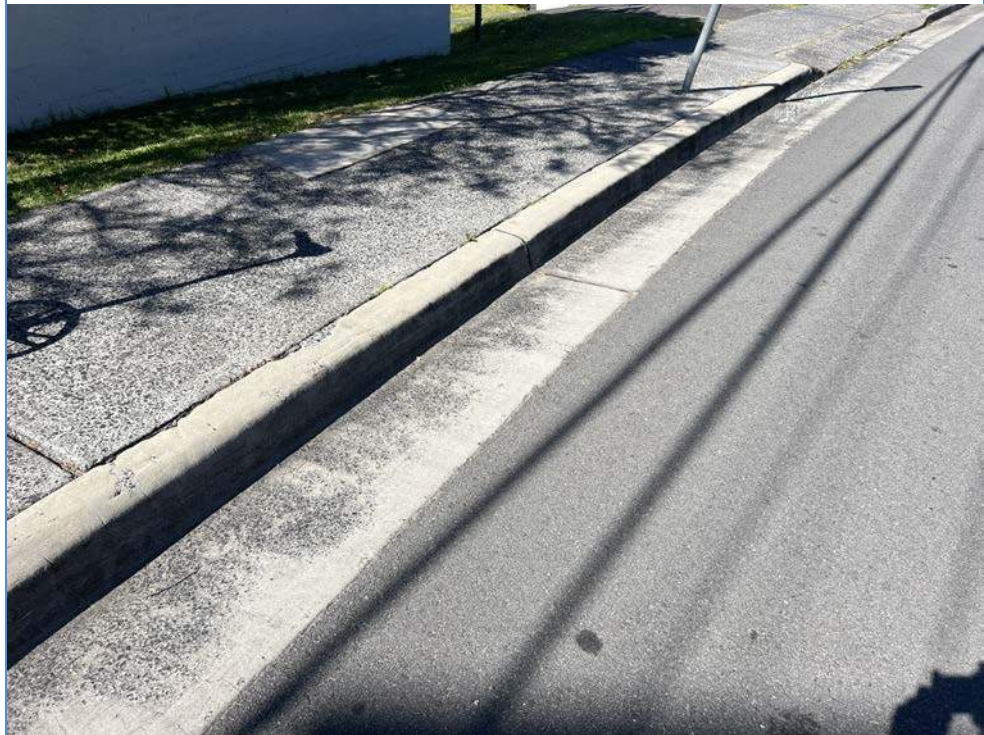
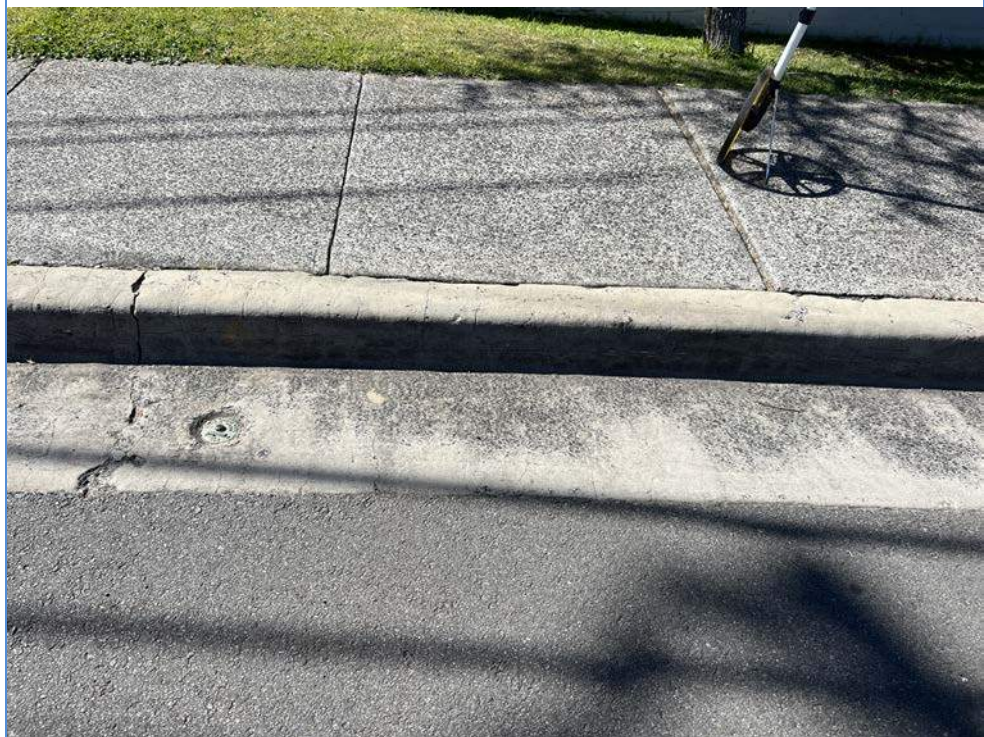
70m

Crack damage throughout the kerb and gutter.

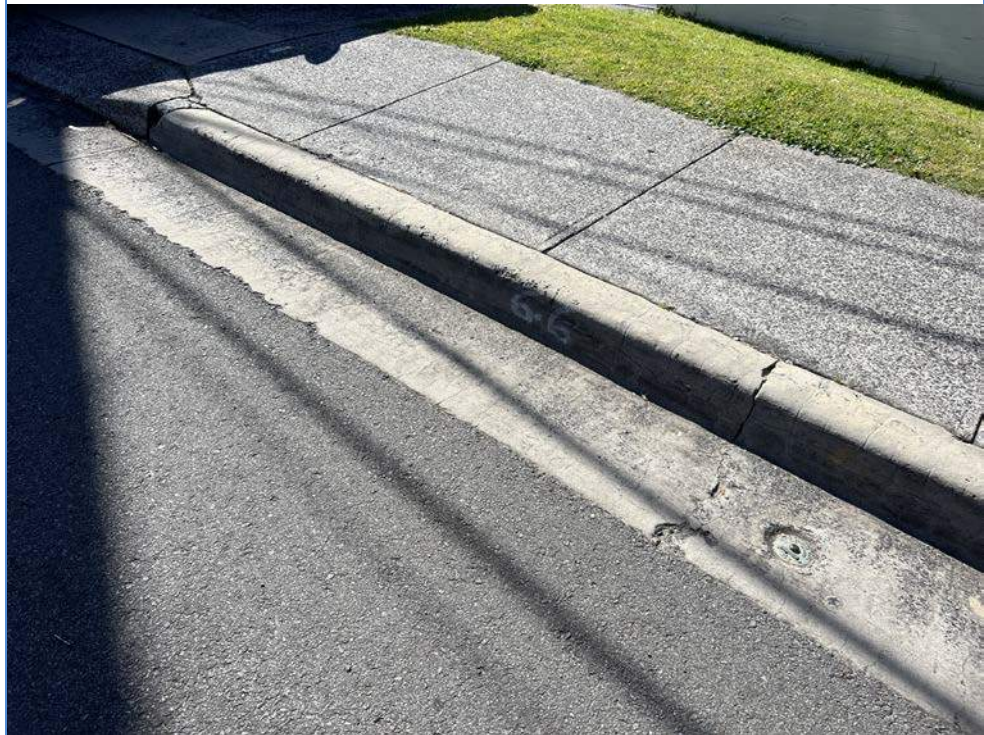
70m

Crack damage throughout the kerb and gutter.

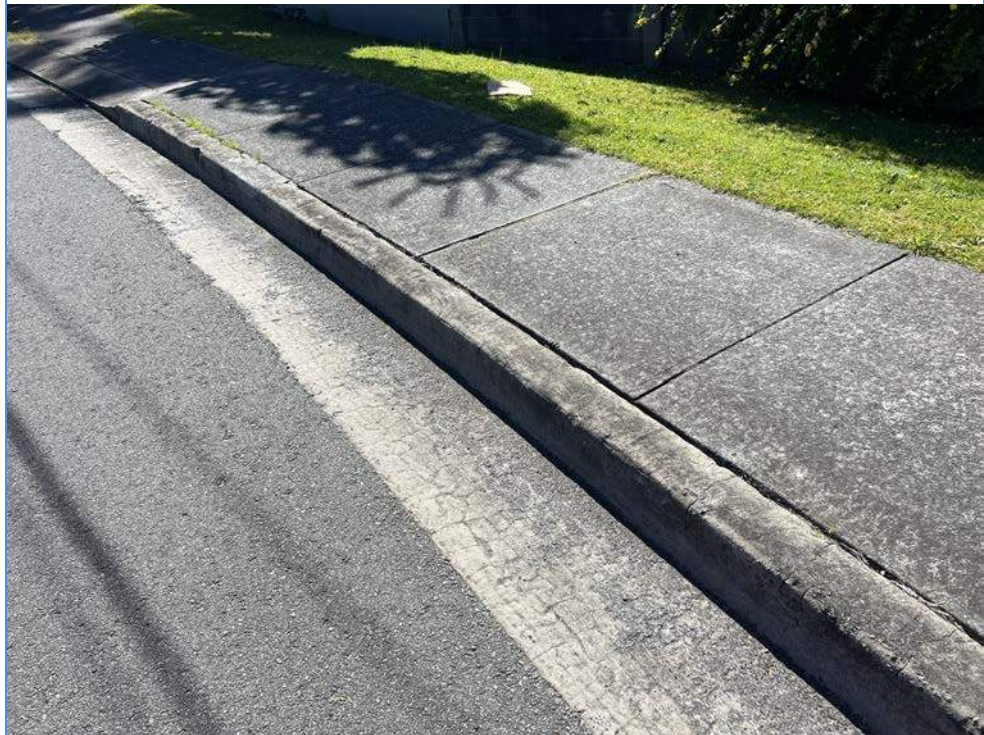
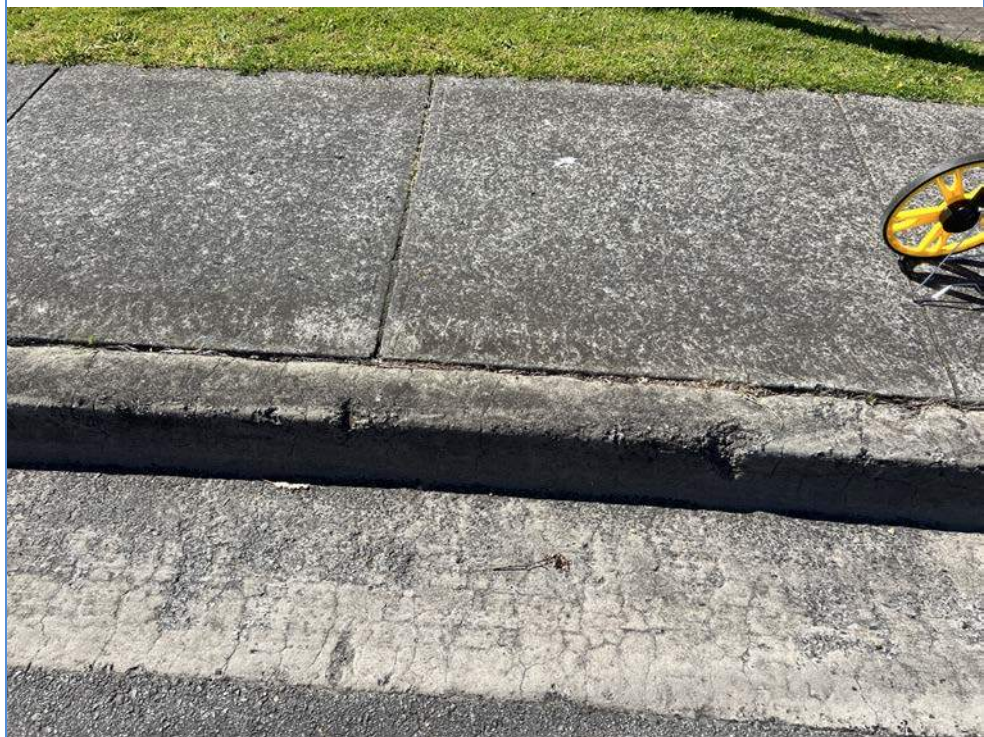
80m

Crack damage throughout the kerb and gutter.

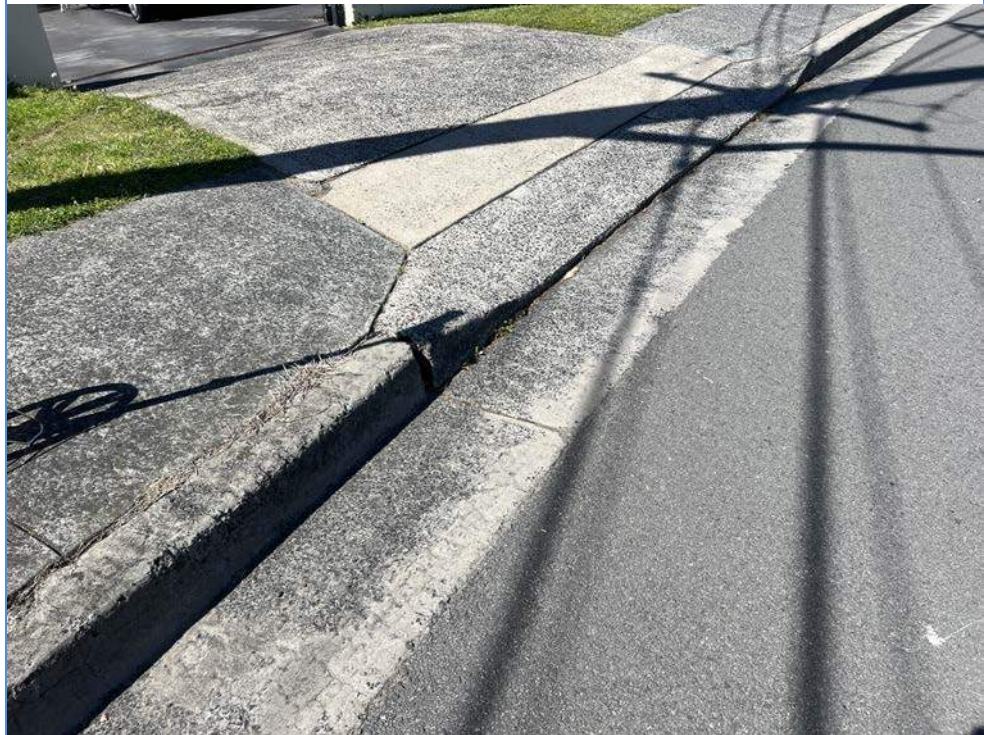
80m

Crack damage throughout the kerb and gutter.

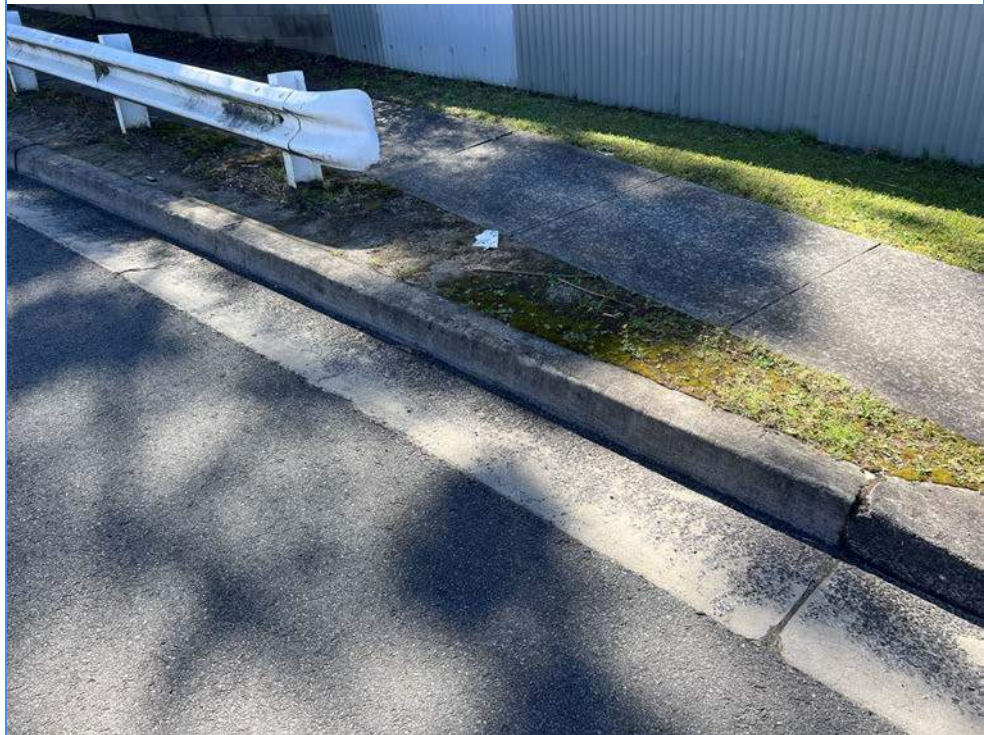
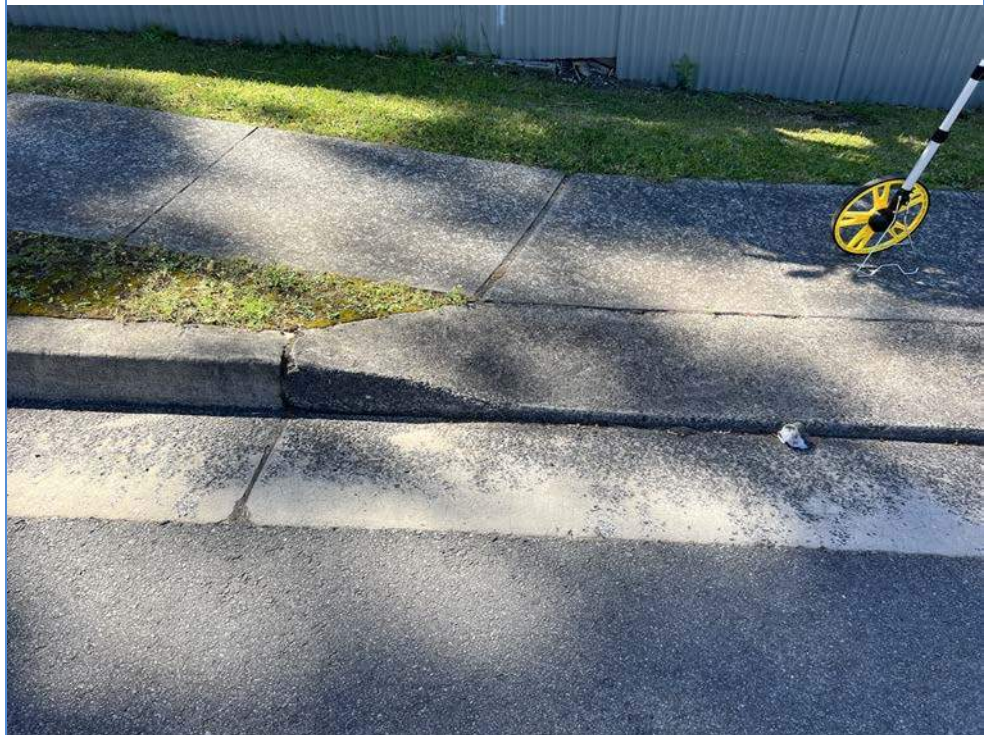
90m

Crack damage to the kerb, gutter and layback.

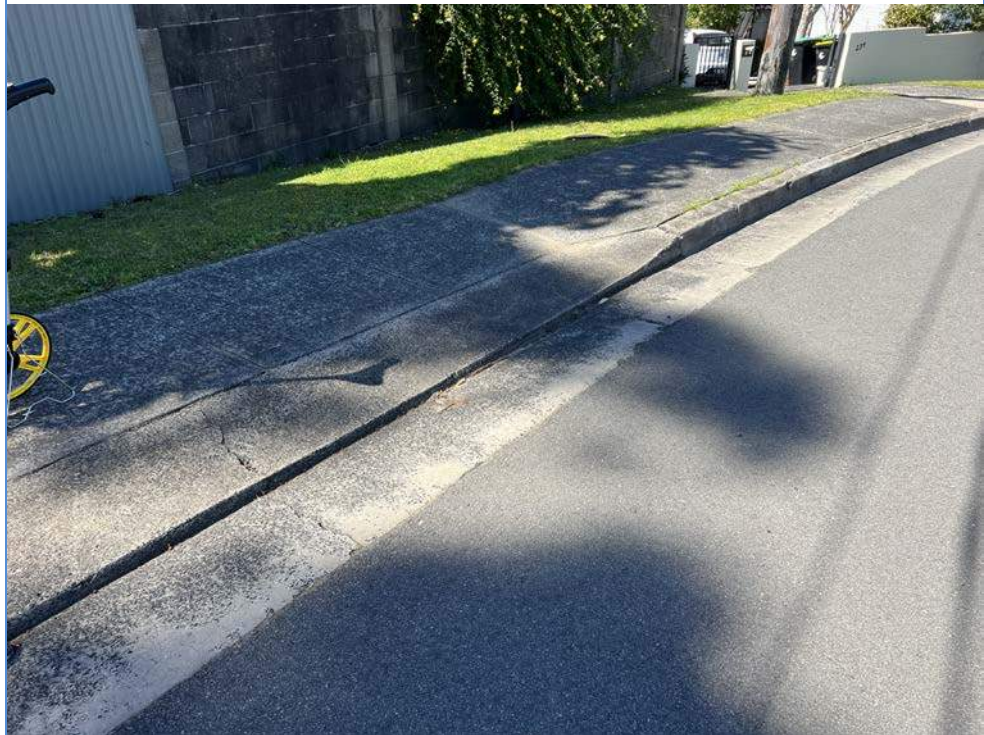
90m

Crack damage to the kerb, gutter and layback.

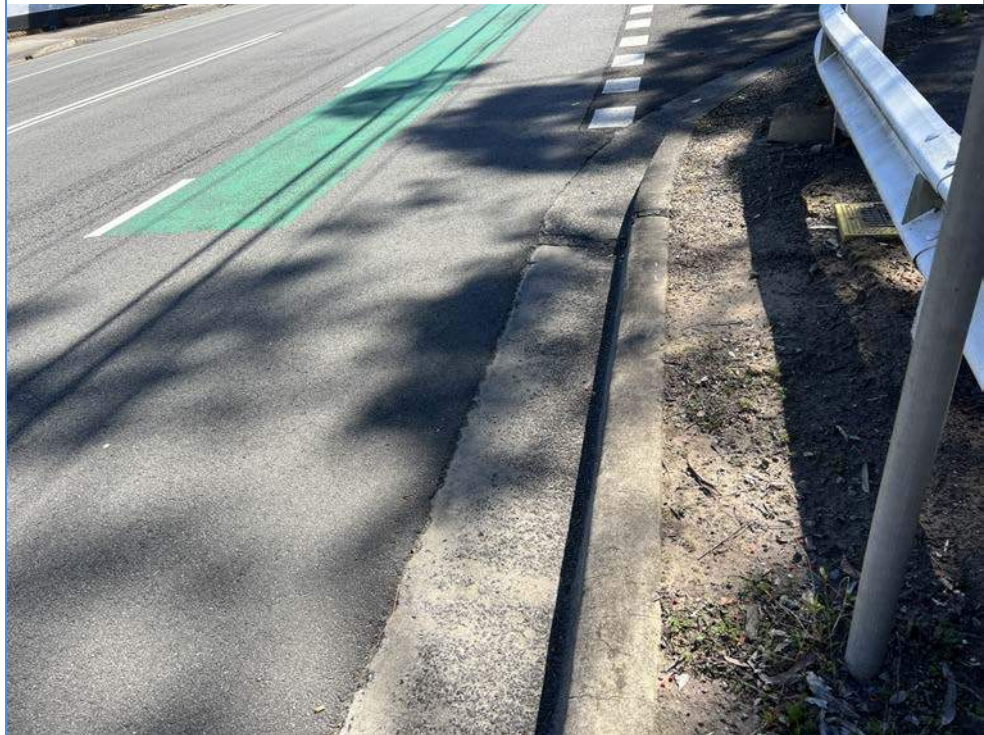
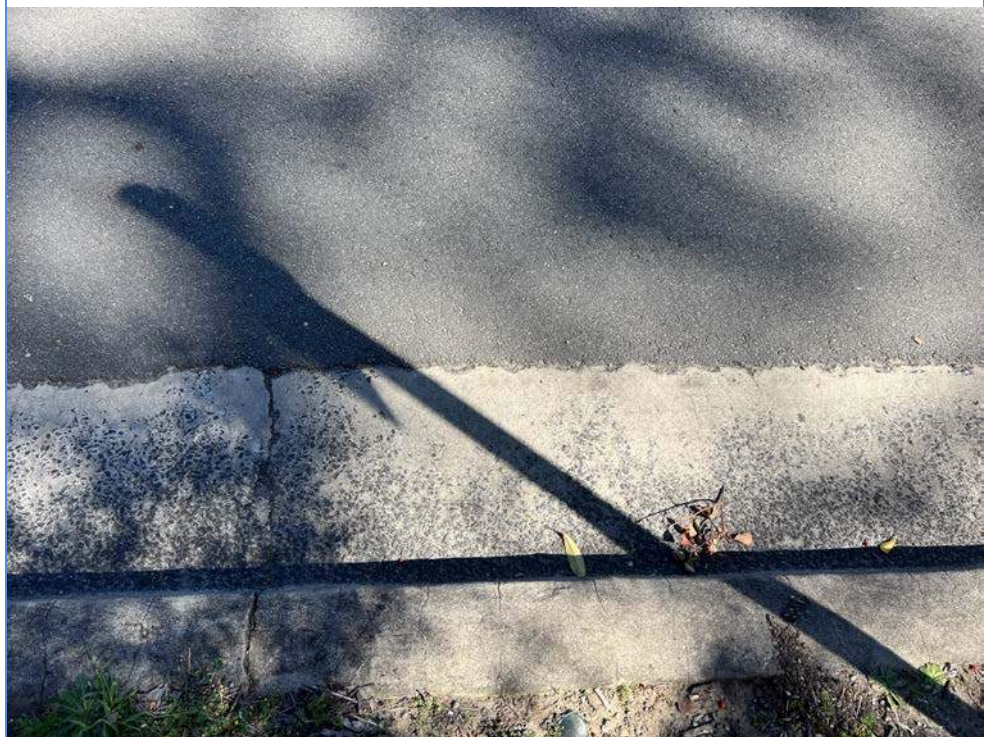
100m

Crack damage to the kerb and gutter.

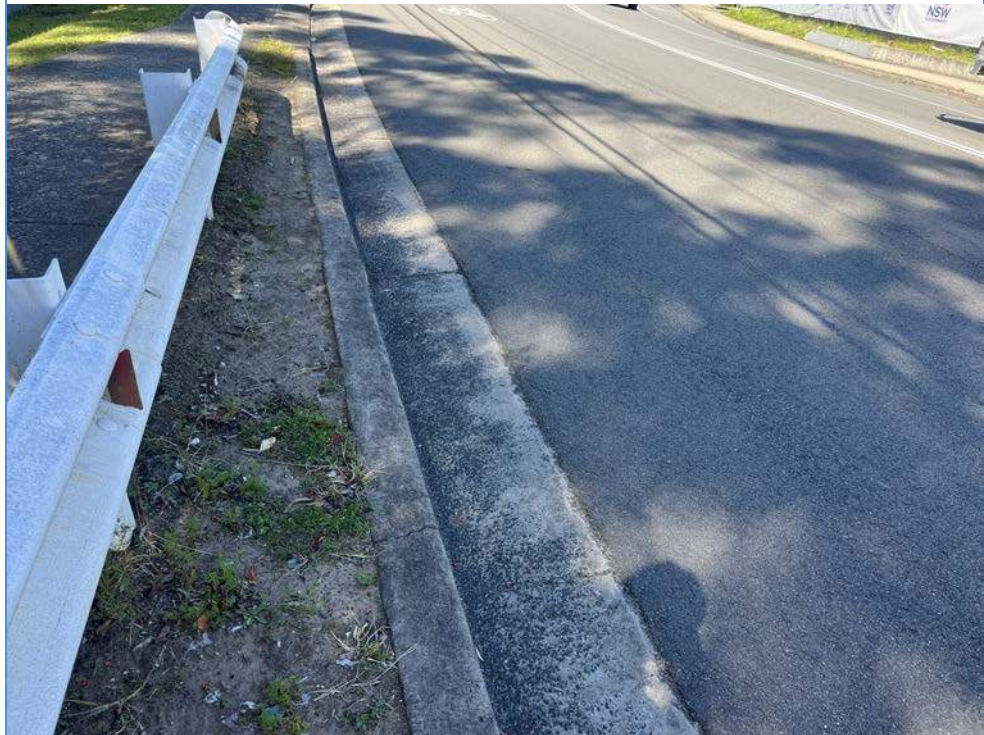
100m

Crack damage to the kerb and gutter.

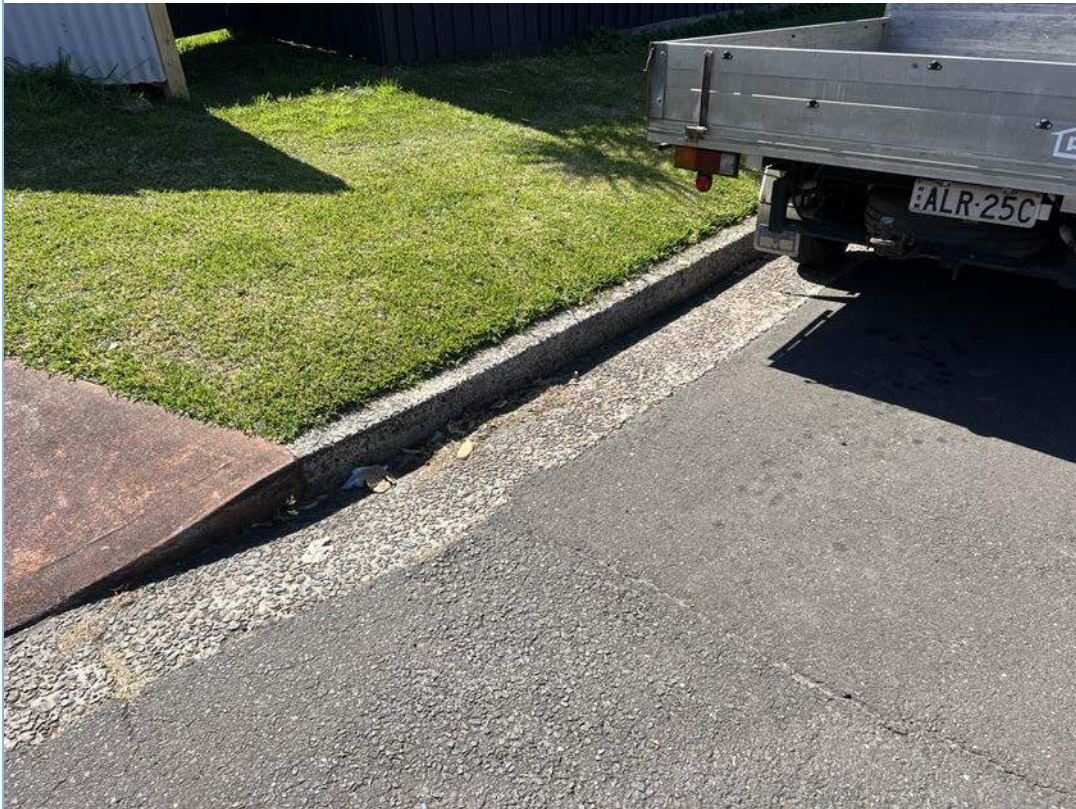
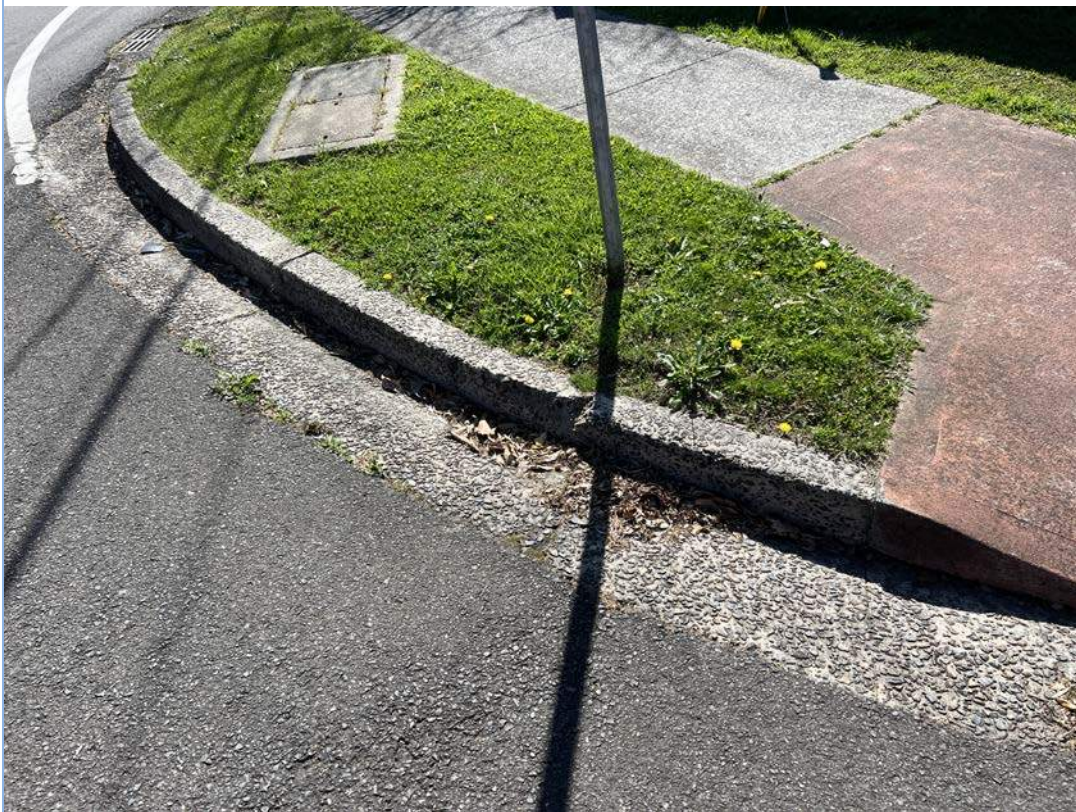
General views of the kerb and gutter showing crack damage at the north side of Sunlea Place.

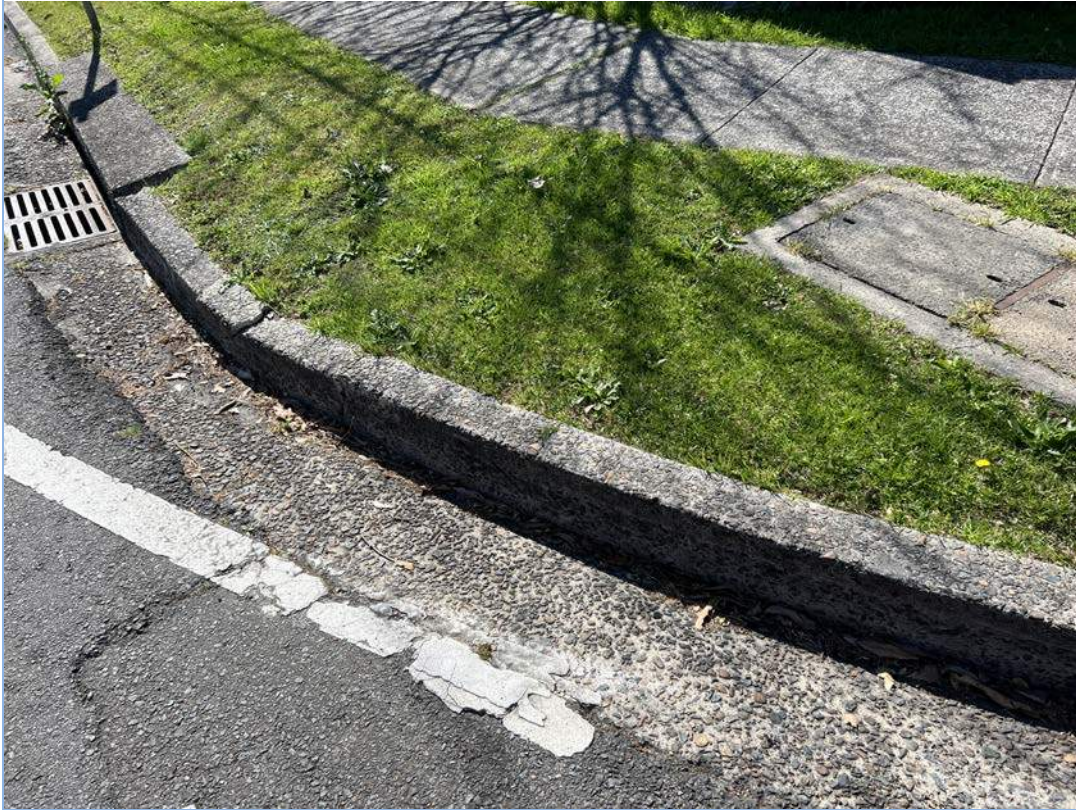
General views of the kerb and gutter showing crack damage at the north side of Sunlea Place.
