The following inspection is of the road surface, kerb and gutter to the western side of Allambie Road starting at the intersection of Arnhem Road and heading towards the intersection of Aquatic Drive at the end point.

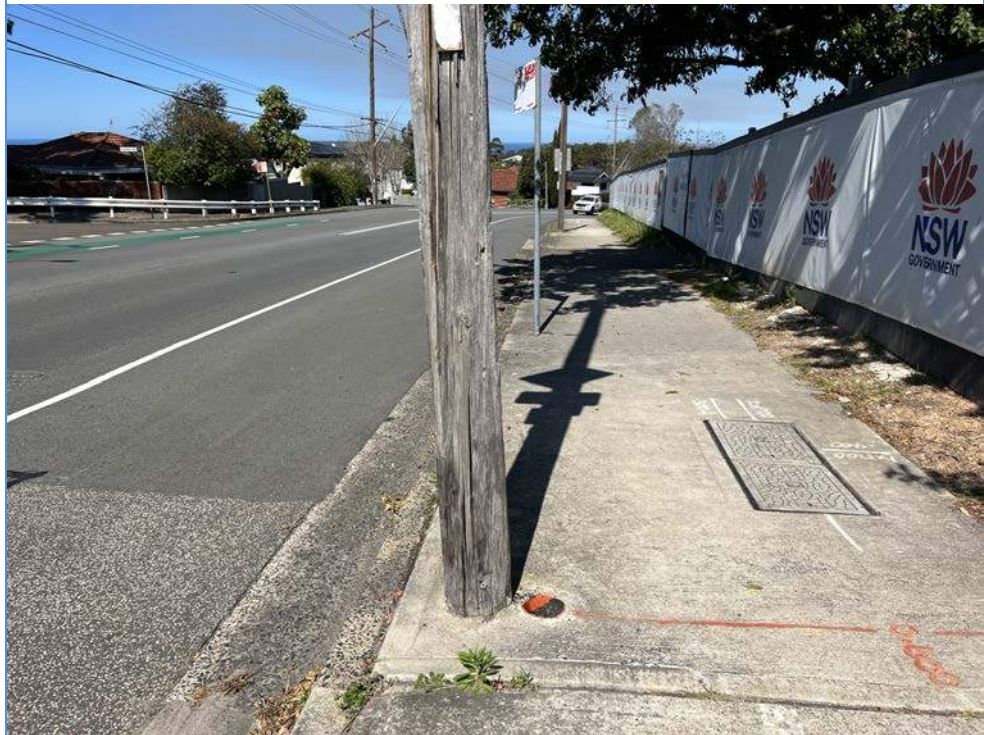
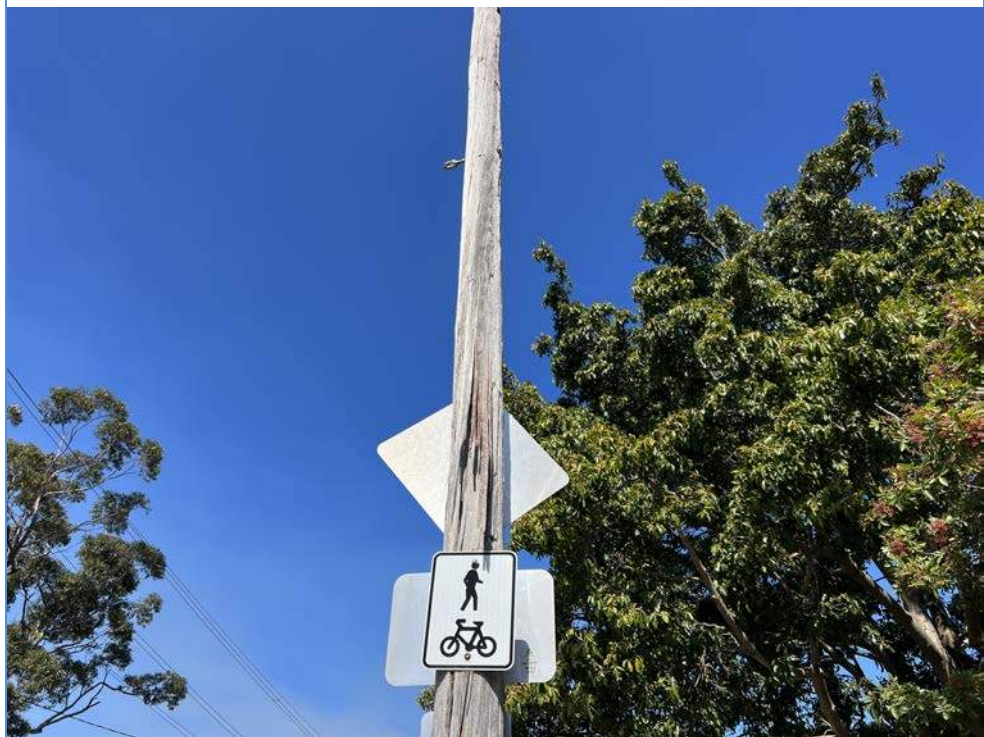
General views of the telegraph pole at the end point.

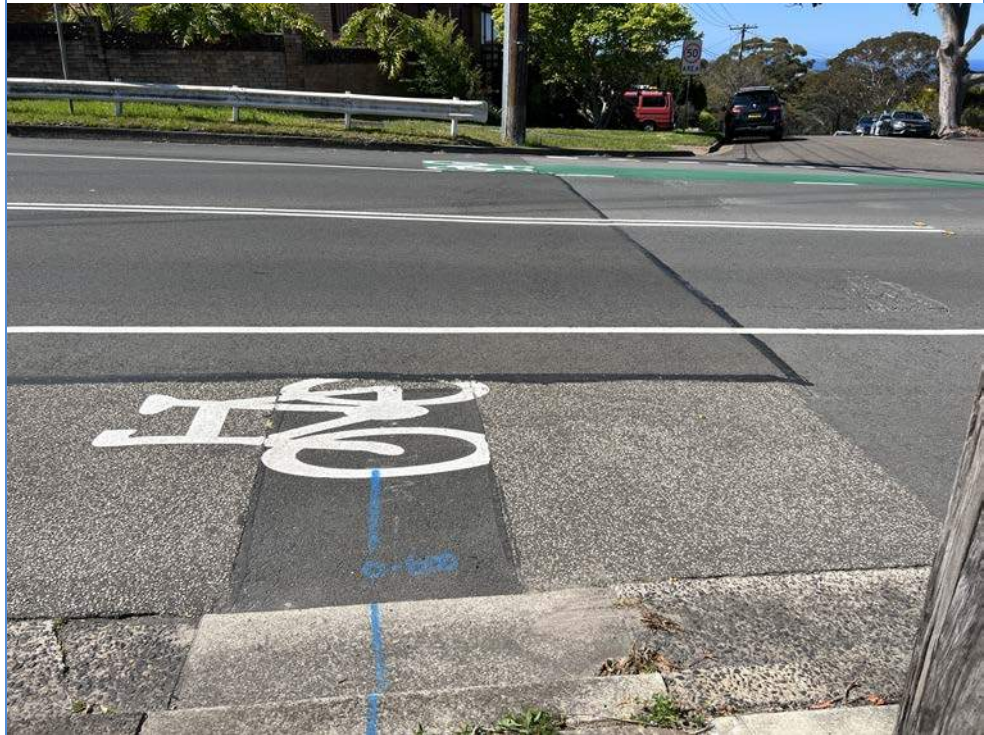
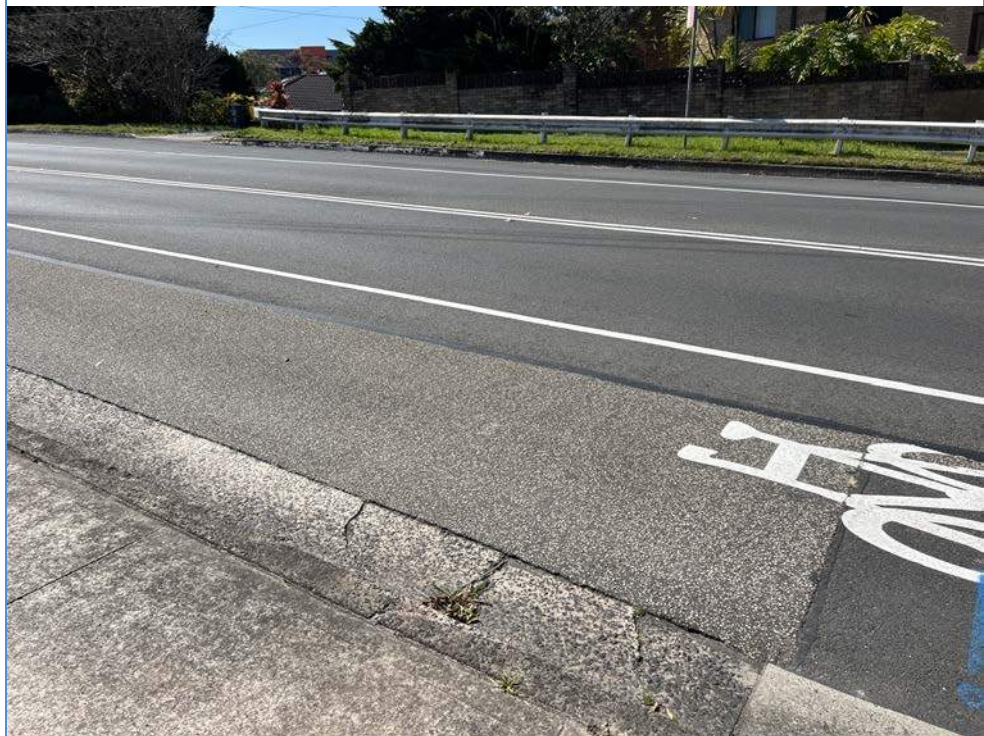
0m

General views of the road surface, kerb and gutter at the start point.

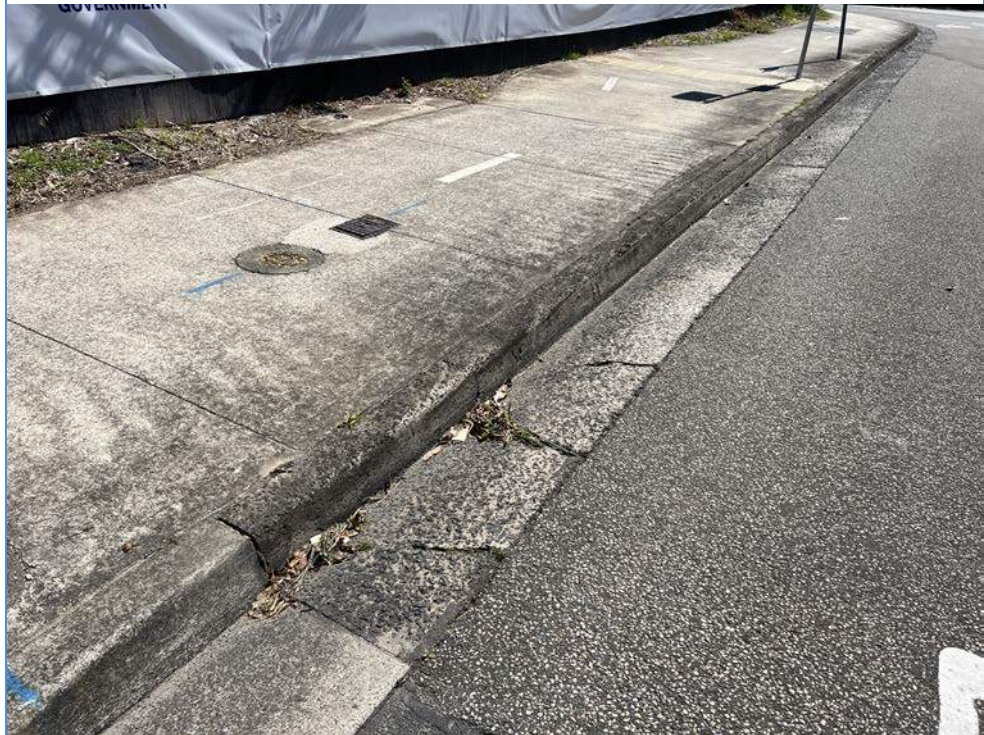
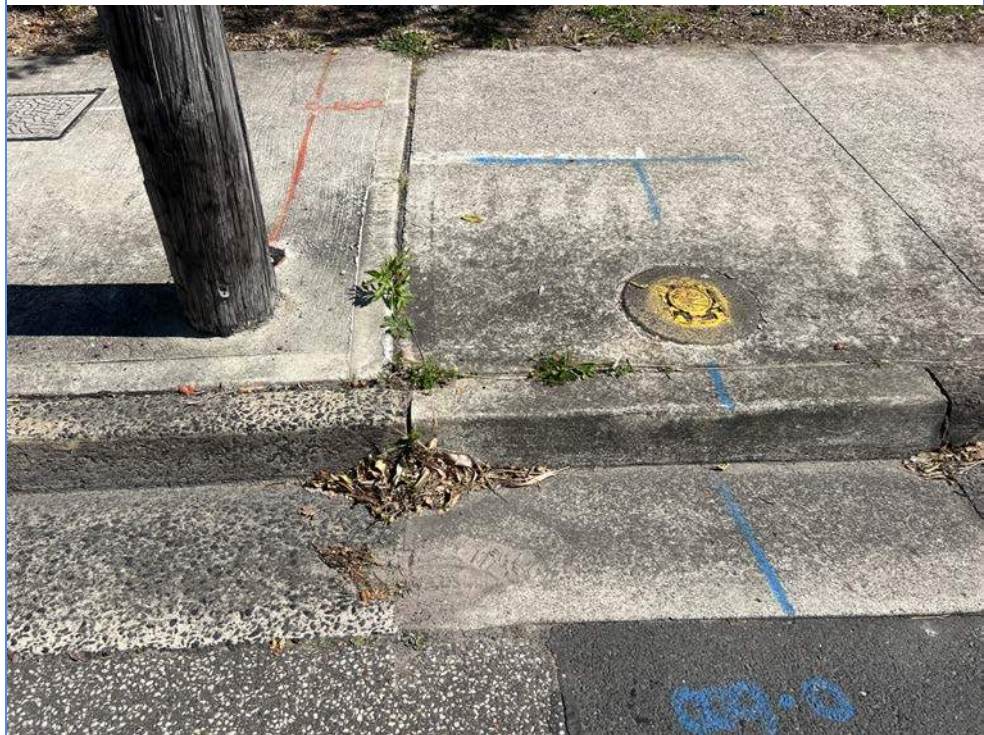
0m

Various cracks to the kerb and gutter at the start point.

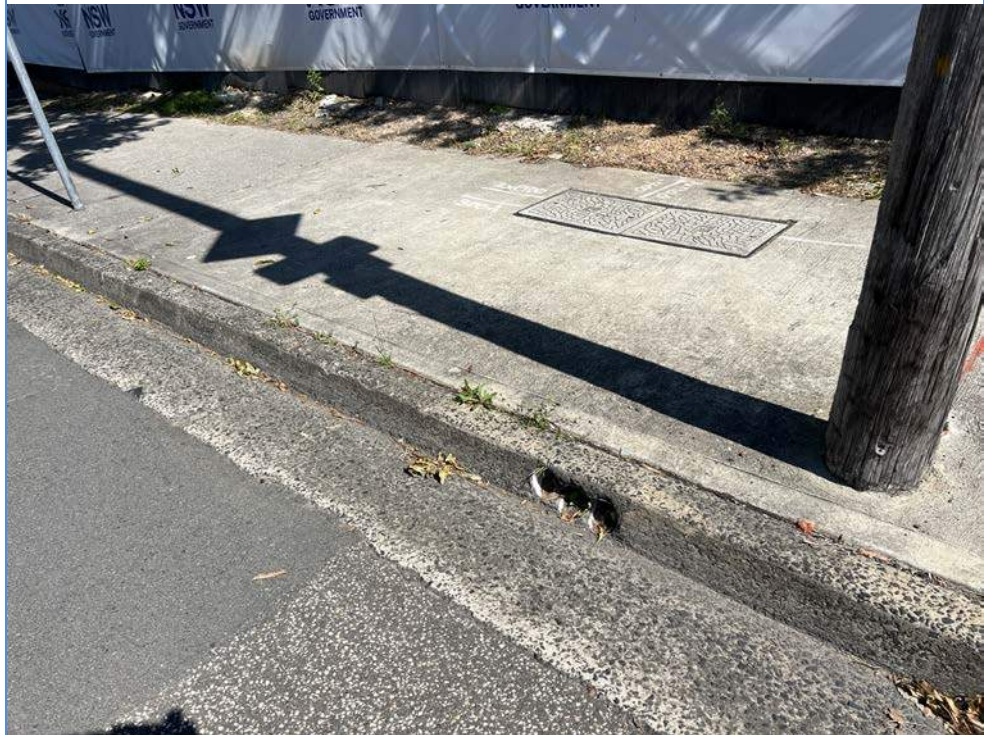
0m

Various cracks to the kerb and gutter at the start point.

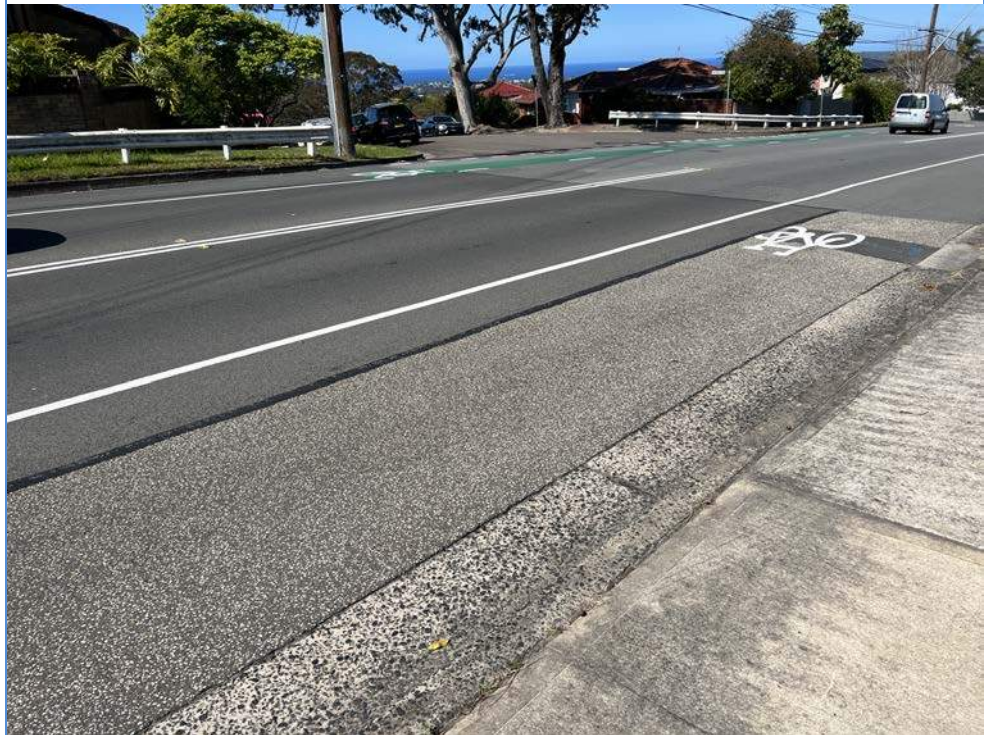
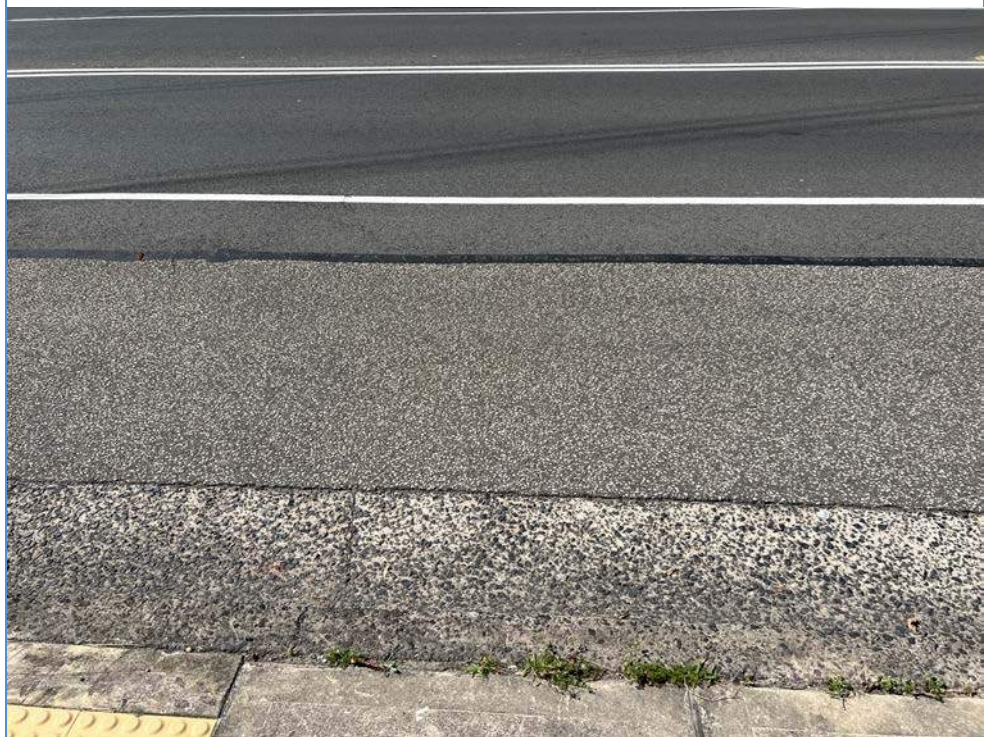
10m

General views of the road surface, kerb and gutter.

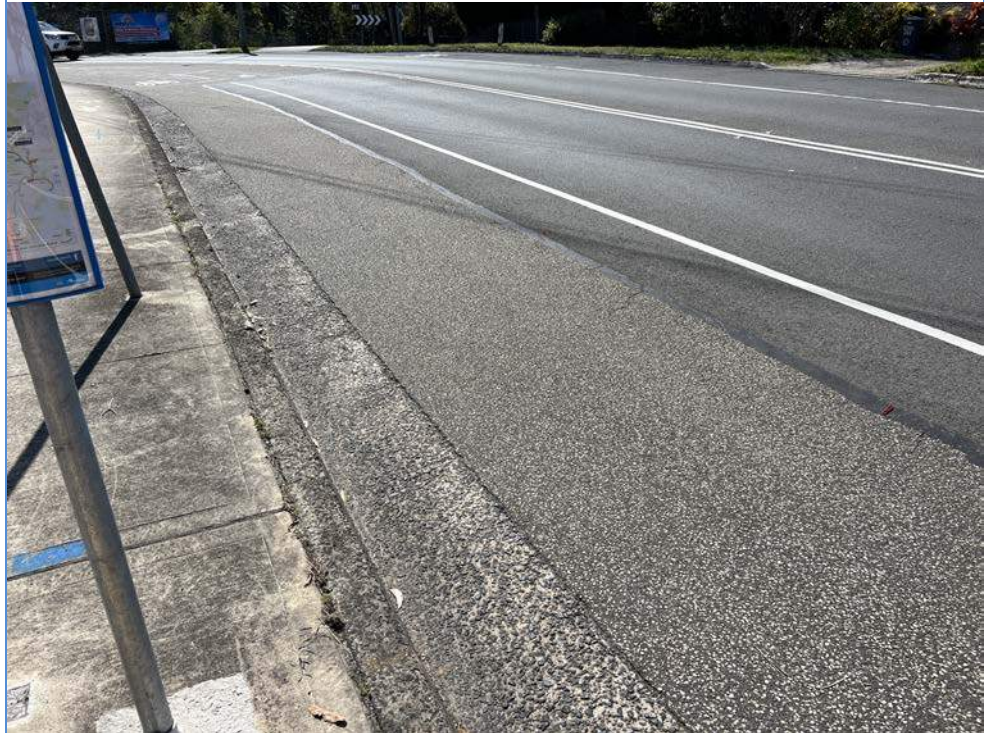
10m

General views of the road surface, kerb and gutter.

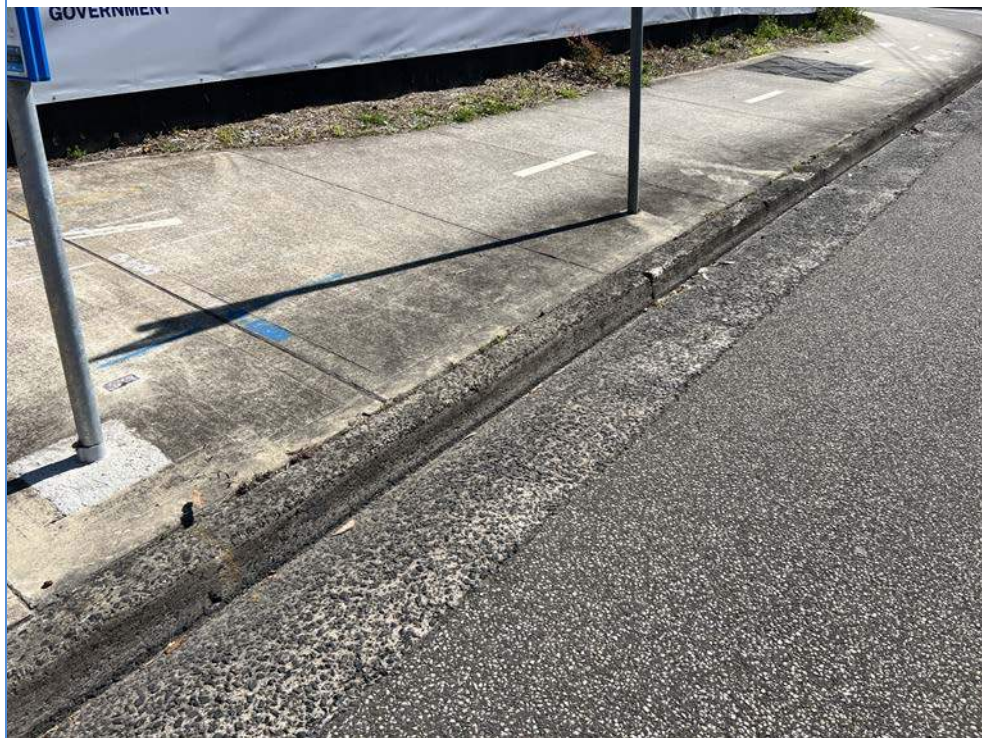
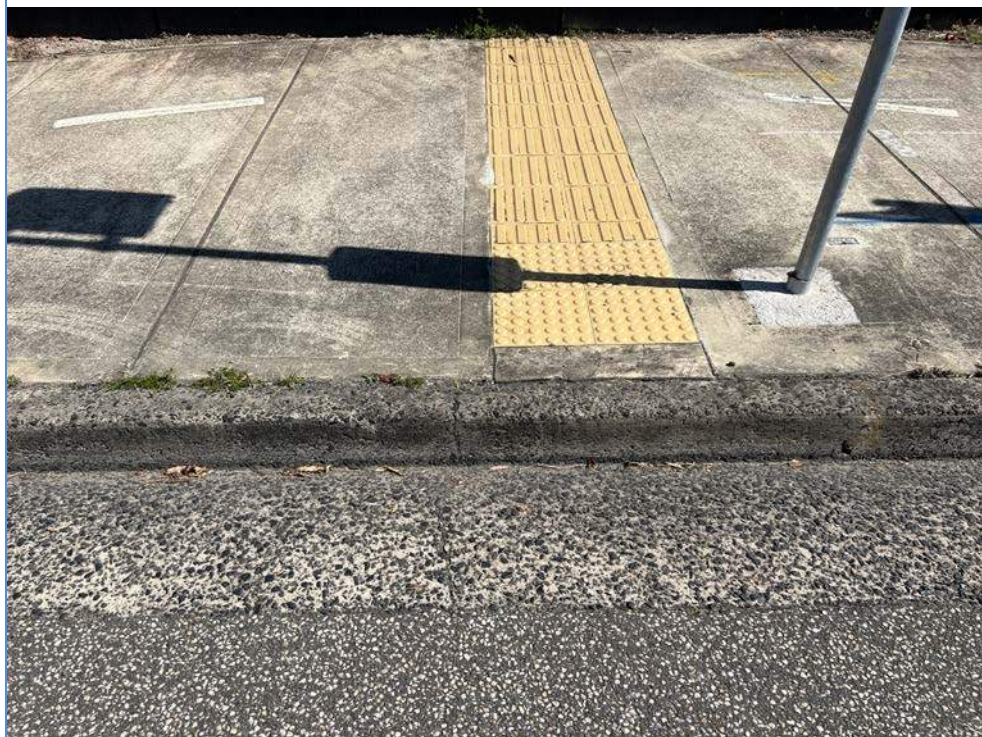
10m

Crack damage to the kerb and gutter.

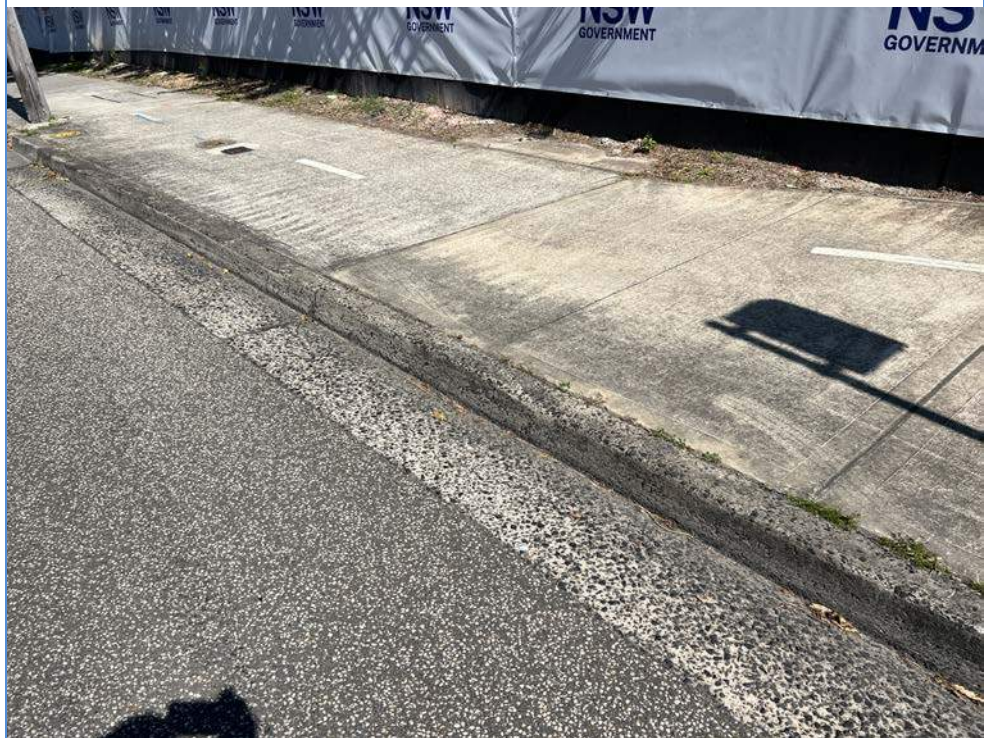
10m

Crack damage to the kerb and gutter.

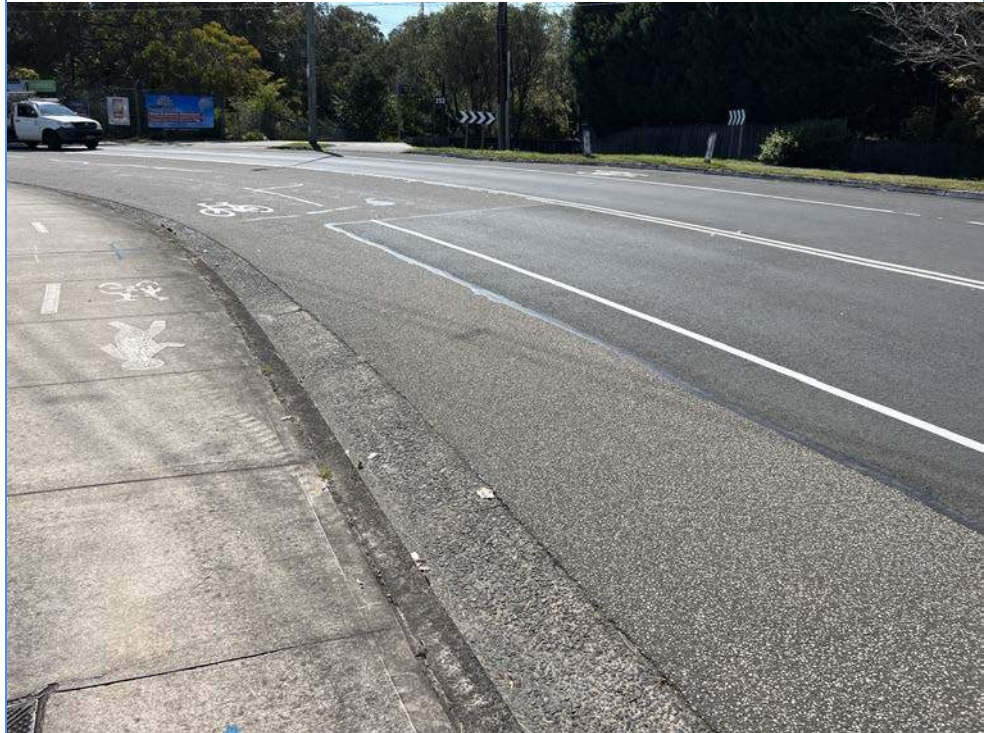
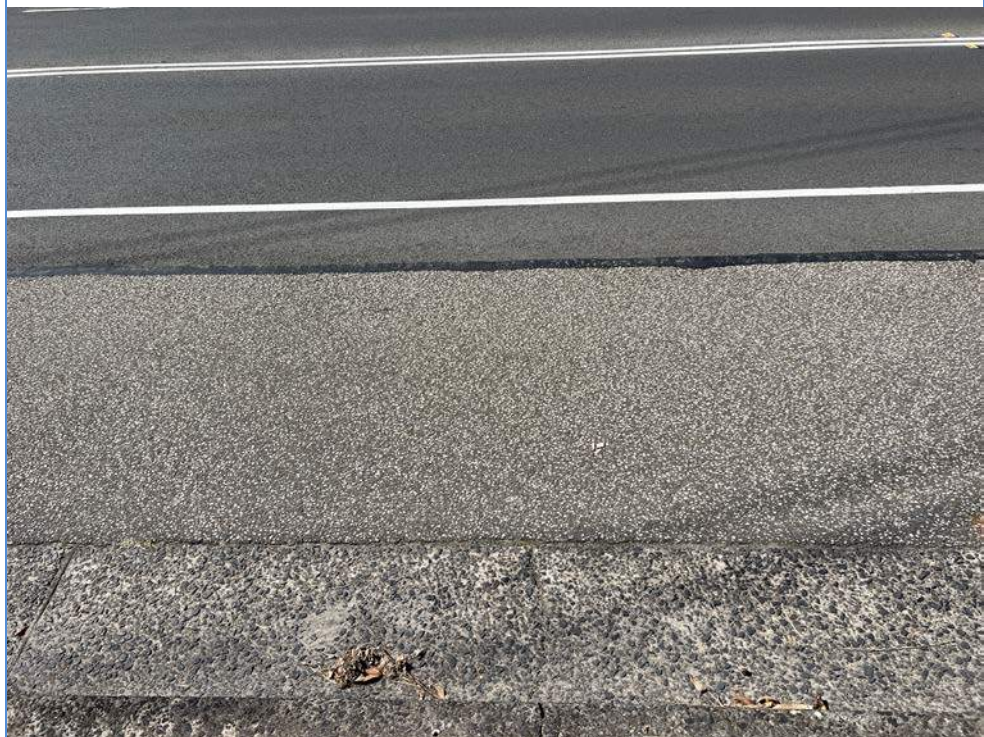
20m

General views of the road surface, kerb and gutter.

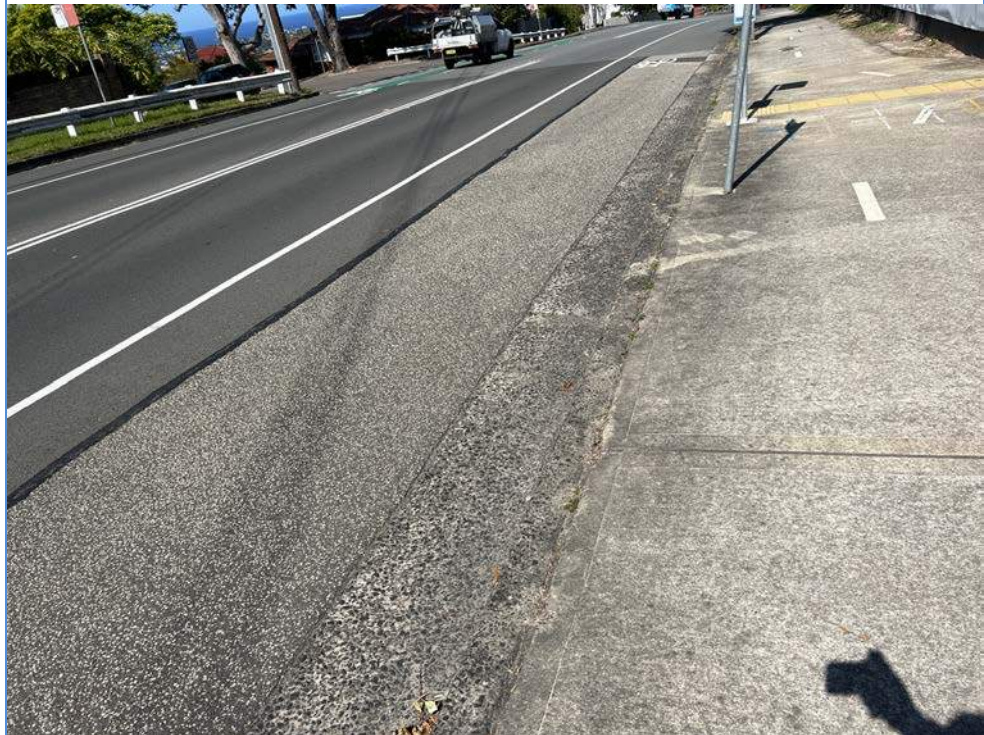
20m

General views of the road surface, kerb and gutter.

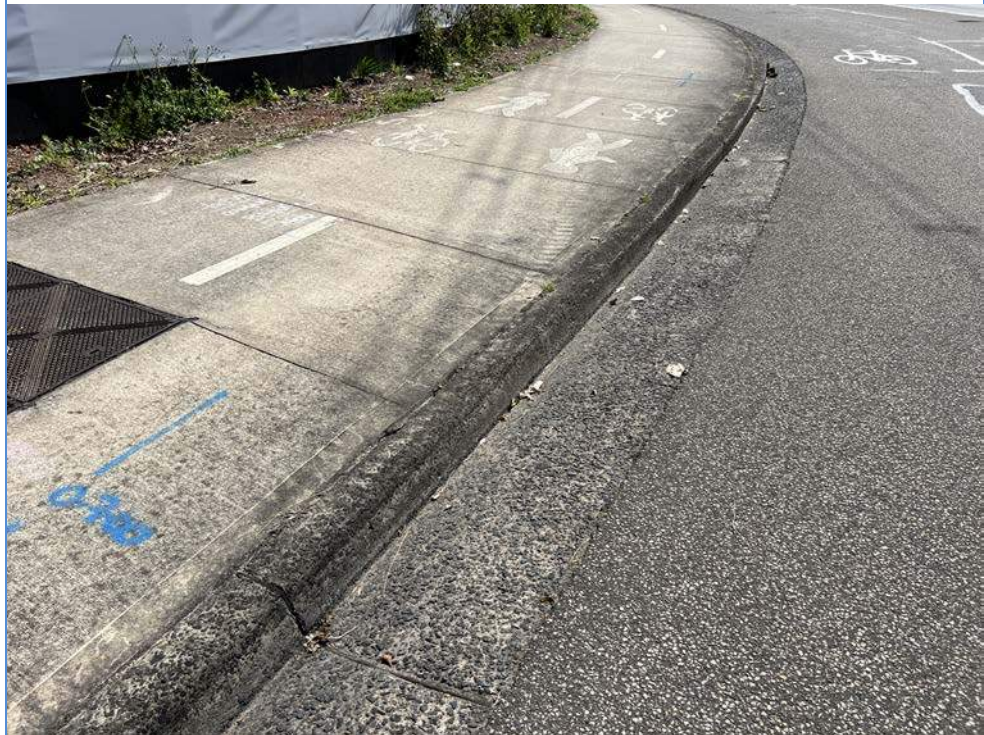
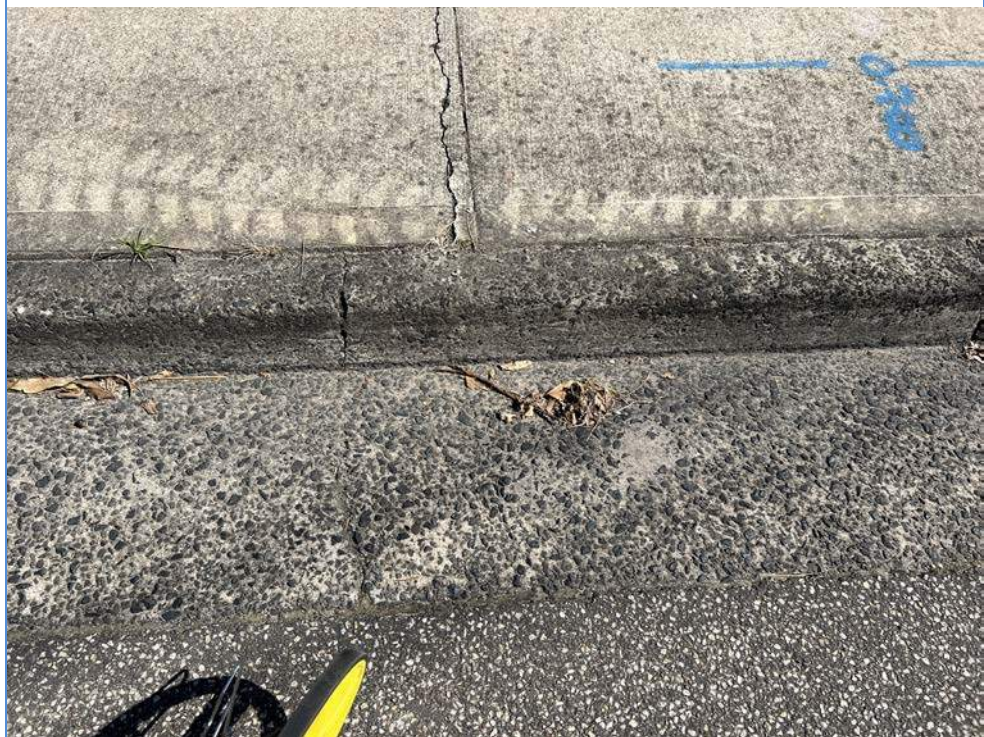
20m

Various cracks to the kerb and gutter.

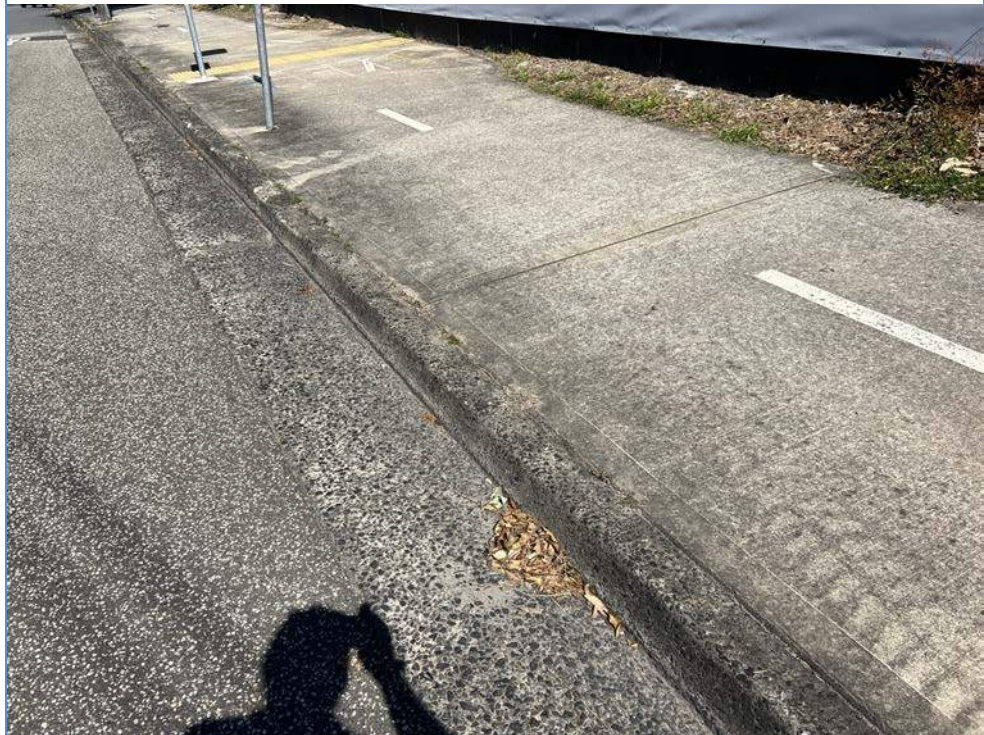
20m

Various cracks to the kerb and gutter.

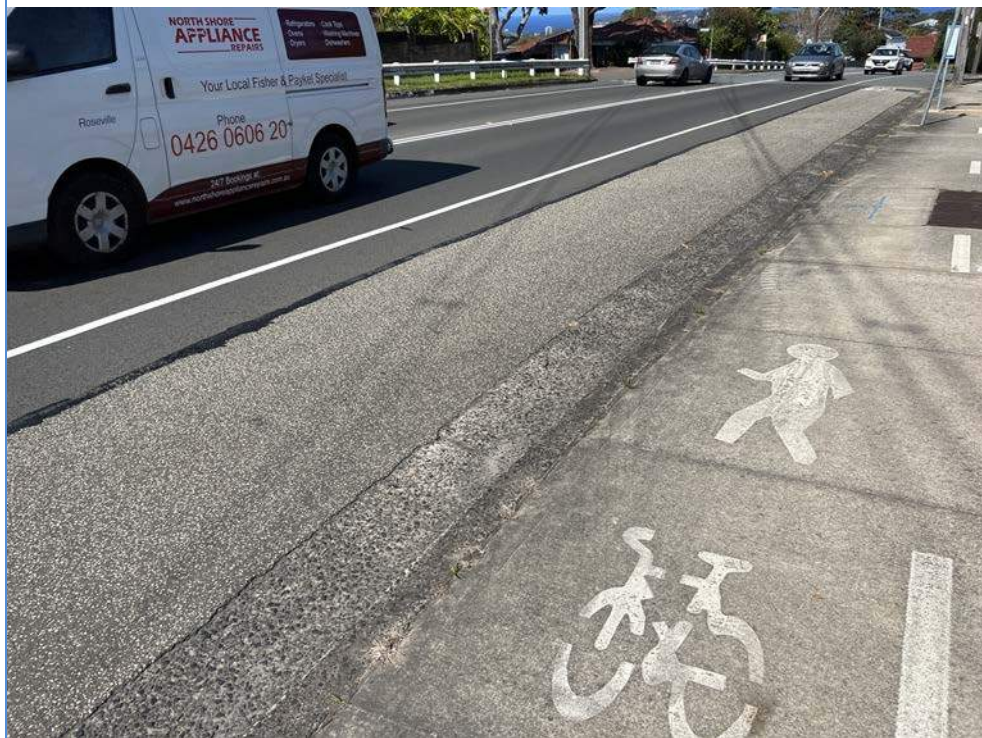
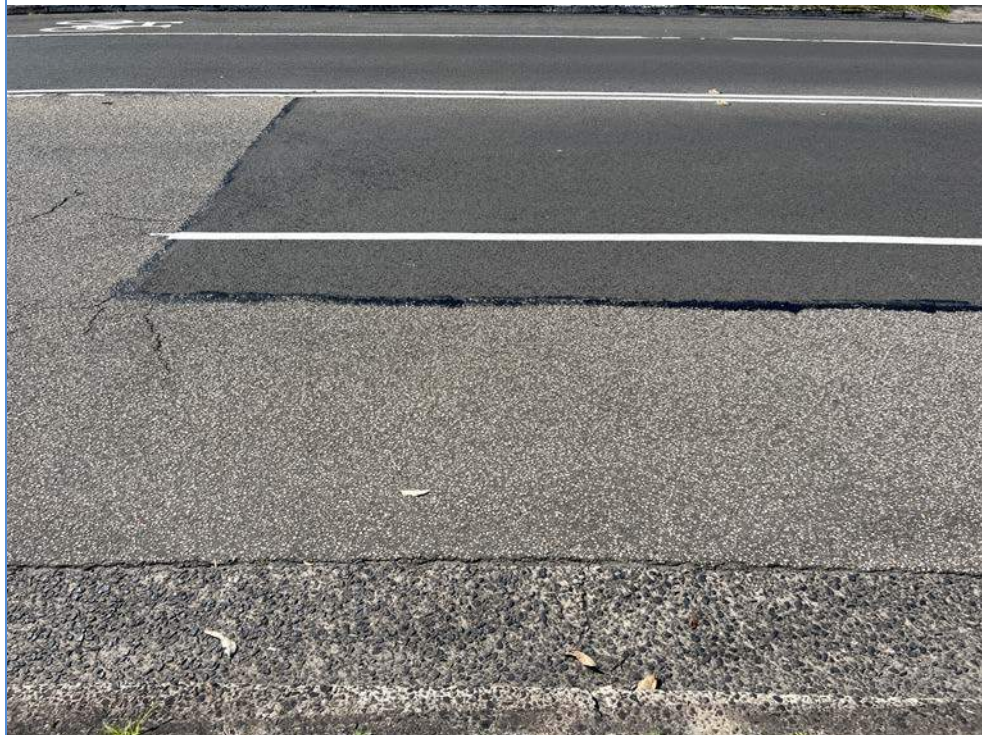
30m

General views of the road surface, kerb and gutter.

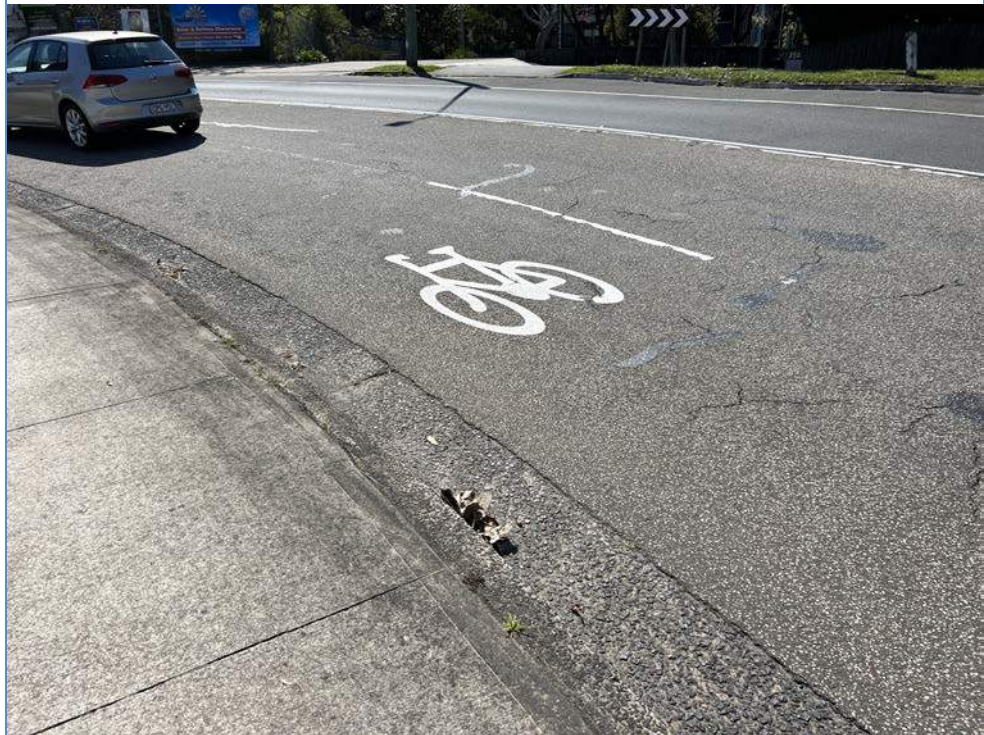
30m

General views of the road surface, kerb and gutter.

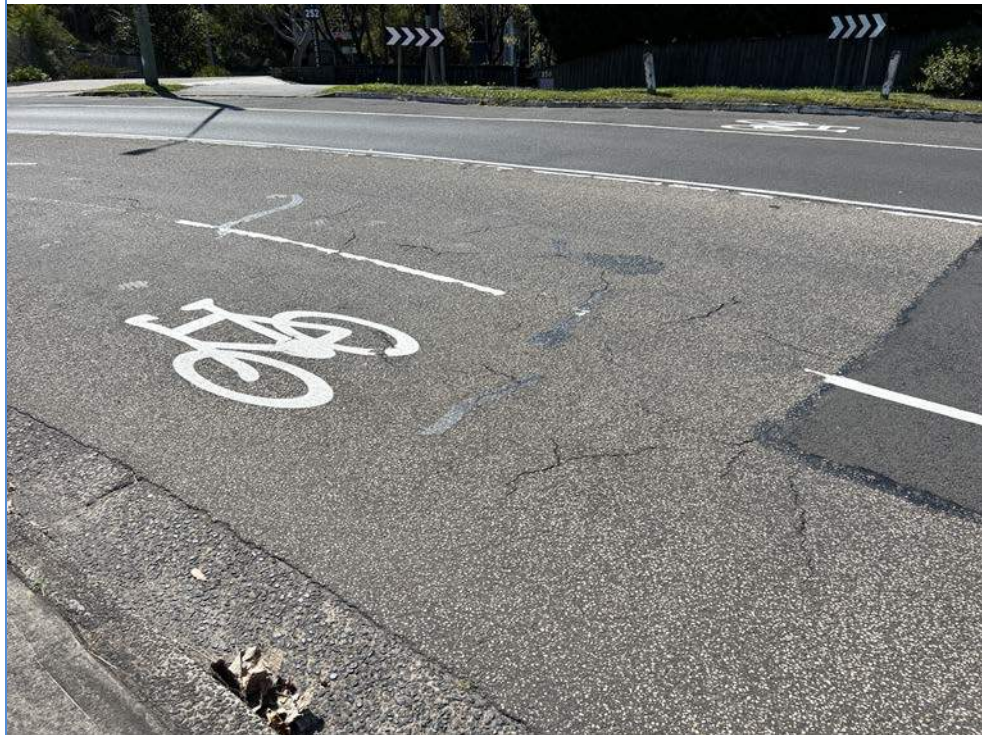
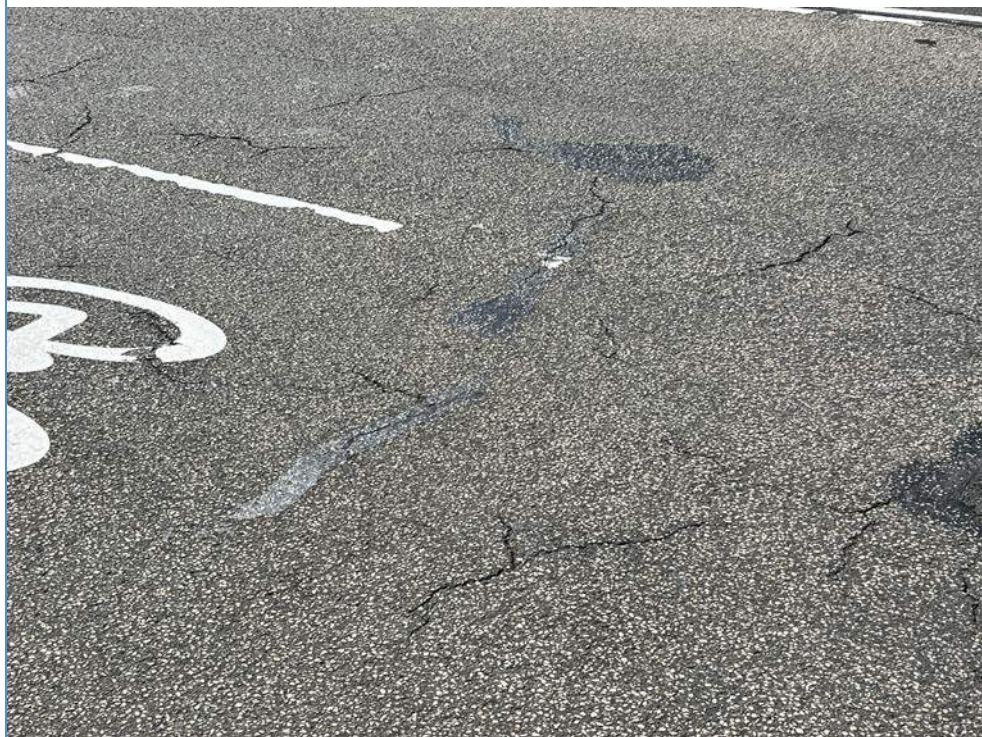
30m

Various cracks to the road surface.

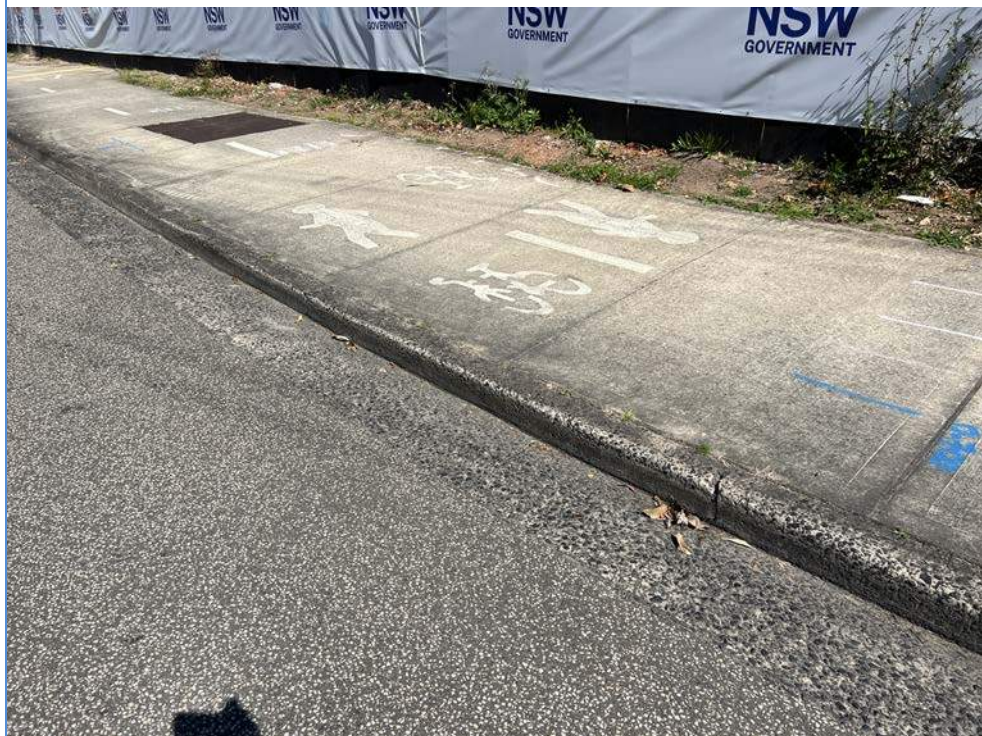
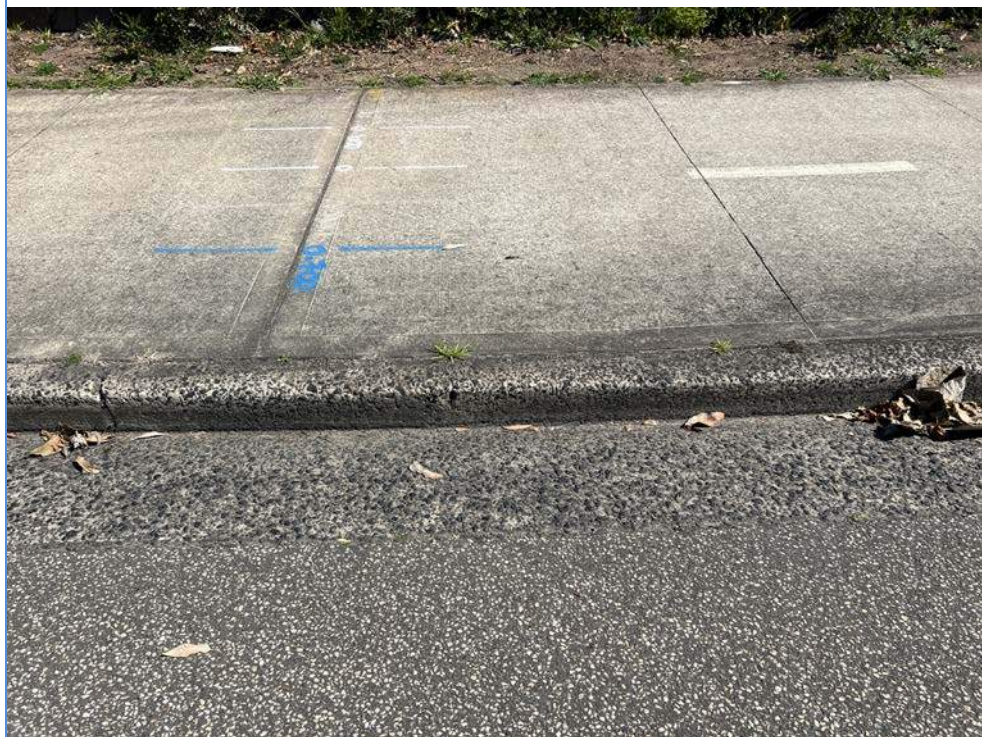
30m

Various cracks to the kerb and gutter.

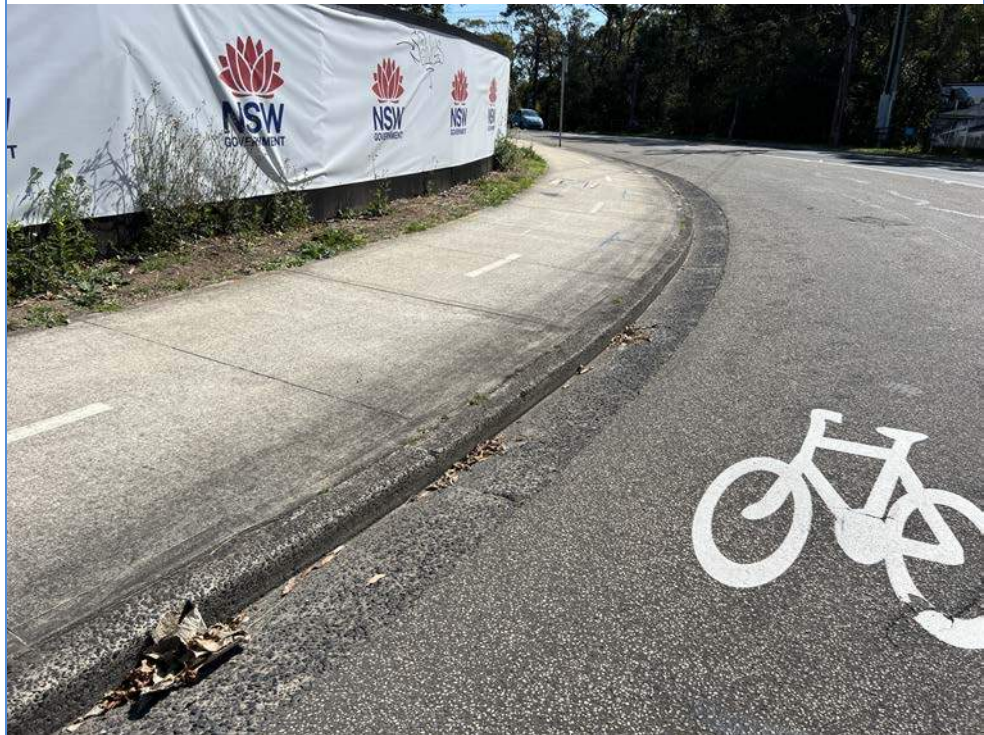
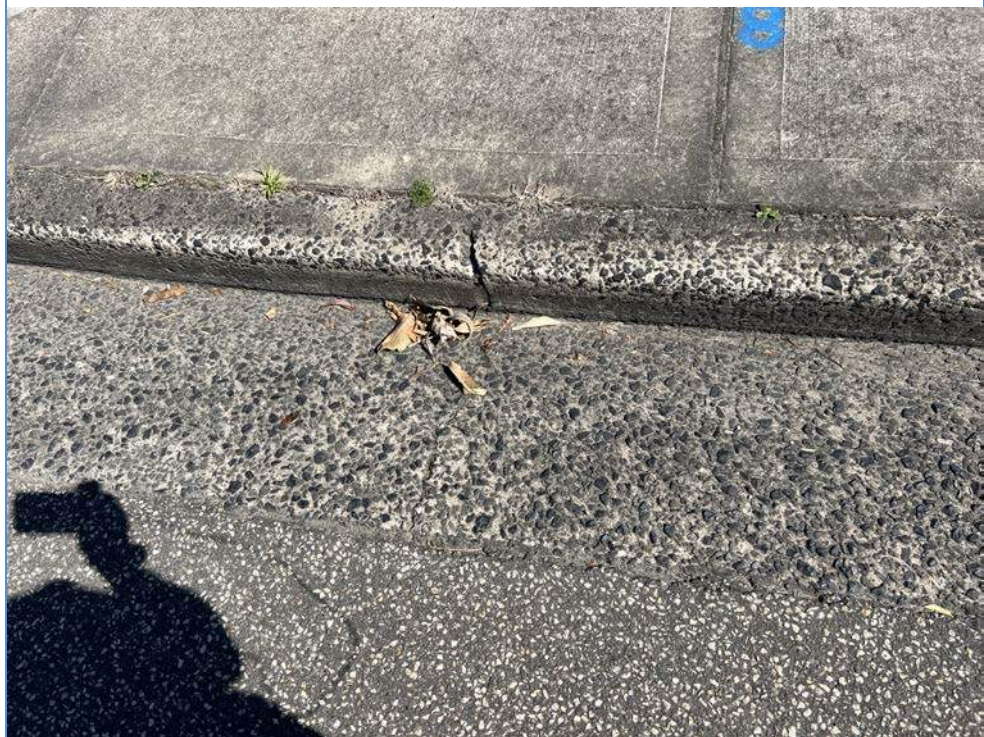
30m

Various cracks to the kerb and gutter.

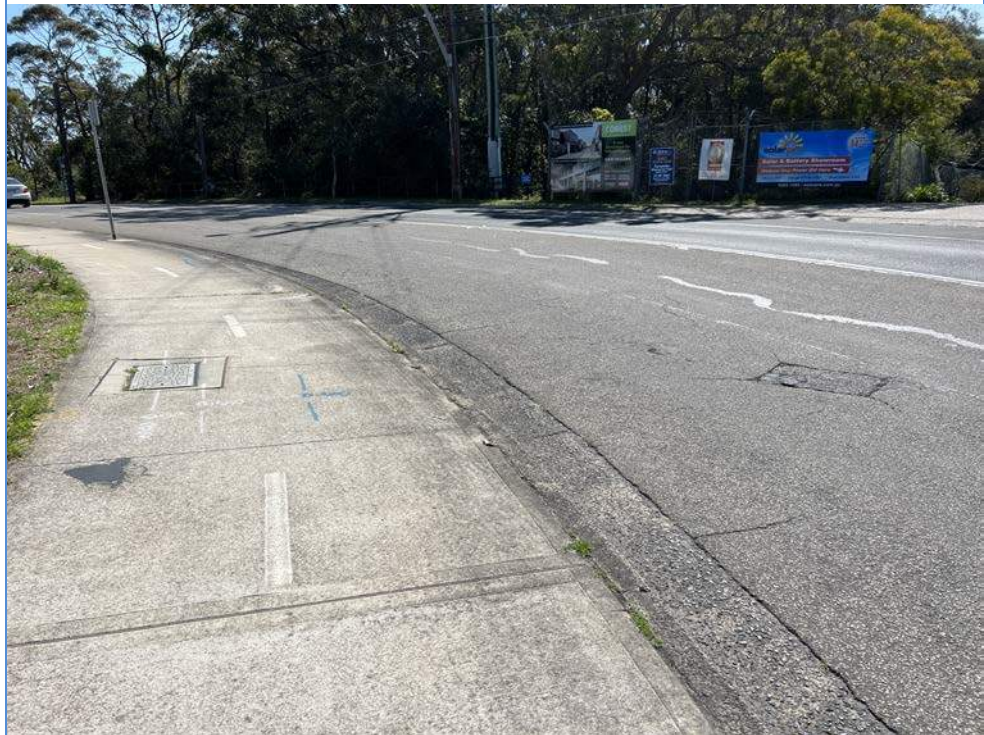
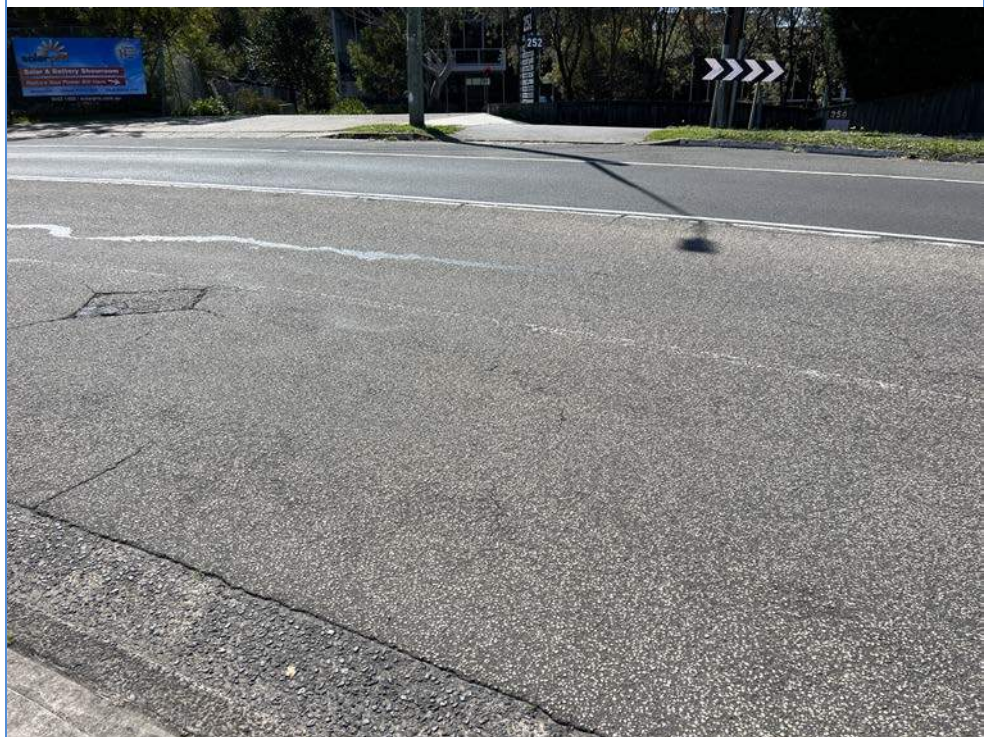
40m

General views of the road surface, kerb and gutter.
