The following inspection is of the road surface, kerb and gutter to the western side of Allambie Road starting at the intersection of Arnhem Road and heading towards the intersection of Aquatic Drive at the end point.

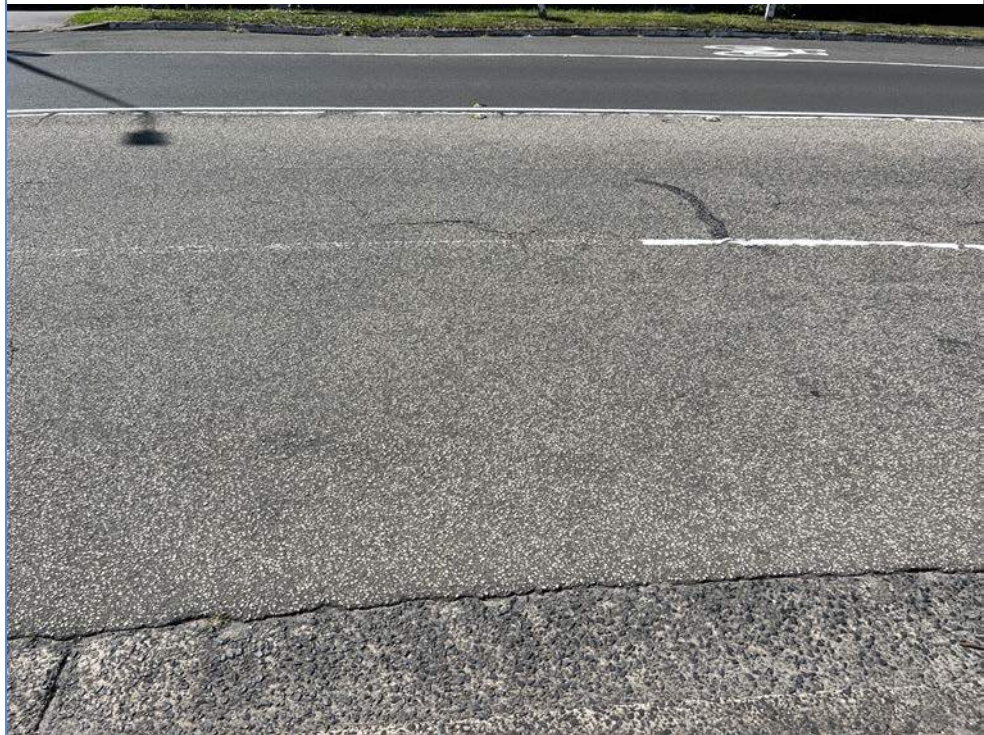
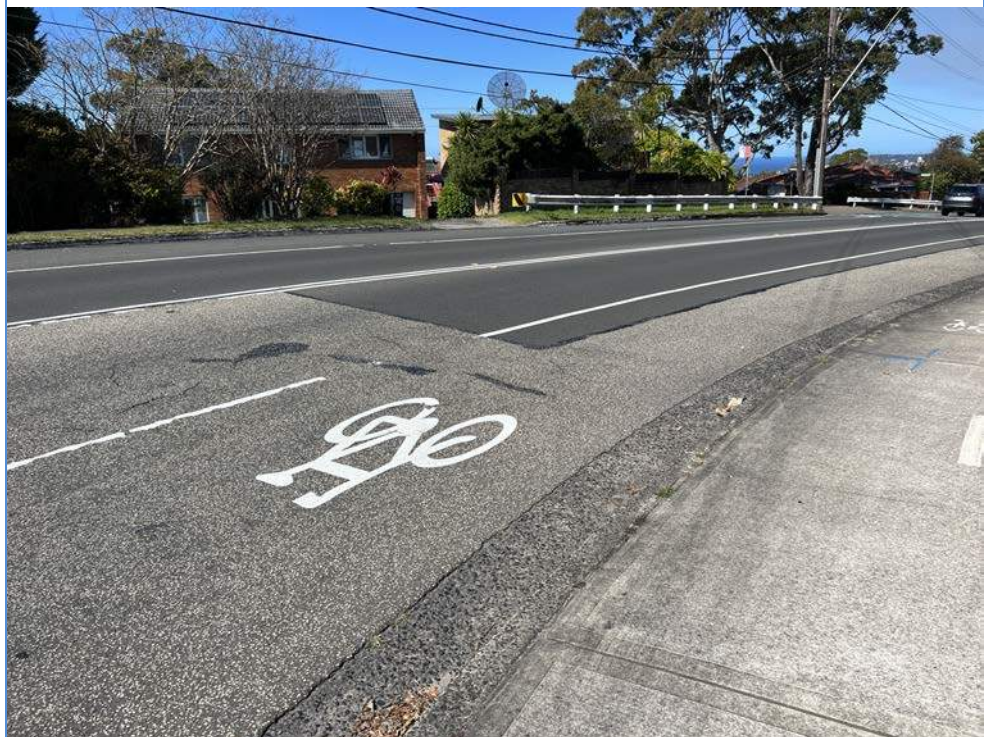
40m

General views of the road surface, kerb and gutter.

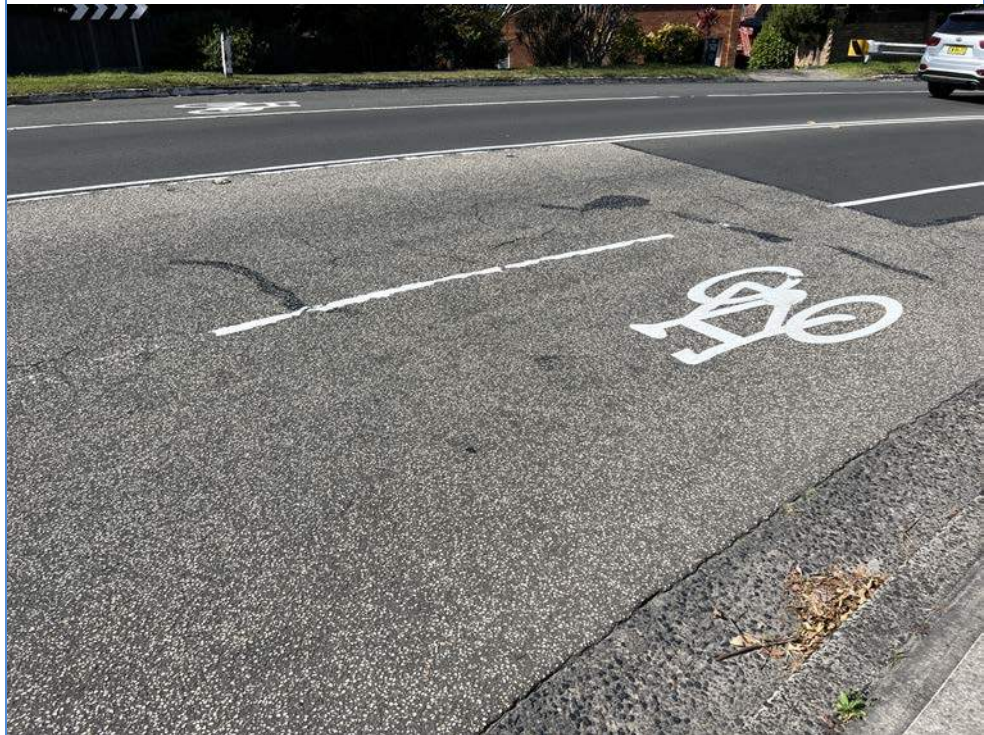
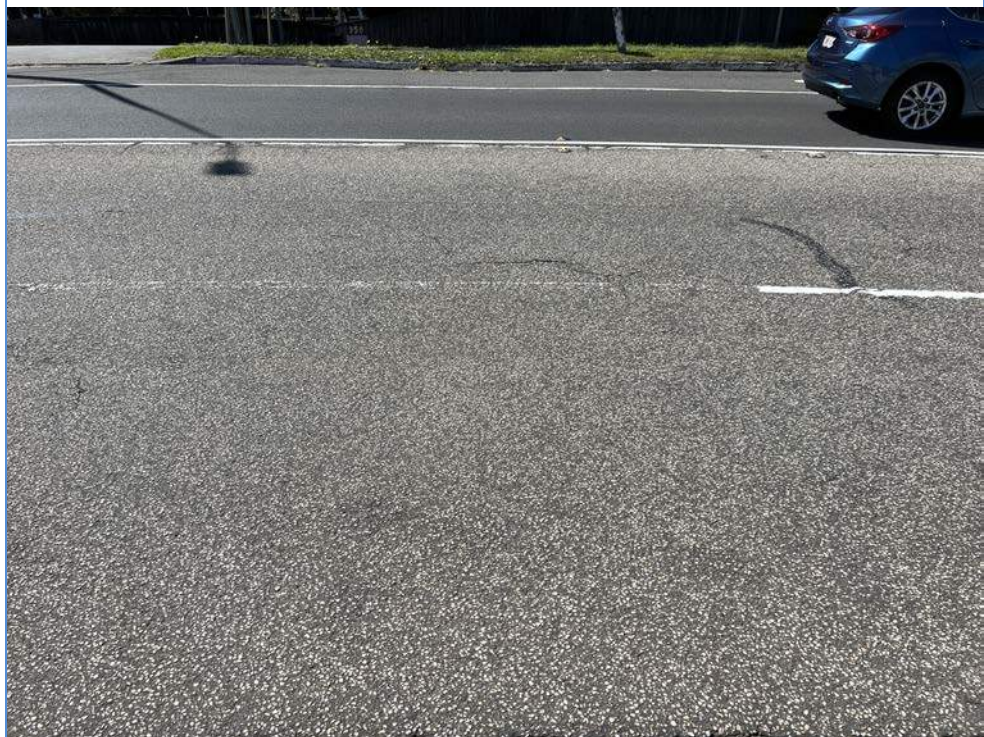
40m

Various cracks to the road surface.

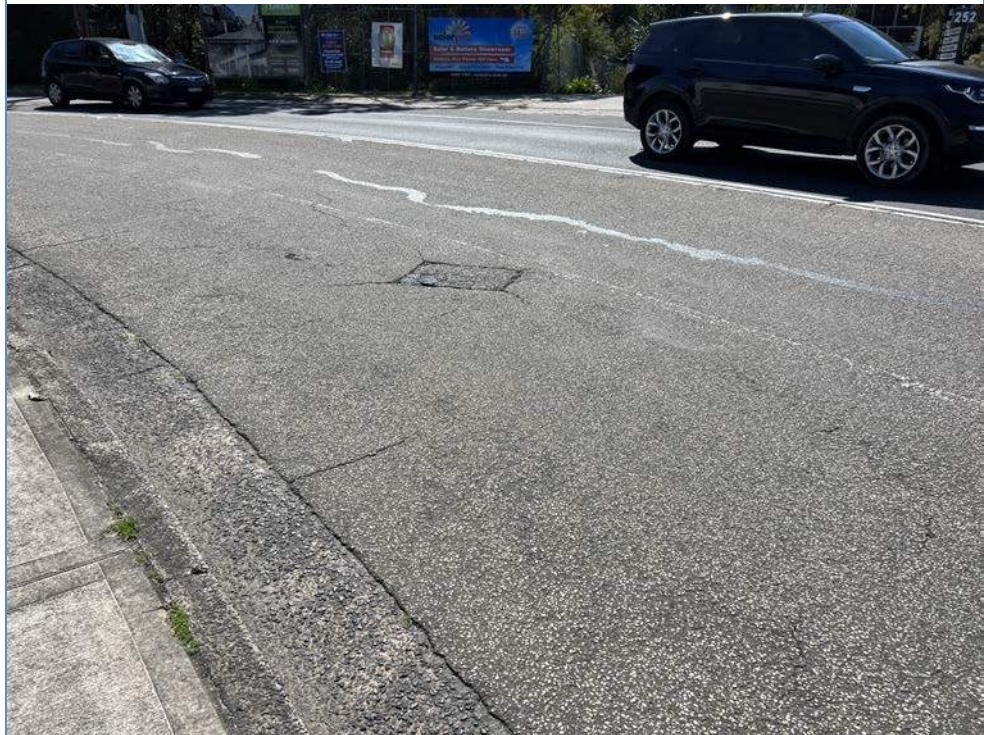
40m

Various cracks to the road surface.

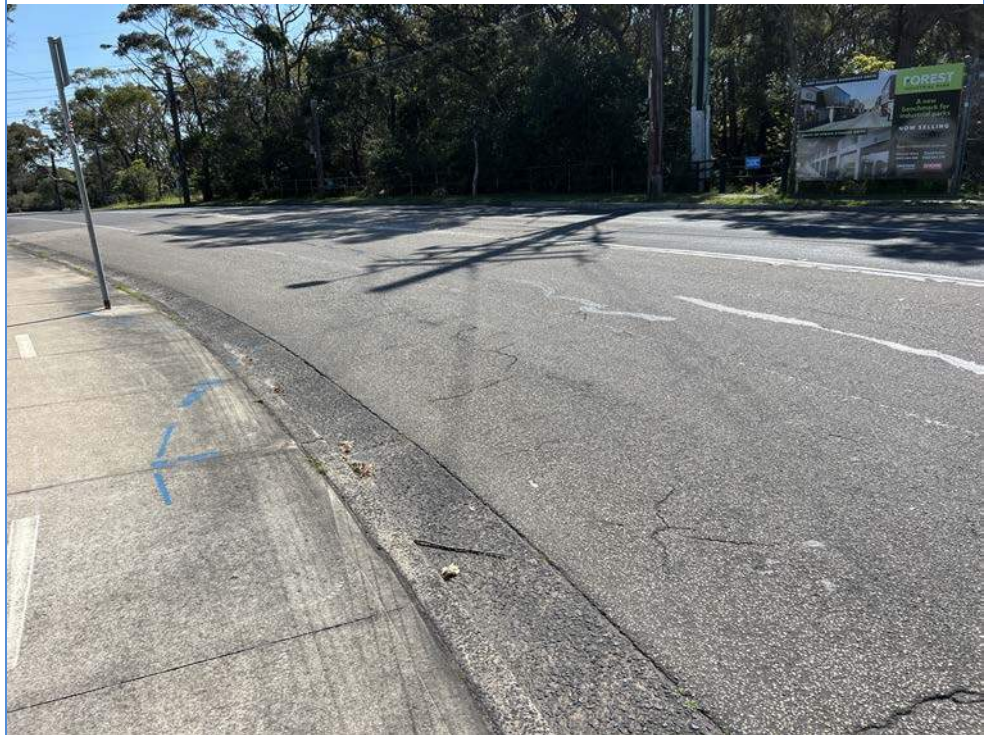
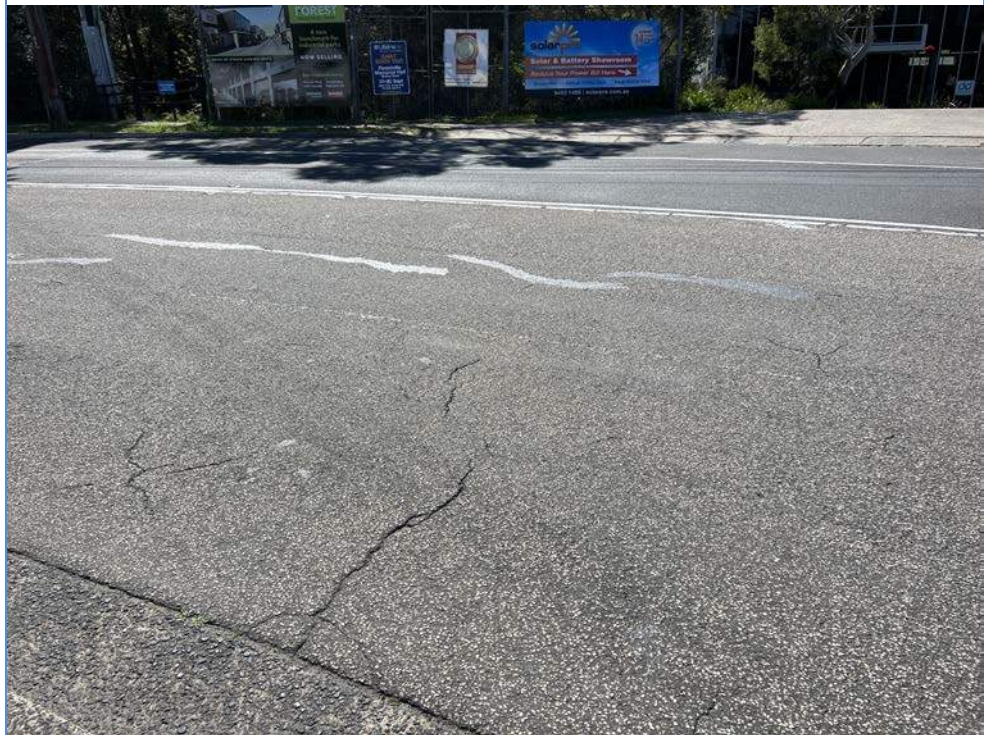
50m

General views of the road surface, kerb and gutter.

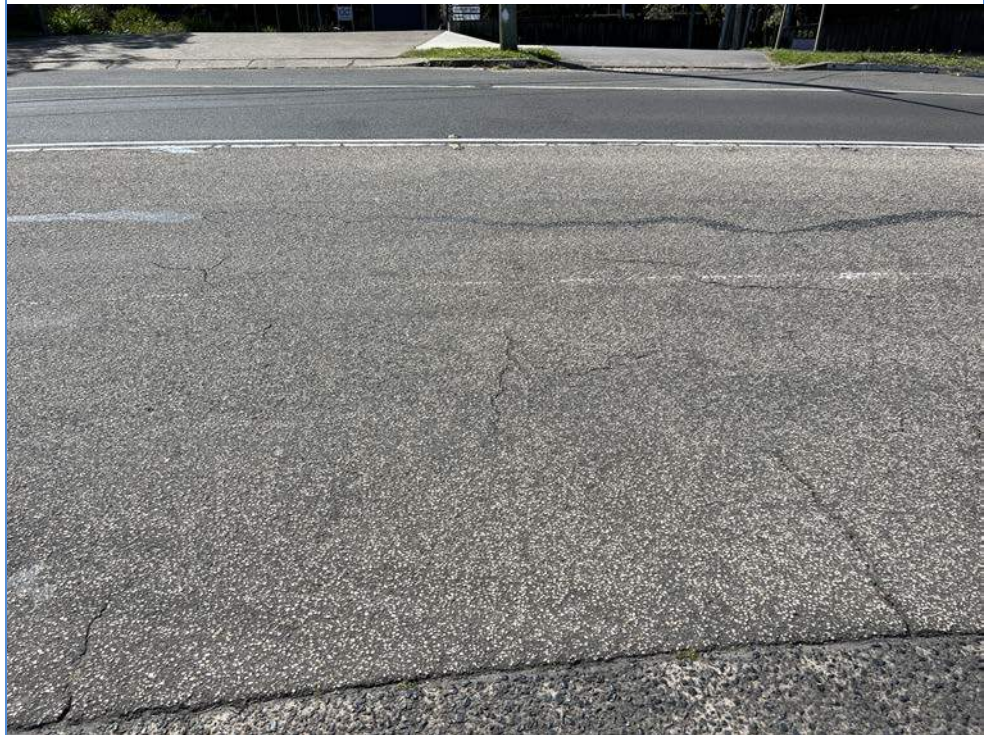
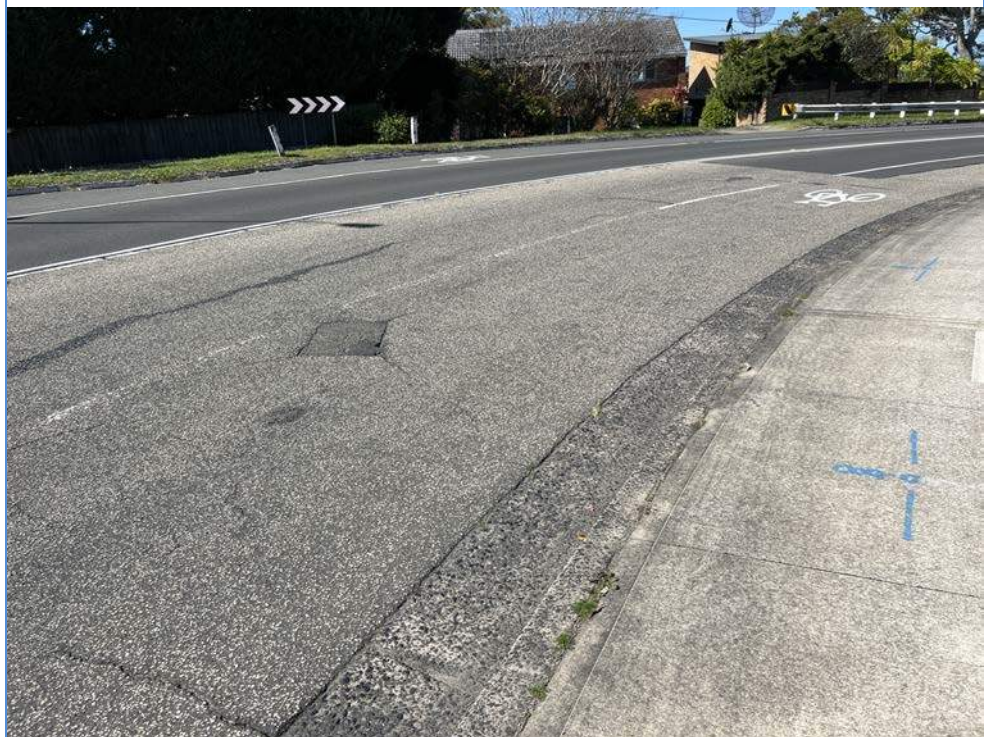
50m

General views of the road surface, kerb and gutter.

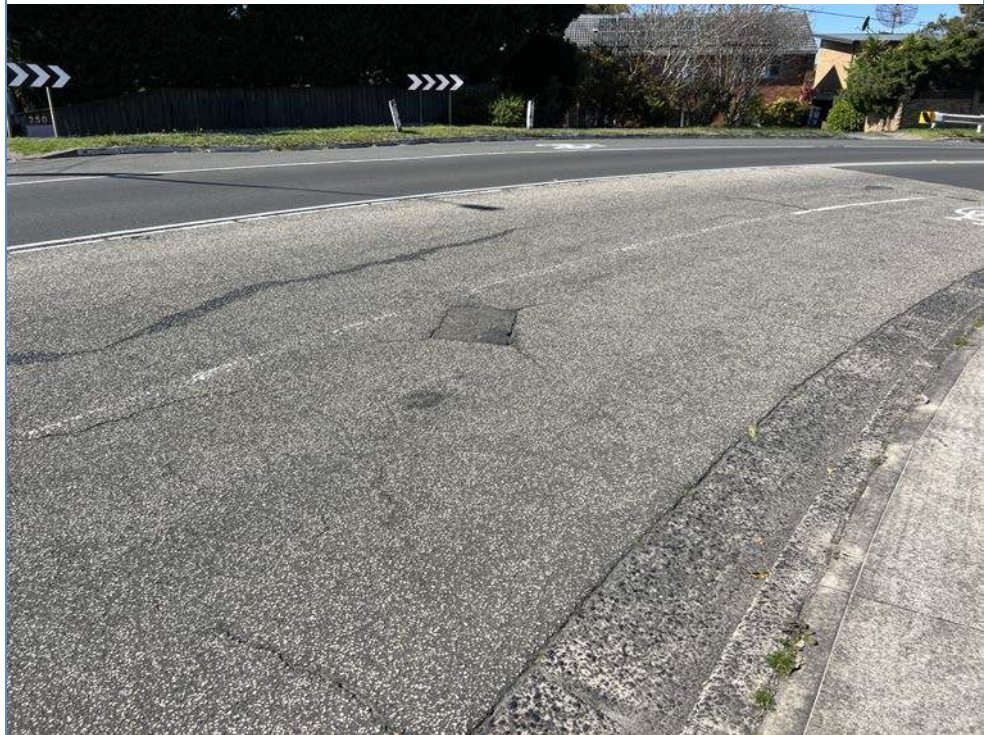
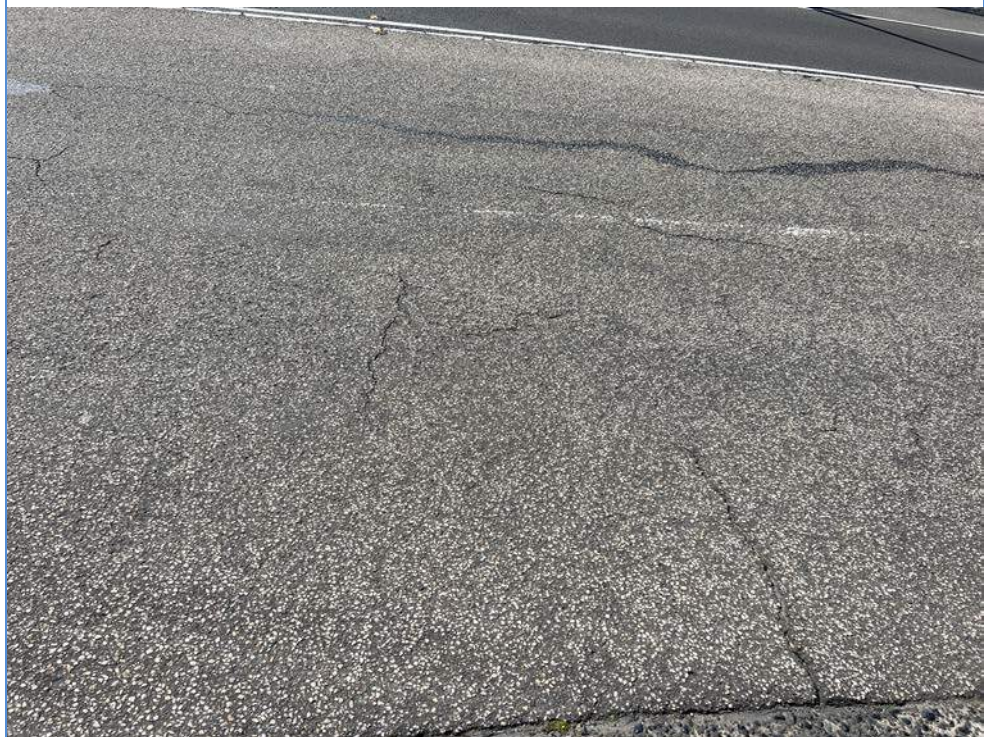
50m

Various cracks throughout the road surface.

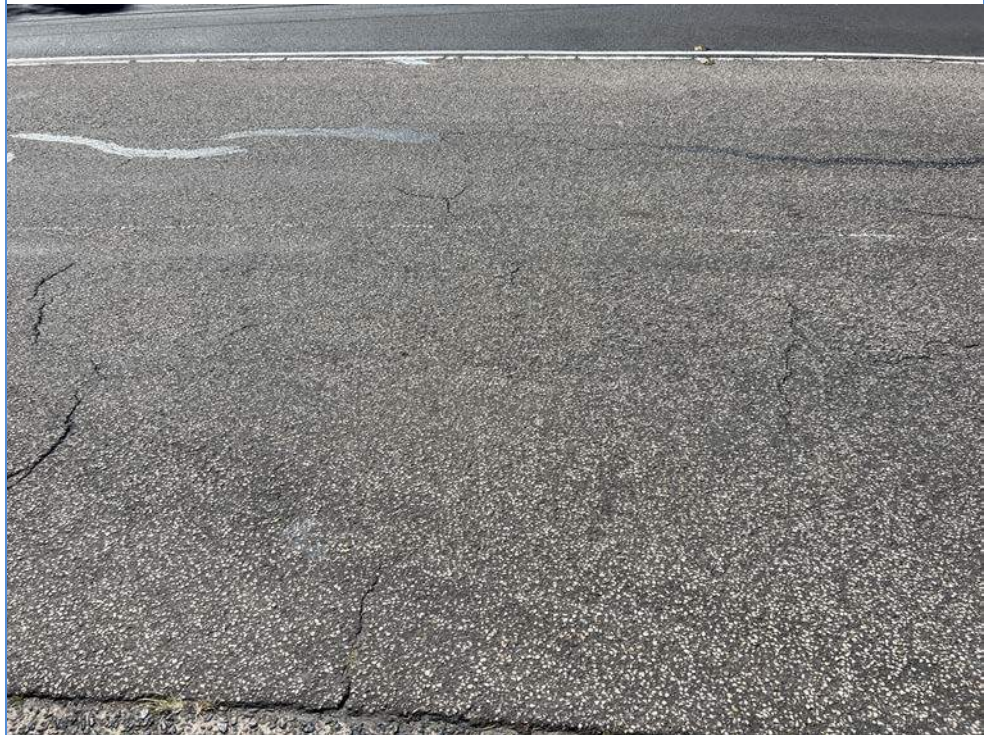
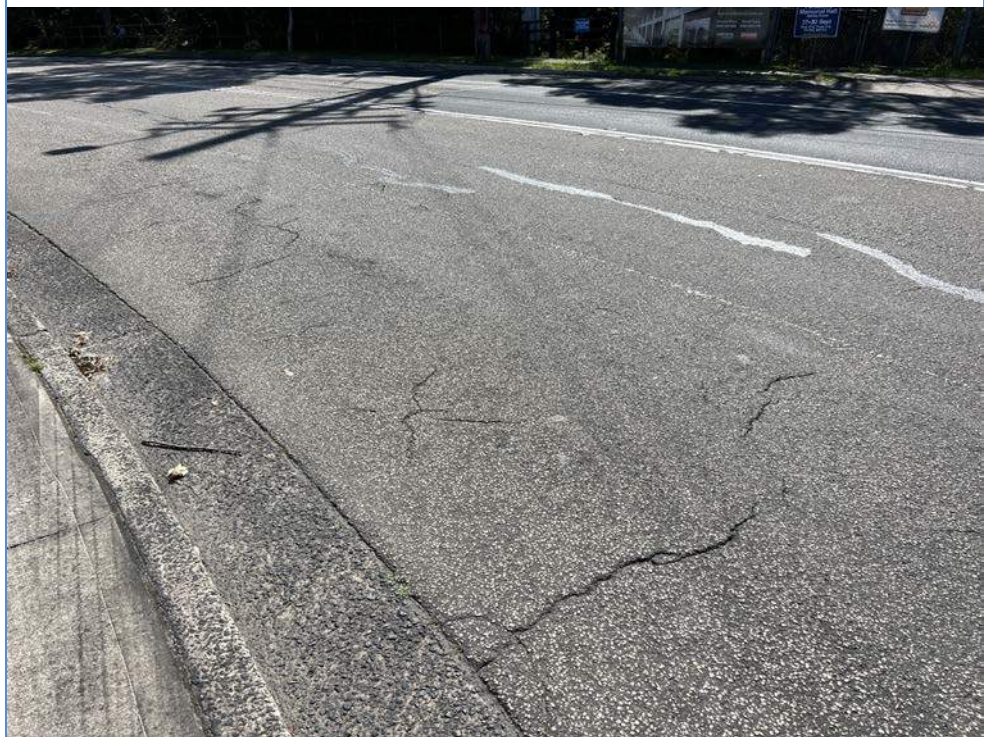
50m

Various cracks throughout the road surface.

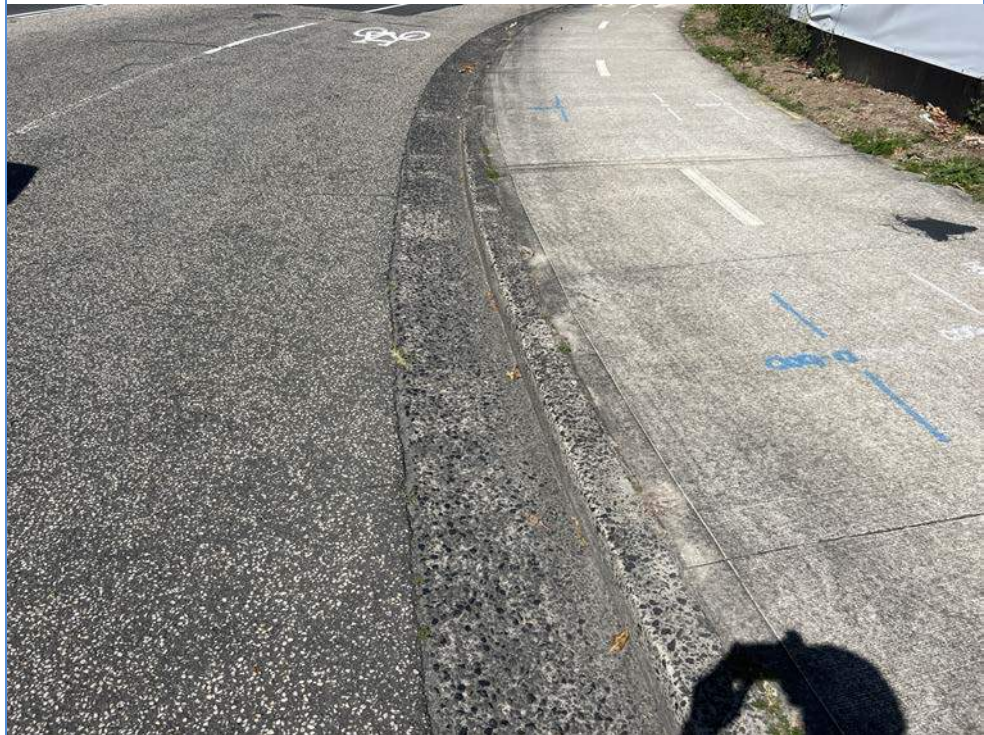
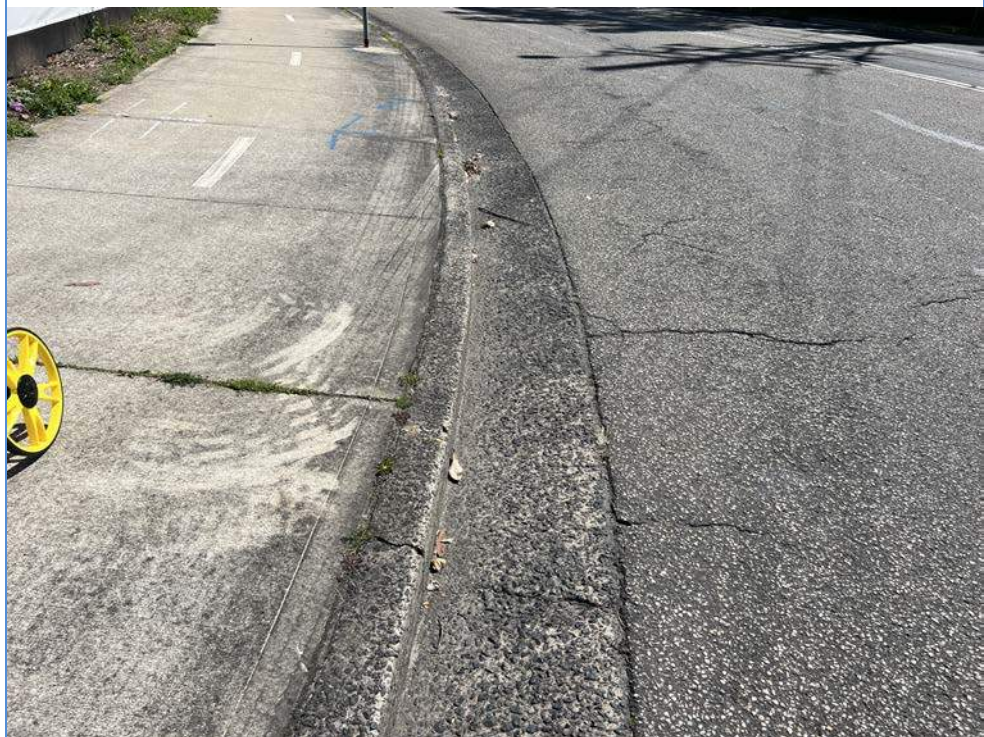
50m

Various cracks to the kerb and gutter.

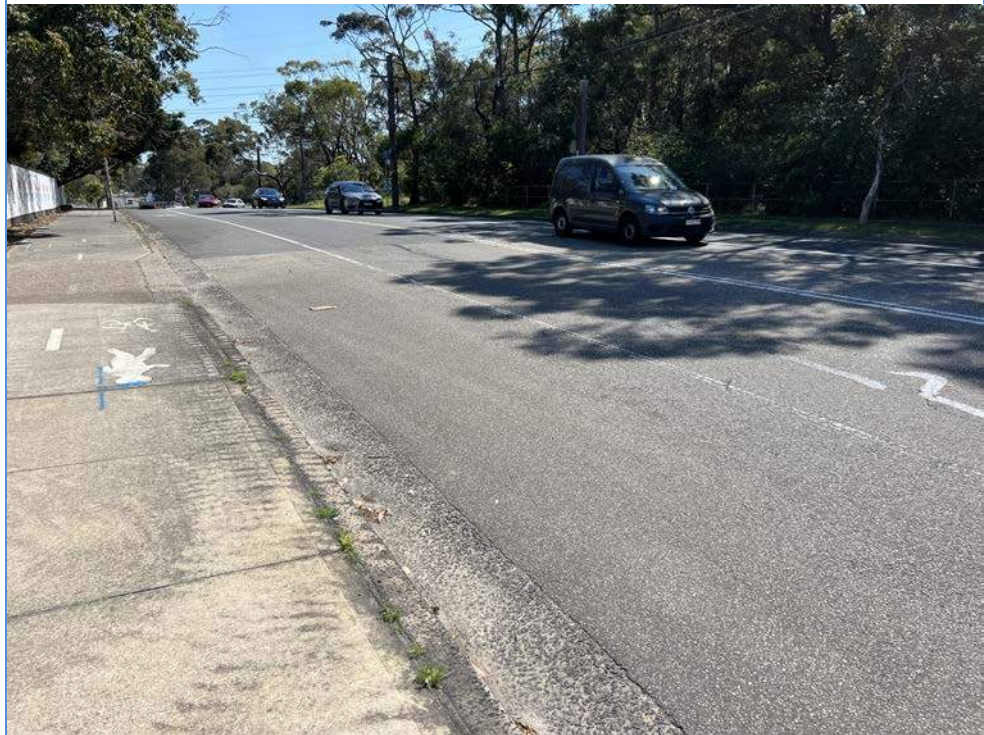
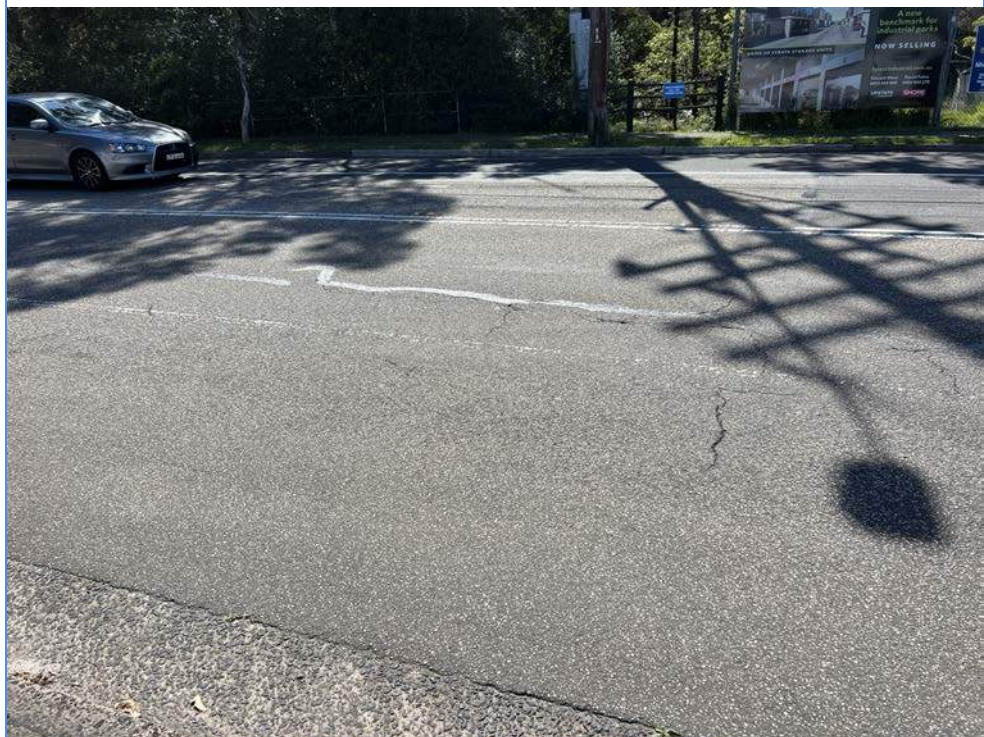
60m

General views of the road surface, kerb and gutter.

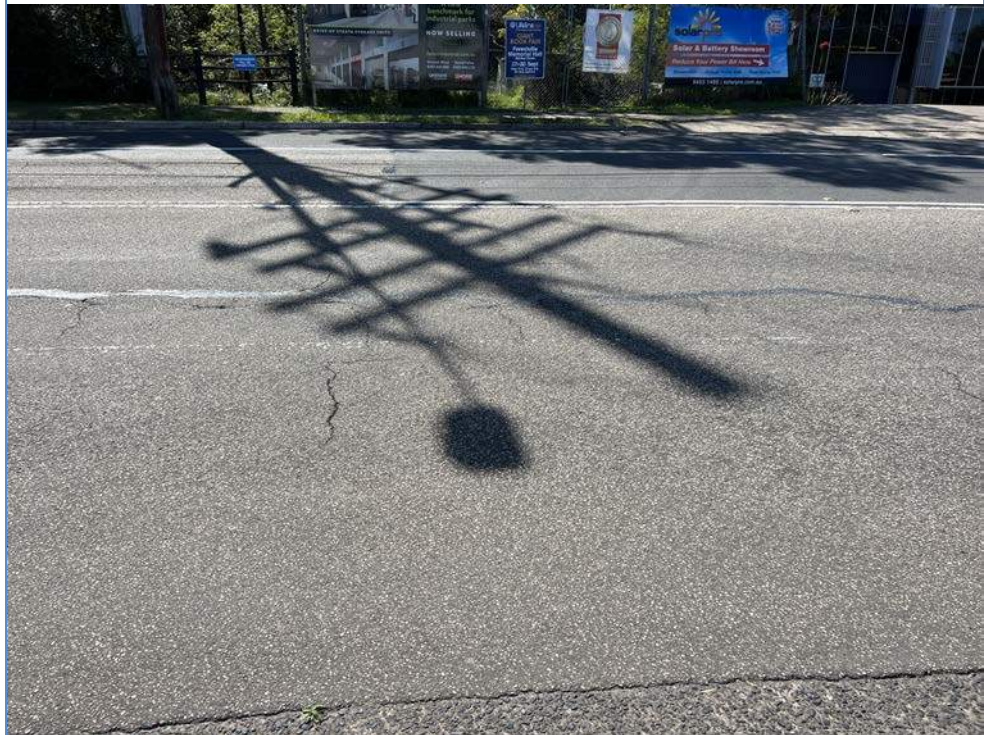
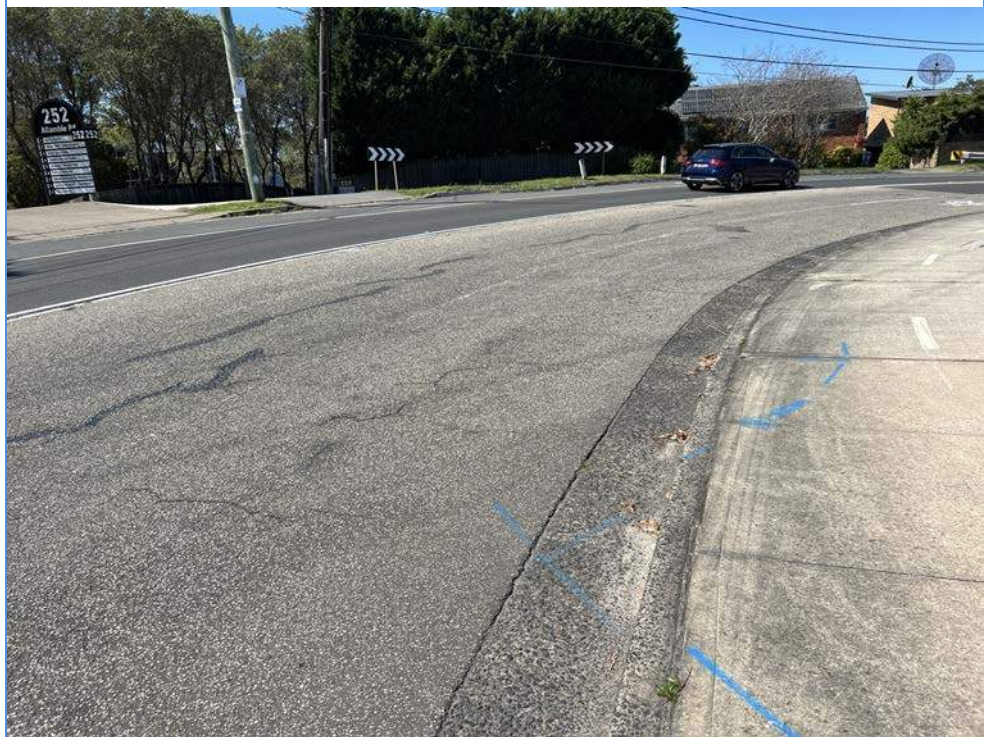
60m

General views of the road surface, kerb and gutter.

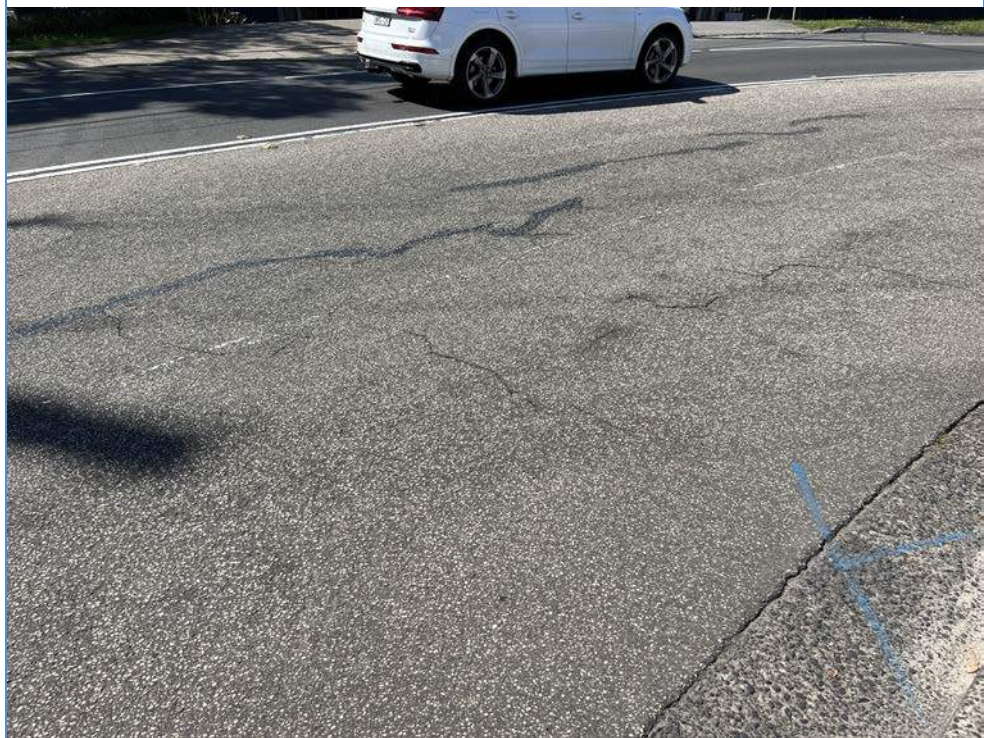
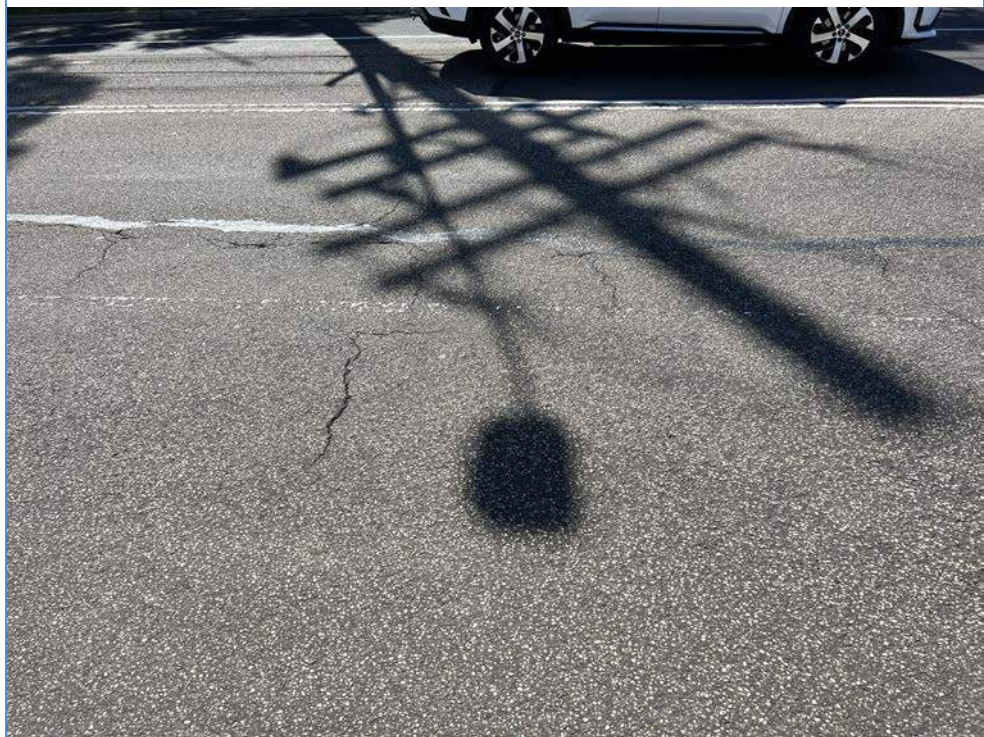
60m

Various cracks to the road surface.

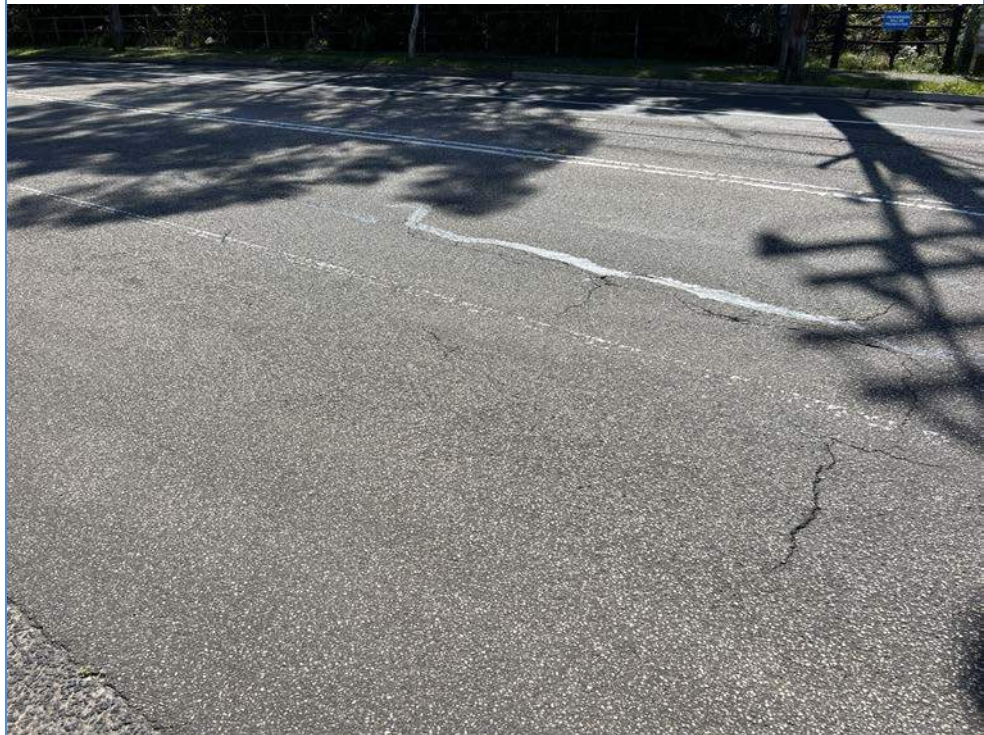
60m

Various cracks to the road surface.

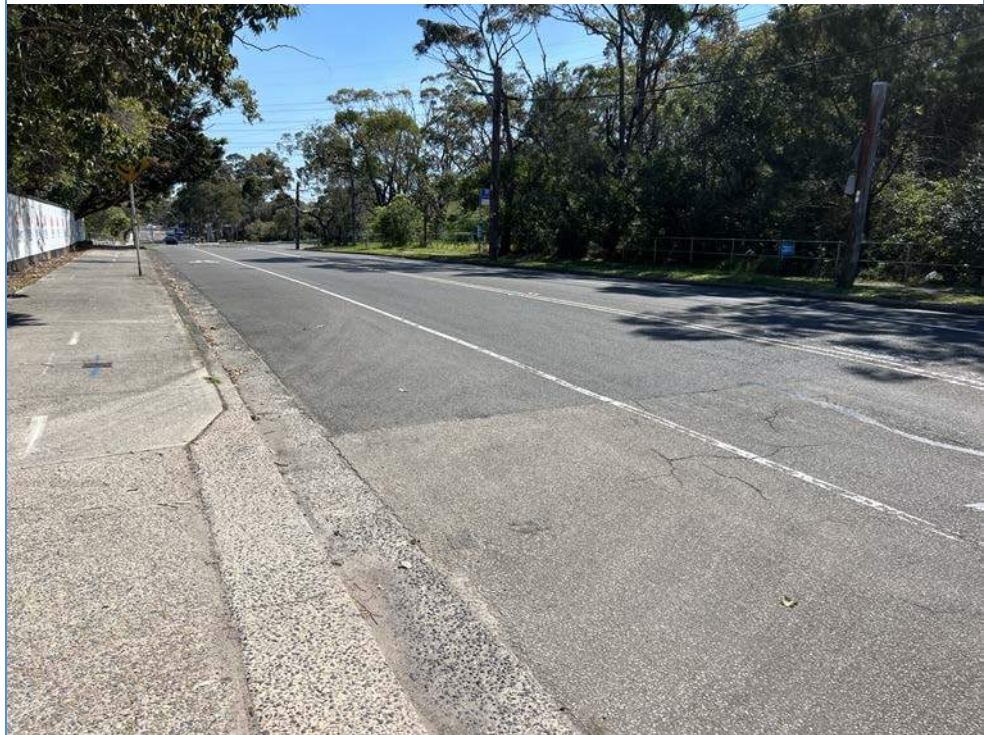
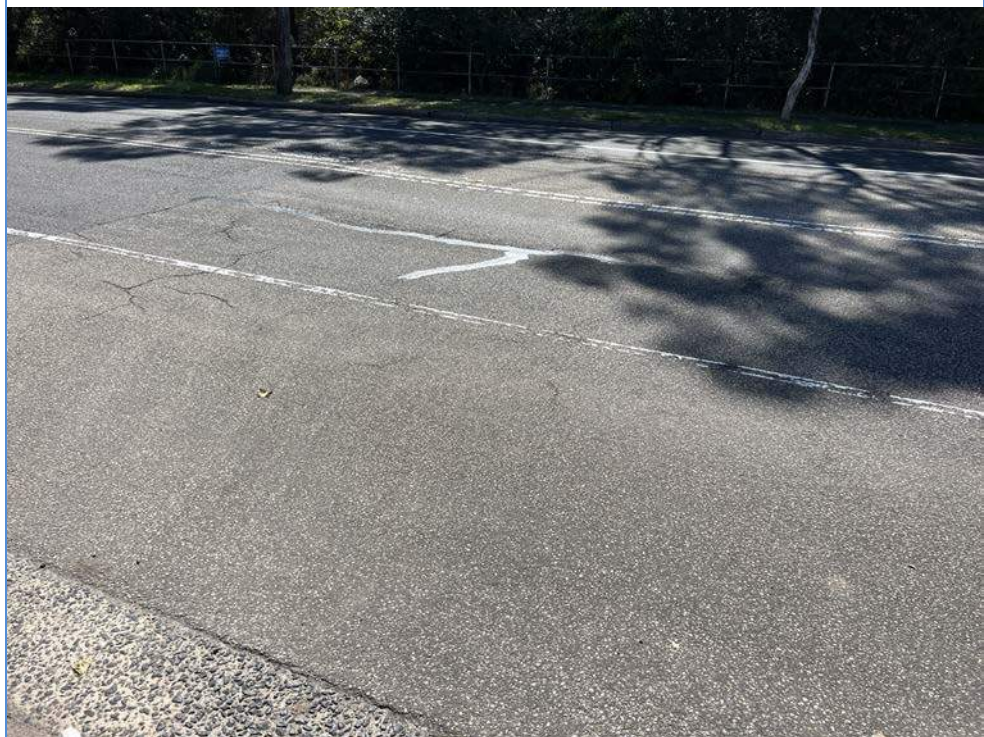
70m

General views of the road surface, kerb and gutter.

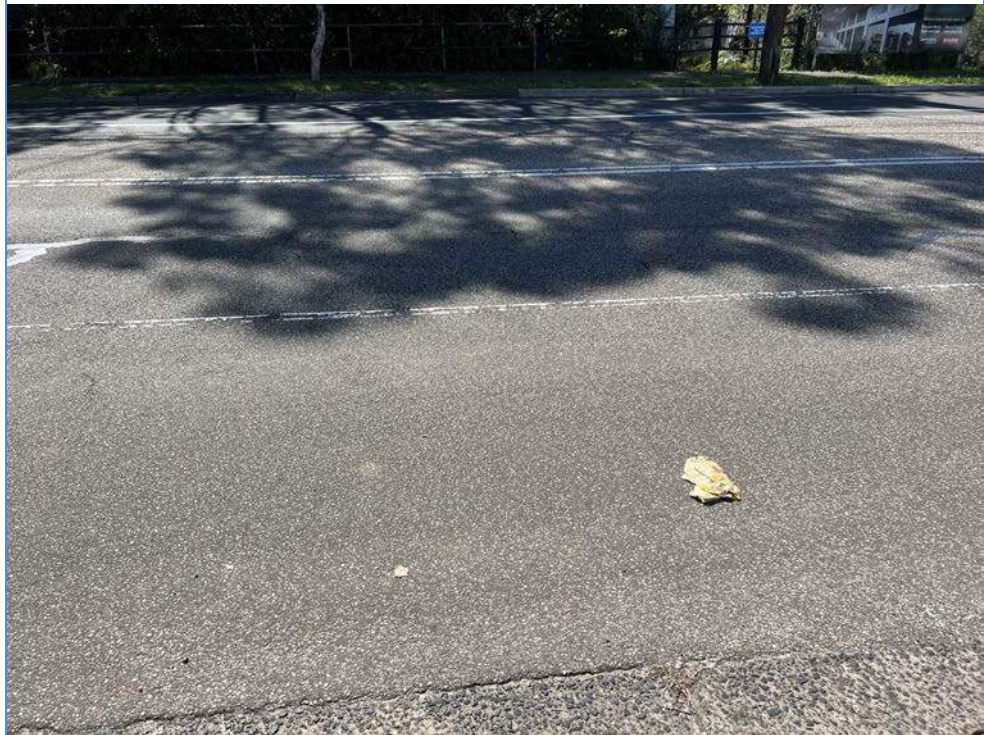
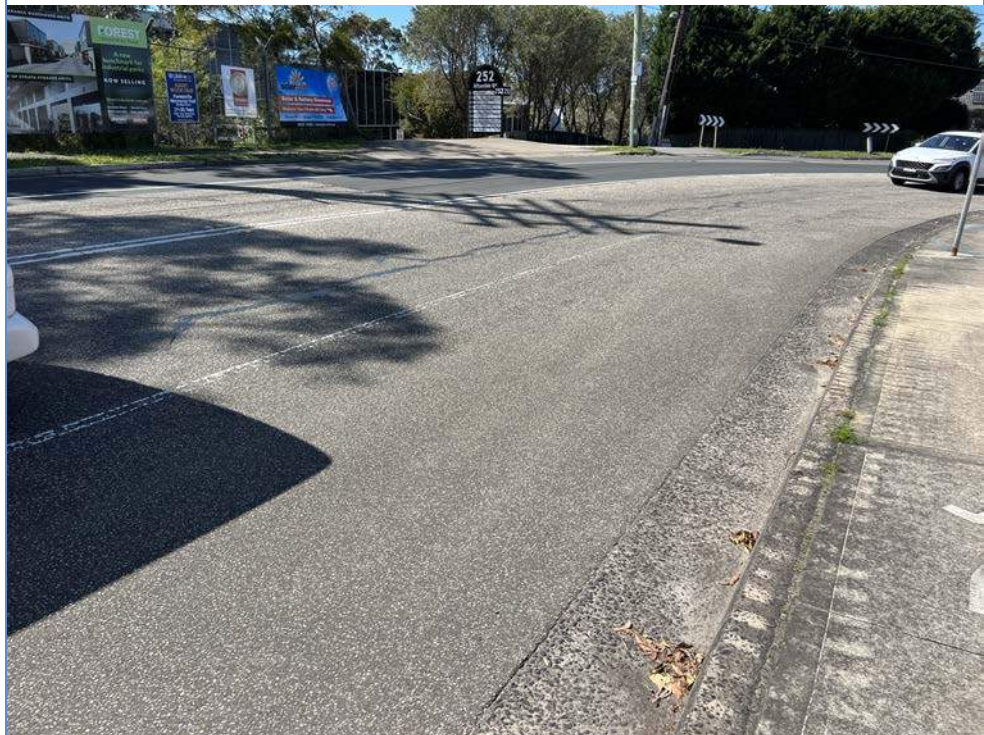
70m

General views of the road surface, kerb and gutter.

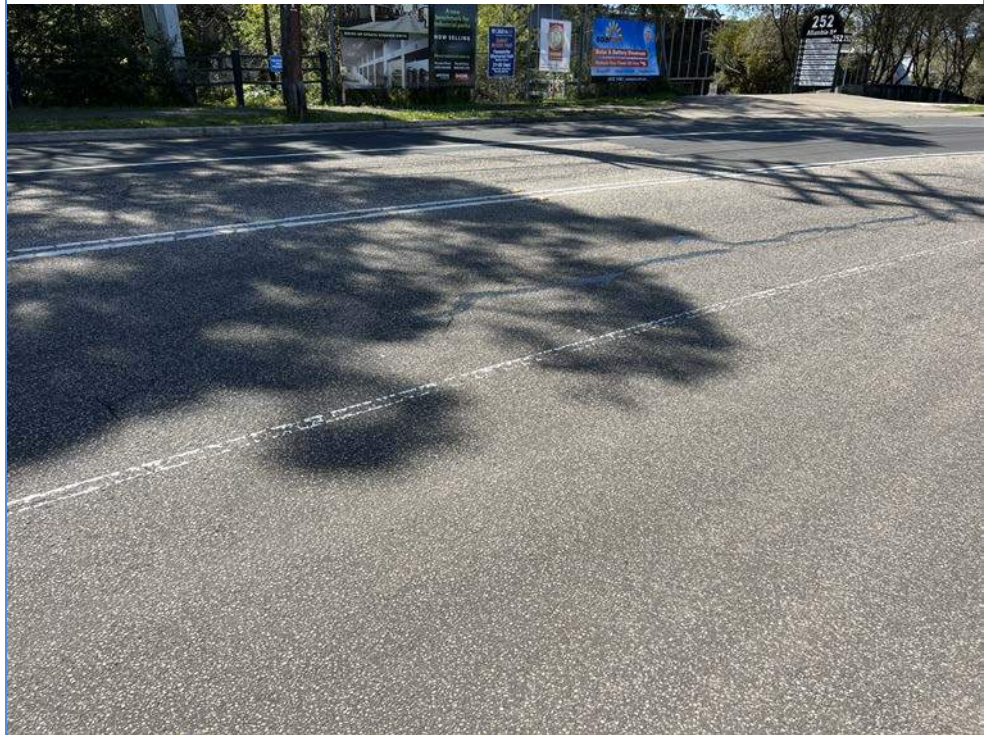
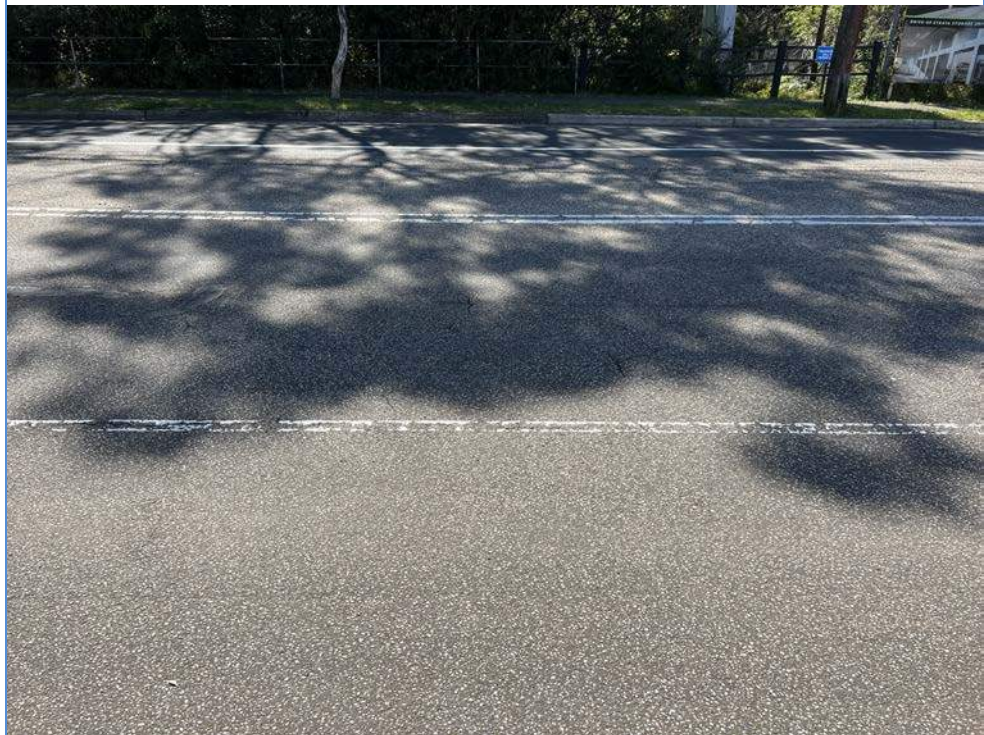
70m

Various cracks to the road surface.

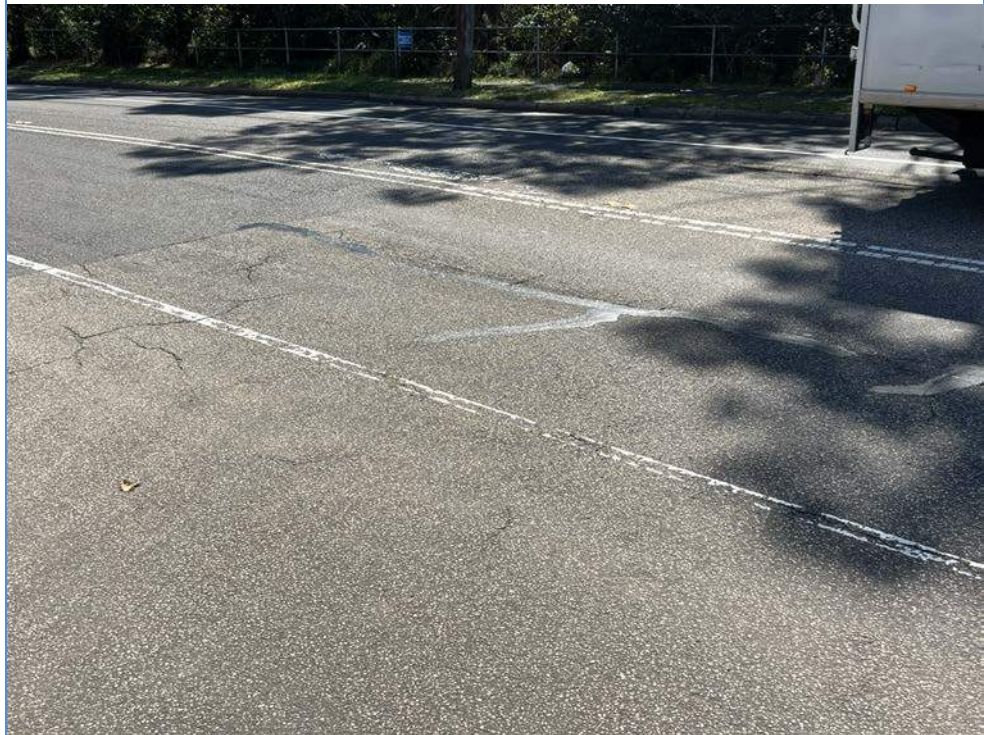
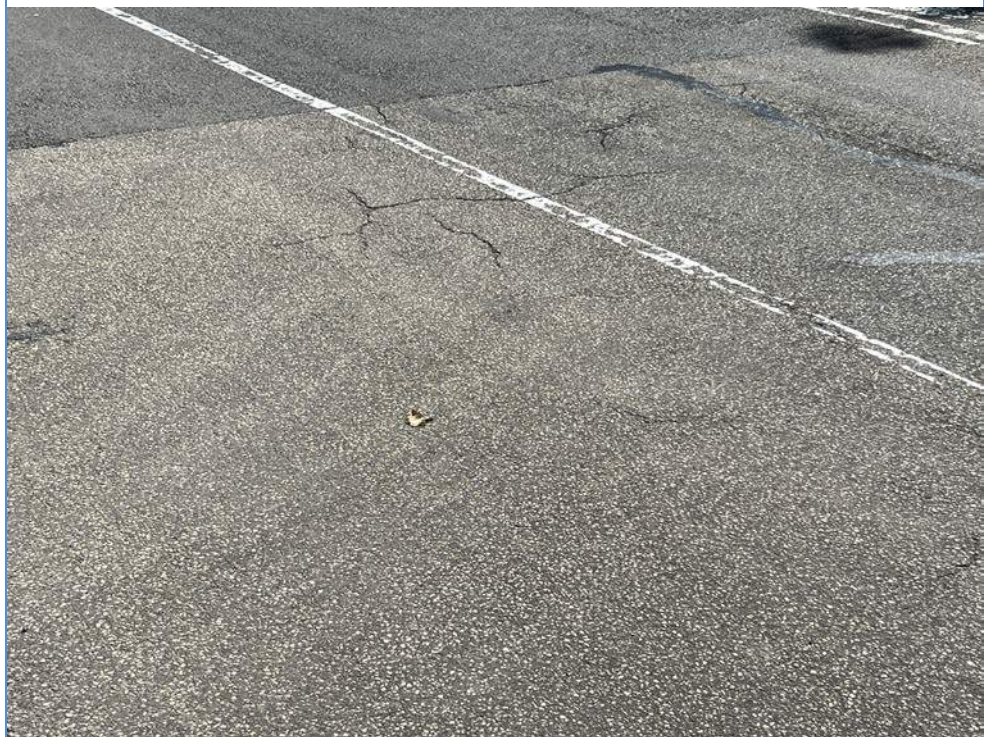
70m

Various cracks to the road surface.

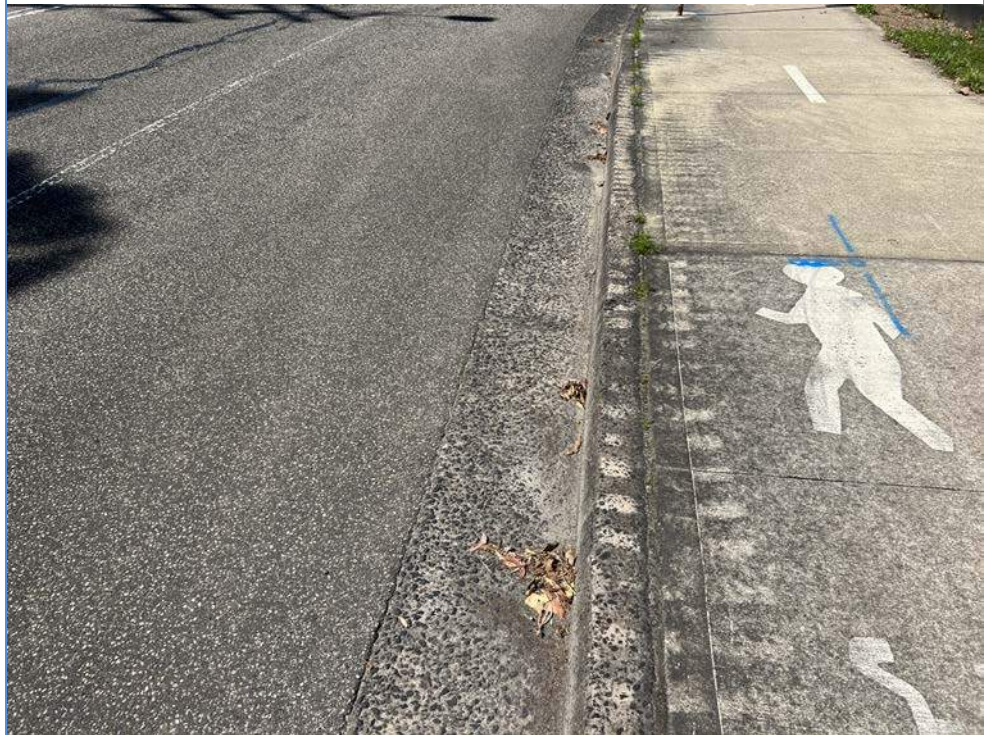
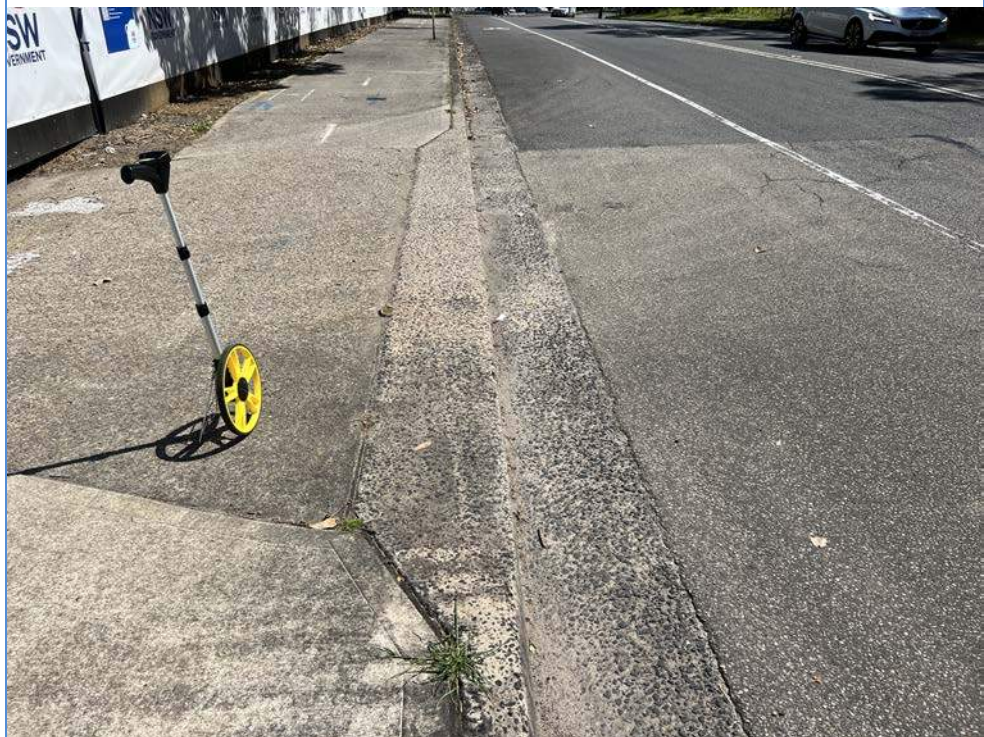
70m

Cracks to the kerb and gutter.
