The following inspection is of the road surface, kerb and gutter to the western side of Allambie Road starting at the intersection of Arnhem Road and heading towards the intersection of Aquatic Drive at the end point.

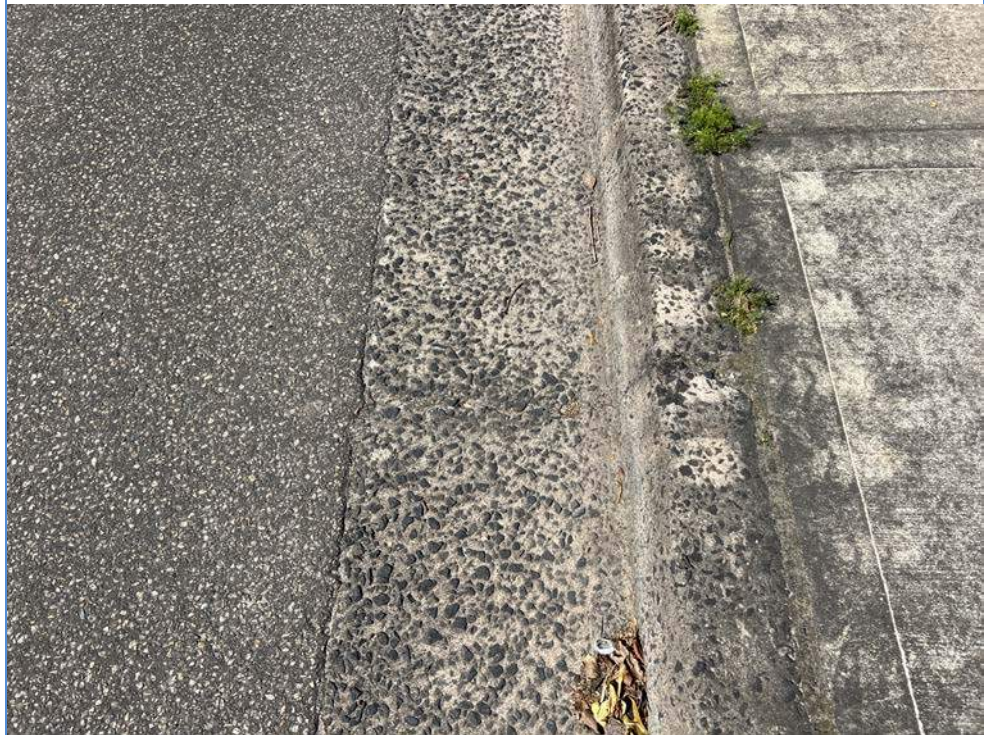
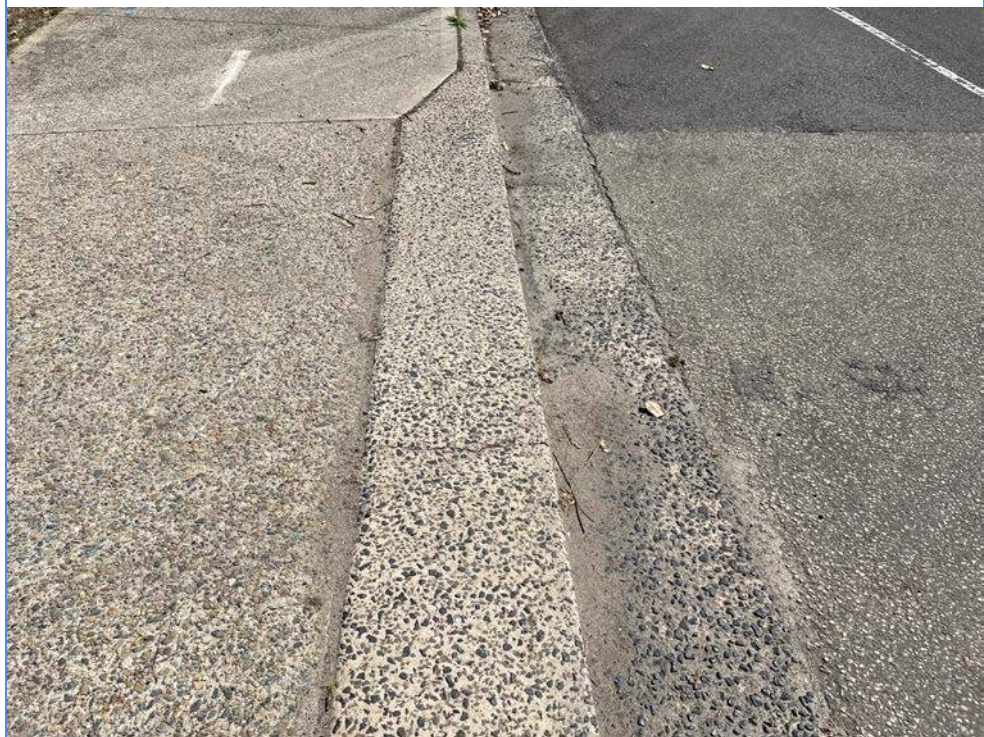
70m

Cracks to the kerb and gutter.

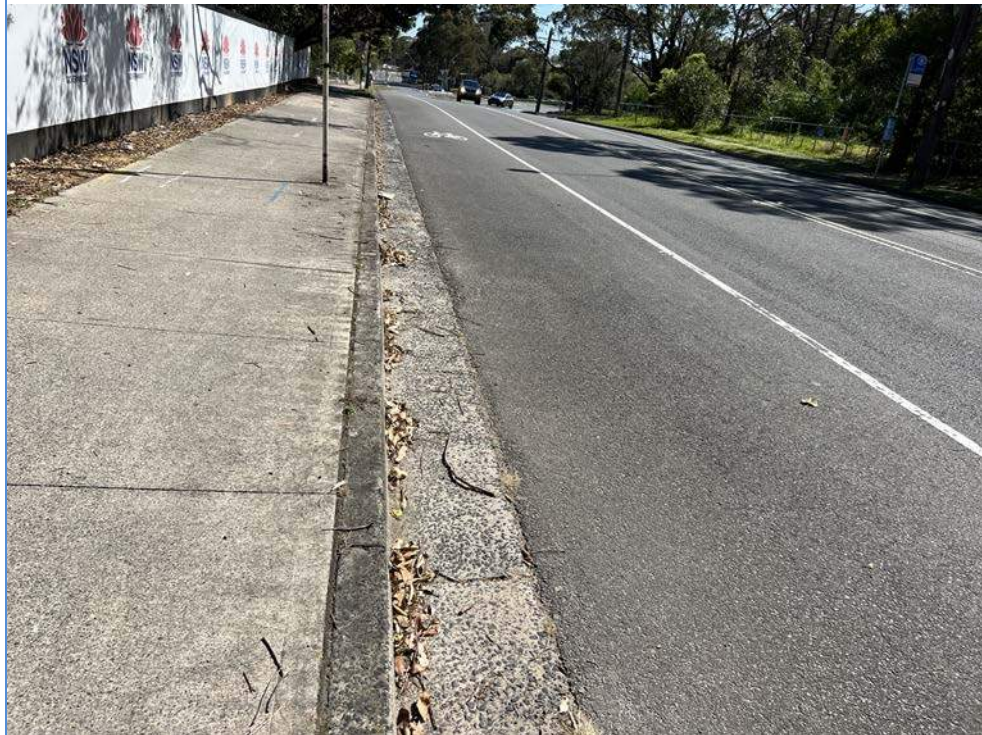
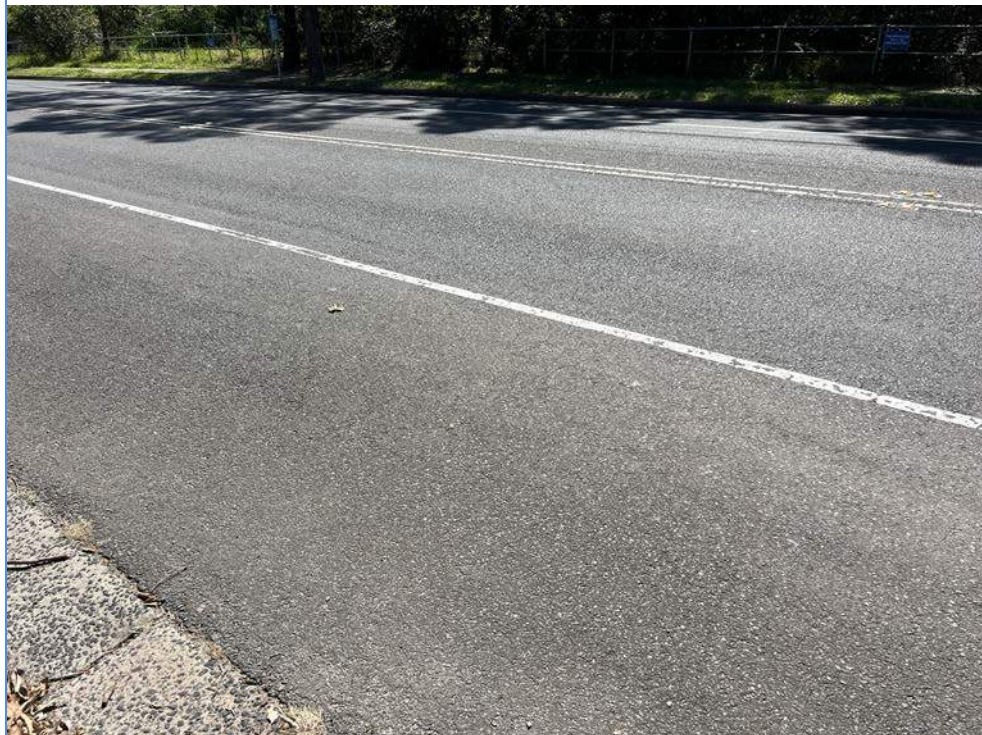
80m

General views of the road surface, kerb and gutter.

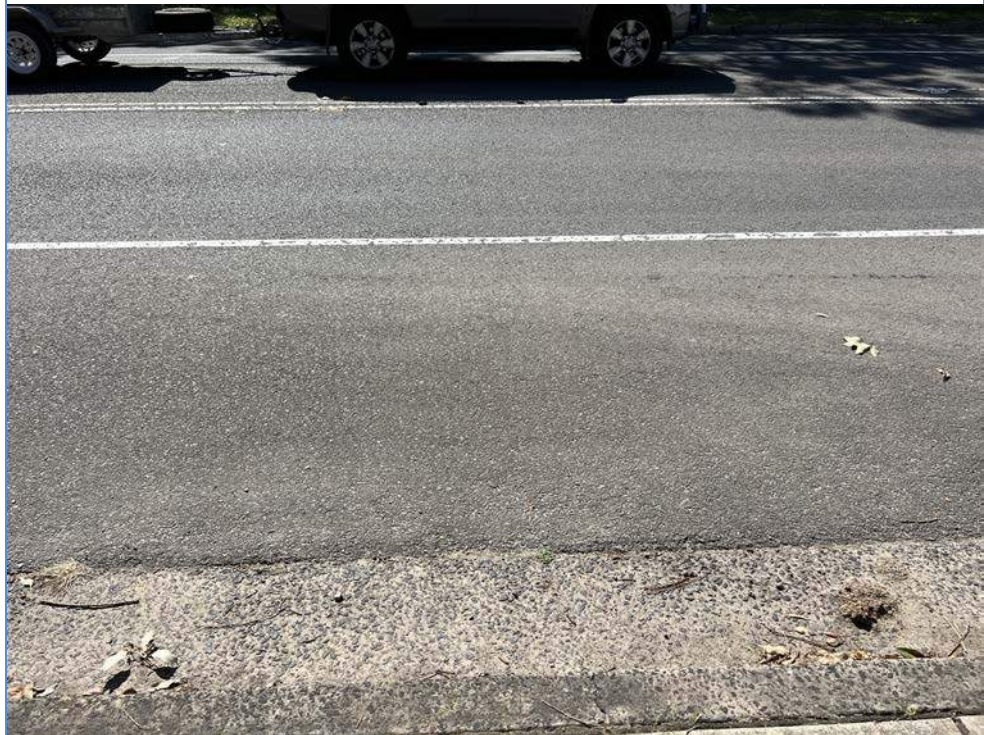
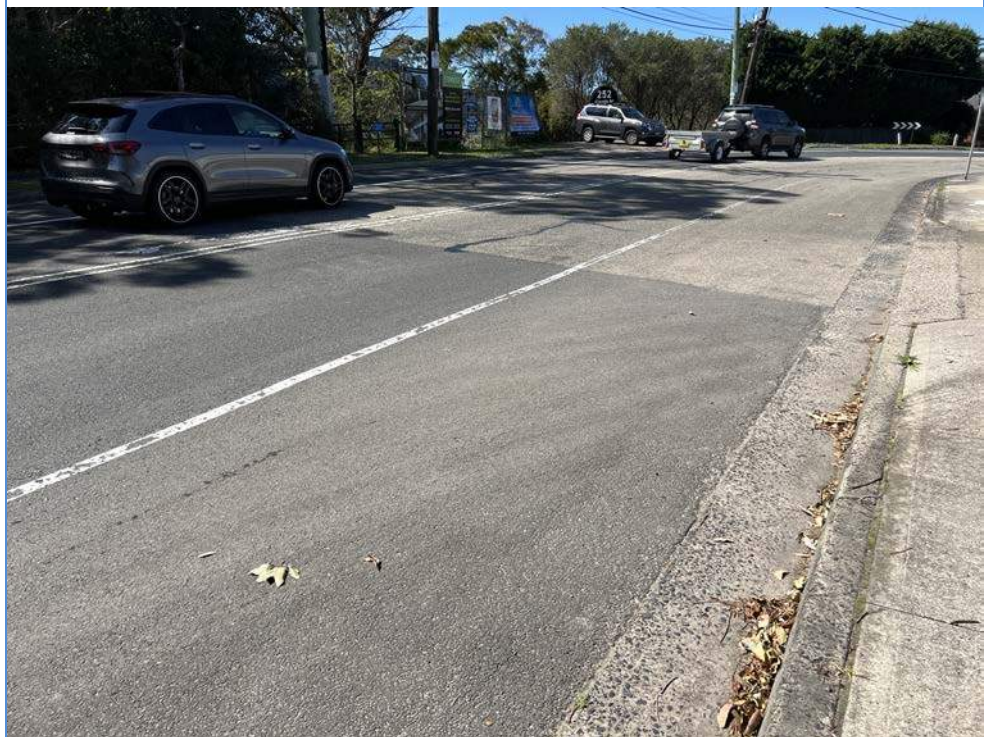
80m

General views of the road surface, kerb and gutter.

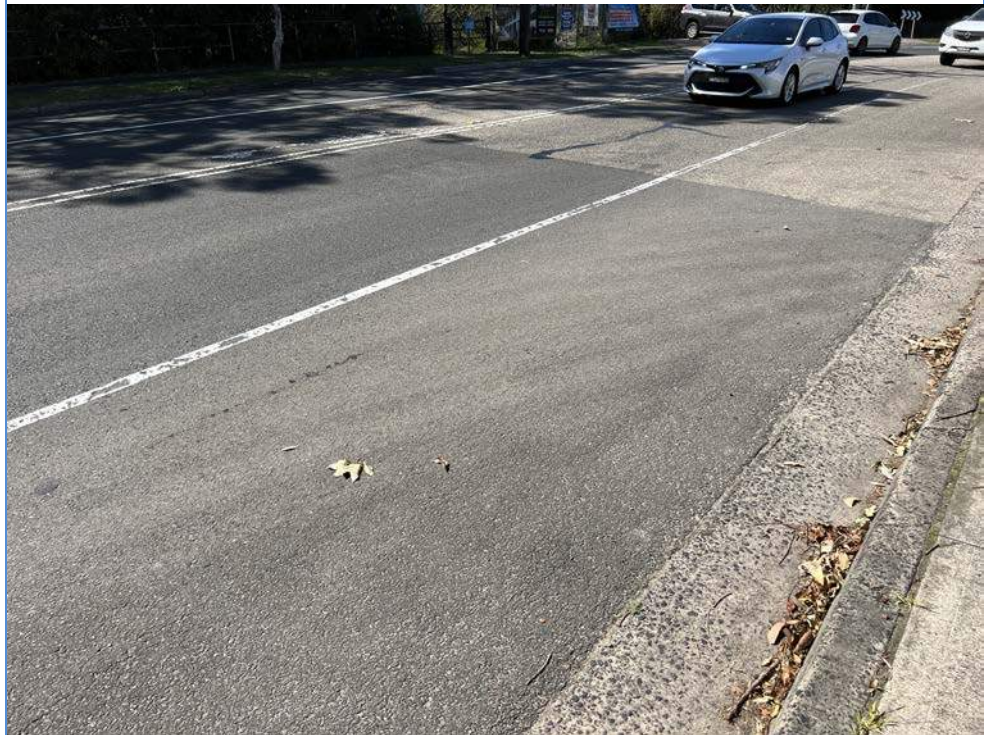
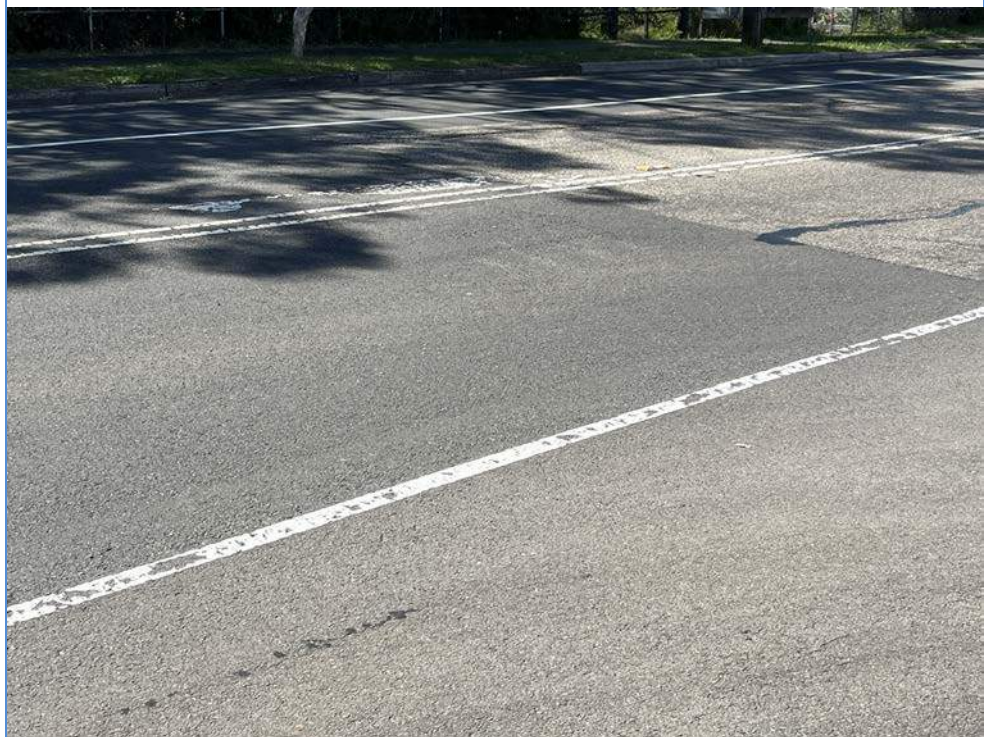
80m

Crack damage to the road surface.
