The following inspection is of the footpath and Council strip to the eastern side of Allambie Road starting at the intersection of Aquatic Drive and Allambie Road and heading in a southerly direction towards the end point at Arnhem Road, Allambie Heights.

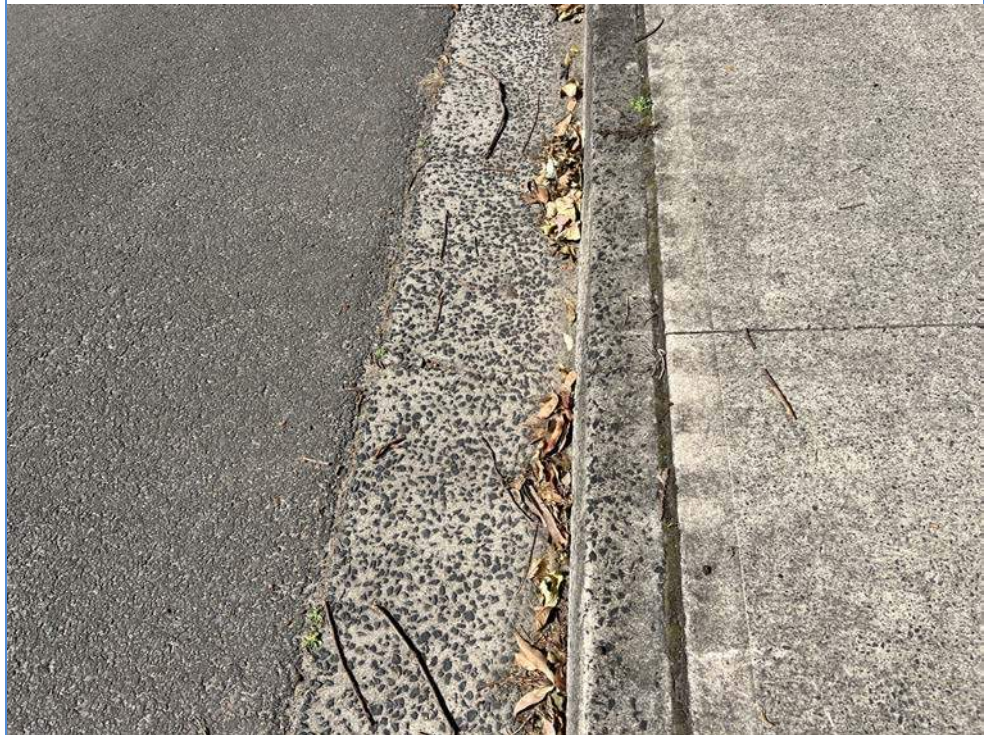
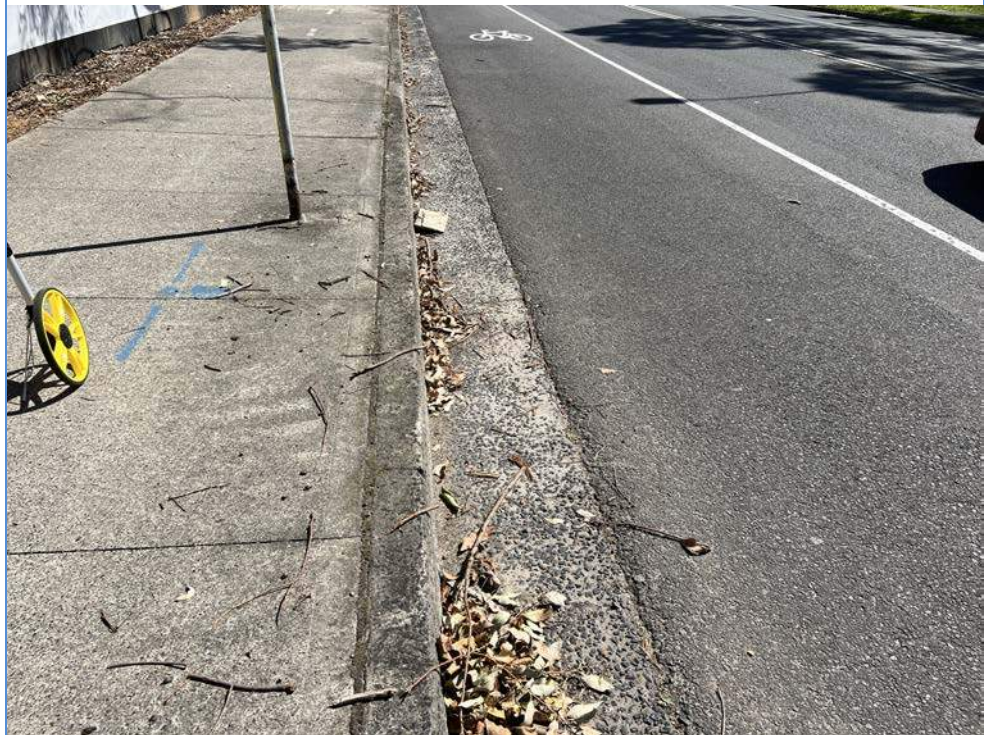
90m

Crack damage to the kerb and gutter.

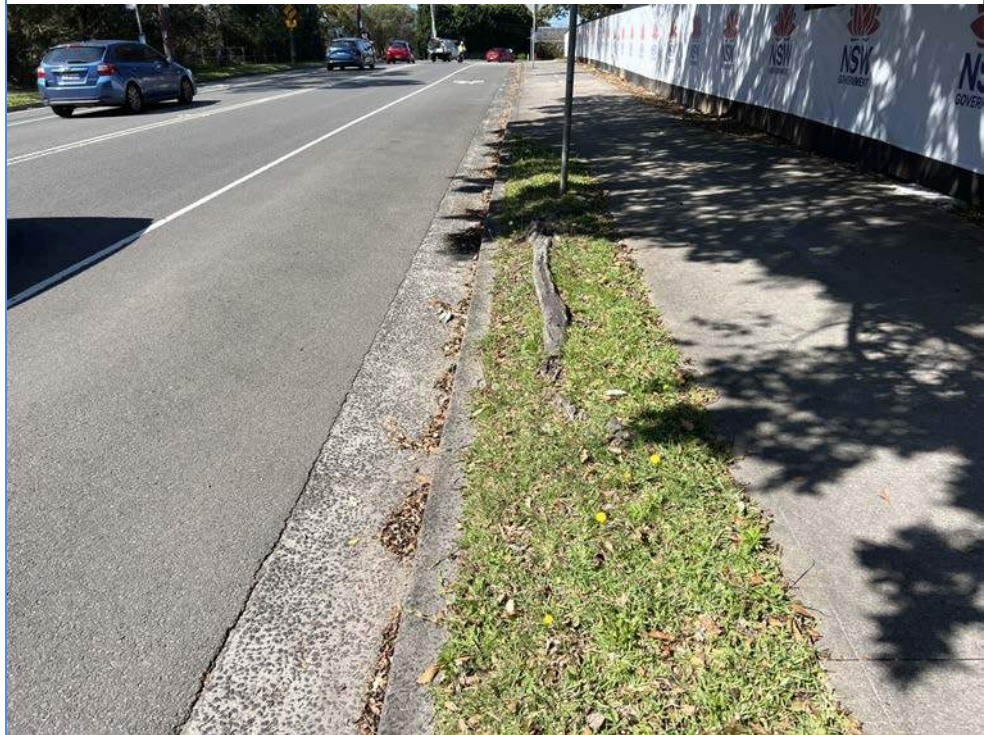
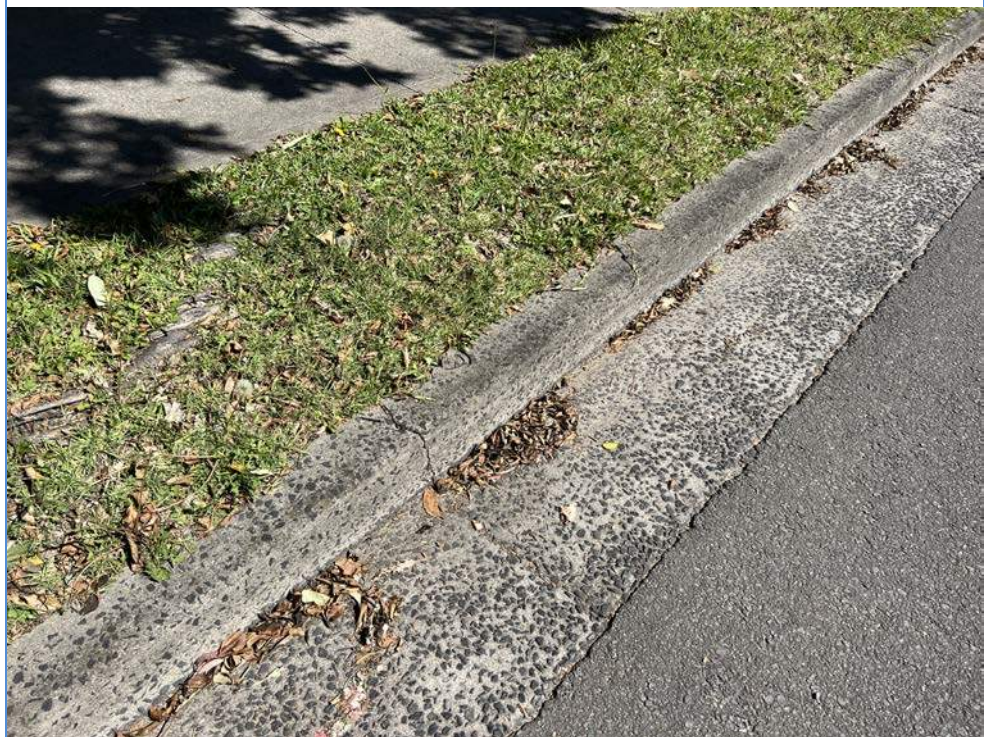
130m

Crack damage to the kerb and gutter.

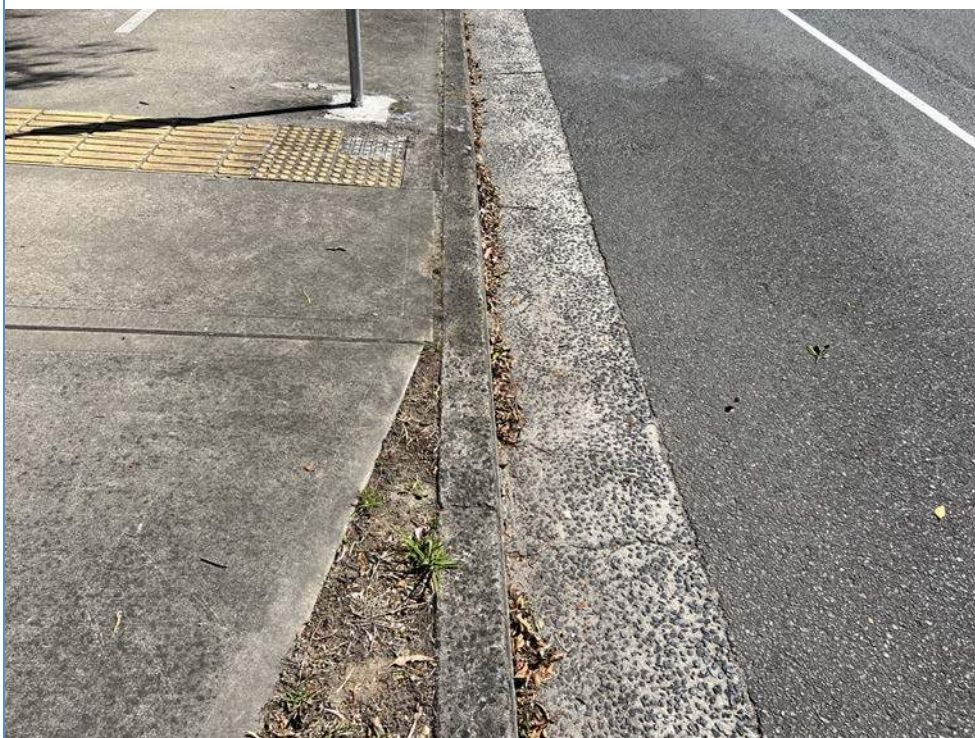
130m

Crack damage to the kerb and gutter.

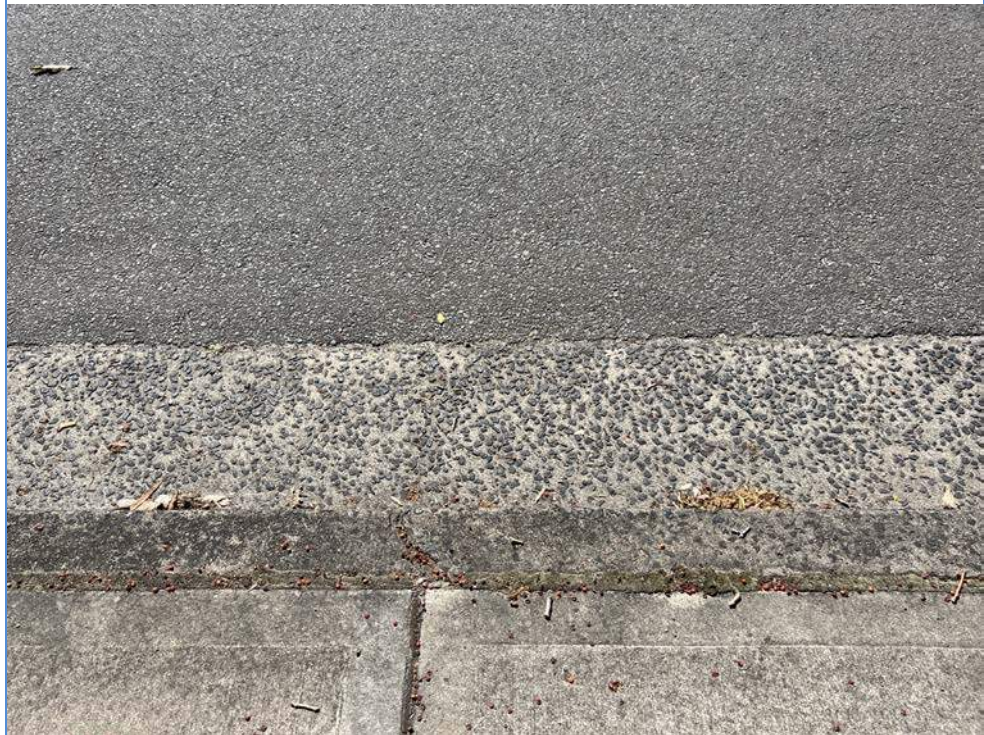
160m

Crack damage to the kerb and gutter.

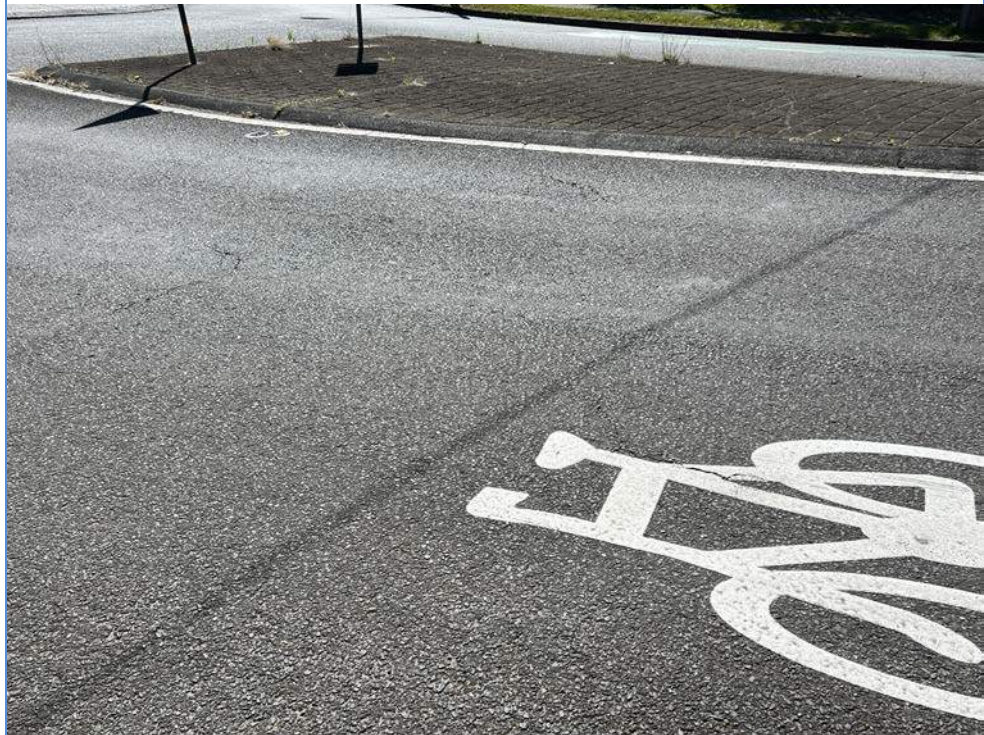
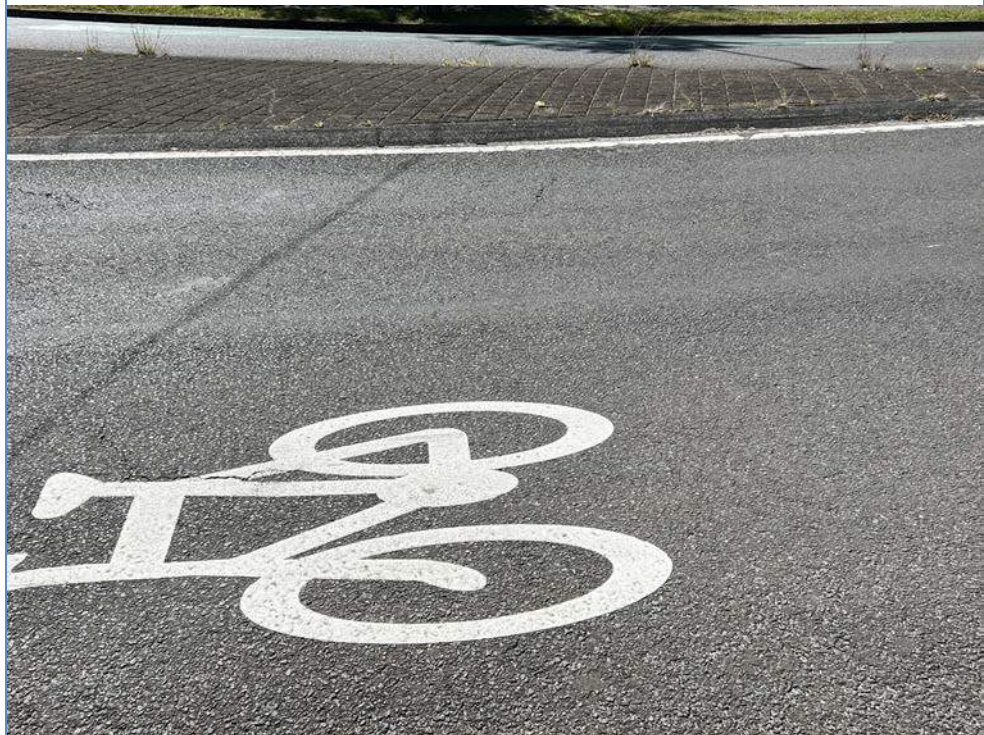
170m

Crack damage noted to the road surface.

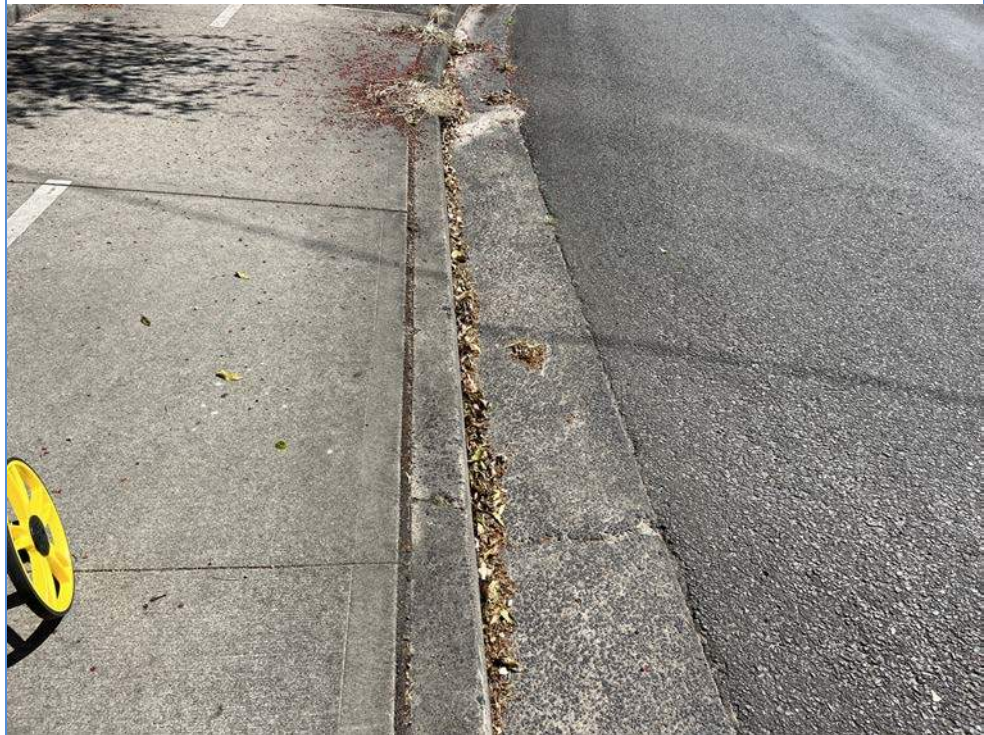
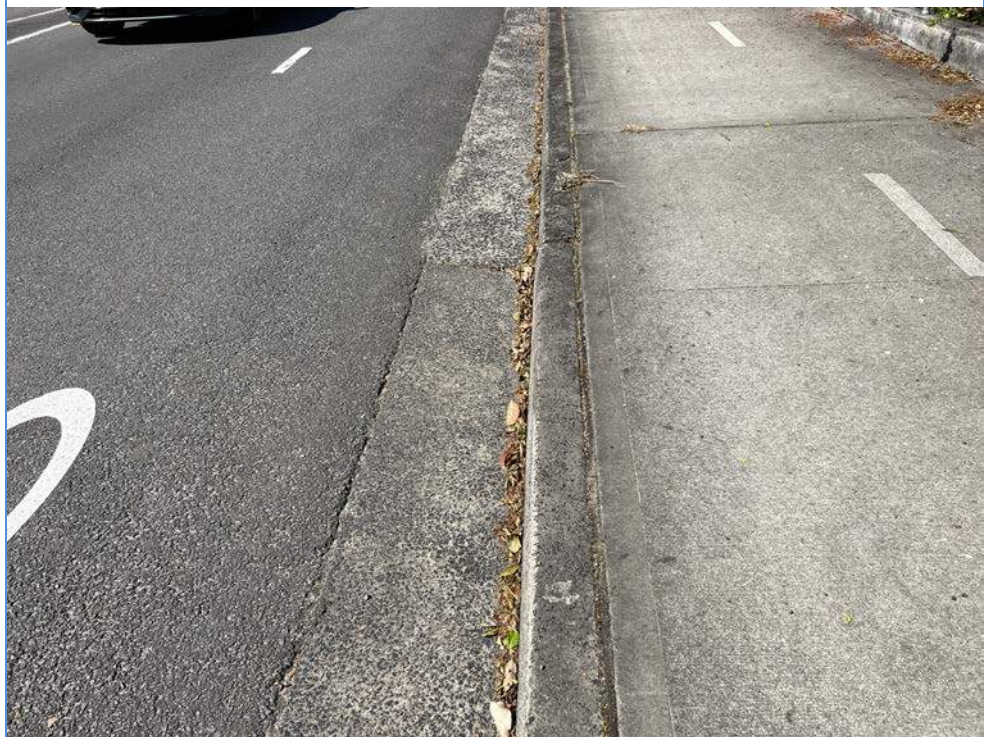
170m

Crack damage noted to the kerb and gutter.

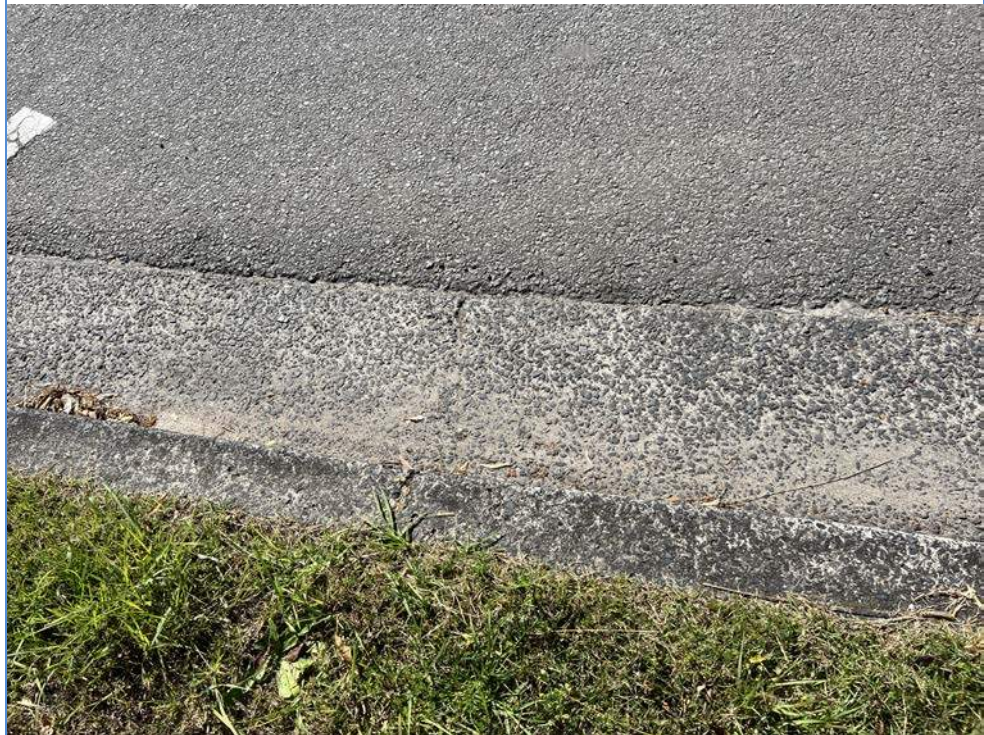
180m

Crack damage to the kerb and gutter.

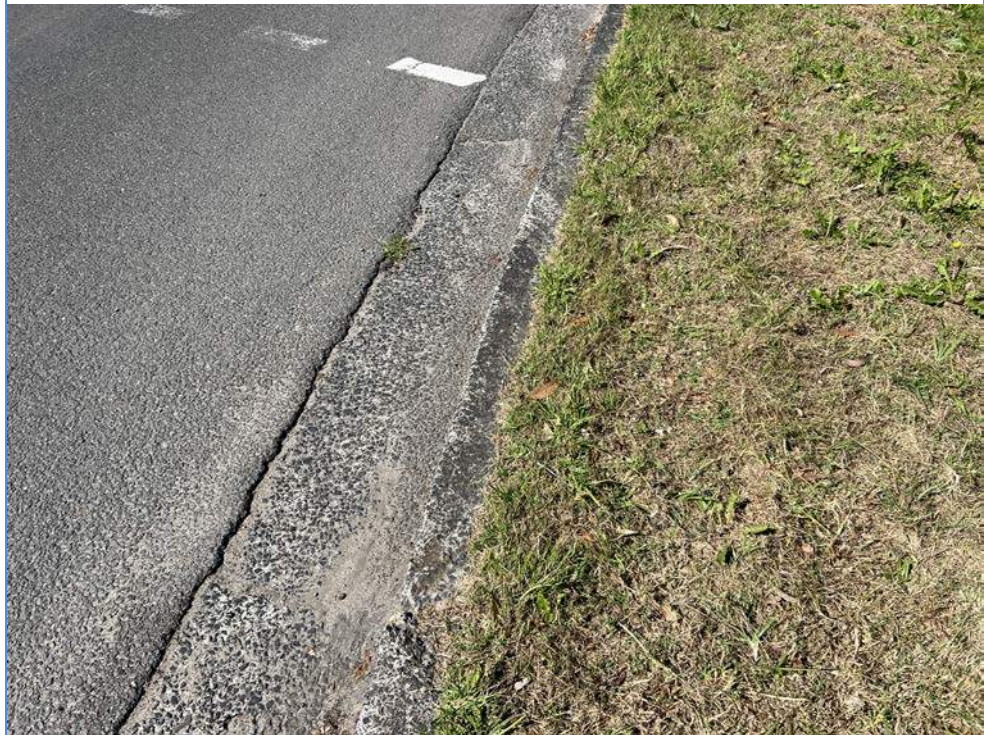
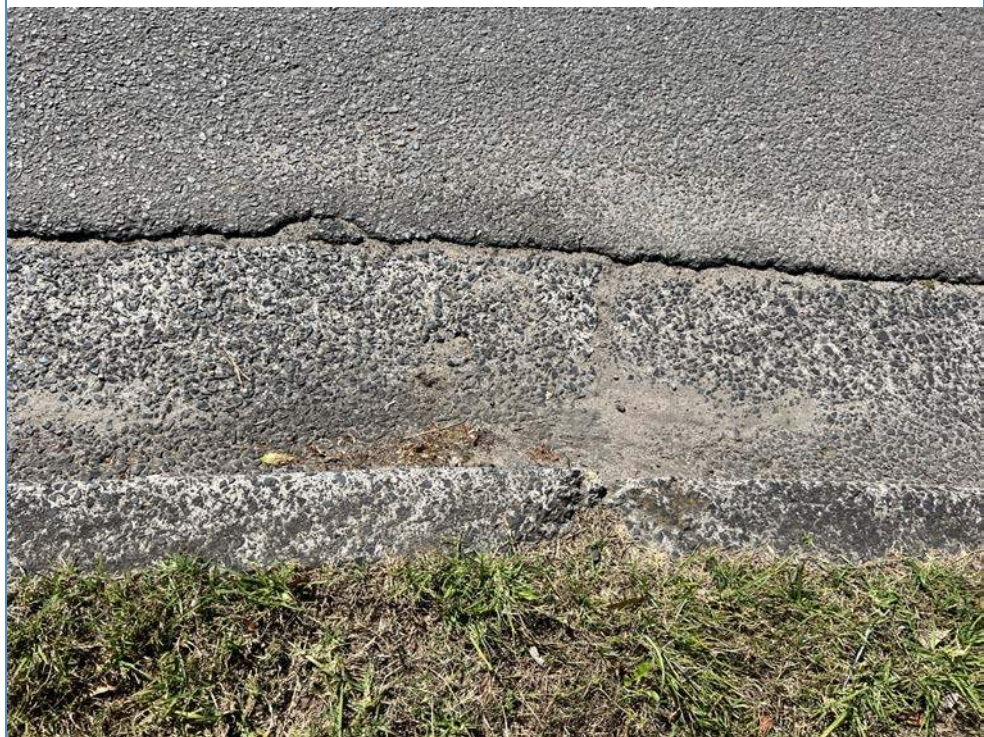
190m

Crack damage to the kerb and gutter.

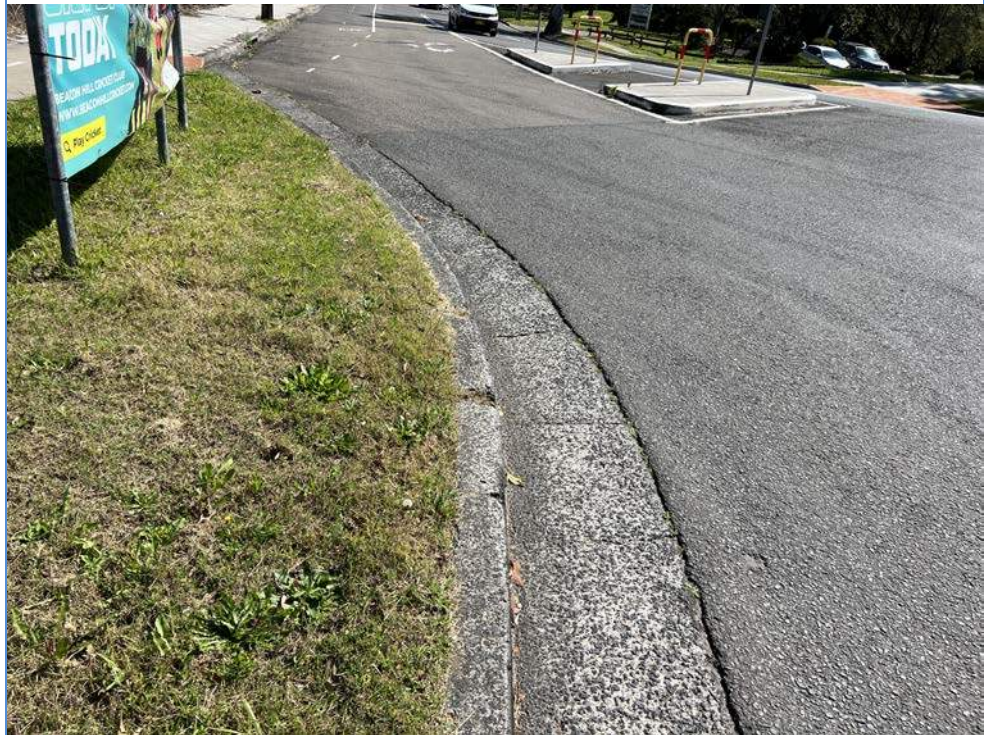
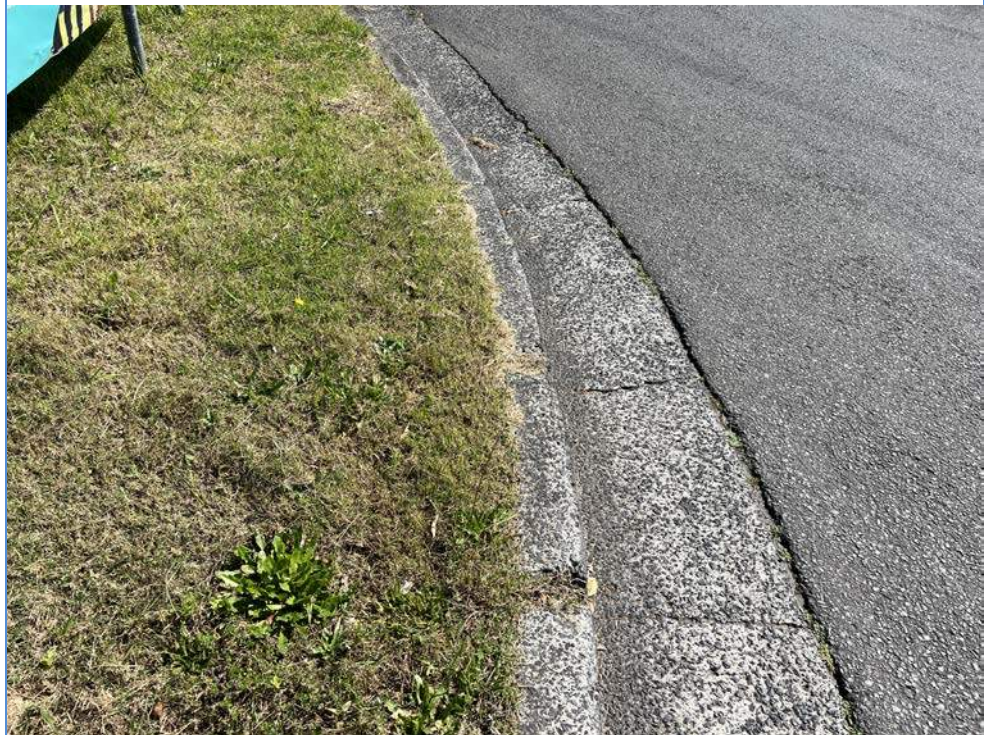
190m

Crack damage to the kerb and gutter.
