The following inspection is of the road surface, kerb and gutter to the eastern side of Allambie Road starting at Arnhem Road, heading north, and finishing at the intersection of Aquatic Drive.

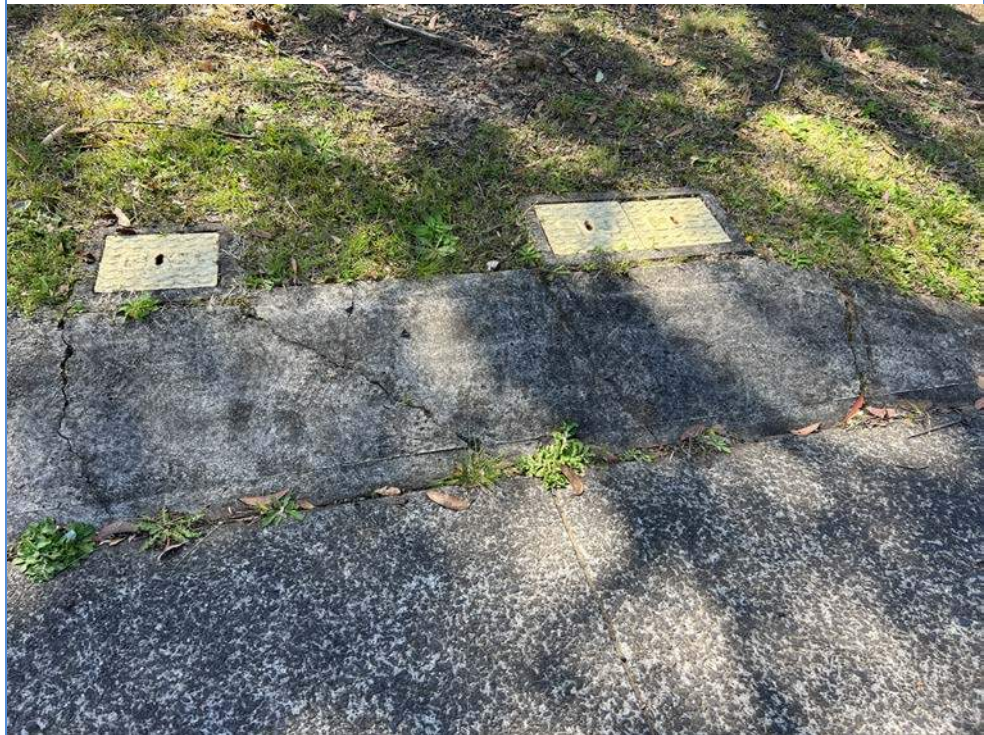
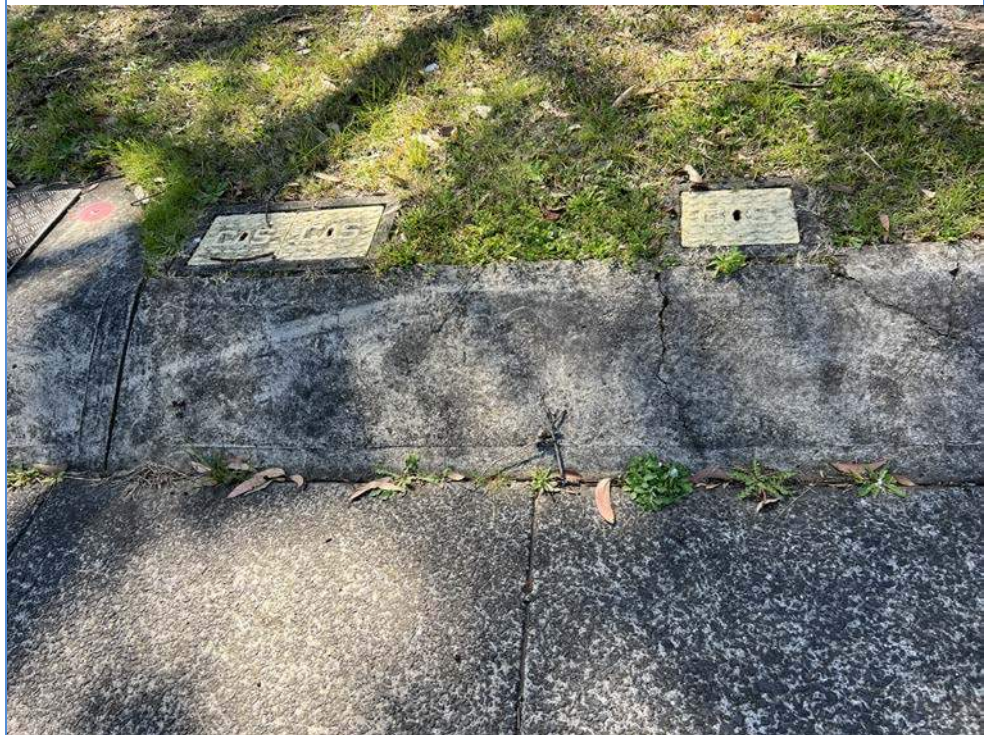
20m

Crack damage to the concrete edging of the footpath.

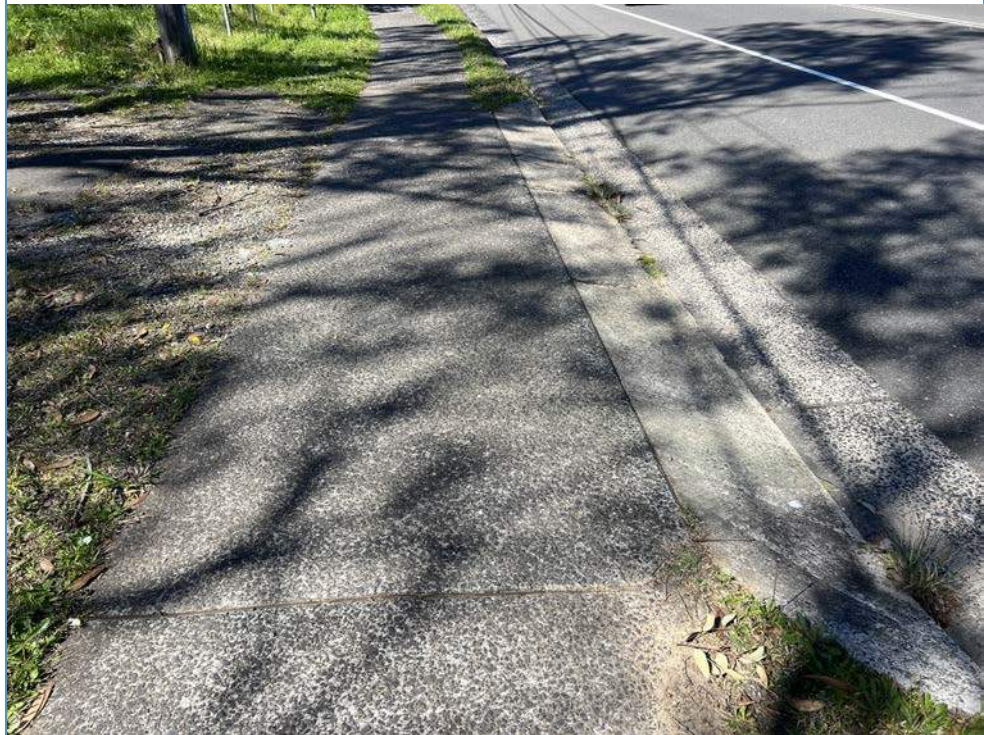
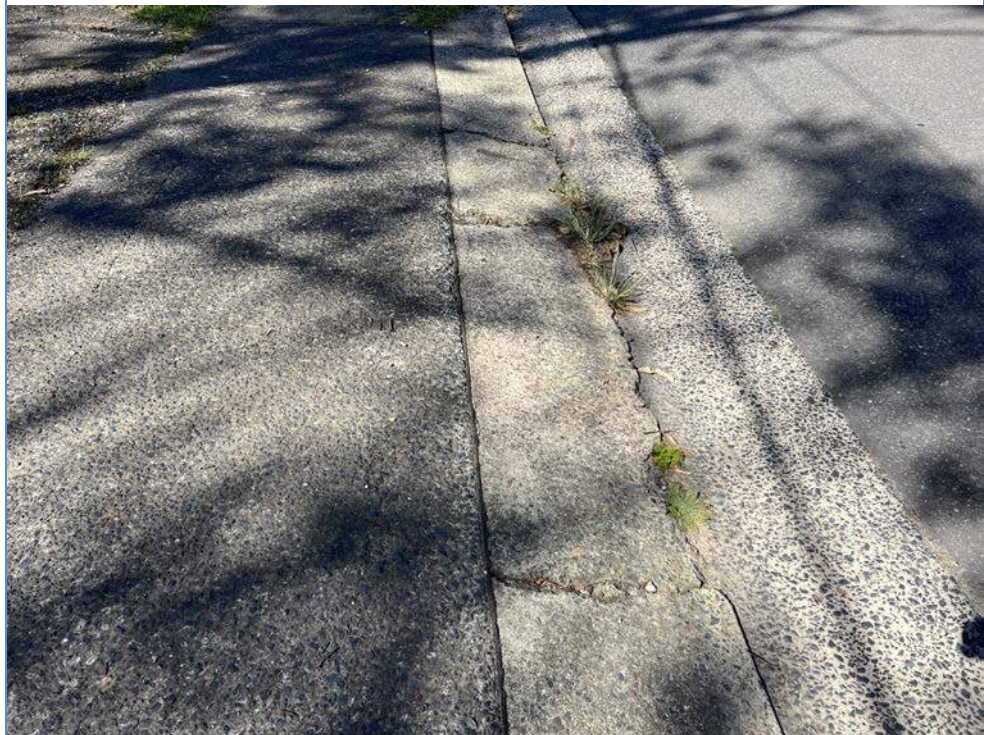
25m

Crack damage to the layback and driveway crossover.

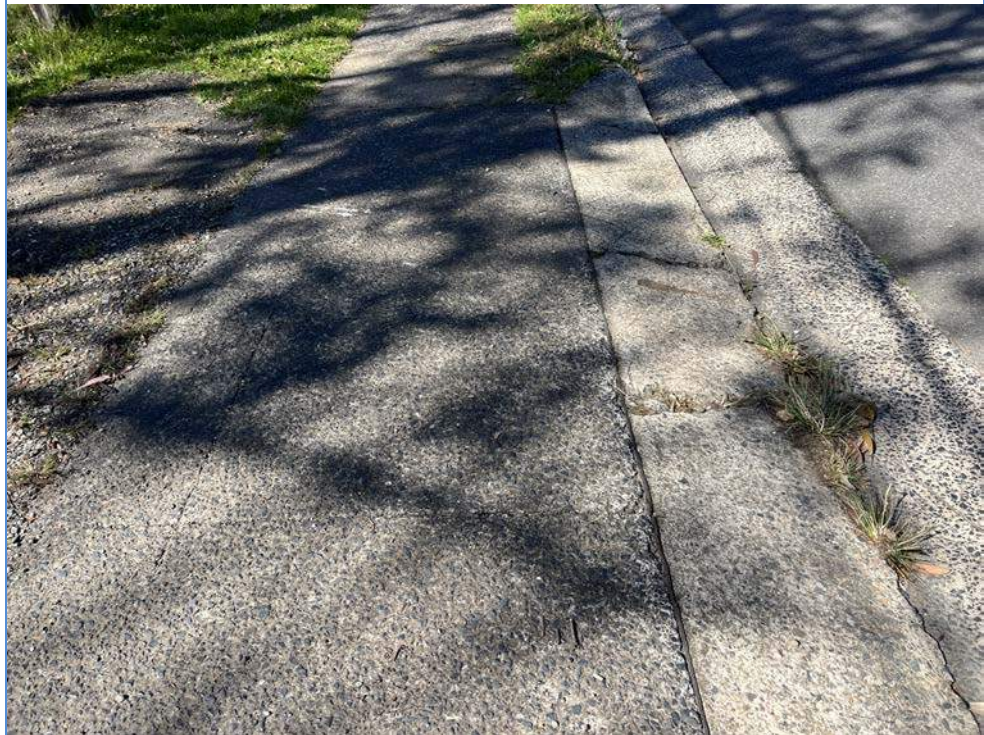
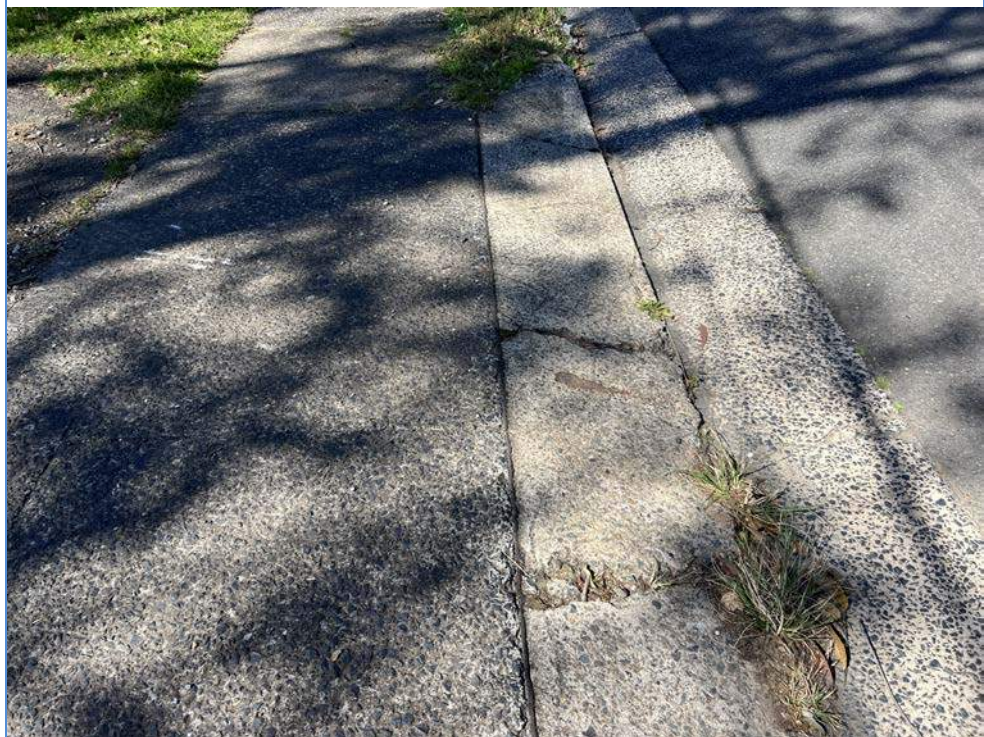
25m

Crack damage to the layback and driveway crossover.

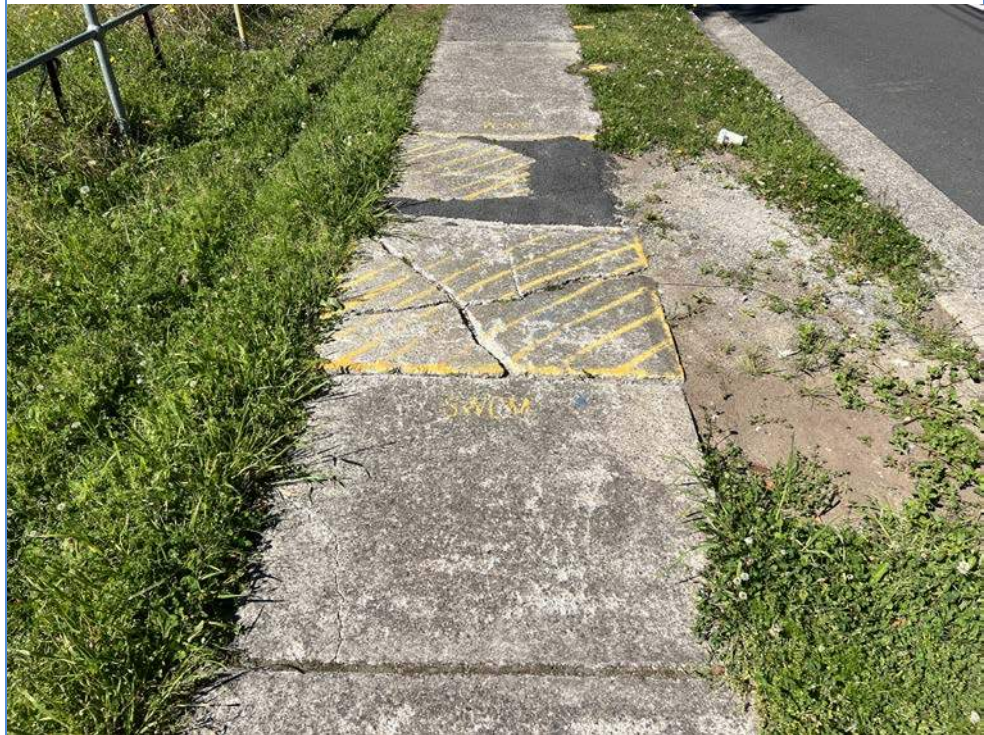
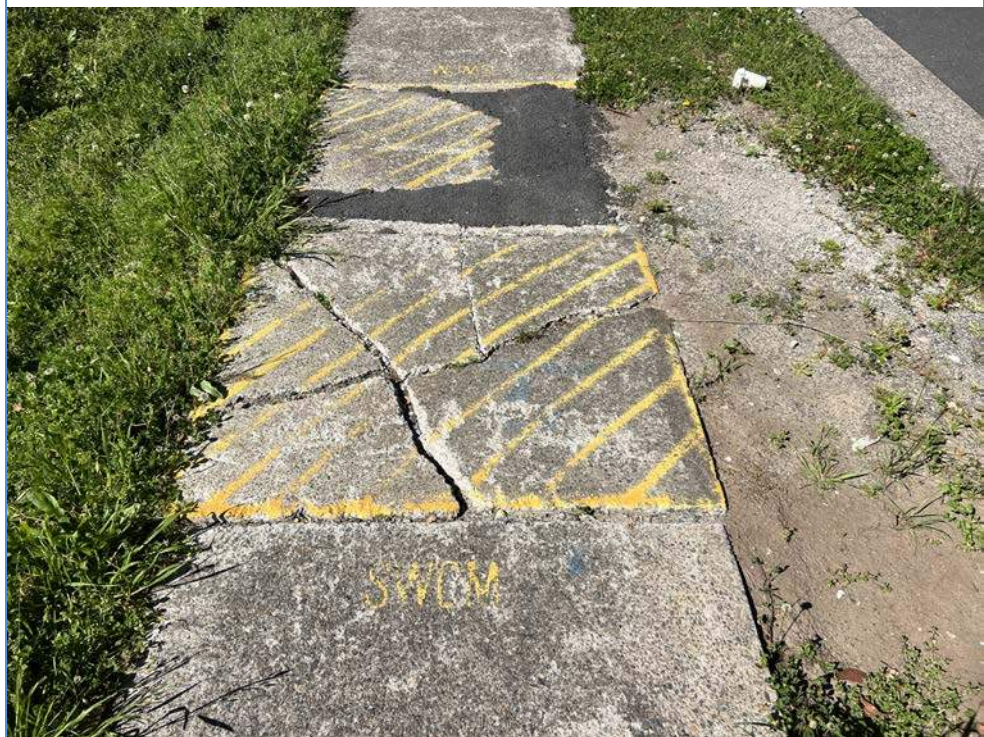
55m

Views of the cracked section of the footpath.

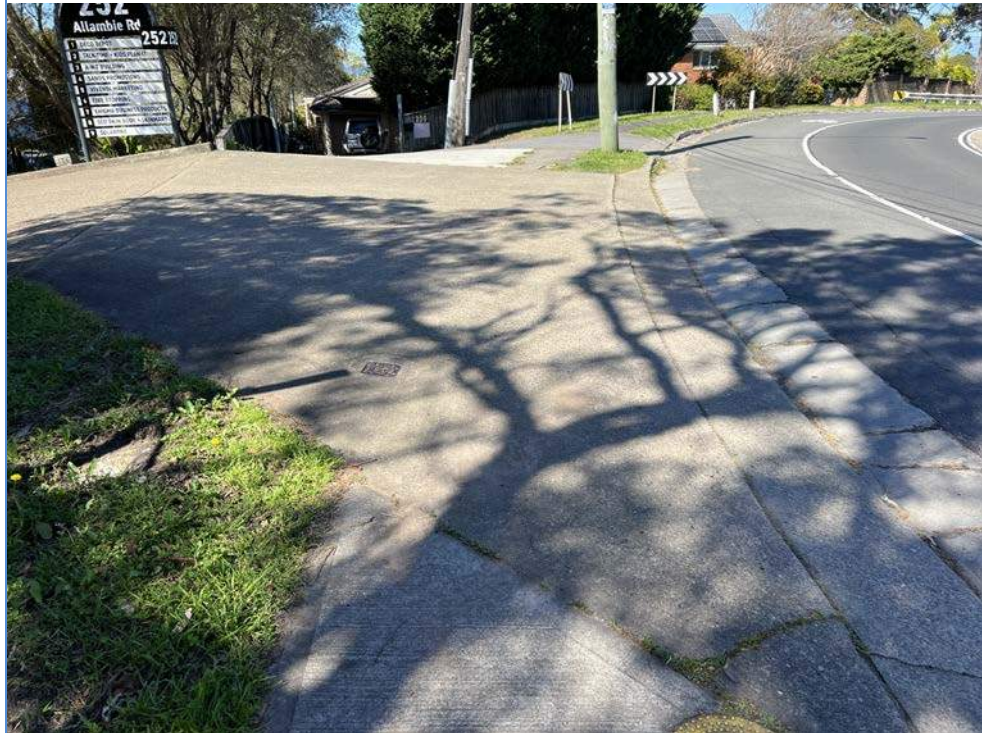
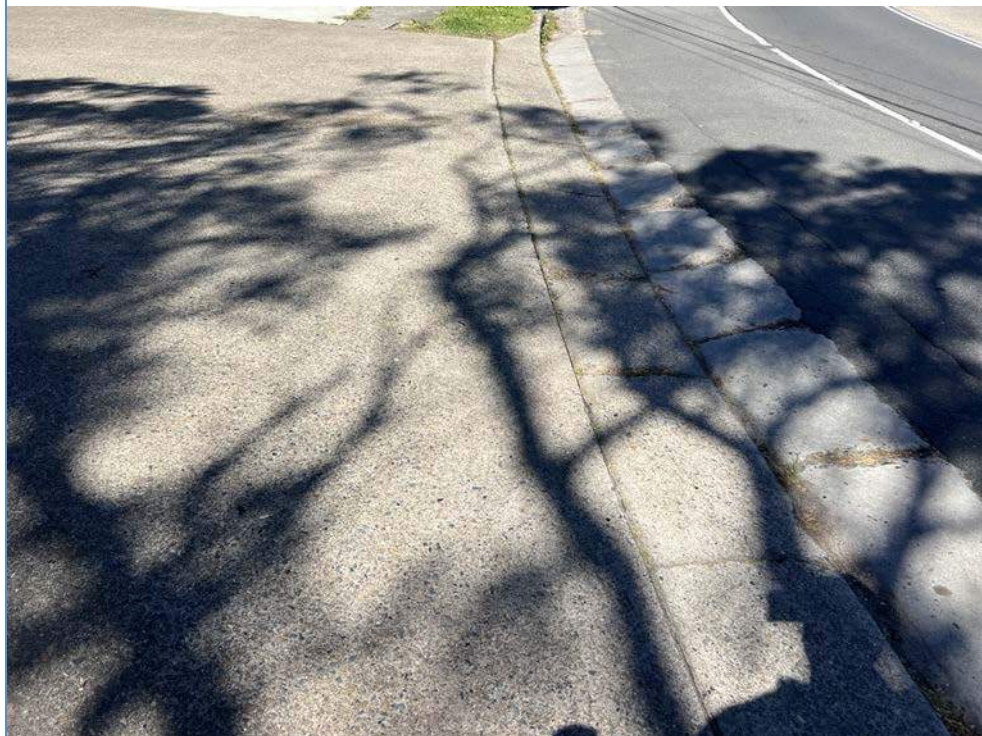
120m

Views of the driveway crossover showing various cracks to the layback.

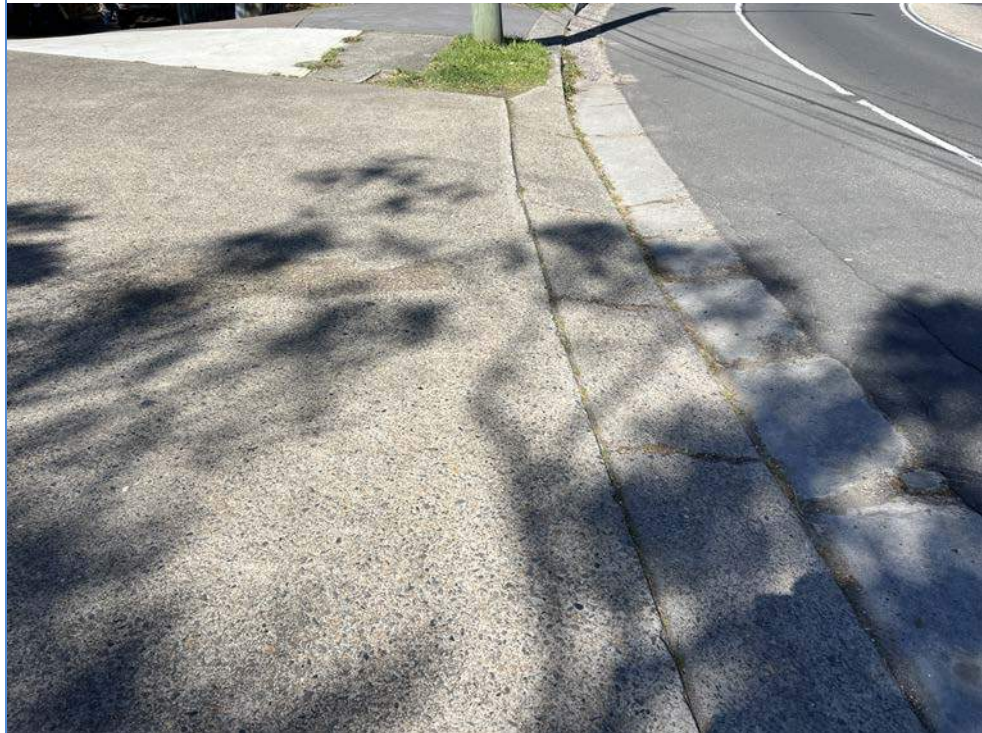
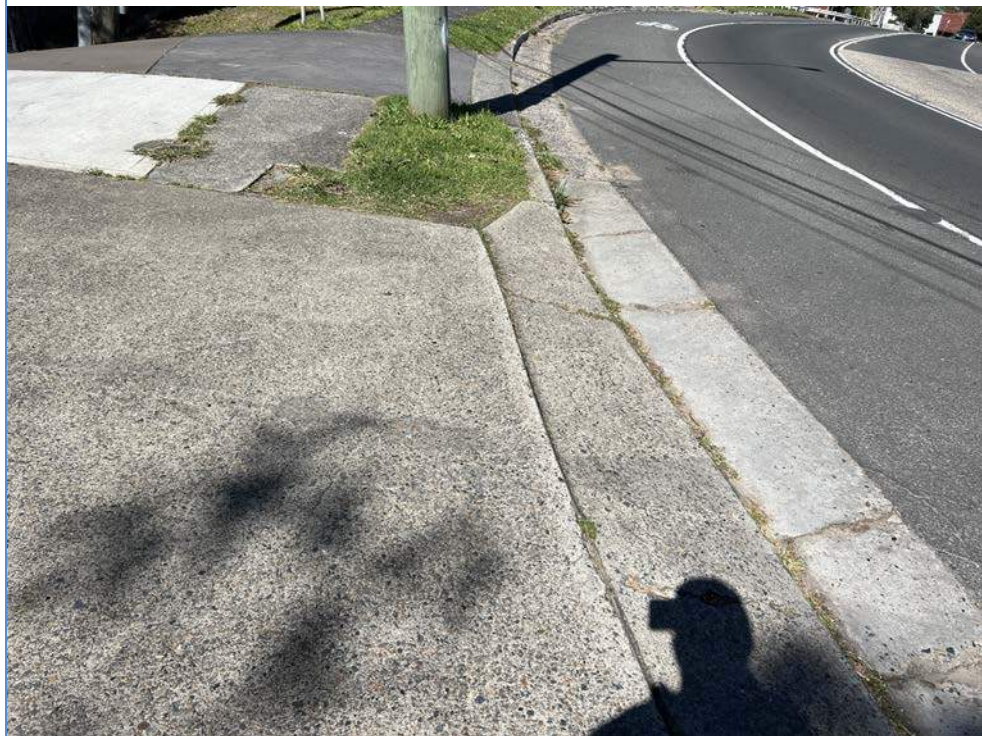
120m

Views of the driveway crossover showing various cracks to the layback.

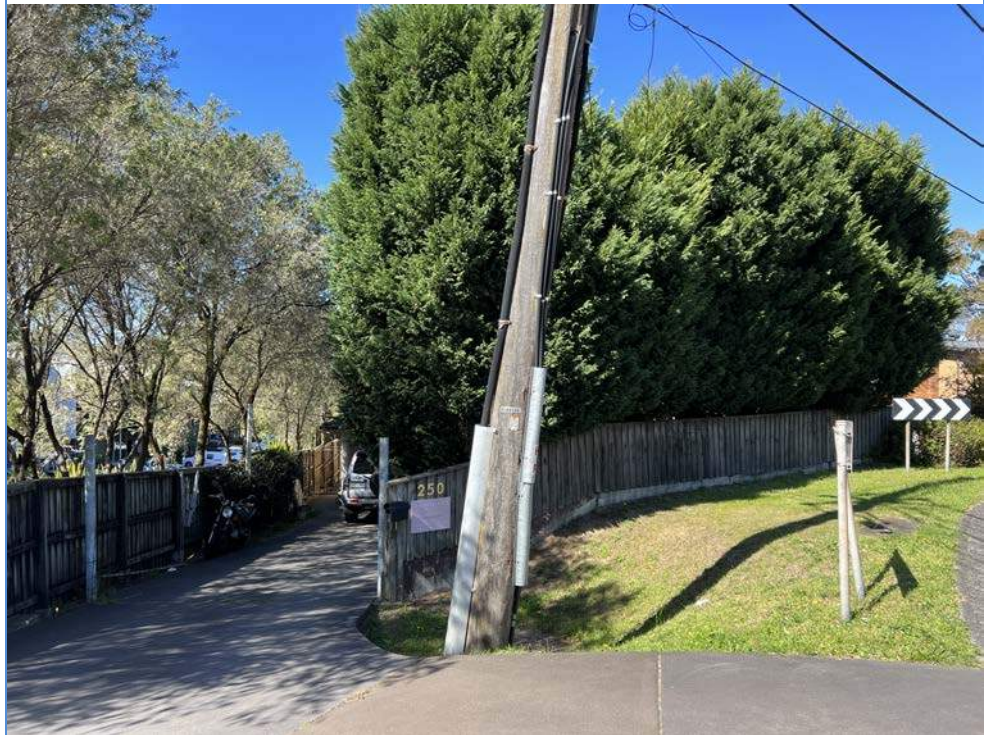
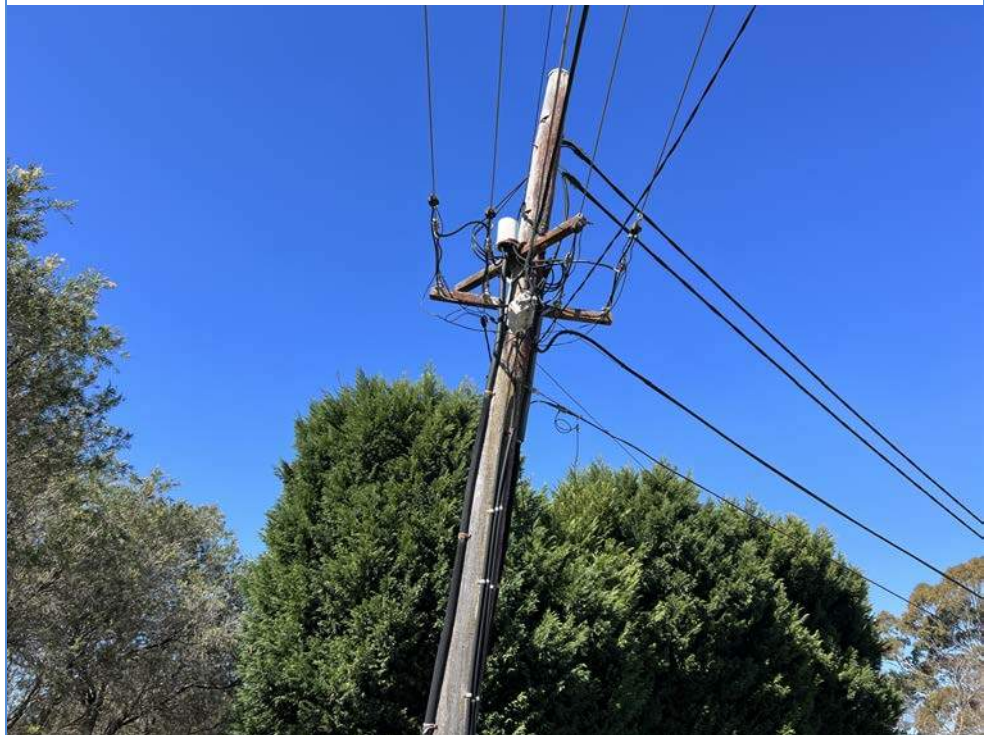
Telegraph pole fronting 250 Allambie Road is leaning.

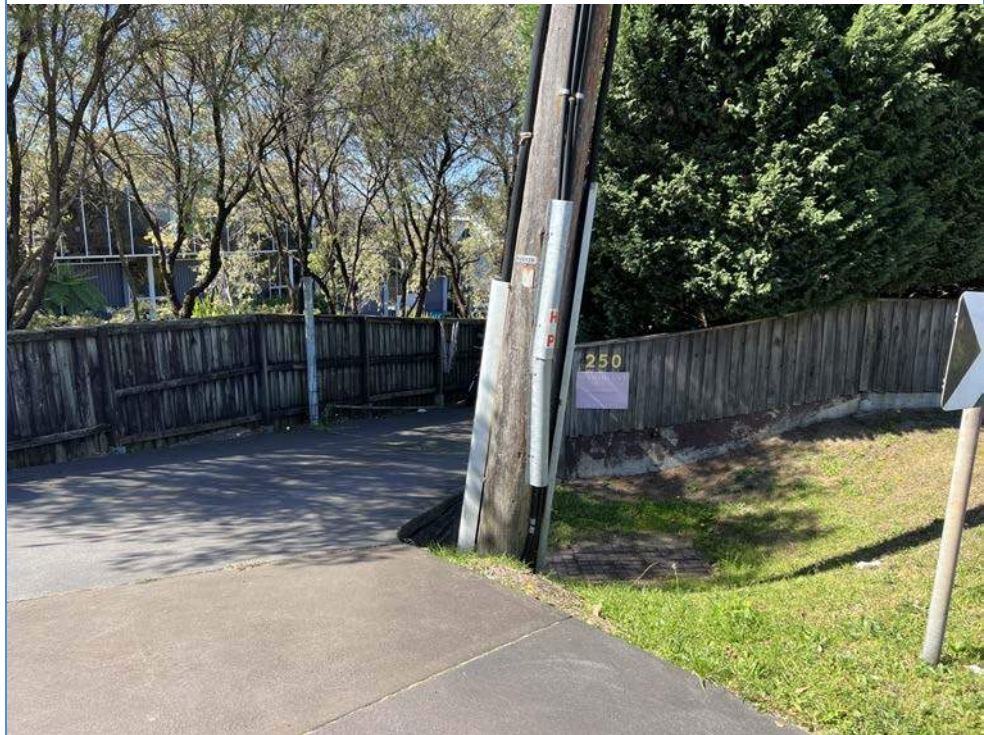
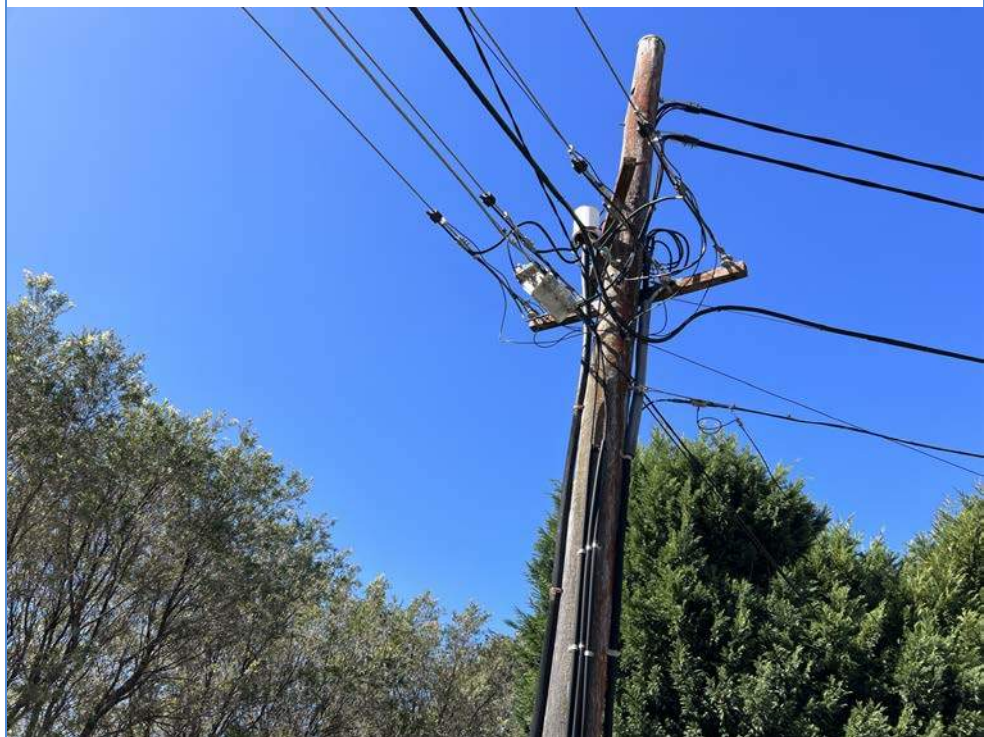
Telegraph pole fronting 250 Allambie Road is leaning.

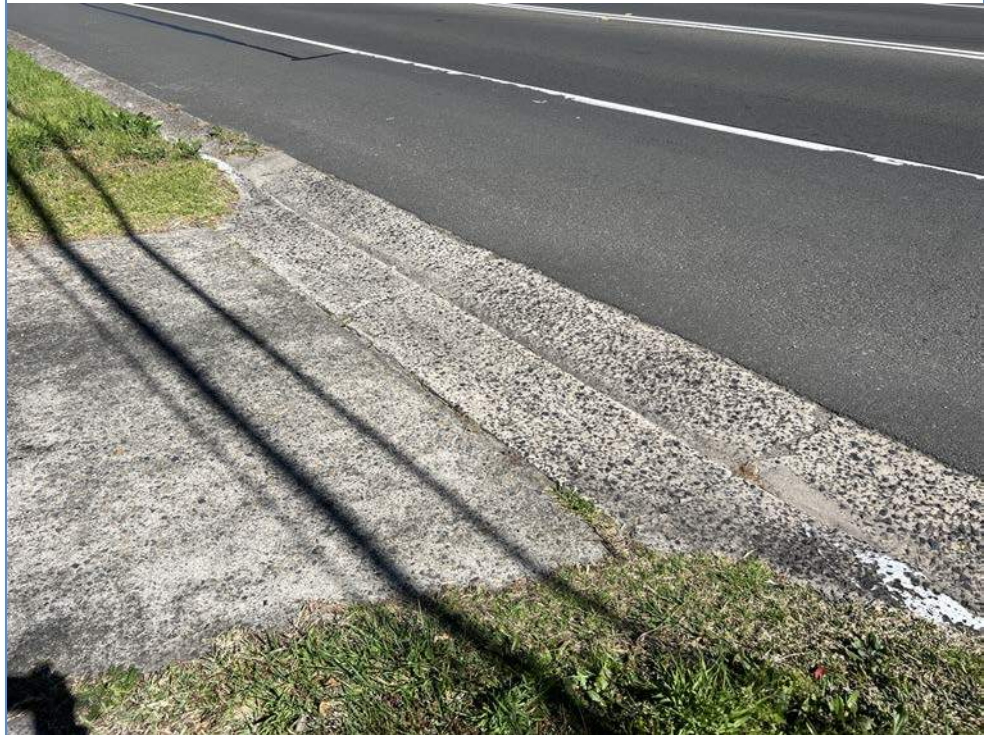
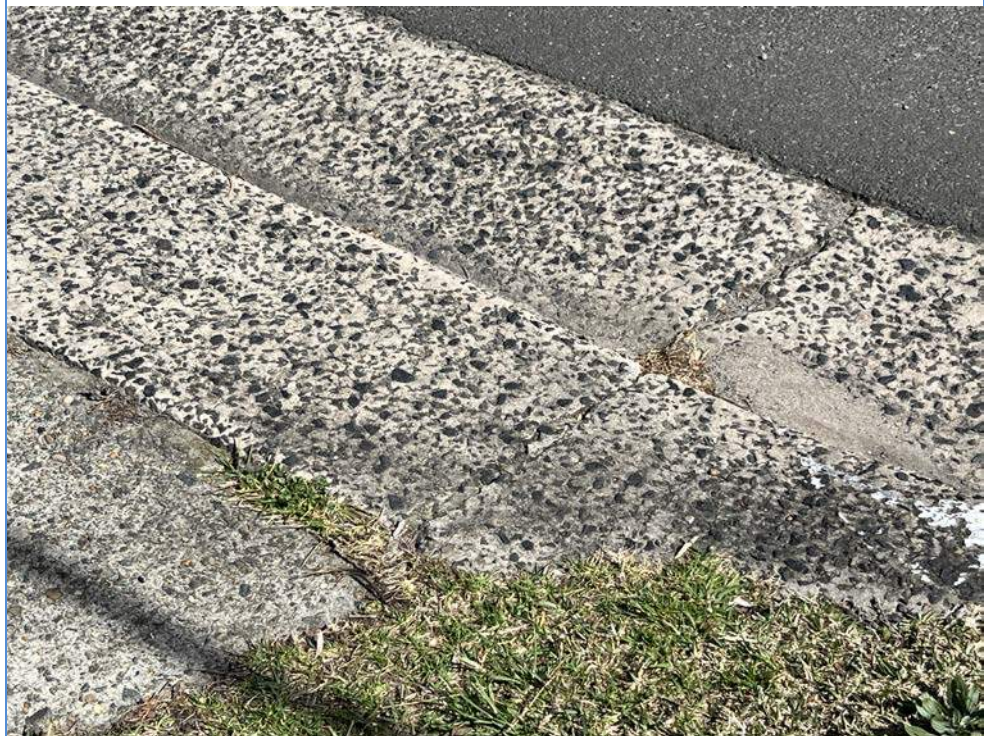
Crack damage to the layback servicing number 248 Allambie Road, Allambie Heights.

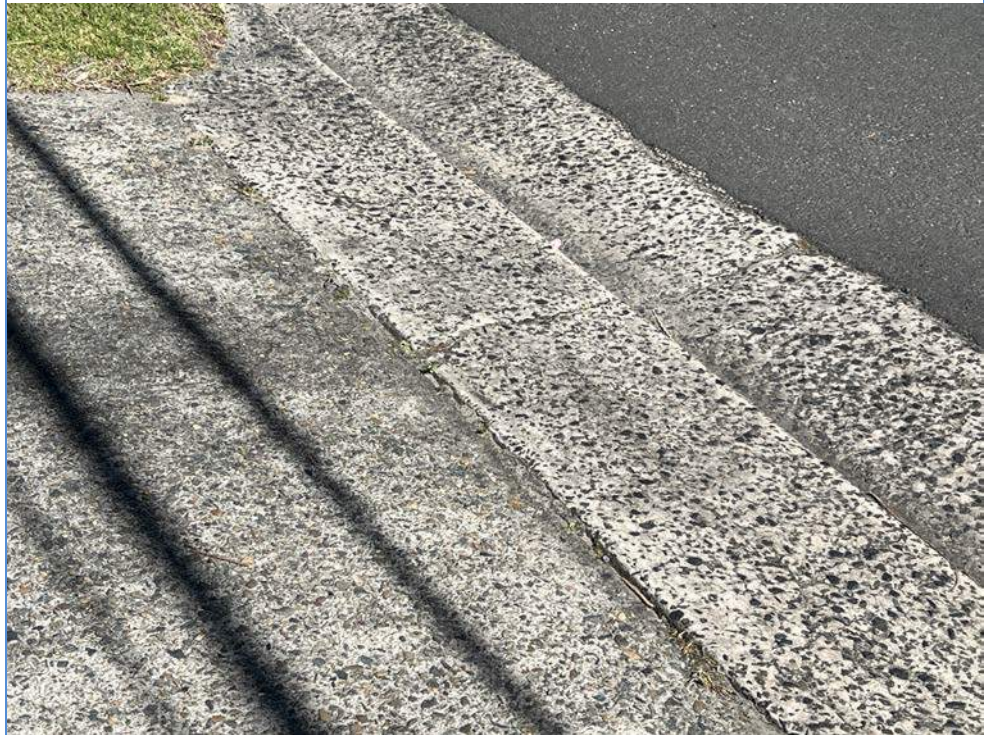
Crack damage to the layback servicing number 248 Allambie Road, Allambie Heights.
