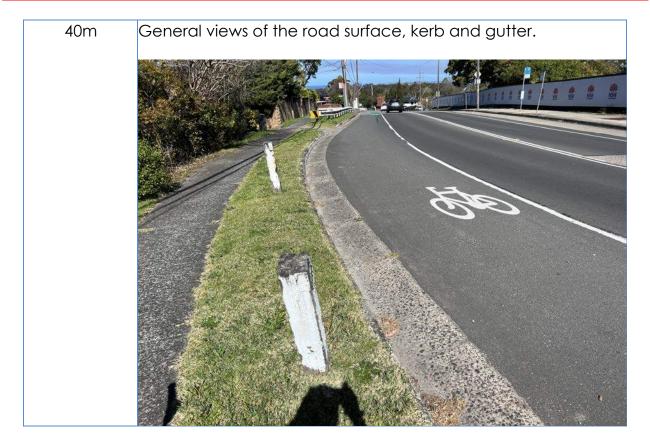
Various cracks to the kerb and gutter.

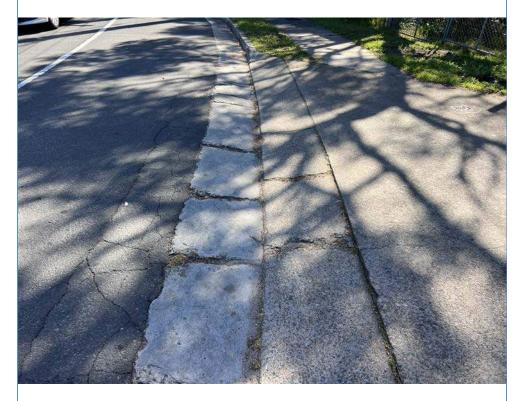
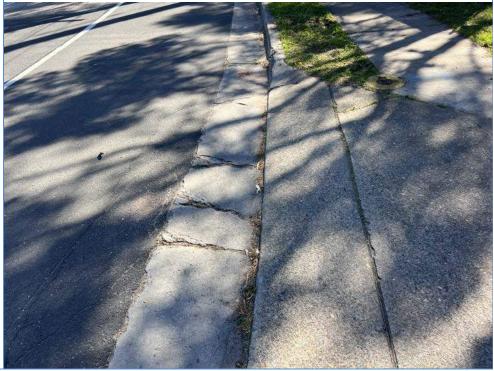
60m Layback and gutter showing multiple cracks.

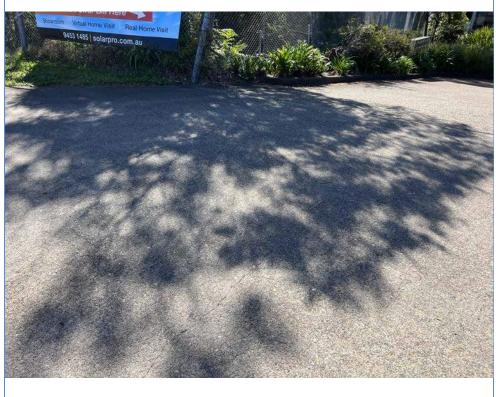
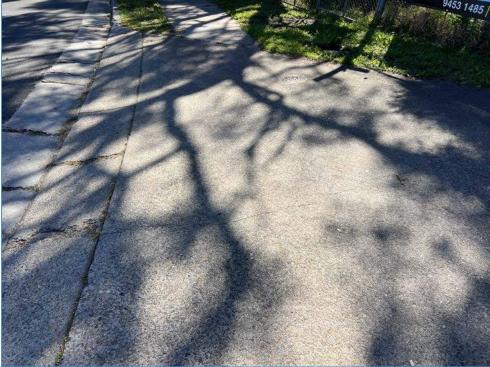
60m Driveway crossover showing crack damage.

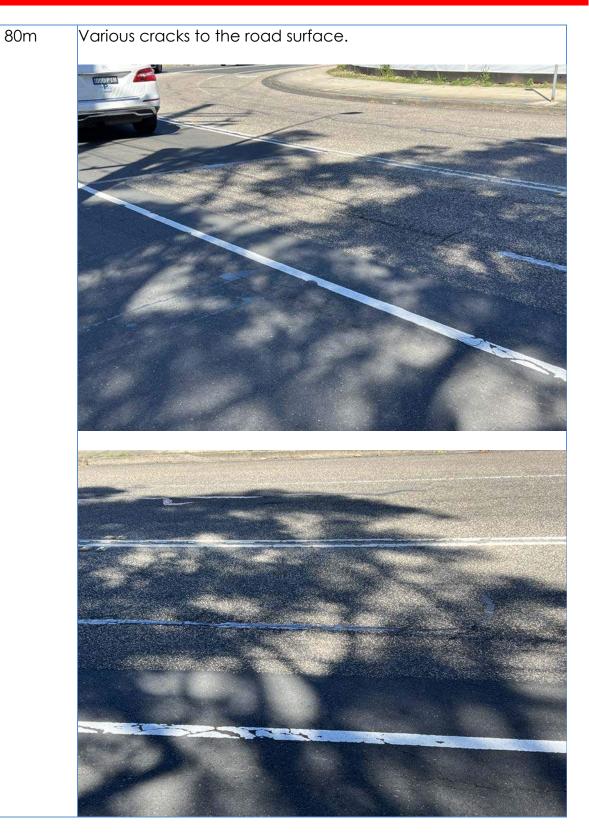
80m Various cracks to the road surface. 80m Crack damage to the kerb and gutter.

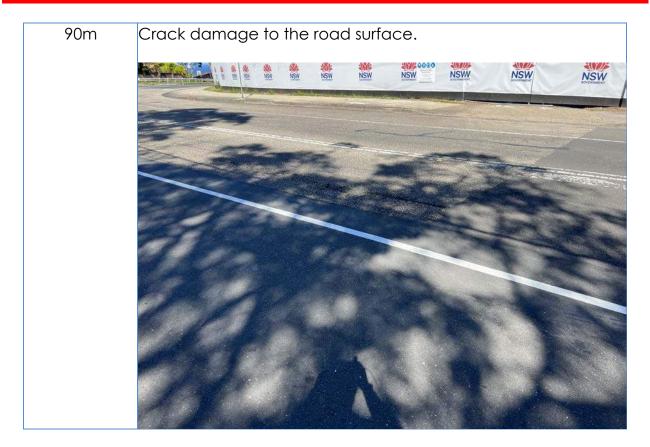
Crack damage to the road surface. NSVN
