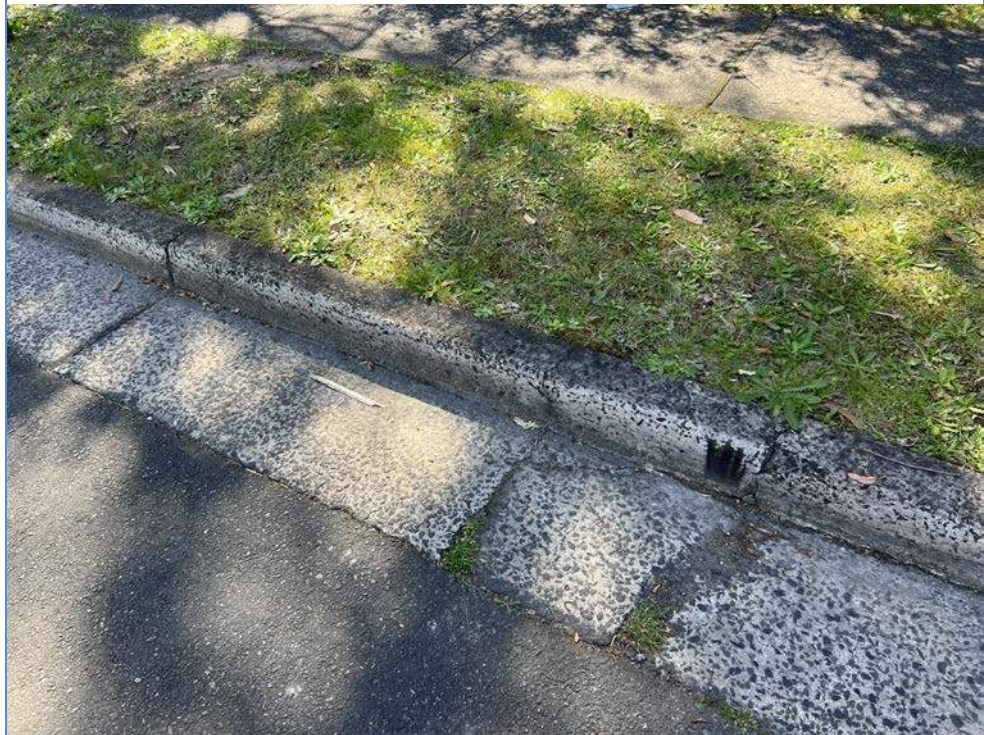
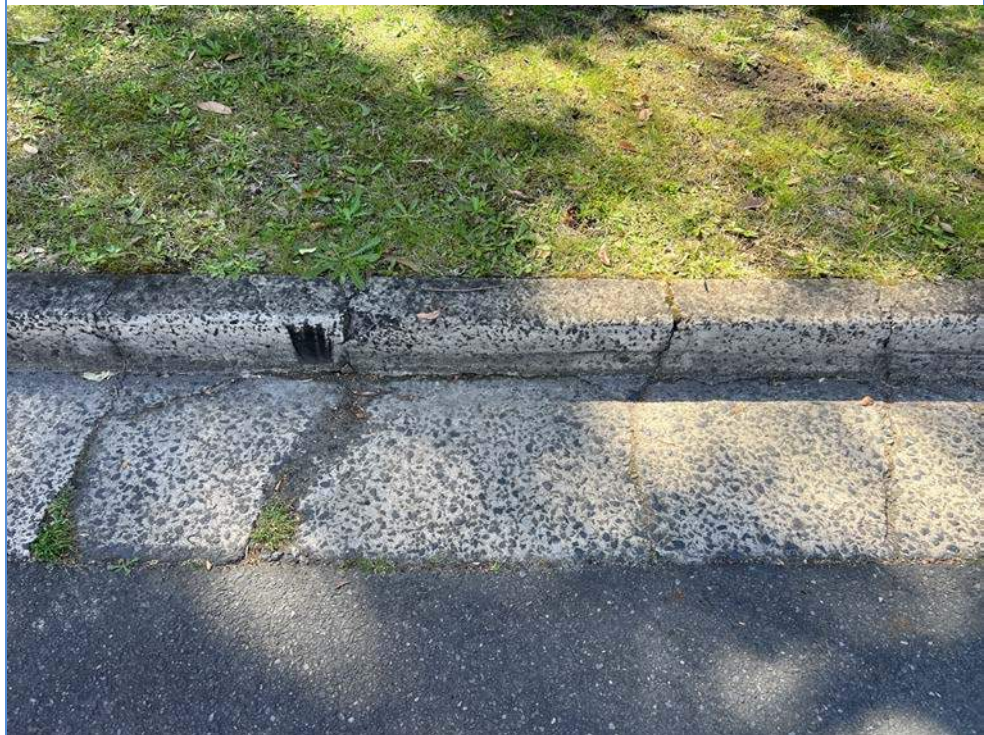
90m

Crack damage to the kerb and gutter.

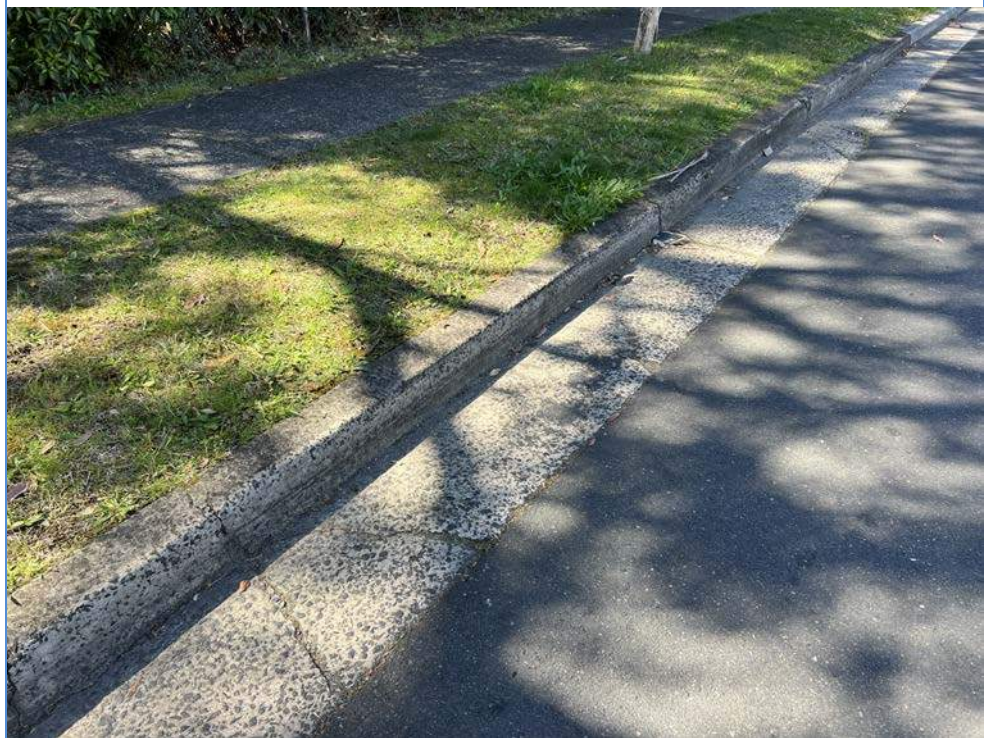
90m

Crack damage to the kerb and gutter.

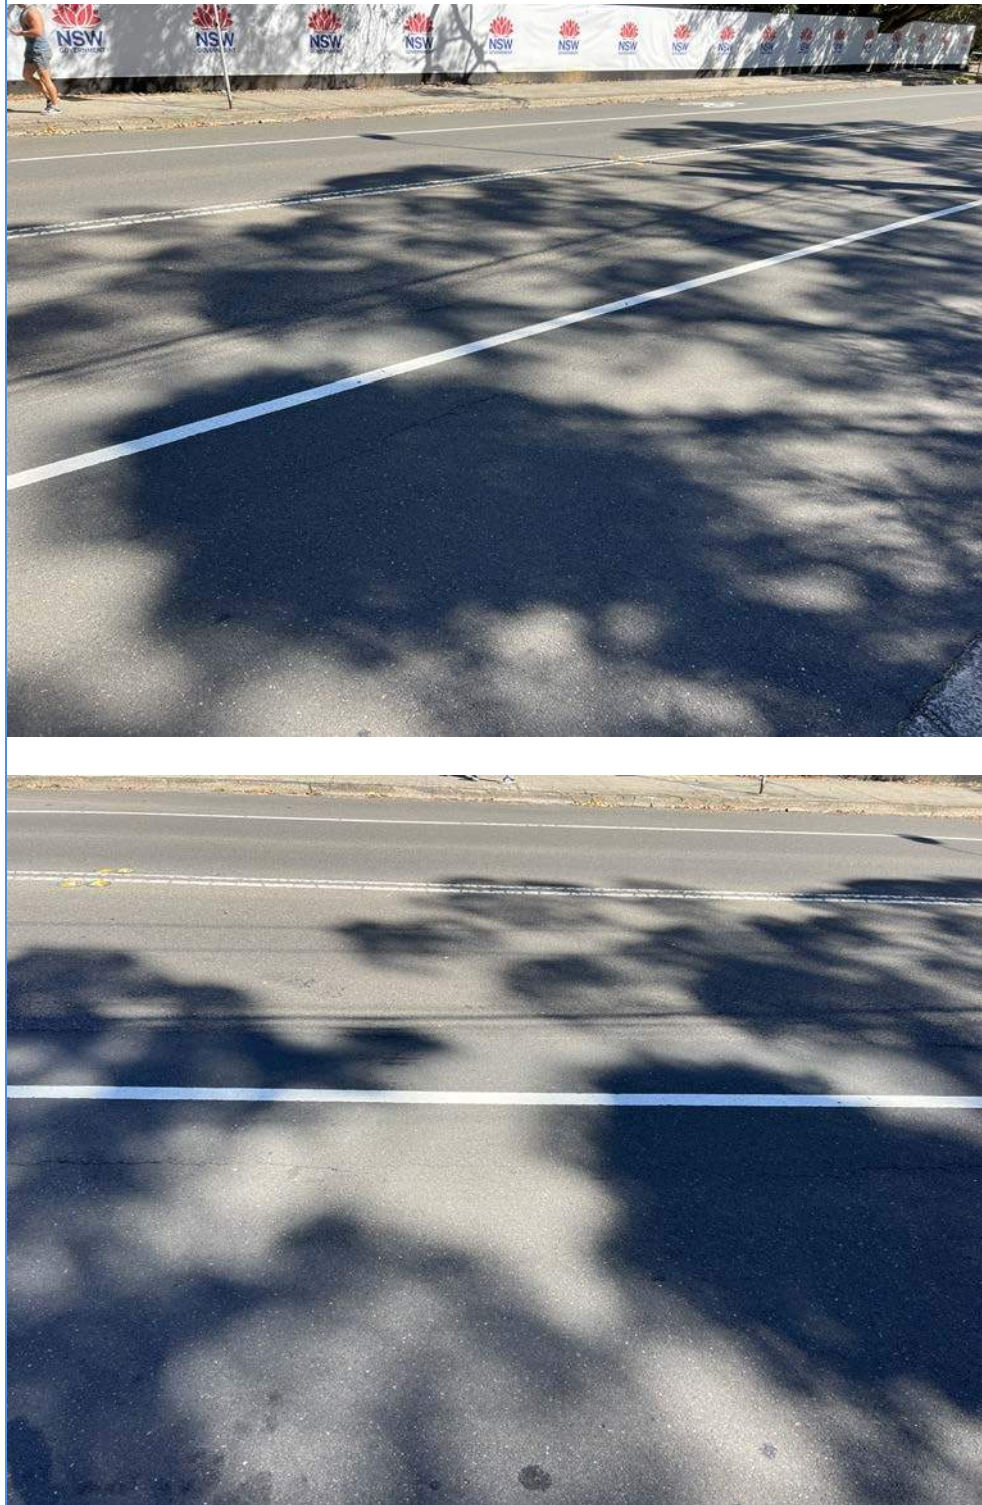
100m

Crack damage to the road surface.

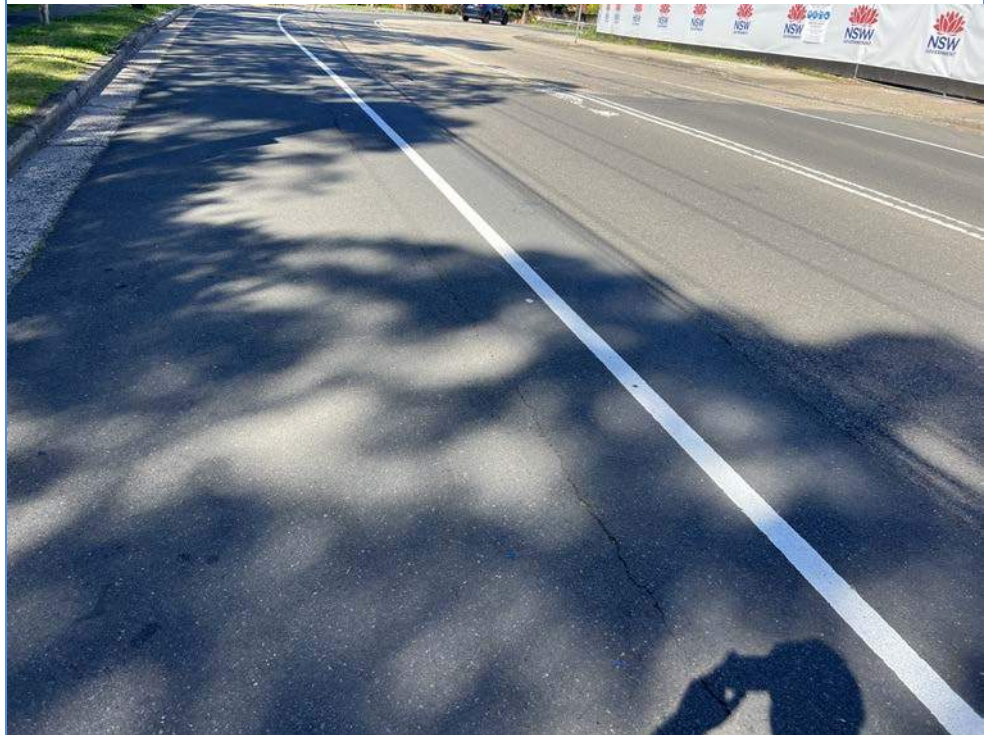
100m

Crack damage to the road surface.

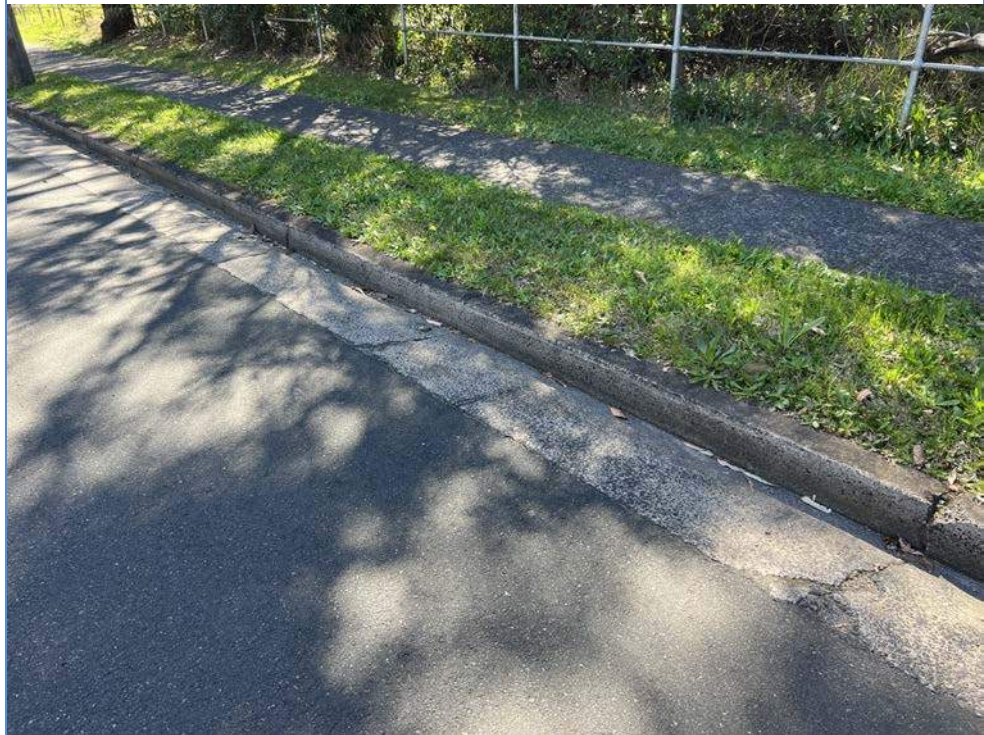
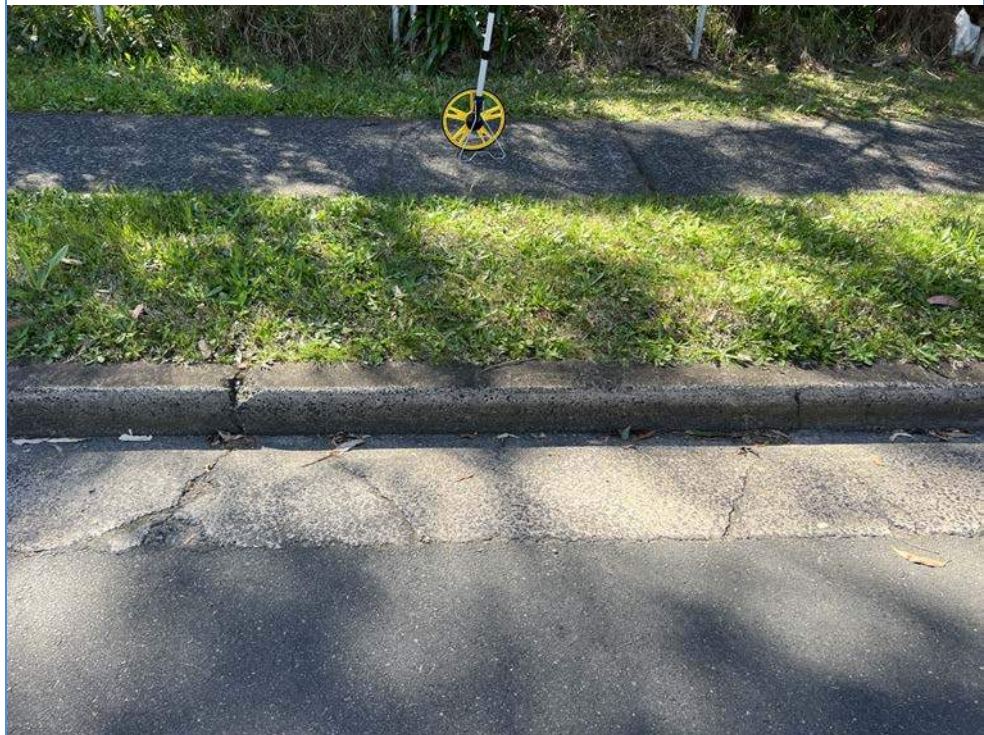
100m

Various cracks to the kerb and gutter.

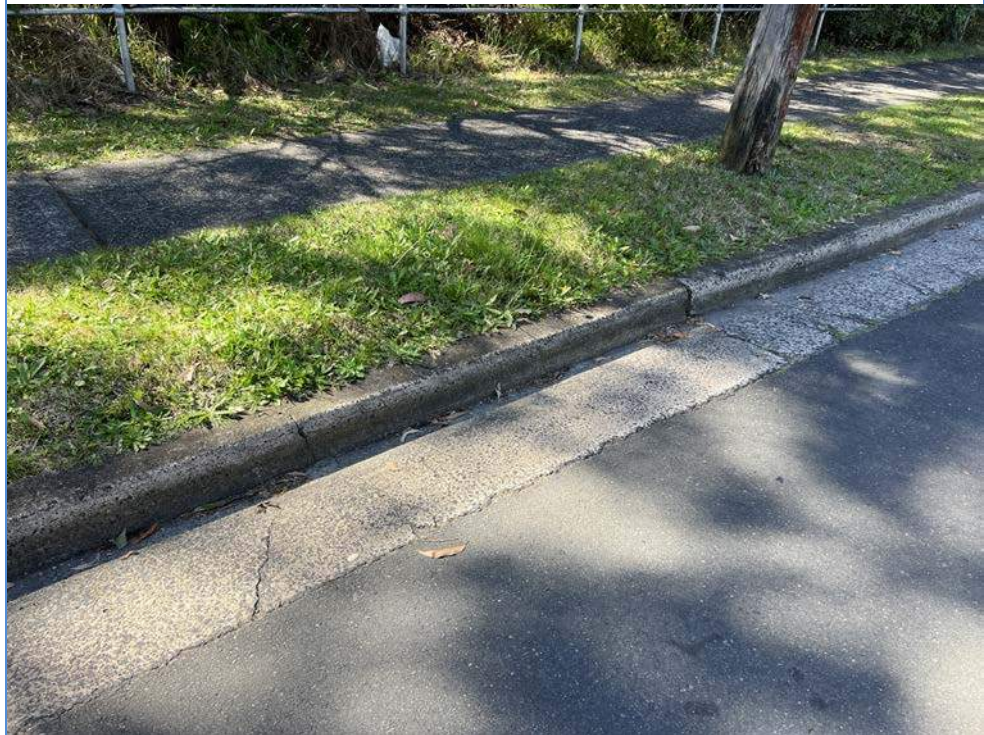
100m

Various cracks to the kerb and gutter.

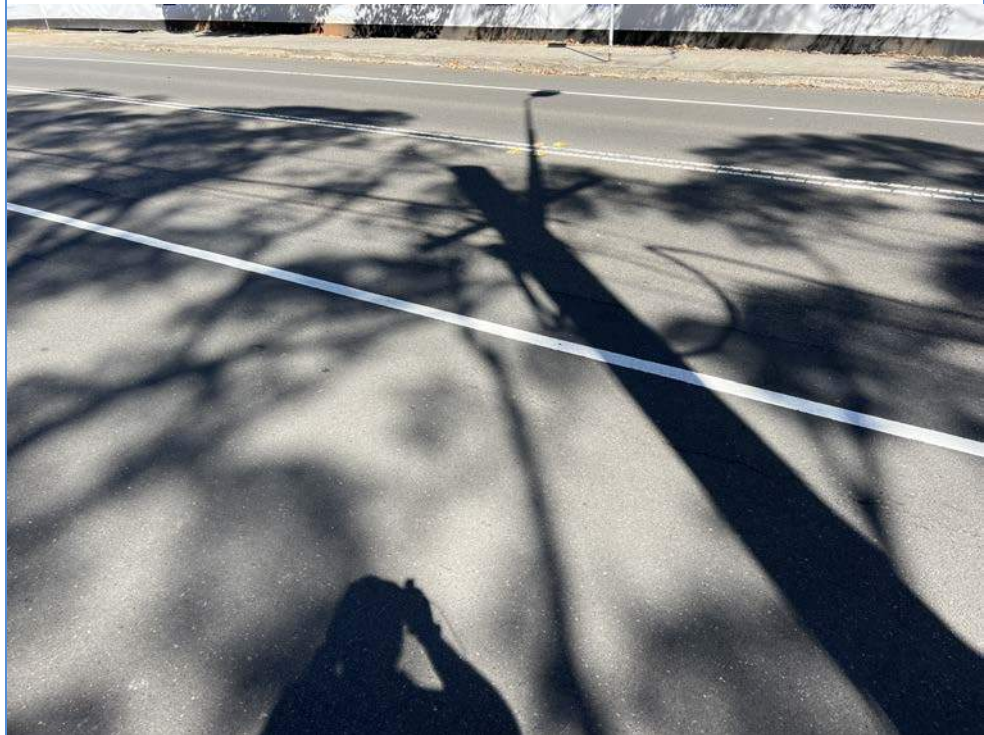
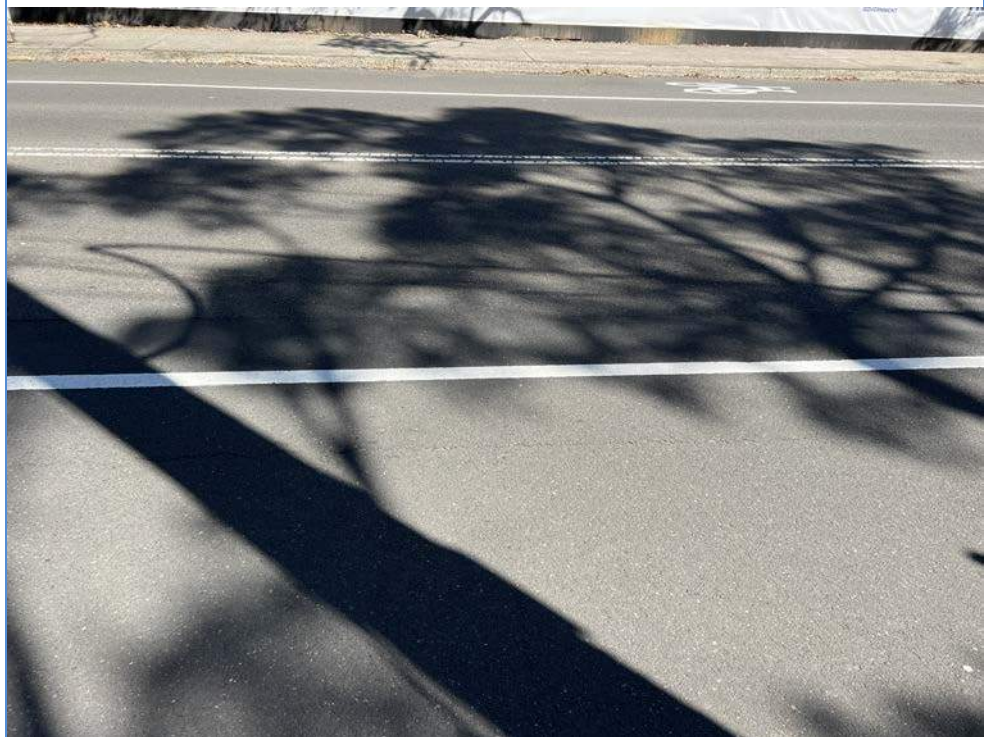
110m

Crack damage to the road surface.

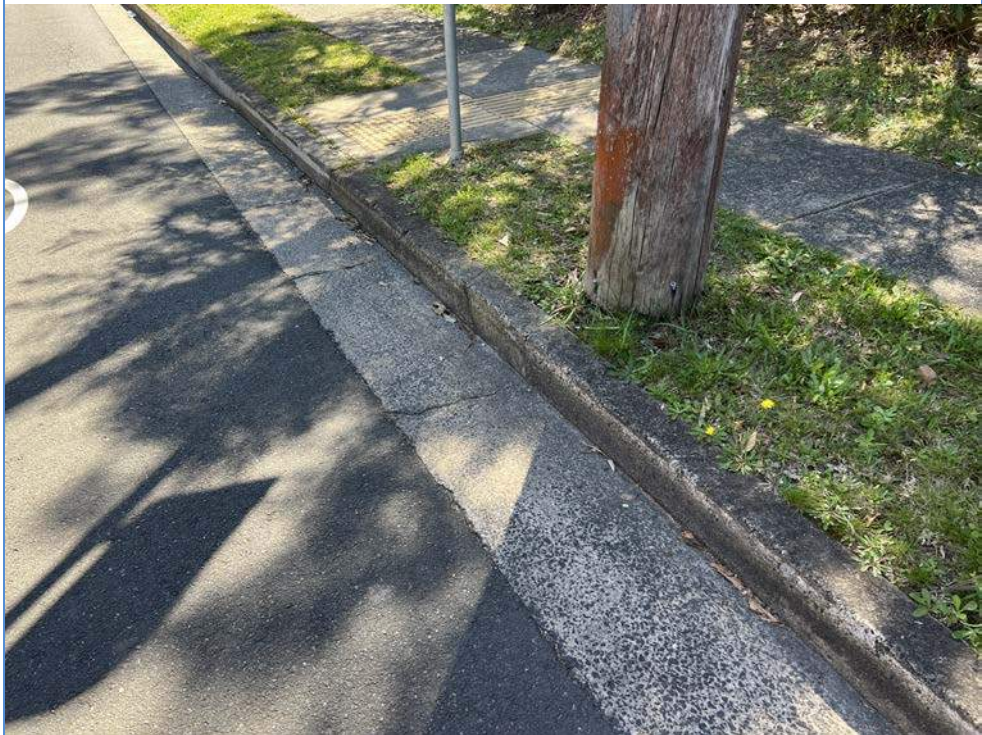
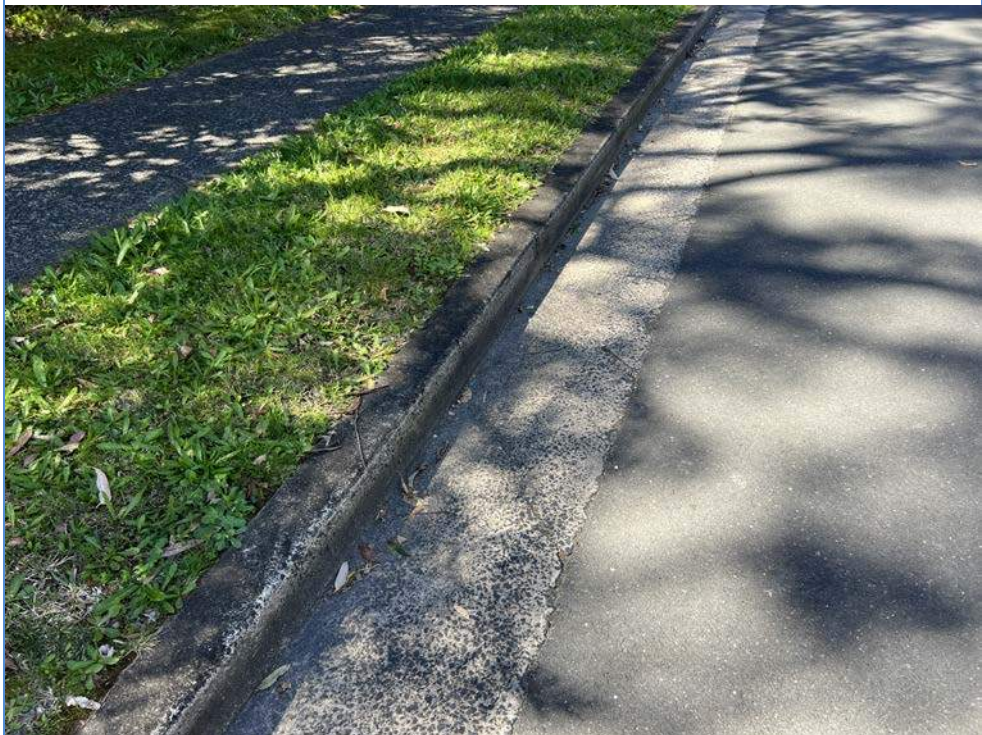
110m

Crack damage to the kerb and gutter.

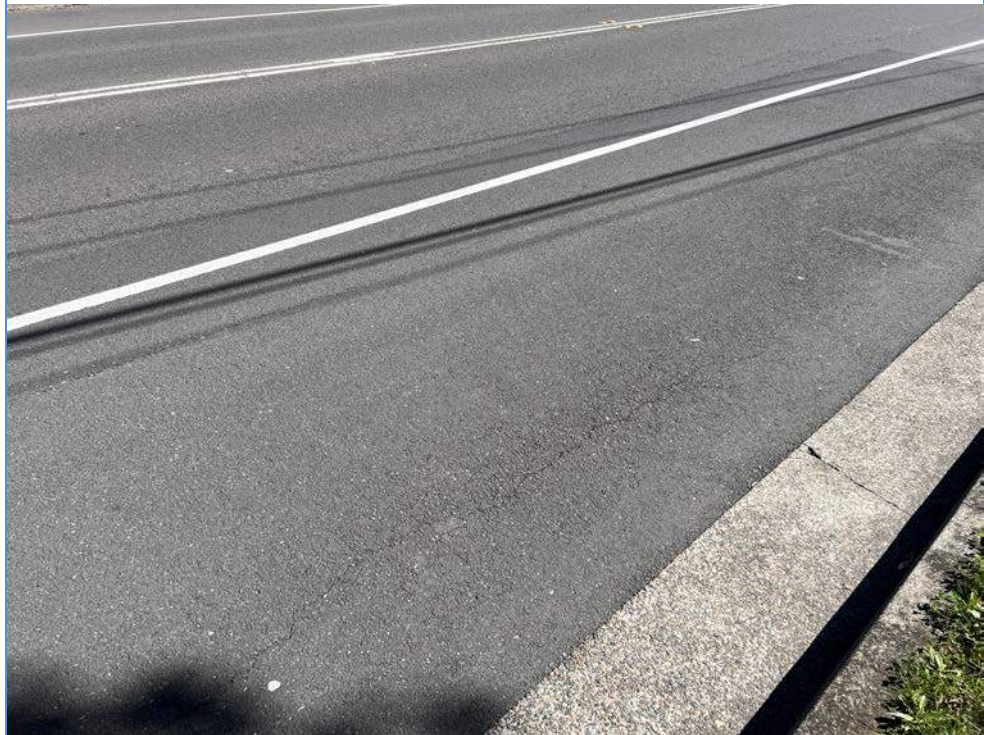
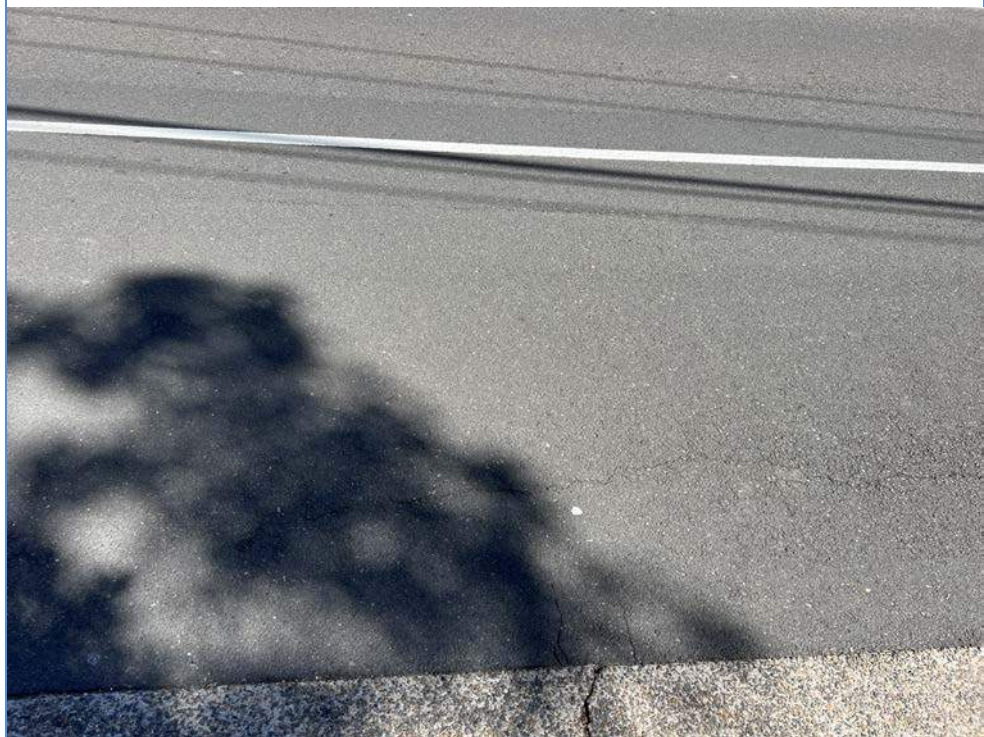
120m

Various cracks to the road surface.

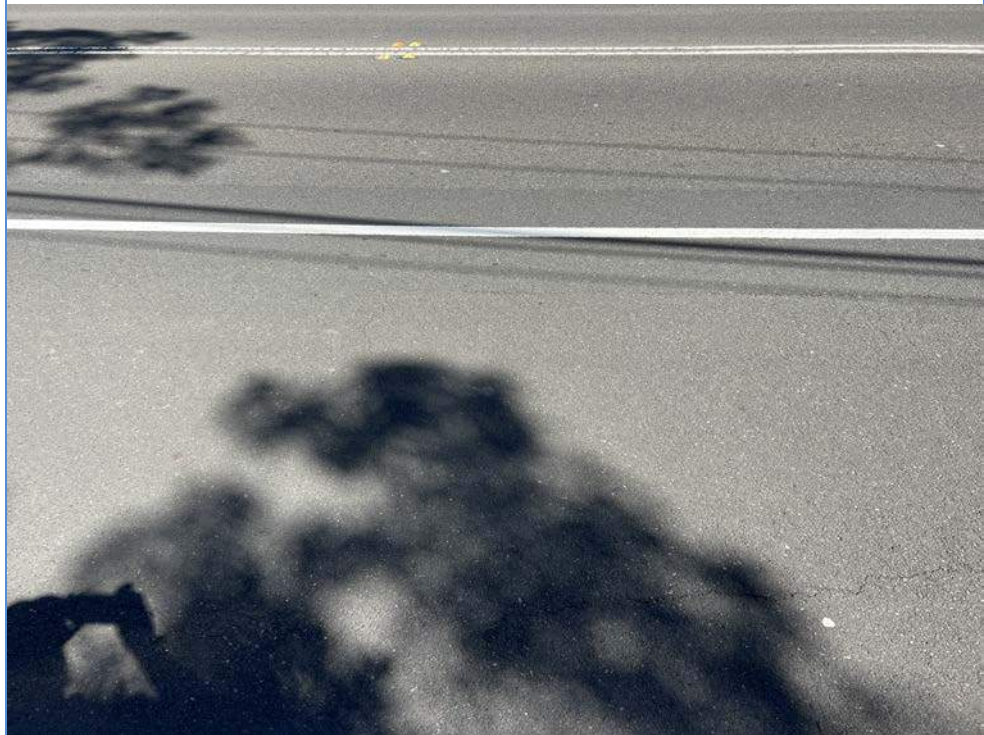
120m

Various cracks to the road surface.

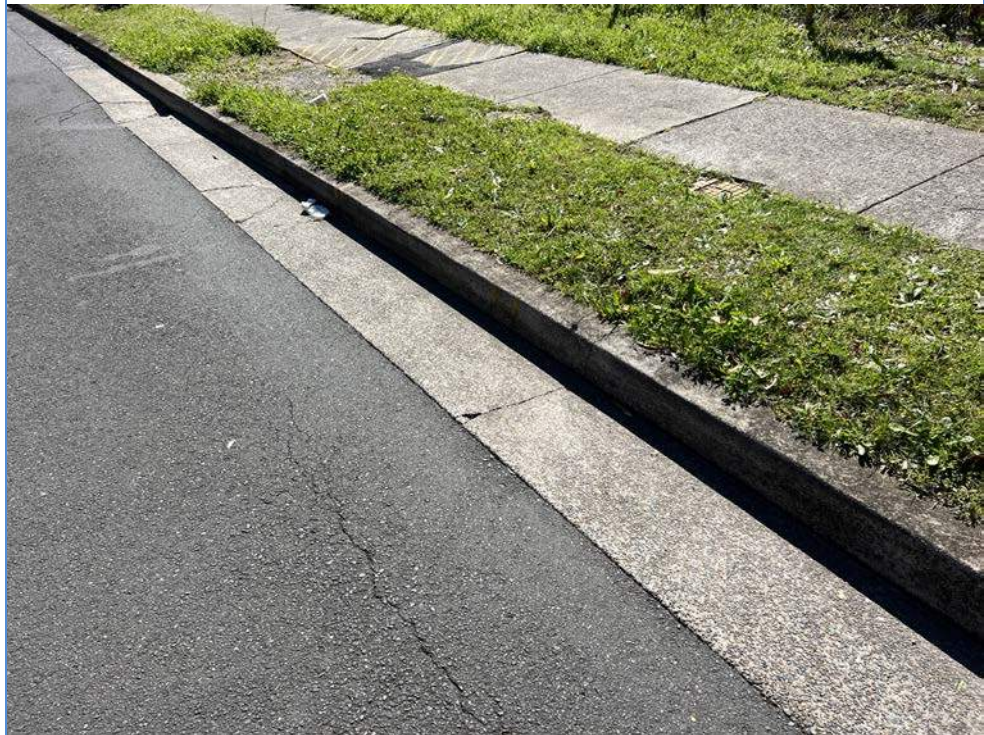
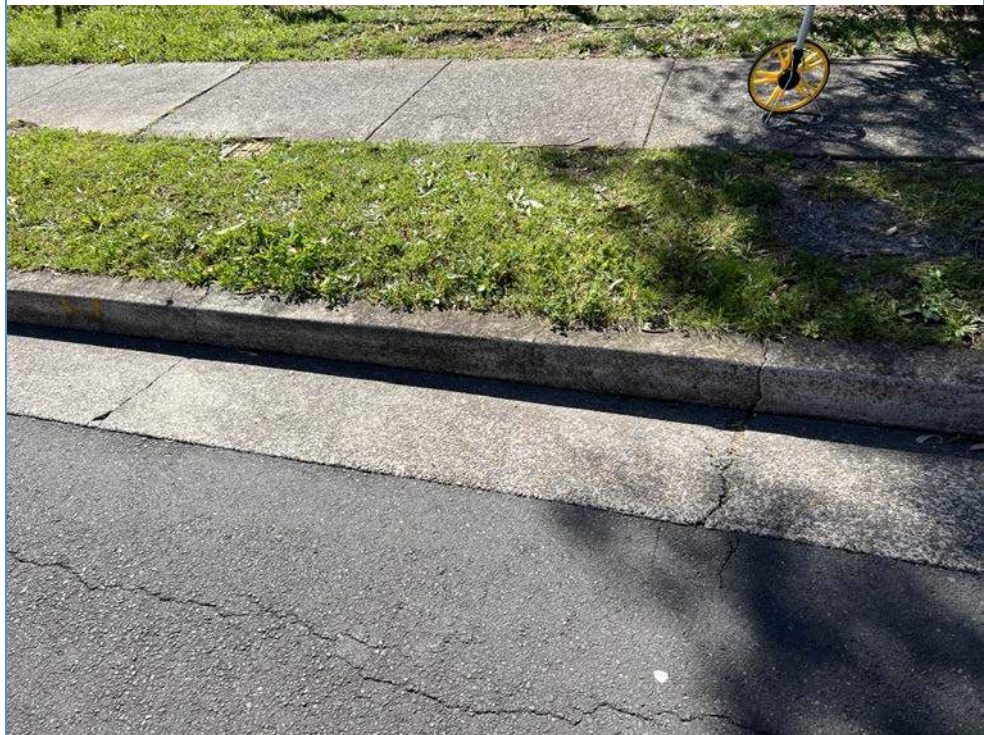
120m

Various cracks to the kerb and gutter.

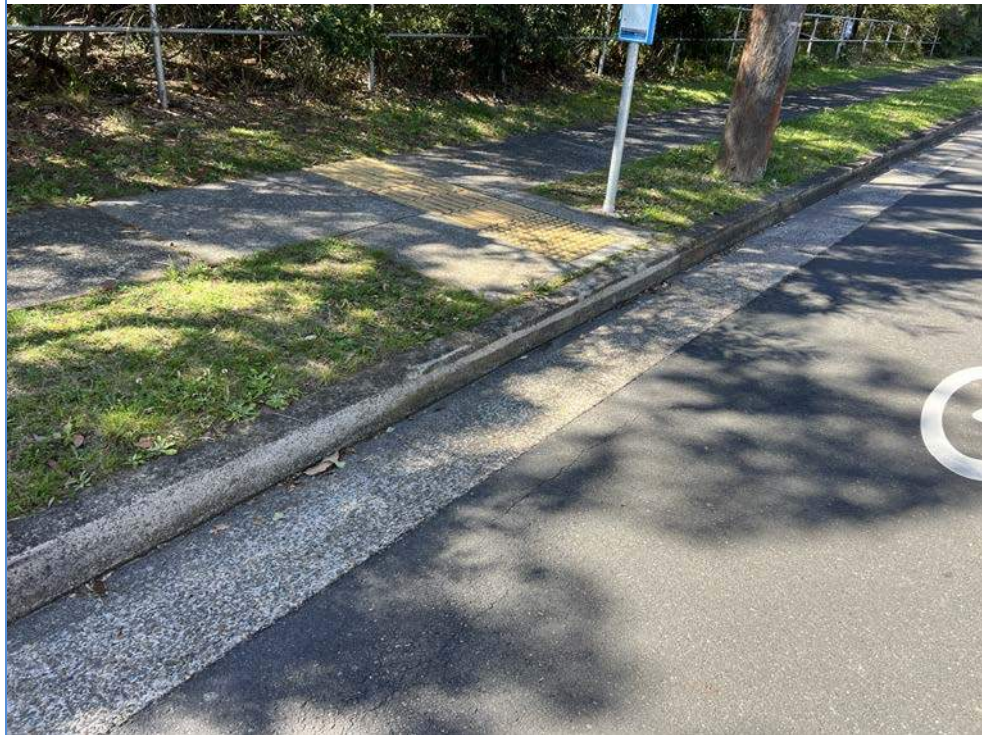
120m

Various cracks to the kerb and gutter.

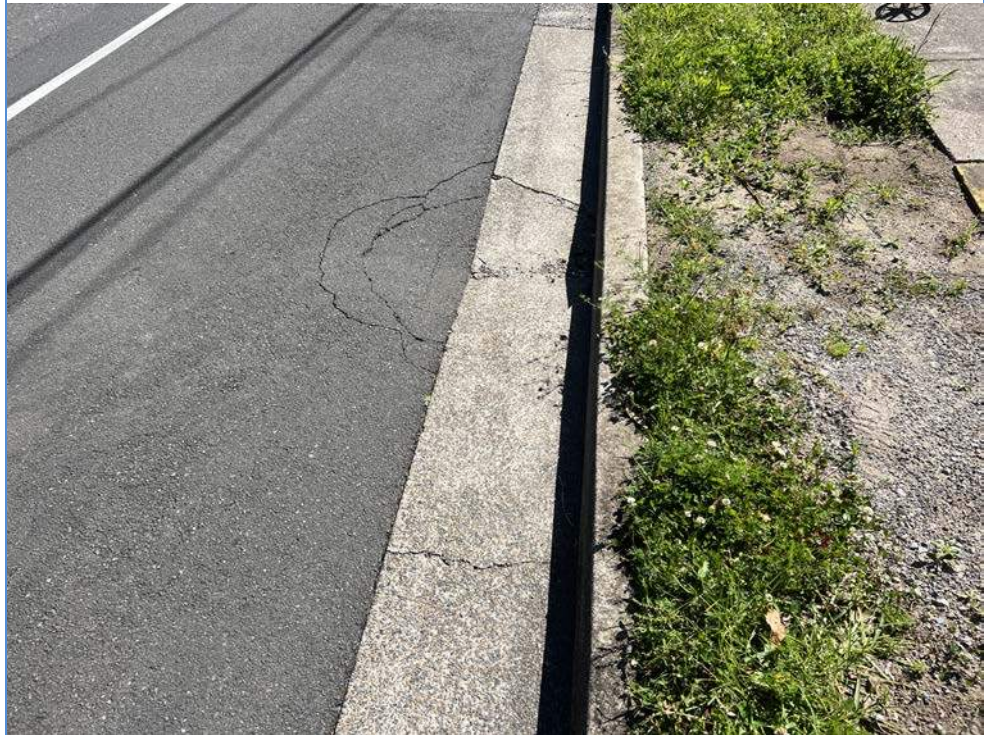
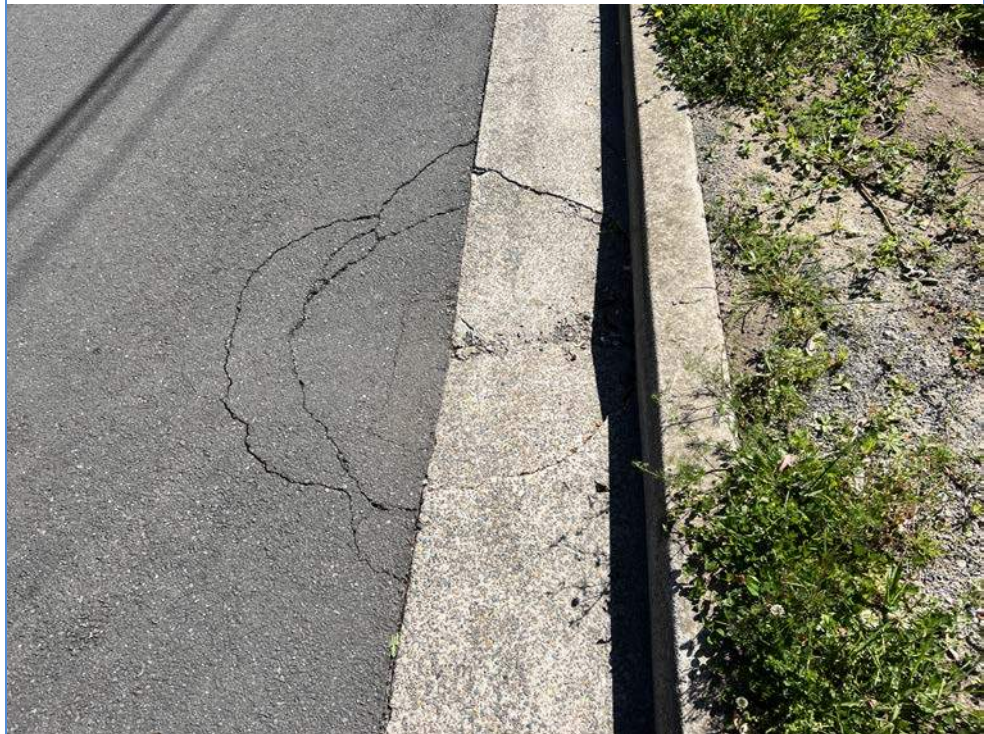
130m

Crack damage and subsidence to the road surface and gutter.

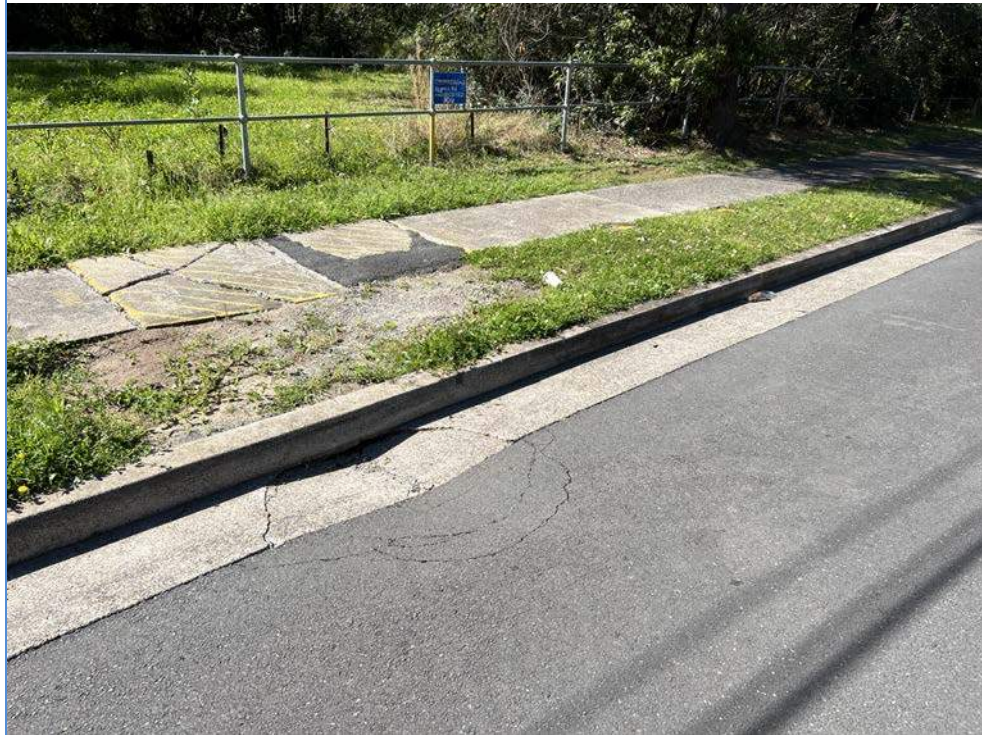
130m

Crack damage and subsidence to the road surface and gutter.

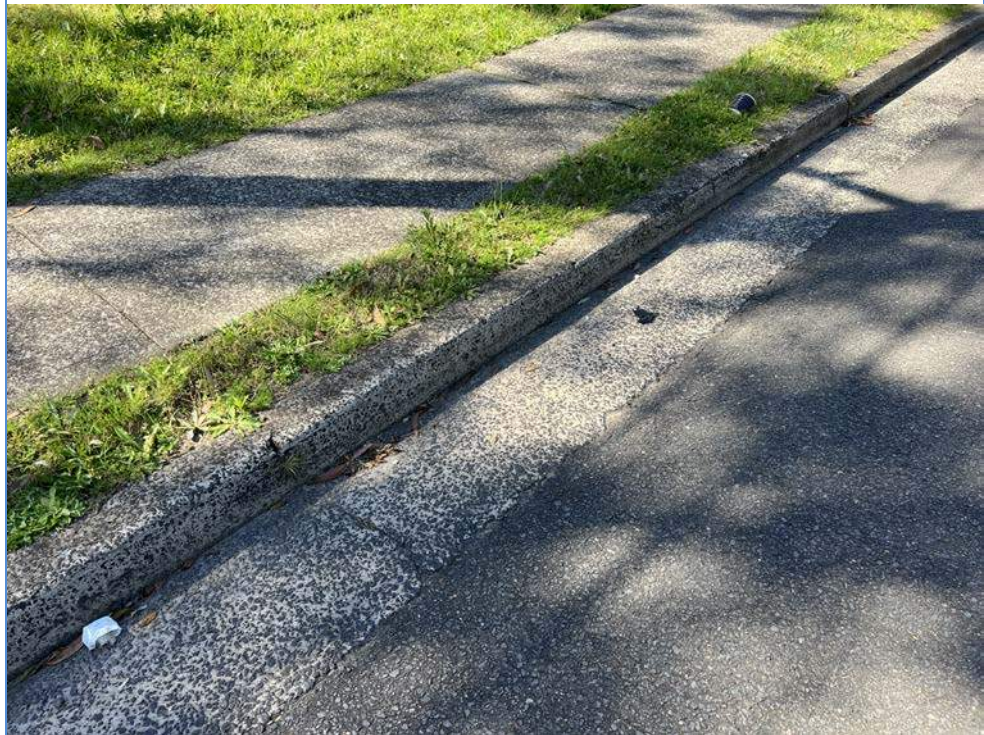
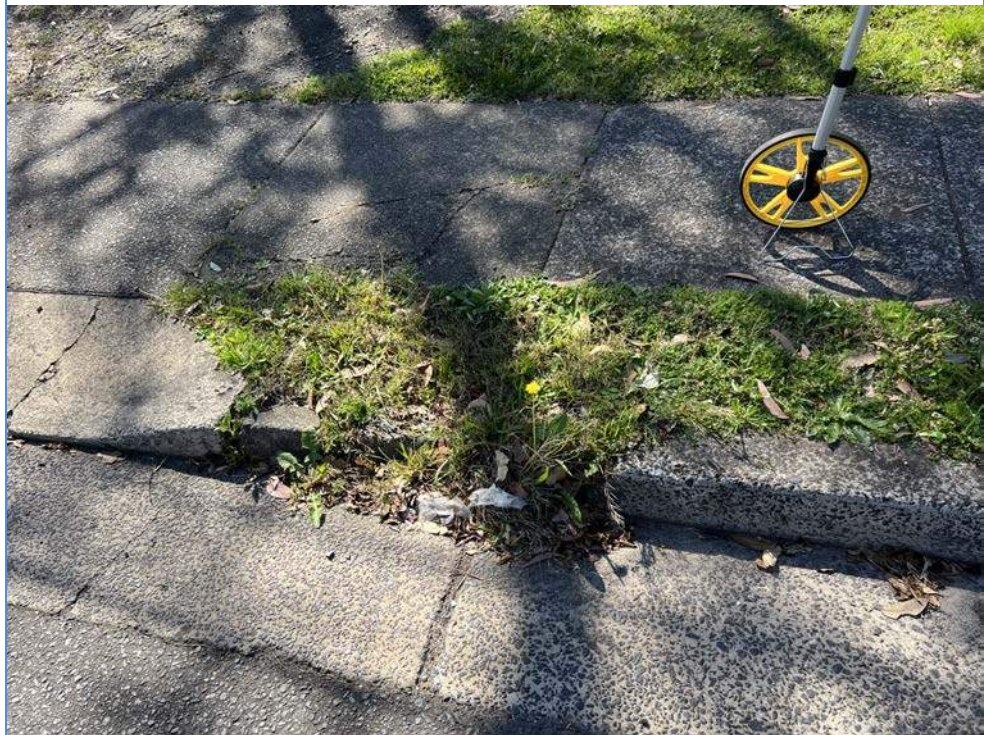
150m

Crack damage to the kerb and gutter.

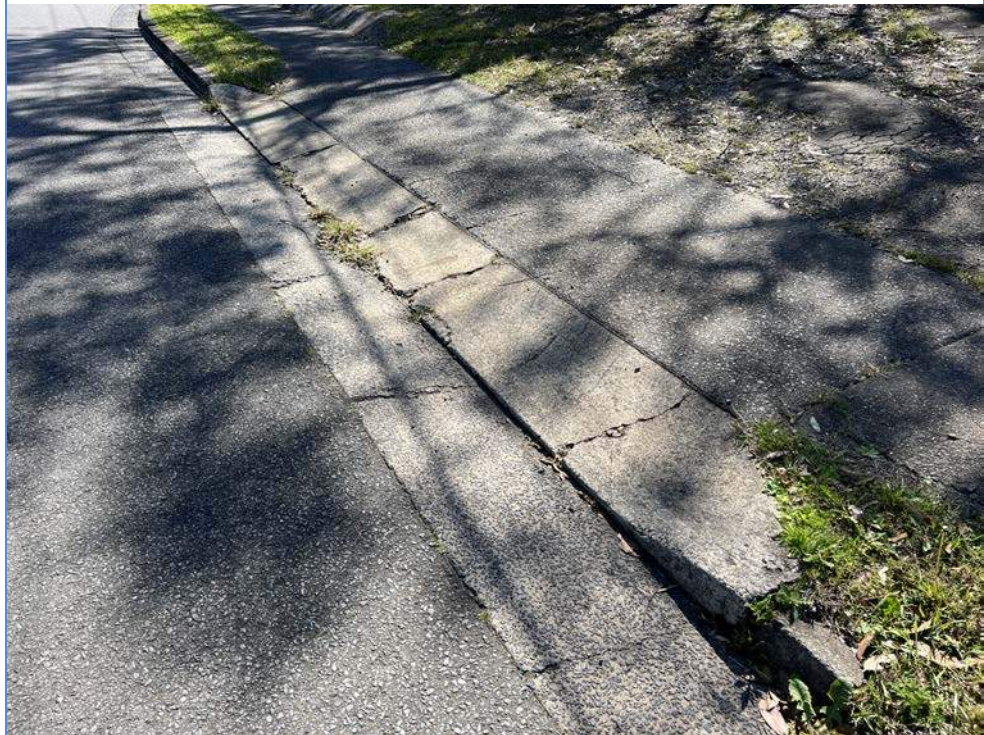
150m

Crack damage to the kerb and gutter.

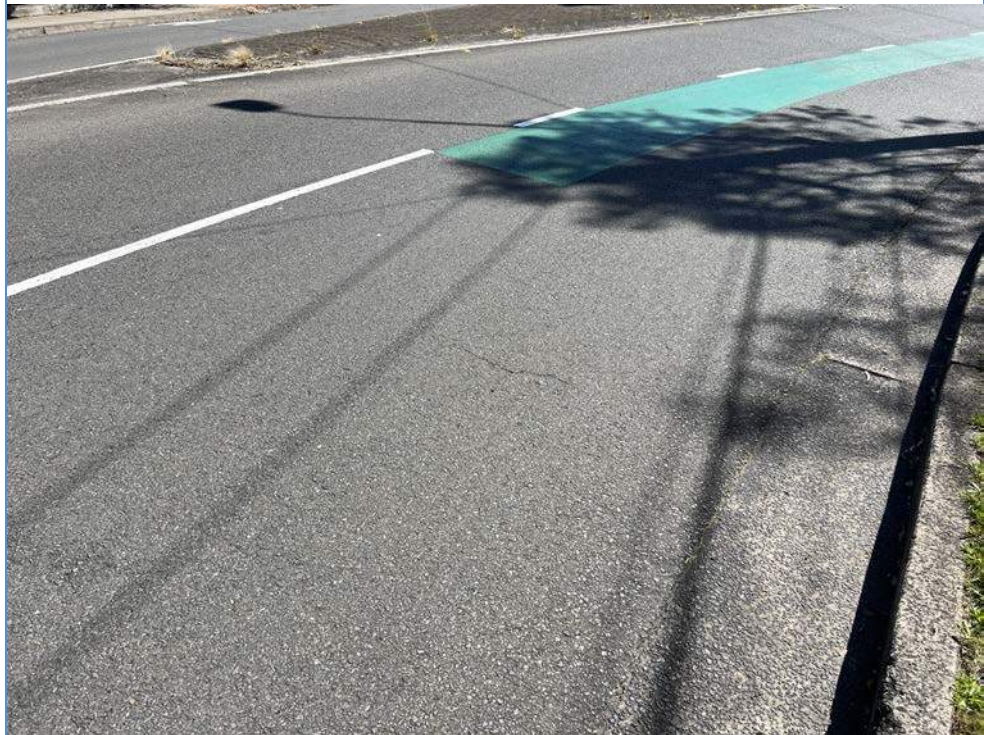
170m

Crack damage to the road surface.

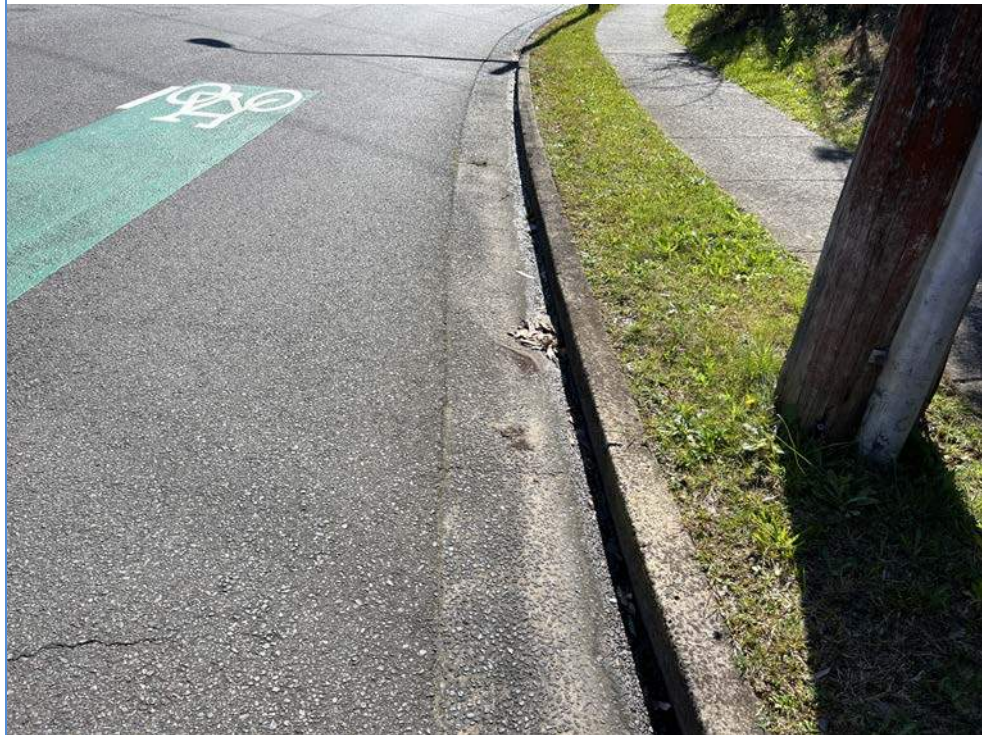
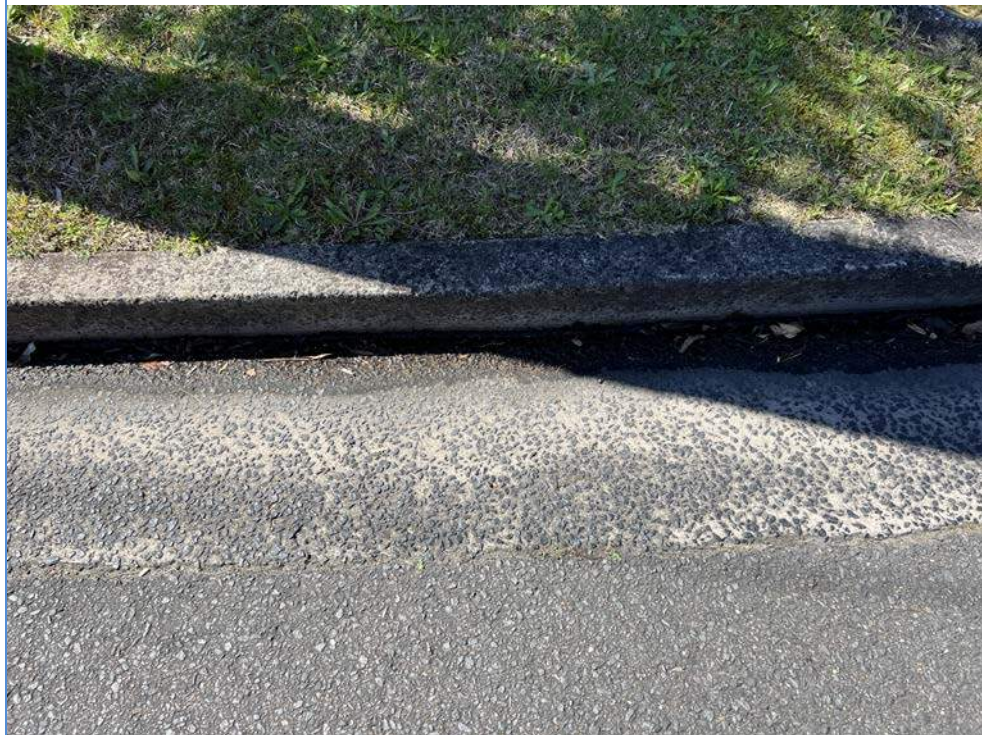
180m

Crack damage to the kerb and gutter.
