The following inspection is of the road surface to the south side of Allambie Road starting at the intersection of Aquatic Drive and Allambie Road at the roundabout, heading in a westerly direction and finishing at the driveway entrance to Arranounbai School.

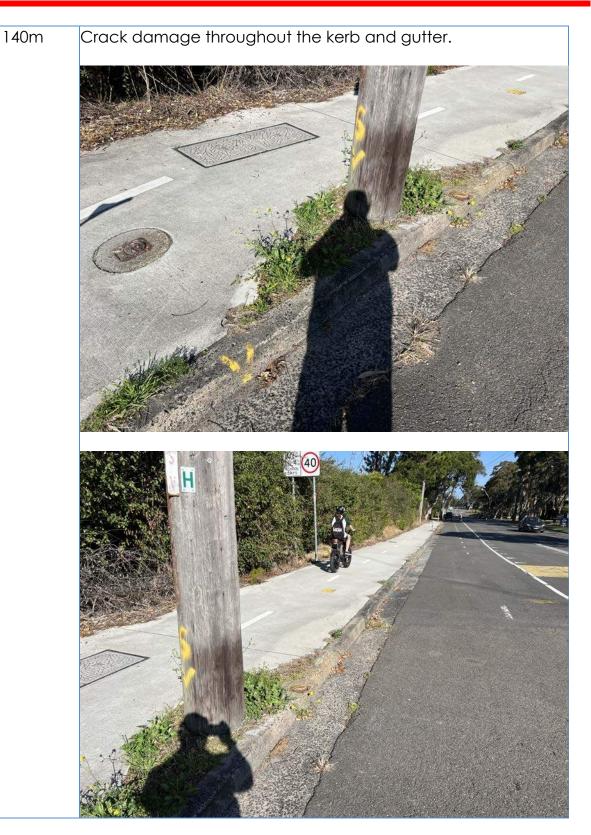
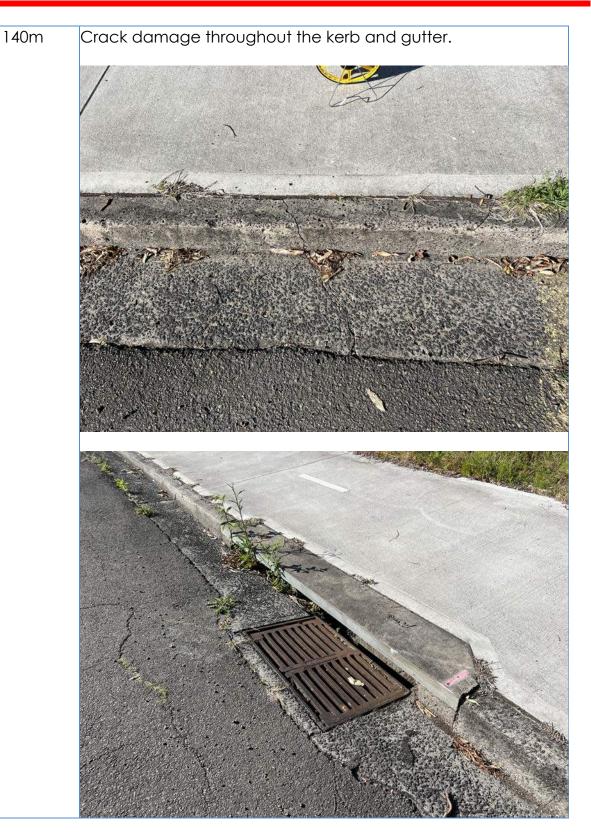
Crack damage throughout the kerb and gutter.

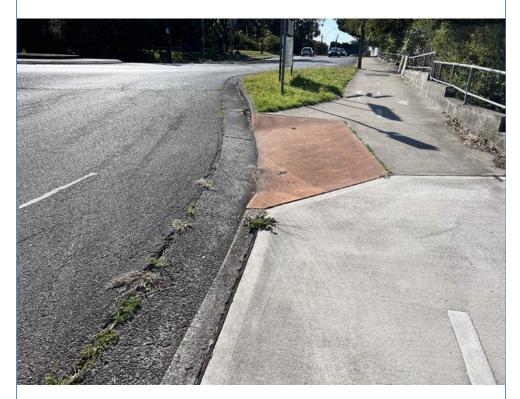
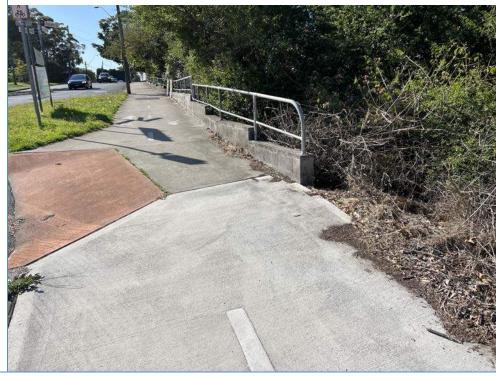
150m General views of the footpath, kerb and gutter.

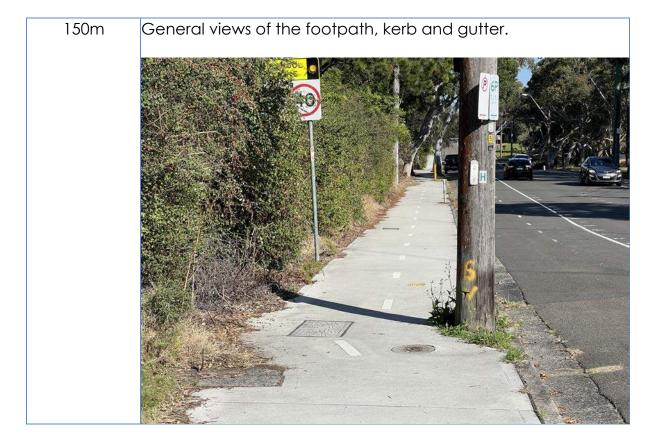
150m General views of the footpath, kerb and gutter.

Crack damage throughout the kerb and gutter.

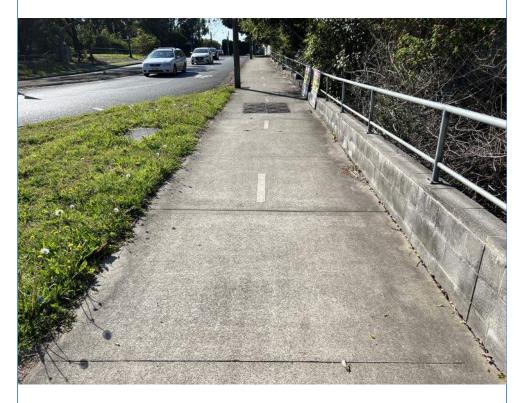
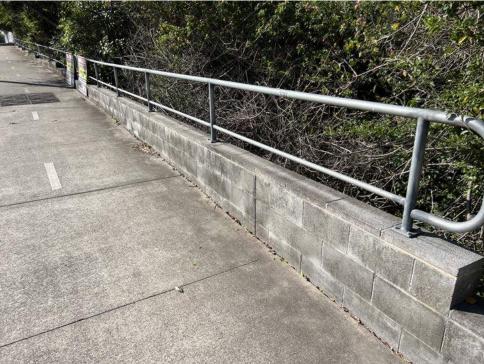
General views of the footpath, kerb and gutter at the end point.

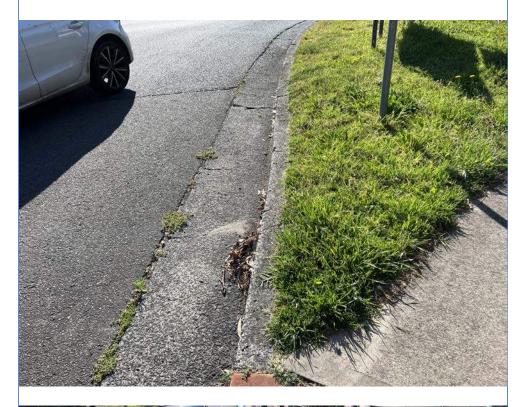
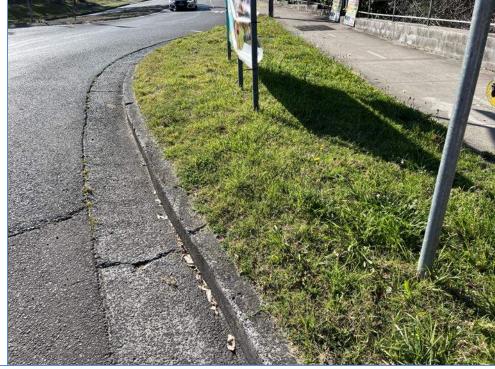
Crack damage throughout the kerb and gutter at the end point.

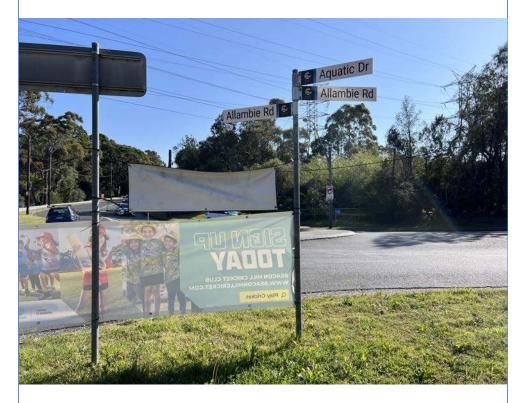
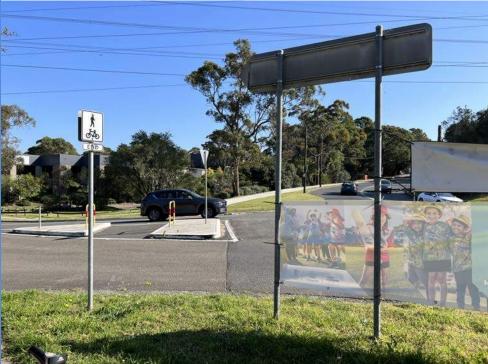
Views of the street signs at the intersection of Aquatic Drive and Allambie Road.

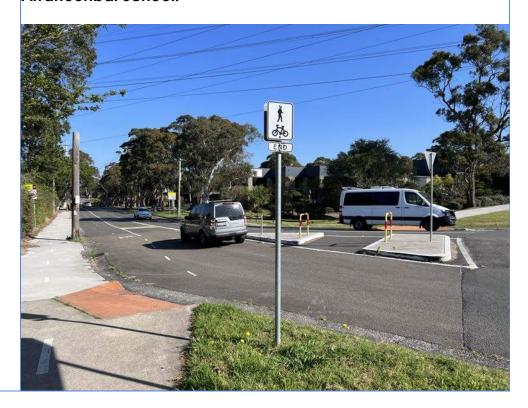
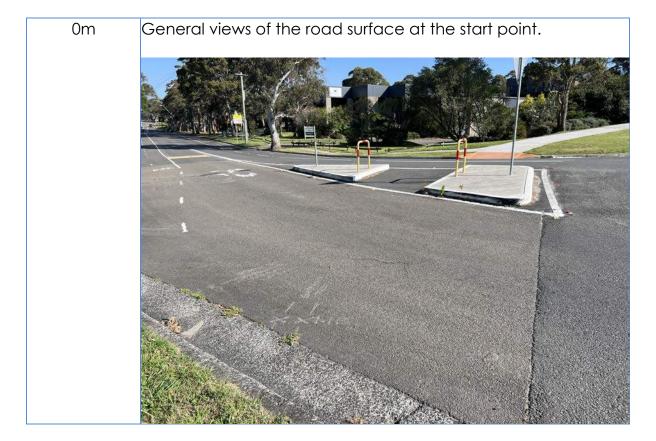
General views of the road surface at the start point.

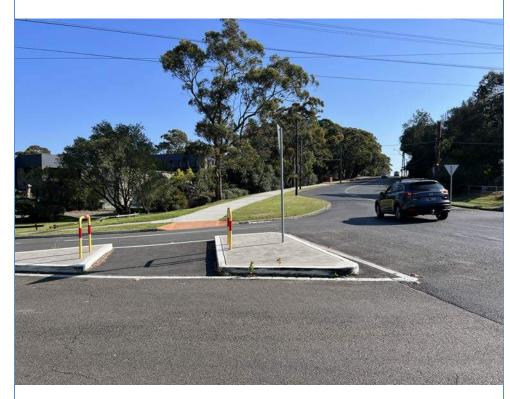
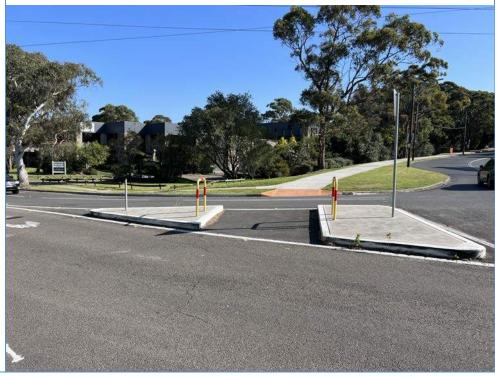
5m Views of the median strip and street sign.

Views of the median strip and street sign.

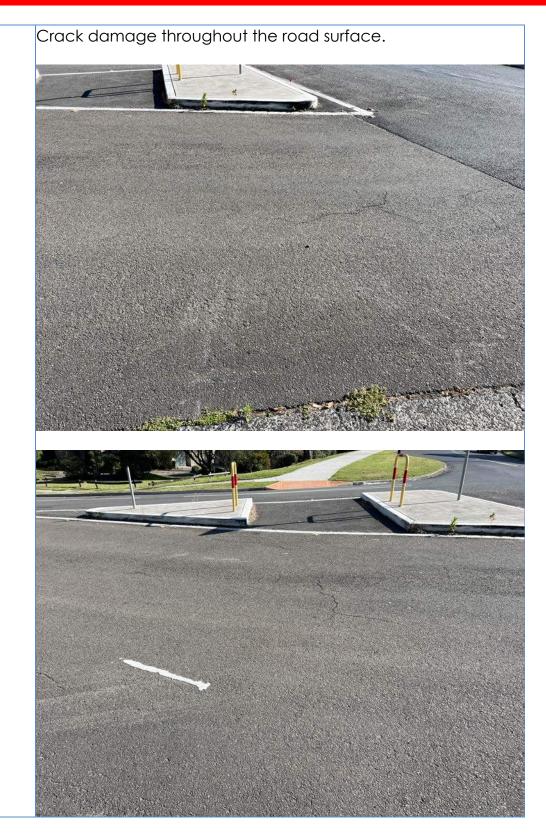
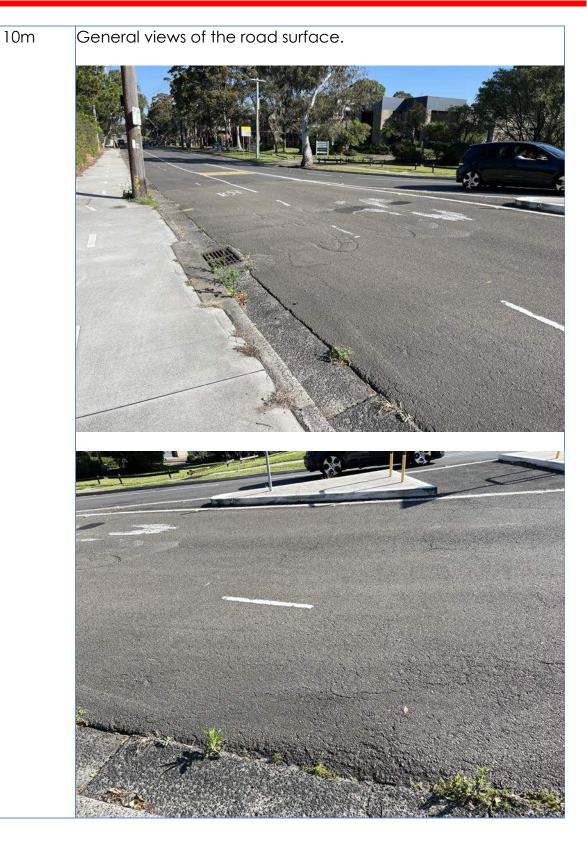
General views of the road surface.
