Notable Items – Section 5

Arranounbai School:

The following inspection is of the driveway and footpath leading from Aquatic Drive through to the Arranounbai School.

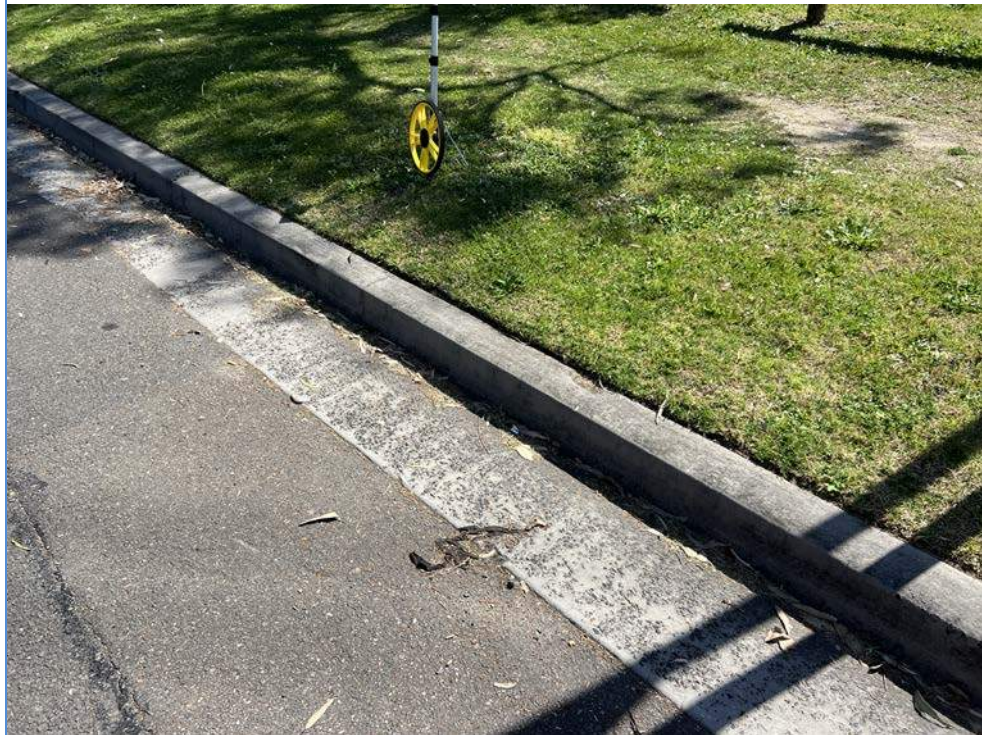
100m

Crack damage to the kerb and gutter.

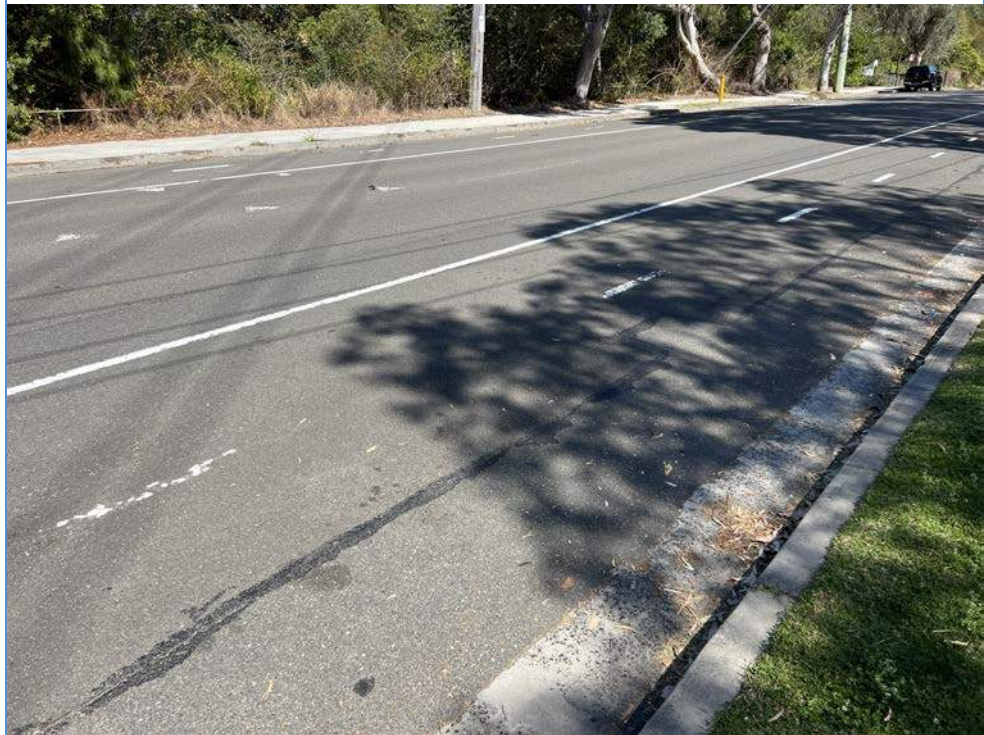
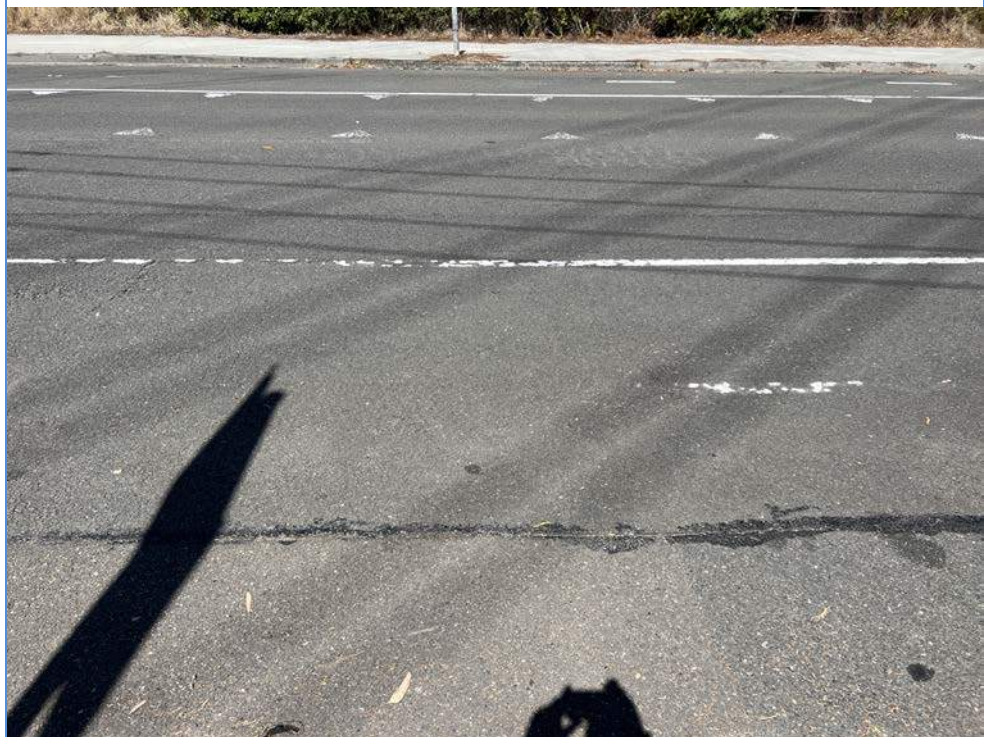
100m

Crocodile cracking to the road surface.

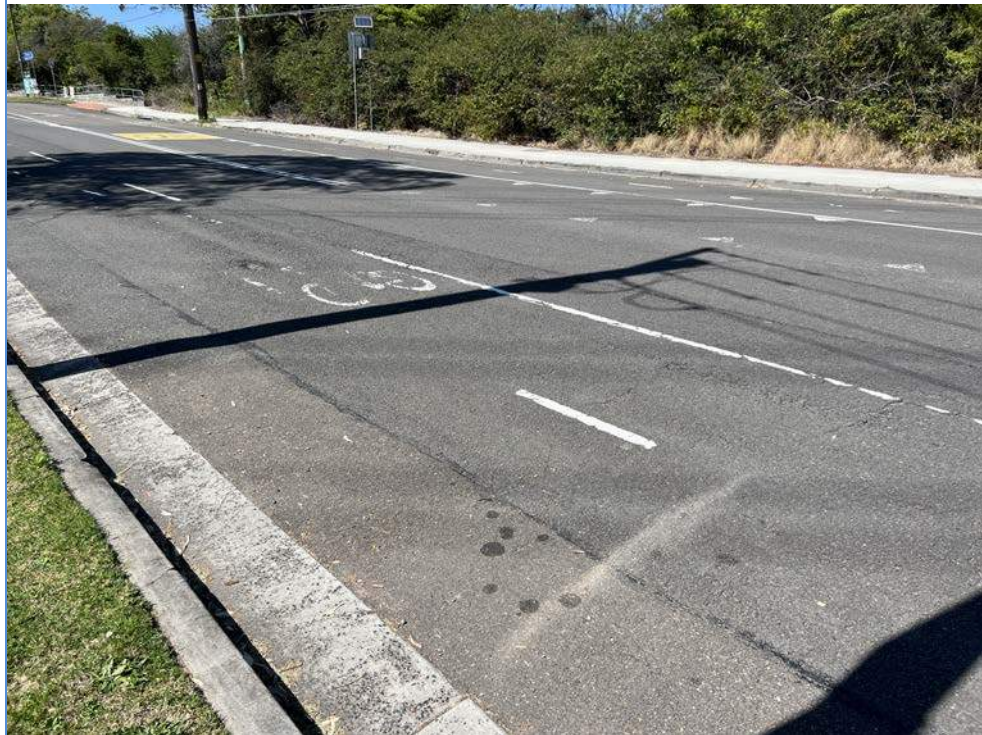
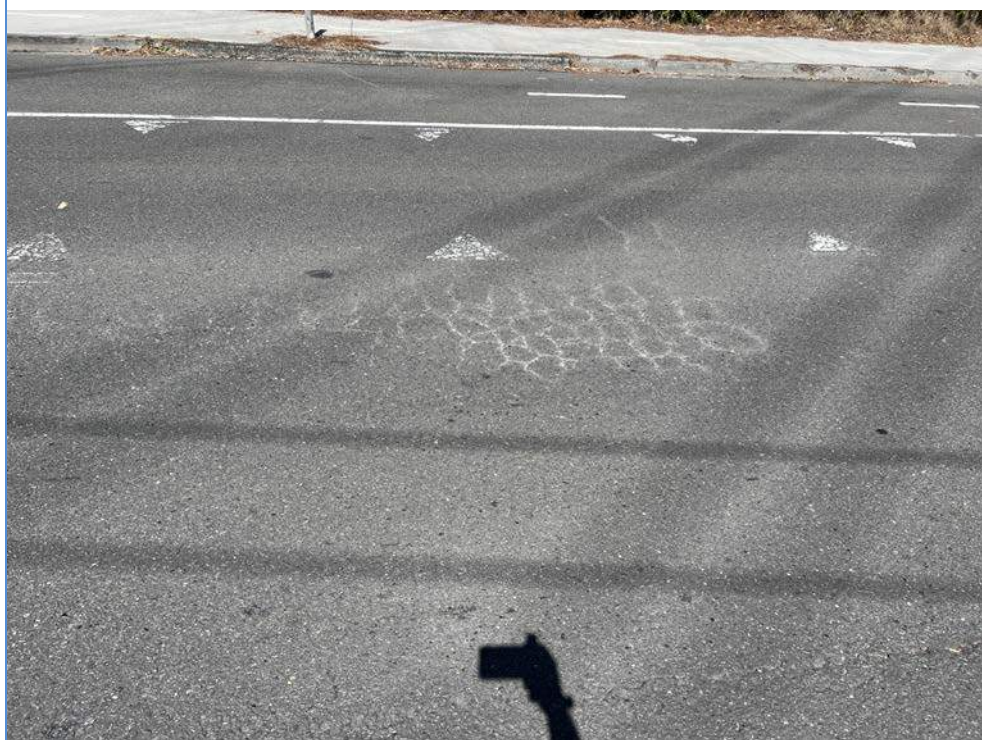
100m

Crocodile cracking to the road surface.

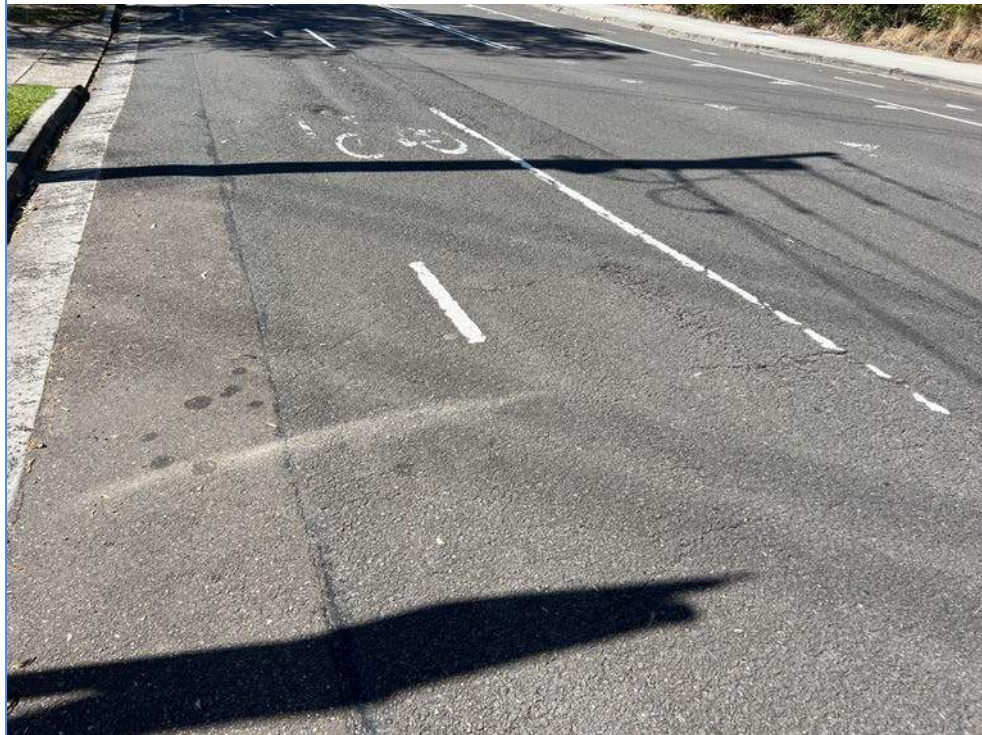
100m

Crocodile cracking to the road surface.

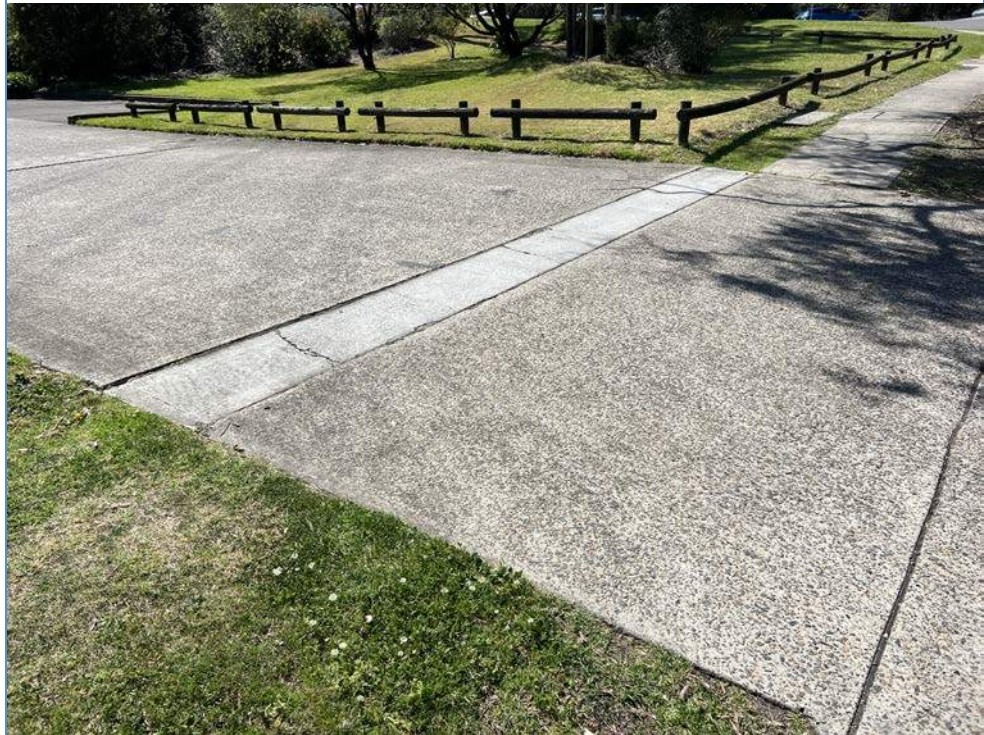
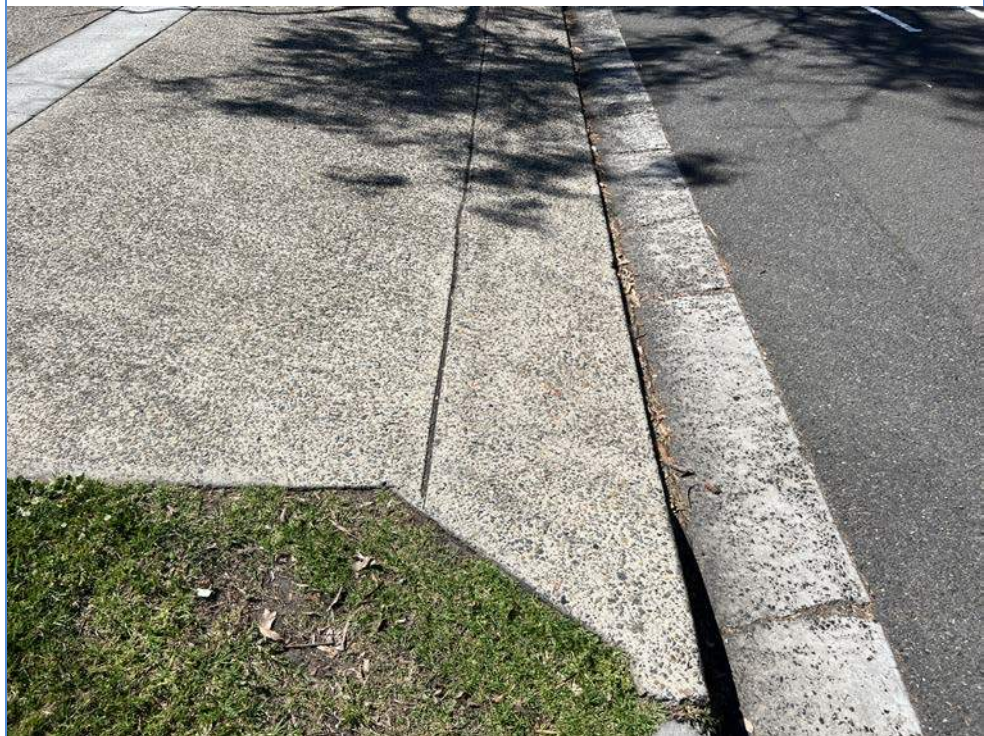
Crack damage throughout the driveway crossover, layback and gutter servicing number 2 Aquatic Drive.

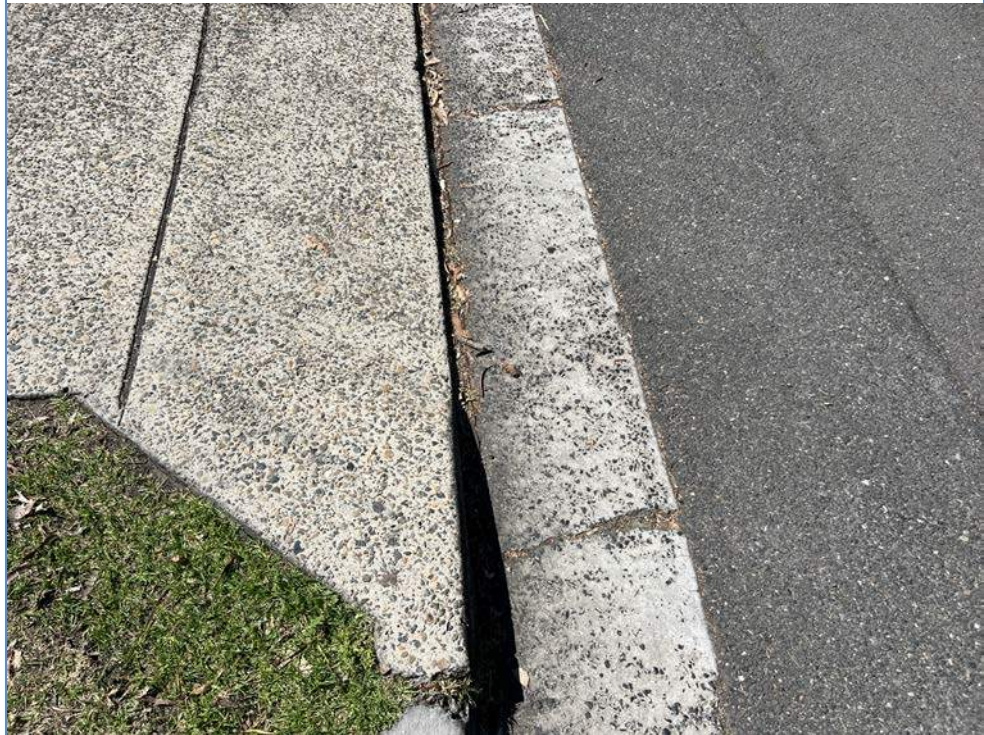
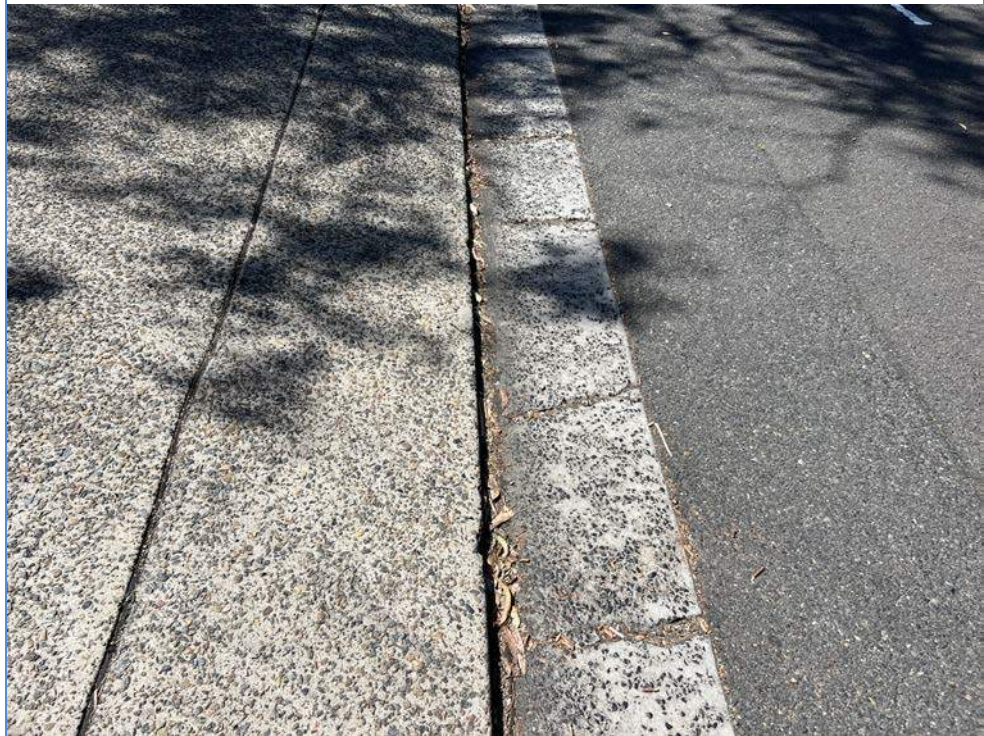
Crack damage throughout the driveway crossover, layback and gutter servicing number 2 Aquatic Drive.

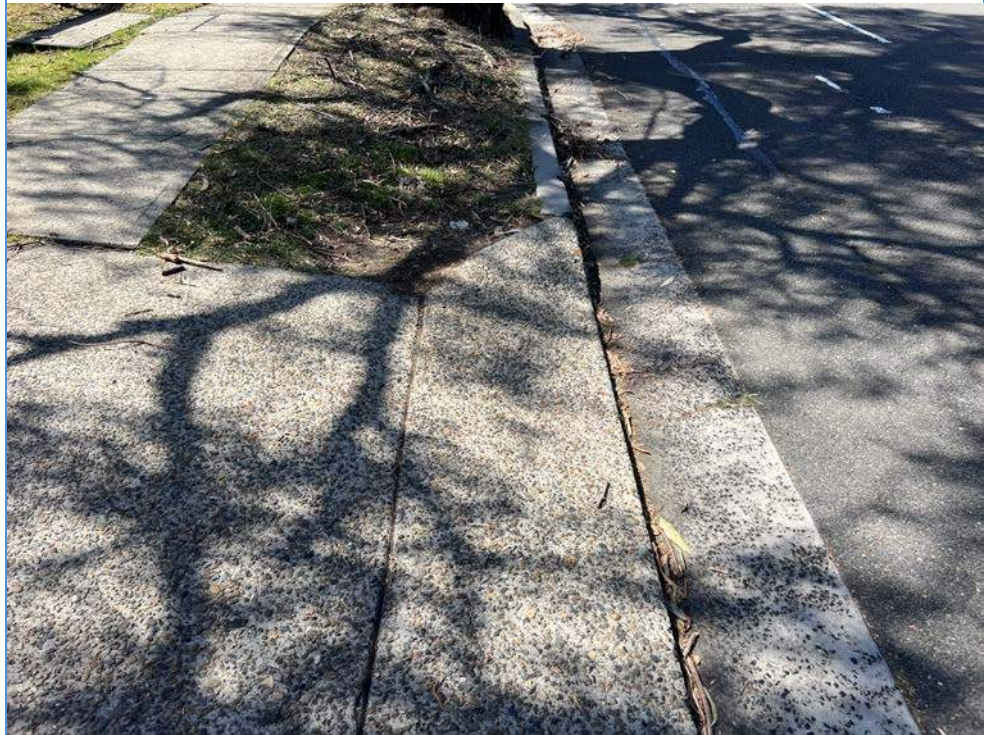
Crack damage throughout the driveway crossover, layback and gutter servicing number 2 Aquatic Drive.

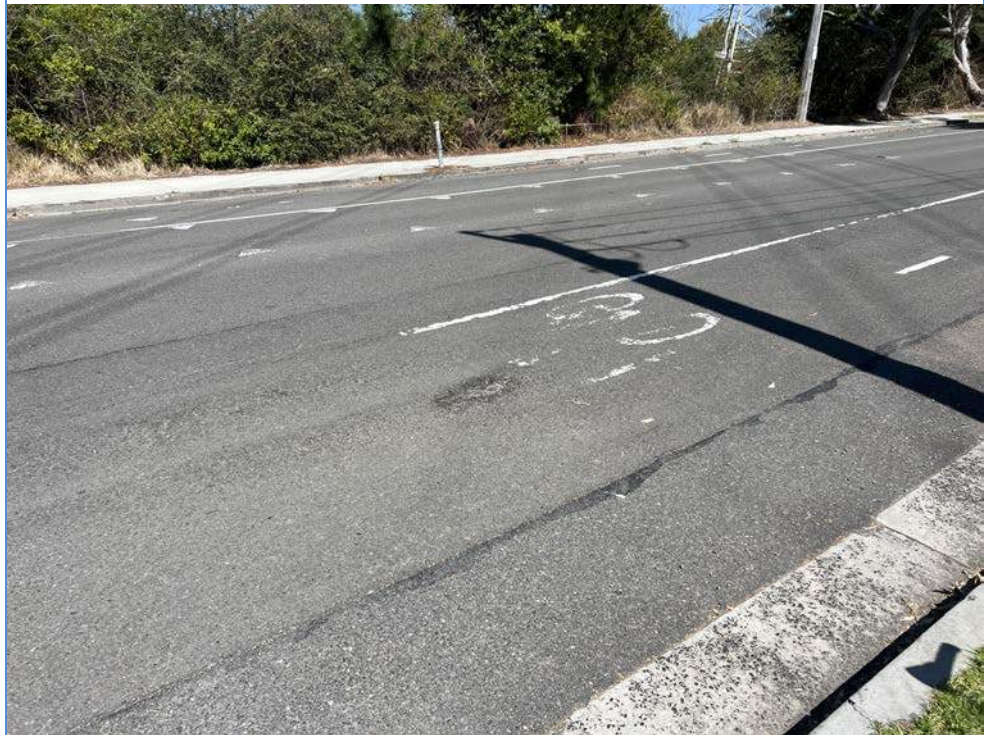
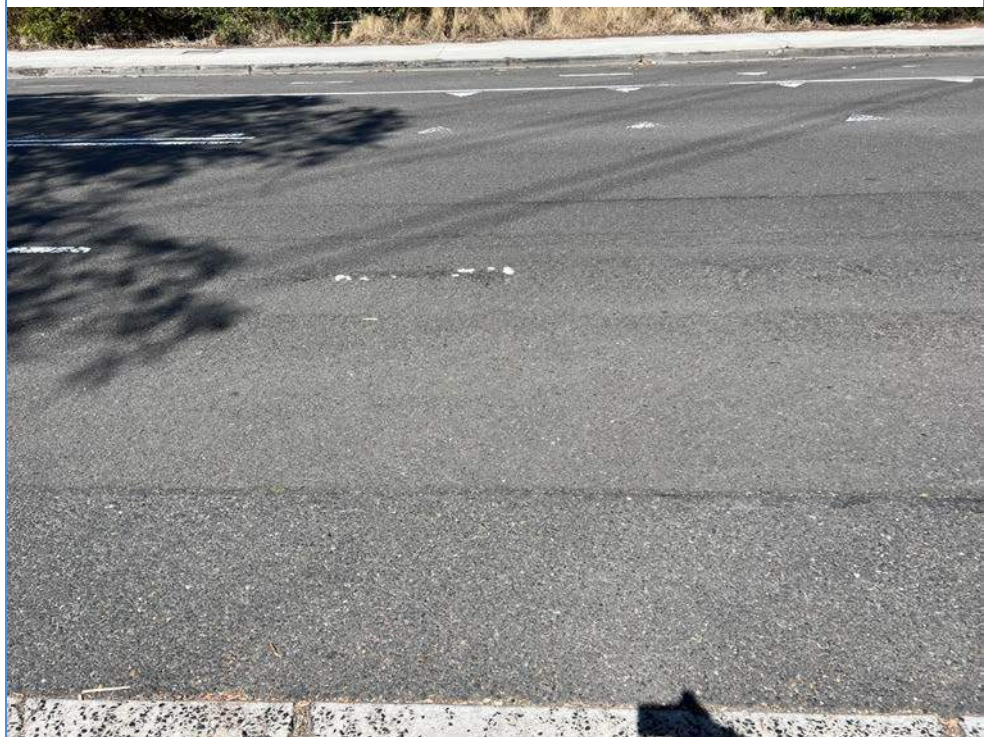
110m

Crack damage to the road surface.

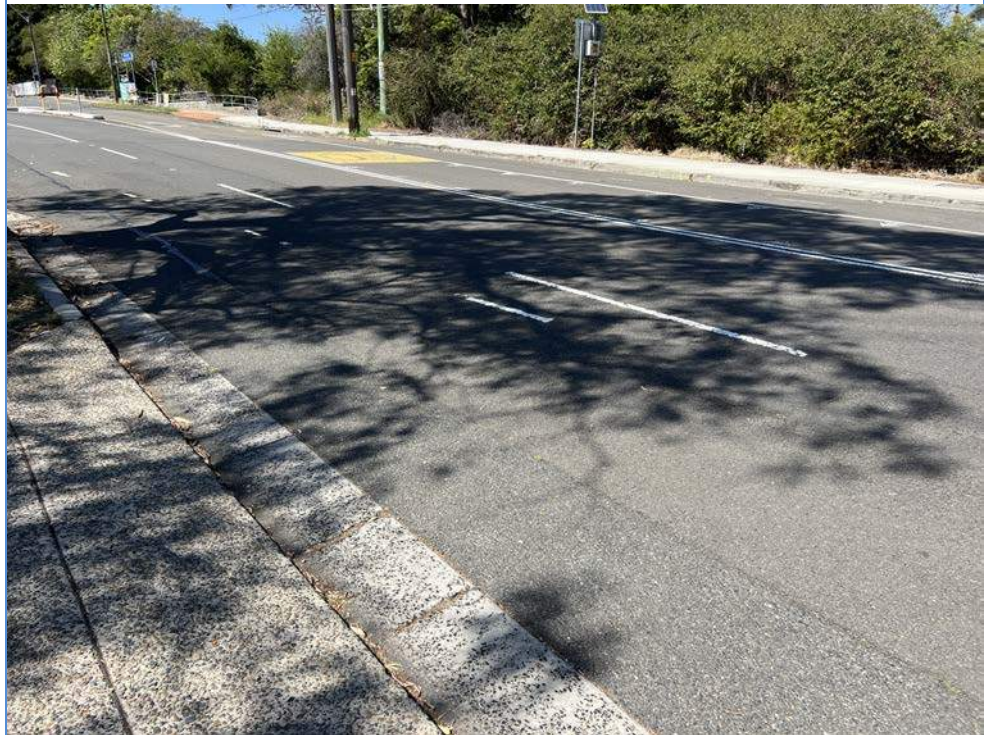
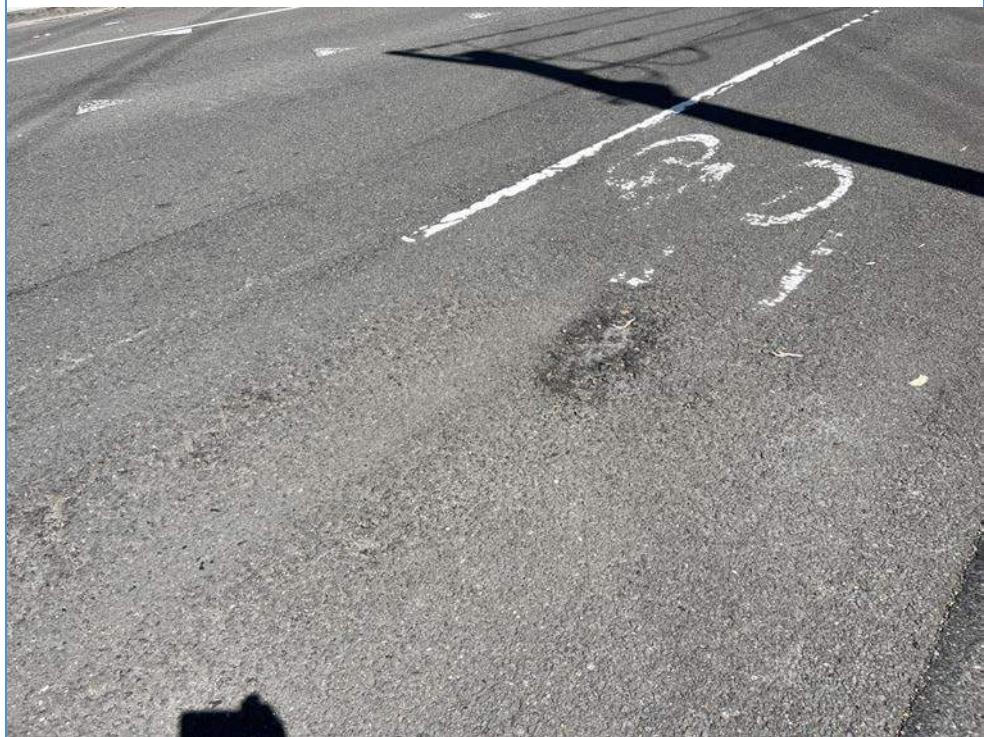
110m

Crack damage to the road surface.

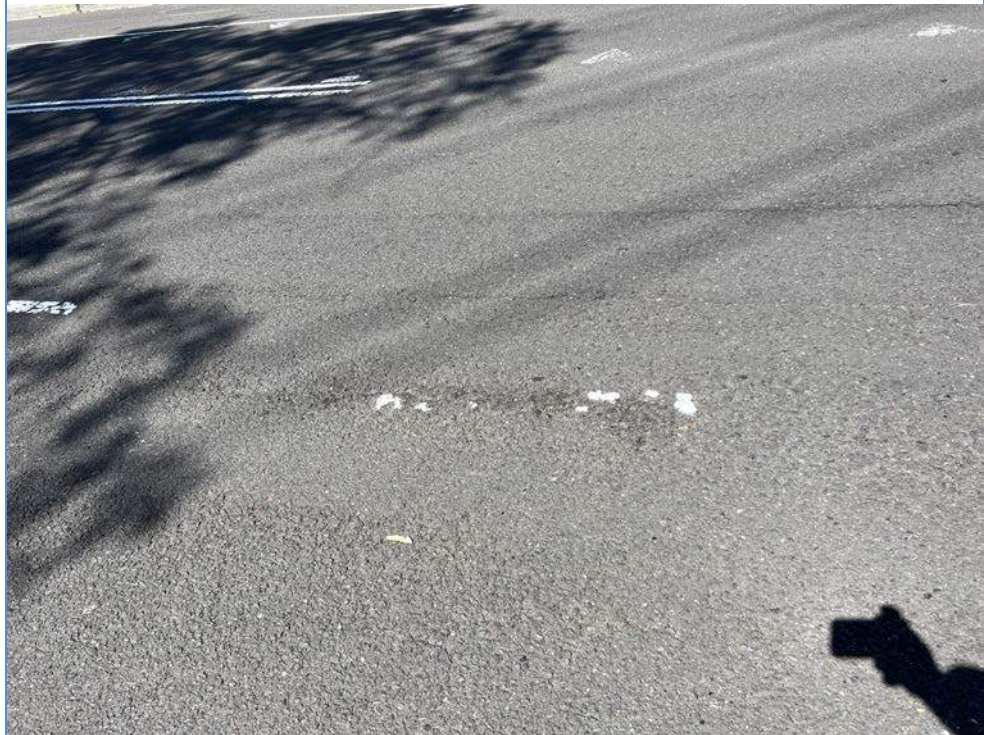
110m

Crack damage to the road surface.

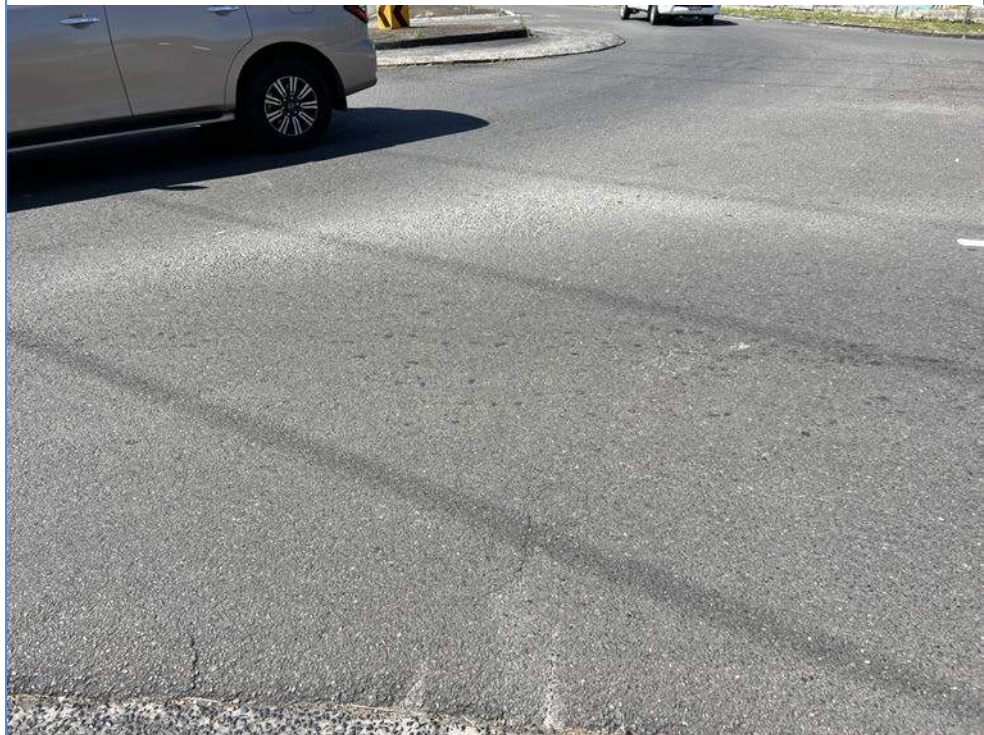
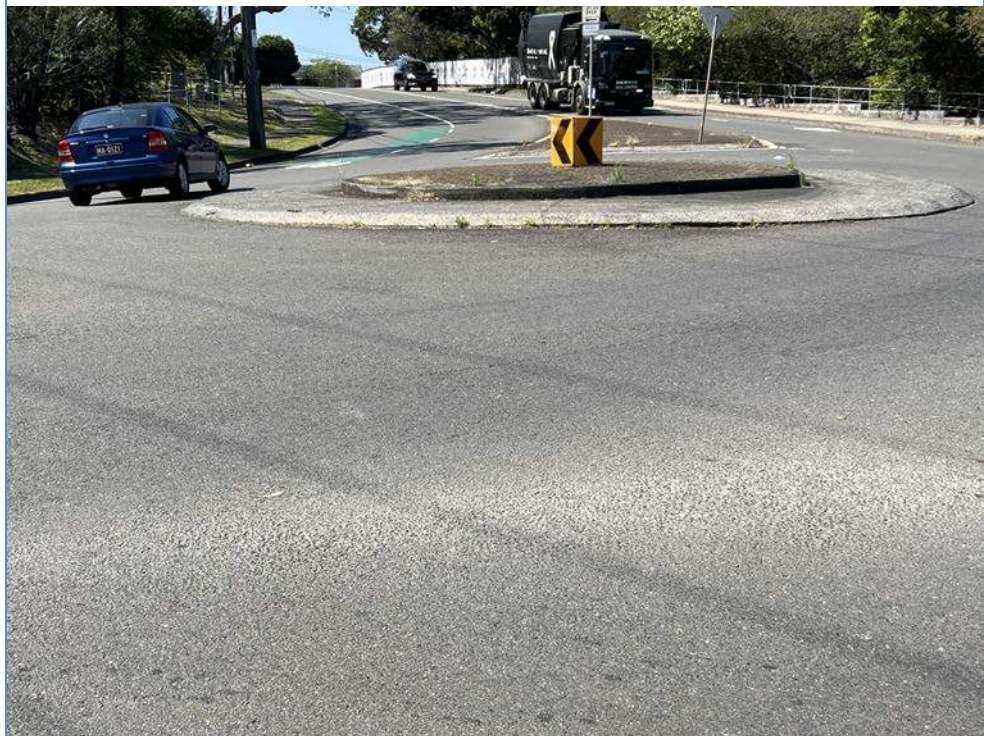
Crack damage throughout the road surface at the roundabout.

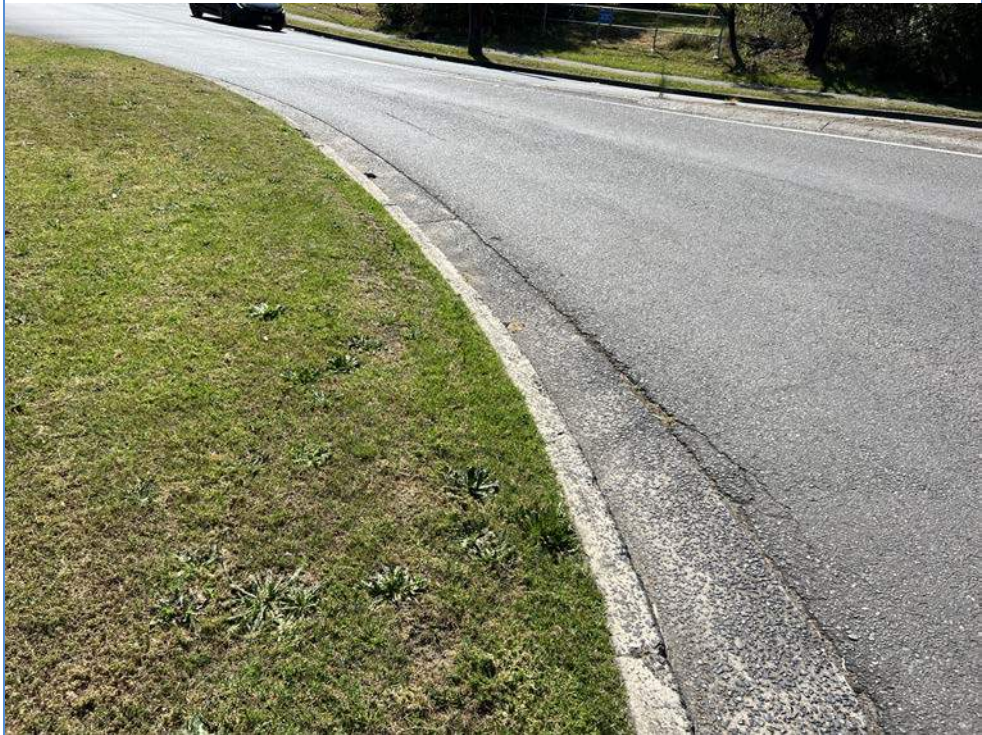
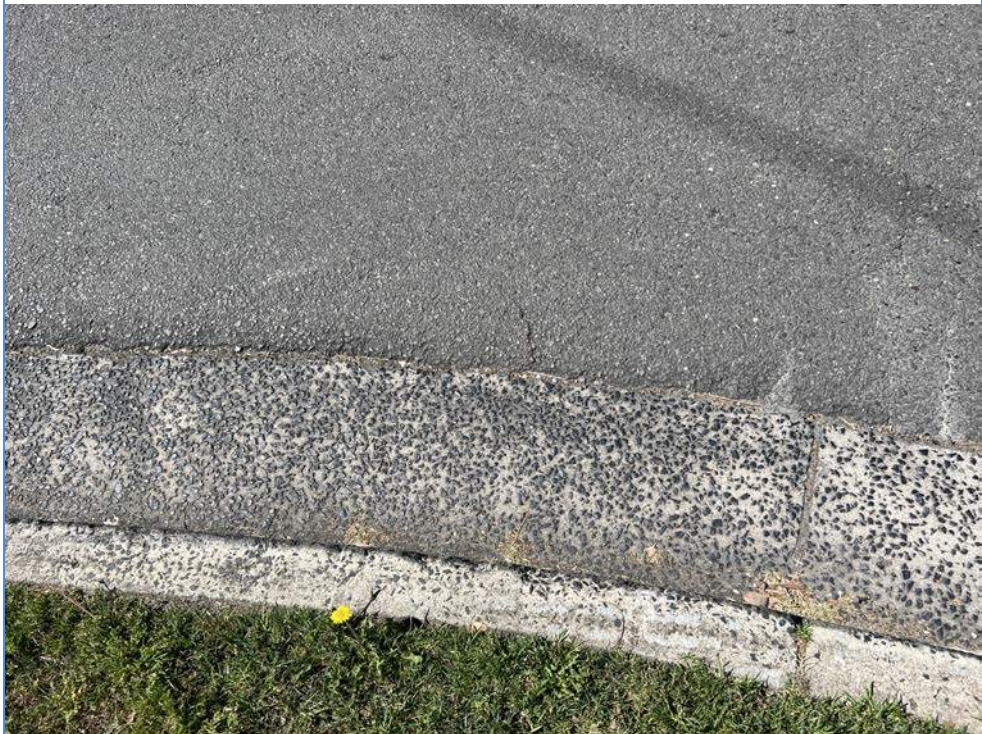
Crack damage to the kerb and gutter at the north side of the roundabout.

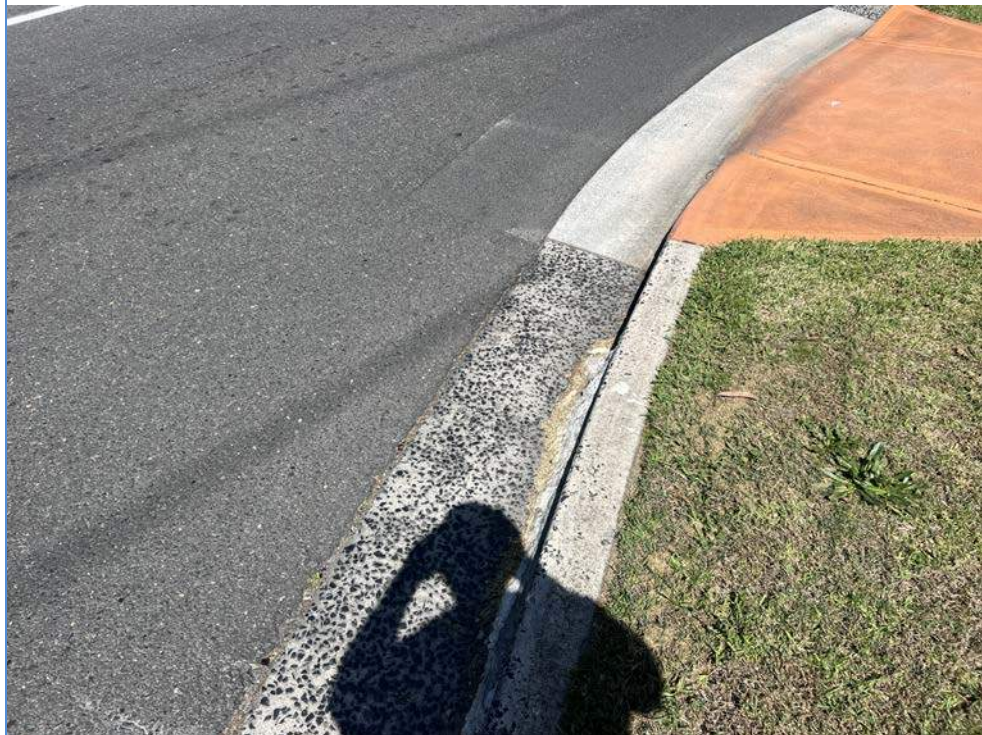
Crack damage to the kerb and gutter at the north side of the roundabout.

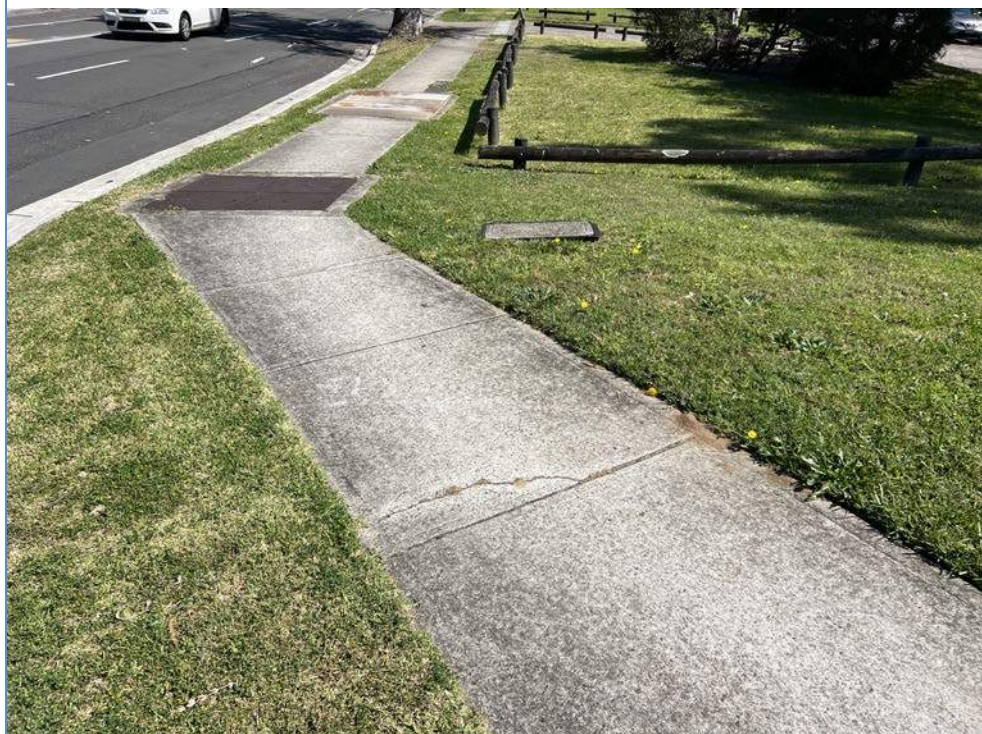
Crack damage to the footpath at the roundabout.

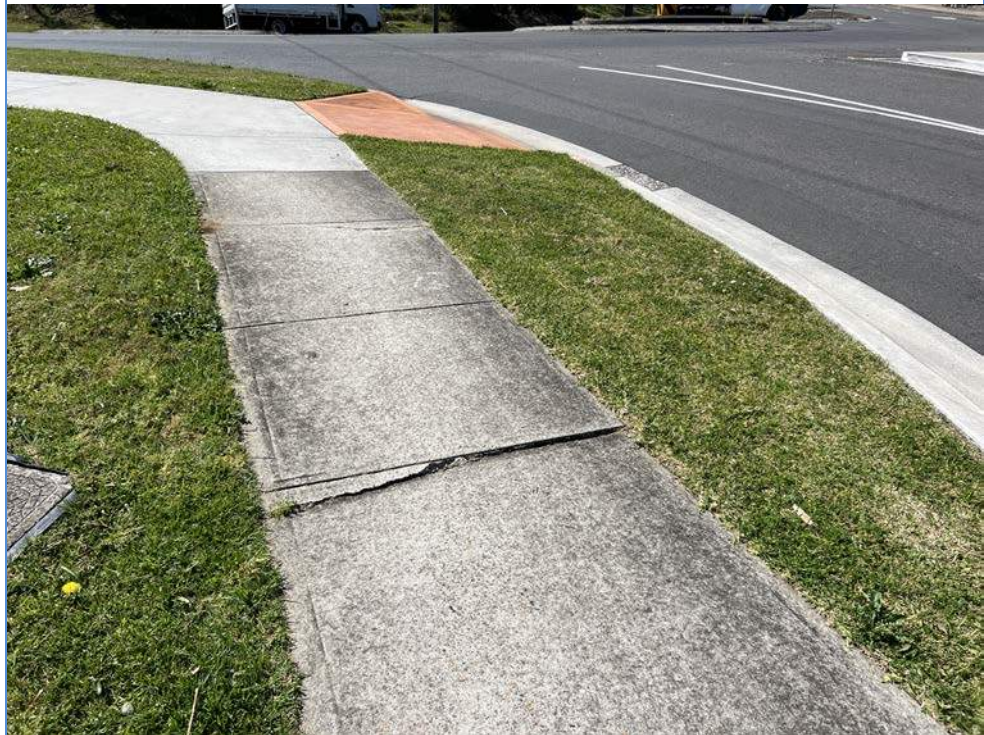
Crack damage to the footpath at the roundabout.

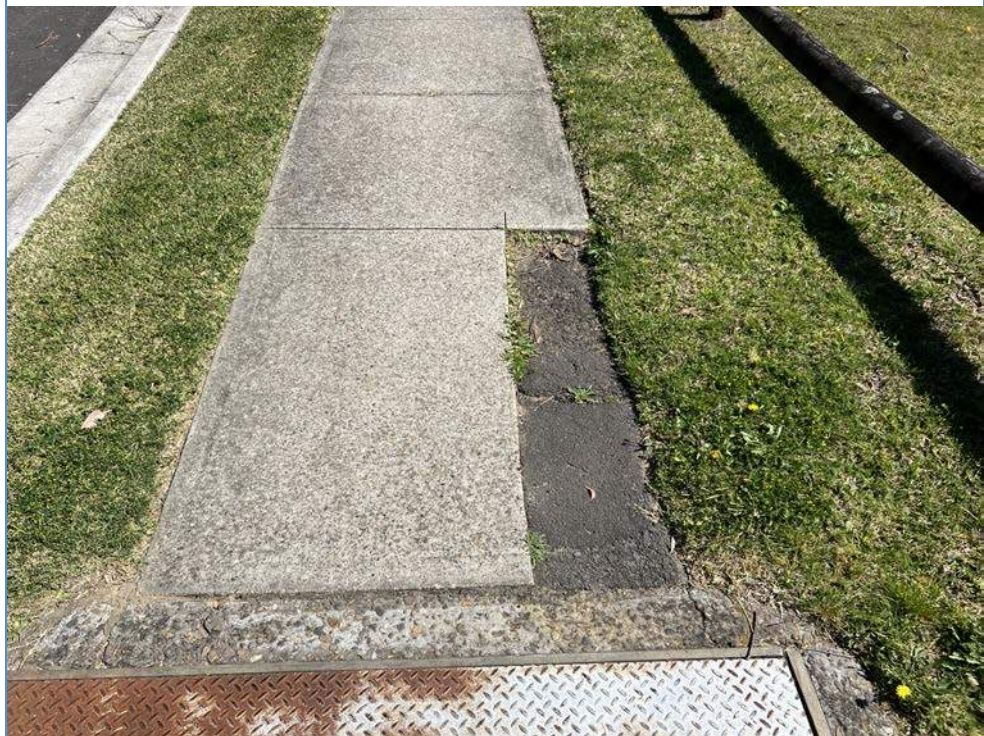
Repaired section noted to the footpath.

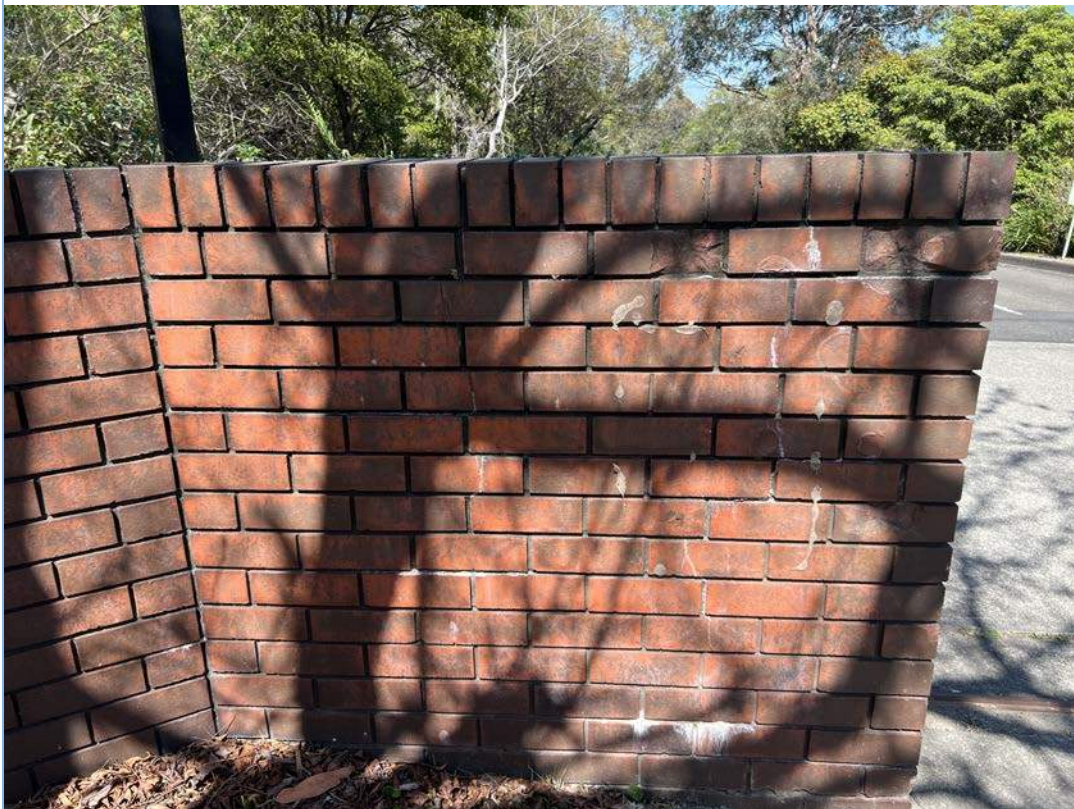
Cracks to the brickwork at the left side of the brick wall.

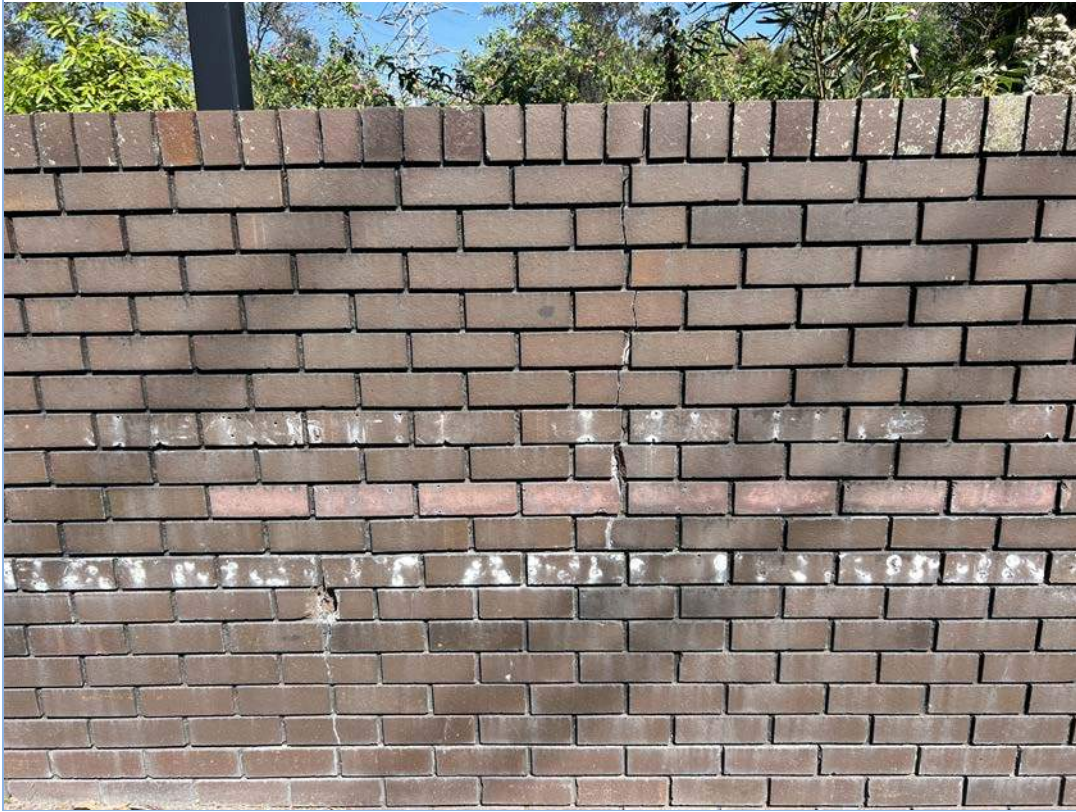
Crack damage to the middle of the brickwork wall.
