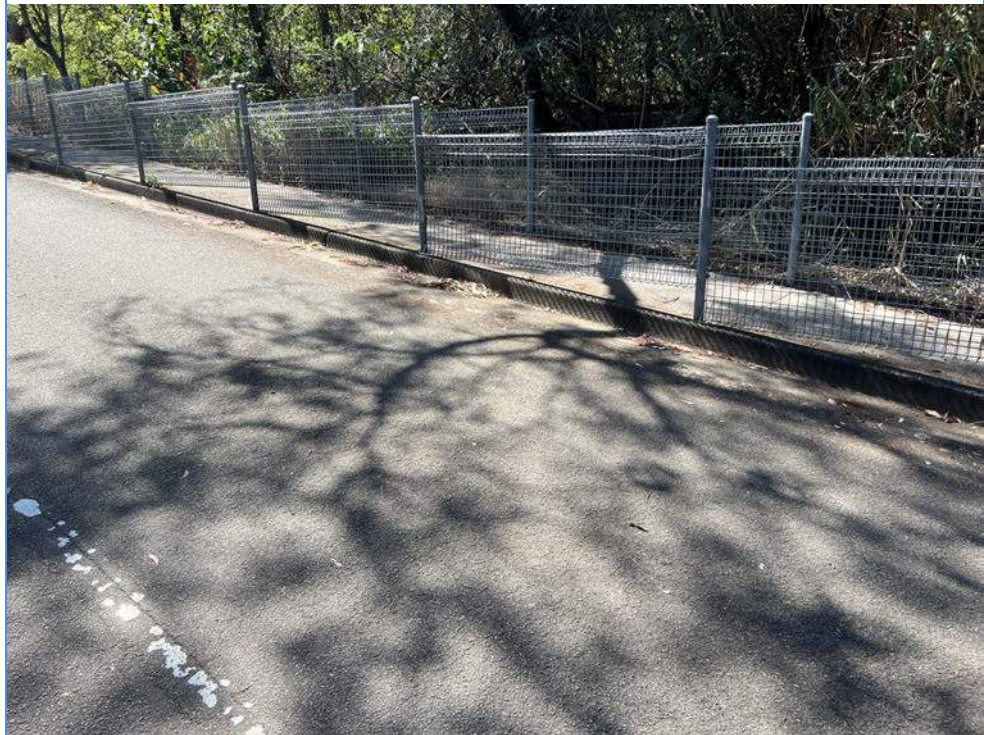
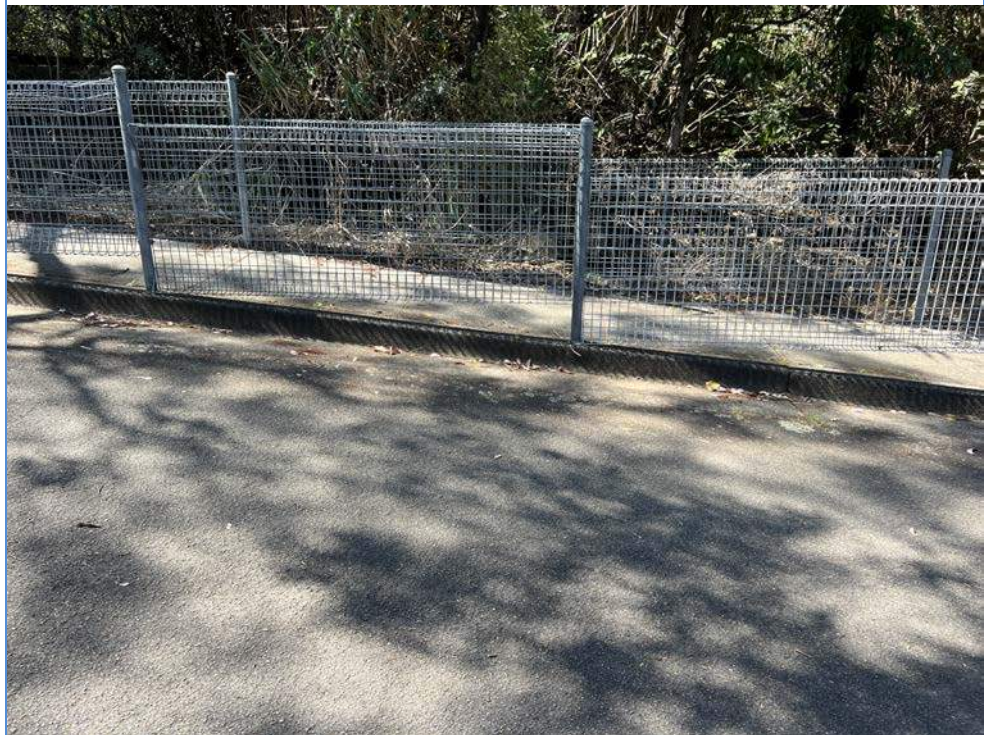
70m

General views of the kerb, gutter and road surface.

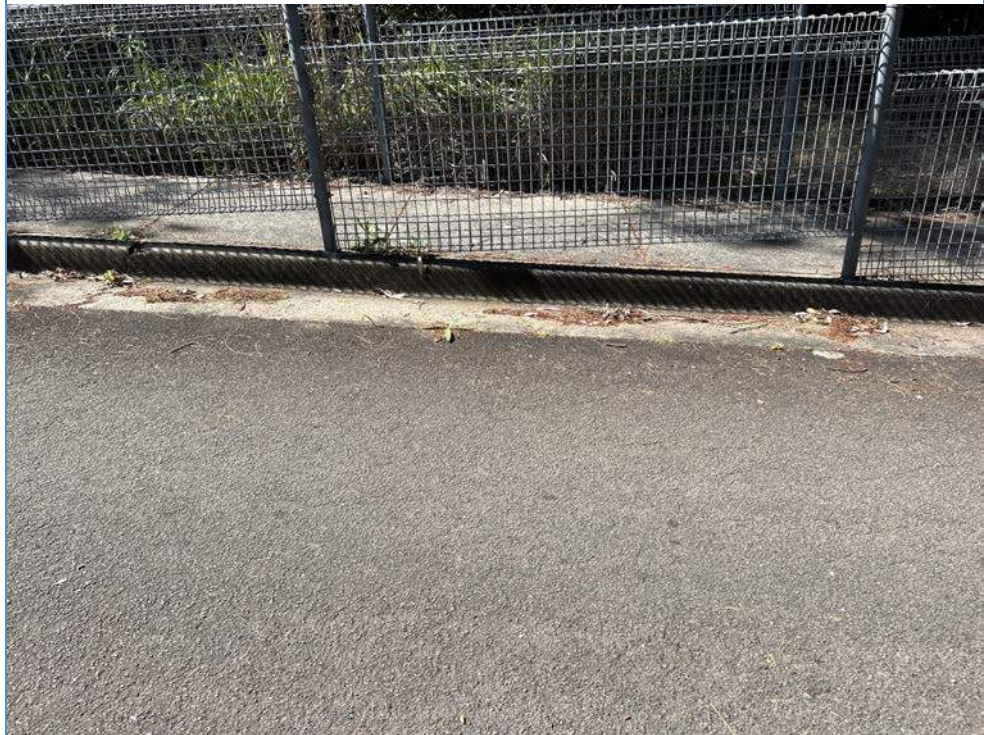
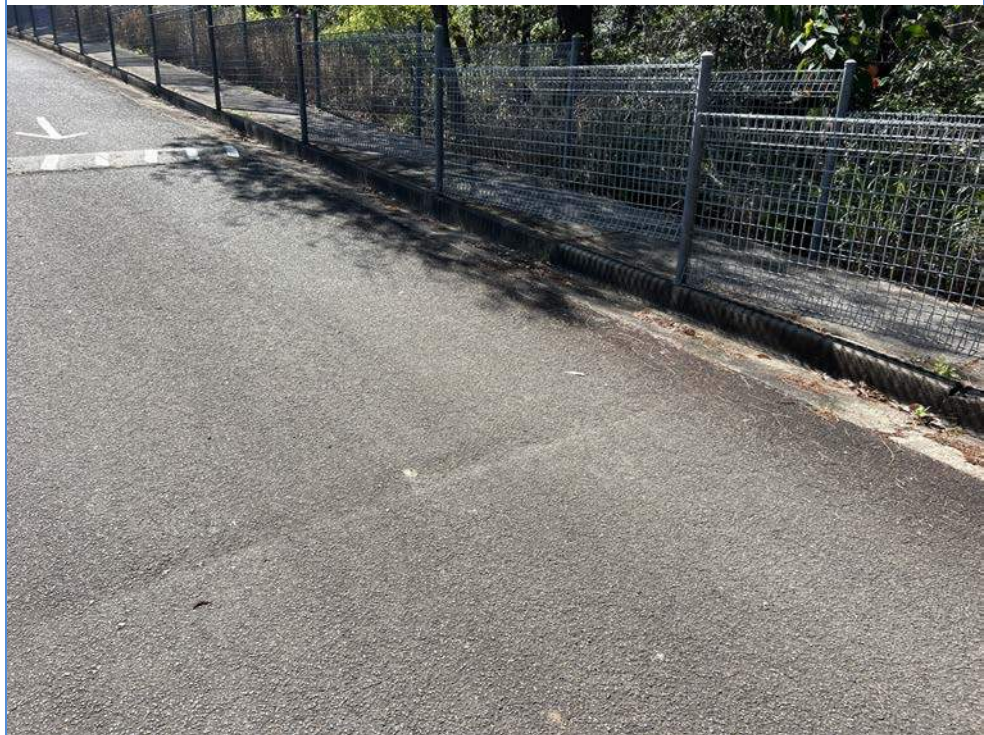
80m

General views of the kerb, gutter and road surface.

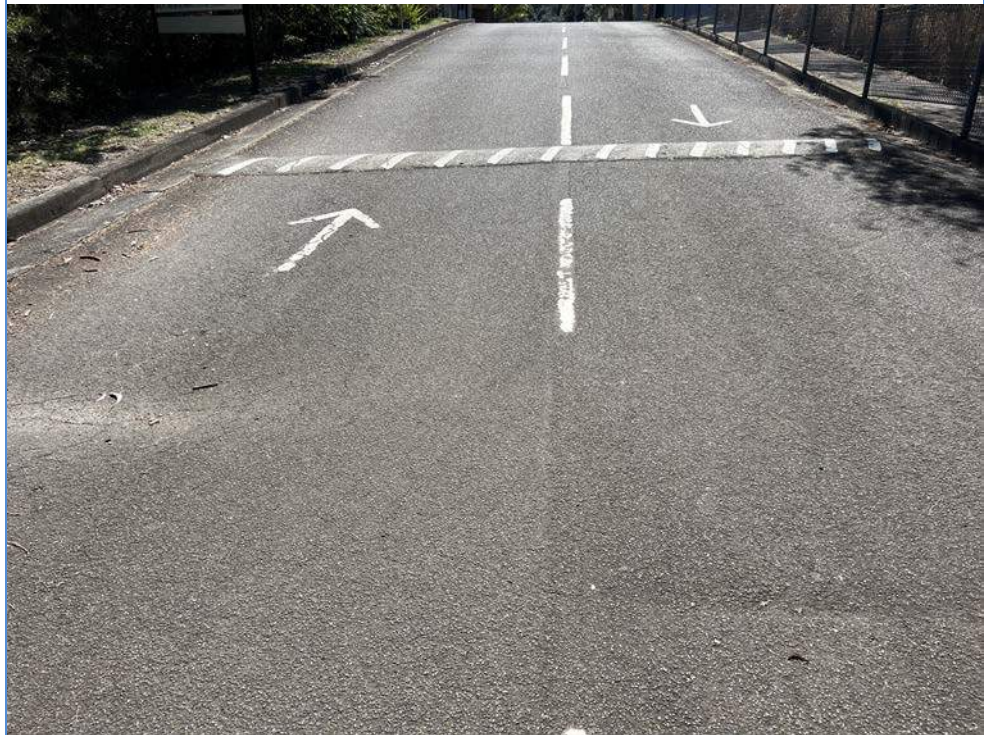
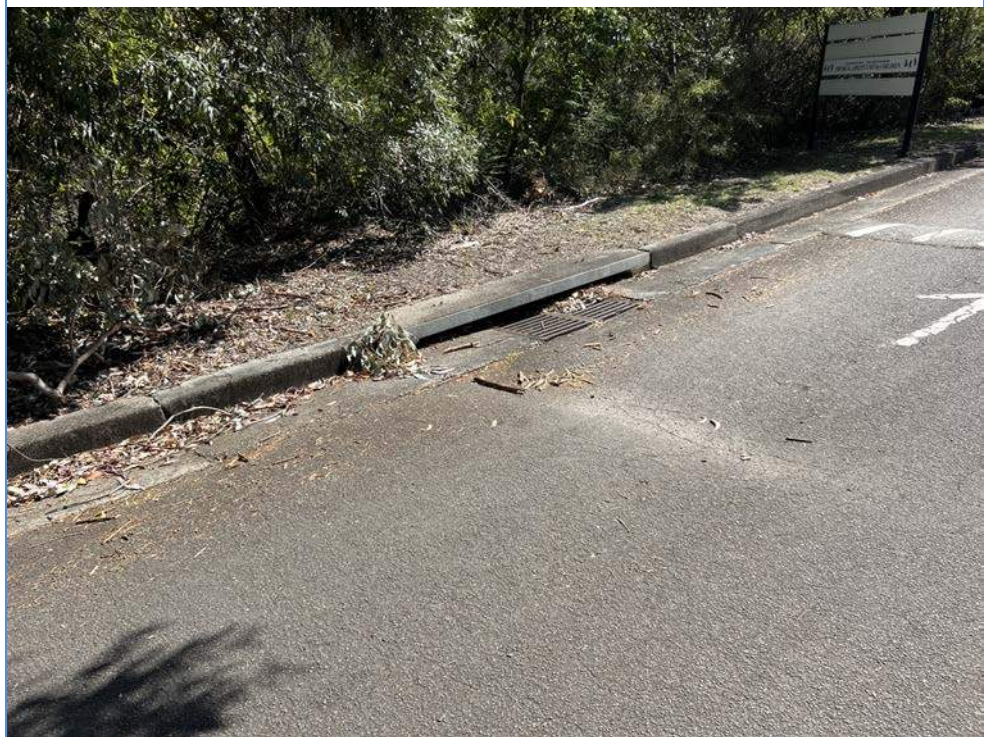
80m

General views of the kerb, gutter and road surface.

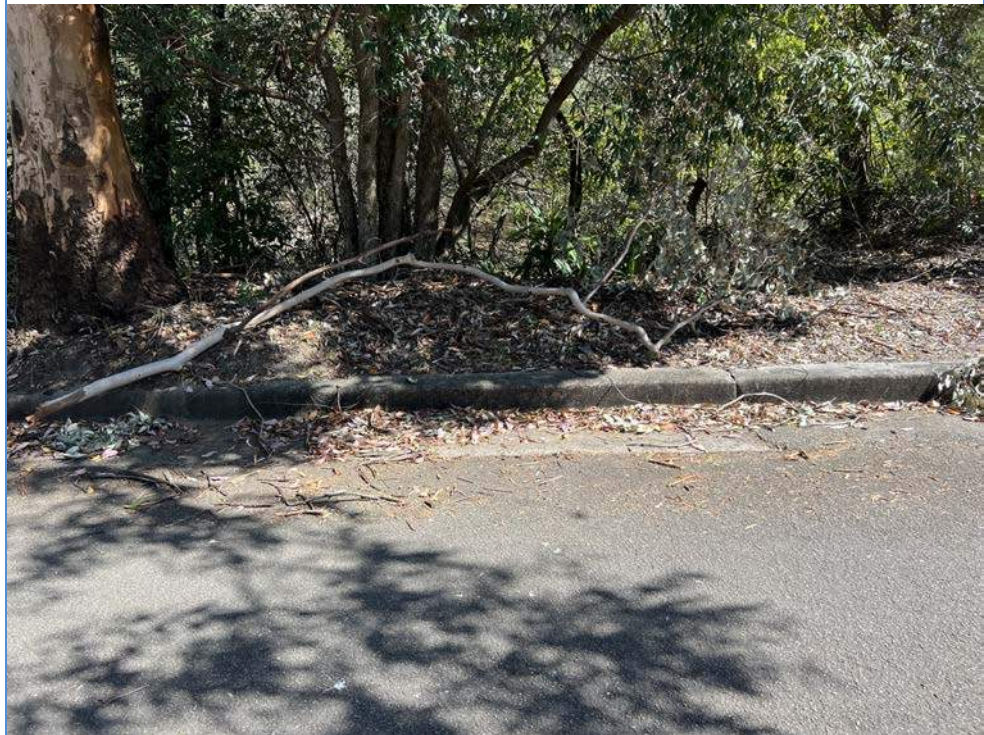
80m

General views of the kerb, gutter and road surface.

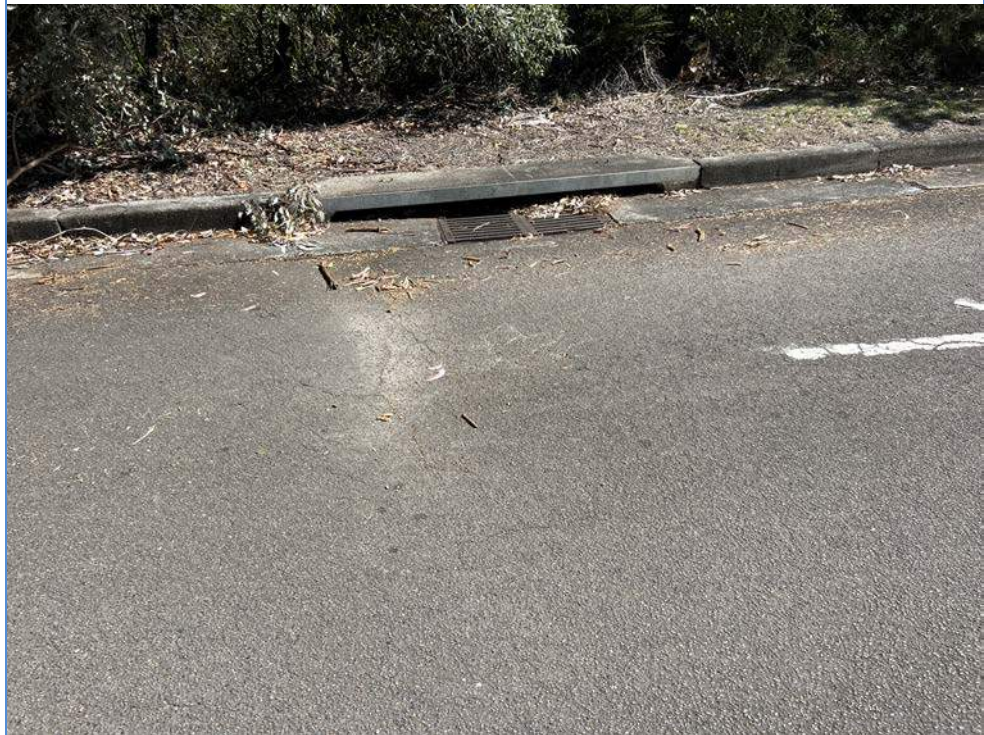
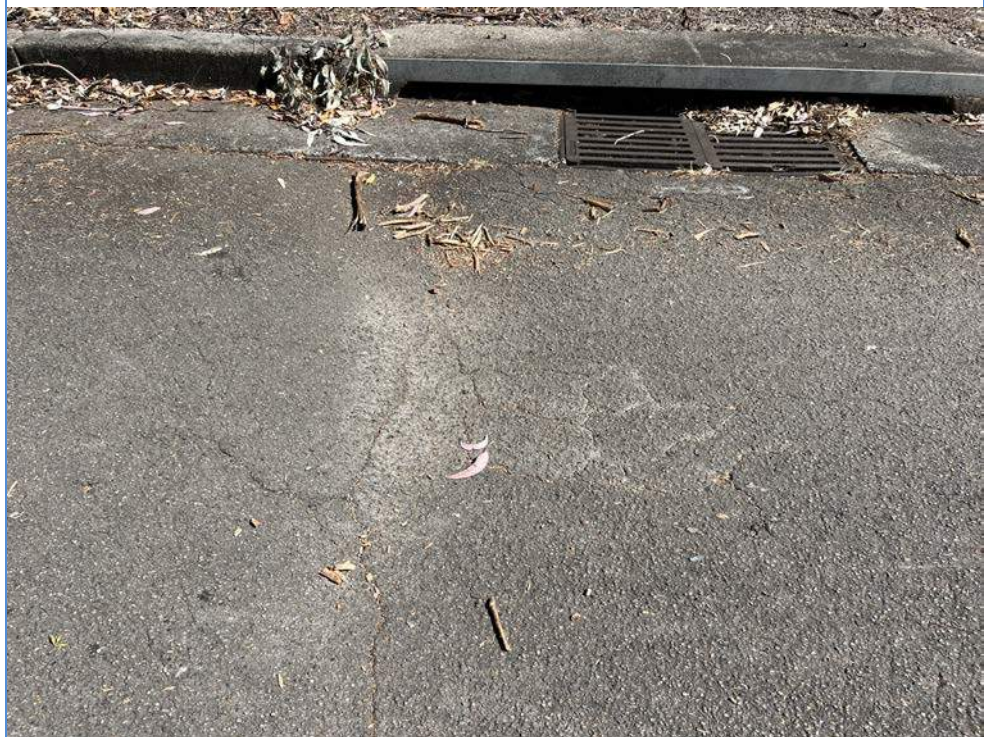
85m

Subsidence and crack damage fronting the stormwater drain.

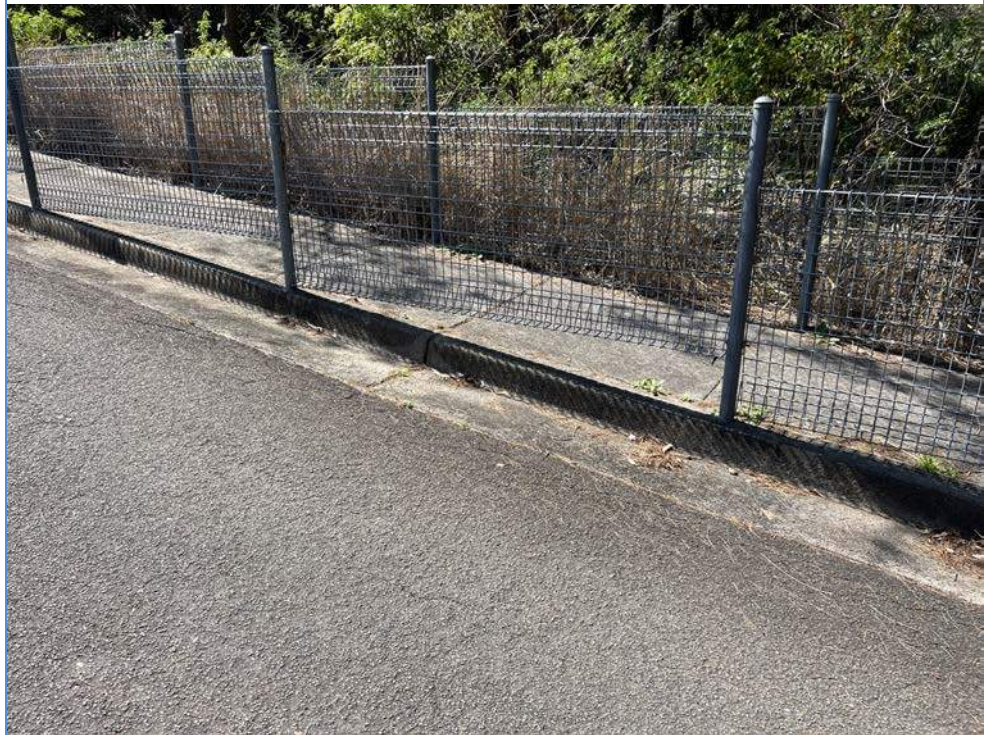
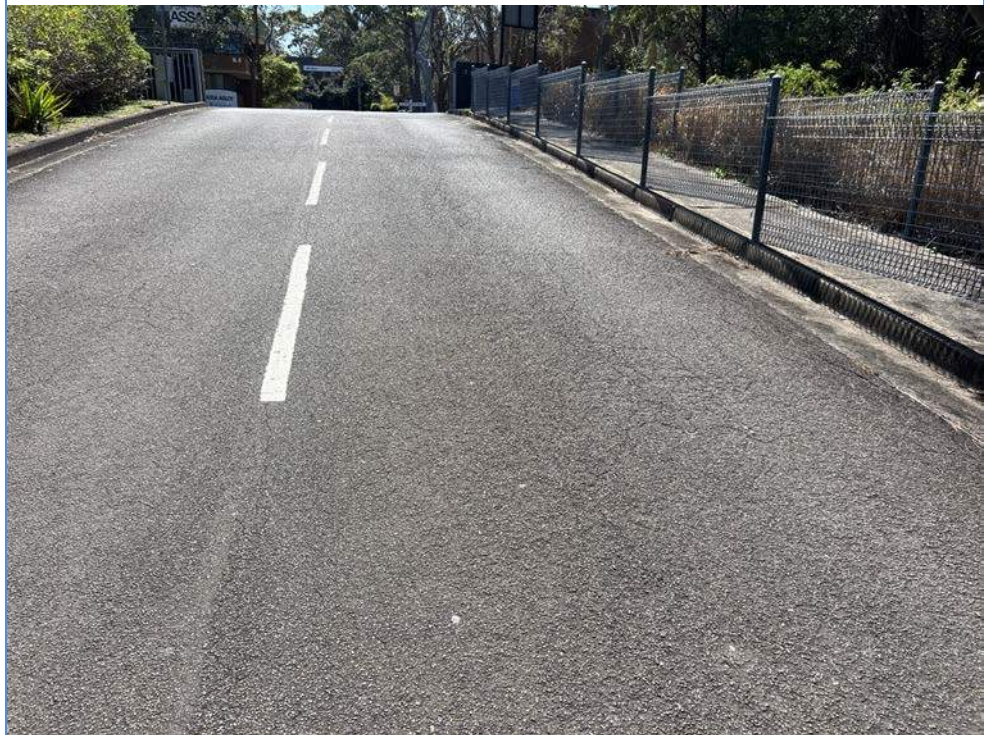
90m

General views of the kerb, gutter and road surface.

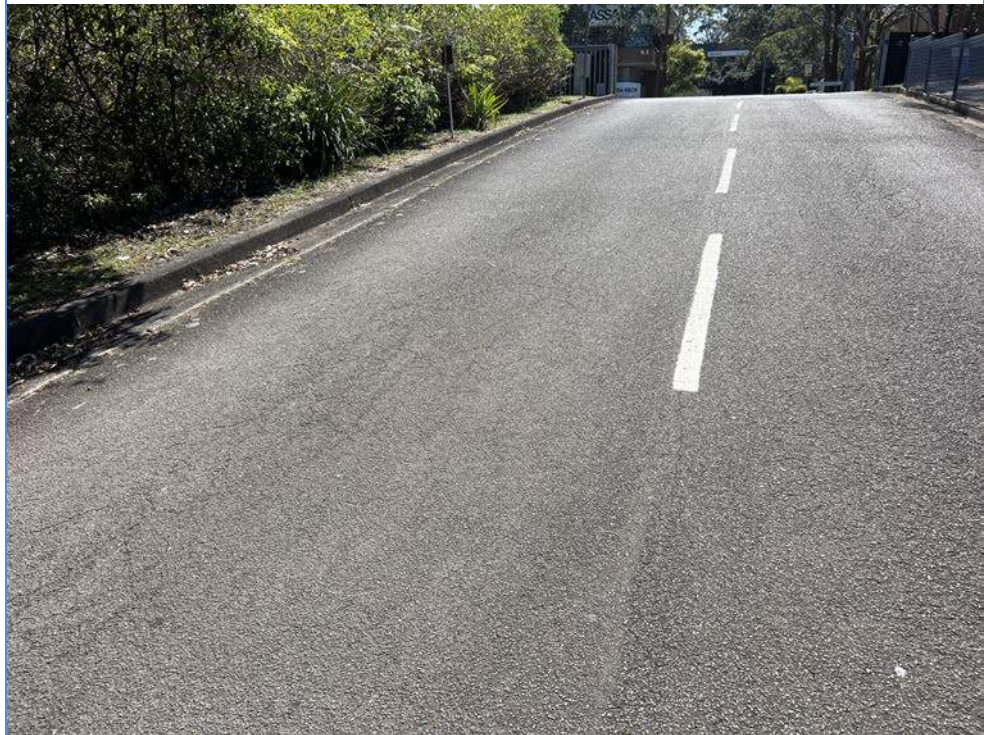
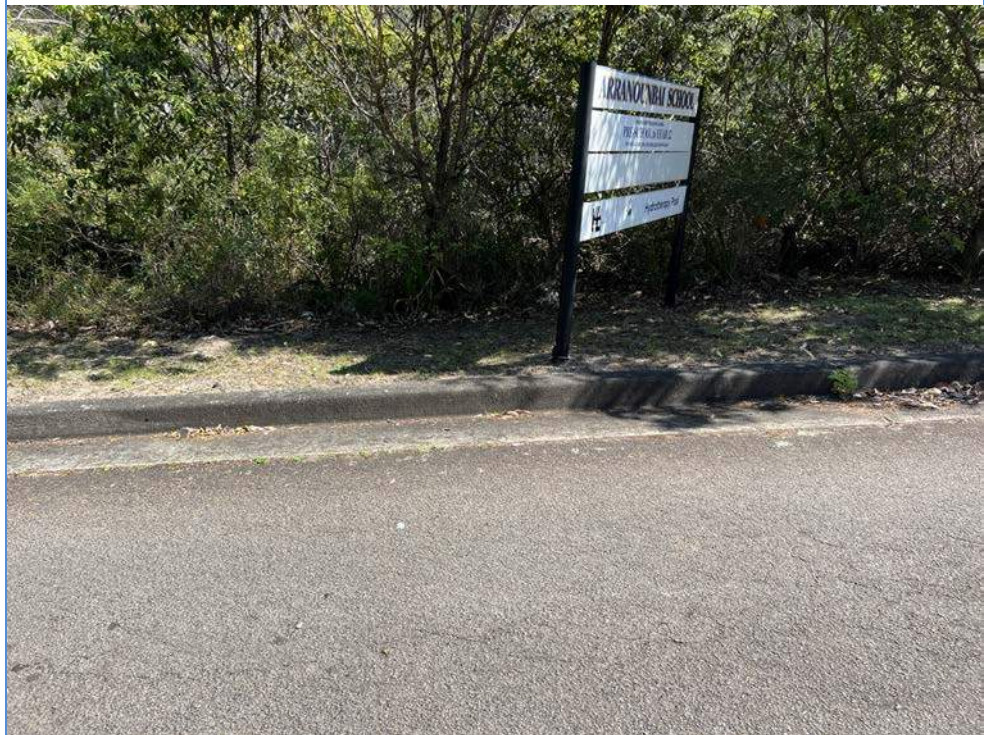
90m

General views of the kerb, gutter and road surface.

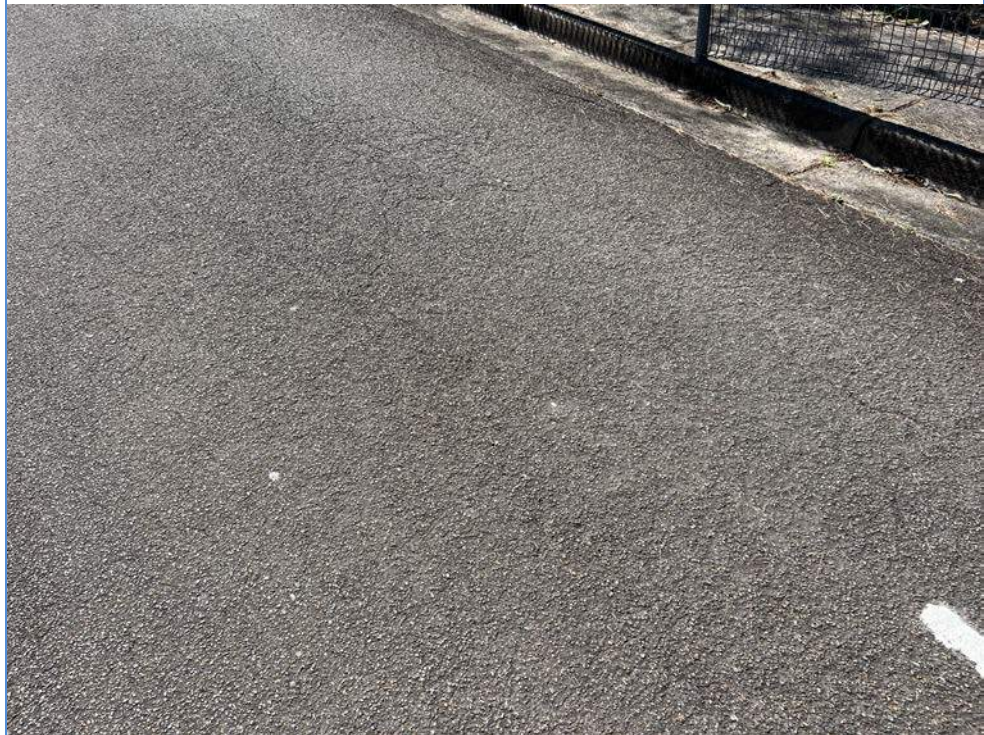
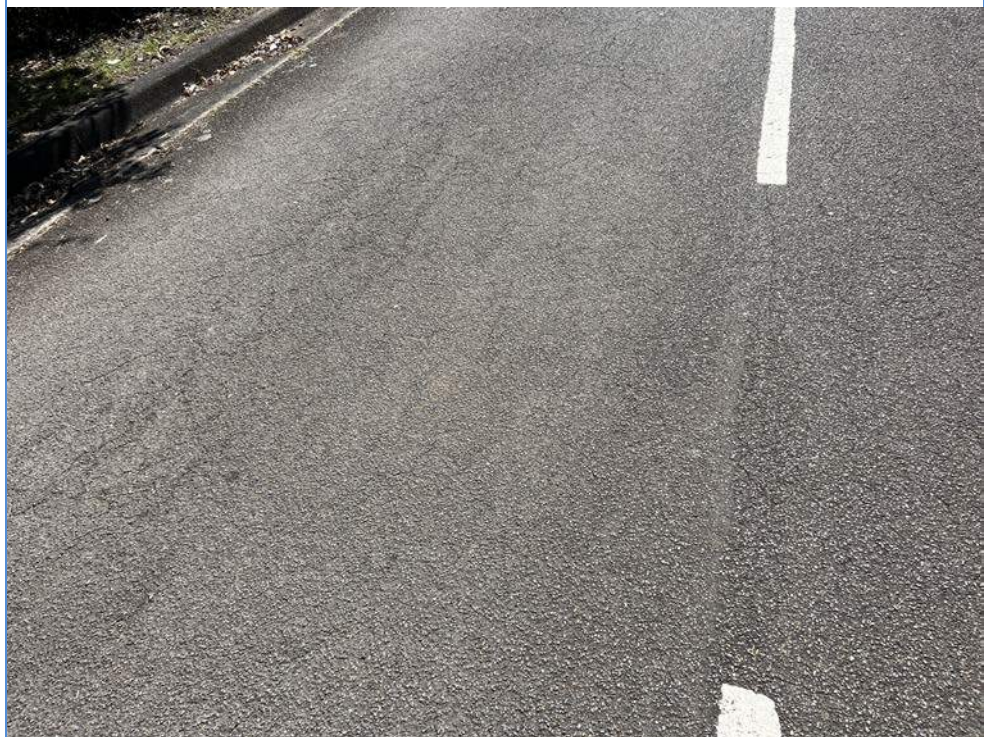
90m

Crack damage throughout the road surface.

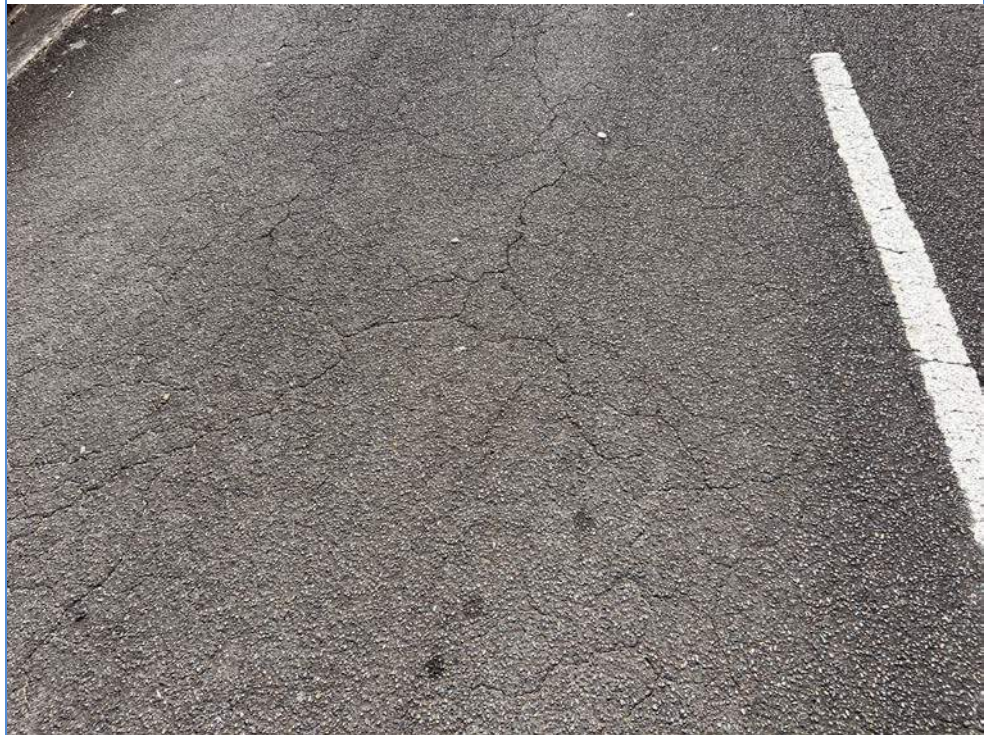
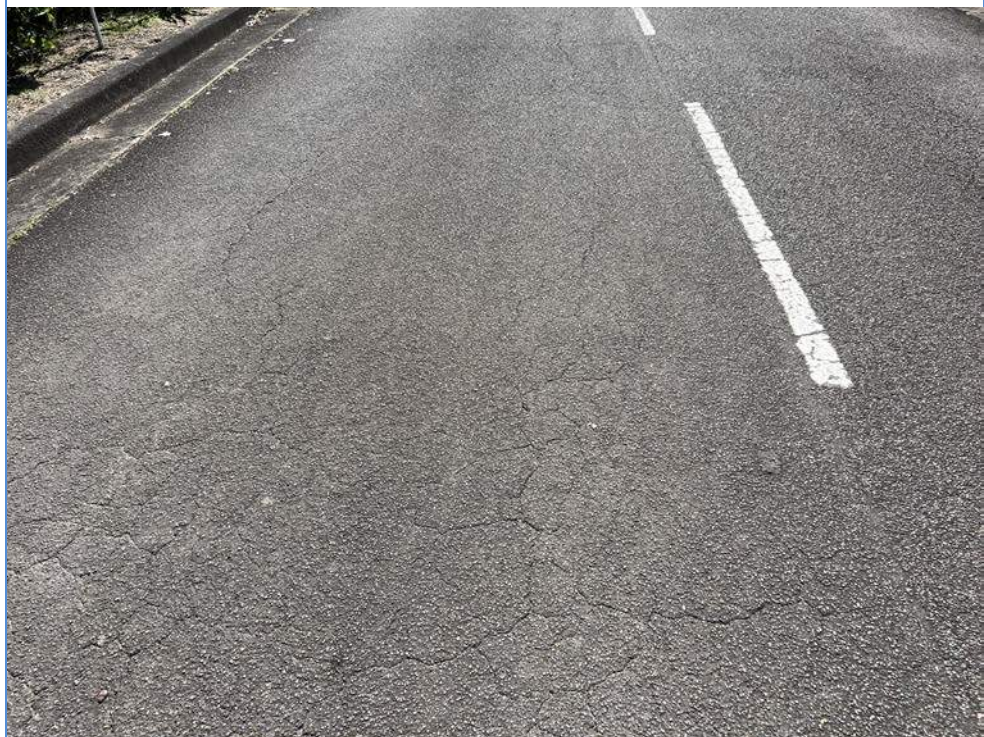
90m

Crack damage throughout the road surface.

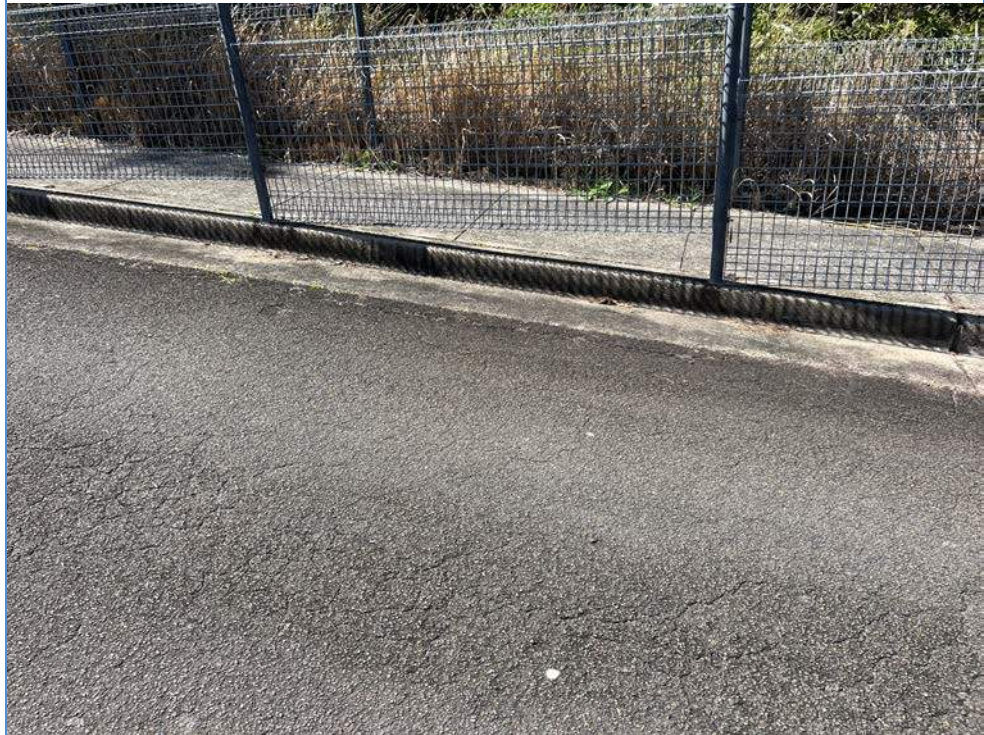
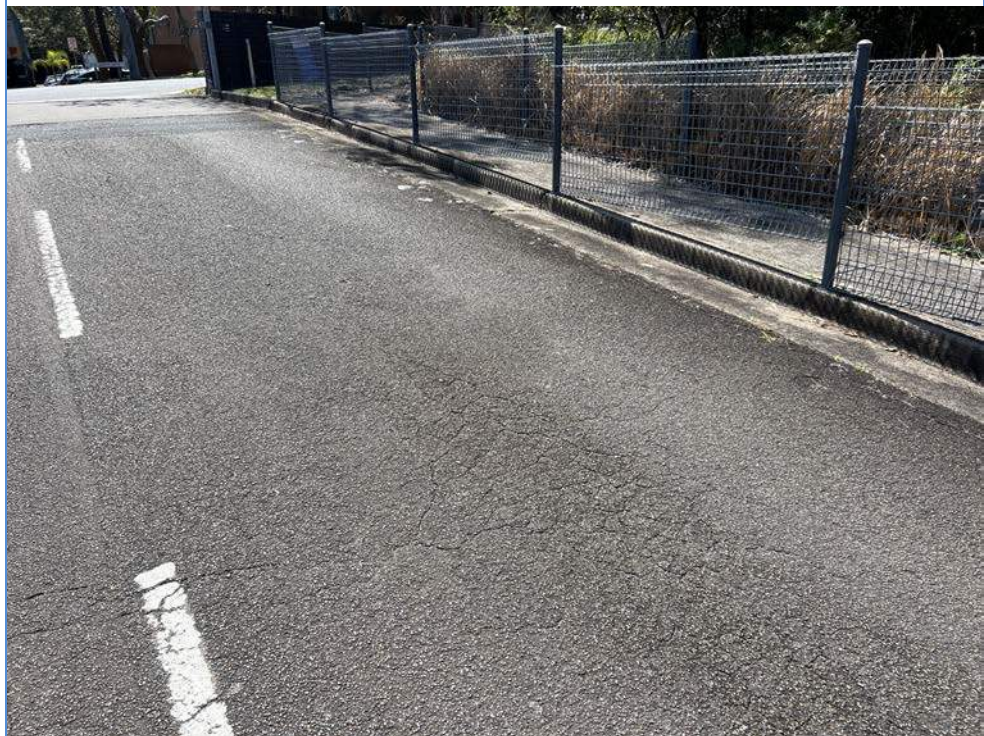
100m

General views of the kerb, gutter and road surface showing crack damage throughout.

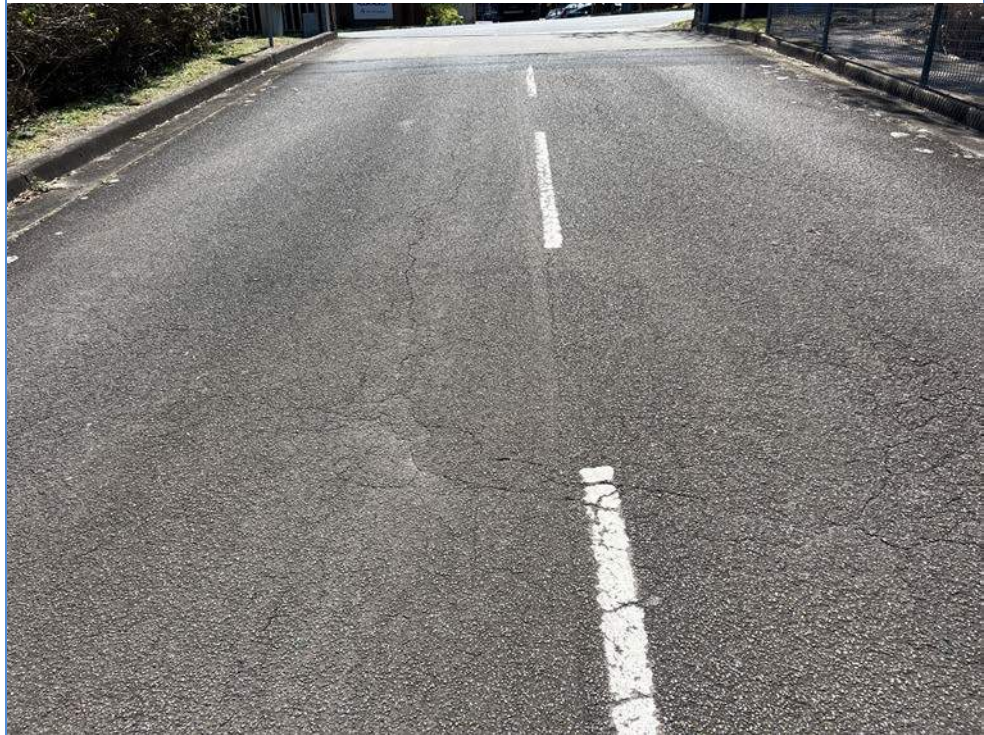
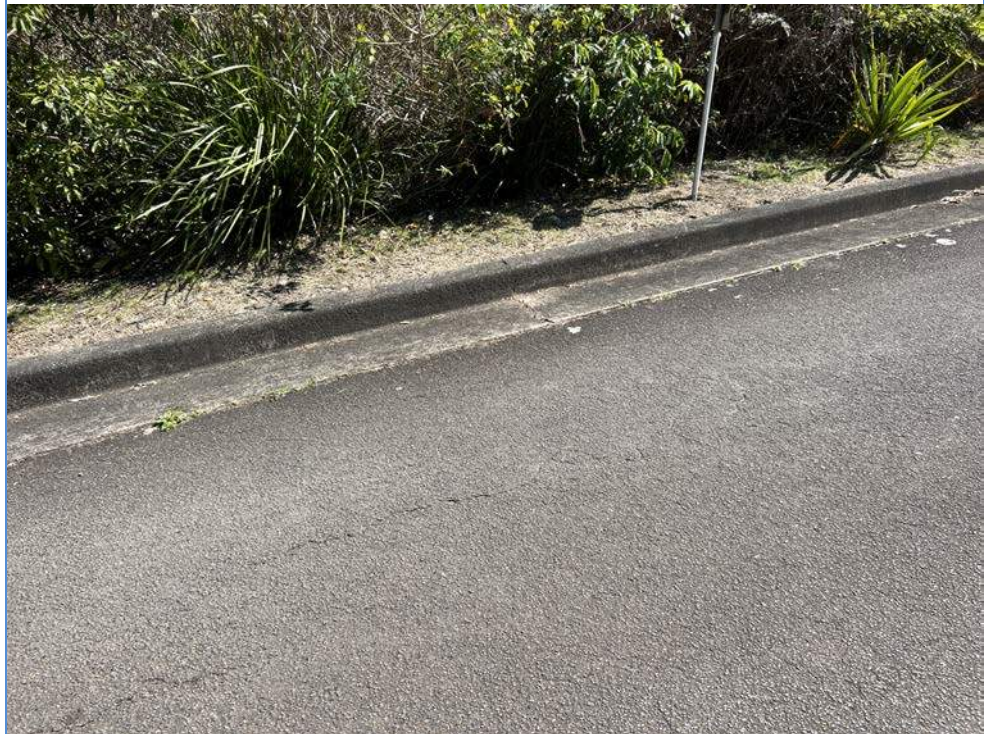
100m

General views of the kerb, gutter and road surface showing crack damage throughout.

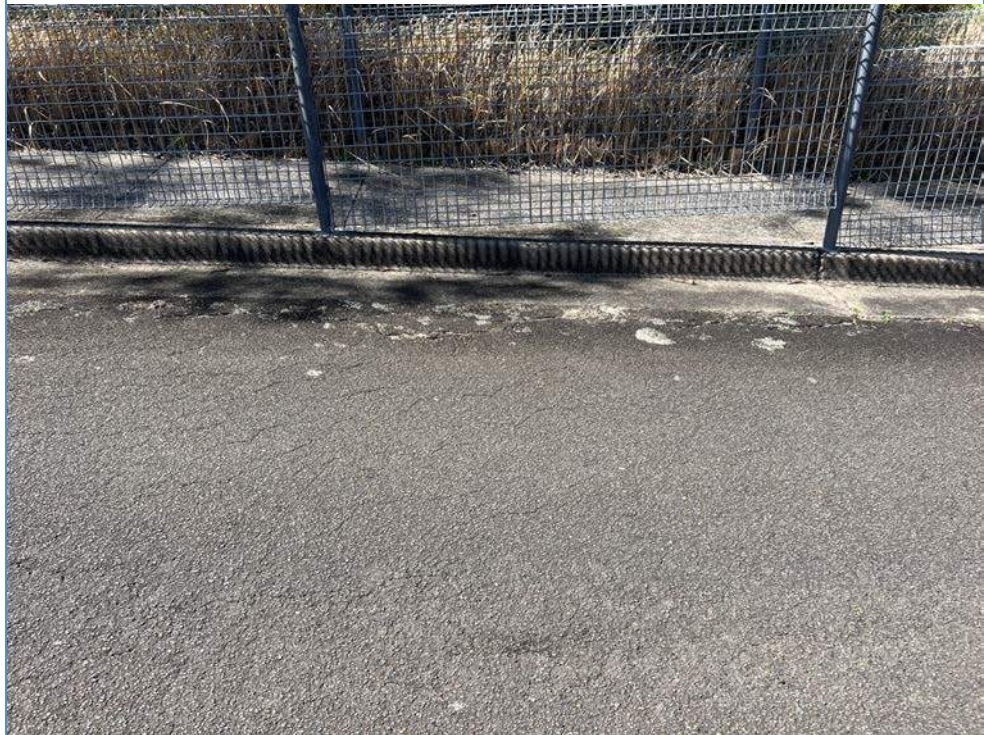
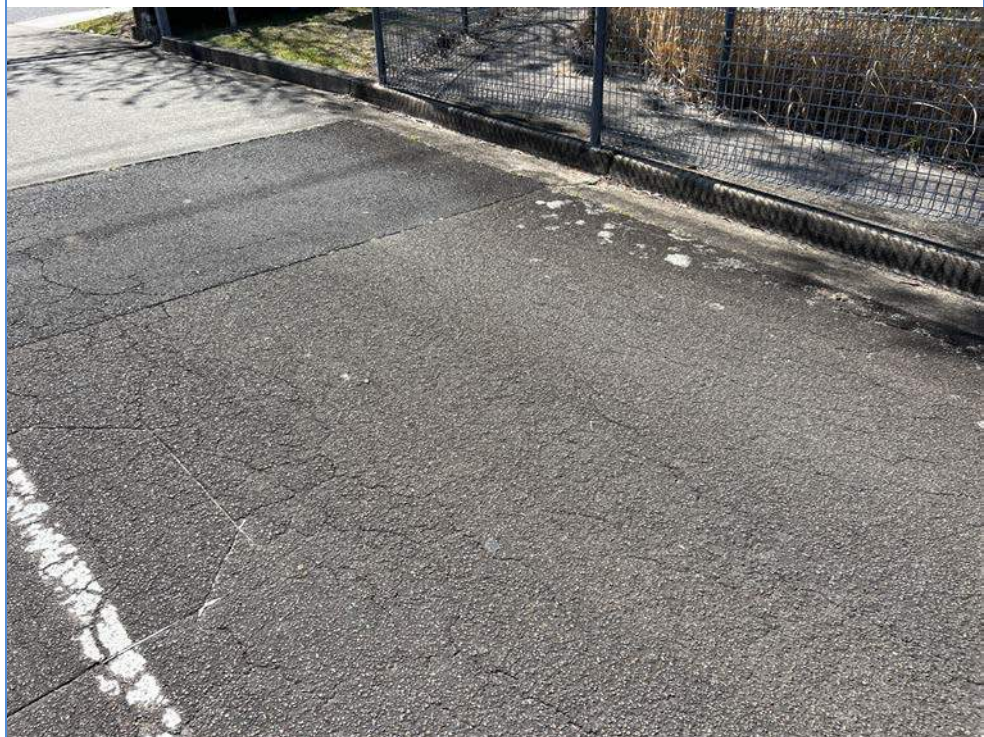
110m

Multiple cracks throughout the road surface.

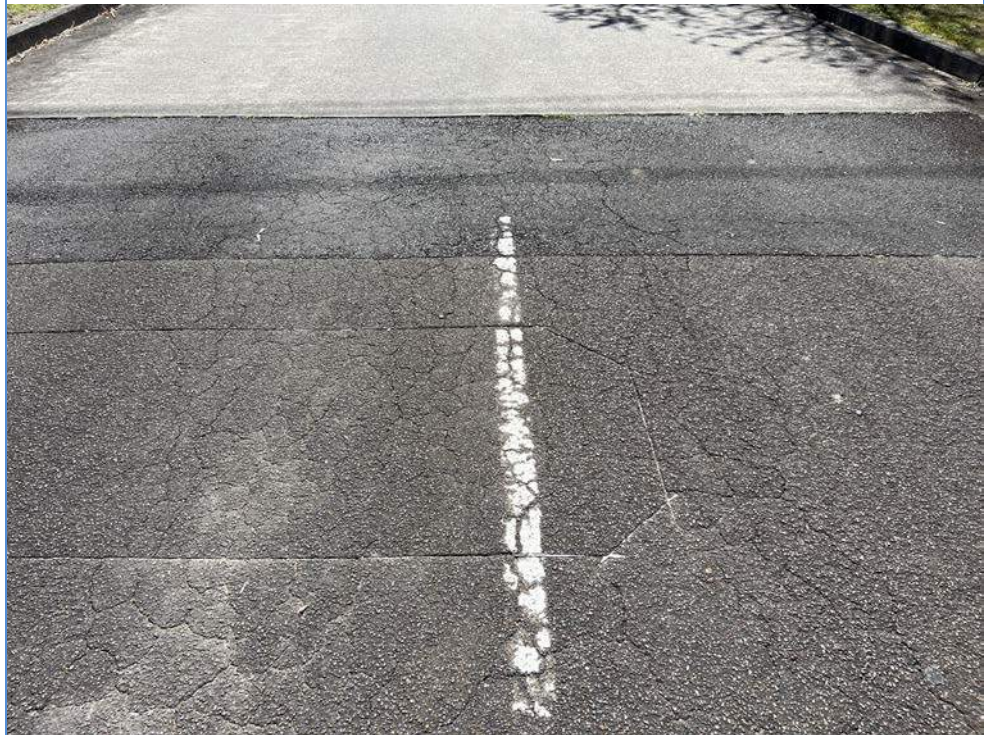
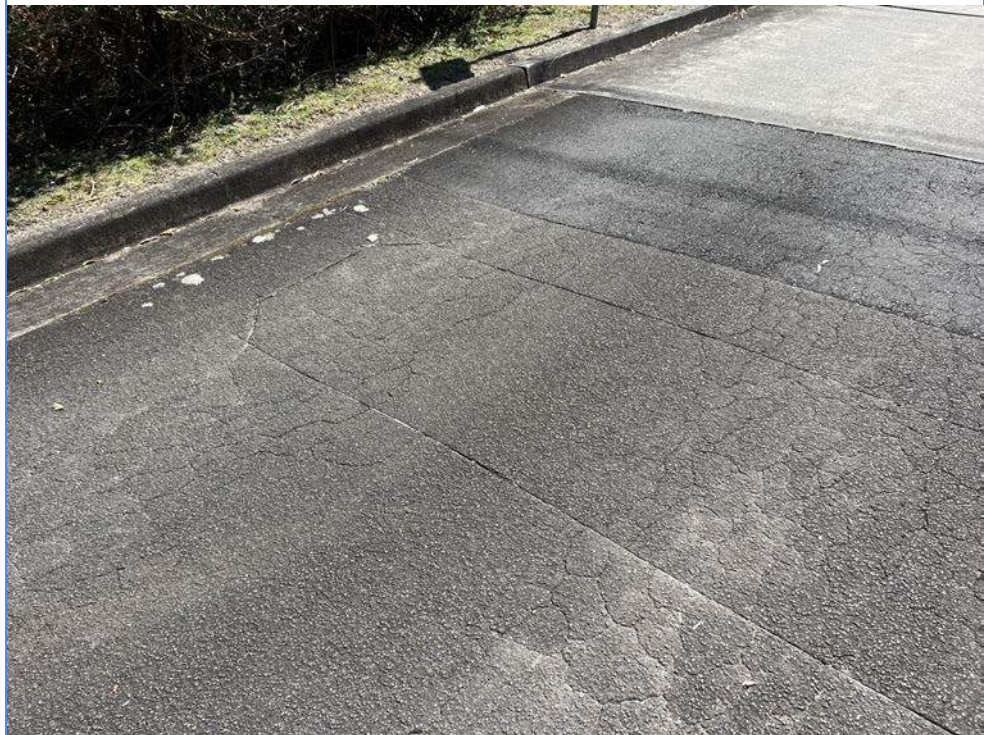
110m

Multiple cracks throughout the road surface.

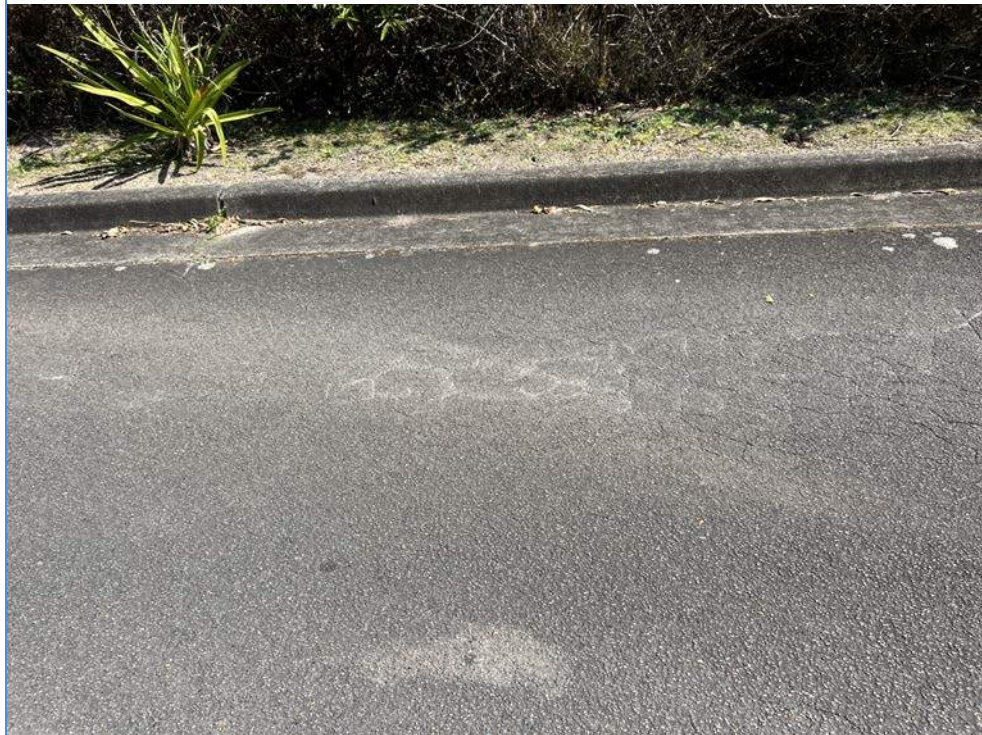
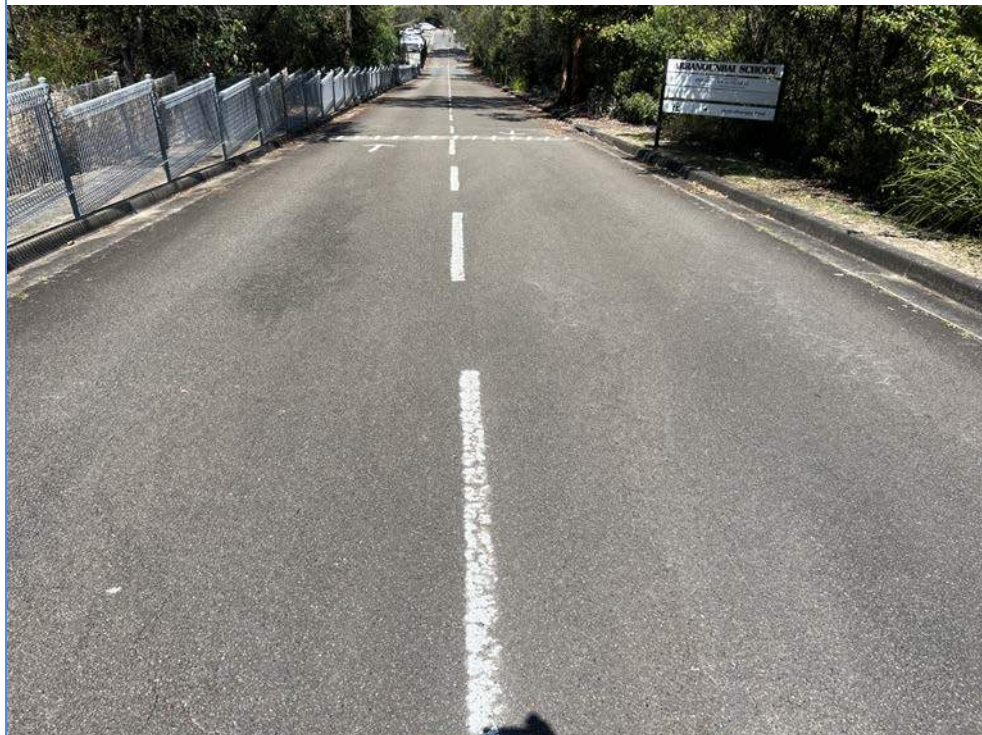
110m

Multiple cracks throughout the road surface.

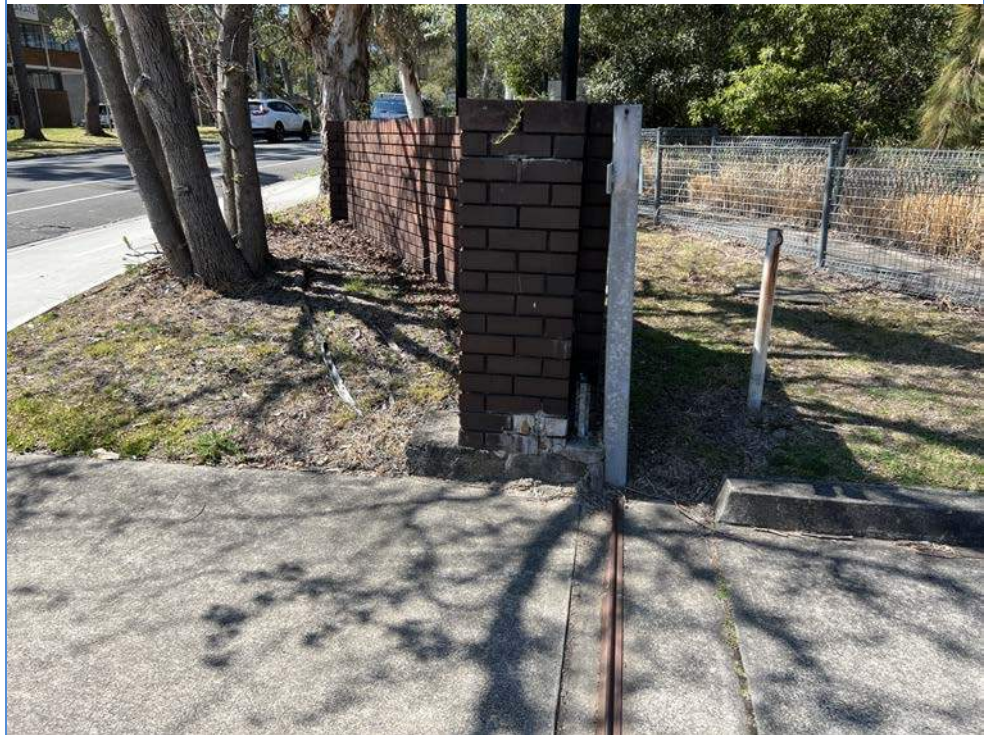
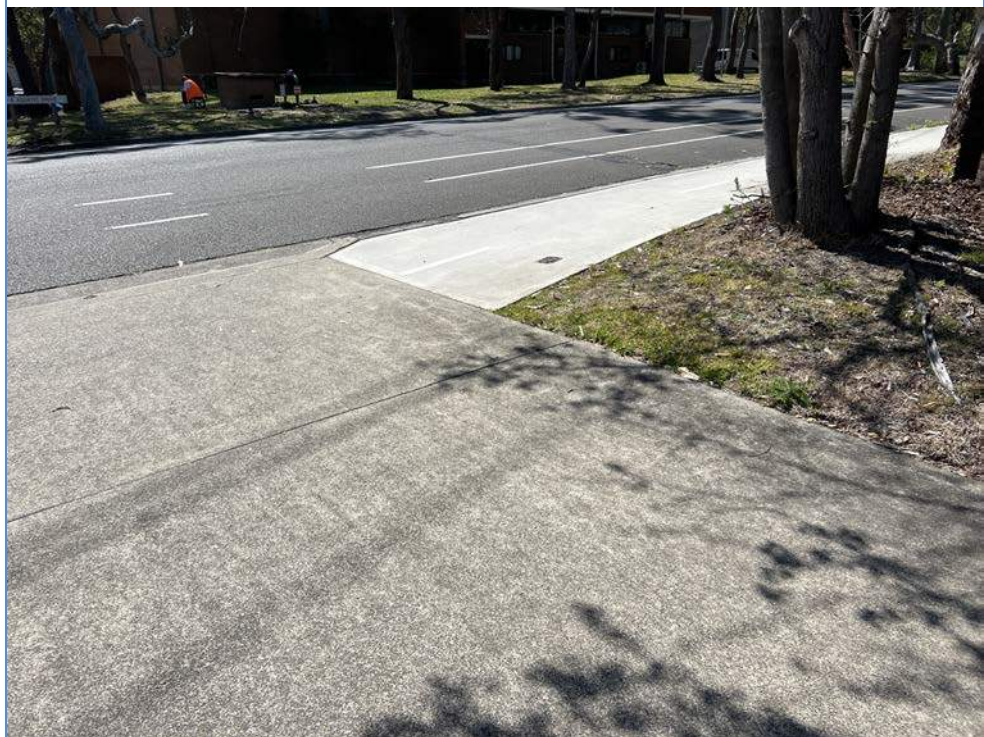
120m

General views of the kerb, gutter and road surface.

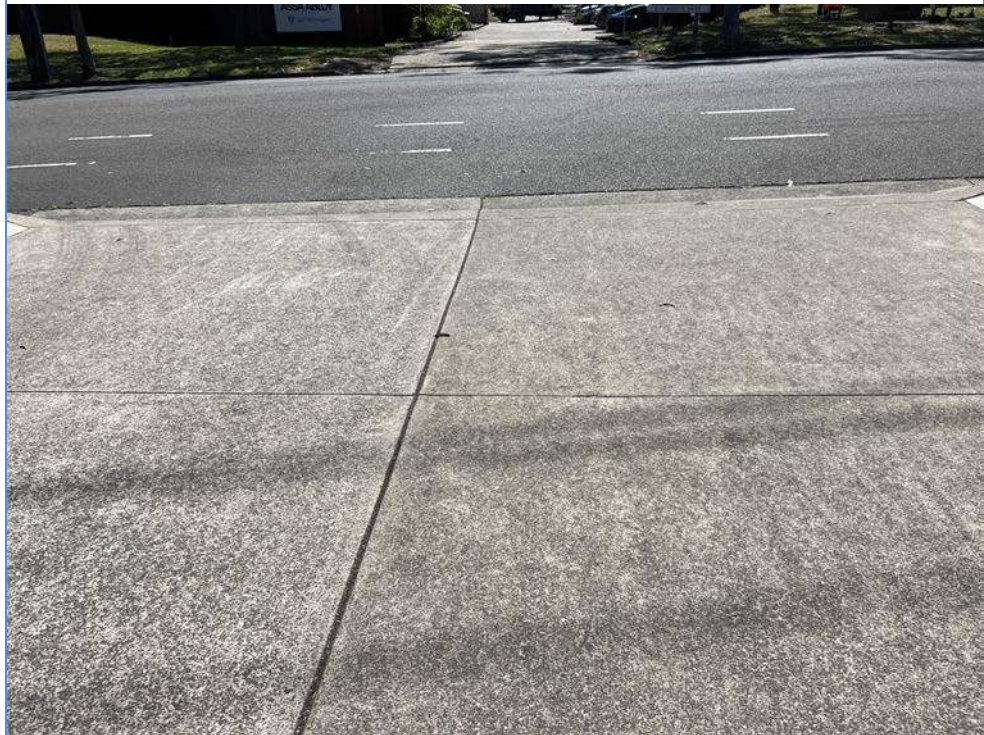
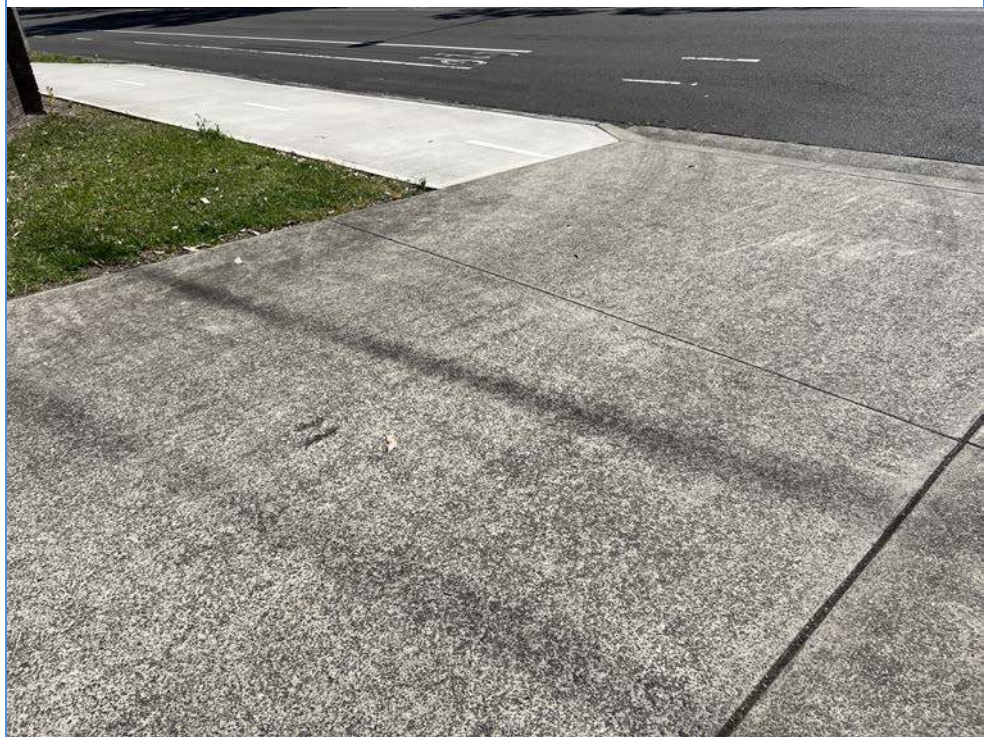
120m

General views of the kerb, gutter and road surface.
