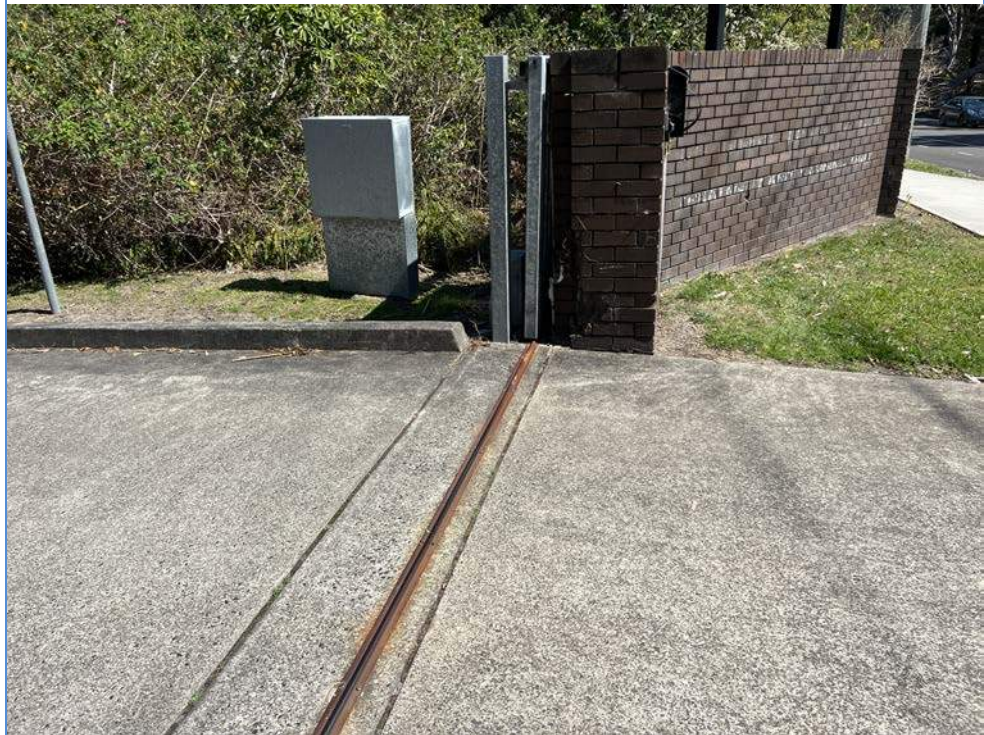
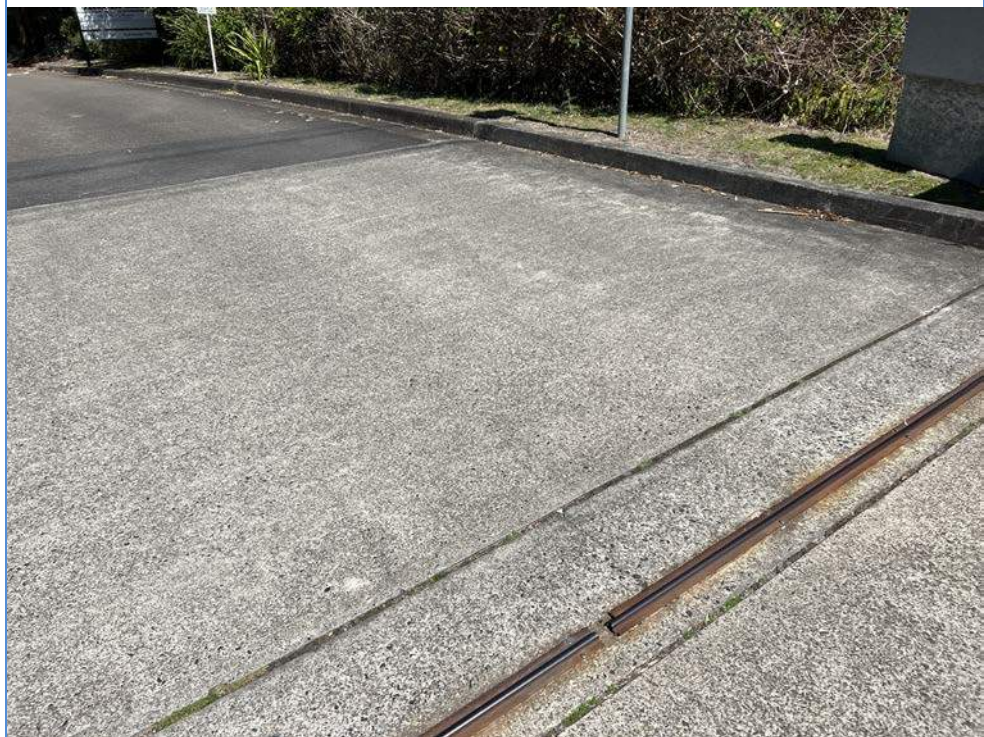
120m

General views of the kerb, gutter and road surface.

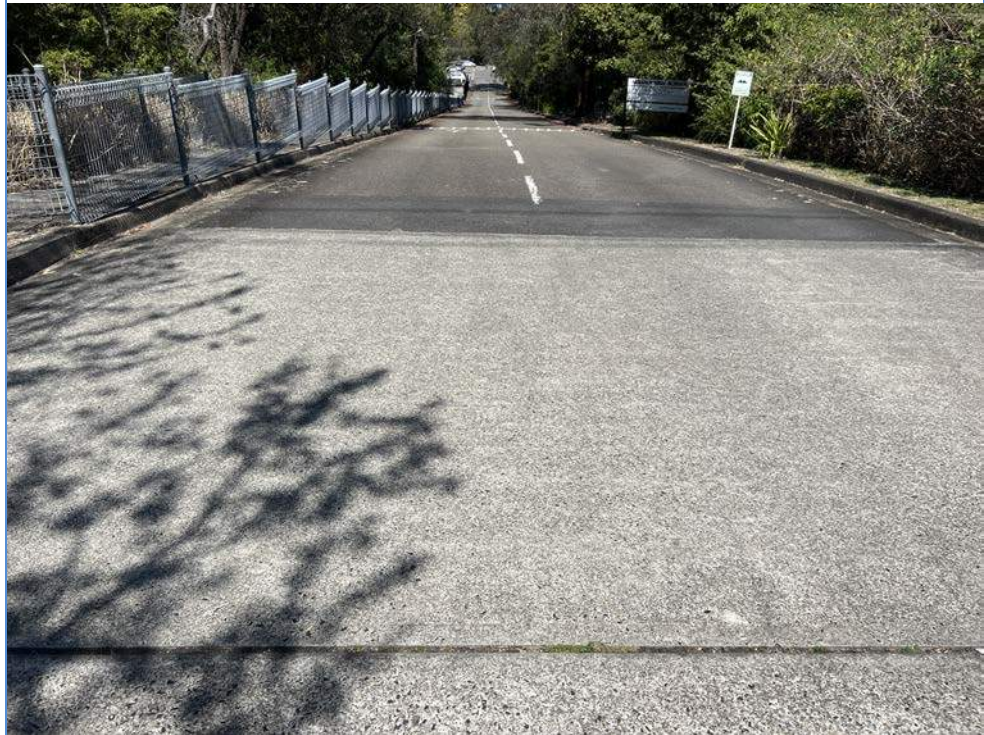
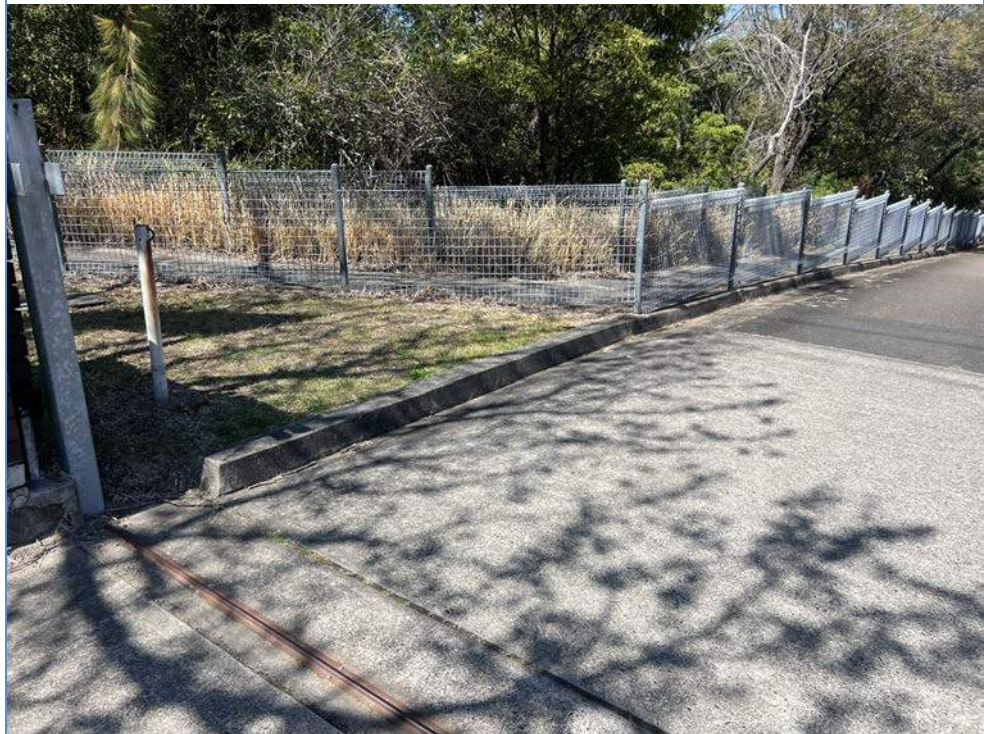
120m

General views of the kerb, gutter and road surface at the end point.
