The Forest High School

Incident Report No 2 – SSD 26876801 Condition A25

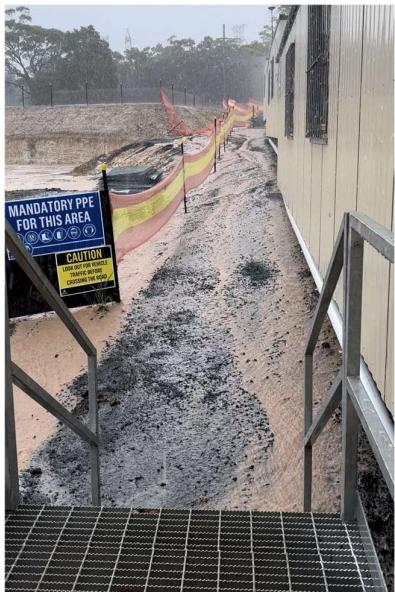
Rainwater flowing down towards the CPA boundary

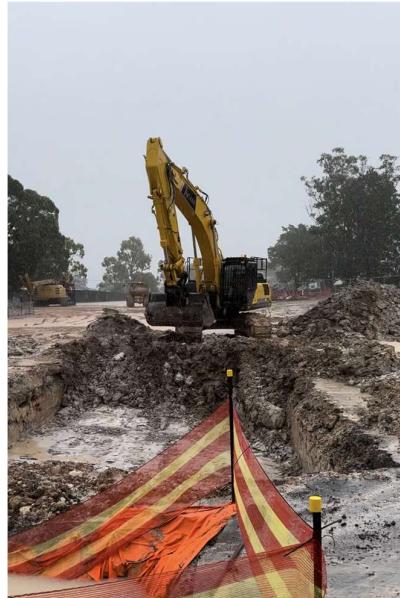
Excavation works to increase the size of sediment basin No 3

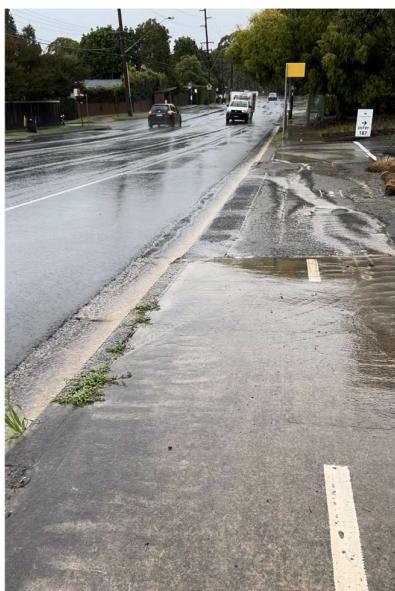
Sediment laden water flowing down Allambie Road

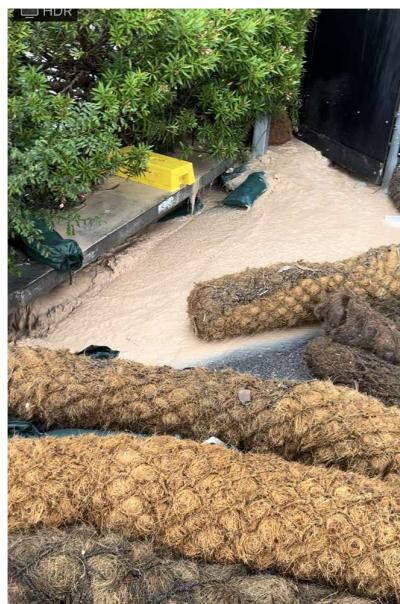
Sediment laden water overflowing
sediment control

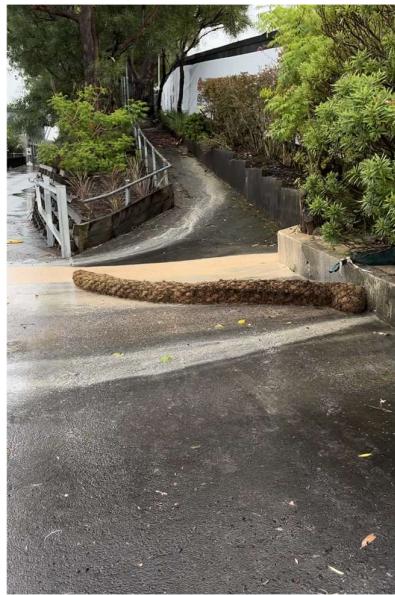
Sediment laden water overflowing sediment control towards CPA drive

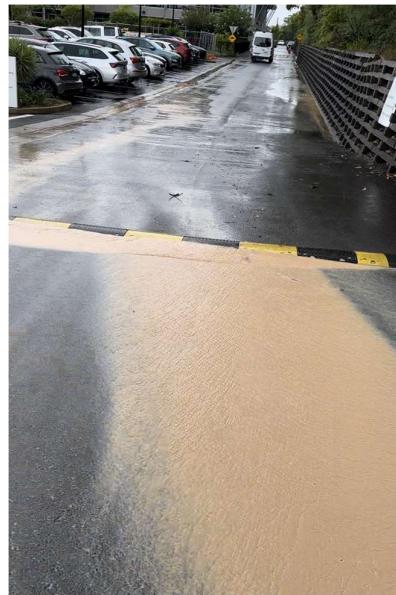
Sediment laden water flowing down the CPA driveway

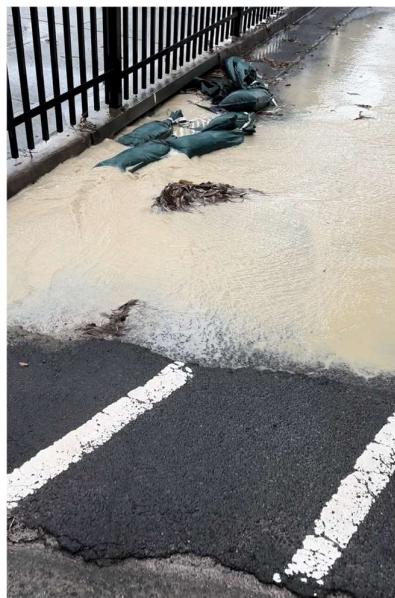
Sediment laden water overflowing sediment control along the DOE road towards Madison way

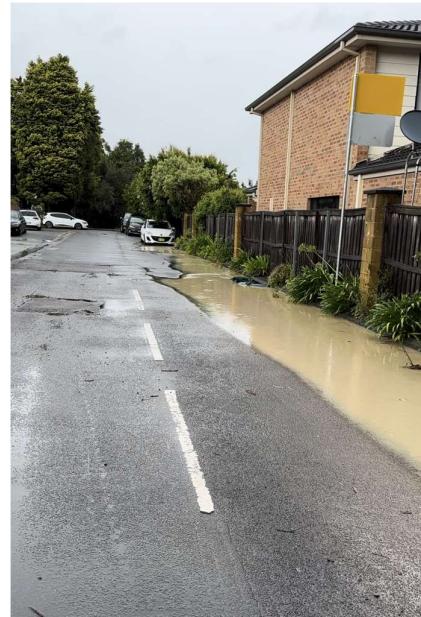
Sediment laden water flowing along Madison way

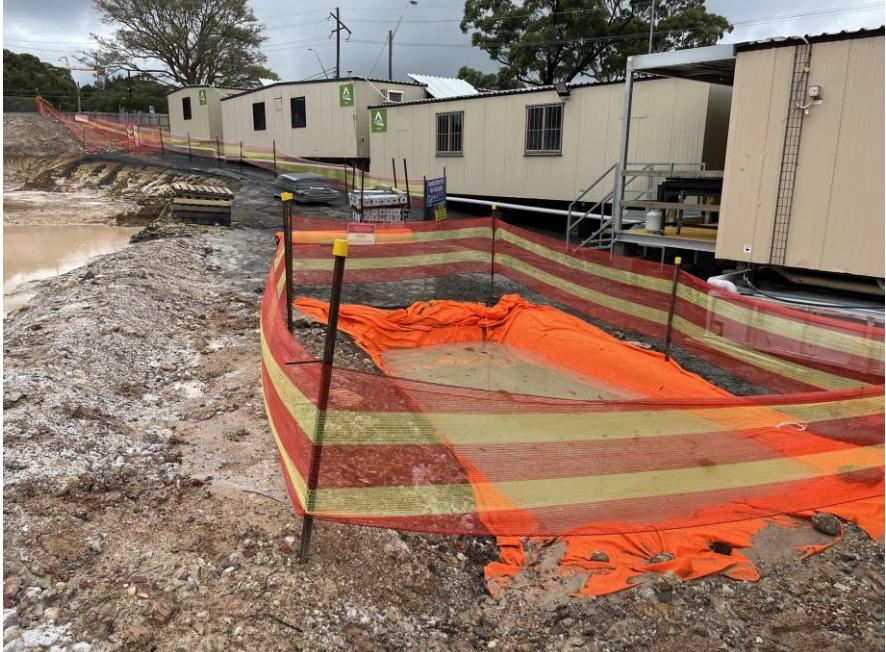
Item	Inspection notes / Recommendations	By - Due:
1	<p>Works Inspected:</p> <p>Sediment and Erosion Control</p> <p>The sediment and erosion control measures that have been implemented on site have been inspected. Refer to the following comments:</p> <ul style="list-style-type: none"> • The sediment and erosion control measures in place are generally compliant. • The sediment basin constructed near the future building Block B is compliant. This basin captures overflow with sediment from the nearby building pads which temporarily hold water.

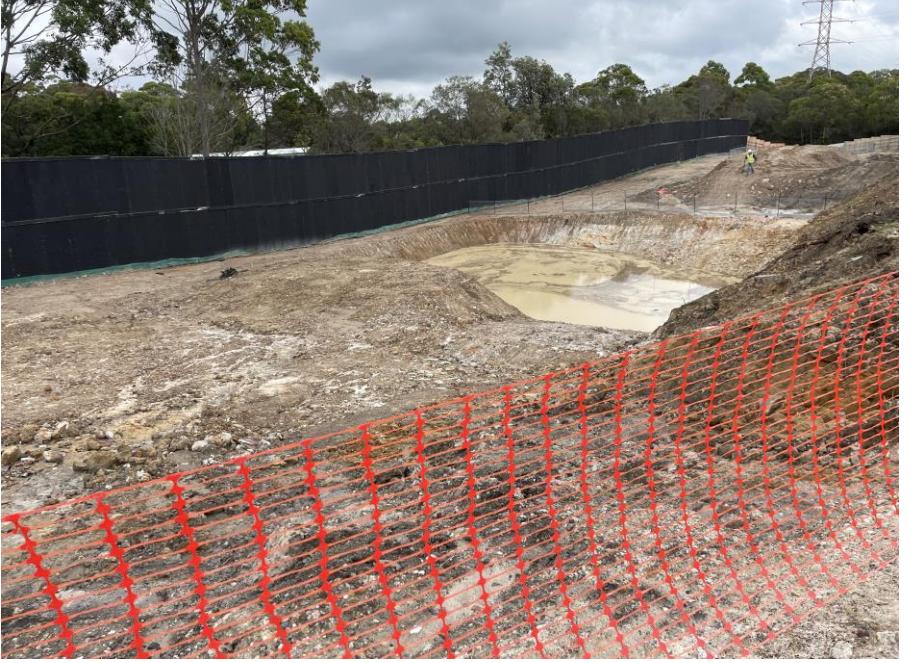
<ul style="list-style-type: none"> • The sediment basin constructed near the future basement carpark is compliant and has sufficient capacity to temporarily hold water and sediment coming from the upstream side.

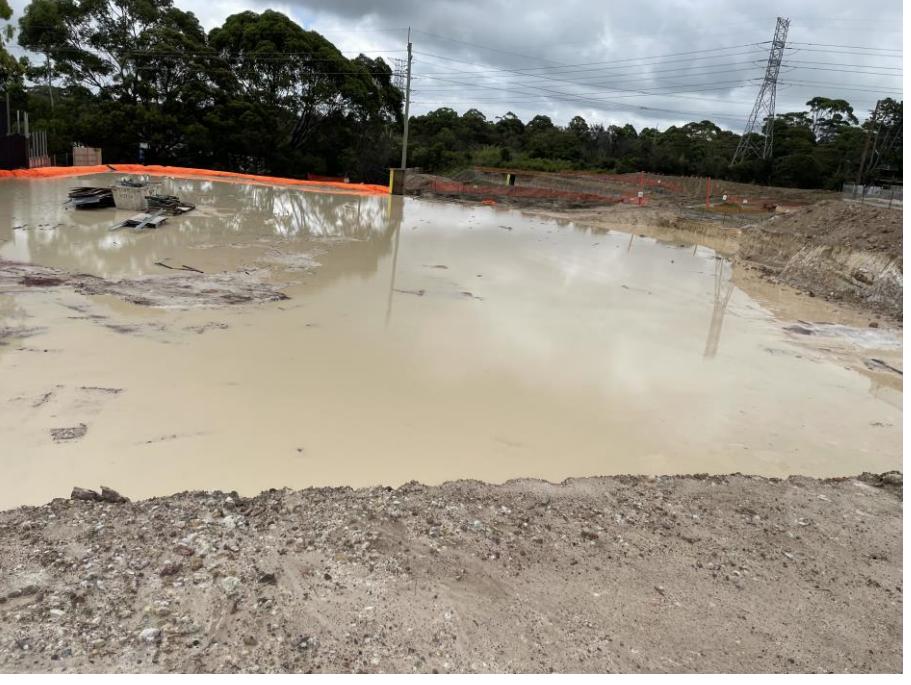
<ul style="list-style-type: none"> The building pads of Block E is acting as a temporary sediment basin. Sand bags and geofabrics have been installed to protect the bund near the neighbouring site. It is recommended to divert the overflow from this area to the sediment basin above via temporary swales.

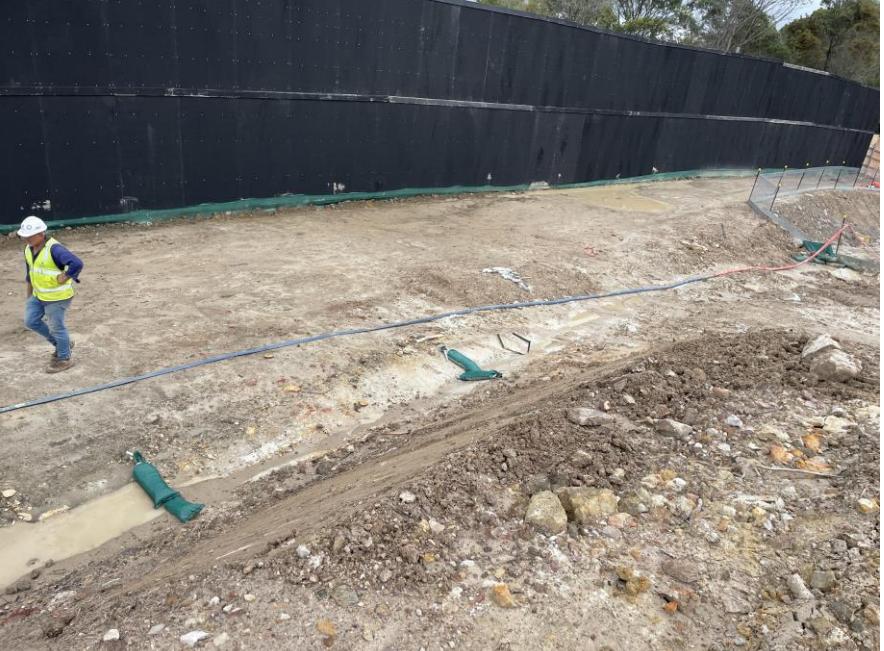
<ul style="list-style-type: none"> The sand bag filters have been installed correctly on the temporary swale directing water to the sediment basin at the location of the future OSD tank 1.

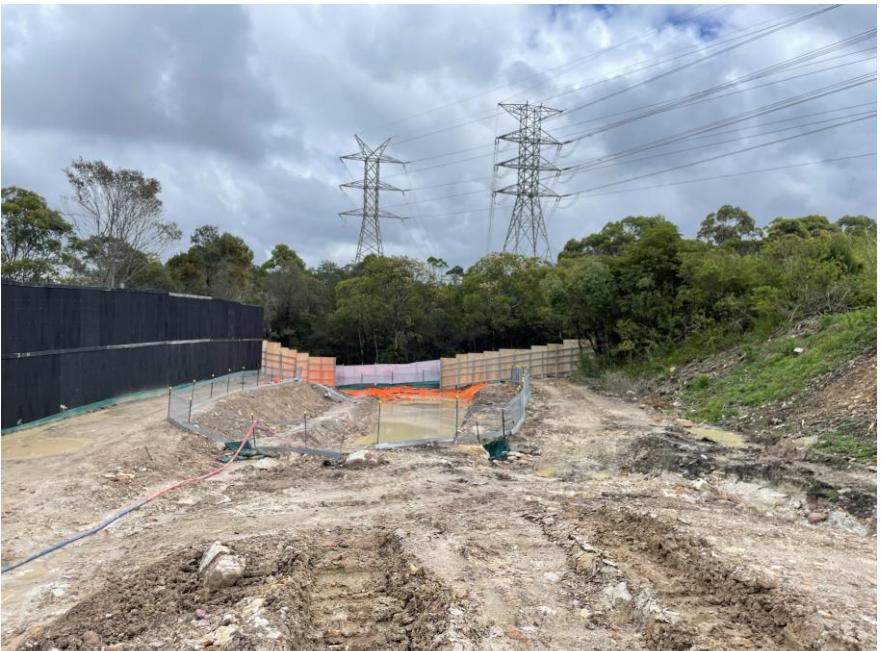
<ul style="list-style-type: none"> The sediment basin at the location of the future OSD tank 1 is working and satisfactory. It is recommended to pump out the ponding water within the sediment basin to the nearest drainage point in time.
