# HERITAGE MANAGEMENT PLAN

**Alexandria Park Community School**

**7 Park Road,**

April 2019

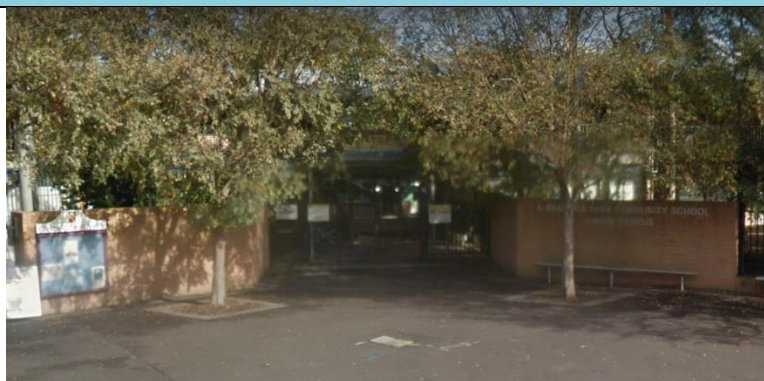
DESCRIPTION	Two-storey brick structure.				
SIGNIFICANCE	EXCEPTIONAL	HIGH	MODERATE	LOW	INTRUSIVE
CONDITION	VERY GOOD	GOOD	FAIR	POOR	VERY POOR
	Fair, usual signs of wear and tear.				
CONDITION SURVEY

Figure 14. View to the façade of Block A (Source: Google Maps).

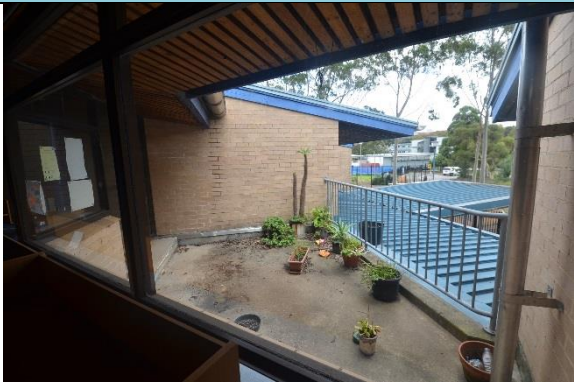
DESCRIPTION	Metal sheeting.				
SIGNIFICANCE	EXCEPTIONAL	HIGH	MODERATE	LOW	INTRUSIVE
CONDITION	VERY GOOD	GOOD	FAIR	POOR	VERY POOR
	Not able to undertake a close inspection of the roofing material. However, evidence of water leaks within the building indicates corrosion and/or dislodgement.				
CONDITION SURVEY

Figure 15. View to the roof form from the interior of Building A first floor.

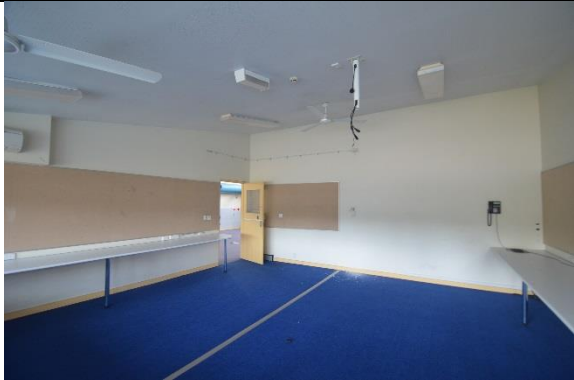
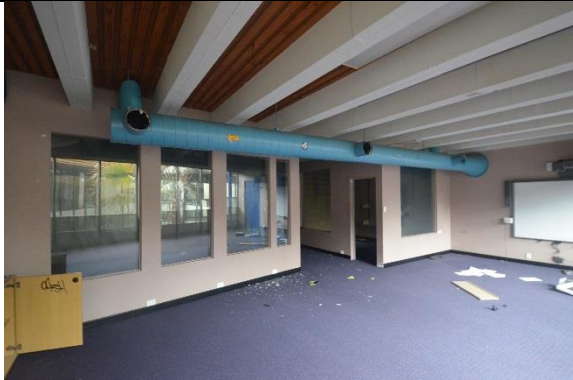
DESCRIPTION	Suspended ceilings, timber and plasterboard.				
SIGNIFICANCE	EXCEPTIONAL	HIGH	MODERATE	LOW	INTRUSIVE
CONDITION	VERY GOOD	GOOD	FAIR	POOR	VERY POOR
	Little signs of damage.				
CONDITION SURVEY

Figure 16. View to plasterboard ceiling of first floor classroom.			Figure 17. View to timber and plasterboard ceiling.

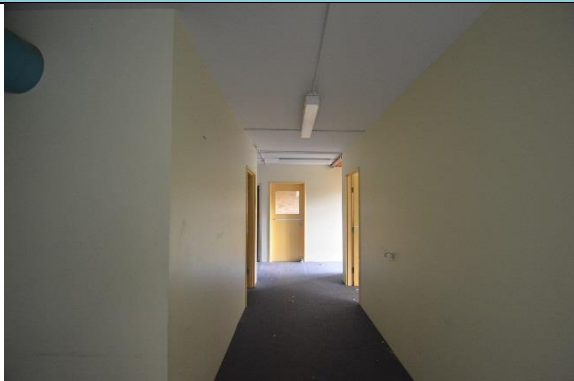
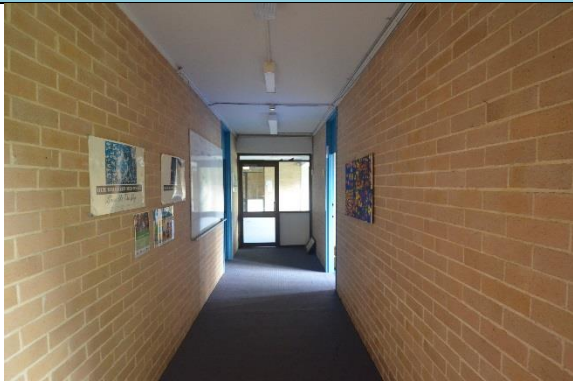
DESCRIPTION	Brick and plasterboard walls.				
SIGNIFICANCE	EXCEPTIONAL	HIGH	MODERATE	LOW	INTRUSIVE
CONDITION	VERY GOOD	GOOD	FAIR	POOR	VERY POOR
	General signs of wear and tear, in addition to holes from services that have been removed and evidence of peeling paint. Brick walls show little signs of deterioration.				
CONDITION SURVEY

Figure 18. View to plasterboard walls.			Figure 19. View to brick walls.

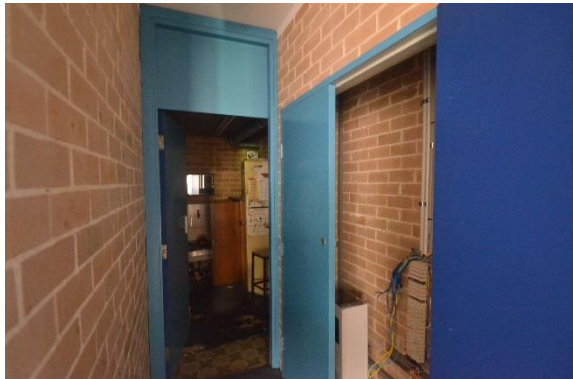
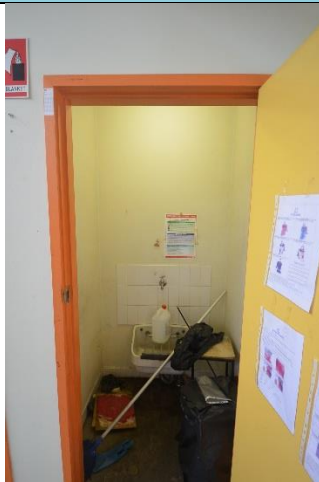
DESCRIPTION	Timber trusses and door frames.				
SIGNIFICANCE	EXCEPTIONAL	HIGH	MODERATE	LOW	INTRUSIVE
CONDITION	VERY GOOD	GOOD	FAIR	POOR	VERY POOR
	Doorways have been subjected to significant movement, shown with scuff marks and the loss of paint in sections.				
	Timber trusses are in good condition and show little signs of damage.				
CONDITION SURVEY

Figure 26. Internal doorway and services cupboard.			Figure 27. Internal doorway, typical detailing.

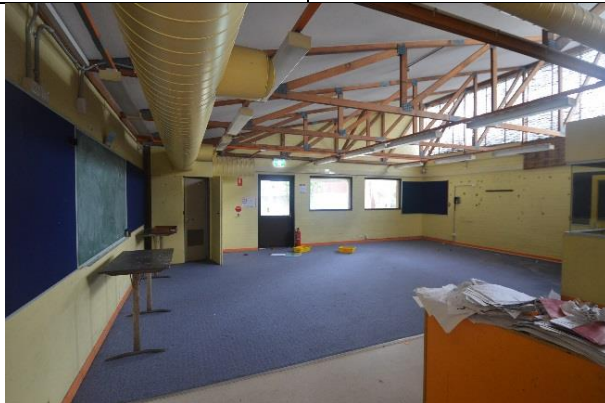
Figure 28. View to exposed timber trusses.

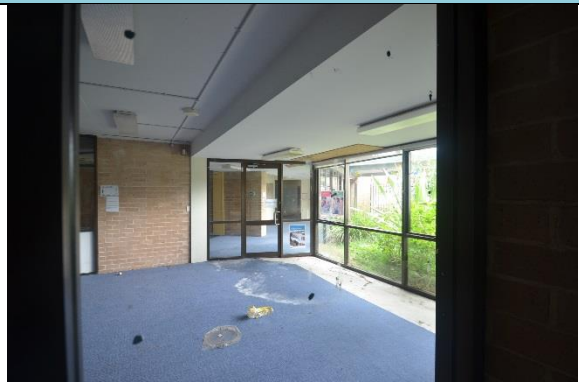
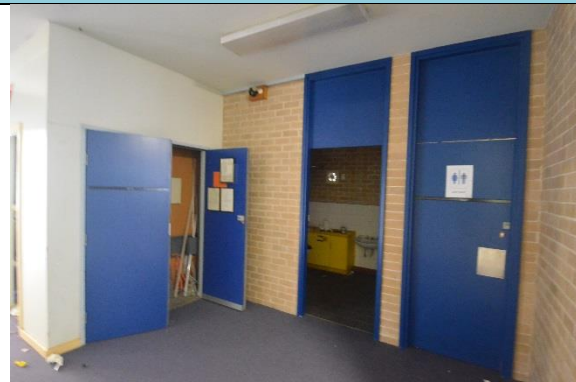
DESCRIPTION	Timber doors, including timber doors with glass panels and aluminium window frames.				
SIGNIFICANCE	EXCEPTIONAL	HIGH	MODERATE	LOW	INTRUSIVE
CONDITION	VERY GOOD	GOOD	FAIR	POOR	VERY POOR
	Timber doors show signs of general wear and tear, notably with sections removed in paint. No signs of damage to existing aluminium window frames.				
CONDITION SURVEY

Figure 29. View to interior of classroom, note aluminium window frames and glass doors.			Figure 30. Timber doors located on the first floor.

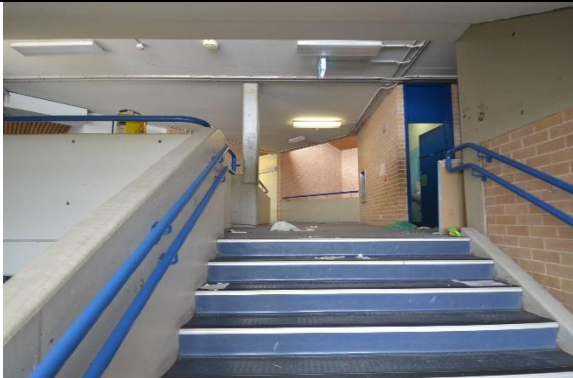
DESCRIPTION	Internal concrete stair connecting the ground floor to the first floor. Vinyl flooring and compliant handrail.				
SIGNIFICANCE	EXCEPTIONAL	HIGH	MODERATE	LOW	INTRUSIVE
CONDITION	VERY GOOD	GOOD	FAIR	POOR	VERY POOR
	General wear and tear, extensive use by students is particularly noticeable on the stair treads.				
CONDITION SURVEY

Figure 31. View to internal concrete stair and balustrade with vinyl covering.

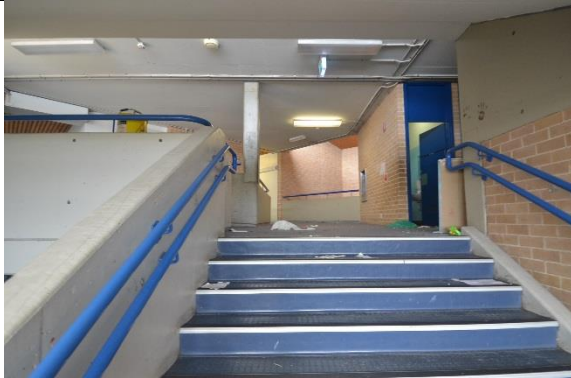
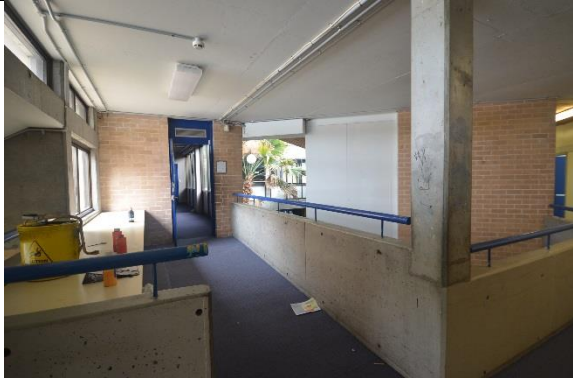
DESCRIPTION	Concrete balustrades and columns, a significant feature within the Sydney School architectural style.				
SIGNIFICANCE	EXCEPTIONAL	HIGH	MODERATE	LOW	INTRUSIVE
CONDITION	VERY GOOD	GOOD	FAIR	POOR	VERY POOR
	No clear signs of damage other than general wear and tear.				
CONDITION SURVEY

Figure 36. View to the internal stair, note the concrete in which the metal balustrade is fixed.			Figure 37. View to the internal concrete columns and balustrade.

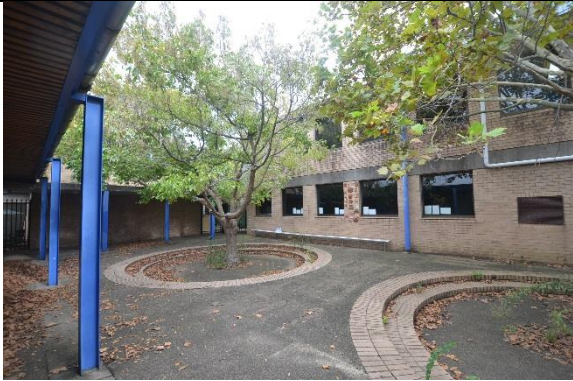
<b>DESCRIPTION</b>	Brick and off form concrete façade.				
<b>SIGNIFICANCE</b>	EXCEPTIONAL	HIGH	MODERATE	<b>LOW</b>	INTRUSIVE
<b>CONDITION</b>	VERY GOOD	GOOD	<b>FAIR</b>	POOR	VERY POOR
Fair, usual signs of wear and tear.					
<b>CONDITION SURVEY</b>

<b>Figure 38.</b> View to façade of Block B from internal courtyard.

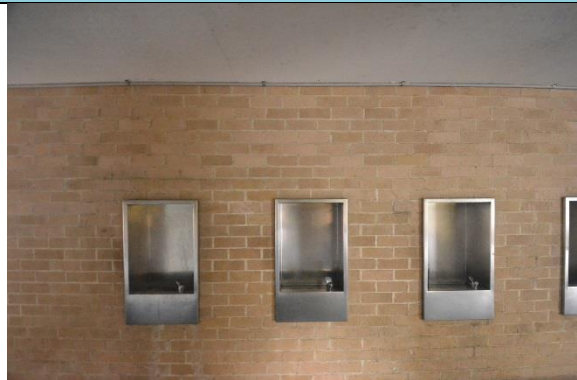
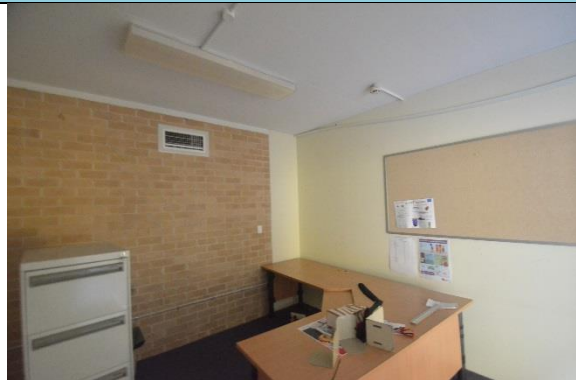
DESCRIPTION	Mixture of brick and plasterboard walls.				
SIGNIFICANCE	EXCEPTIONAL	HIGH	MODERATE	LOW	INTRUSIVE
CONDITION	VERY GOOD	GOOD	FAIR	POOR	VERY POOR
	General signs of wear and tear, in addition to holes from services that have been removed and evidence of peeling paint. Brick walls show little signs of deterioration.				
CONDITION SURVEY

Figure 44. Internal brick walls including water fountains.			Figure 45. View to internal plasterboard and brick walls.

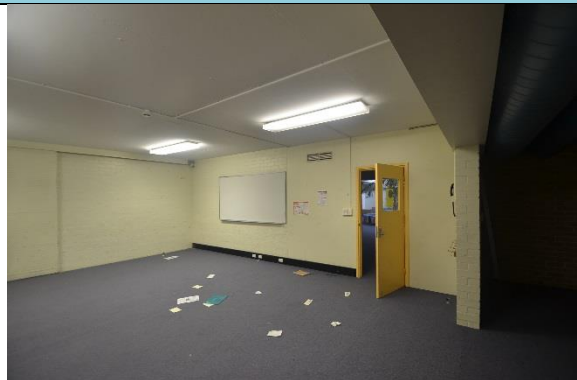
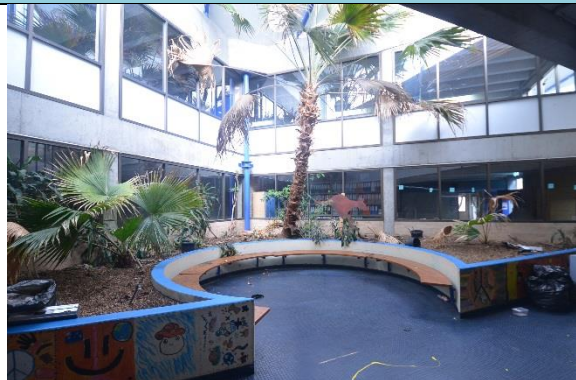
DESCRIPTION	Combination of carpet, vinyl and tiling.				
SIGNIFICANCE	EXCEPTIONAL	HIGH	MODERATE	LOW	INTRUSIVE
CONDITION	VERY GOOD	GOOD	FAIR	POOR	VERY POOR
	Vinyl – general signs of wear and tear.				
	Carpet – due to water damage, sections of the carpet are presenting signs of mould in addition to the general signs of wear and tear.				
Tiling – located throughout the bathrooms, general wear and tear but no clear signs of damage.					
CONDITION SURVEY

Figure 46. View to carpet of ground floor classroom.			Figure 47. View of vinyl flooring in internal courtyard.

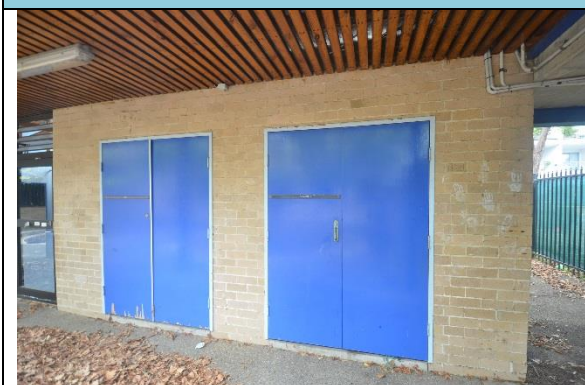
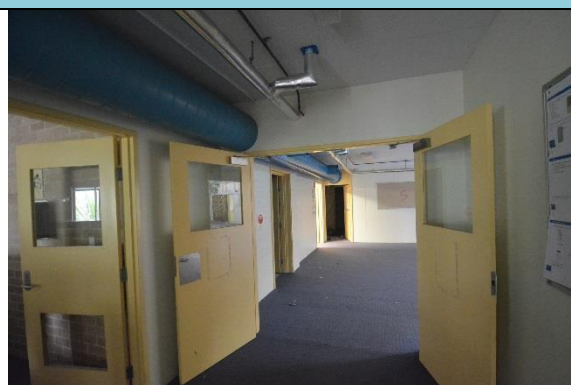
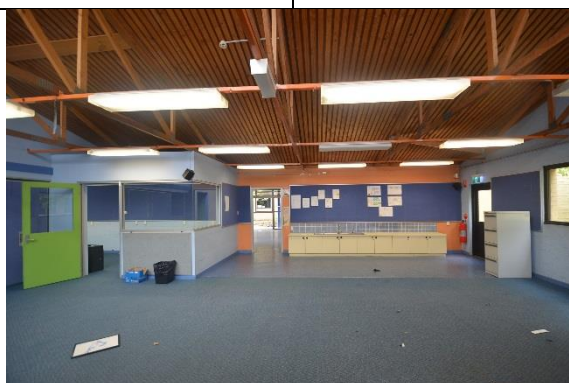
DESCRIPTION	Timber trusses and door frames.				
SIGNIFICANCE	EXCEPTIONAL	HIGH	MODERATE	LOW	INTRUSIVE
CONDITION	VERY GOOD	GOOD	FAIR	POOR	VERY POOR
	Doorways have been subjected to significant movement, shown with scuff marks and the loss of paint in sections. Timber trusses are in good condition and show little signs of damage.

Figure 50. View to external service cupboards.

Figure 51. View to internal swing doors.

Figure 52. View to timber trusses.

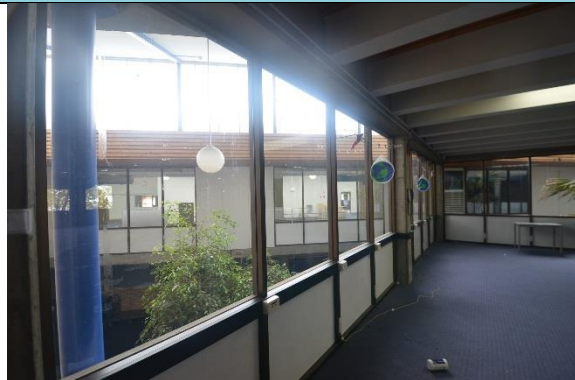
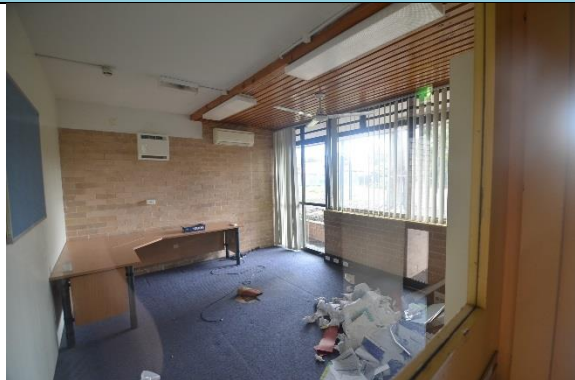
DESCRIPTION	Timber doors, including timber doors with glass panels and aluminium window frames.				
SIGNIFICANCE	EXCEPTIONAL	HIGH	MODERATE	LOW	INTRUSIVE
CONDITION	VERY GOOD	GOOD	FAIR	POOR	VERY POOR
	Timber doors show signs of general wear and tear, notably with sections removed in paint.				
CONDITION SURVEY

Figure 53. View to aluminium window frames.			Figure 54. View to internal classroom.

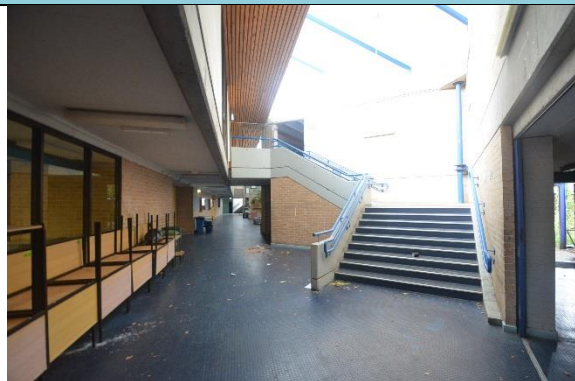
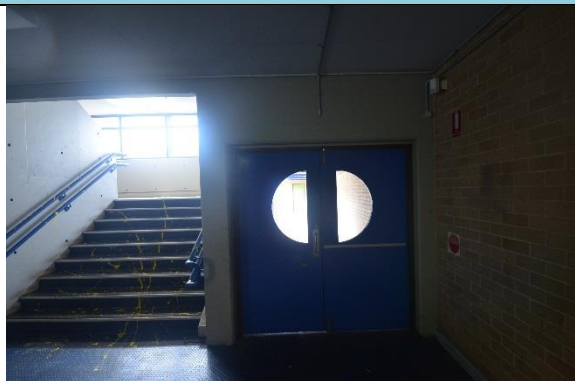
DESCRIPTION	Concrete stair and balustrade with vinyl flooring.				
SIGNIFICANCE	EXCEPTIONAL	HIGH	MODERATE	LOW	INTRUSIVE
CONDITION	VERY GOOD	GOOD	FAIR	POOR	VERY POOR
	Concrete stair and balustrade do not demonstrate signs of poor condition. Vinyl shows signs of general wear and tear.				
CONDITION SURVEY

Figure 55. View to internal stairs.			Figure 56. View to internal stairs, note splattered paint across balustrade and vinyl.

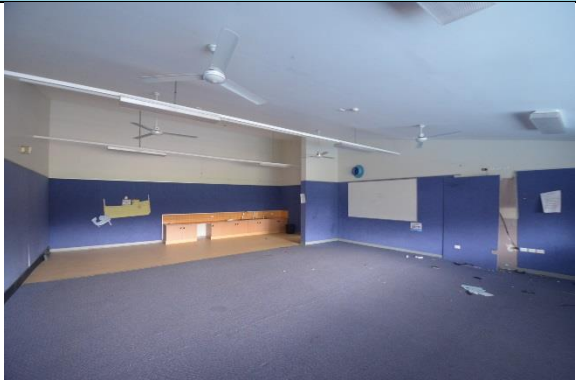
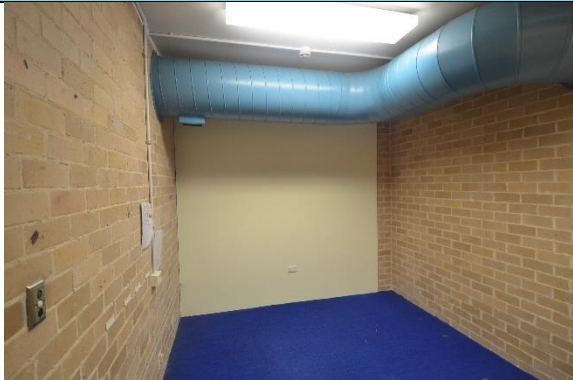
DESCRIPTION	Services include the air conditioning units and heaters.				
SIGNIFICANCE	EXCEPTIONAL	HIGH	MODERATE	LOW	INTRUSIVE
CONDITION	VERY GOOD	GOOD	FAIR	POOR	VERY POOR
	Services have been installed with little consideration to the visual impact upon the building. However, the services appear to be in working order.				
CONDITION SURVEY

Figure 57. View to interior of classroom on first floor with ceiling fans.			Figure 58. View to interior of classroom with vents.

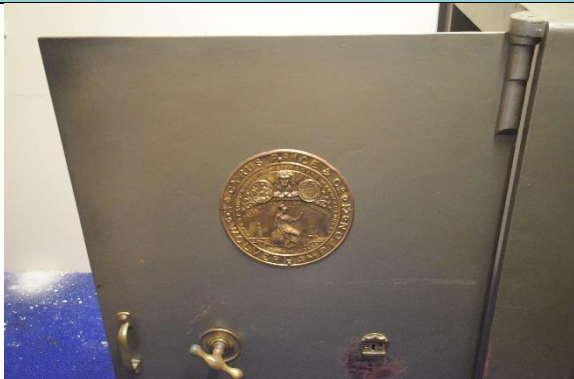
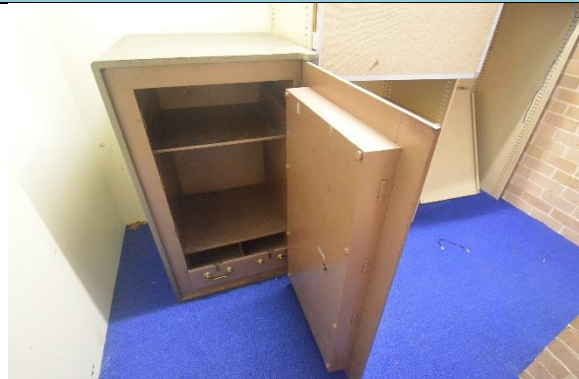
DESCRIPTION	The former safe, the emblem states Cyrus Price & Co, Wolverhampton.				
SIGNIFICANCE	EXCEPTIONAL	HIGH	MODERATE	LOW	INTRUSIVE
CONDITION	VERY GOOD	GOOD	FAIR	POOR	VERY POOR
	Clear scratches and dints in the existing.				
CONDITION SURVEY

Figure 59. Close-up view of safe.			Figure 60. View to interior of safe.

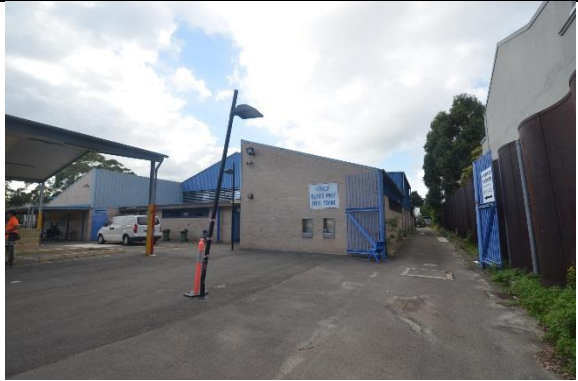
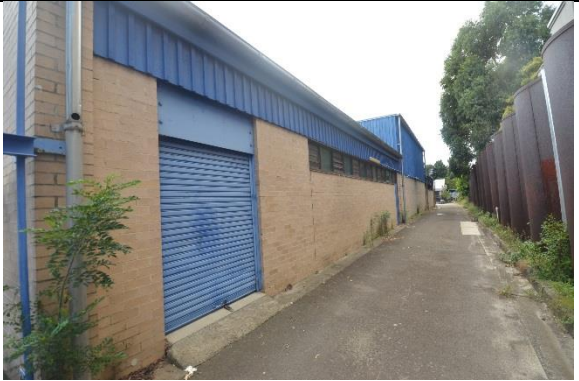
DESCRIPTION	Brick façade with corrugated iron features and roller door.				
SIGNIFICANCE	EXCEPTIONAL	HIGH	MODERATE	LOW	INTRUSIVE
CONDITION	VERY GOOD	GOOD	FAIR	POOR	VERY POOR
General signs of wear and tear.					
CONDITION SURVEY

Figure 61. View to exterior of Block C, facing south-east.			Figure 62. View to side elevation of Block C.

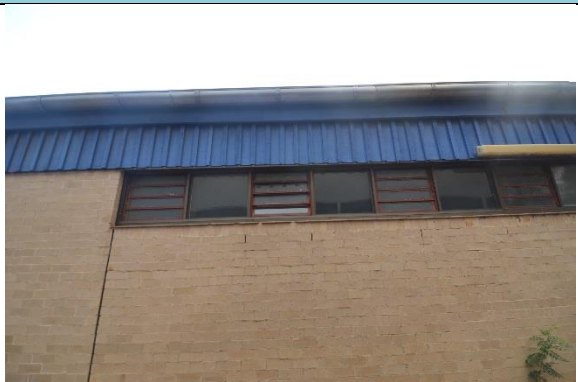
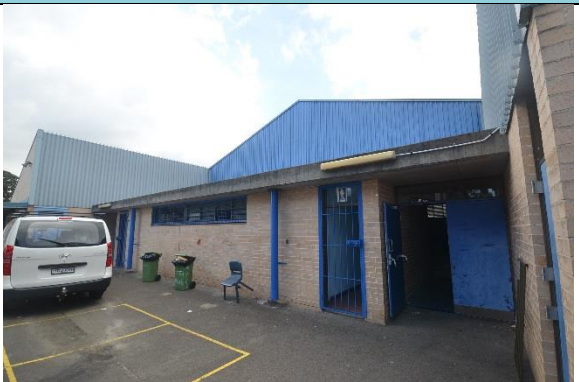
DESCRIPTION	Metal sheeting.				
SIGNIFICANCE	EXCEPTIONAL	HIGH	MODERATE	LOW	INTRUSIVE
CONDITION	VERY GOOD	GOOD	FAIR	POOR	VERY POOR
Not able to undertake a close inspection of the roofing material however evidence of water leaks from the interior indicates corrosion and dislodgement.					
CONDITION SURVEY

Figure 63. View to existing gutters.			Figure 64. View to northern elevation.

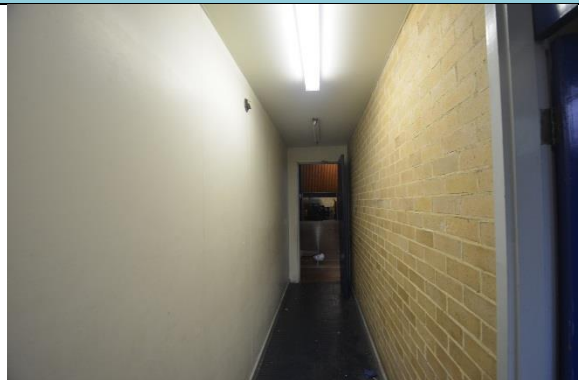
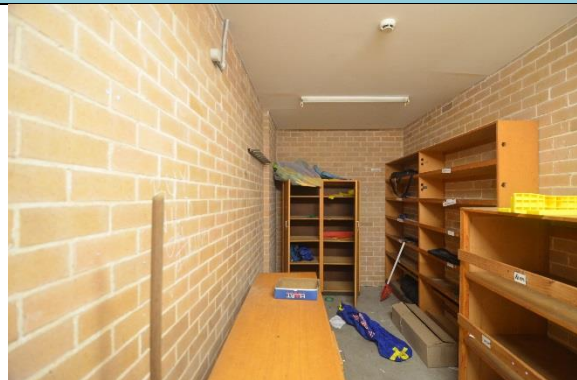
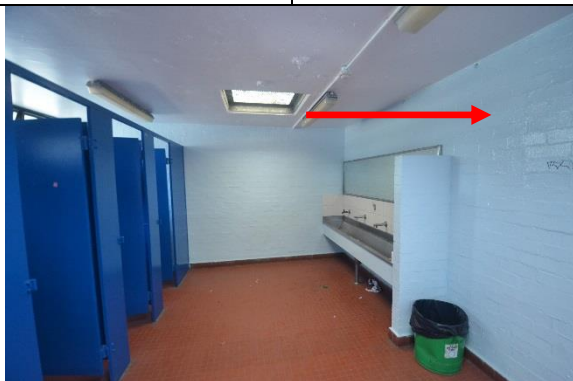
DESCRIPTION	Brick and plasterboard walls. The existing bathroom walls are tiled.				
SIGNIFICANCE	EXCEPTIONAL	HIGH	MODERATE	LOW	INTRUSIVE
CONDITION	VERY GOOD	GOOD	FAIR	POOR	VERY POOR
	General signs of wear and tear, in addition to holes from services that have been removed and evidence of peeling paint. Brick walls show little signs of deterioration. Tiling on bathroom walls in fair condition, no signs of mould or deterioration.				
CONDITION SURVEY

Figure 70. View to internal brick and plasterboard walls.			Figure 71. View to internal brick walls.

Figure 72. View to interior of primary bathroom, red arrow indicates tiled wall.

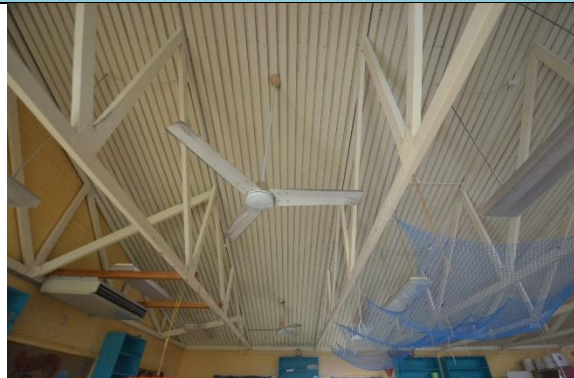
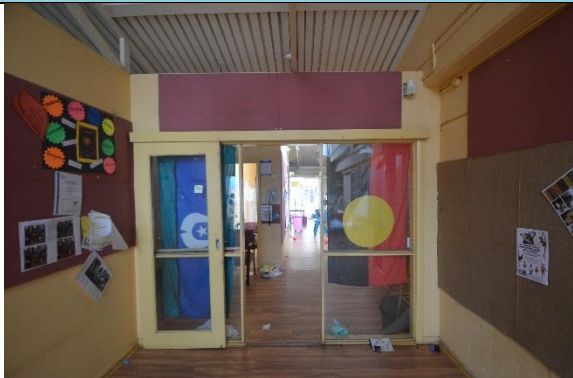
DESCRIPTION	Timber trusses and door frames.				
SIGNIFICANCE	EXCEPTIONAL	HIGH	MODERATE	LOW	INTRUSIVE
CONDITION	VERY GOOD	GOOD	FAIR	POOR	VERY POOR
	Doorways have been subjected to significant movement, shown with scuff marks and the loss of paint in sections. Timber trusses are in good condition and show little signs of damage.				
CONDITION SURVEY

Figure 77. View to timber ceiling and trusses.			Figure 78. Internal sliding doors.

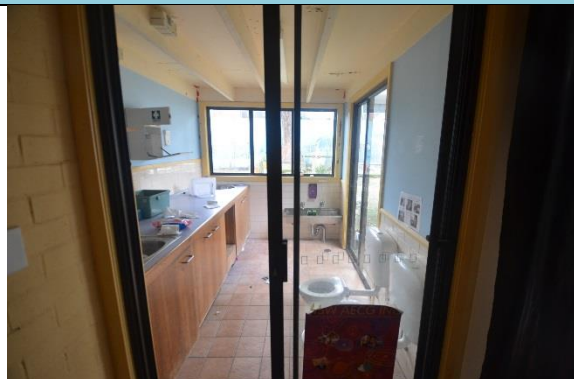
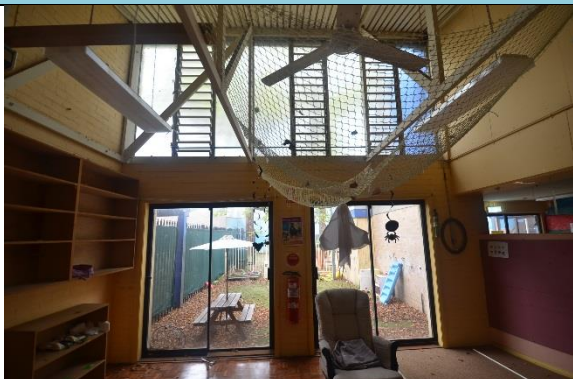
DESCRIPTION	Doors, including timber and glass and aluminium window frames.				
SIGNIFICANCE	EXCEPTIONAL	HIGH	MODERATE	LOW	INTRUSIVE
CONDITION	VERY GOOD	GOOD	FAIR	POOR	VERY POOR
	Timber doors show signs of general wear and tear, notably with sections removed in paint.				
CONDITION SURVEY

Figure 79. Glass sliding door.			Figure 80. Rear elevation, includes glass sliding doors, louvres and additional windows, set in aluminium frames.

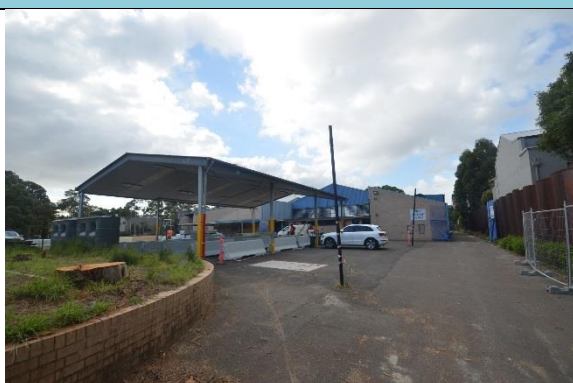
DESCRIPTION	Metal outdoor structure.				
SIGNIFICANCE	EXCEPTIONAL	HIGH	MODERATE	LOW	INTRUSIVE
CONDITION	VERY GOOD	GOOD	FAIR	POOR	VERY POOR
	Little signs of deterioration.				
CONDITION SURVEY

Figure 83. View to the outdoor shade structure.
