SINSW Centre Of Excellence (Richmond)

Road Safety Audit

Detailed Design Stage

JN22024_Report01 Rev01 - TTW Richmond COE

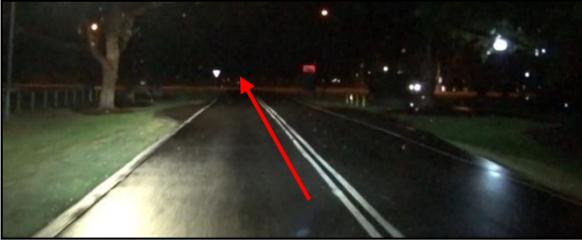
Item Location	Safety Hazard Finding	Frequency	Severity	Level Of Risk	Project Manager Response
1. Intersection Delineation Londonderry Road	<p>There is no delineation on the terminating leg of the T-intersection.</p> <p>There is a risk at night or during adverse weather that a motorist may not sight the intersection point and approach the intersection at high speed (accelerating after exiting the 40 zone) with insufficient time to decelerate to a stop before entering the through lane resulting in side impact collisions from through vehicles.</p>

Improbable	Minor	Medium	Signage and line marking plan to be developed for this area, including retro-reflective pavement markers (RRPMs), T-intersection advance warning signage, and T-intersection terminating signage (<<< >>>).

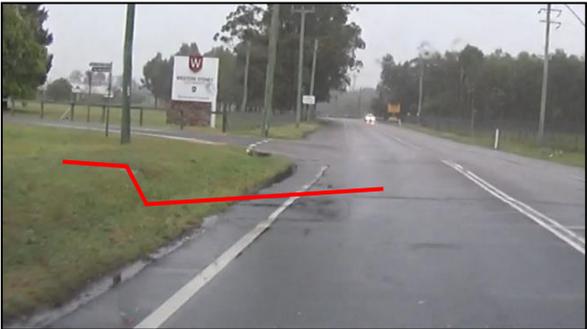
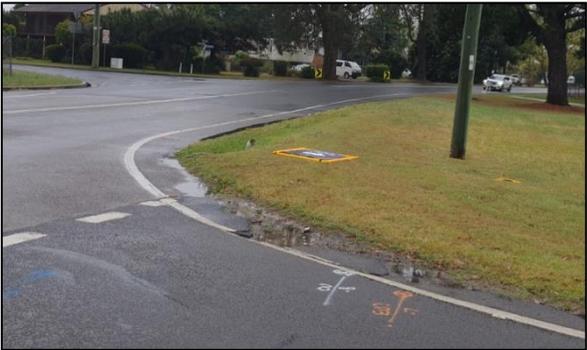
2. Drainage Londonderry Road	<p>The proposed widening works at the Londonderry Road intersection creates a road formation cut profile and no drainage infrastructure is proposed.</p> <p>There is a risk that water may pond into the through travel lanes of a 60 km/h zone resulting in aquaplaning incidents.</p> <p>There is a risk that ponding water may damage the pavement surface creating vehicle/motorcycle destabilisation incidents resulting in run-off-road or head-on collisions, particularly when negotiating a corner.</p> <p>There is a risk that water flows may erode the edge of the pavement creating a vertical drop that may</p>	Probable	Serious	Intolerable	<p>Existing blocked pipe to be replaced and improved as part of intersection works which should reduce ponding.</p> <p>A drainage channel to bring water off the roadway will also be considered in the detailed design.</p> <p>Pavement and/or kerb design to be reviewed to avoid erosion.</p>

snag an errant vehicle resulting in vehicle roll incidents.

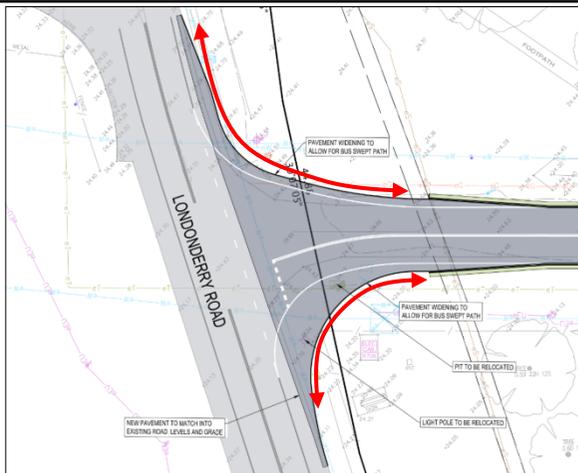
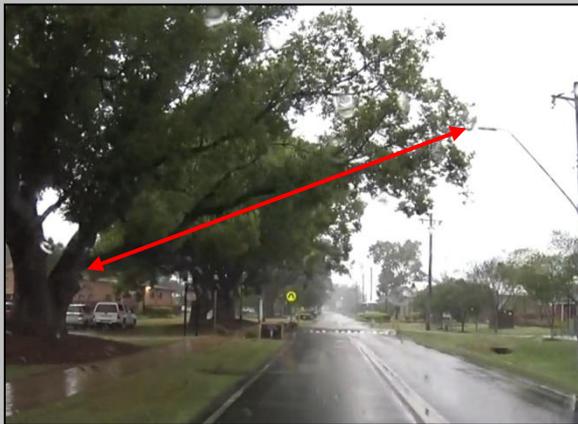
<p>3. Overhanging Branches Extent of Works</p>	<p>There are low and overhanging branches throughout the extent of works.</p> <p>There is a risk that a branch may fall on a vehicle or fall into the travel lane and be impacted by a vehicle resulting in injury to vehicle occupants.</p> <p>There is a risk that a vehicle may impact overhanging branches causing them to fall onto the vehicle or into the travel lane and be impacted by another vehicle resulting in injury to vehicle occupants.</p>	<p>Improbable</p>	<p>Minor</p>	<p>Medium</p>	<p>Height clearances and tree conditions under review with arborist, it is anticipated that pruning will be required to various trees.</p> <p>Some residual overhang of trees is expected as part of the urban design of the space and to retain tree canopy coverage of the area. Ongoing review and maintenance may be required by WSU.</p>
---	---	-------------------	--------------	---------------	---

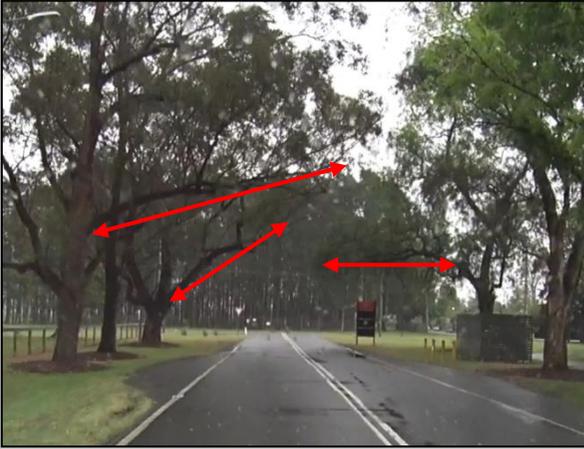
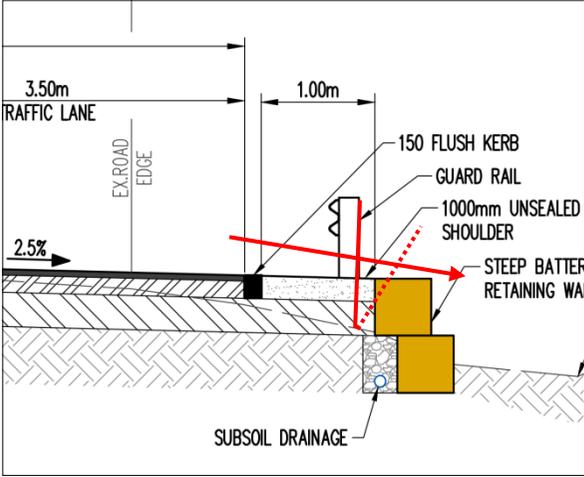
Item Location	Safety Hazard Finding	Frequency	Severity	Level Of Risk	Project Manager Response
<p>4. Barrier Post Support Extent of Works</p>

<p>There is insufficient support provided behind the barrier post. There is a risk that an errant vehicle may not be contained by the barrier resulting in a vehicle reaching a hazard, snag/roll incidents and injury to occupants.</p>

<p>Improbable</p>	<p>Serious</p>	<p>Medium</p>	<p>Road sections will be designed to provide the required support distance behind guard rails; design to manufacturer requirements once a barrier product is selected.</p>

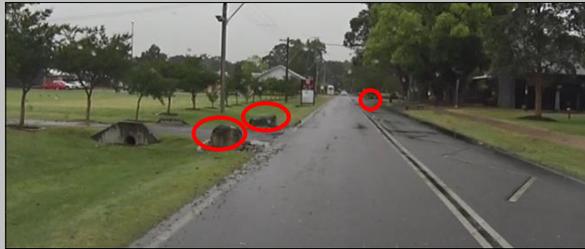
Item Location	Safety Hazard Finding	Frequency	Severity	Level Of Risk	Project Manager Response						
<p>7. Large Rocks Extent of Works</p>	<p>There are large rocks adjacent to the travel lane throughout the extent of works.</p> <p>There is a risk that an errant vehicle may impact a non-frangible hazard resulting in vehicle damage or injury to vehicle occupants.</p>	Occasional	Minor	Medium	To be reviewed with WSU and deleted where possible.

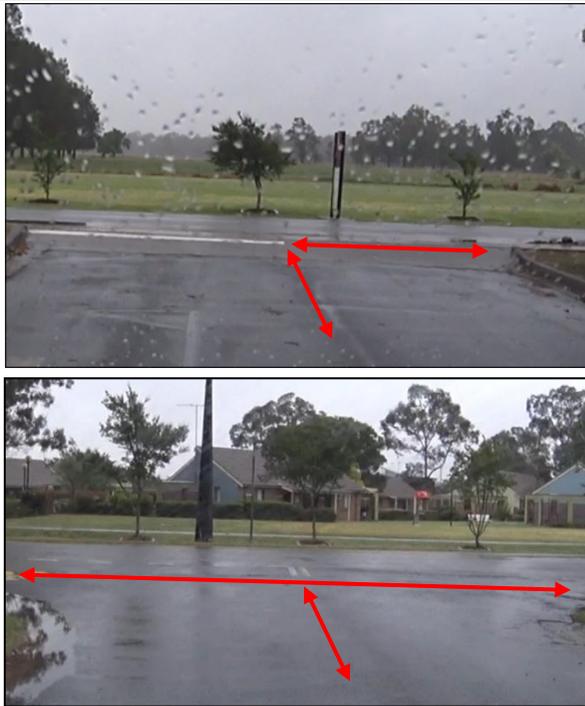
<p>9. Ponding water Extent of works</p>	<p>On site it was observed that pavement water was ponding against raised pedestrian crossings, against the raised grassed verge, at blocked drains and at pavement depressions throughout the site.</p> <p>Specific locations include Vines Drive at Yarramundi Road and side road opposite Yarramundi Road.</p> <p>There is a risk that ponding water may damage the pavement surface creating vehicle/motorcycle destabilisation incidents resulting in run-off-road or head-on collisions.</p> <p>There is a risk that water flows may erode the edge of the pavement resulting in vehicle snag/roll incidents.</p>	Occasional	Minor	Medium	Stormwater strategy to be finalised in detailed design.

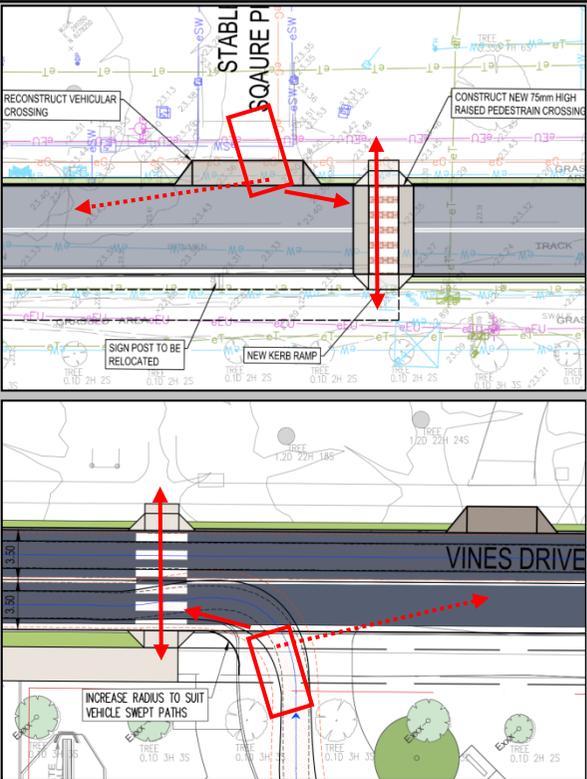
12.
 Pedestrian Crossing
 Sight
 Extent of Works

There are multiple pedestrian crossings, both existing and proposed, without line marking, signage and lighting.

The legal requirement for a motorist to give-way at a pedestrian crossing that is not line marked and only sign posted in one direction is not clear.

An inconsistent approach to pedestrian facilities may increase driver confusion/frustration, and decrease pedestrian compliance.

There is a risk that an approaching motorist may not anticipate a pedestrian stepping out into the travel lane resulting in pedestrian-vehicle collisions.

Improbable

Serious

Medium

Consistency of crossing treatments is under review. Any crossings in the final design will have line marking and signage in both directions.

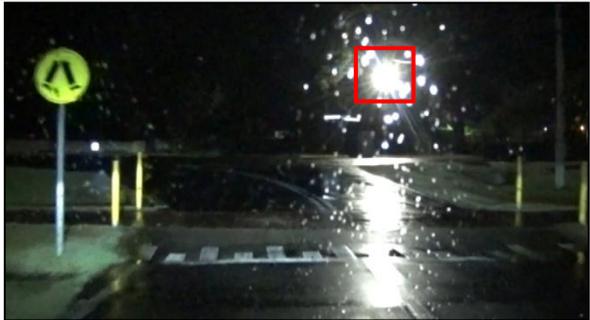
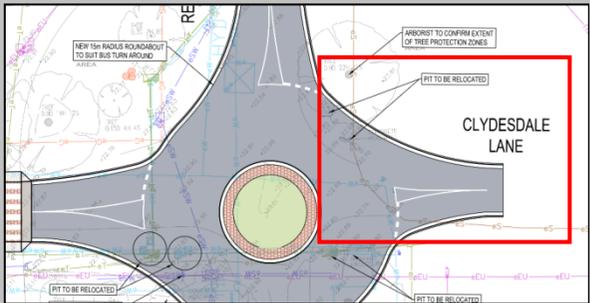
Item Location	Safety Hazard Finding	Frequency	Severity	Level Of Risk	Project Manager Response		
<p>15. Survey Clydesdale Lane</p>	<p>There is no survey provided at the Clydesdale Lane leg on the roundabout. The proposed alignment of the leg appears to be offset from Vines Drive and from the existing Clydesdale Lane. The proposed width does not match the existing width.</p> <p>There is a risk that staggered alignments and incomplete works may resulting in run-off-road incidents.</p>	Probable	Limited	Medium	<p>Further survey is being undertaken, final design will suit surveyed configuration.</p>

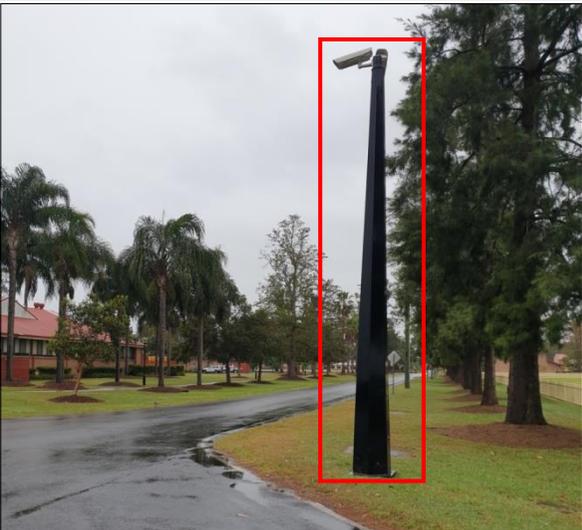
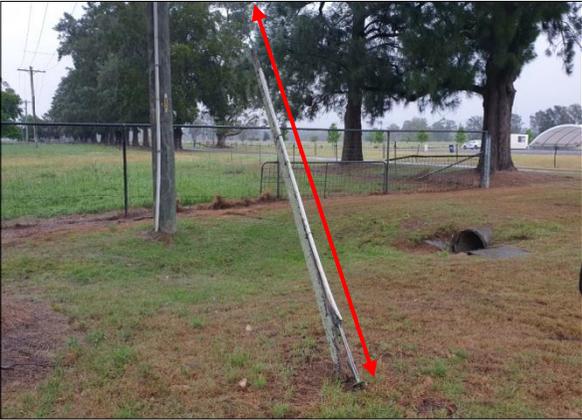
<p>16. Infrastructure Clydesdale Lane</p>	<p>There is existing infrastructure at the intersection of Clydesdale Lane including a brick hydrant enclosure, stay pole, and CCTV pole.</p> <p>There is a risk that a pedestrian or motorist may impact hazards in pedestrian paths, clear zones, or in the travel lane.</p>	Frequent	Minor	Intolerable	<p>Existing infrastructure to be relocated as part of roundabout works.</p>

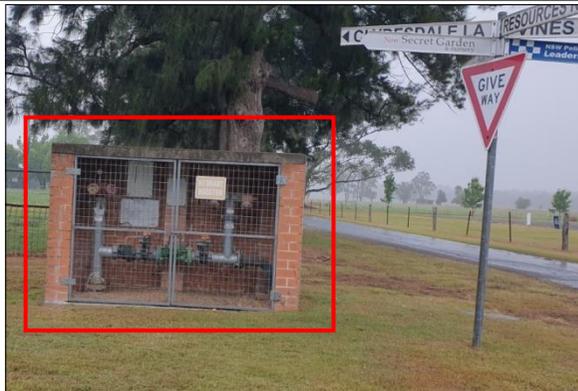
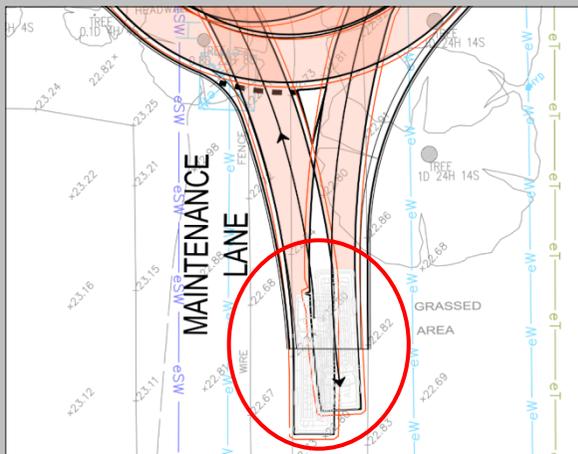
17.
Width
Maintenance Lane

The turning path plan for the roundabout shows 2-way traffic colliding at the Maintenance Lane splitter island, however the Maintenance Lane Carpark turning path plan indicates there is sufficient width for 2-way traffic.

There is a risk that the existing width on Maintenance Lane may not be sufficient for 2-way traffic resulting in side-swipe or head-on collisions with oncoming traffic, run-off-road incidents, or collisions with roadside infrastructure, hazards or pedestrians.

Frequent Minor Intolerable

Treatment for two-way traffic along Maintenance Lane is under review. Traffic movements are generally expected to be one-way (e.g. arrivals in the morning, departures in the afternoon) so limited two-way traffic is expected. A priority system can be designed, and will ensure sufficient space for vehicles off the circulating area of the roundabout.

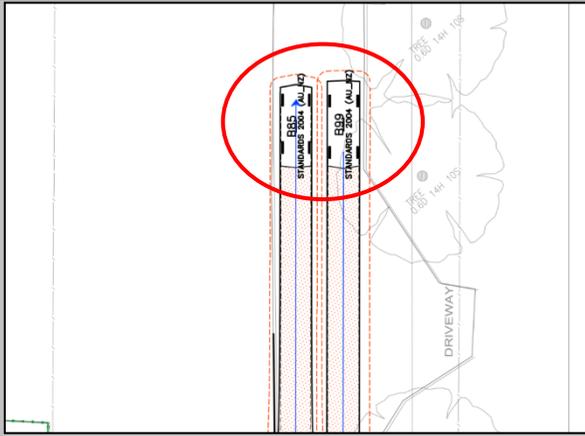
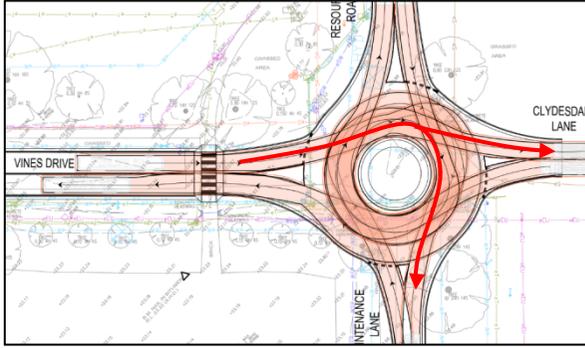
Item Location	Safety Hazard Finding	Frequency	Severity	Level Of Risk	Project Manager Response
<p>18. Vehicle Restrictions Roundabout</p>	<p>There are roads with no through route, turn around areas, or termination warnings provided at decision points.</p> <p>There are no vehicle restrictions provided where large vehicle turning paths are not provided to confirm access is achievable.</p> <p>There is a risk that a vehicle may enter a restricted road and undertake unsafe movements such as long reversing, U-turns, multiple point turns, or mounting pedestrian areas to exit out of the road resulting in pedestrian-vehicle collisions, collisions with other vehicles or roadside infrastructure.</p>	Occasional	Minor	Medium	<p>Vehicle restriction signage will be reviewed and considered with the university, however large vehicles may be required to service the surrounding facilities. No Through Road signage may be suitable.</p>

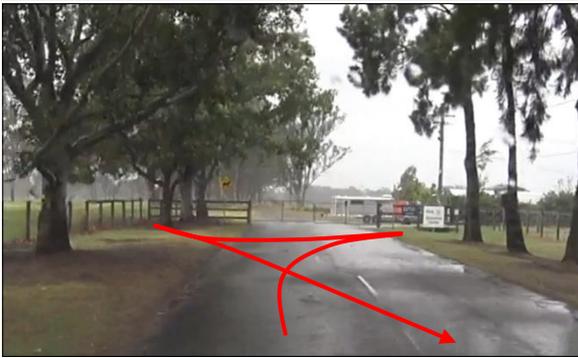
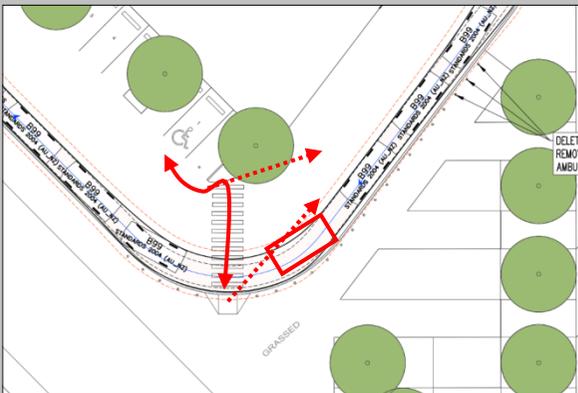
19.
Pedestrian Crossing
DO-PU

The pedestrian crossing inside the DO-PU area has no lighting, no signage, no kerb ramp on the northern side, a tree blocking sight from the northern side and requires a pedestrian to cross 2 lanes of approaching traffic.

There is a risk that an approaching motorist may not sight a pedestrian stepping out into the travel lane resulting in pedestrian-vehicle collisions.

There is a risk that a parked vehicle may restrict sight between a through vehicle and a pedestrian resulting in pedestrian-vehicle collisions.

Probable

Serious

Intolerable

Zebra crossing to be deleted to avoid confusion, signage and line marking for PUDO vehicles and tree to be reviewed.

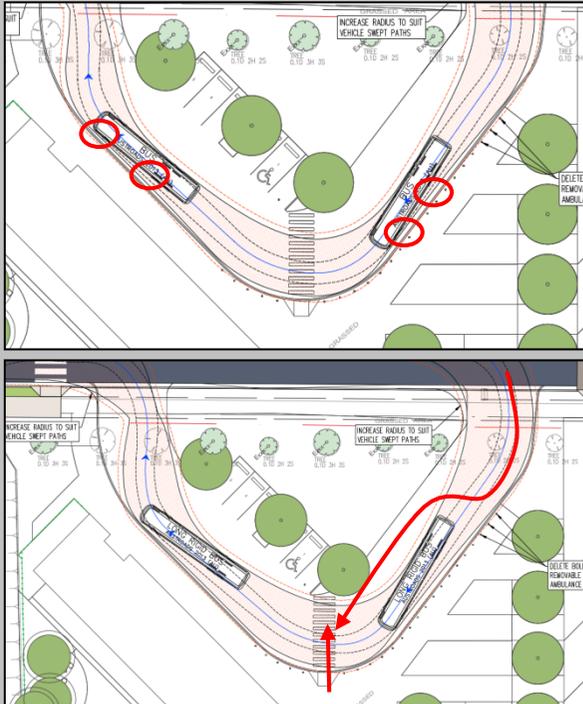
Item Location	Safety Hazard Finding	Frequency	Severity	Level Of Risk	Project Manager Response
<p>21. Large Vehicle Angle DO-PU</p>	<p>The provided turn paths for the large vehicle in the DO-PU facility indicates the vehicle cannot pull up parallel to the kerb, particularly at mid/rear doors.</p> <p>There is a risk that large vehicle may pull up a significant distance from the kerb and require a pedestrian to step across a wide gap or step down onto the road and up to the bus/kerb resulting in trip-fall injuries.</p> <p>There is a risk that a stopped bus may partially block the through lane, encouraging a motorist to travel around the bus in close proximity to a pedestrian crossing, resulting in pedestrian-vehicle collisions.</p>	Probable	Limited	Medium	<p>Acknowledged that some blockages may occur for the largest vehicles. Buses to be encouraged to use Vines Drive bus stop wherever possible. Buses may be required to manoeuvre to be parallel / closer to the kerb.</p>

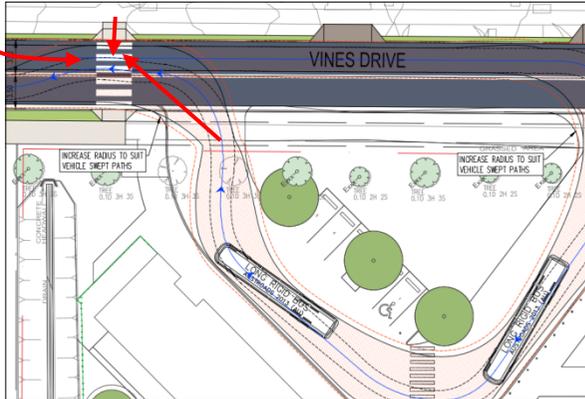
Item Location	Safety Hazard Finding	Frequency	Severity	Level Of Risk	Project Manager Response	
<p>22. Large Vehicle Turning DO-PU</p>	<p>The provided turning paths show a large vehicle requiring oncoming travel lanes to exit the DO-PU area in close proximity to intersections and pedestrian crossings.</p> <p>It is unclear to the audit team of the proposed timing of small vehicles and large vehicles using the DO-PU area.</p> <p>There is a risk that a turning vehicle may impact a pedestrian or an oncoming/turning/queued vehicle.</p>	Occasional	Minor	Medium	<p>Frequency of buses is expected to be very low, and not at times when car usage for the drop-off and pick-up area is occurring. Acknowledged that large vehicles may need to use the full carriageway of Vines Drive; visibility in this area is generally good. Pedestrian crossing to be deleted to avoid conflict of priority.</p>

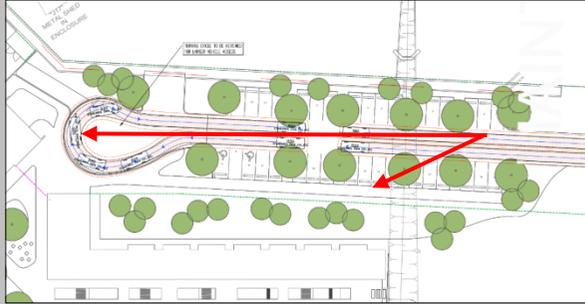
<p>23. Pedestrian Access Southern Parking</p>	<p>It is unclear to the audit team of the proposed pedestrian access from parking spaces to facilities, particularly for the northern side.</p> <p>There is a risk that a pedestrian may travel along vehicle lanes resulting in pedestrian-vehicle collisions.</p>	Improbable	Minor	Low	<p>Footpath is provided along southern side of car park. Some pedestrian activity through the car park aisle may occur.</p>
