# DARLINGTON PUBLIC SCHOOL REDEVELOPMENT

## Appendix Q — Detailed Site Investigation

Report on  
Detailed Site Investigation for Contamination

Proposed Upgrade Works  
Darlington Public School, 417 Abercrombie Street,  
Darlington, NSW

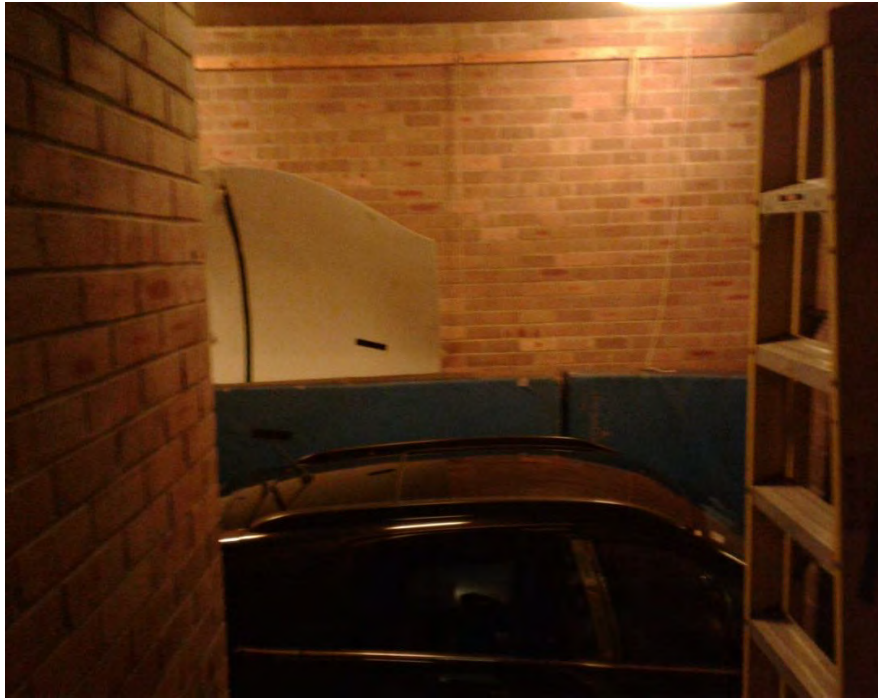
Photograph 1: B00A - R0002, Interior, Garage walls, Brick, nil hazardous materials identified.

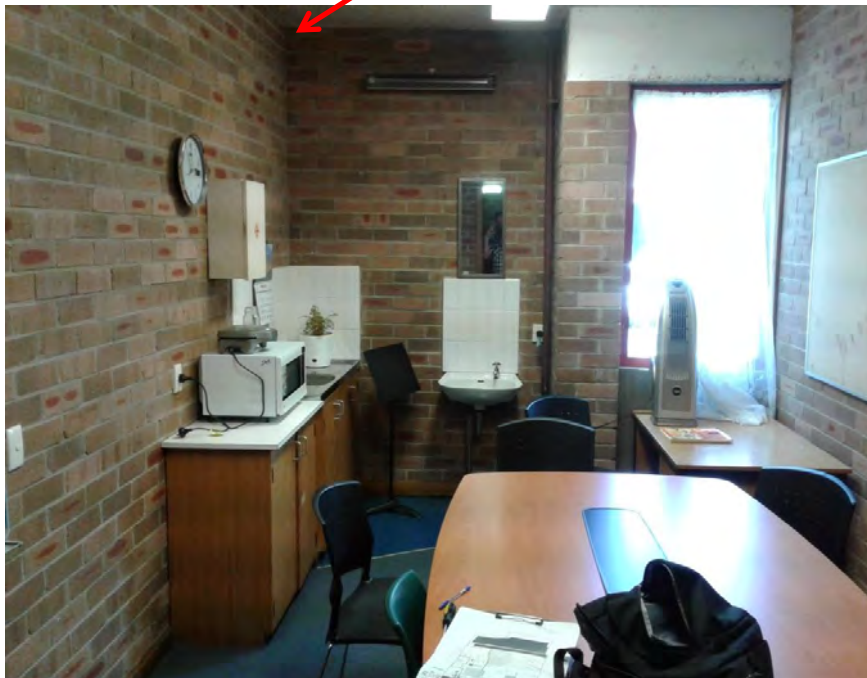
Photograph 2: B00A - R0006, Interior, Ceiling structure, Vermiculite, no asbestos detected by analysis.

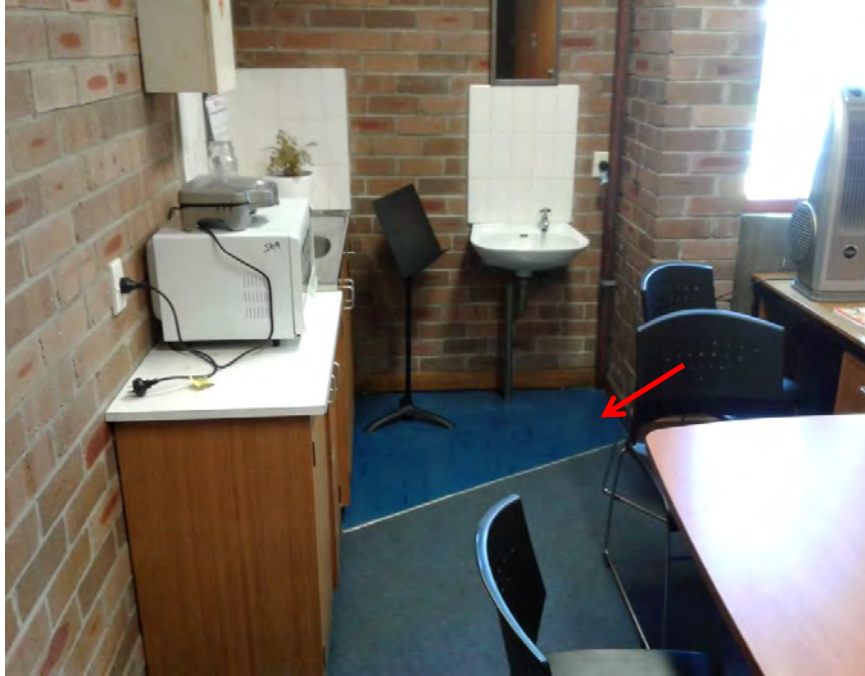
Photograph 3: B00A - R0006, Interior, Flooring material, Vinyl tiles, no asbestos detected by analysis.

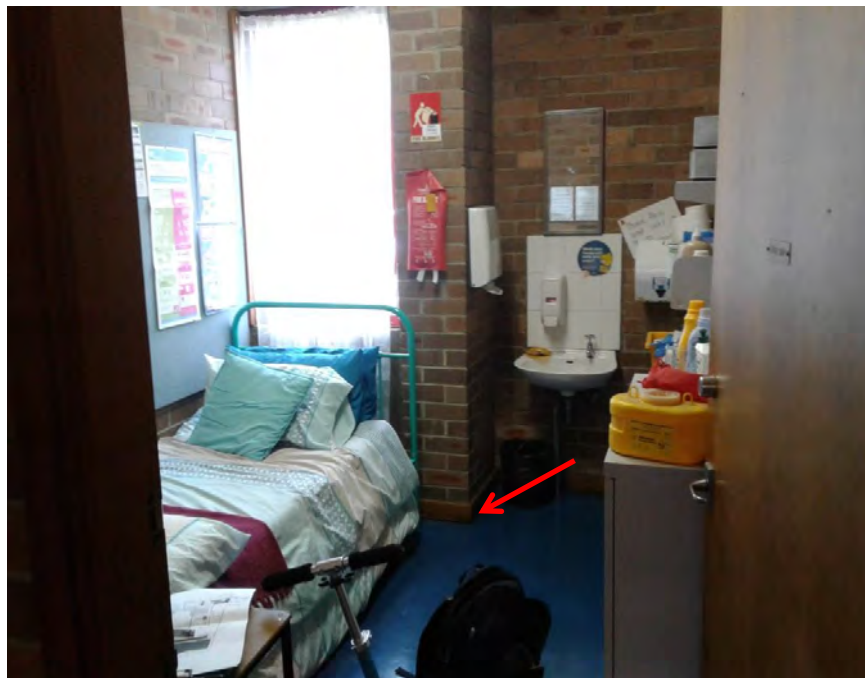
Photograph 4: B00A - R0009, Interior, Flooring material, Vinyl tiles, no asbestos detected by analysis.

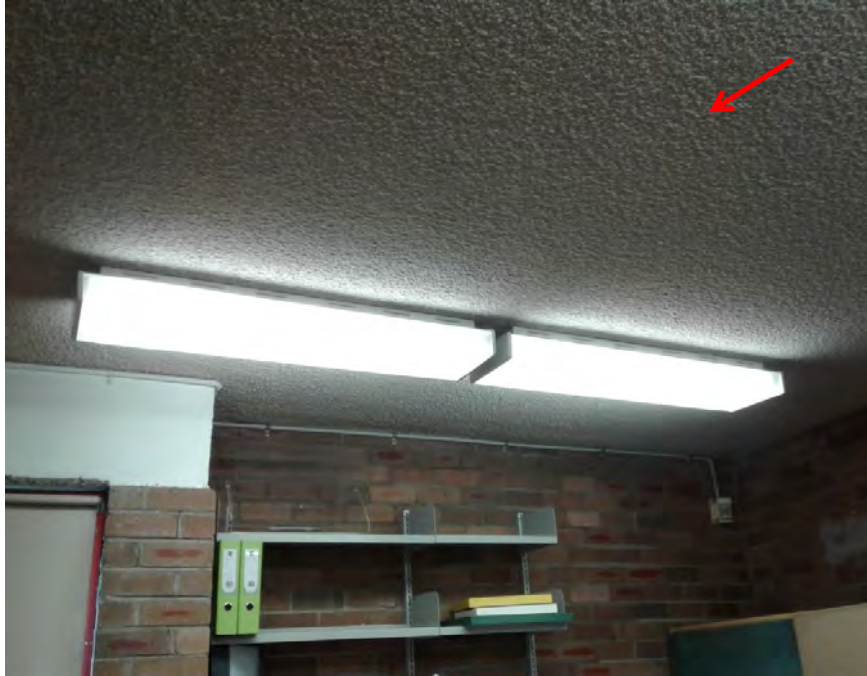
Photograph 5: B00A - R0011, Interior, Ceiling structure, Vermiculite, no asbestos detected by analysis.

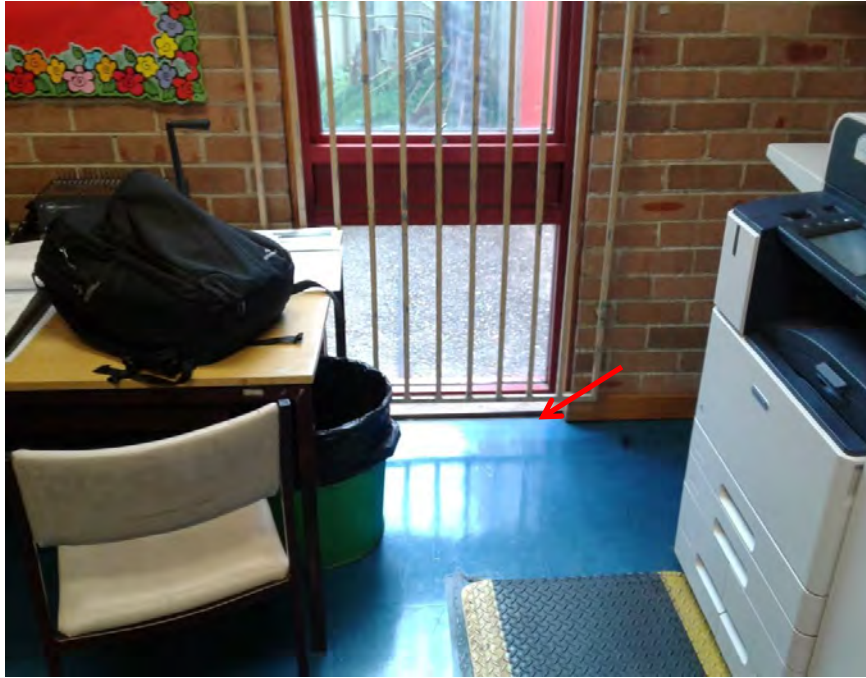
Photograph 7: B00A - R0017, Interior, Flooring material, Vinyl tiles, no asbestos detected by analysis.

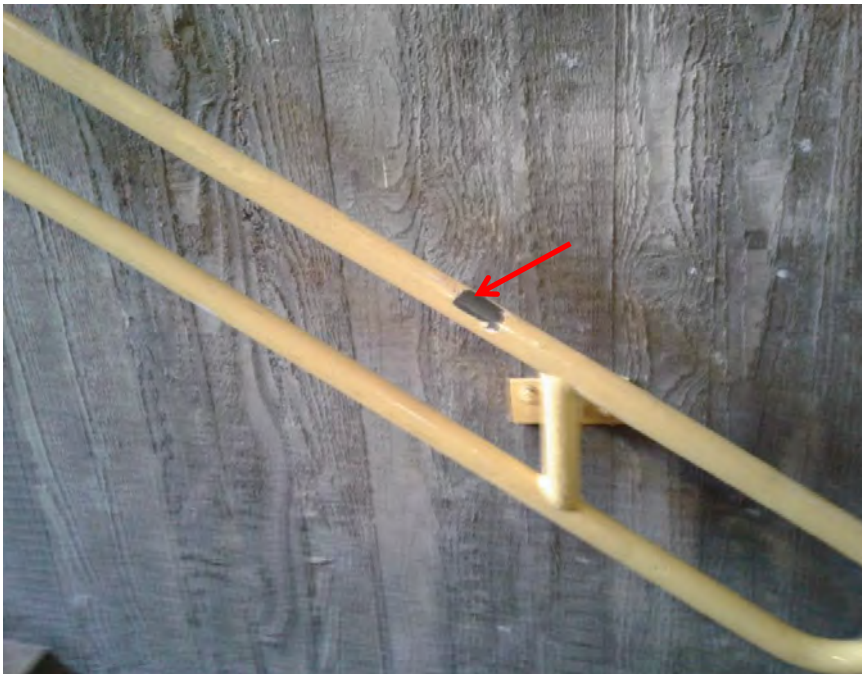
Photograph 8: B00A - R0019, Interior, Hand rails on stairs, Yellow paint, non-lead paint ( $\leq 0.1\%$  lead w/w).

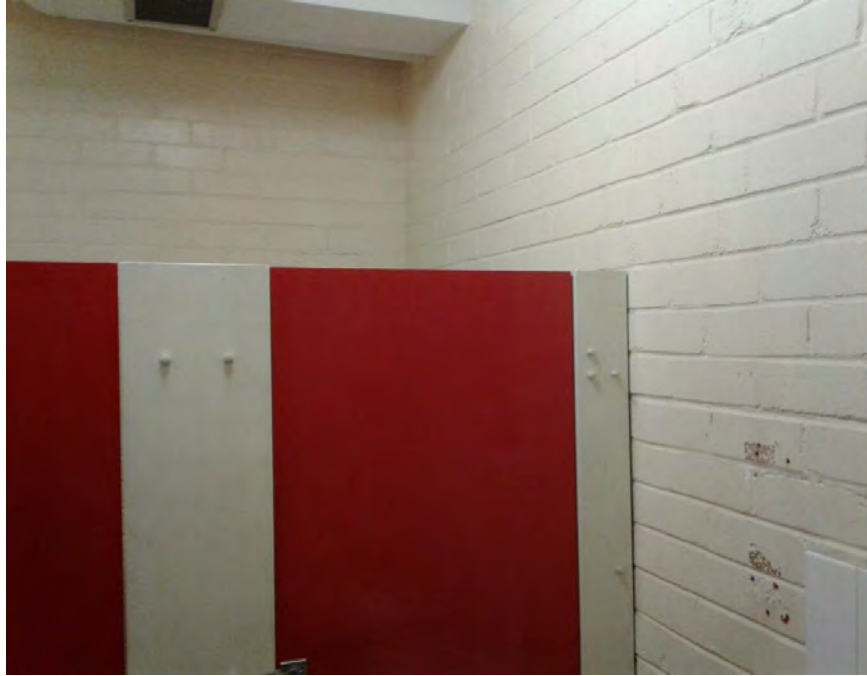
Photograph 9: B00A - R0021, Interior, Partitions in toilet, Compressed FCS sheeting, asbestos detected by analysis.

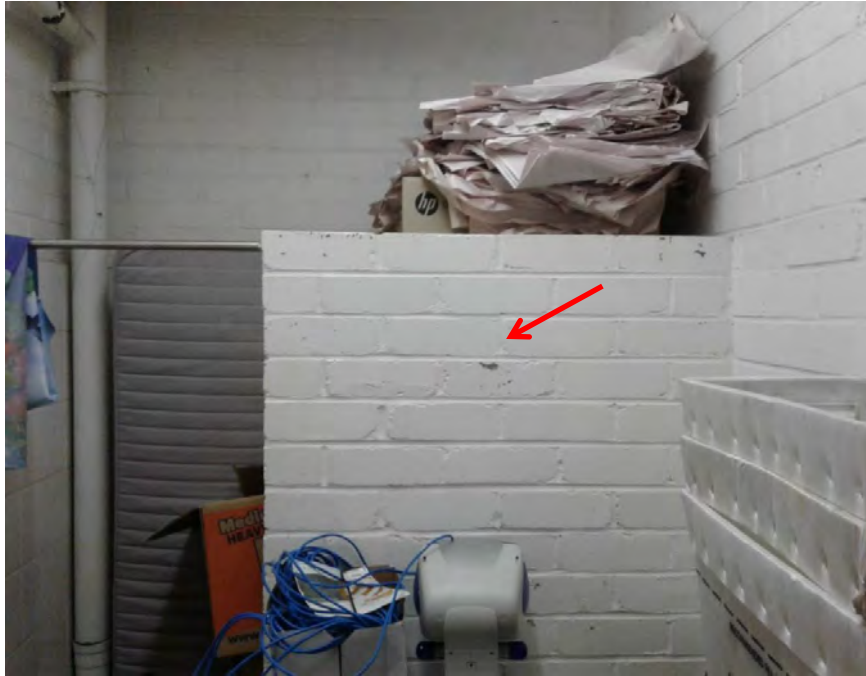
Photograph 11: B00A - R0023, Interior, Brick walls, Beige paint, non-lead paint ( $\leq 0.1\%$  lead w/w).

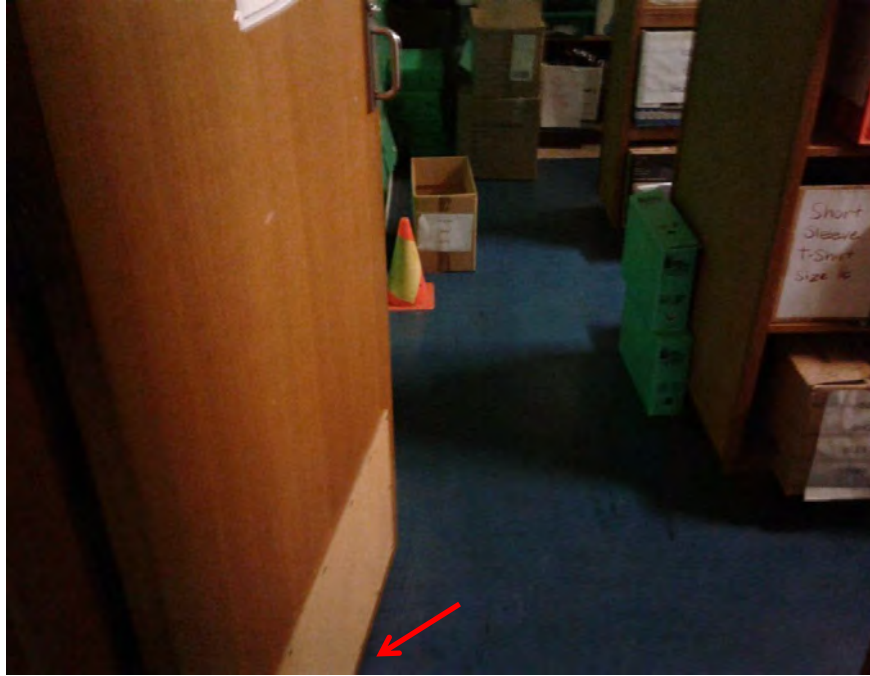
Photograph 13: B00A - R0032, Interior, Flooring material, Vinyl tiles under flooring, asbestos detected by analysis.

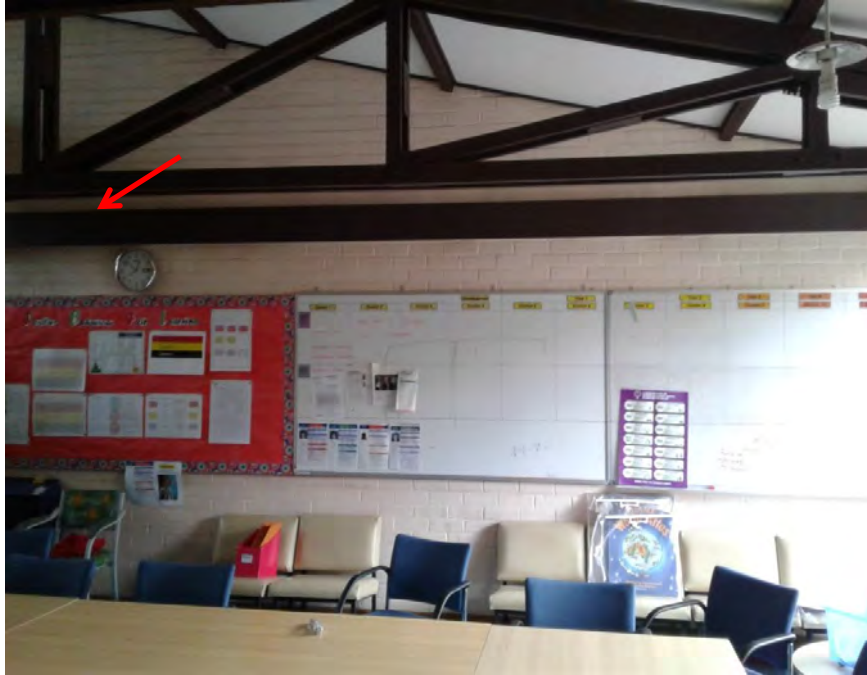
Photograph 15: B00A - R1002, Interior, Timber rafters, Dust above rafters, elevated lead (>0.5 mg/m<sup>2</sup>).

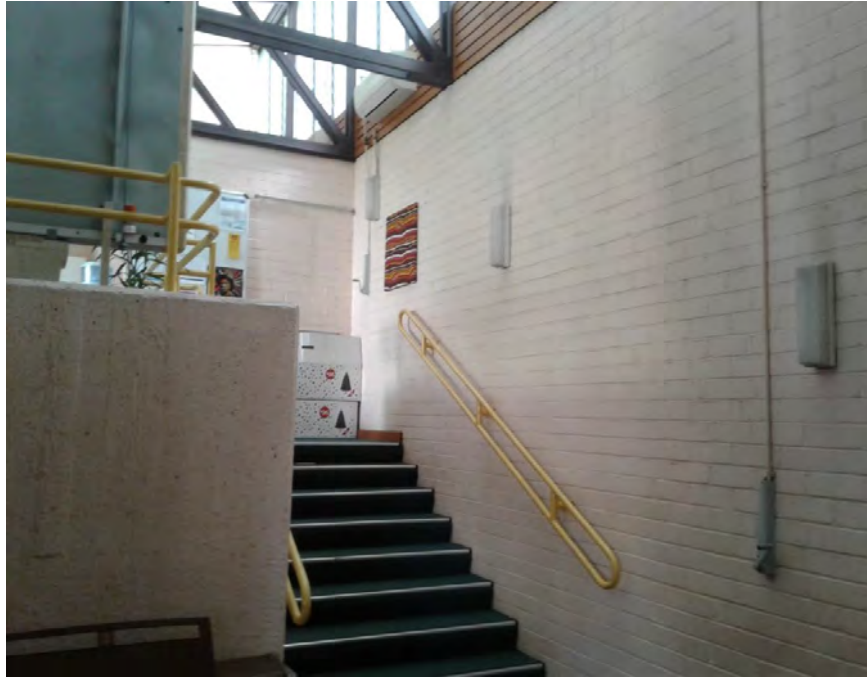
Photograph 17: B00A - R1017, Interior, -, -, nil hazardous materials identified.

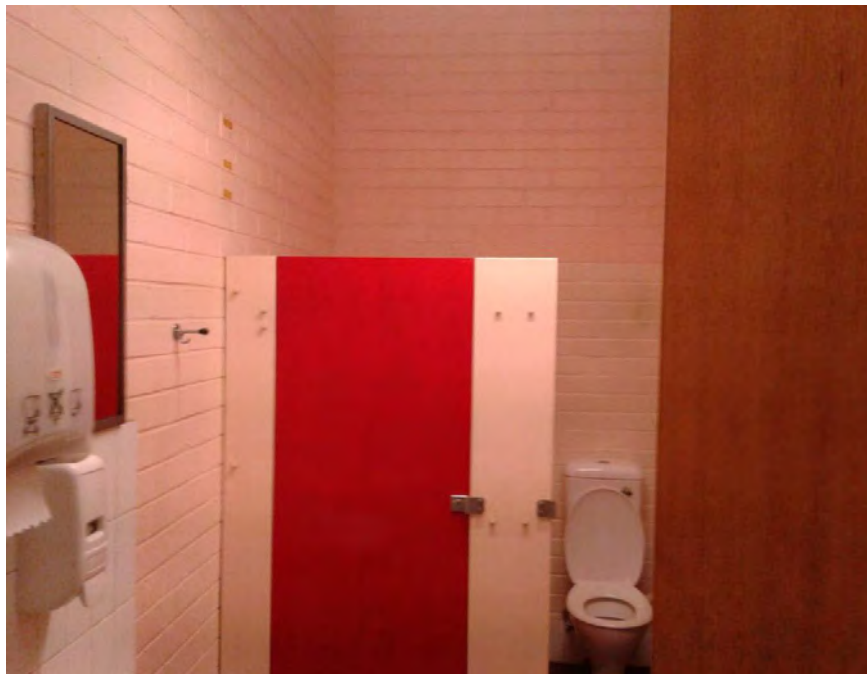
Photograph 18: B00A - R1018, Interior, Partitions in toilet, Compressed FCS sheeting, asbestos detected by analysis.

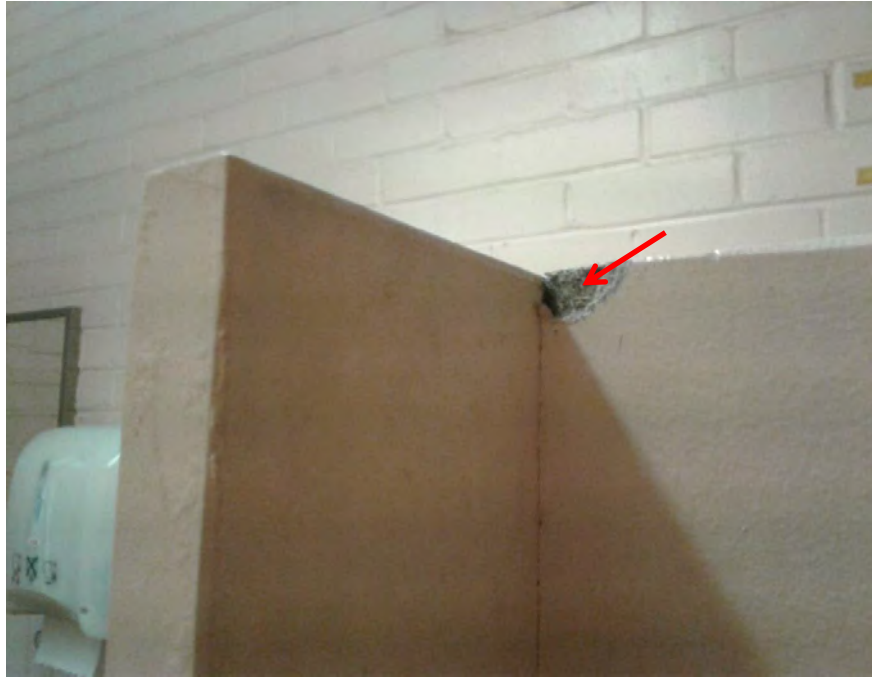
Photograph 19: B00A - R1019, Interior, Partitions in toilet, Compressed FCS sheeting, asbestos detected by analysis.

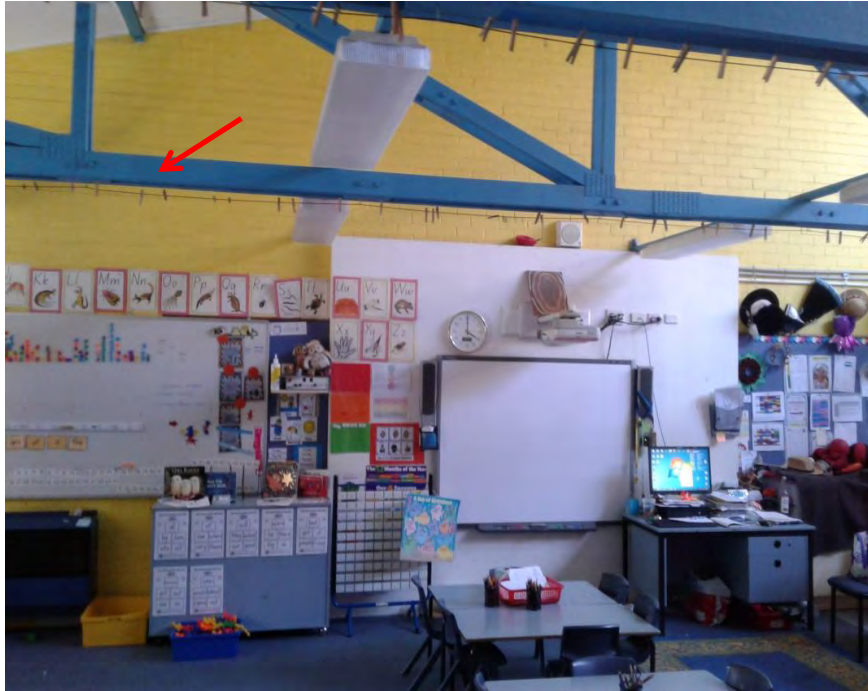
Photograph 20: B00B - R0020, Interior, Timber rafters, Blue paint, non-lead paint ( $\leq 0.1\%$  lead w/w).

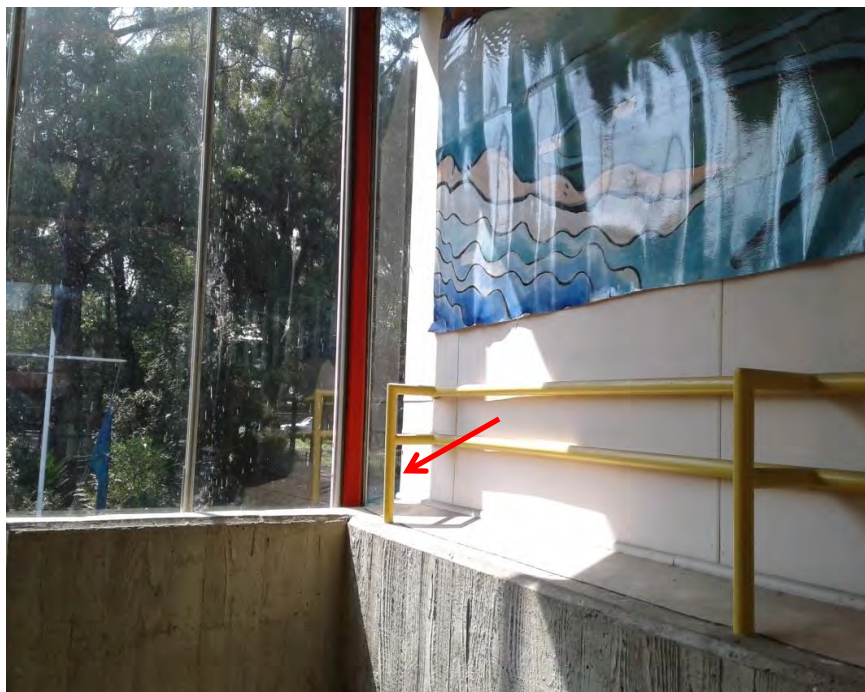
Photograph 21: B00B - R0025, Interior, FCS sheeting on wall, FCS sheeting, no asbestos detected by analysis.

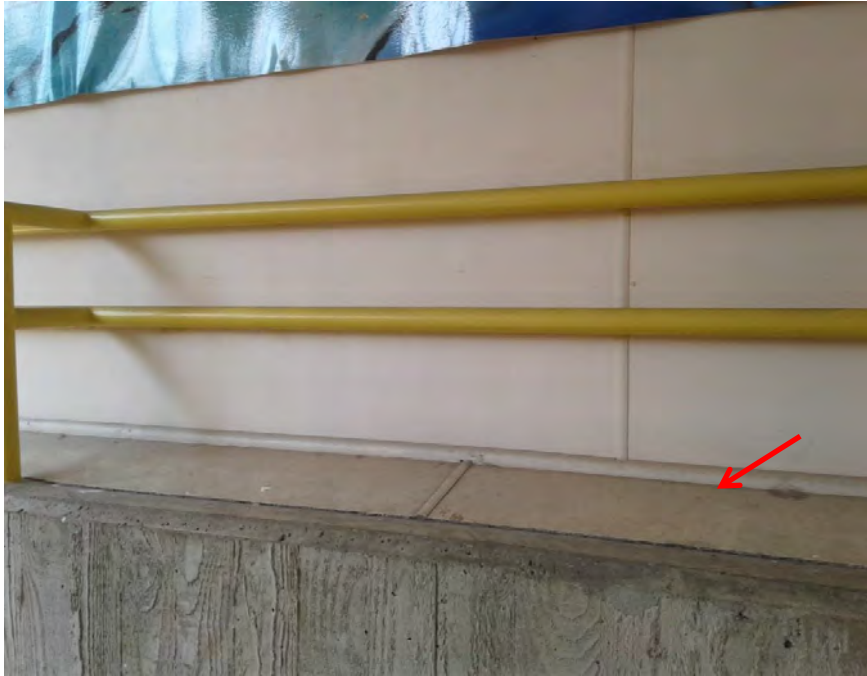
Photograph 22: B00B - R0025, Interior, FCS sheeting on wall, FCS sheeting, no asbestos detected by analysis.

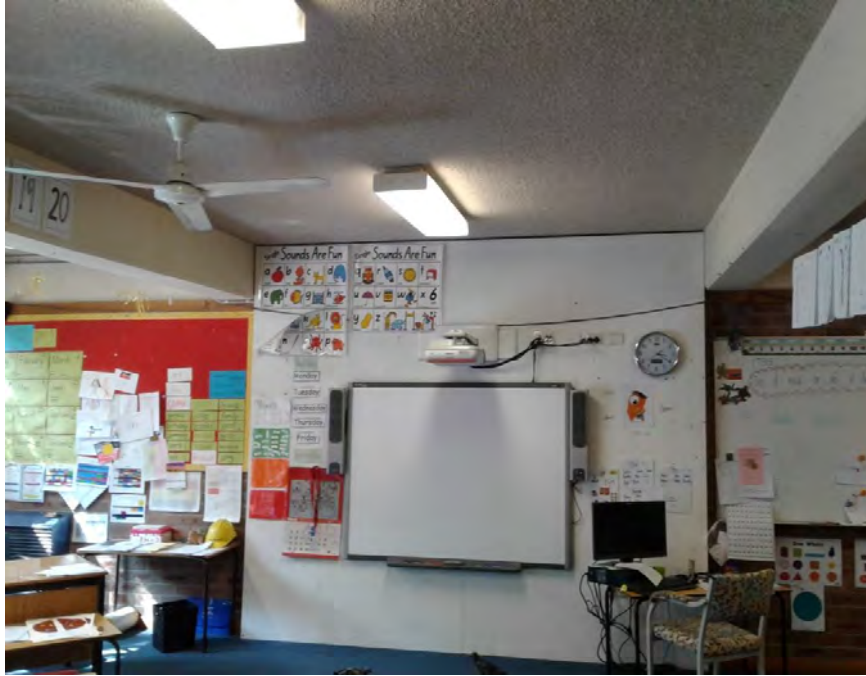
Photograph 24: B00B - R1002, Interior, Flooring material, Vinyl tiles under flooring, asbestos detected by analysis.

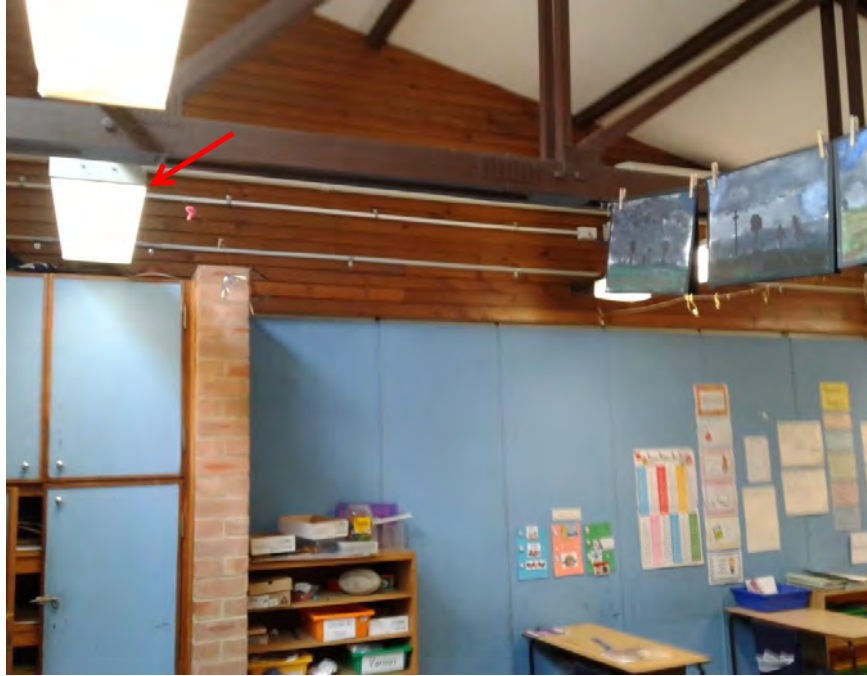
Photograph 26: B00B - R1003, Interior, Light fitting, Dust above light fitting, elevated lead (>0.5 mg/m2).

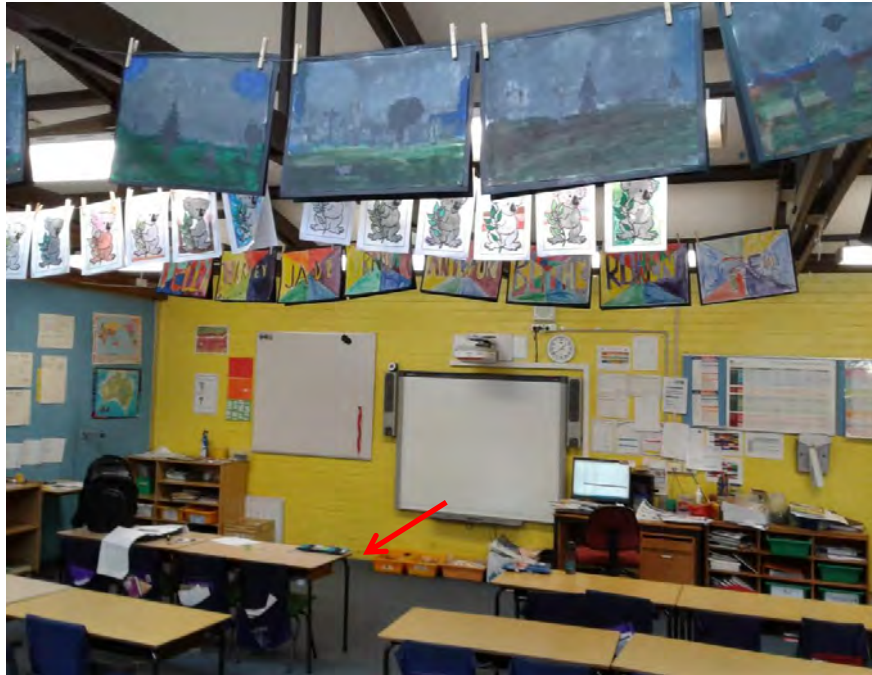
Photograph 28: B00B - R1011, Interior, Timber skirting board near flooring, Yellow Paint, non-lead paint ( $\leq 0.1\%$  lead w/w).

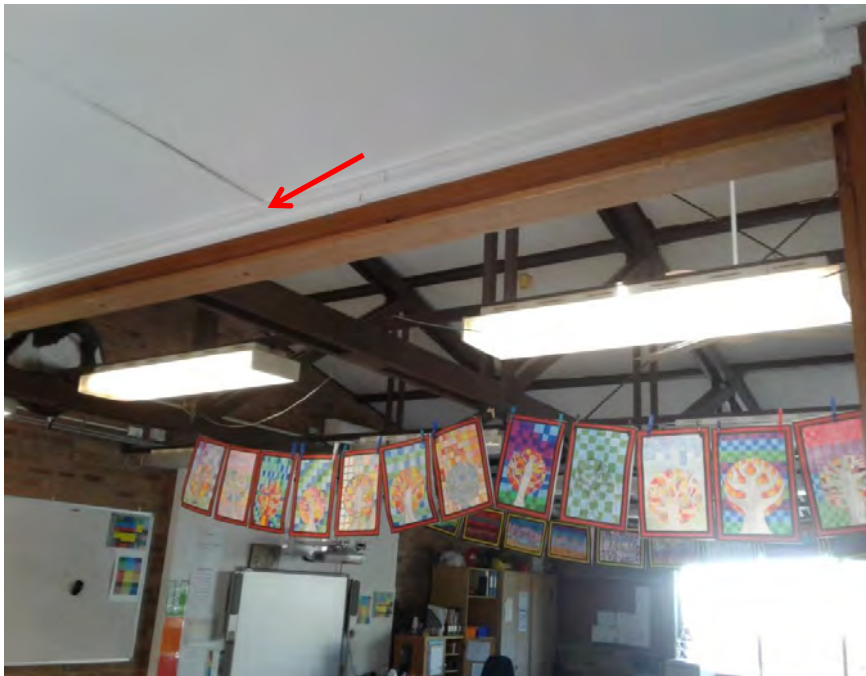
Photograph 29: B00B - R1014, Interior, Ceiling structure, White Flaking Paint, non-lead paint ( $\leq 0.1\%$  lead w/w).

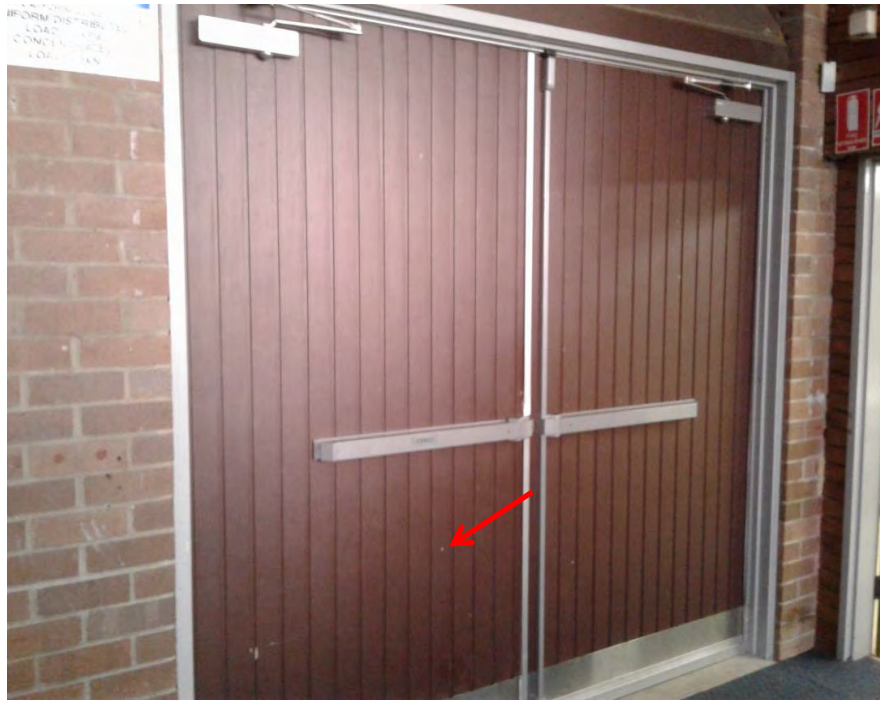
Photograph 30: B00C - R0001, Interior, Timber door frame, Brown Paint, non-lead paint ( $\leq 0.1\%$  lead w/w).

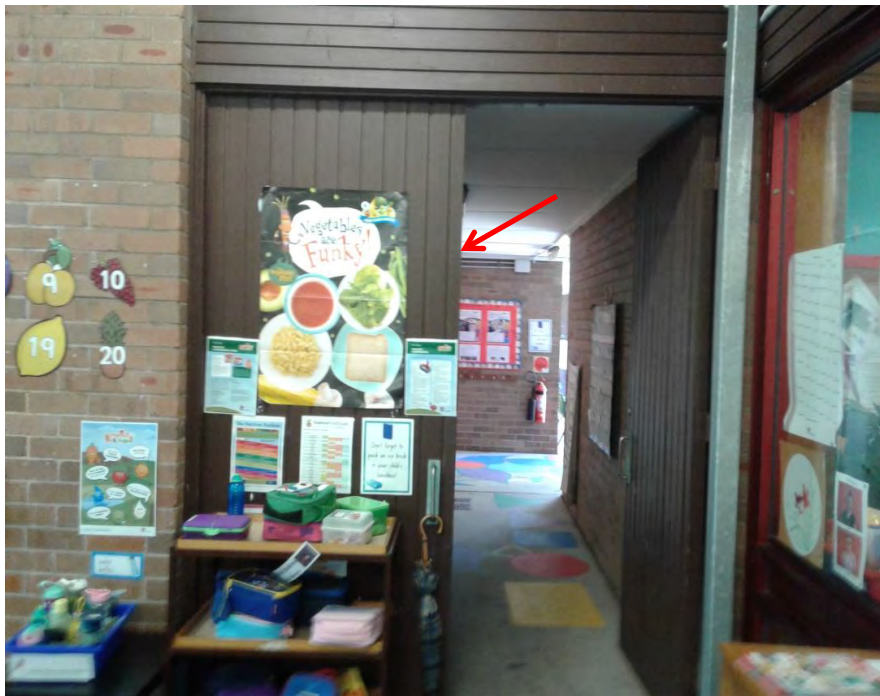
Photograph 31: B00C - R0002, Interior, Timber door frame, Brown Paint, non-lead paint ( $\leq 0.1\%$  lead w/w).

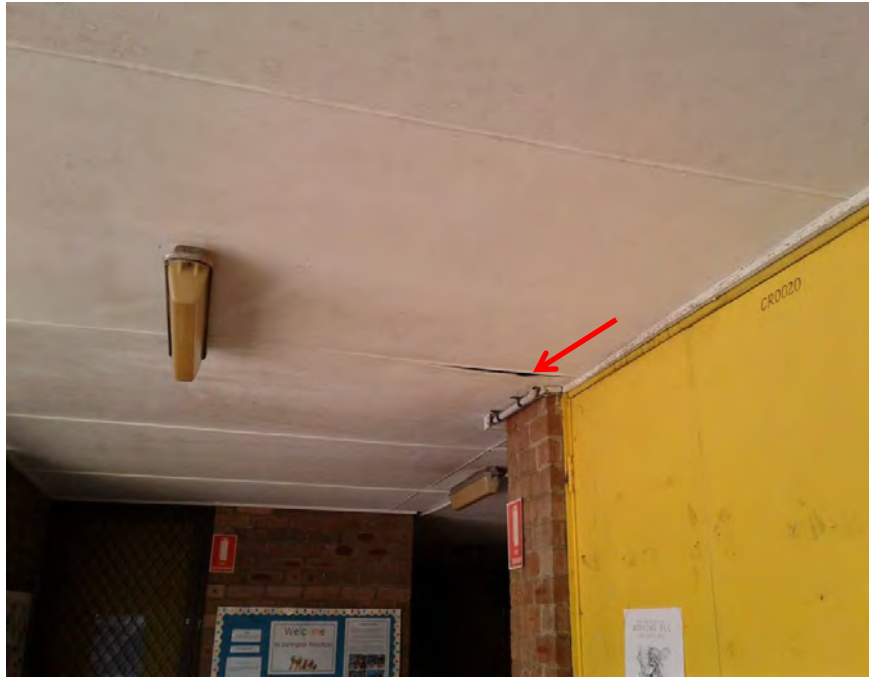
Photograph 32: B00C - R0005, Interior, Ceiling structure, FCS sheeting, no asbestos detected by analysis.

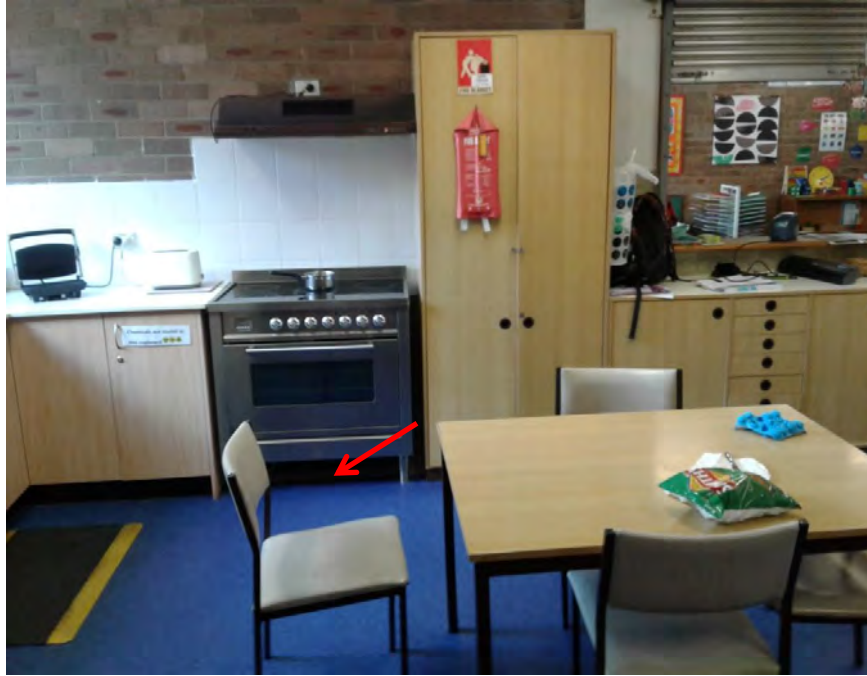
Photograph 34: B00C - R0006, Interior, Flooring material, Vinyl tiles, no asbestos detected by analysis.

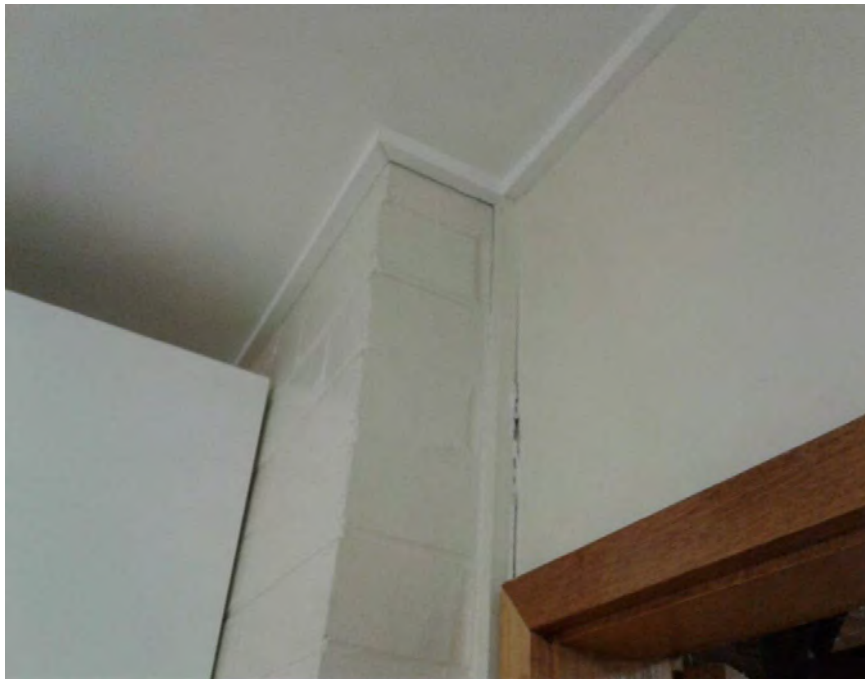
Photograph 35: B00C - R0010, Interior, Partitions in toilet, Beige Paint, non-lead paint ( $\leq 0.1\%$  lead w/w).

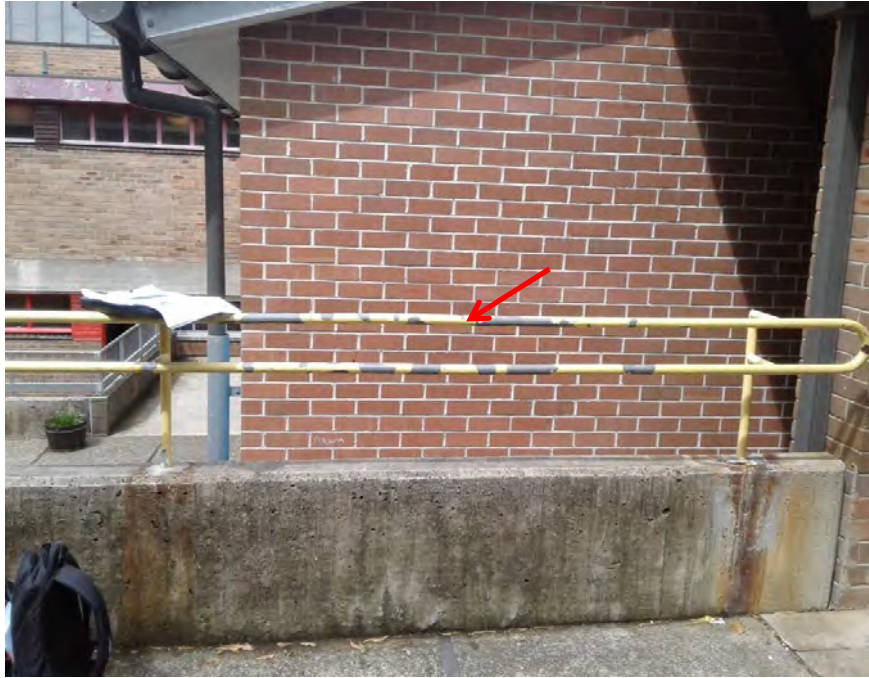
Photograph 36: B00C - R0024, Exterior, Hand rails, Yellow Paint, lead paint (>0.1% lead w/w).

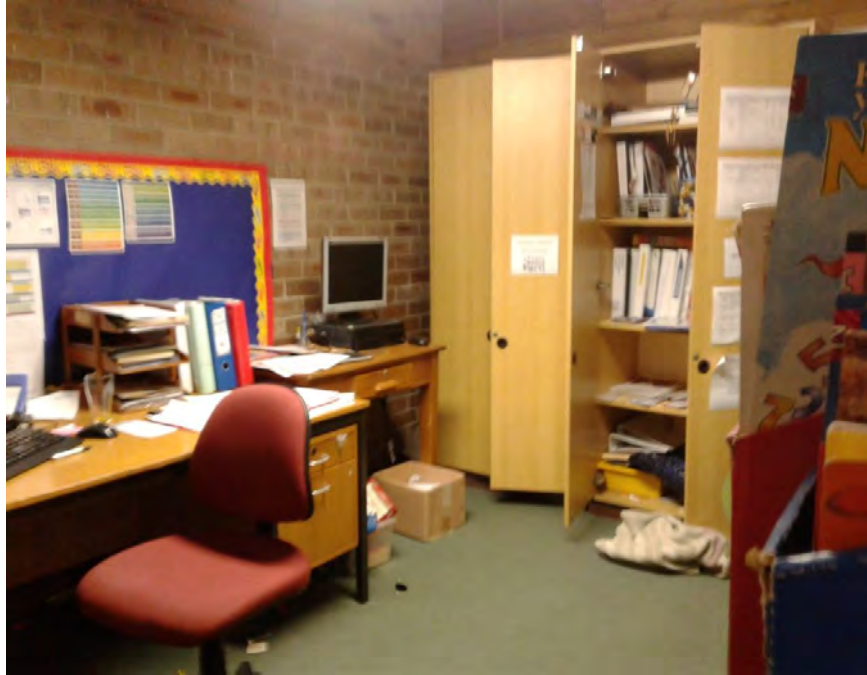
Photograph 38: B00C - R0029, Interior, Flooring material, Vinyl tiles under flooring, no asbestos identified visually.
