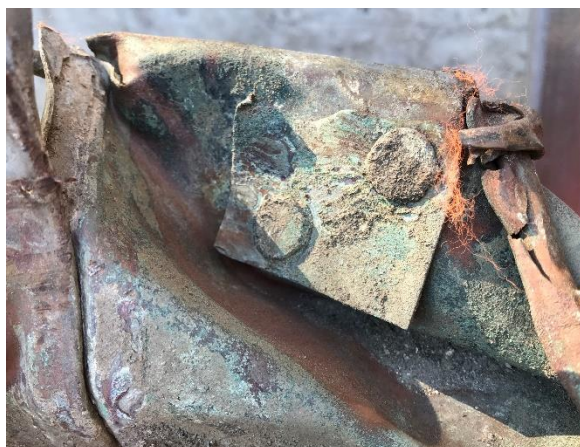
Figure 13. Hand-made rivets attaching remains of broken metal strut

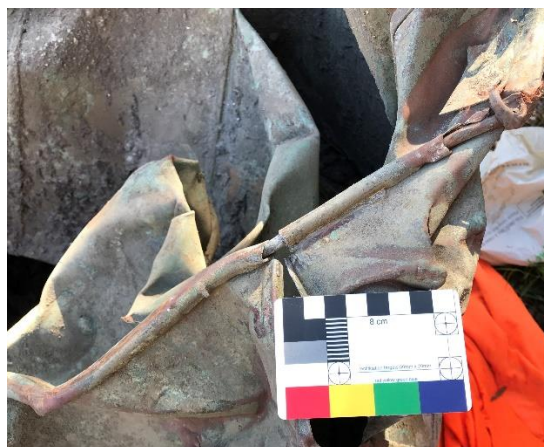
Figure 14. Rolled rim with metal rod core

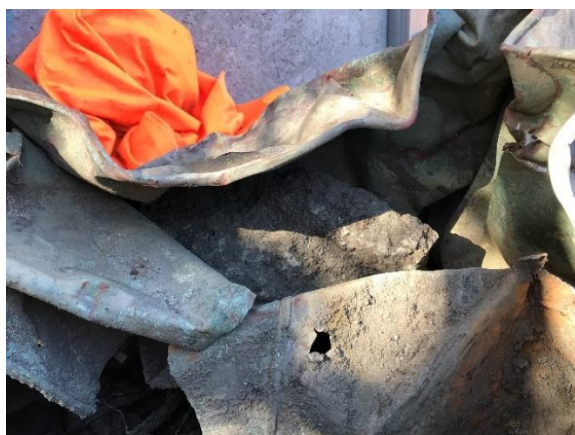
Figure 15. Concrete debris inserted between inner and outer pans. Hole punched through pan wall below

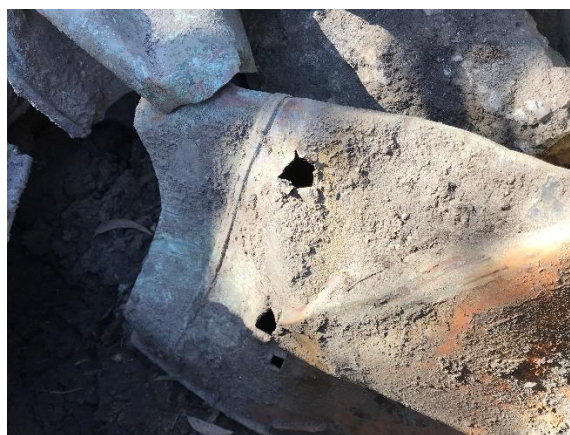
Figure 16. Detail of folded seam and two holes punched in wall of outer pan

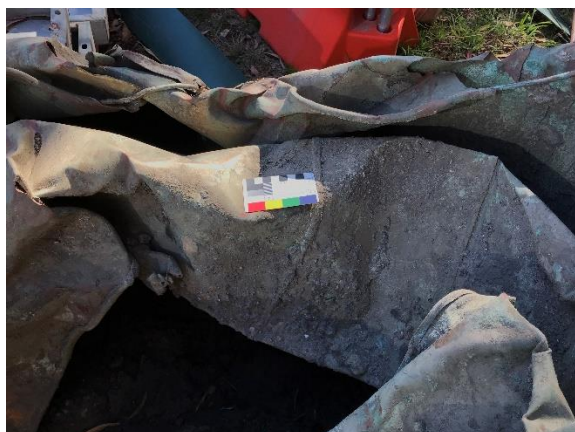
Figure 17. Detail of two folded seams in wall of inner pan

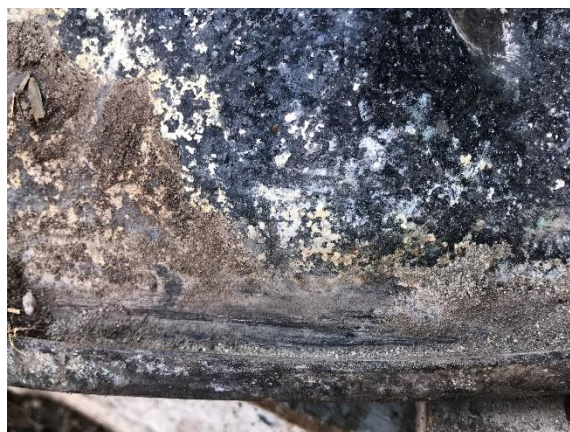
Figure 18. Detail of folded seam at base of outer pan

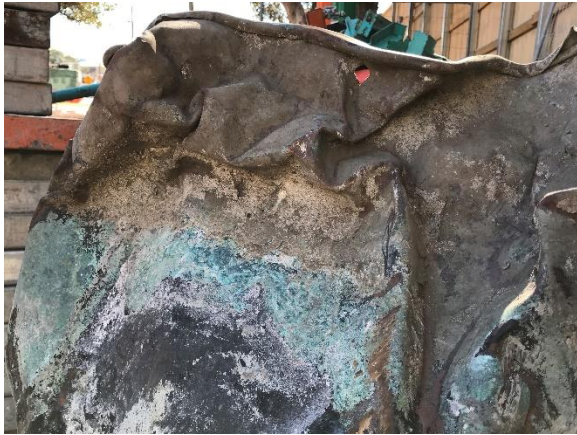
Figure 19. Detail of adherent dirt and corrosion product with clear line indicating depth to which the pans were set in soil/ concrete

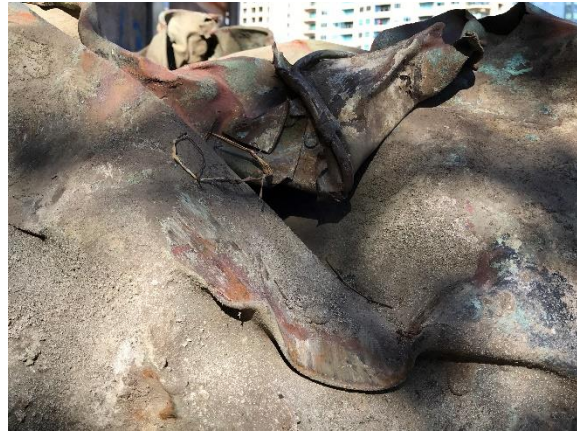
Figure 20. Detail of severe crumpling and folding of pan wall

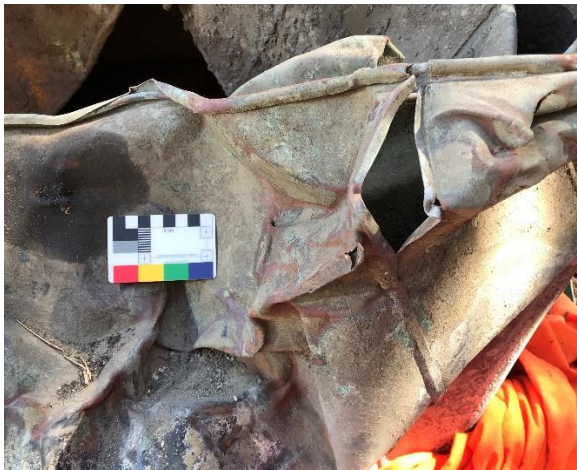
Figure 21. Detail of split seam on wall of outer pan

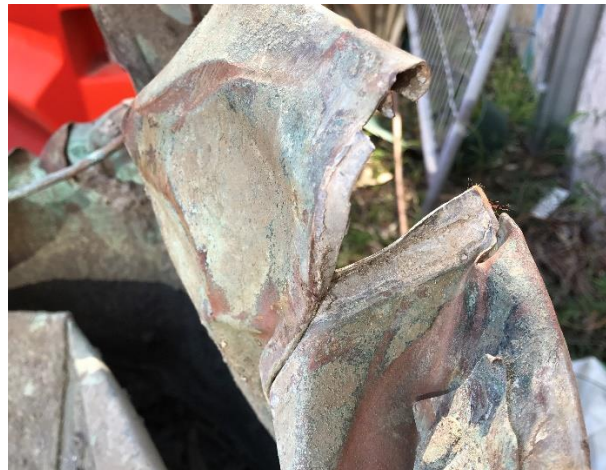
Figure 22. Detail of split seam on outer pan at rim

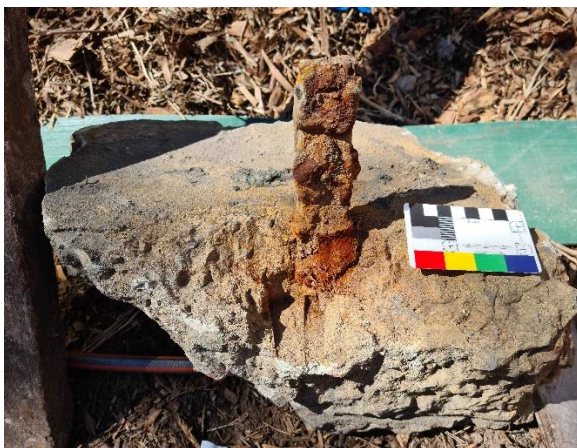
Figure 23. Concrete with iron pin removed from in between pans (provided by Curio Projects)
