Fort Street Public School

ARBORICULTURAL DEVELOPMENT IMPACT ASSESSMENT REPORT

Prepared by Birds Tree Consultancy

25 January 2021

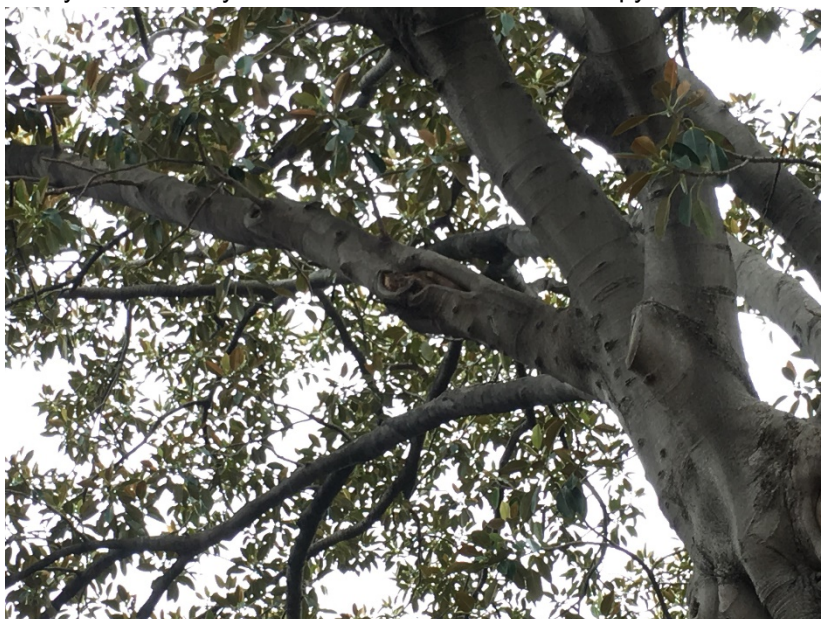
primary branch on eastern side at point of high lever arm stress 1.5m from junction in long horizontal end weighted branch. There is also decay in secondary branch on northern side of canopy.

Figure 1 - Tree 1 Decay on eastern side of canopy

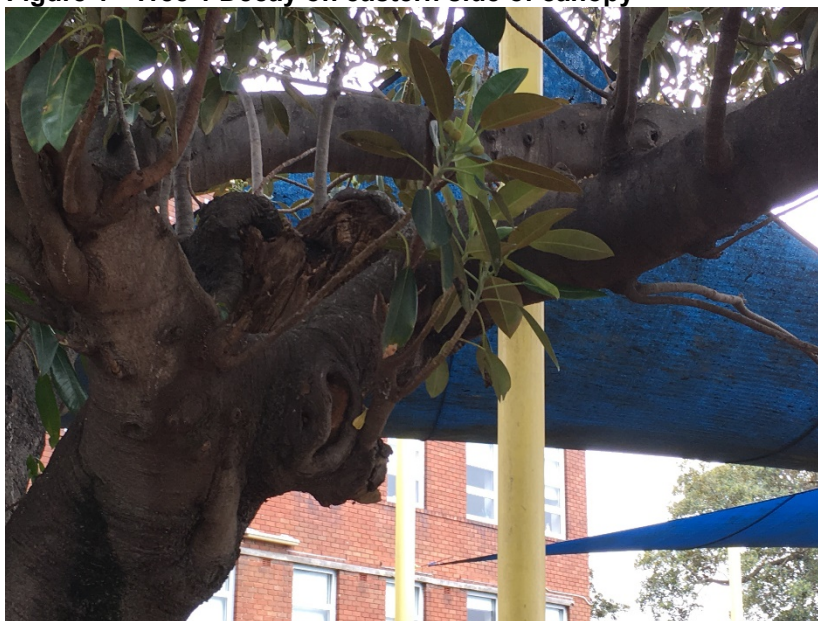
Figure 2 - Decay in secondary branch north of Tree 1

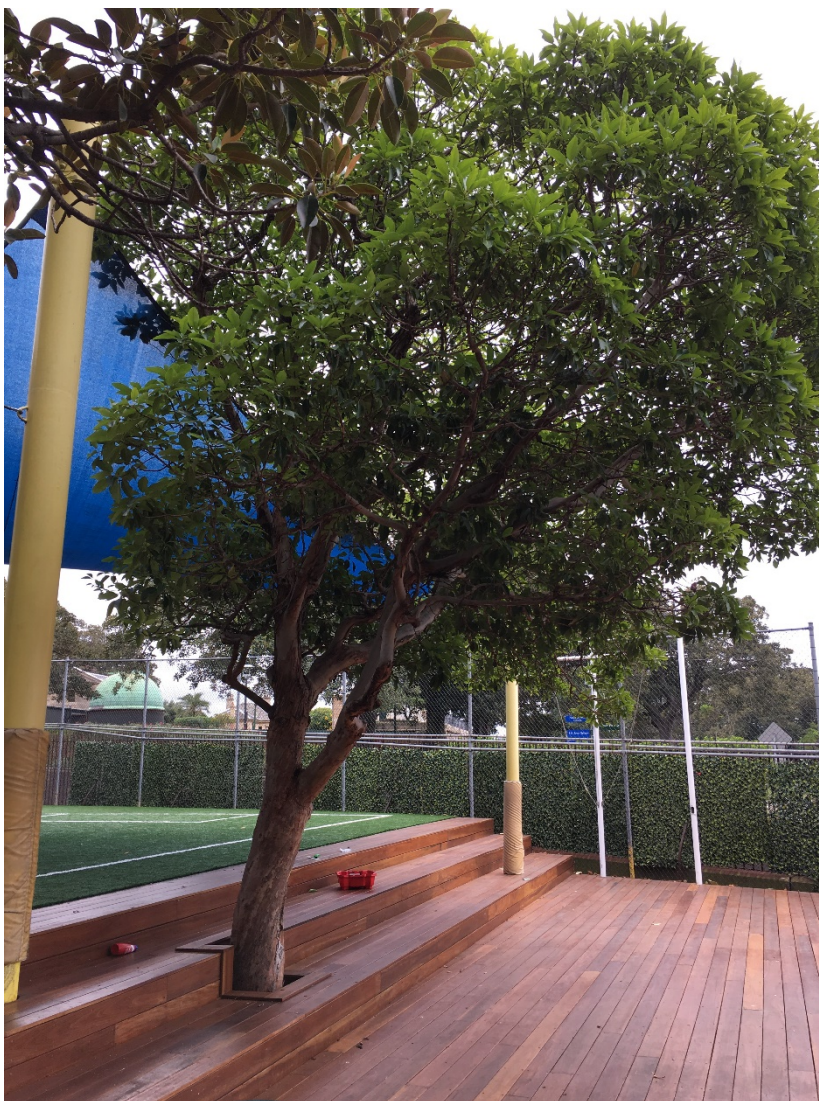
Figure 3 - Tree 2

This mature tree is located within timber decking and it is approximately 7m tall with a canopy spread of 6m. It has a single trunk with a DBH of 360mm. This tree is in good health and condition with minimal deadwood and epicormic growth.

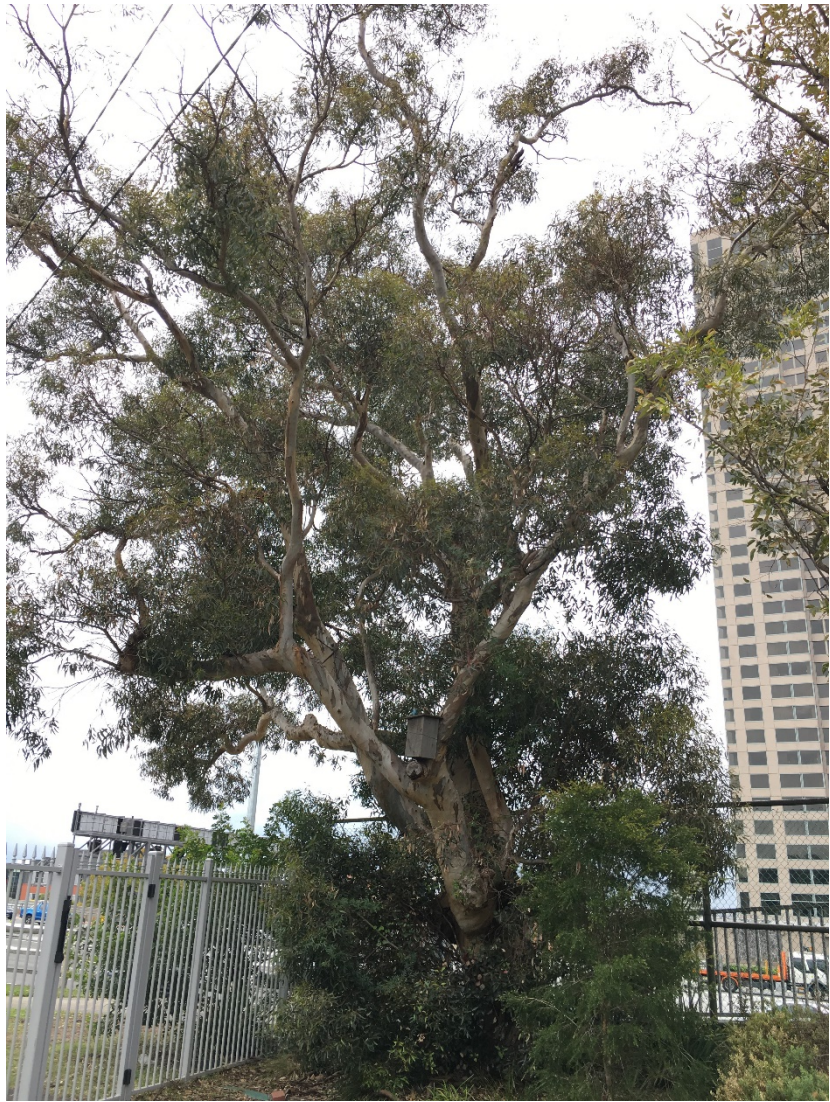
Figure 4 - Tree 4

This mature tree is approximately 16m tall with a canopy spread of 12m. It has a single trunk with a DBH of 1900mm. This tree is in fair health and declining condition with a thinning canopy, moderate deadwood, significant epicormic growth and significant apical dieback.

Tree 4 is in fair but declining condition with a thinning canopy, moderate deadwood and epicormic growth with significant apical dieback.

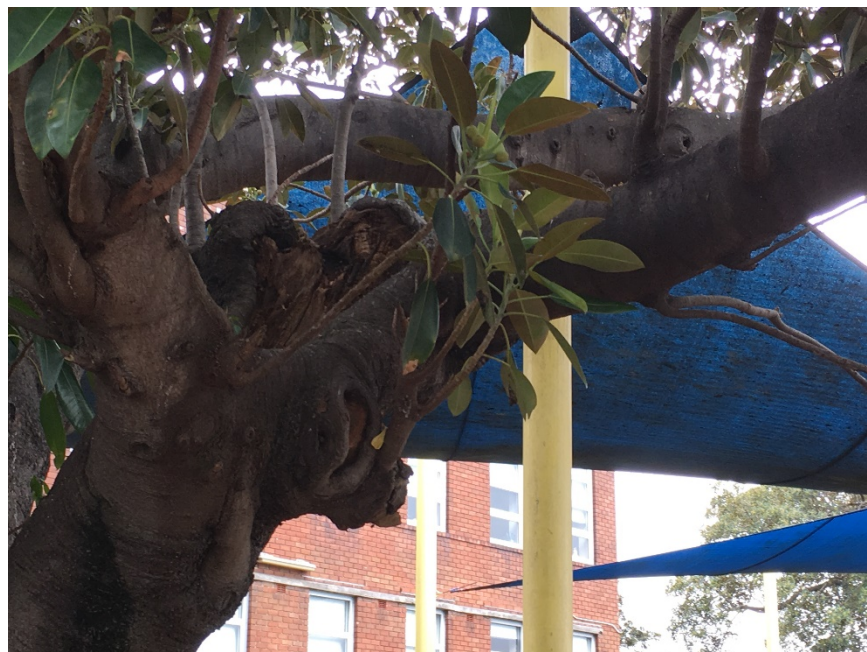
Tree 1 is found to have a moderate risk rating for failure of the branch at Location 1 and accordingly poses a significant hazard to life. In order to remove the risk posed by this branch, we recommend the removal of this branch at the secondary junction.

Figure 2 - Decay at Location 1

From 2.0 cm to 6.0 cm	: Sound wood
From 6.0 cm to 8.0 cm	: Decay/Cavity
From 8.0 cm to 11.0 cm	: Incipient wood
From 11.0 cm to 29.0 cm	: Decay/Cavity
From 29.0 cm to 31.0 cm	: Sound wood
From 0.0 cm to 0.0 cm	:

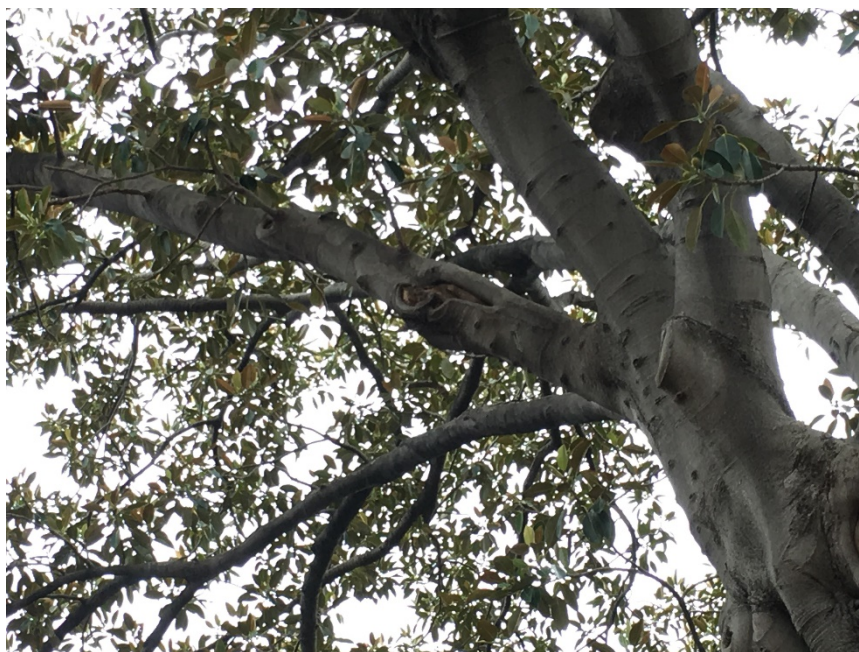
Figure 3 - Decay at Location 2

From	1.5 cm	to	7.0 cm	:	Sound wood
From	7.0 cm	to	29.0 cm	:	Decay/Cavity
From	29.0 cm	to	34.5 cm	:	Sound wood
From	34.5 cm	to	0.0 cm	:	
From	0.0 cm	to	0.0 cm	:	
From	0.0 cm	to	0.0 cm	:

We recommend that this tree be monitored regularly and re-tested annually.

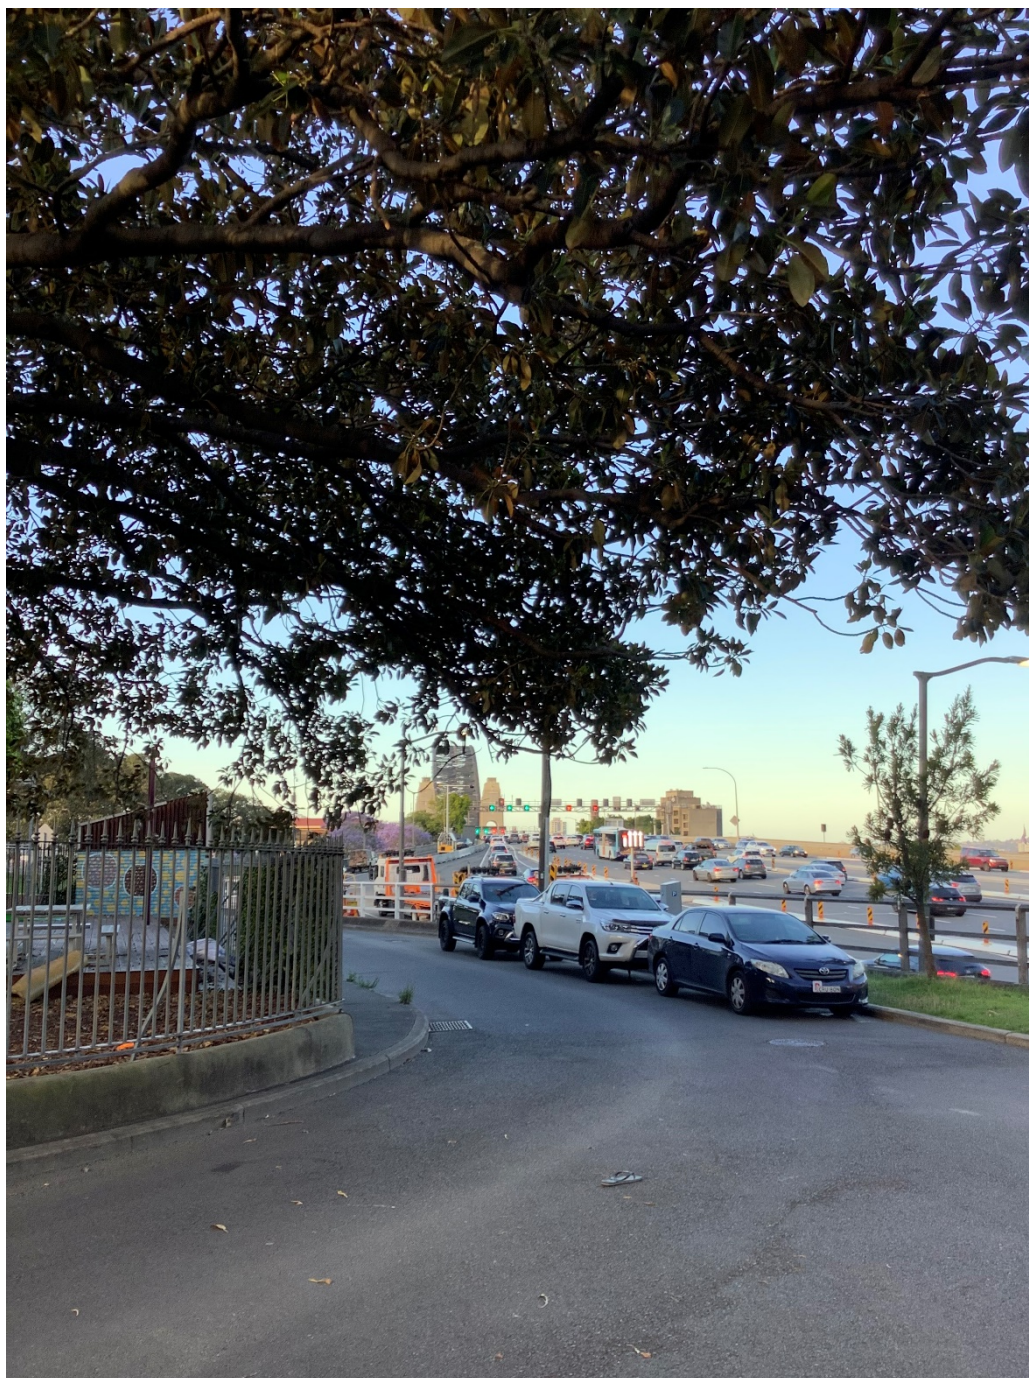
Figure 1 - Canopy overhanging Upper Fort Street.

Selective pruning is required to provide canopy clearance of 4.2m for construction vehicular access. Three tertiary branches are required to be removed as shown in Figures 2, 3 and 4. Branches are required to be removed to provide free clearance of 4.2m. All pruning is to be carried out under the supervision of the Site Arborist (AQF Level 5) by an arborist with qualifications of AQF Level 3 or higher. All pruning is to be in accordance with *AS4373-2007 Pruning of Amenity Trees*.
