Report on  
Hazardous Building Materials (HBM) Survey

Hastings Secondary College - Port Macquarie Campus  
16 Owen Street, Port Macquarie

Prepared for  
School Infrastructure NSW  
on behalf of Department of Education

Project 89754.01  
April 2021

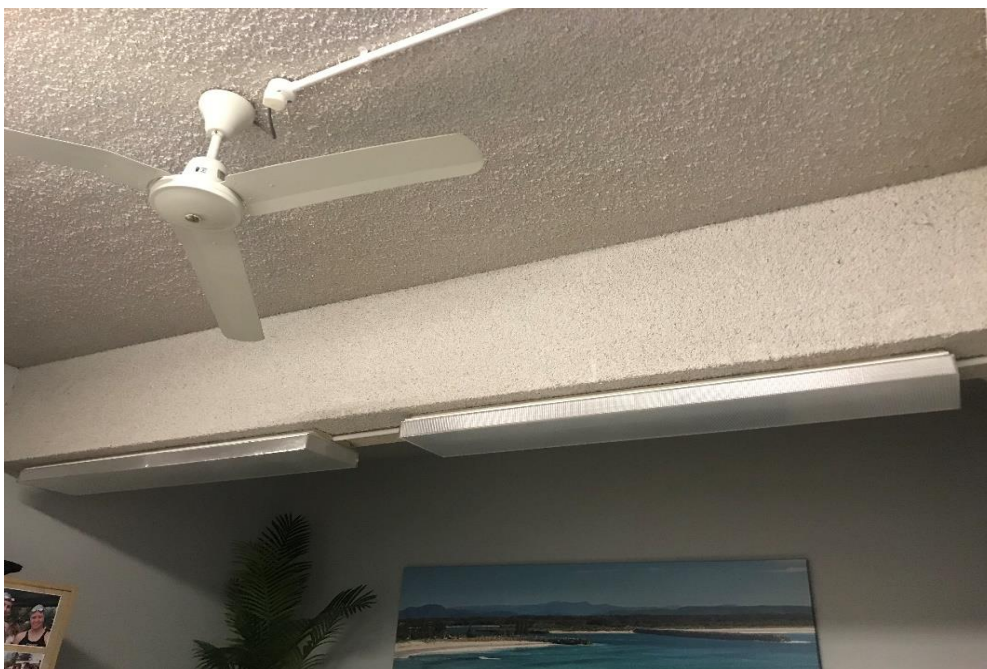
Photograph 1: B00A, rooms and areas in general, fluorescent light fittings in general, capacitors, insulating oil, PCB (assumed).

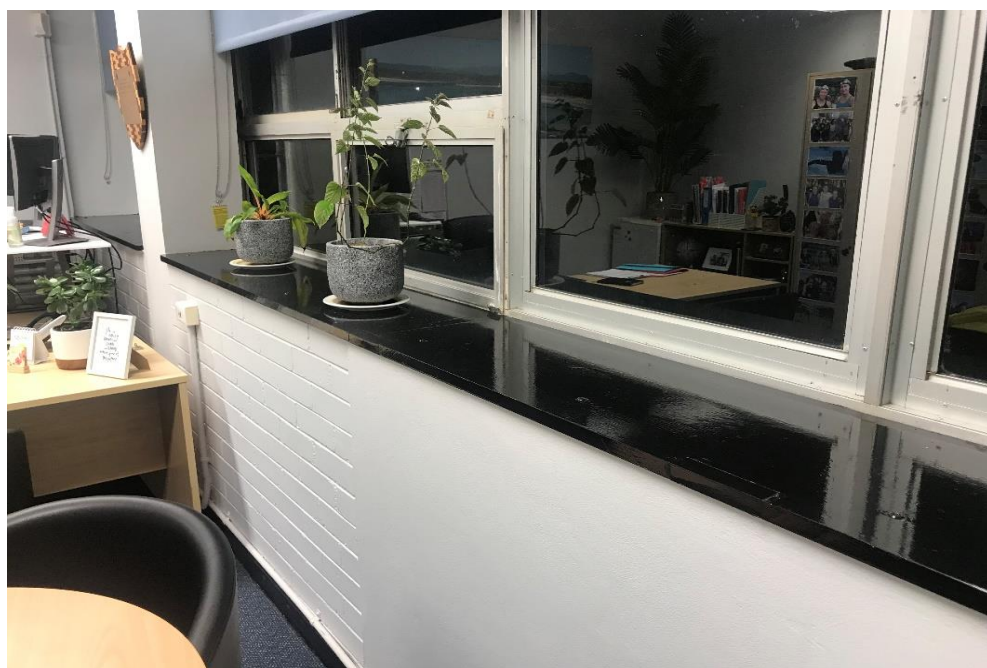
Photograph 2: B00A, AR0015, window sill, fibre cement board, asbestos detected by analysis.

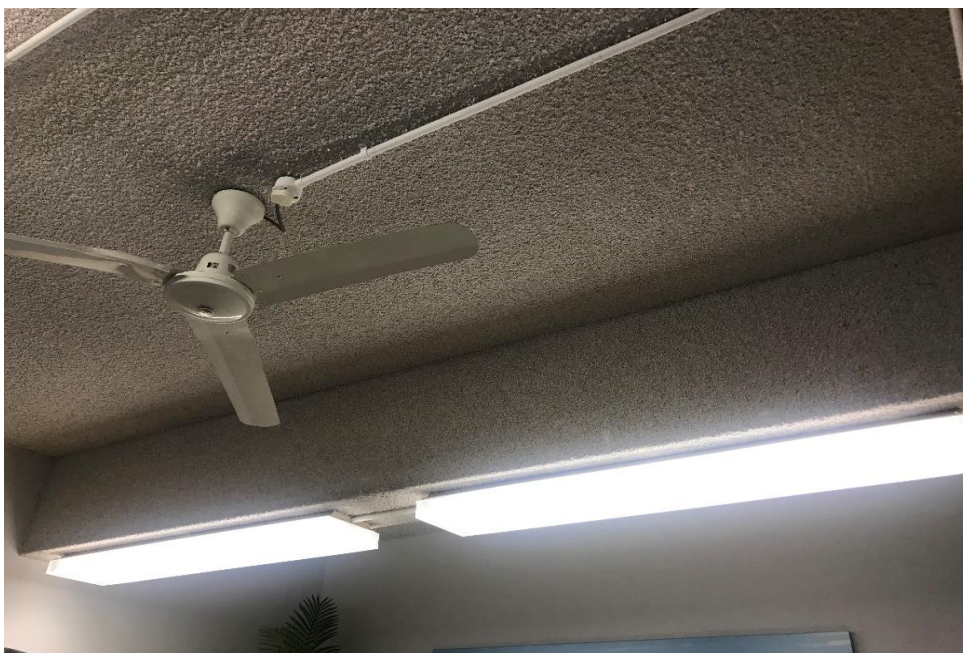
Photograph 3: B00A, AR0015, ceiling, vermiculite, no asbestos detected by analysis, SMF detected.

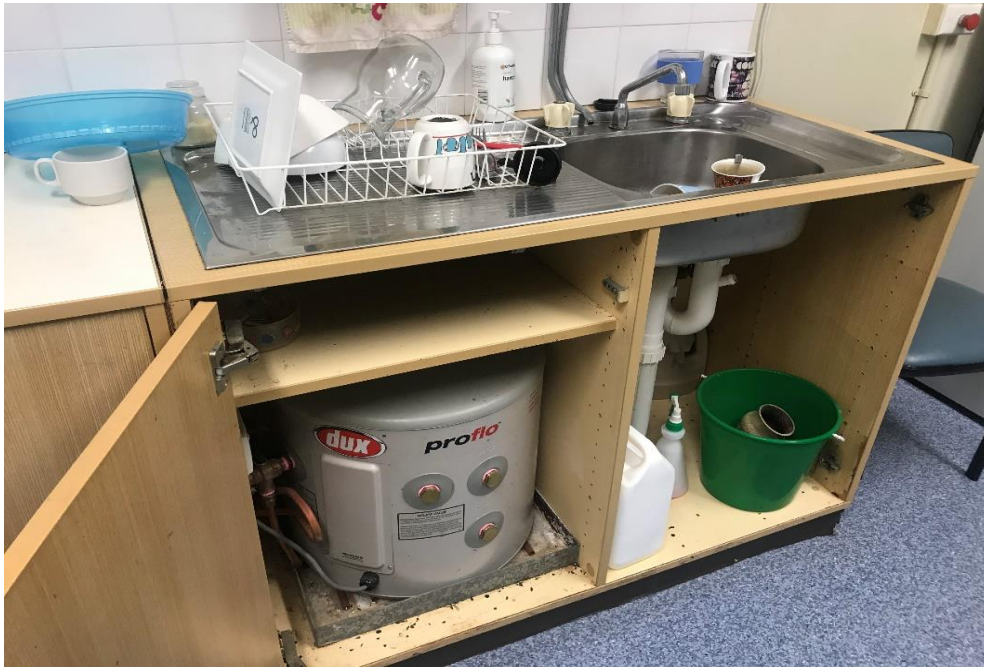
Photograph 5: B00A, AR0019, hot and boiling water unit(s), insulation, assumed SMF or foam insulation.

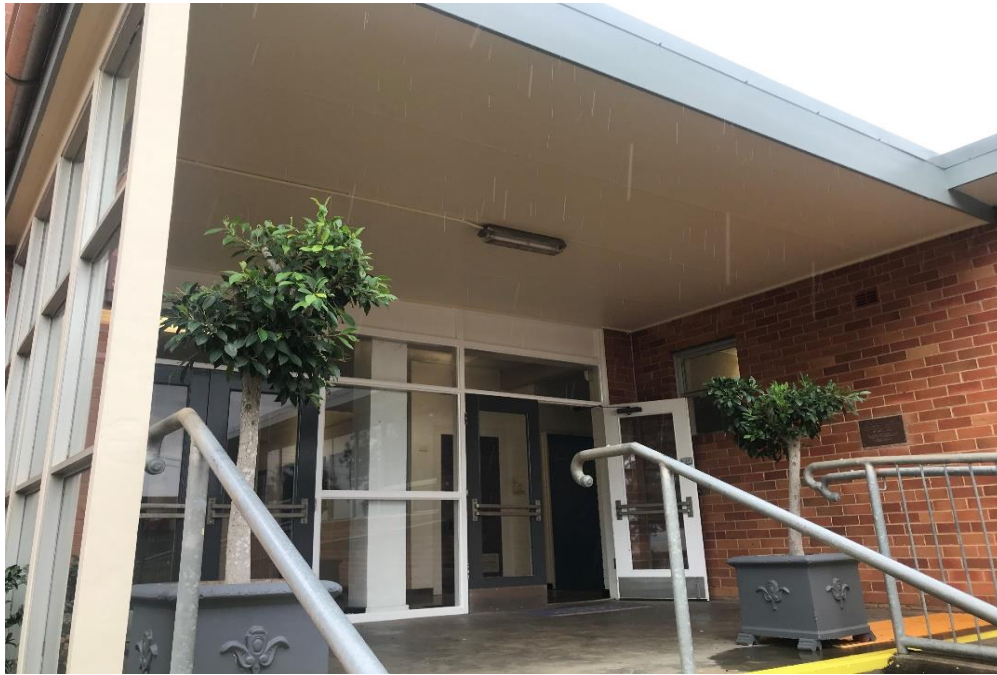
Photograph 7: B00A, AR0042, ceiling, fibre cement sheeting, asbestos detected by analysis.

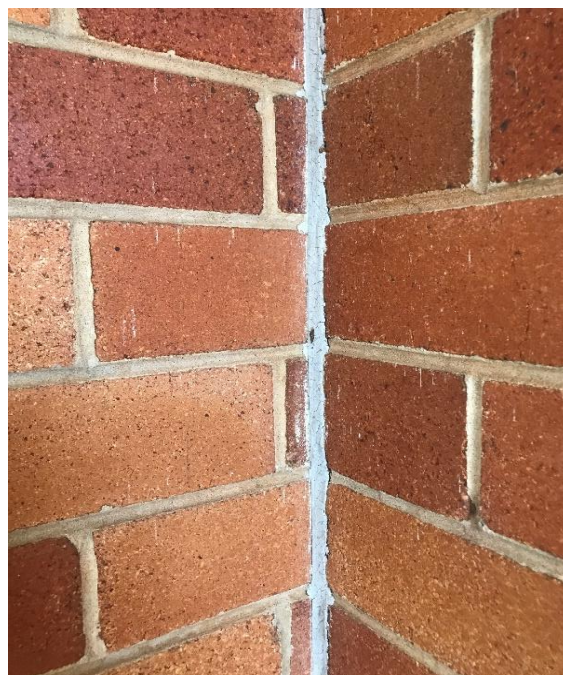
Photograph 9: B00A, AR0042, southeast corner, brick wall, expansion gap, joint mastic, asbestos detected by analysis.

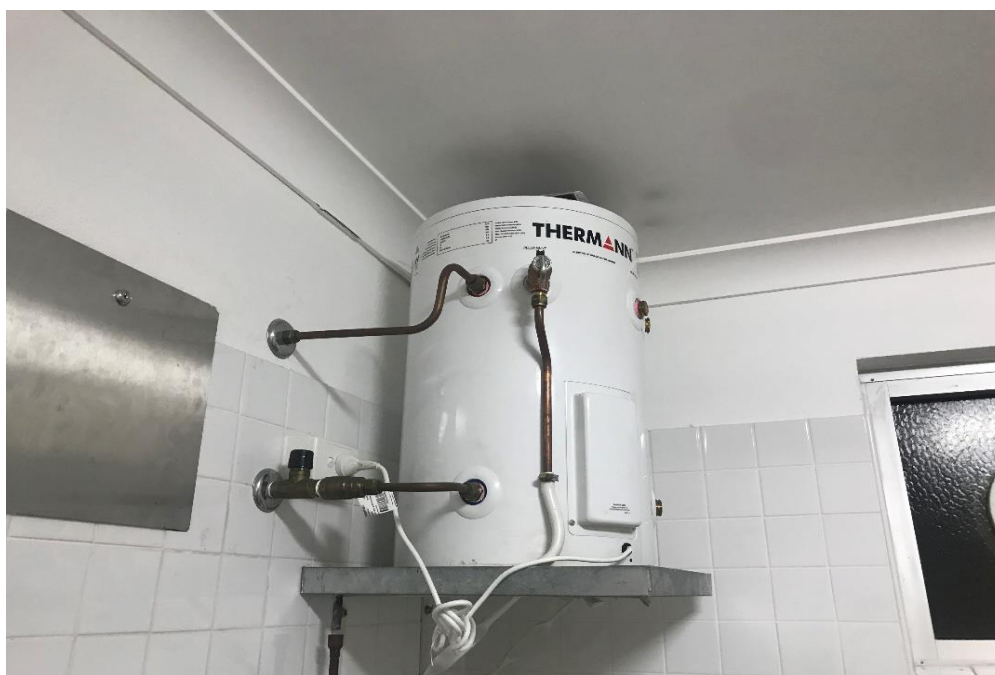
Photograph 10: B00A, AR0055, hot water unit, insulation, assumed SMF or foam insulation.

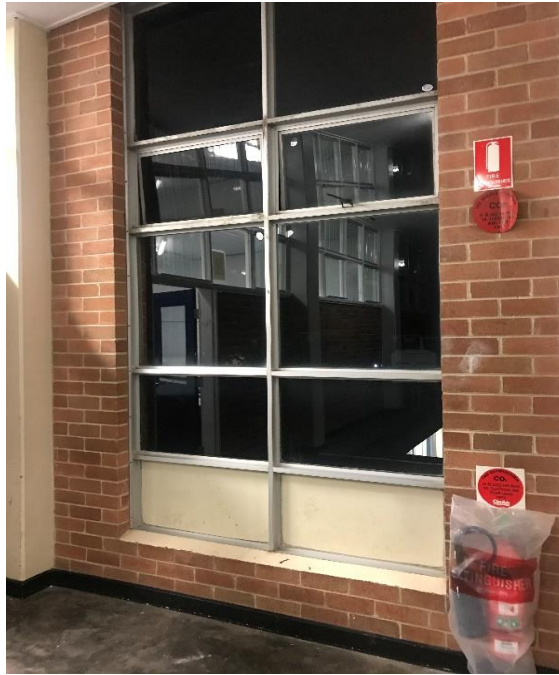
Photograph 11: B00A, first floor, room above AR0046, window frame, infill panels, asbestos (assumed).

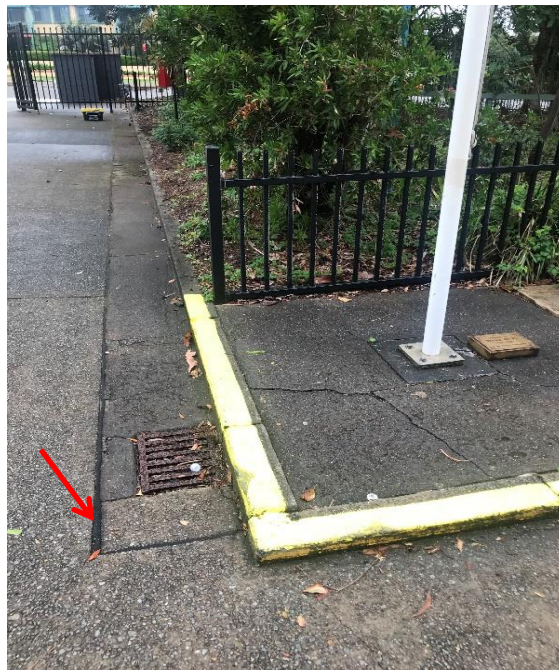
Photograph 12: B00A, exterior, exterior, northwest of building (near flagpole), expansion gap in paving, bitumastic, no asbestos detected by analysis, SMF detected.

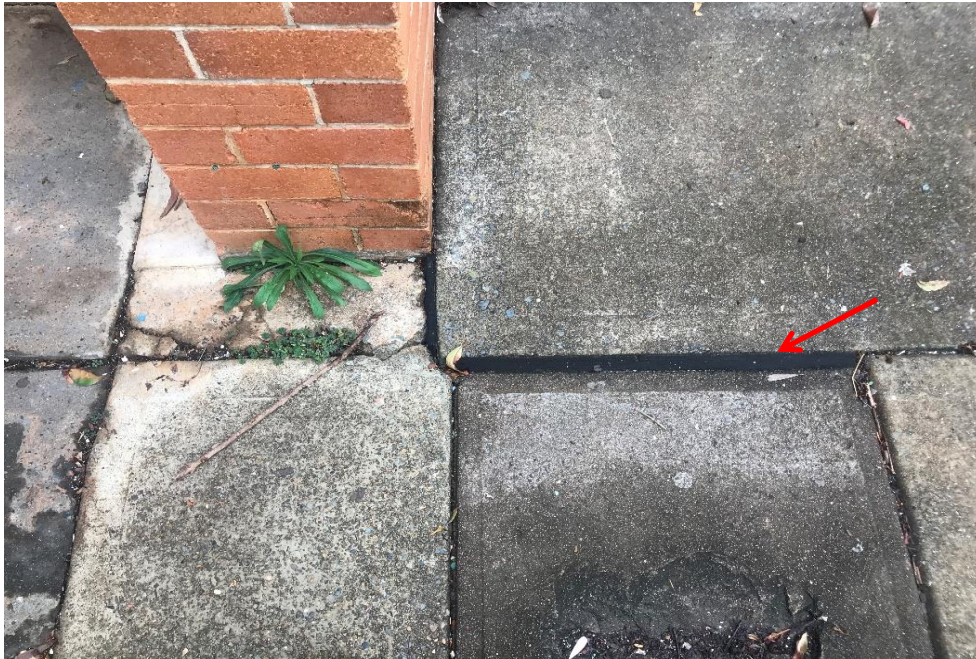
Photograph 13: B00A, exterior, exterior, northwest of building (near AR0024), expansion gap in paving, bitumastic, no asbestos detected by analysis, SMF detected.

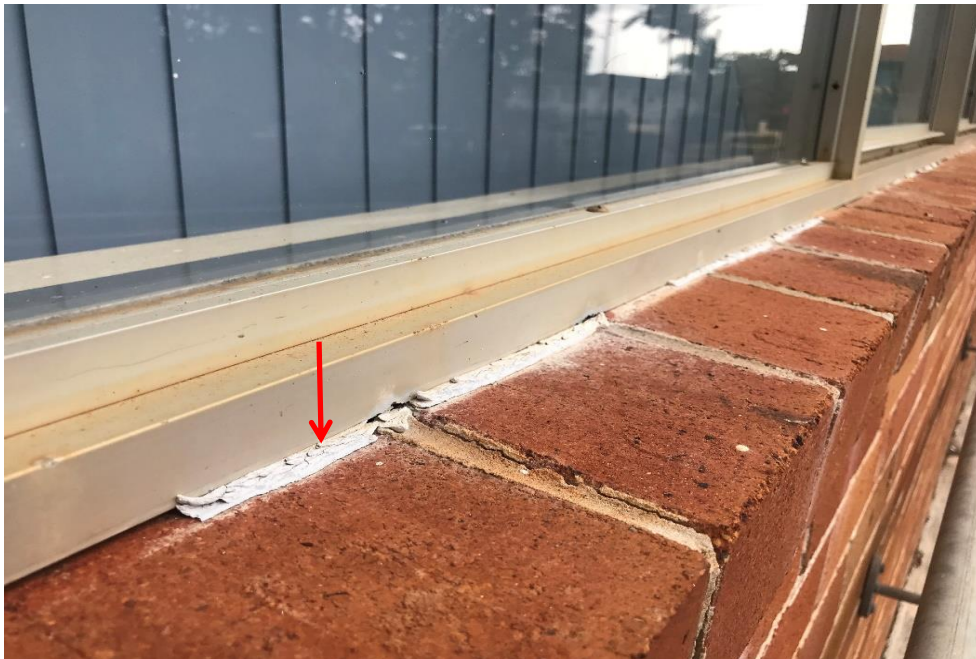
Photograph 14: B00A, exterior, adjacent north AR0020, between window frame and brick wall, putty, asbestos detected by analysis.

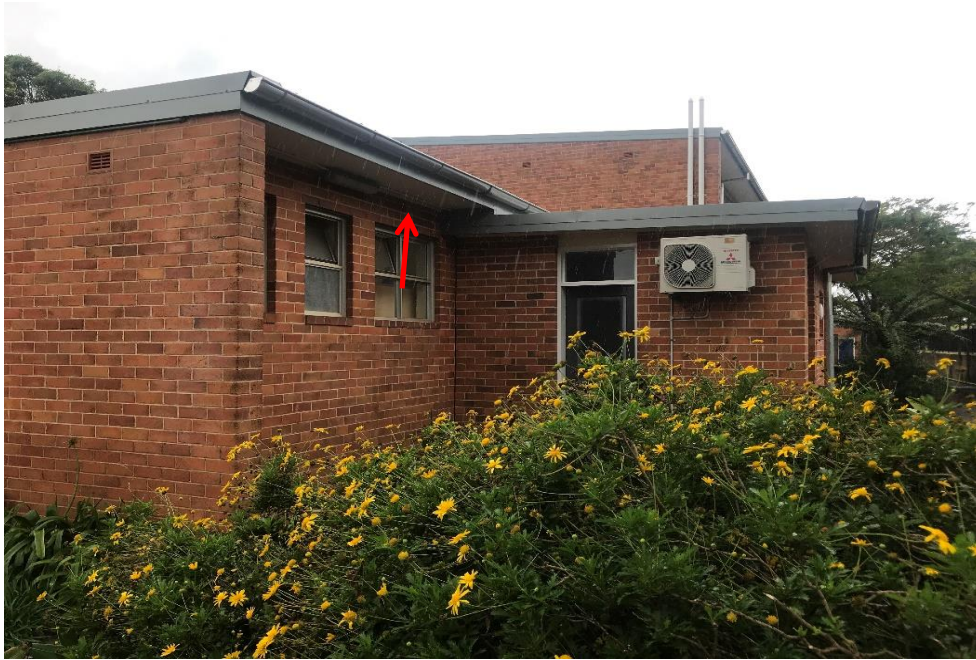
Photograph 17: B00A, exterior, fibre cement sheeting, upper eave south west corner, fibre cement, asbestos detected by analysis.

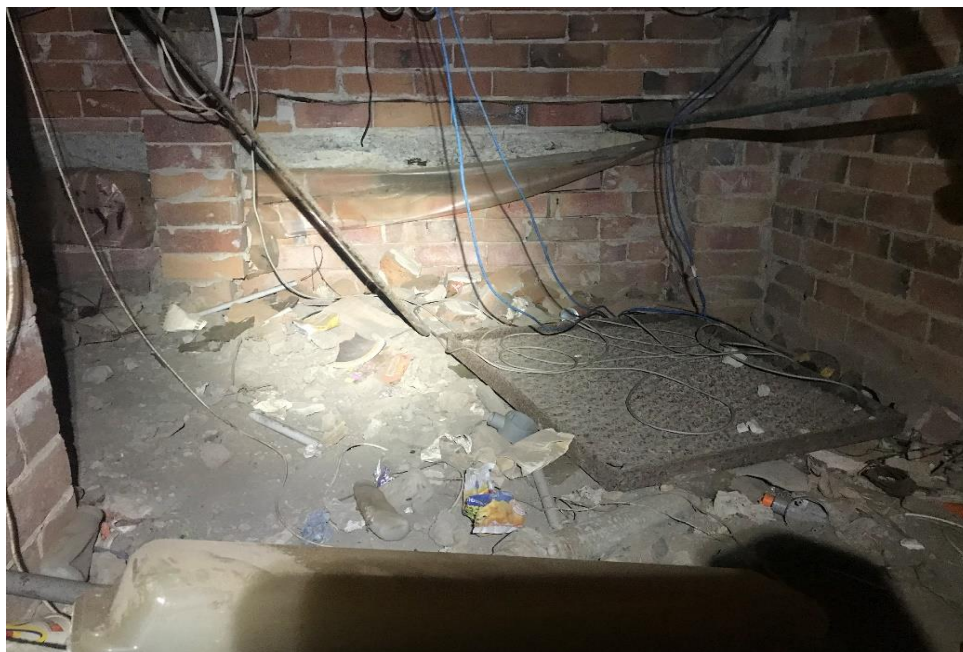
Photograph 18: B00A, building subfloor, throughout, materials in general, no asbestos identified visually however access limited.

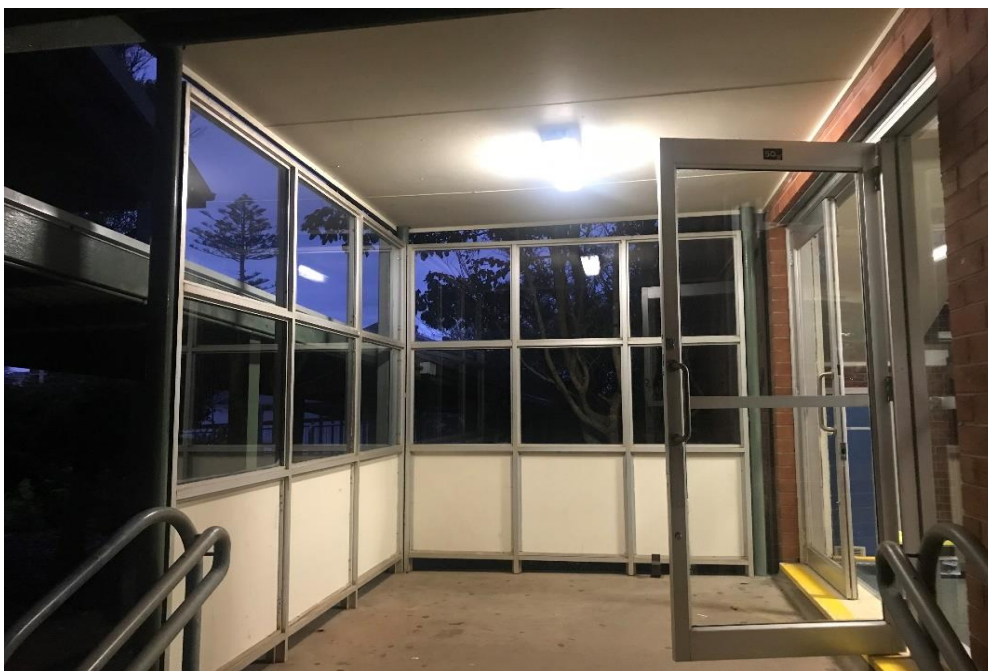
Photograph 1: B00B, BR0019, ceiling, fibre cement sheet, asbestos detected by analysis.

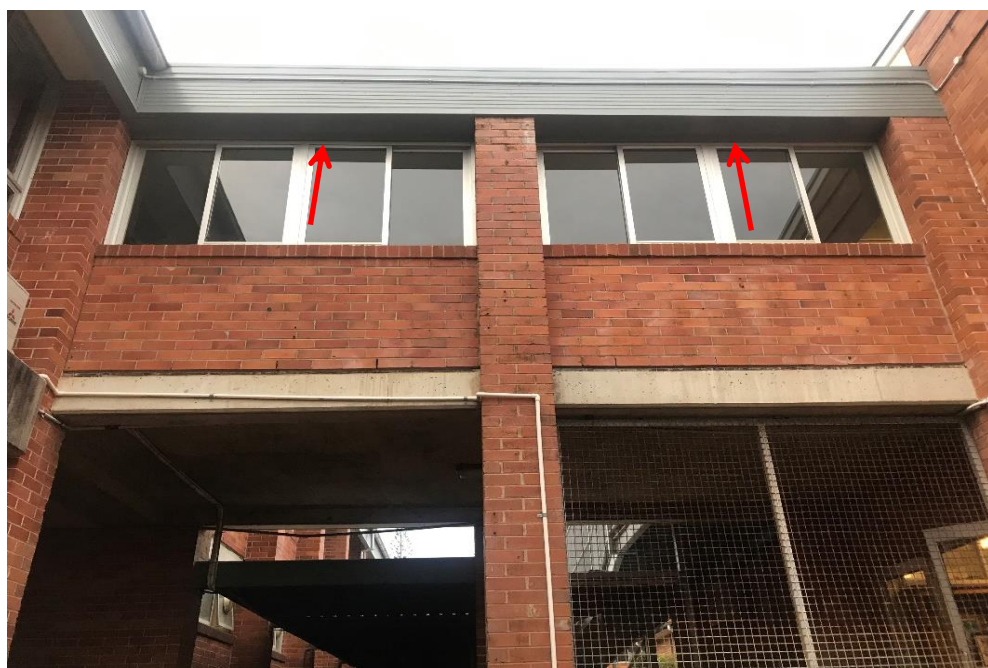
Photograph 2: B00B, BR0020 / BR1023, eaves, assumed fibre cement sheeting, asbestos (assumed).

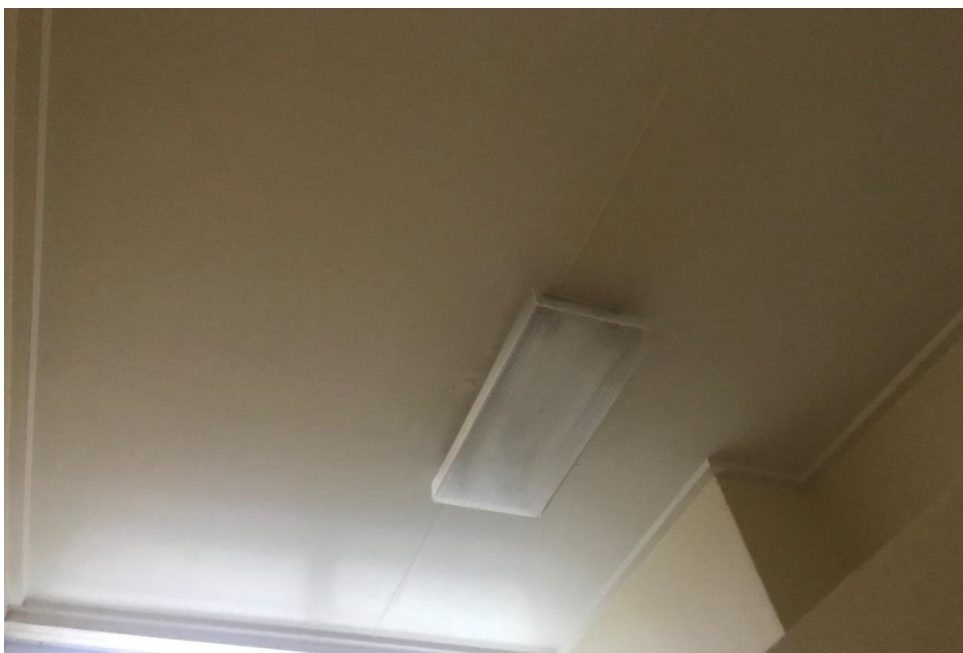
Photograph 3: B00B, BR1020, ceiling, fibre cement sheeting, asbestos detected by analysis.

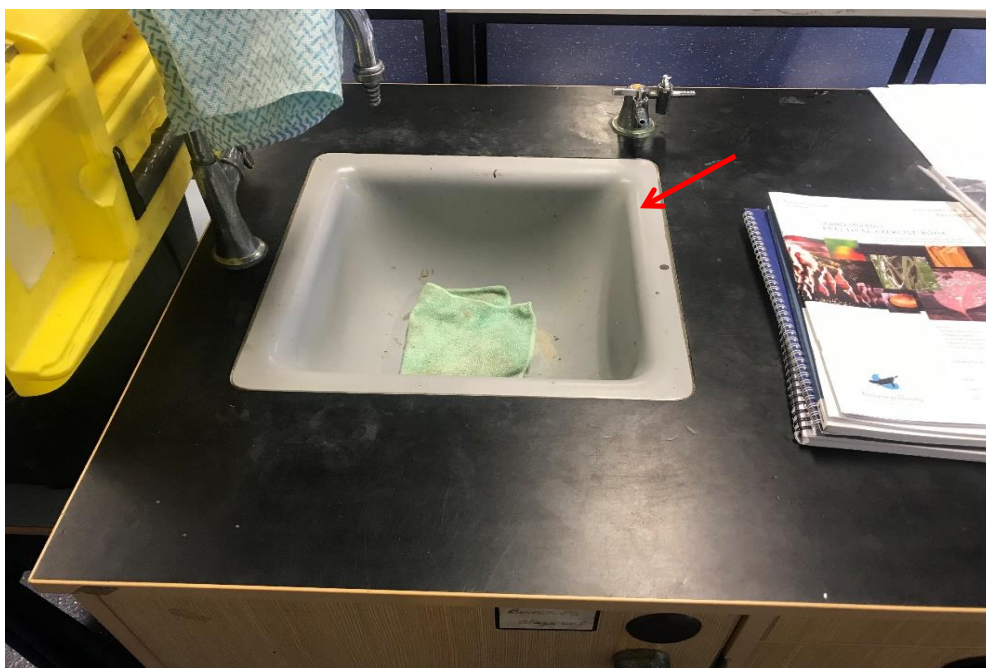
Photograph 6: B00B, BR0004, teacher's desk, moulded sink, SMF (assumed).

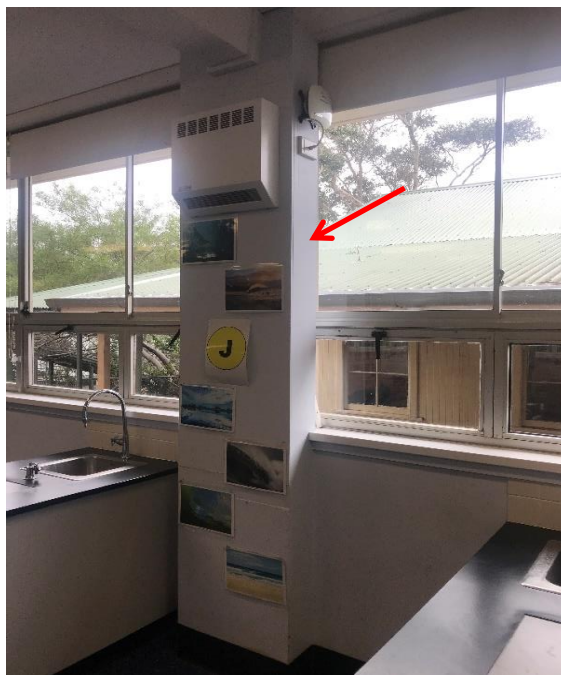
Photograph 7: B00B, BR0009, north and west wall, enclosed building boxes, internal material(s), unknown.

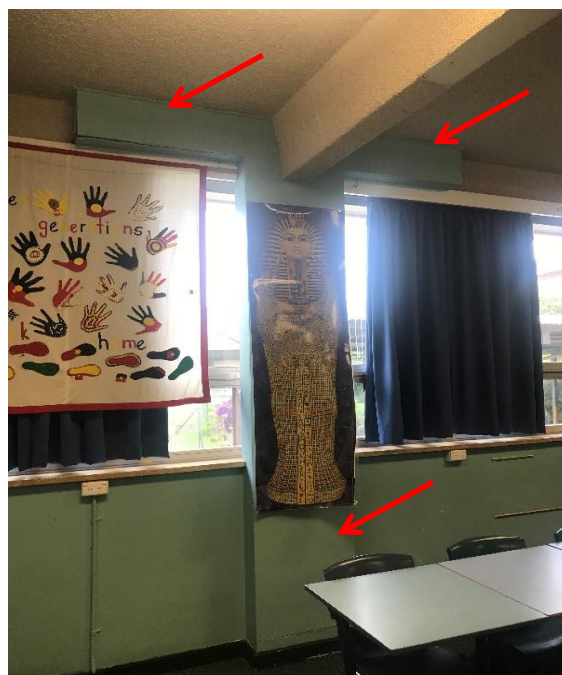
Photograph 8: B00B, BR0012, north wall, enclosed T-shape building box, internal material(s), unknown.

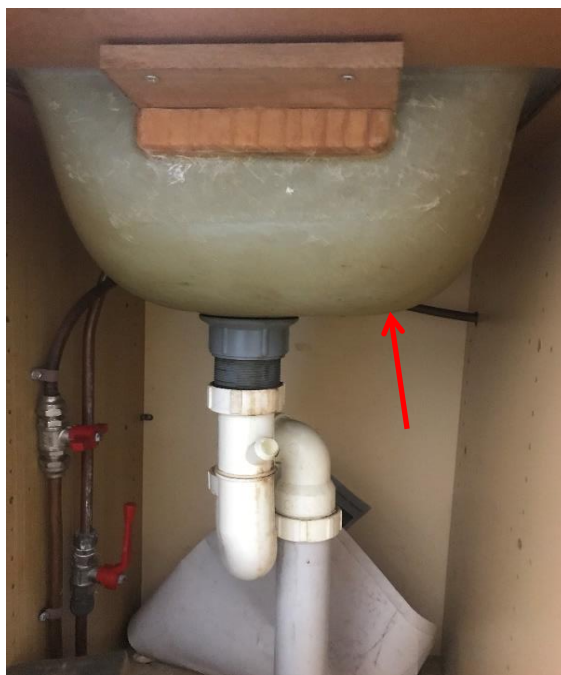
Photograph 9: B00B, BR0012, teacher's desk, moulded sink, no asbestos detected by analysis, SMF detected.

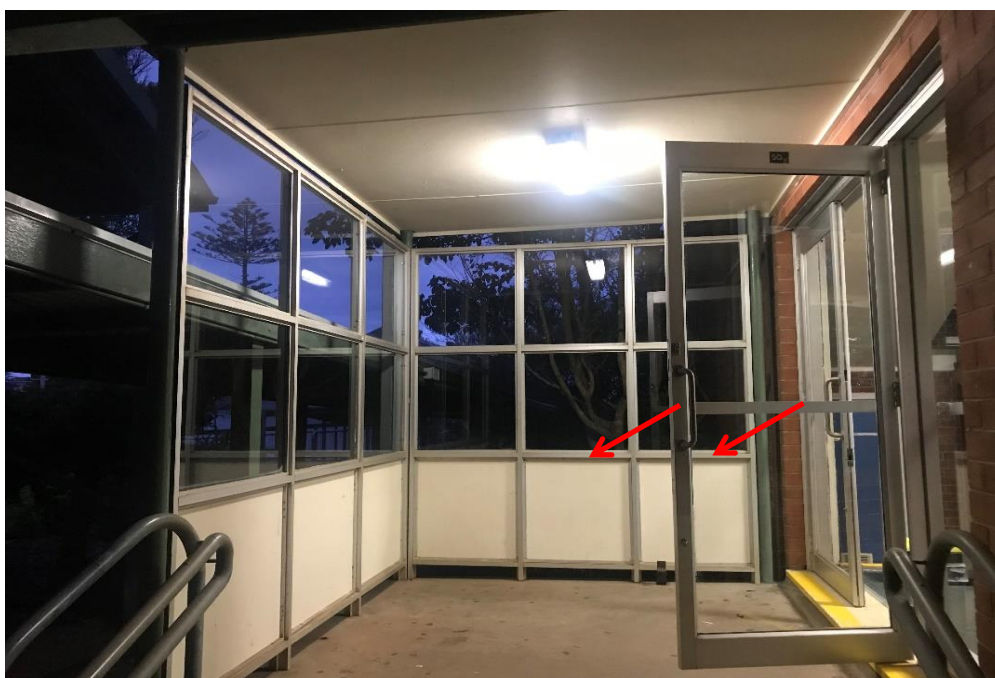
Photograph 10: B00B, BR0019, portion of infill panels (type 3), fibre cement, asbestos detected by analysis.

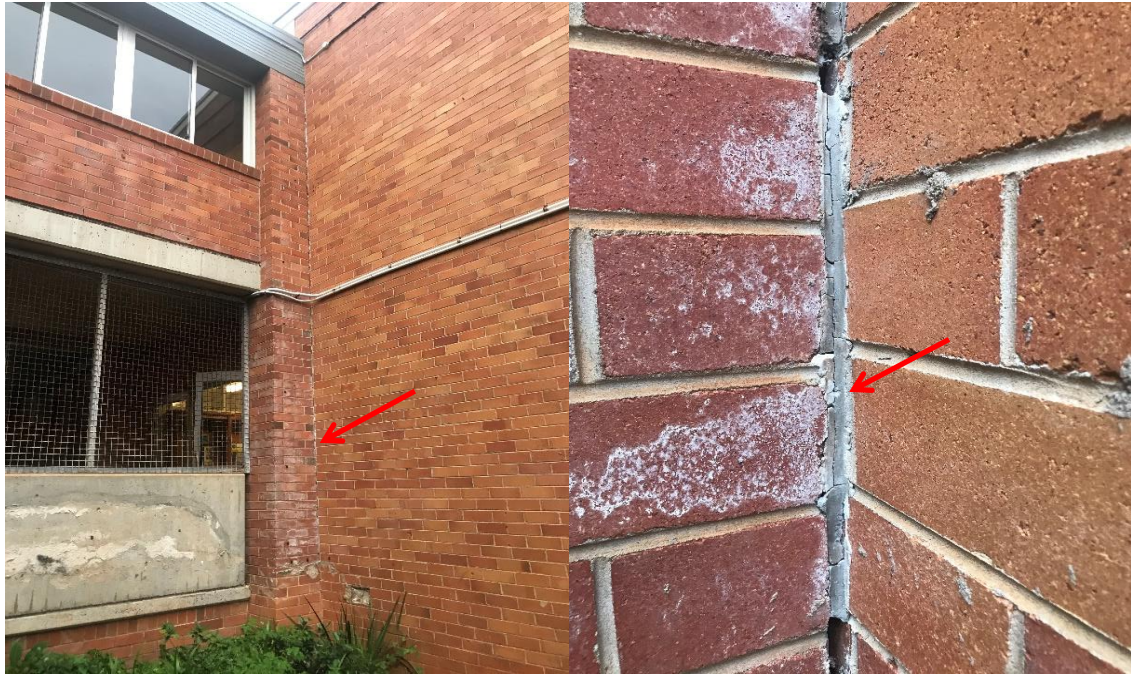
Photograph 11: B00B, BR0020 / BR1023, exterior brick wall, expansion gap, grey putty, asbestos detected by analysis.

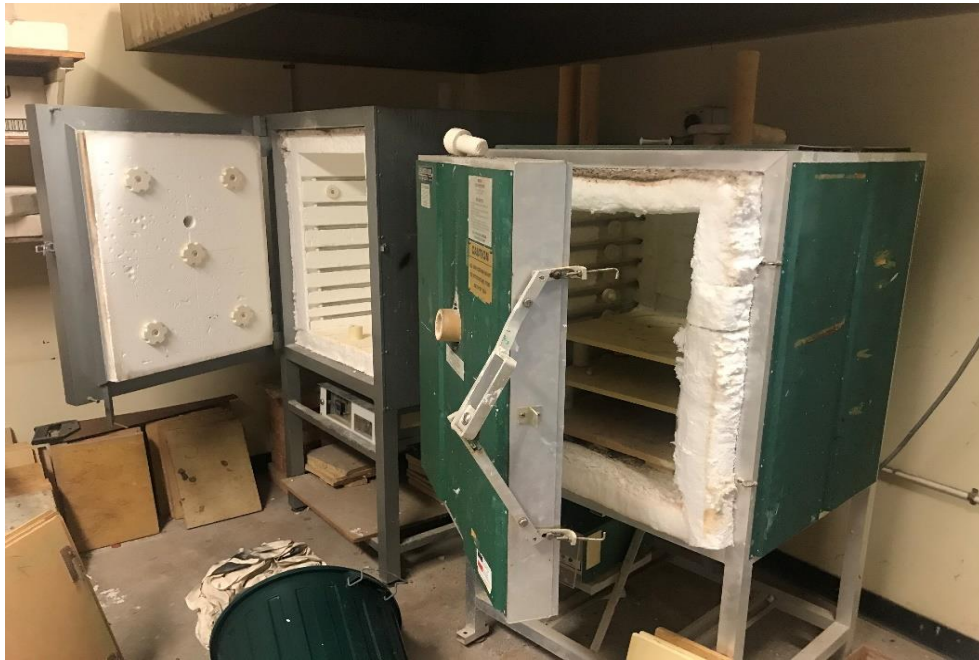
Photograph 15: B00B, BR1017, green and grey kilns, insulation, no asbestos detected by analysis, SMF detected.

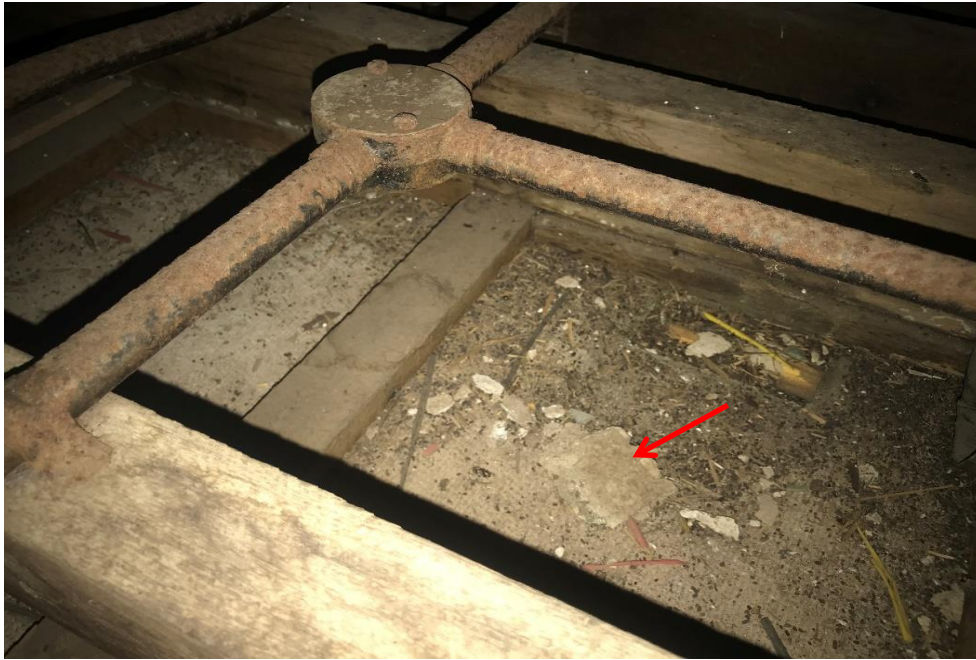
Photograph 17: B00B, BR1021, top of ceiling, minor fibre cement sheeting debris, asbestos (assumed).

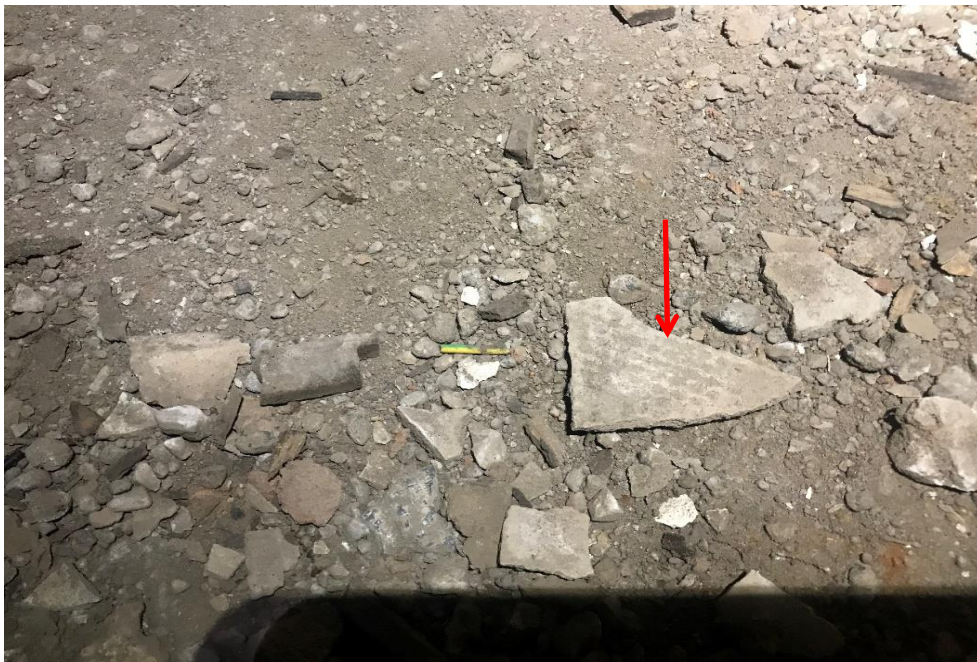
Photograph 20: B00B, subfloor, ground surface, fibre cement fragment(s), asbestos detected by analysis.

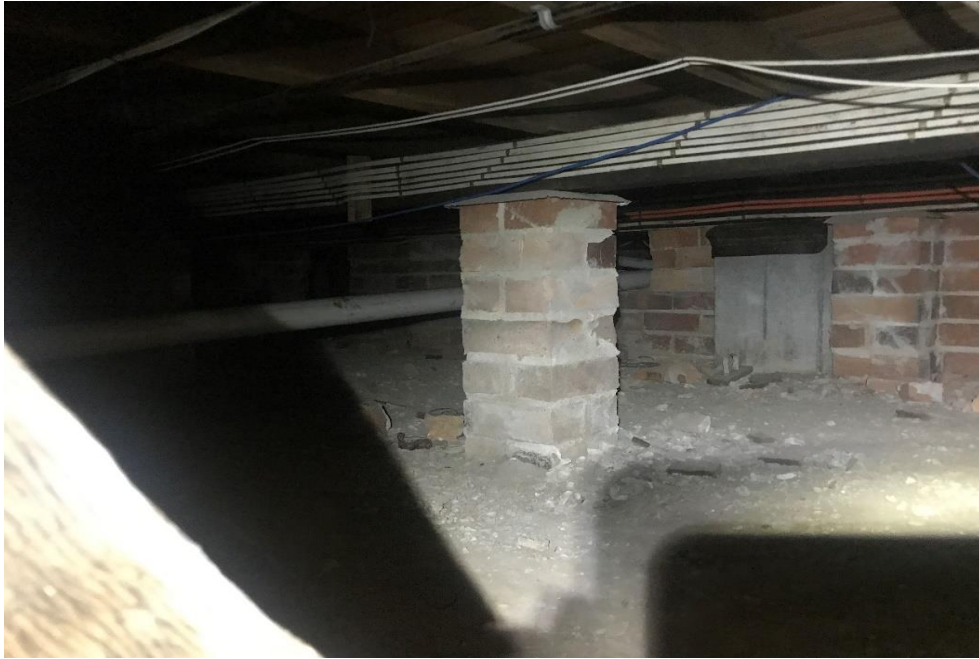
Photograph 21: B00B, building subfloor, throughout, materials in general, access limited.

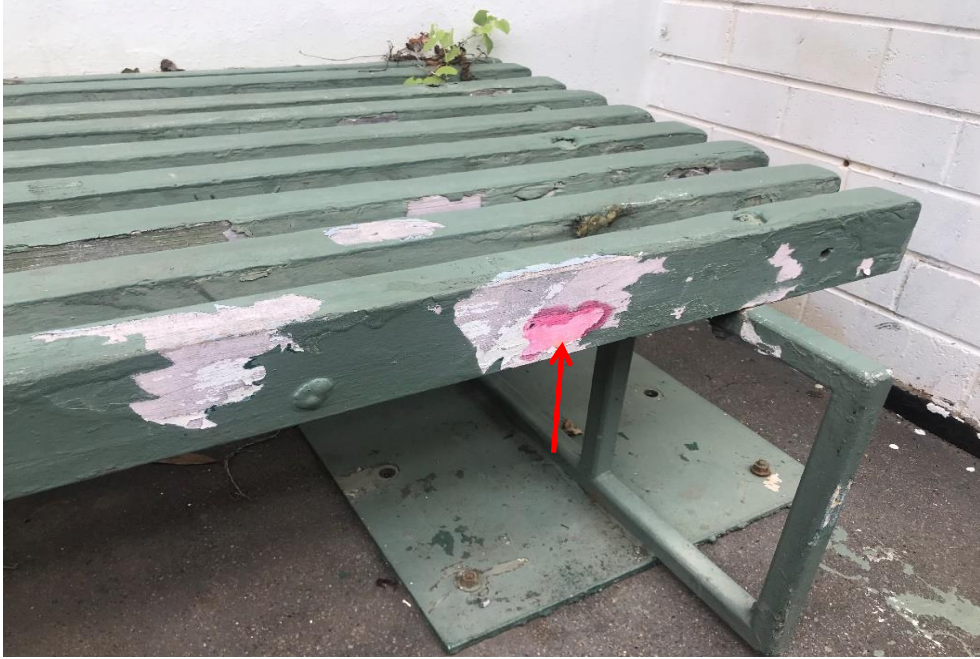
Photograph 23: B00B, exterior, northern façade, timber seating, green and underlying cream paint, lead paint (>0.1% lead w/w).

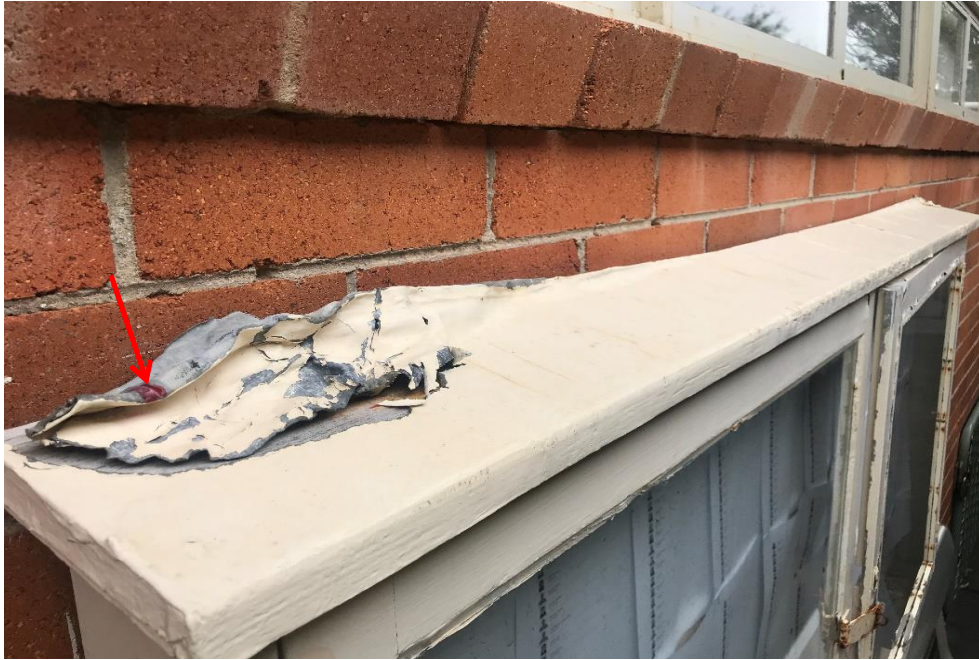
Photograph 25: B00B, exterior, northern façade, notice board, flashing, positive for lead.

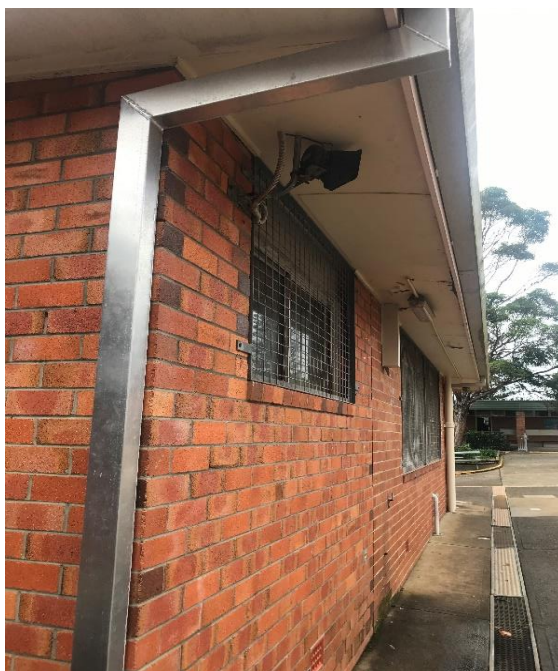
Photograph 1: B00C, exterior, eave linings, fibre cement sheet, asbestos detected by analysis.

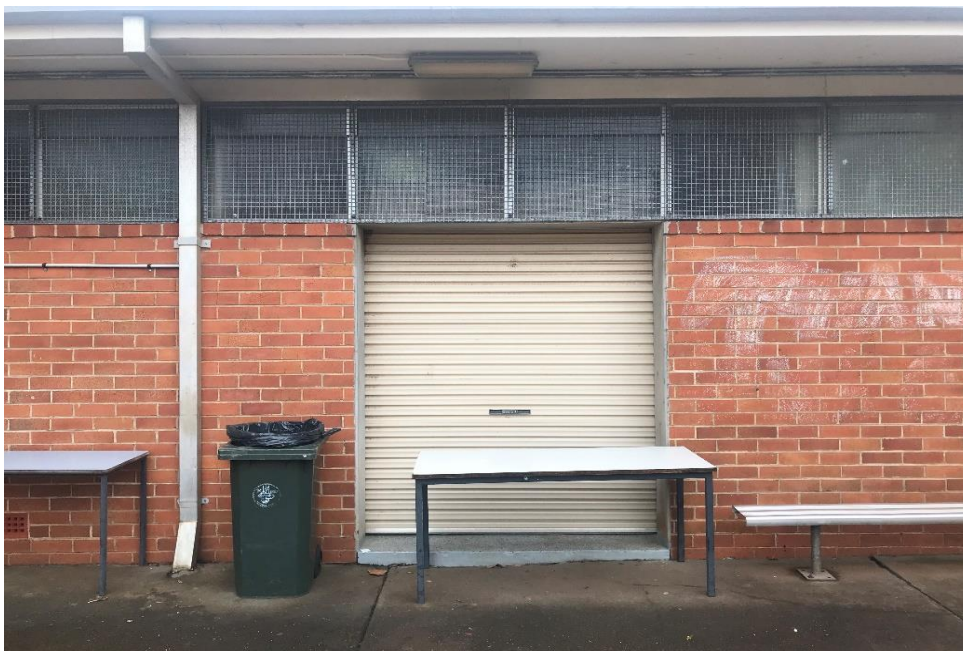
Photograph 3: B00C, exterior, concrete paving outside CR0006 roller door, expansion gap, bitumastic, asbestos detected by analysis.

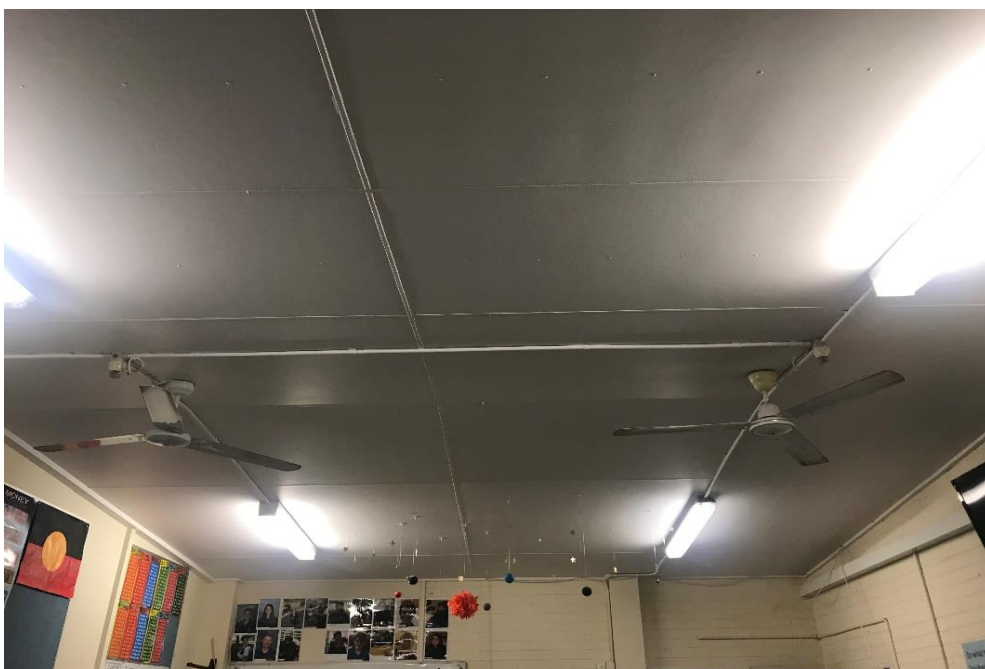
Photograph 6: B00C, CR0016, ceiling, fibre cement sheeting, asbestos detected by analysis.

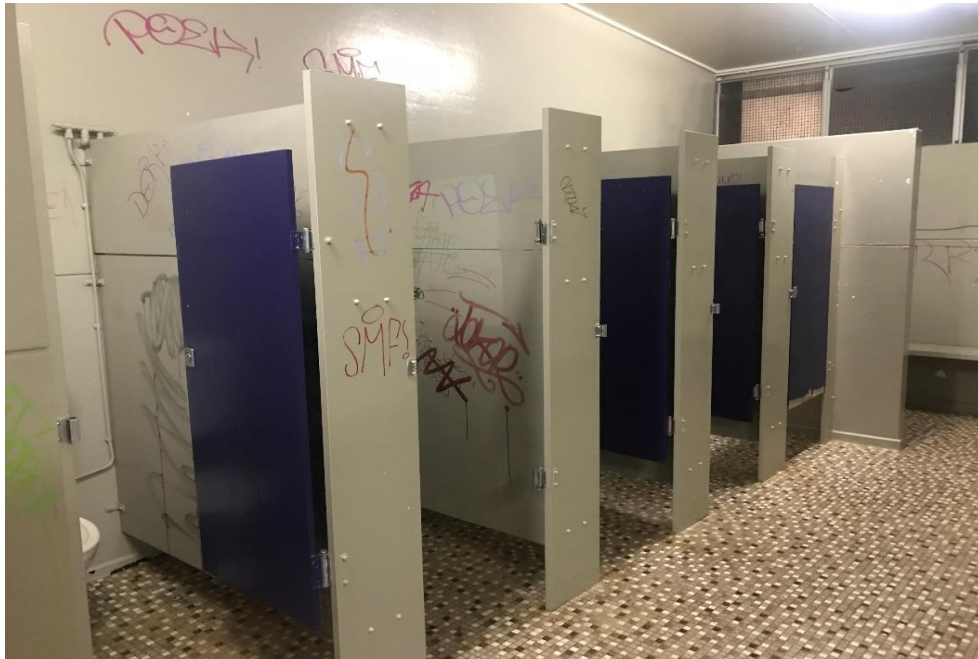
Photograph 7: B00C, CR0005, cubicles, partition walls, fibre cement board, asbestos detected by analysis.

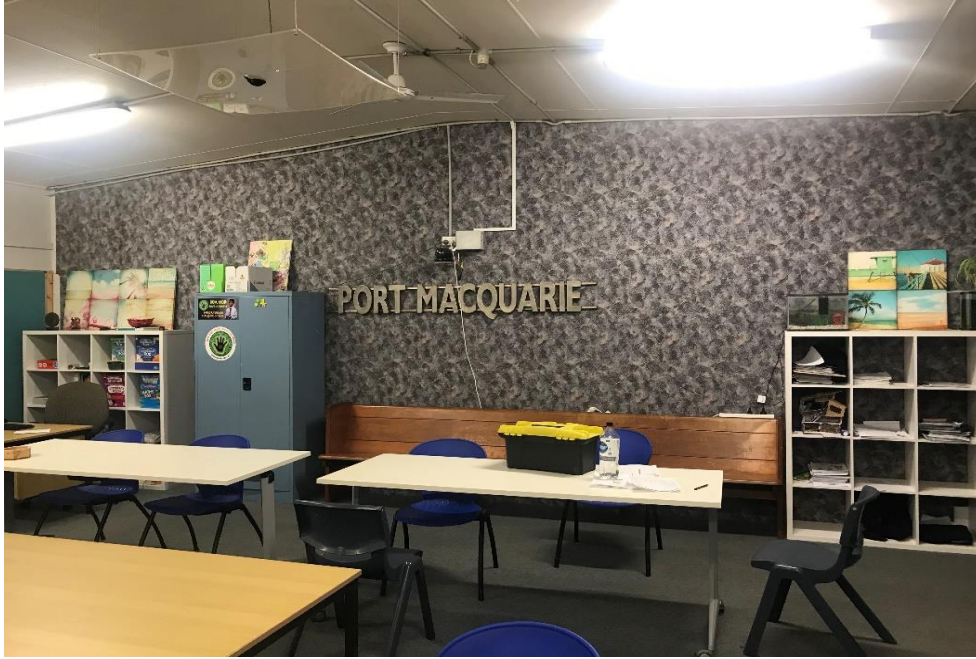
Photograph 9: B00C, CR0015, western wall, below carpet/textile lining, wall lining , unknown.

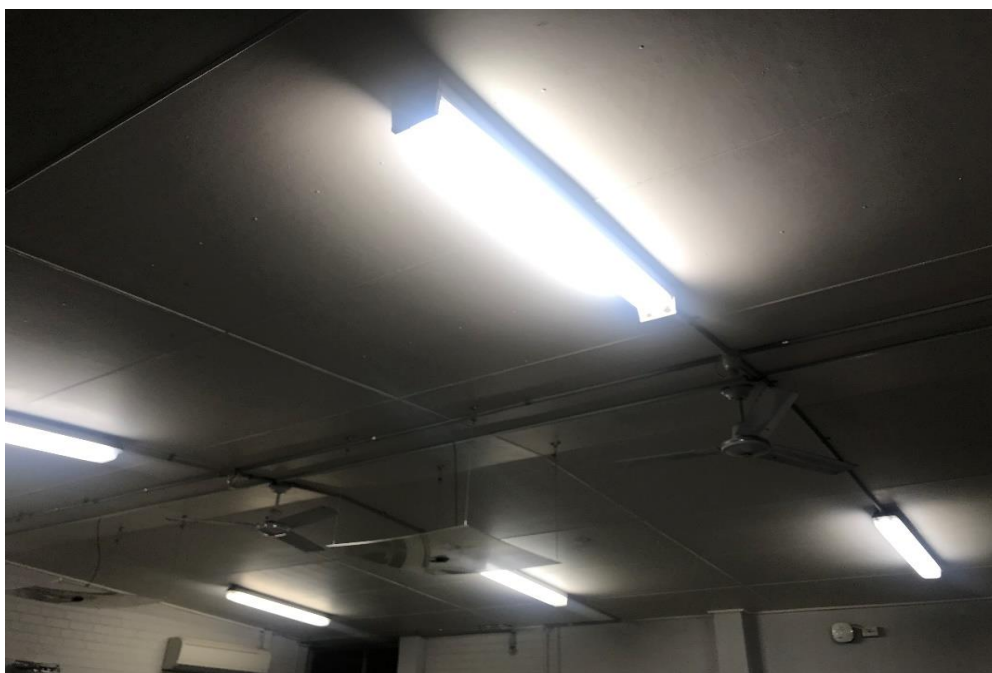
Photograph 11: B00C, rooms and areas in general, fluorescent light fittings in general, capacitors, insulating oil, PCB (assumed).

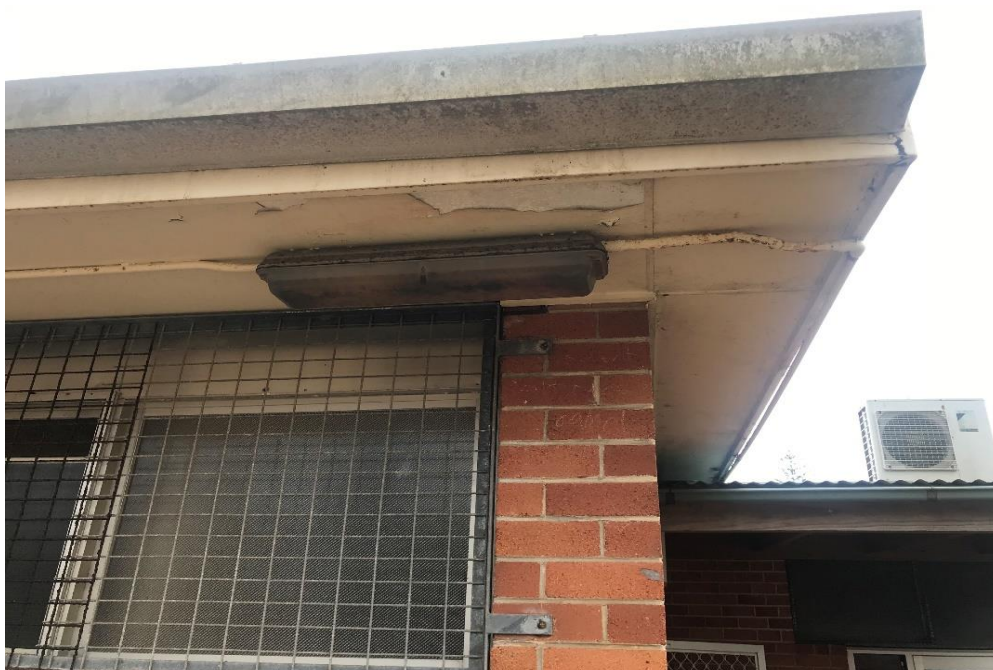
Photograph 12: B00C, rooms and areas in general, fluorescent light fittings in general, capacitors, insulating oil, PCB (assumed).

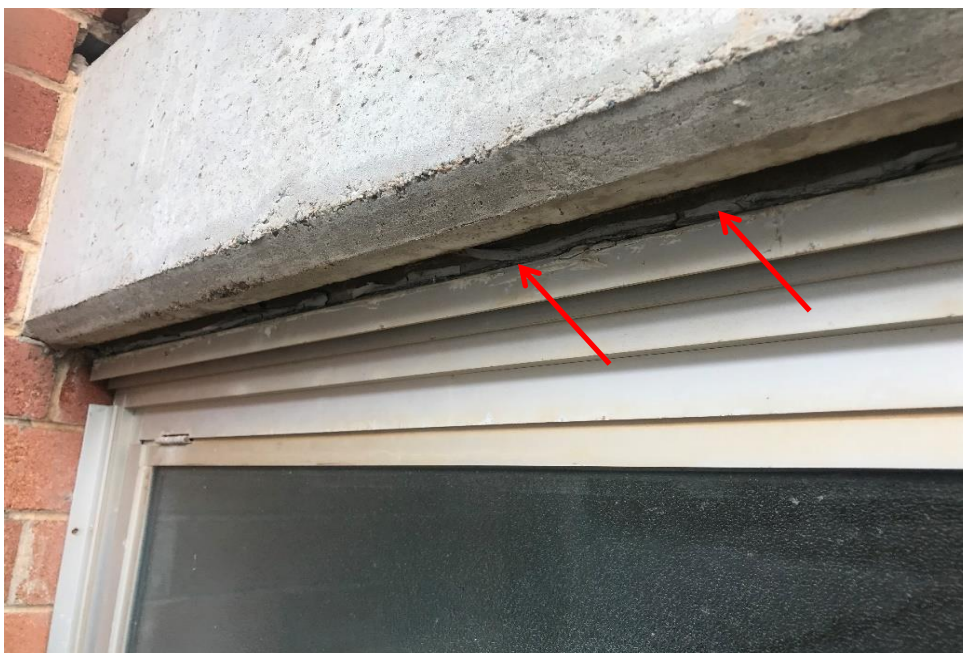
Photograph 3: B00L, exterior, western façade, north end, between window frame and wall, mastic, asbestos detected by analysis.
