Report on  
Hazardous Building Materials (HBM) Survey

Hastings Secondary College - Port Macquarie Campus  
16 Owen Street, Port Macquarie

Prepared for  
School Infrastructure NSW  
on behalf of Department of Education

Project 89754.01  
April 2021

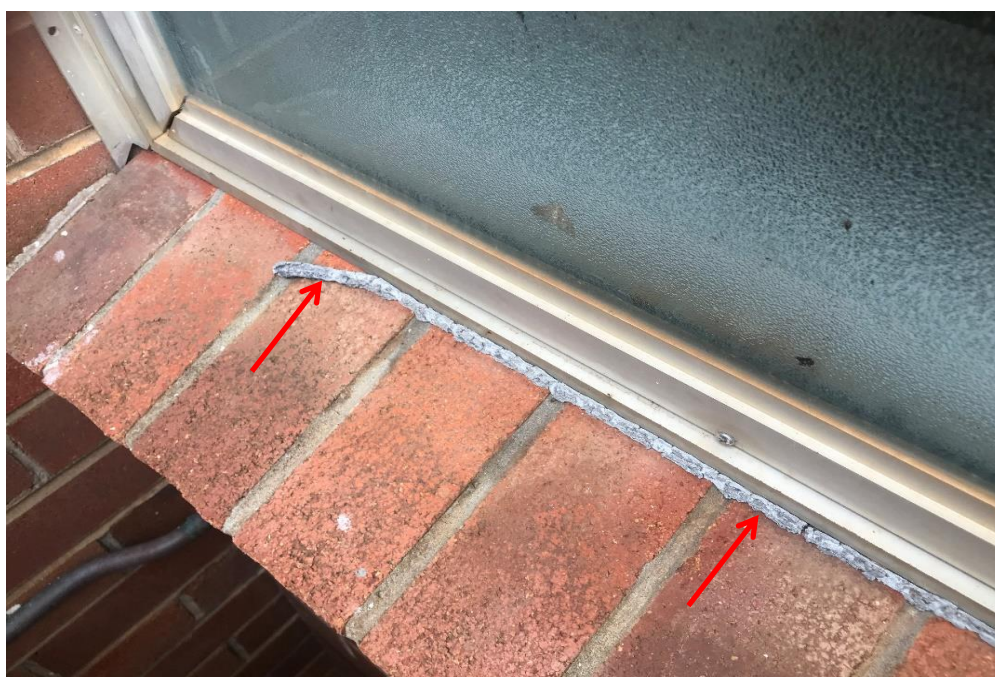
Photograph 4: B00L, exterior, western façade, centre, between window frame and wall, mastic, asbestos detected by analysis.

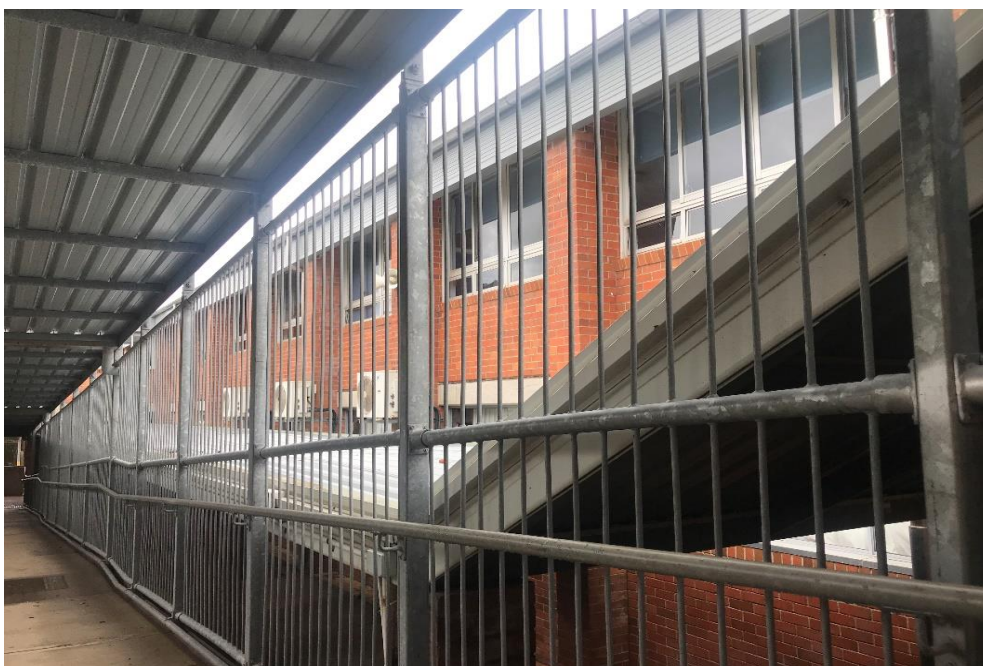
Photograph 6: B00L, exterior, western façade, materials to upper sections generally, limited access.

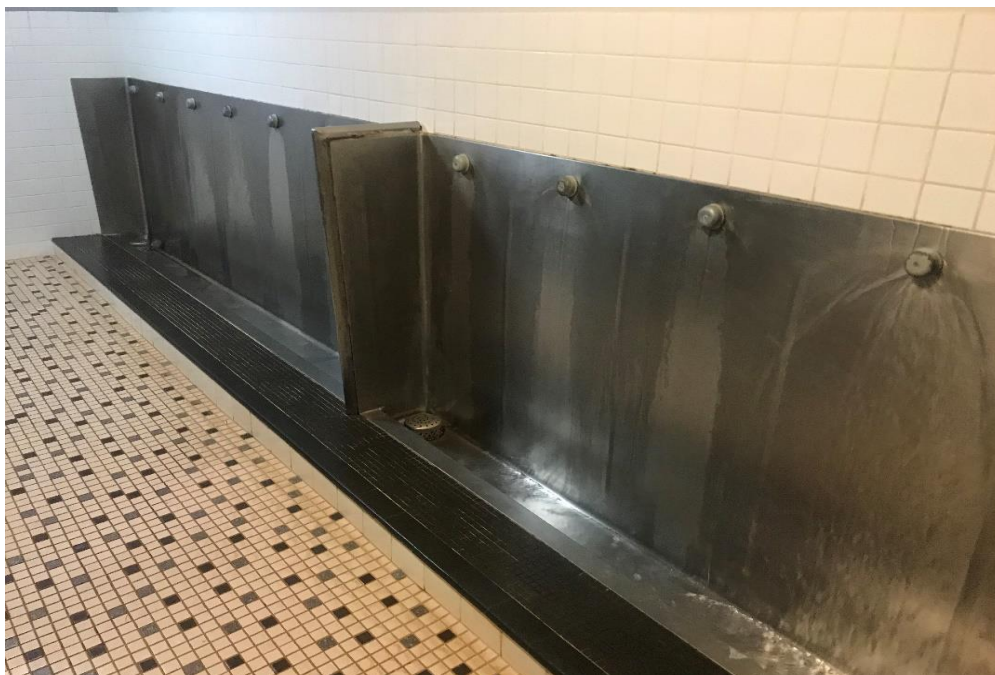
Photograph 7: B00L, LR0013, rear of urinal, possible bituminous lining, unknown.

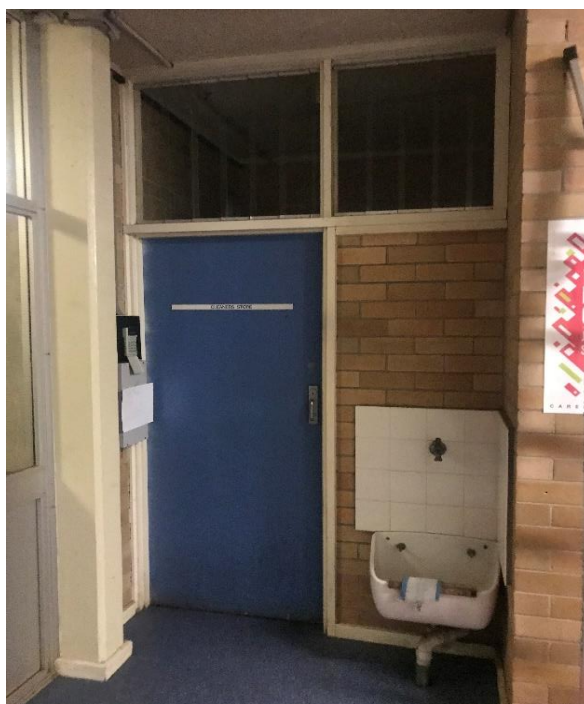
Photograph 8: B00L, LR0019, ceiling, vermiculite, non asbestos (assumed).

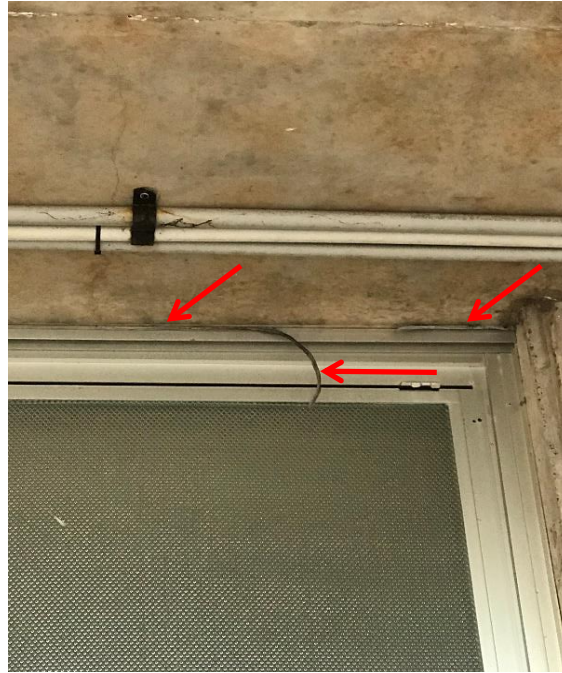
Photograph 9: B00L, LR0042, aluminium window and door sets, between window/door frame and wall, putty , asbestos detected by analysis.

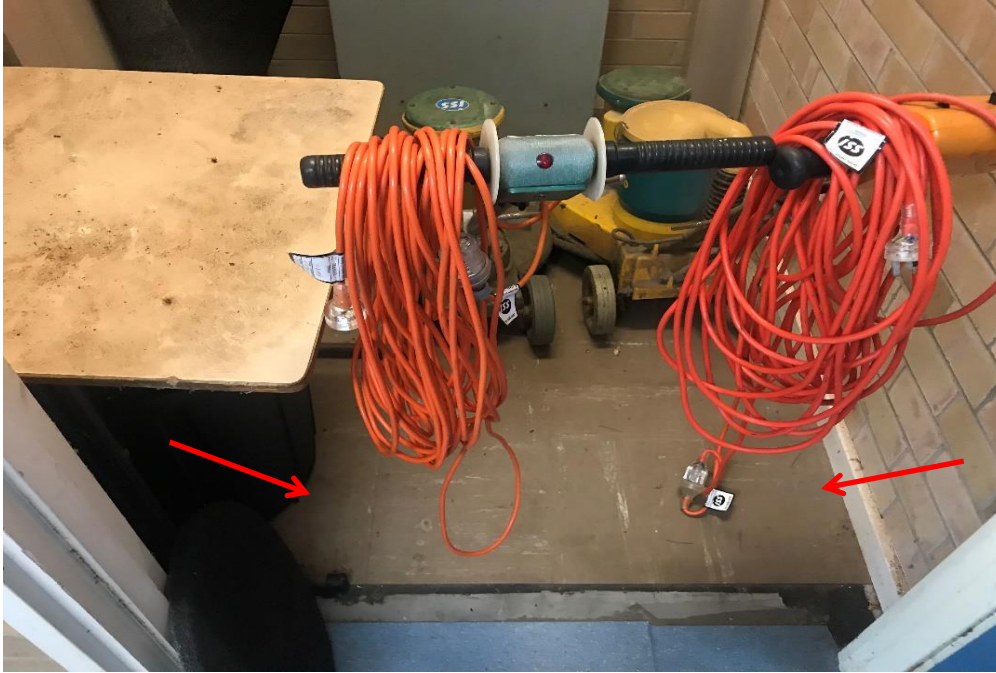
Photograph 11: Typical brown vinyl tile with white streaks to floors (including below carpets and vinyl sheeting), asbestos detected by analysis.

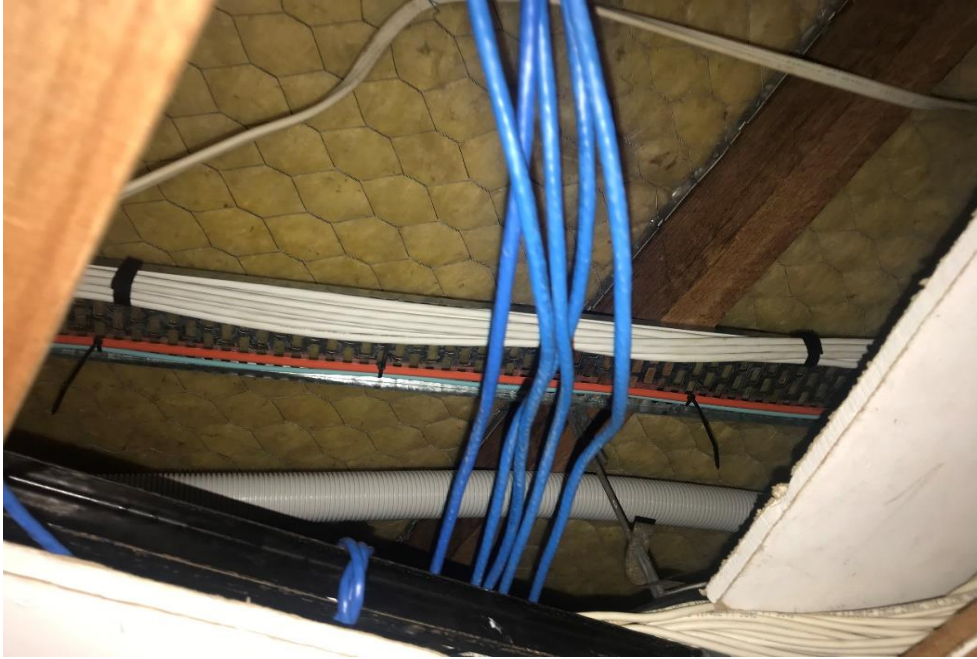
Photograph 15: B00L, LR1022, ceiling cavity, underside of roof, insulation, SMF identified visually.

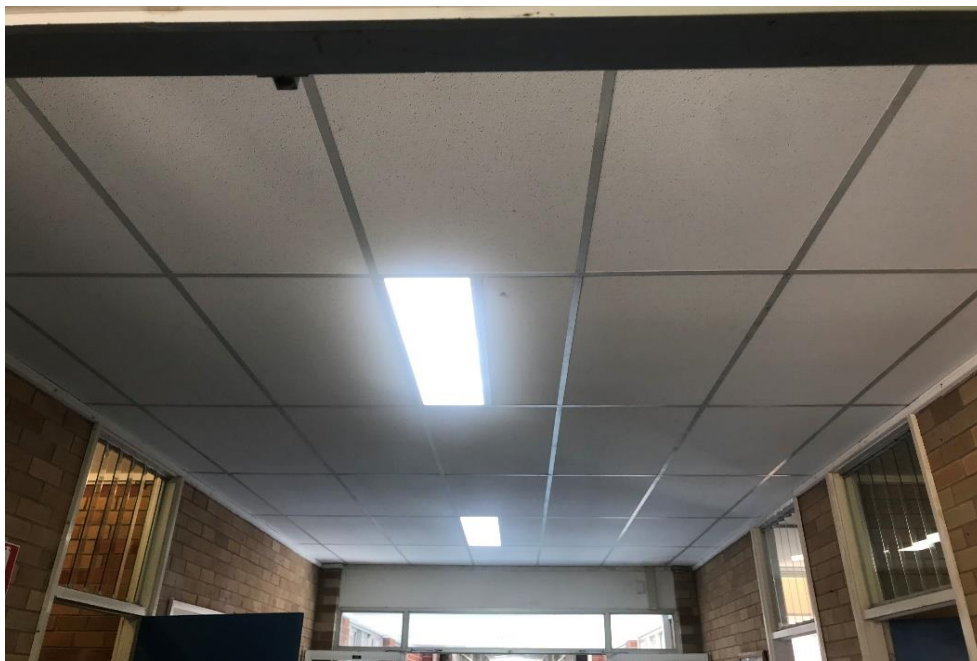
Photograph 16: B00L, LR1025, false ceiling, ceiling tiles, SMF identified visually.

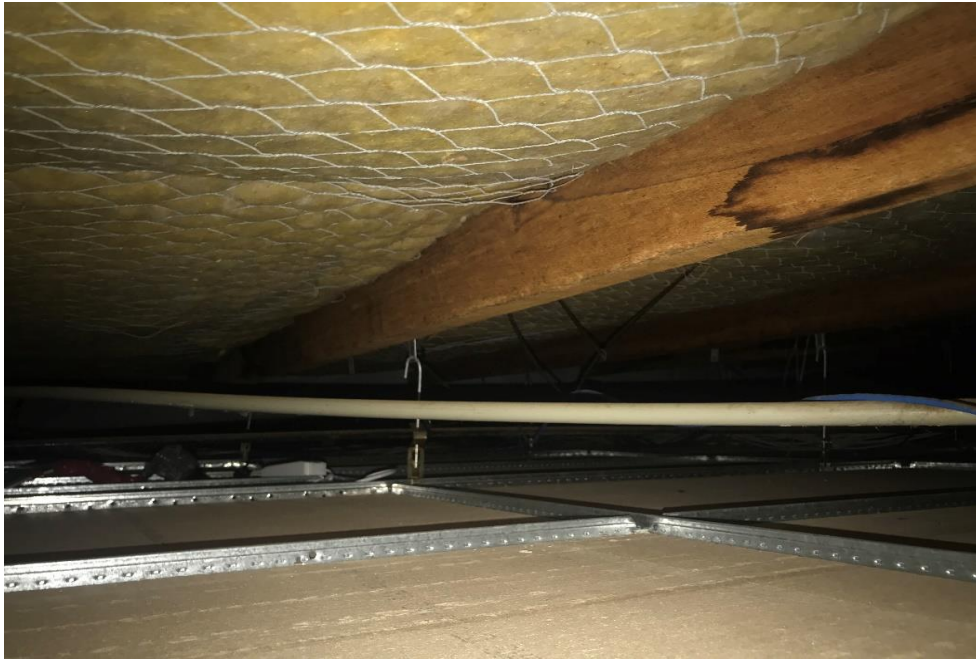
Photograph 17: B00L, LR1025, ceiling cavity, insulation to roof, SMF identified visually.

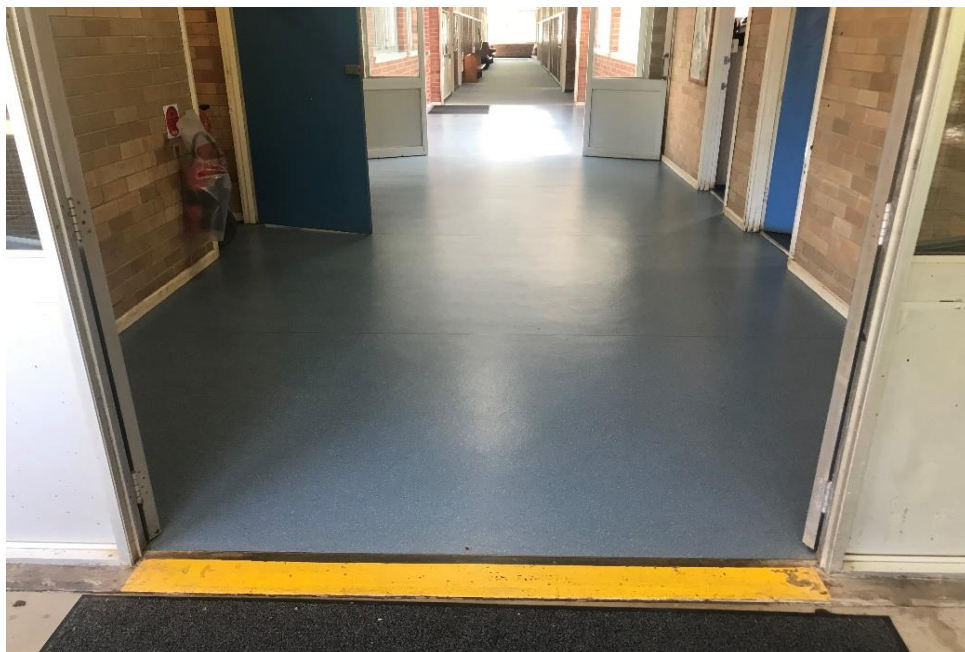
Photograph 18: B00L, LR1025, floor, below blue vinyl sheeting, vinyl tiles, asbestos detected by analysis.

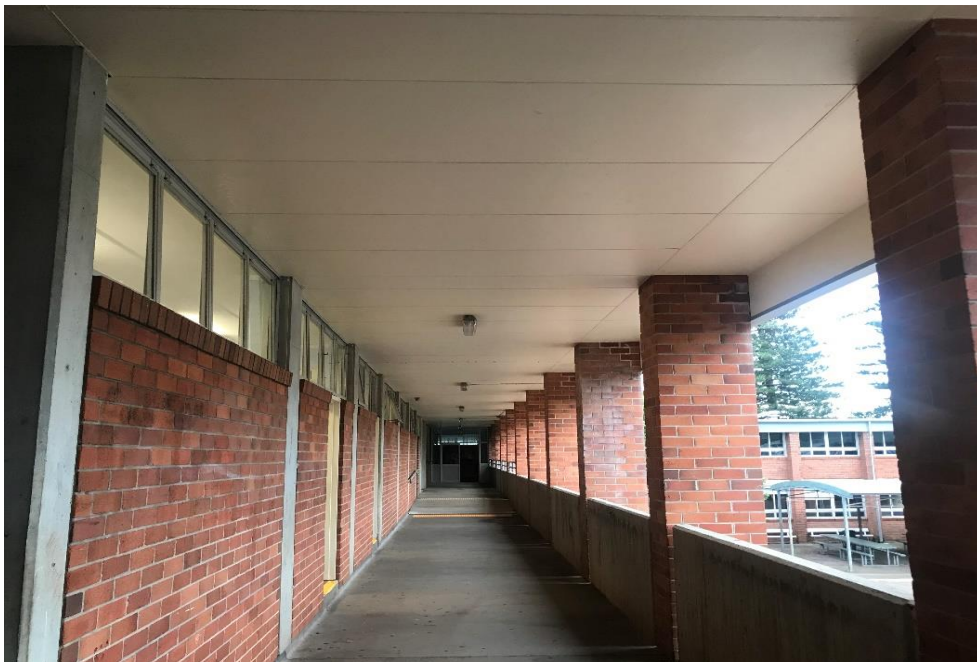
Photograph 20: B00L, LR1036, ceiling, fibre cement sheeting, asbestos detected by analysis.

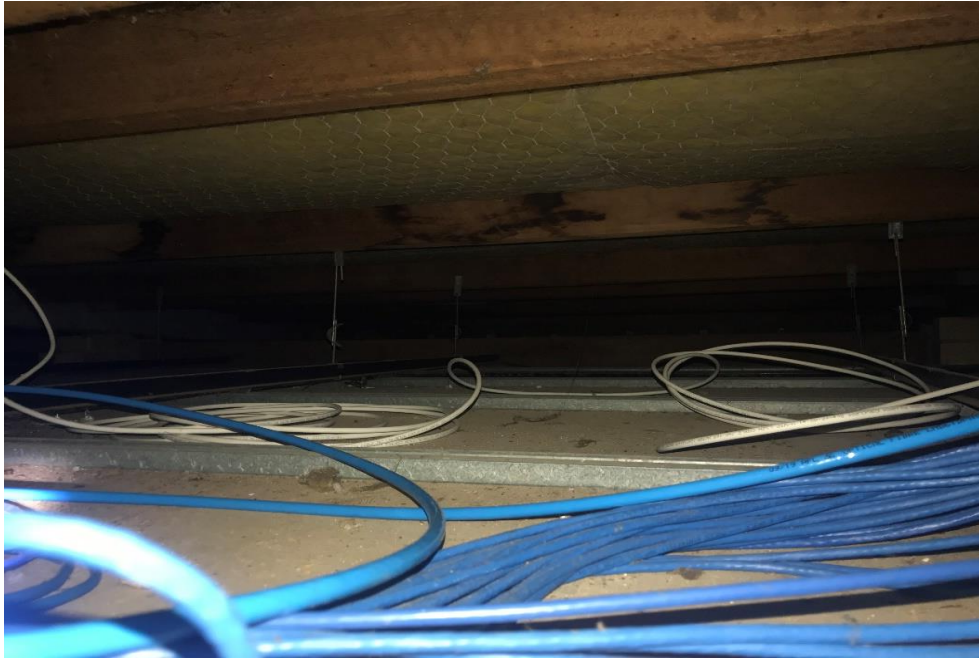
Photograph 21: B00L, LR1022, ceiling cavity, settled dust/debris, elevated lead ( $\geq 0.5 \text{ mg/m}^2$ ).

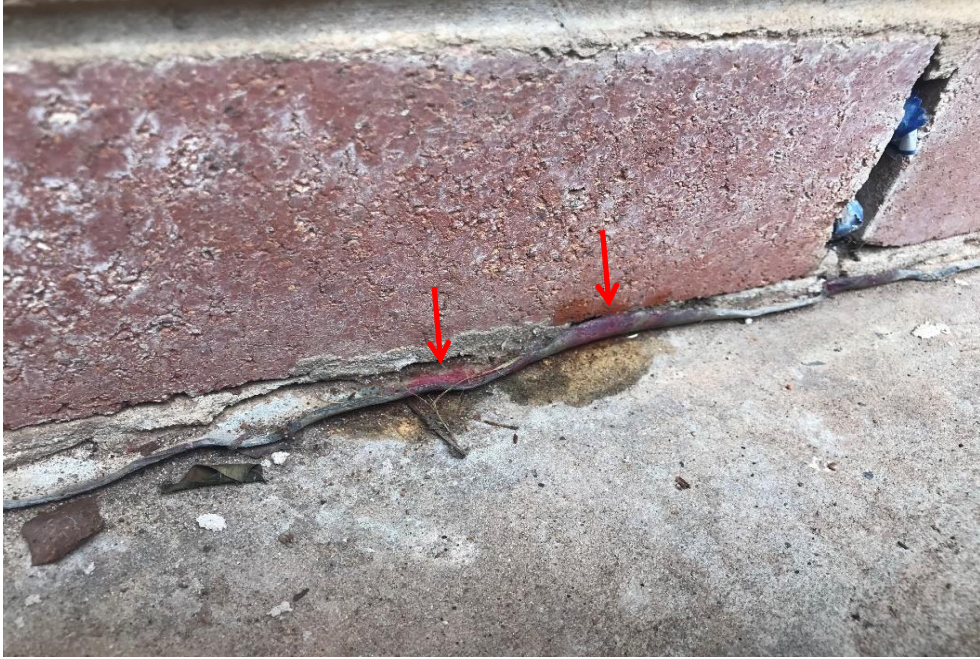
Photograph 23: B00L, exterior, western façade, northern end, typical flashing, positive for lead.

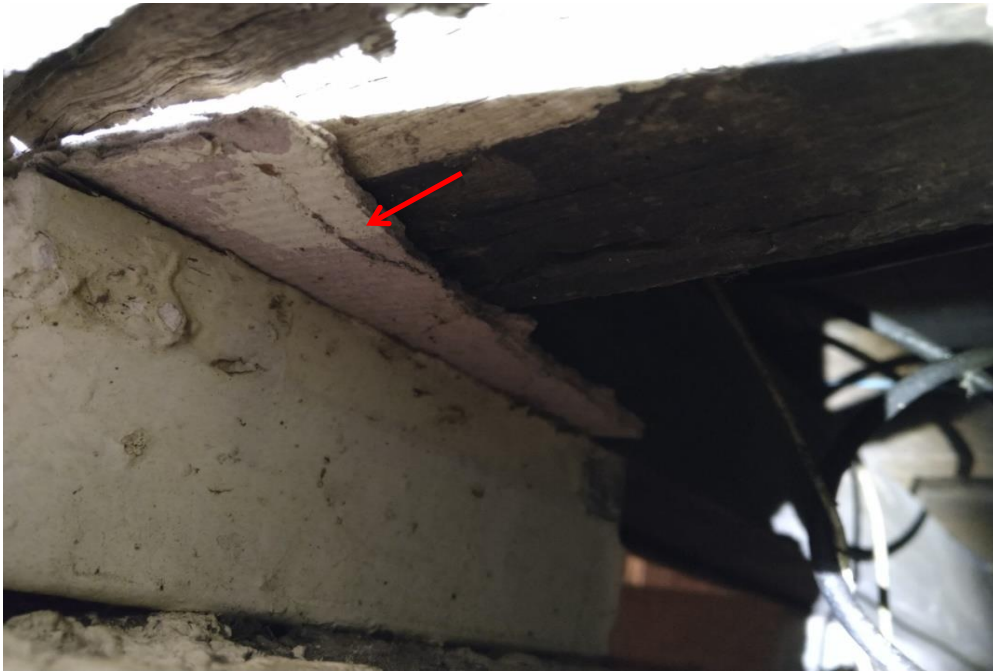
Photograph 1: B00S, subfloor, packing to accessible brick pier, fibre cement, no asbestos detected by analysis.

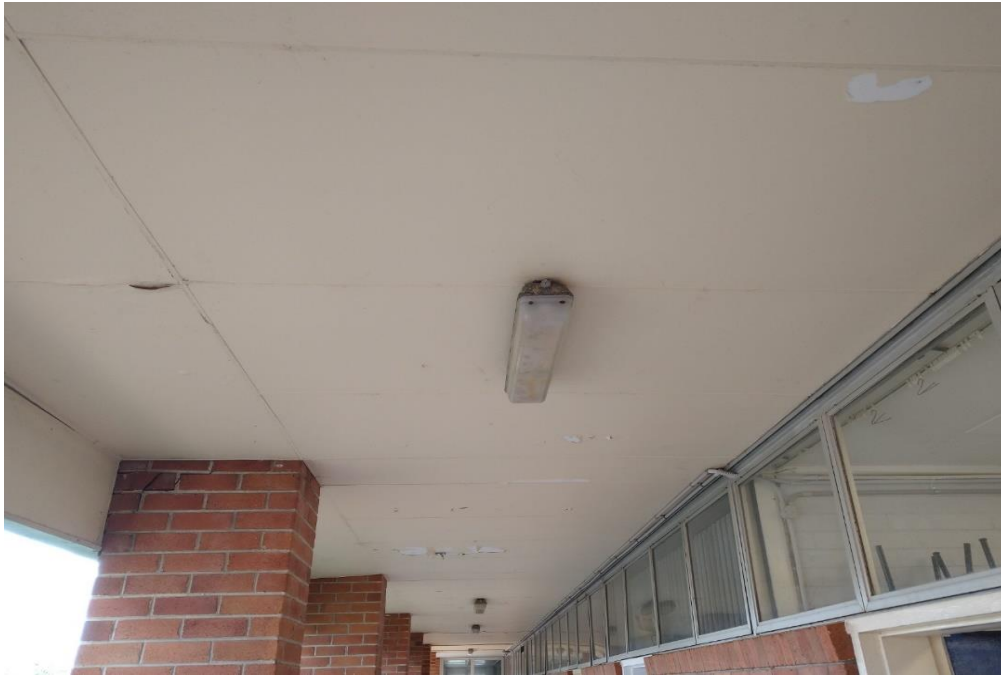
Photograph 1: B00T, R0016, ceiling, fluorescent lights, capacitors, PCB (assumed).

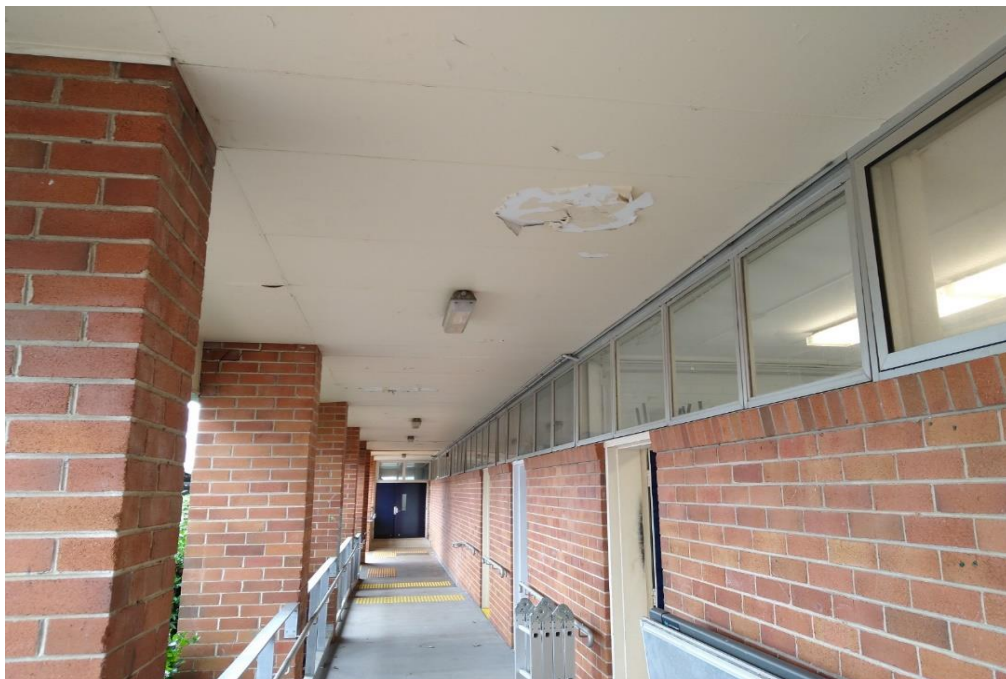
Photograph 2: B00T, R0016, ceiling, fibre cement, asbestos detected by analysis.

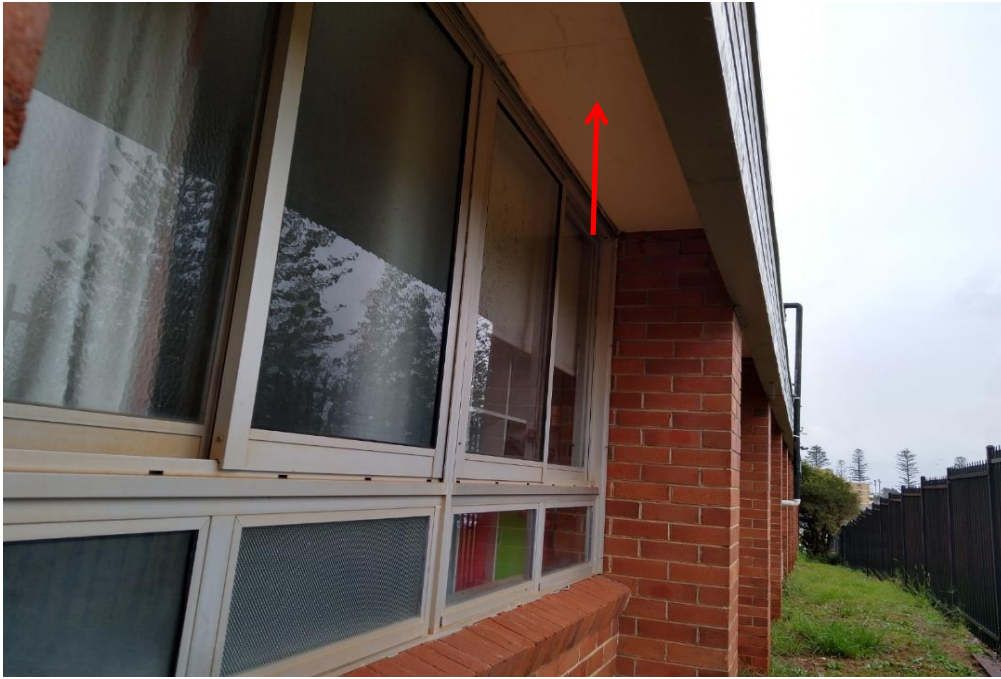
Photograph 3: B00T, exterior, eave lining (eastern aspect), fibre cement, asbestos detected by analysis.

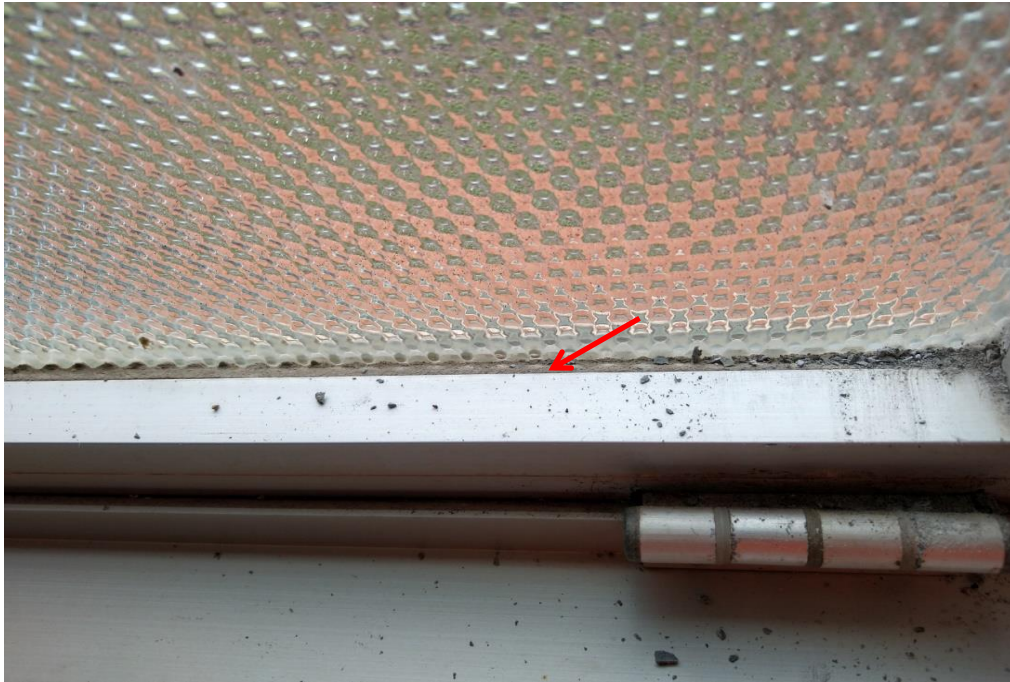
Photograph 5: B00T, R0011, eastern windows, putty/mastic, asbestos detected by analysis.

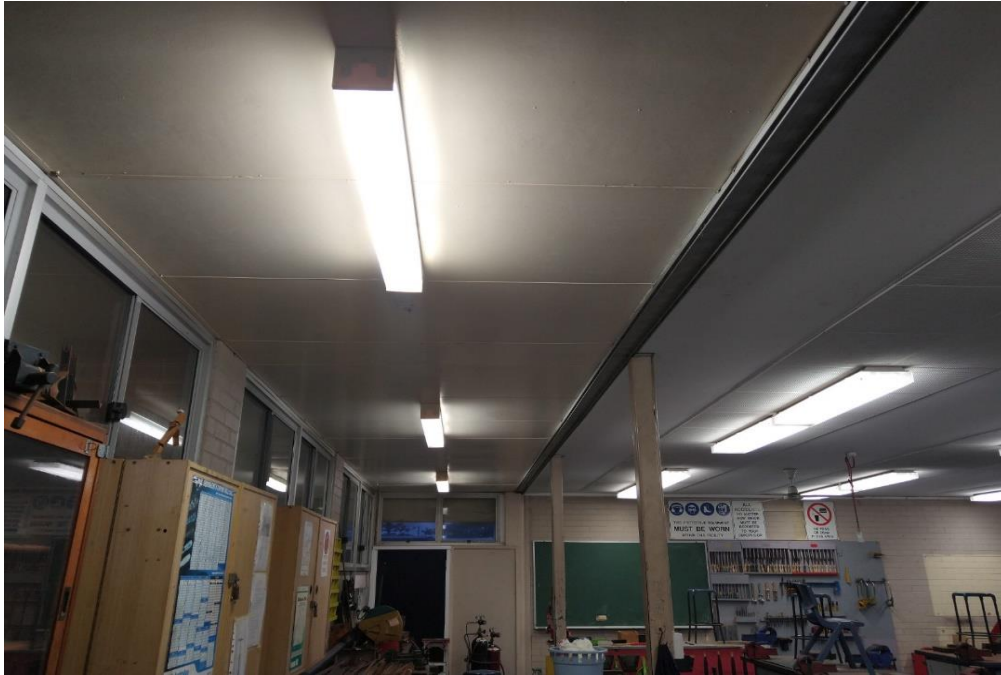
Photograph 7: B00T, R0014, ceiling panels along western side of room , fibre cement , asbestos detected by analysis.

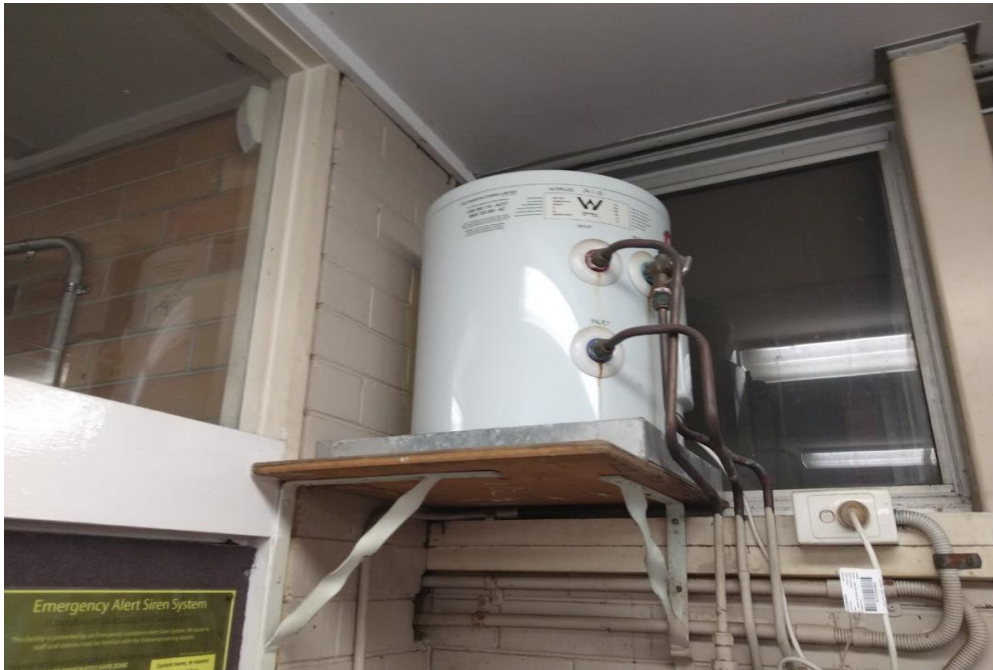
Photograph 9: B00T, R0014, hot water heater, insulation, SMF identified visually.

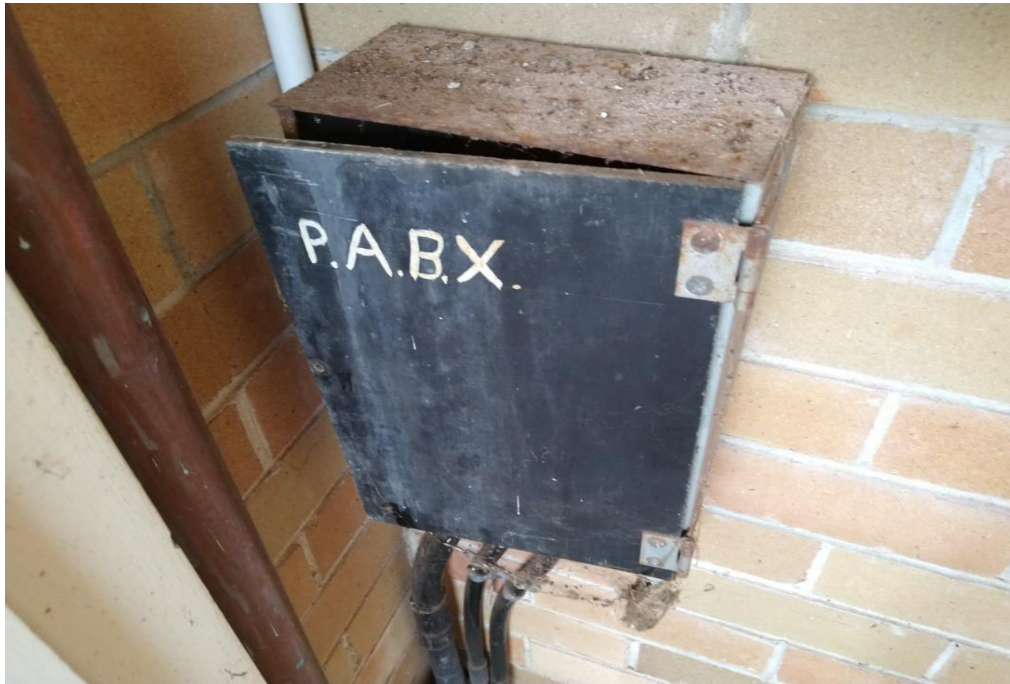
Photograph 11: B00T, R0002, electrical cupboard, electrical backing board, asbestos (assumed).

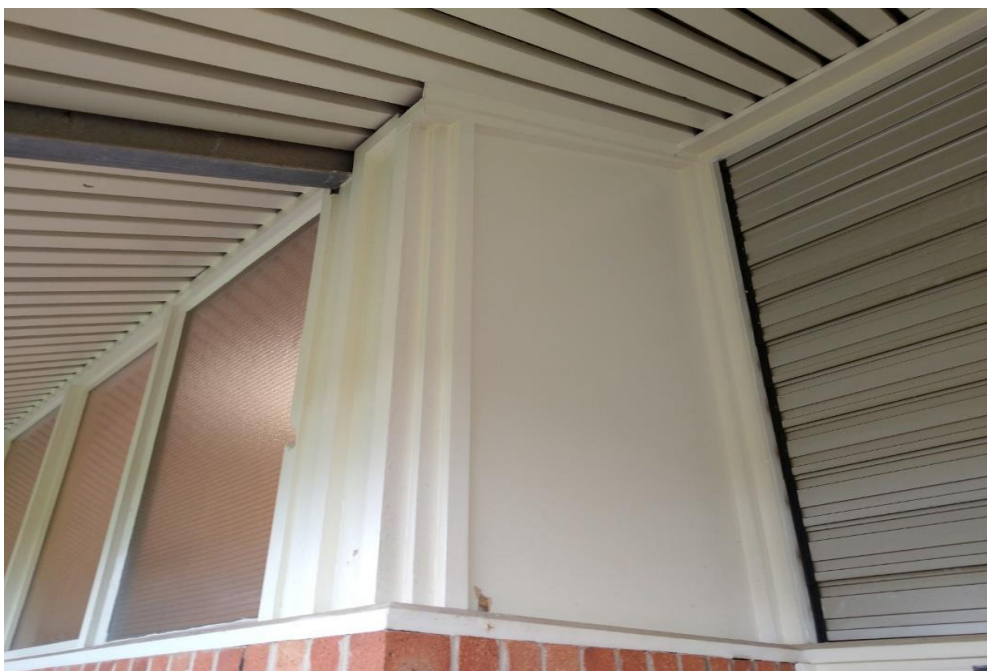
Photograph 1: BMPC, exterior, walls, cream paints and undercoats, non-lead paint ( $\leq 0.1\%$  lead w/w).

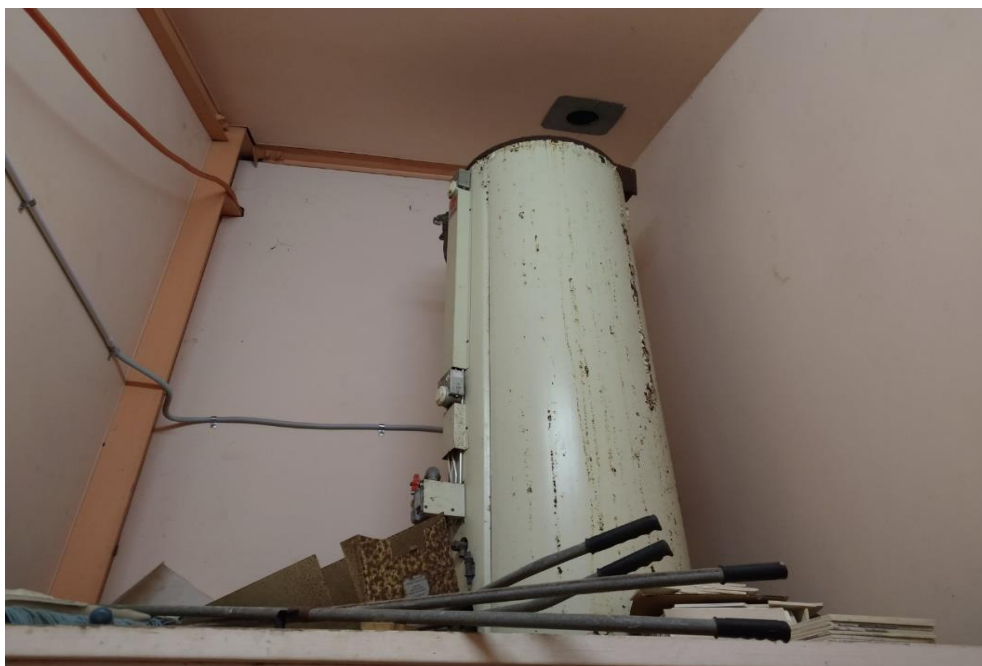
Photograph 2: BMPC, R0003, hot water heater, insulation, asbestos (assumed).

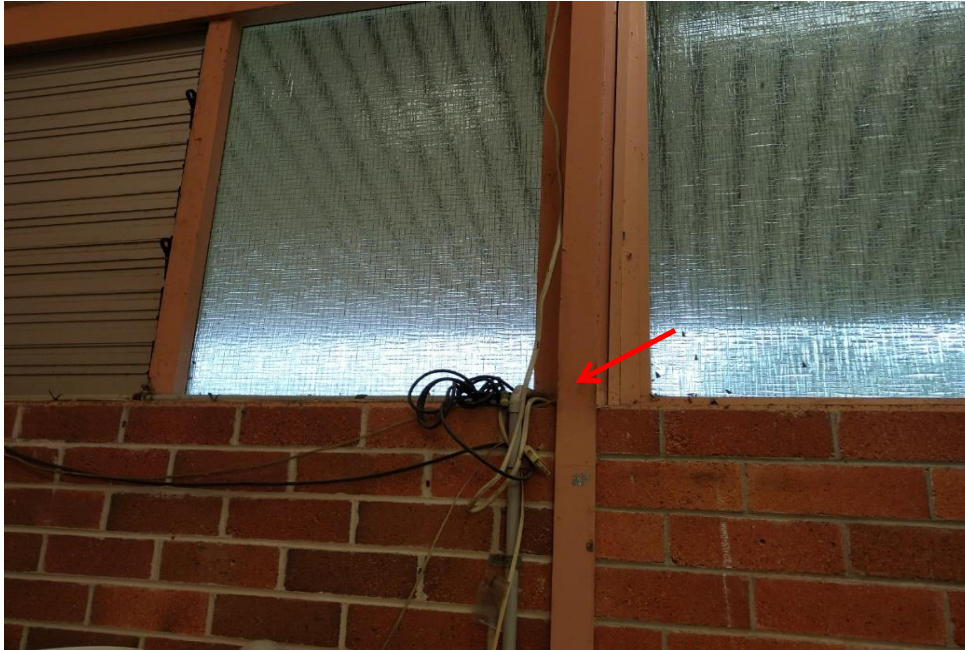
Photograph 3: BMPC, R0009, walls, pink paint , lead paint (>0.1% lead w/w).

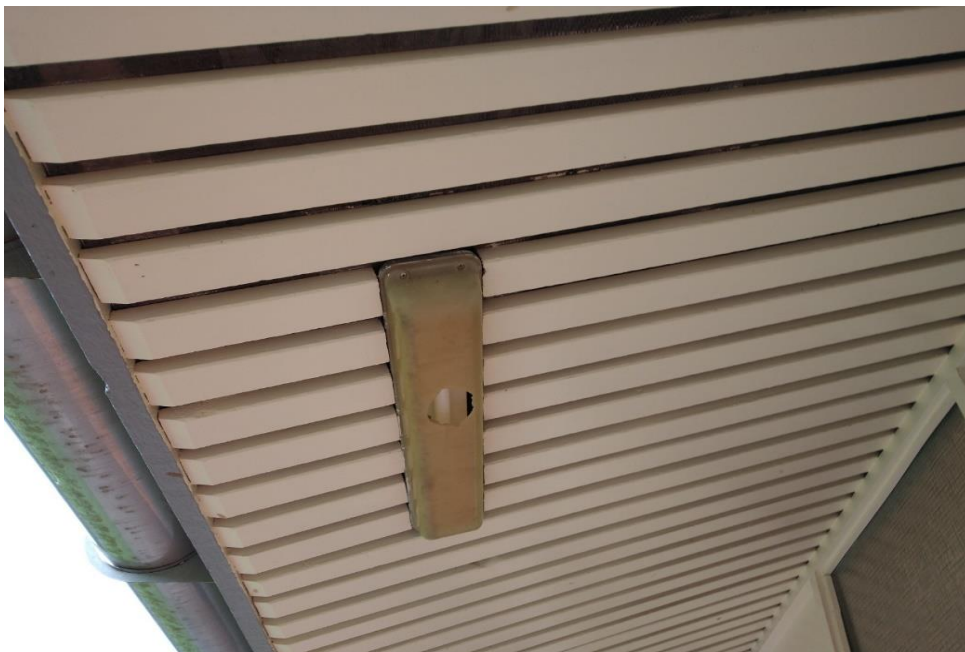
Photograph 4: BMPC, fluorescent lights, nil PCB assumed based on building construction date (circa 1985).

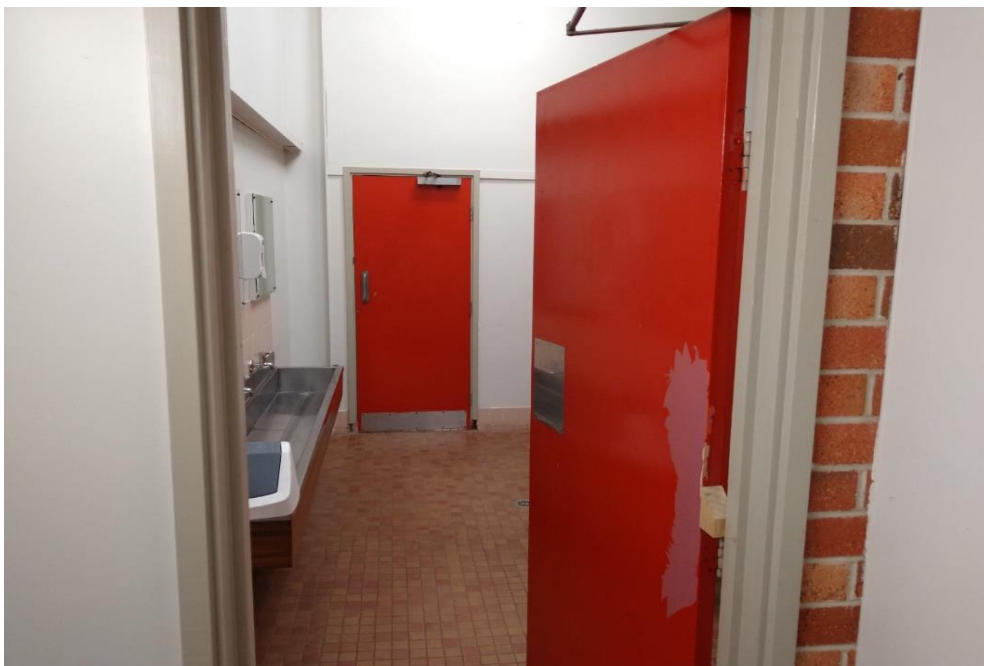
Photograph 5: BMPC, R0002, doors, red paint, non-lead paint (>0.1% lead w/w).

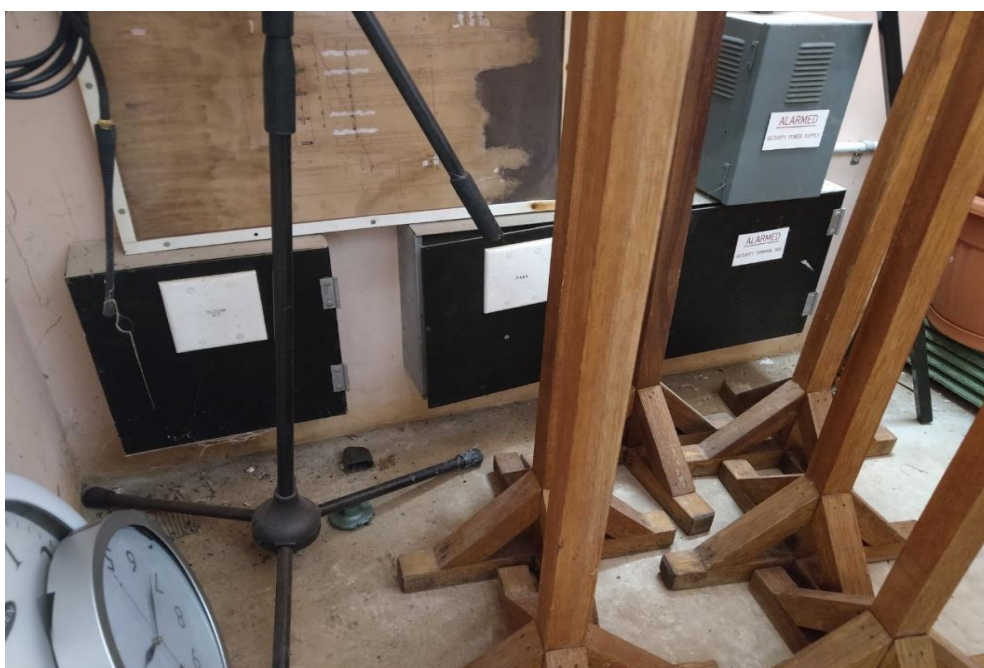
Photograph 6: BMPC, R0014, electrical cupboard, electrical backing board(s), asbestos (assumed).

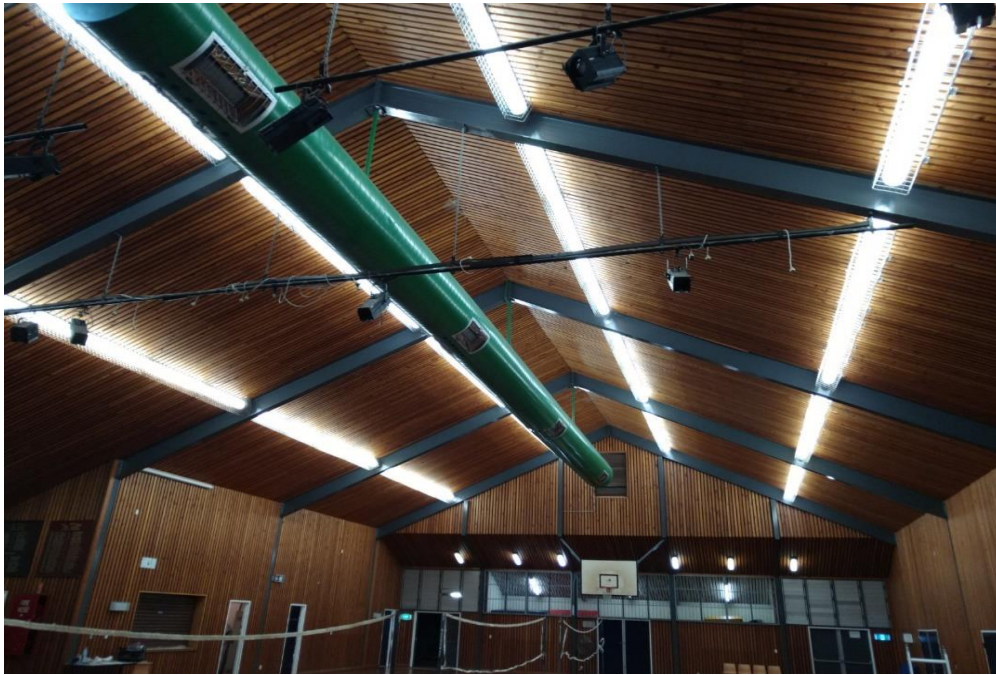
Photograph 7: BMPC, R0005, ceiling, air handling duct work, green paint, lead paint (assumed).

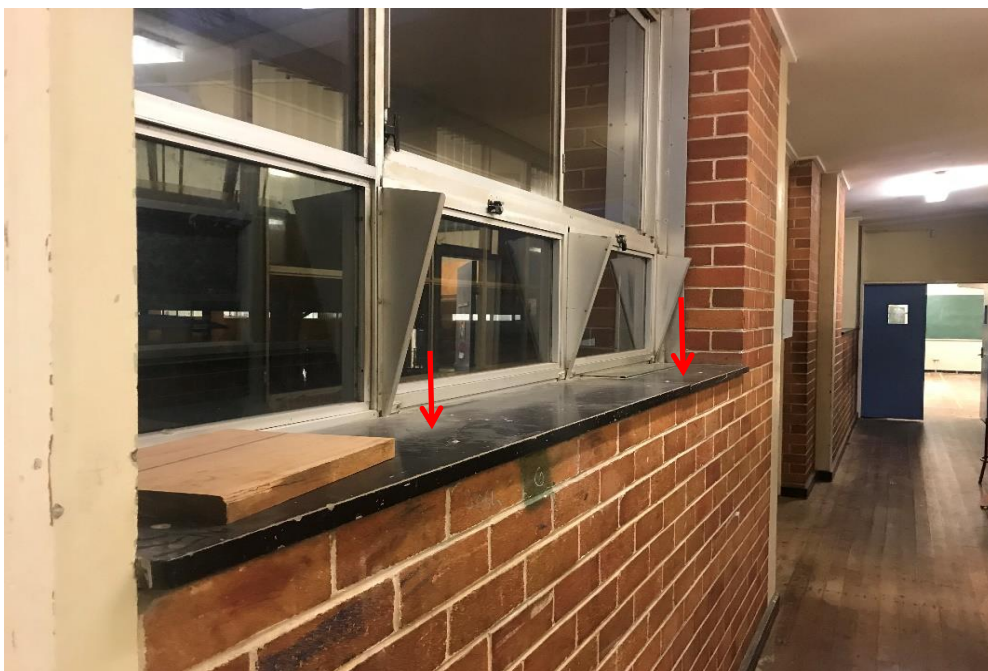
Photograph 1: BTAS, typical window sill lining(s), fibre cement, asbestos detected by analysis.

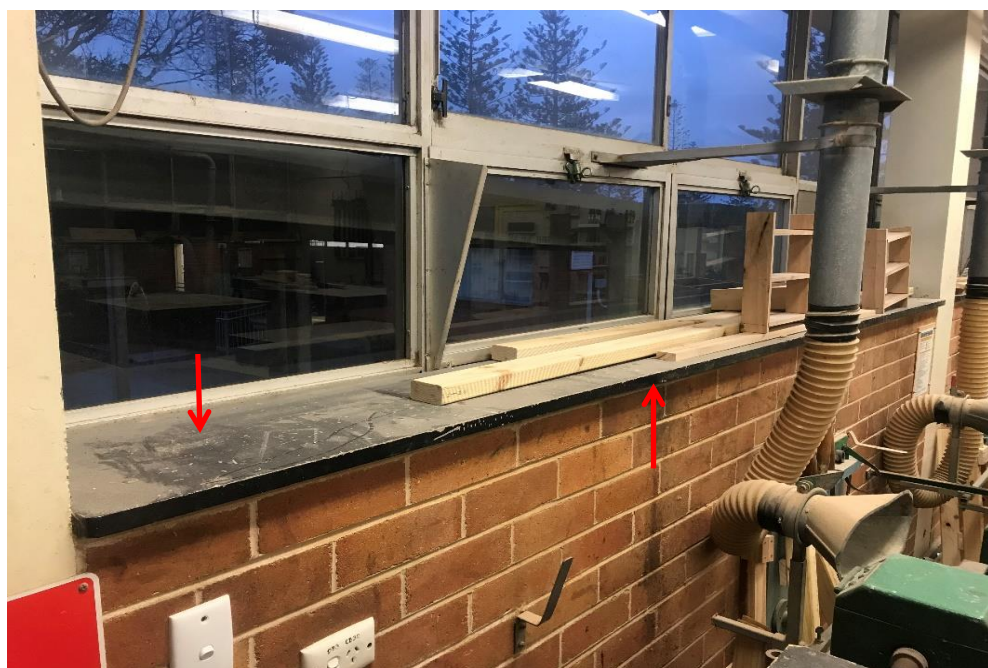
Photograph 2: BTAS, typical window sill lining(s), fibre cement, asbestos detected by analysis.

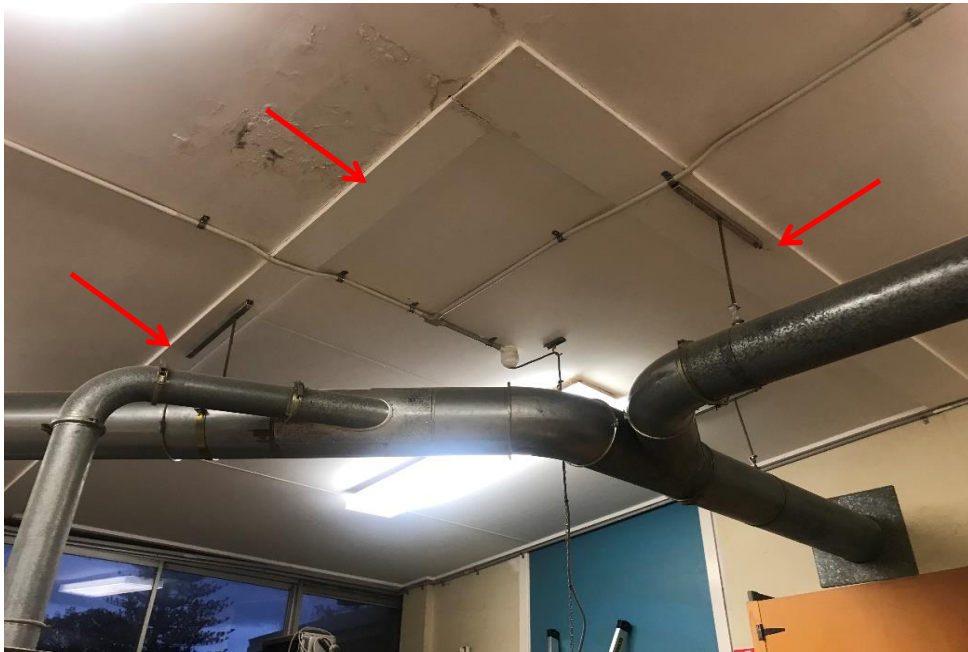
Photograph 3: BTAS, TASR0001, southwestern section, ceiling lining, fibre cement, asbestos (assumed).

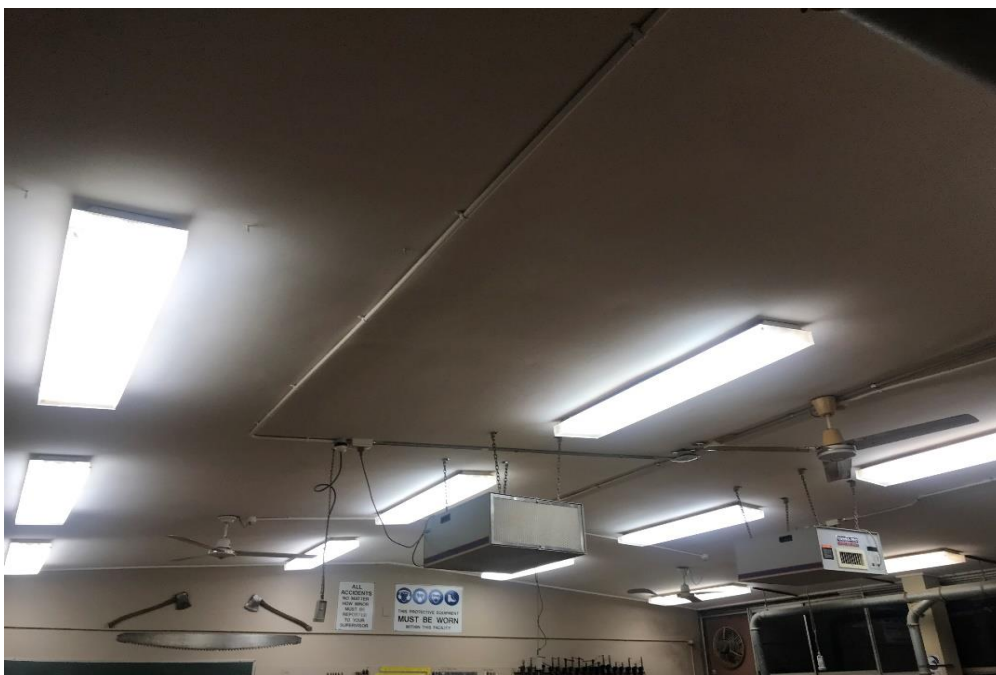
Photograph 4: BTAS, rooms and areas in general, fluorescent light fittings in general, capacitors, insulating oil, PCB (assumed).

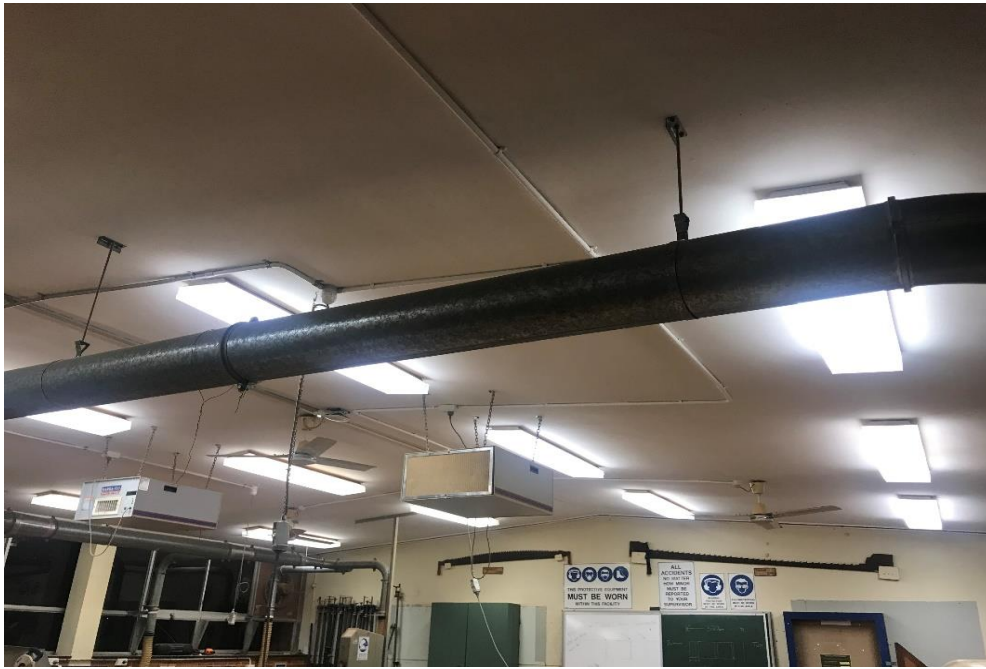
Photograph 5: BTAS, rooms and areas in general, fluorescent light fittings in general, capacitors, insulating oil, PCB (assumed).

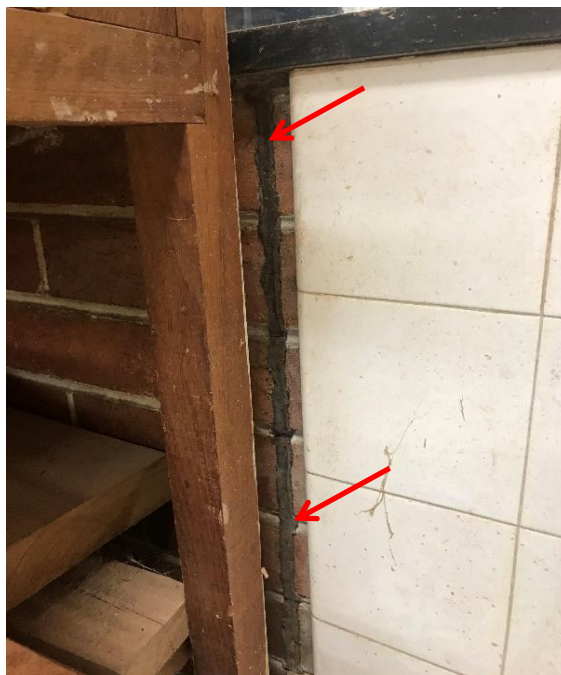
Photograph 7: BTAS, TAS-R0018, brick wall, expansion joint, mastic/sealant, asbestos detected by analysis.
