## DEMOLITION PLAN

S block, bus shelter, concrete ramp and pavements.  
Hastings Secondary College, Port Macquarie

# **ROOF VOID DUST INVESTIGATION**

## **HASTINGS SECONDARY COLLEGE - PORT MACQUARIE CAMPUS - BLOCK S**

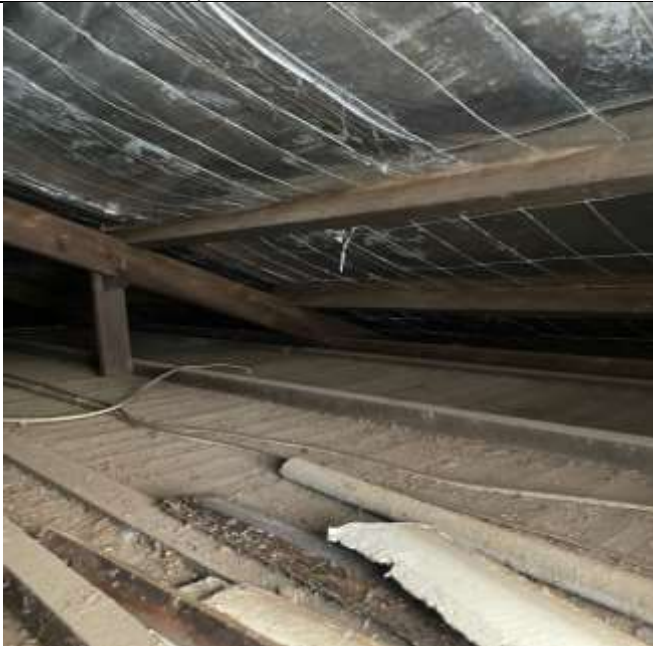
Photo 3: Building materials within Block S roof void with heavy dust build up

Remediation of the lead containing dust is recommended throughout the roof void of Block S prior to demolition to limit potential migration of contaminants and exposure risk to both workers who enter the roof void and any potential contamination to classrooms and other occupied/neighbouring areas from roof void dust disturbance.

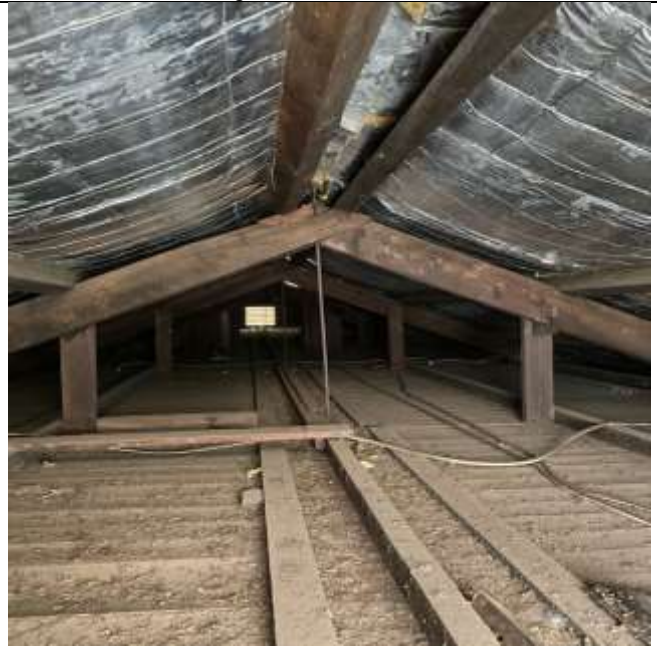
Photo 4: Block S internal roof void – heavy dust build-up present and sarking in good condition

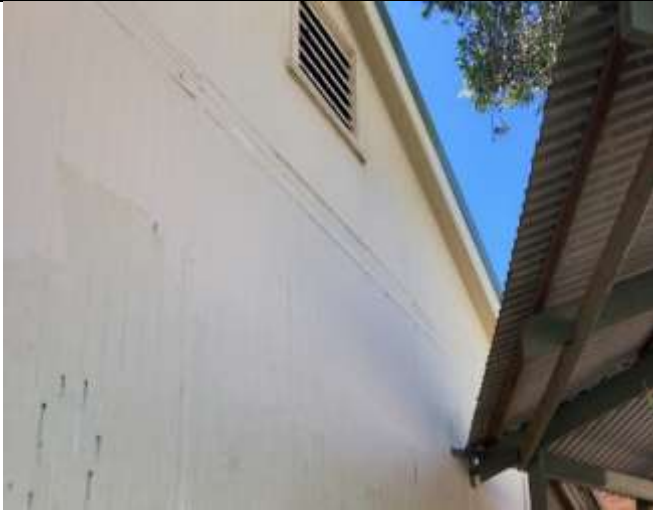
Photo 5: Presumed ACM eave linings

It is recommended the asbestos eave linings to Block S be removed prior to lead dust remediation works.

It is recommended the following general steps are followed for the safe remediation of the presumed non-friable ACM eave lining to Block S:
