Hazardous Materials Management Plan

Hastings Secondary College, Port Macquarie Campus
16 Owen Street, Port Macquarie NSW

Prepared for
FKG Group Pty Ltd

Project 206888.00
December 2021

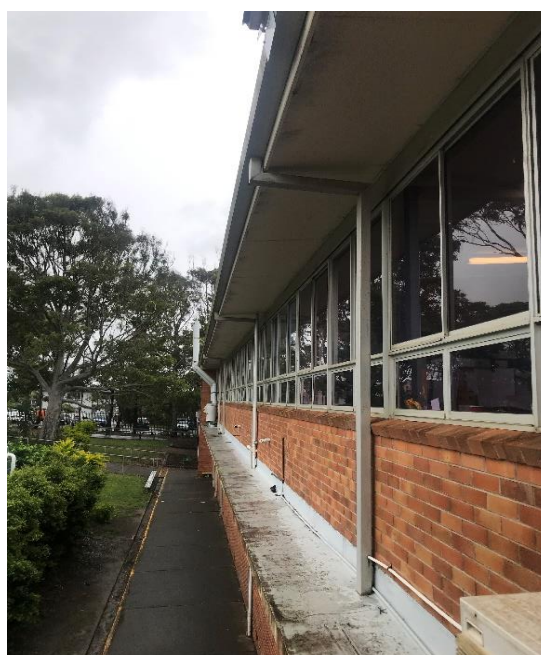
Photograph 4: B00B, exterior, eave linings generally, fibre cement sheeting, asbestos detected by analysis.

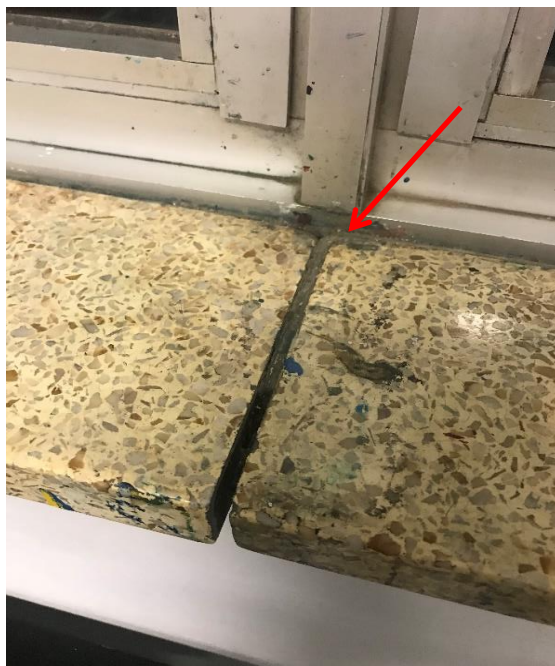
Photograph 5: Photograph shown is similar to B00B, BR0002, between window frame and terrazzo sill, putty, asbestos detected by analysis.

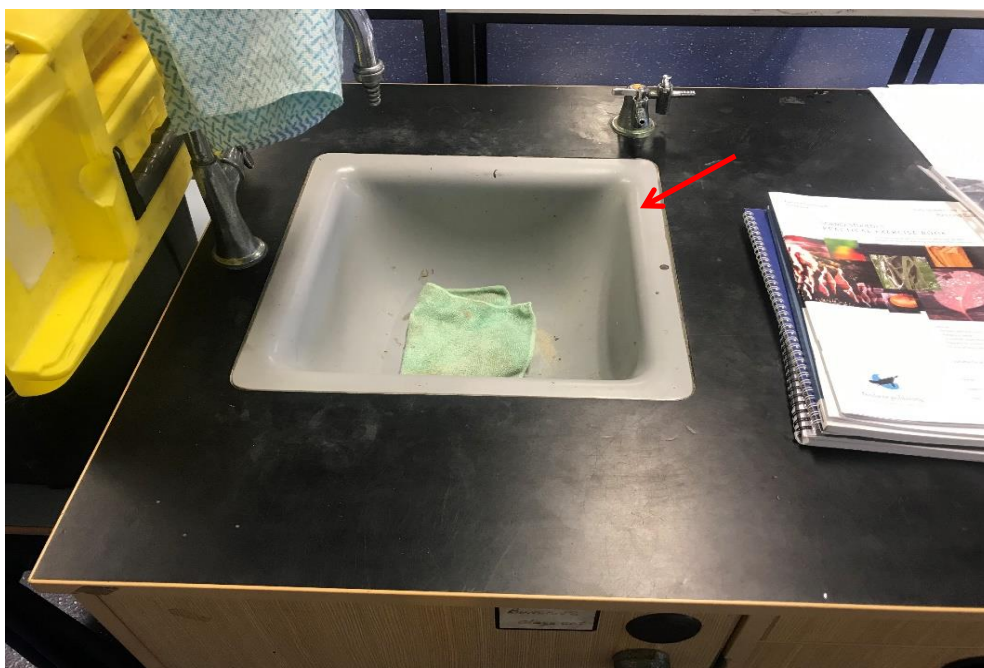
Photograph 6: B00B, BR0004, teacher's desk, moulded sink, SMF (assumed).

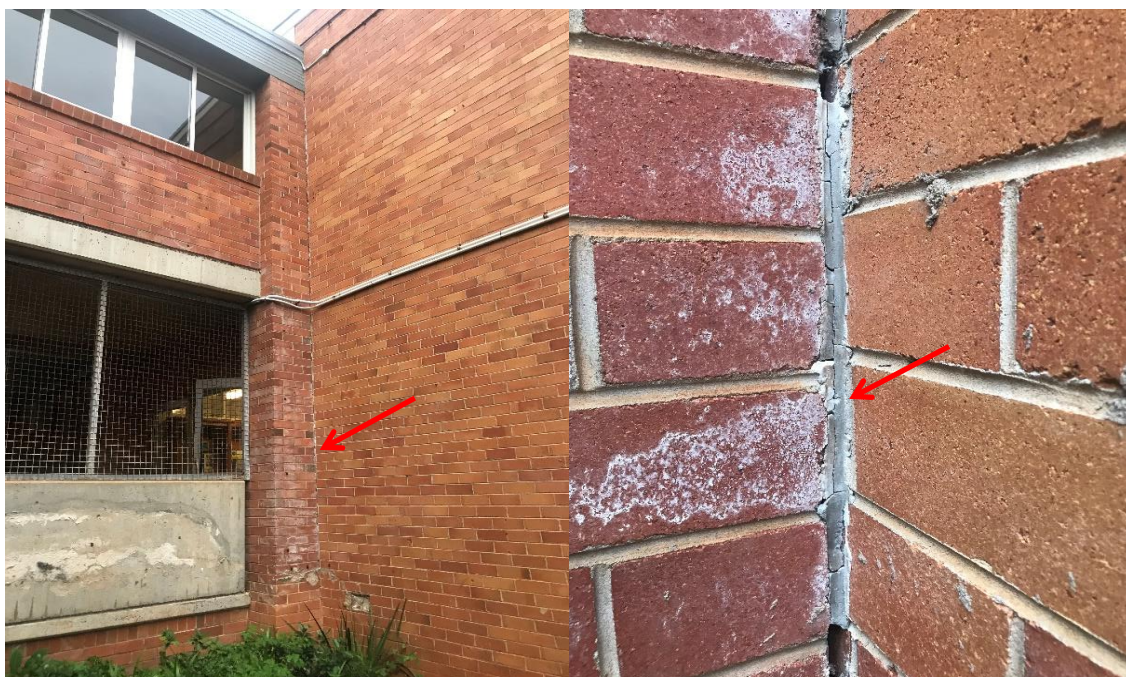
Photograph 11: B00B, BR0020 / BR1023, exterior brick wall, expansion gap, grey putty, asbestos detected by analysis.

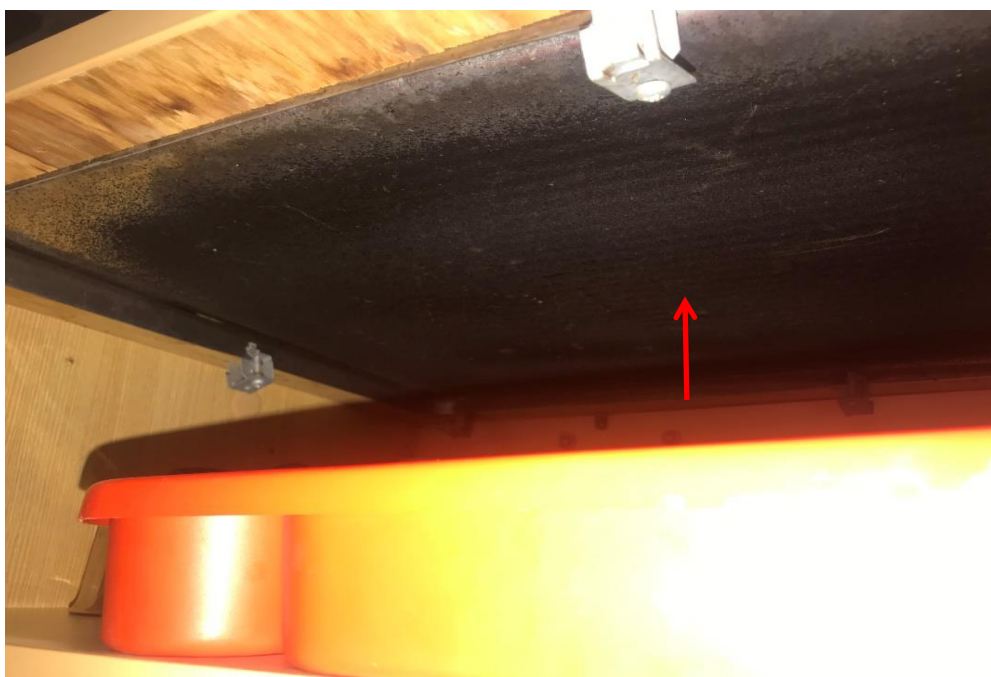
Photograph 12: B00B, BR1002, underside of sink, bituminous lining, asbestos detected by analysis.

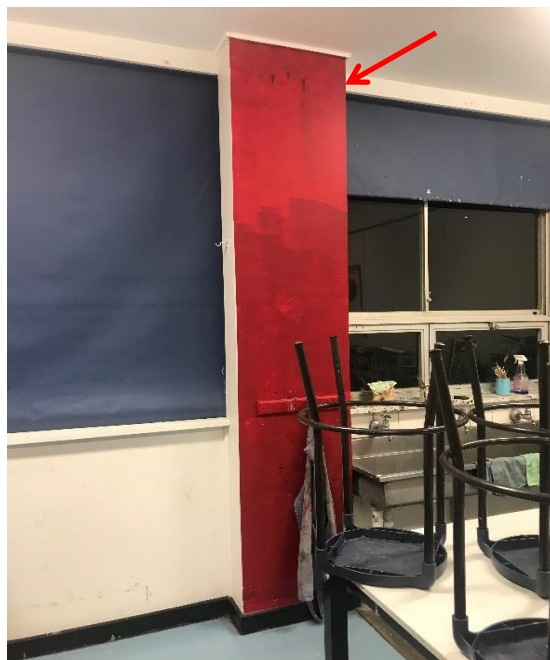
Photograph 13: B00B, BR1014, north wall, red building box, internal material(s), unknown.

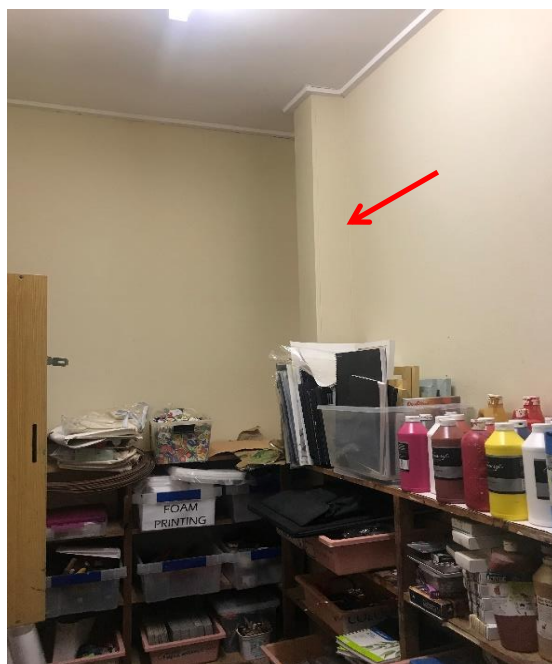
Photograph 14: B00B, BR1015, southwest corner, building box, internal material(s), unknown.

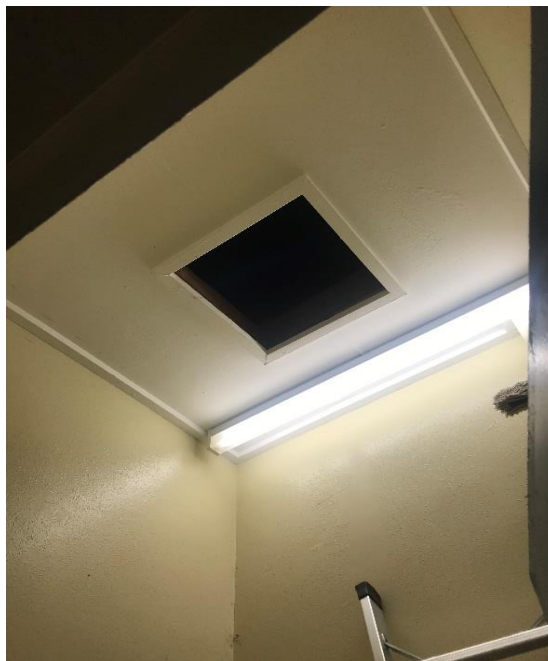
Photograph 16: B00B, BR1021, ceiling, fibre cement sheeting, asbestos detected by analysis.

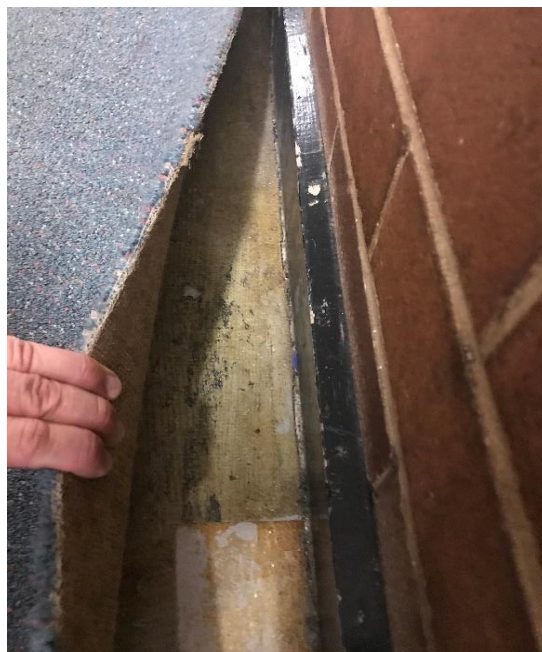
Photograph 18: B00B, BR1022, floor, below carpet, vinyl tile, asbestos detected by analysis.

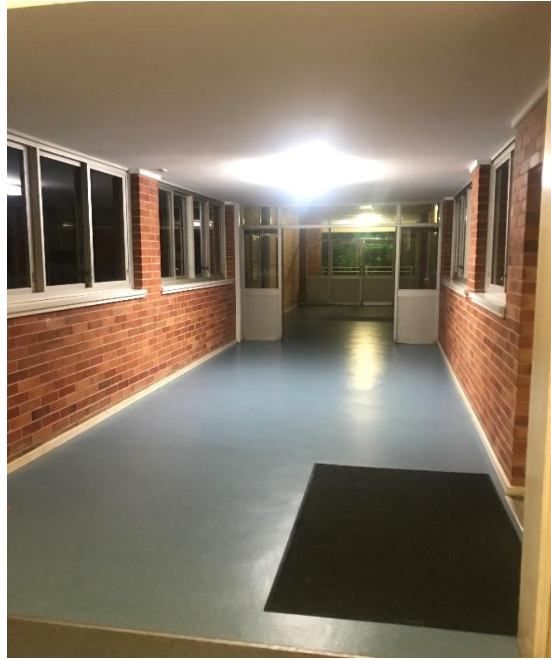
Photograph 19: B00B, BR1023, floor below vinyl sheeting, possible vinyl tile containing asbestos, limited access for inspection.

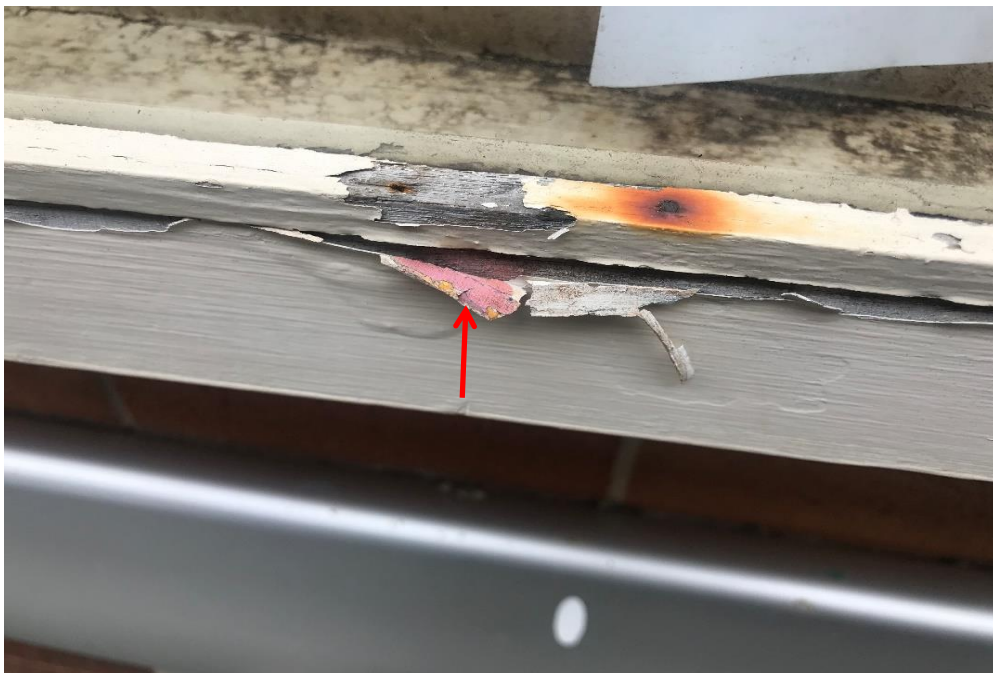
Photograph 22: B00B, exterior, northern façade, notice board, cream and underlying white paint, lead paint (>0.1% lead w/w).

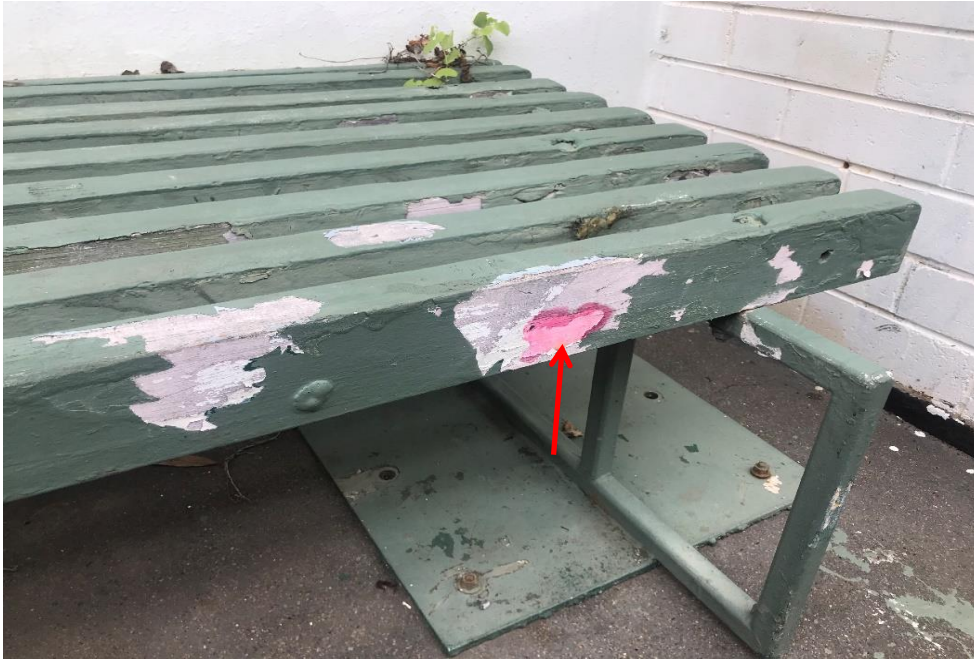
Photograph 23: B00B, exterior, northern façade, timber seating, green and underlying cream paint, lead paint (>0.1% lead w/w).

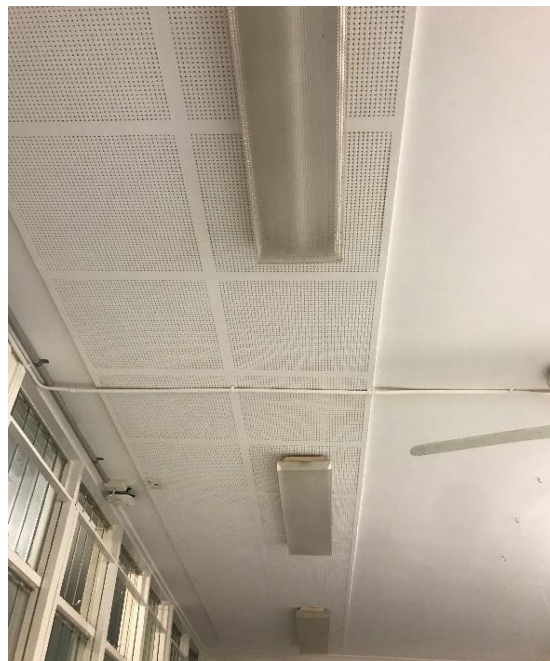
Photograph 24: B00B, rooms and areas in general, fluorescent light fittings in general, capacitors, insulating oil, PCB (assumed).

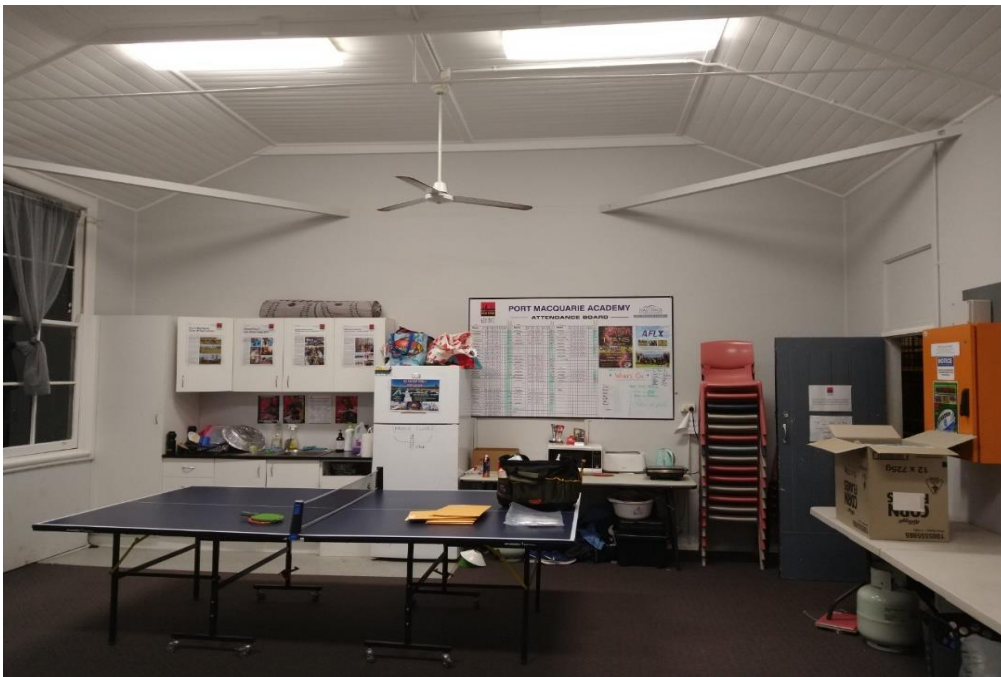
Photograph 2: B00S, SR0002, walls throughout, undercoat paints, positive for lead.
