Construction Hazardous Material Management Plan (CHMMP)

Kingscliff Public School Upgrade

SSD-8378620

November 2023

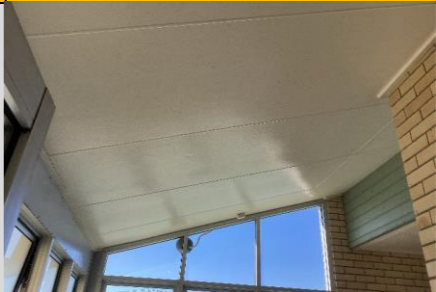
12	9/09/2023	Asbestos	External, level 1	Southern side of building	High level soffit	Fibre cement sheeting	Ref: AS01/AS04	Positive	Non-Friable	Good	35m2	Low Risk

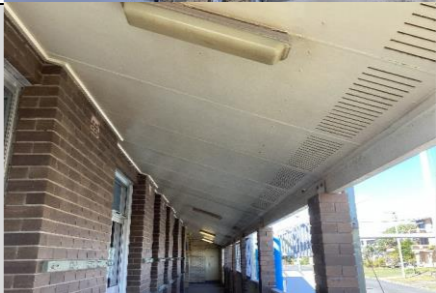
13	9/09/2023	Asbestos	External, level 1	Western side of building / AR1002	Awning / ceilings	Fibre cement sheeting	Ref: AS01/AS04	Positive	Non-Friable	Good	85m2	Low Risk

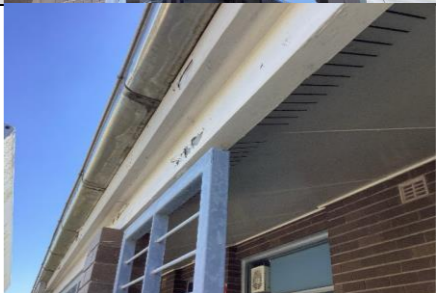
14	9/09/2023	Lead Paint	External, throughout	Perimeter	Timber boards	White - upper coloured paint system	LC01	Positive	N/A	Low Damage	>100	Low Risk

14	>0.1% lead content, remove flaking sections and over paint with a lead-free paint. Remove under controlled conditions in accordance withers/NZS 4361.2:2017 Guide to hazardous paint management prior to renovation or demolition works.

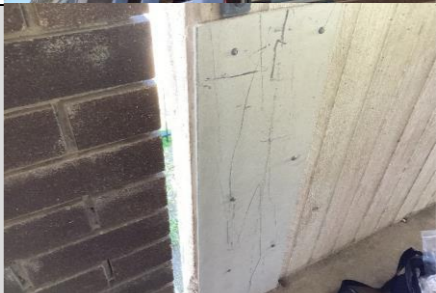
15	9/09/2023	Asbestos	External, level 1	Western side of building / AR1002	Infill to balcony concrete walls	Fibre cement sheeting	AS05	Negative	-	-	-	-	-

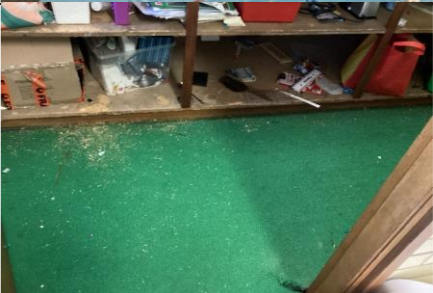
ID	Date Identified	Hazmat Type	Area / Level	Location / Room	Feature	Item Description	Sample No.	Sample Status	Friability	Condition	Qty (m ²)	Risk Assessment	Comments	Photo
46	9/09/2023	Asbestos	Internal, Level 1	AR1006	Floor beneath carpet	Green vinyl floor tiles	Ref: AS22	Assumed Negative	-	-	-	-	Including Negative X Ray Diffraction Analysis.	 
47	9/09/2023	Asbestos	Internal, Level 1	AR1001	Floor beneath carpet	Blue vinyl floor tiles	AS24	Positive	Non-Friable	Good	25m2	Low Risk	Serpentine detected - Chrysotile* detected following X-ray diffraction (XRD) Analysis.	 
48	9/09/2023	Asbestos	Internal, Level 1	AR1003	Floor beneath carpet	Blue vinyl floor tiles	Ref: AS24	Assumed Positive	Non-Friable	Good	24m2	Low Risk	Serpentine detected - Chrysotile* detected following X-ray diffraction (XRD) Analysis.

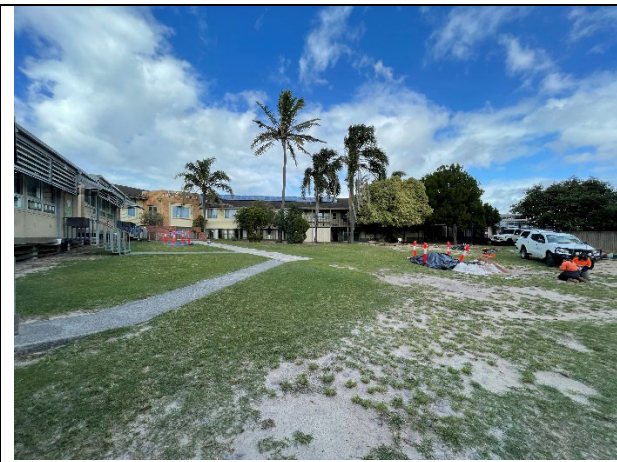
Photo 1: Site location with trench and stockpiles in background

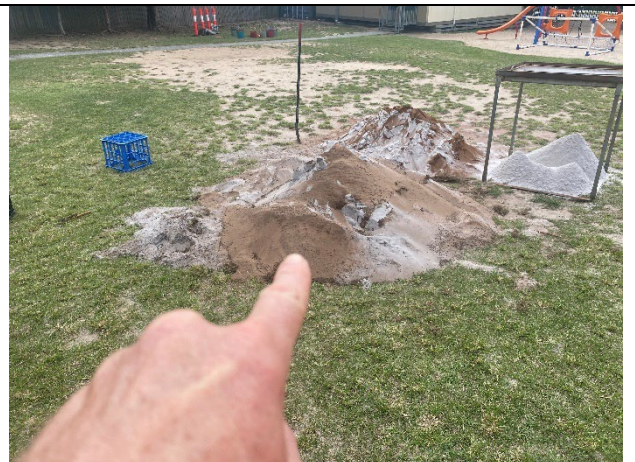
Photo 2: Stockpiled material excavated from trench

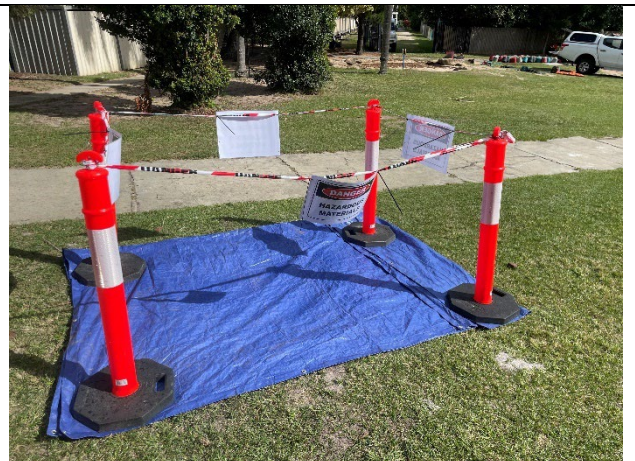
Photo 4: Covered trench with asbestos warning signage and tape

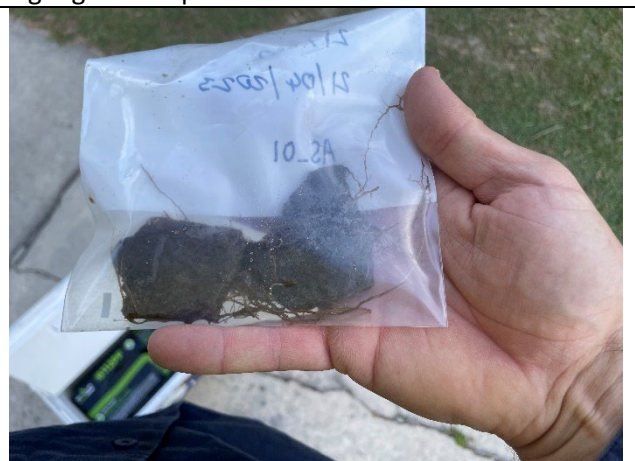
Photo 6: Asbestos fragments found within trench
