AIRBORNE FIBRE MONITORING

Lindfield Learning Village - Stage 2A

100 Elton Road
Lindfield NSW 2070

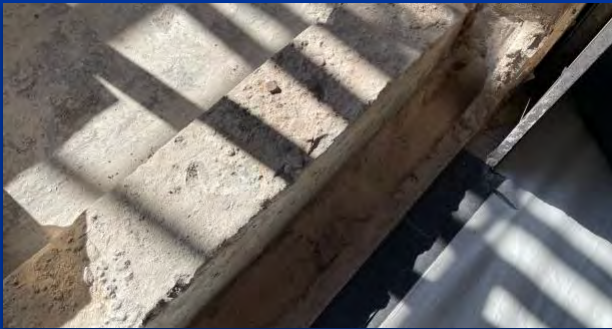
**Photo 1**

Area following the removal of asbestos packers
on hob in doorway on Level 3 - Zone N.

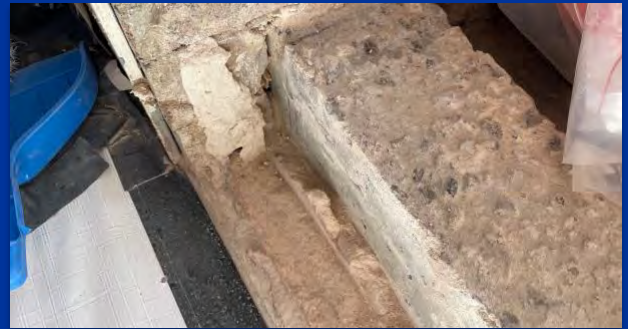
**Photo 2**

Area following the removal of asbestos packers
on hob in doorway on Level 3 - Zone N.

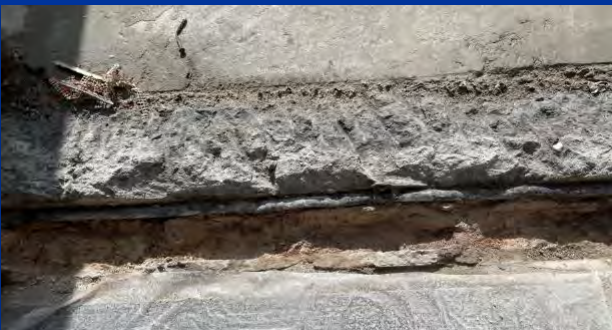
**Photo 3**

Area following the removal of asbestos packers
on hob in doorway on Level 4 - Zone N.

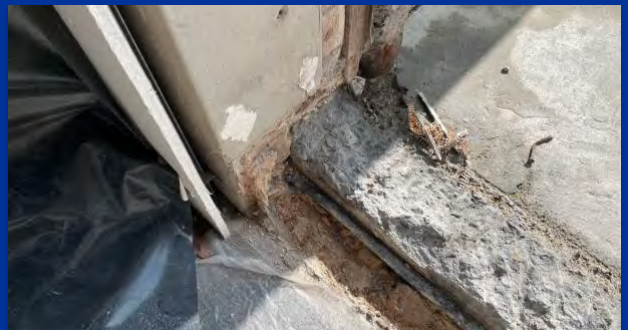
**Photo 4**

Area following the removal of asbestos packers
on hob in doorway on Level 4 - Zone N.

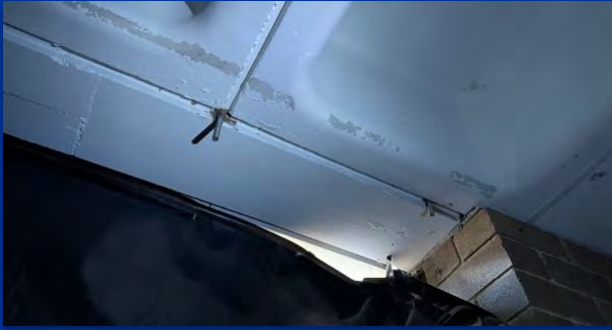
Photo 1

Ceiling following drilling works for brace installation.

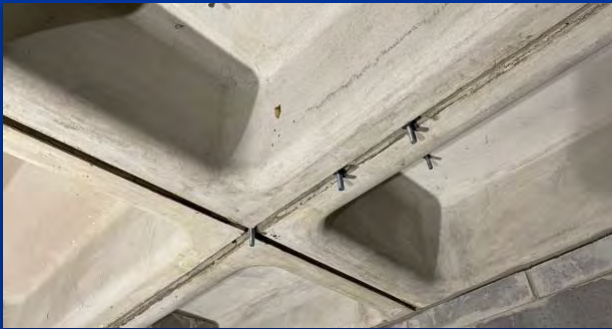
Photo 1

Ceiling following drilling works and installation of ceiling bracing.

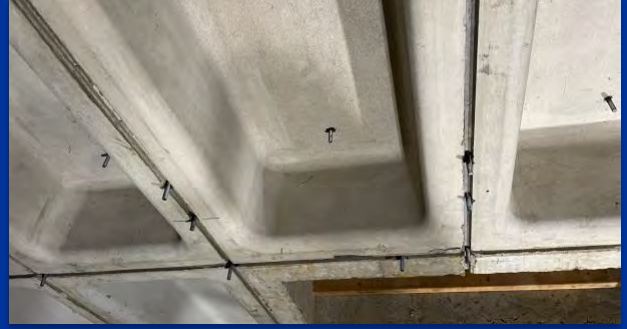
Photo 2

Ceiling following drilling works and installation of ceiling bracing.

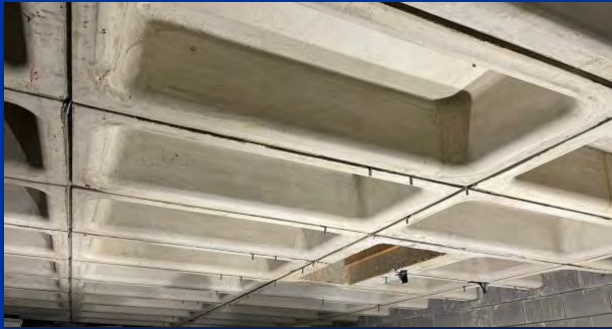
Photo 3

Ceiling following drilling works and installation of ceiling bracing.

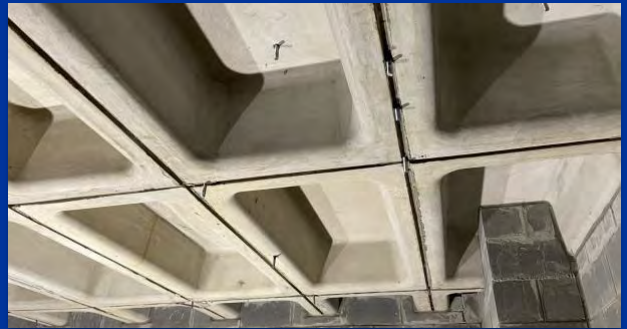
Photo 4

Ceiling following drilling works and installation of ceiling bracing.

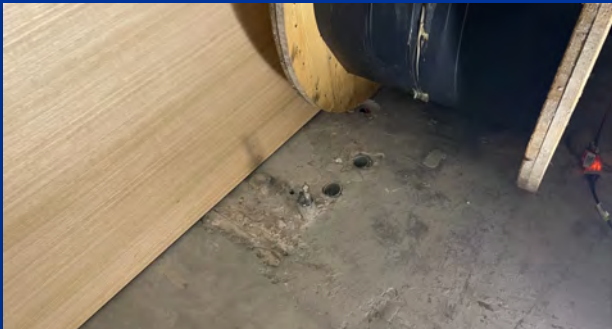
Photo 1

Surface of work area following decontamination and make-safe.

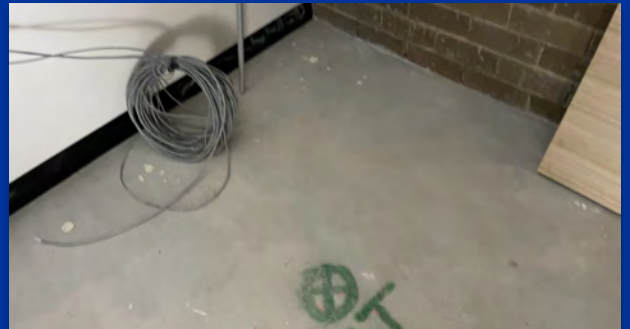
Photo 2

Surface of work area following decontamination and make-safe.

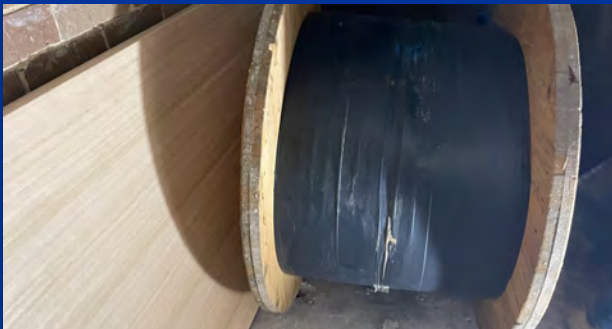
Photo 3

Surface of work area following decontamination and make-safe.

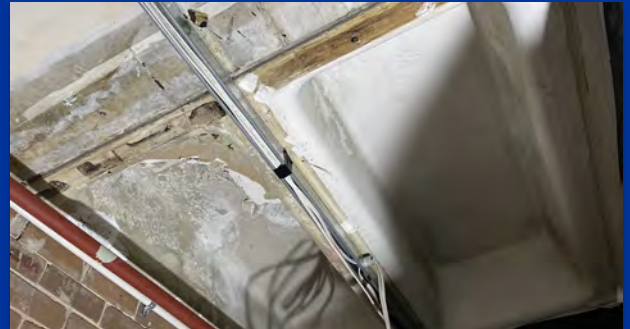
Photo 4

Ceiling following decontamination and make-safe.

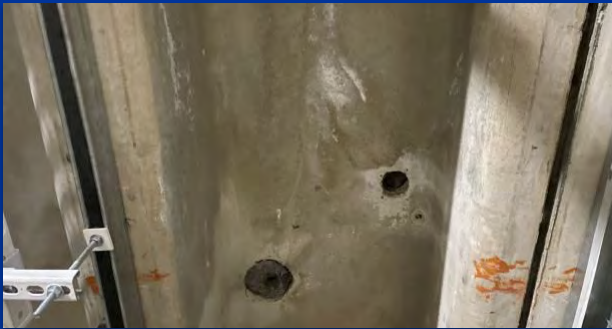
Photo 1

Waffle ceiling following the removal of damaged section of waffle ceiling and encapsulation of exposed edges.

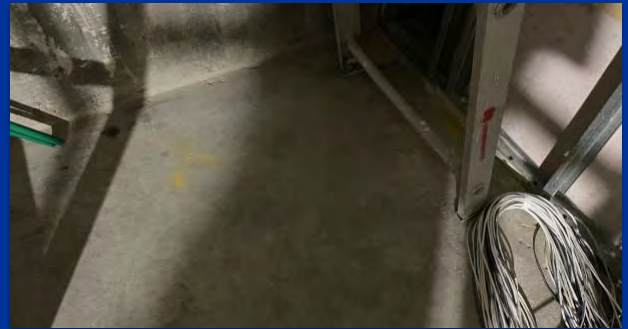
Photo 2

Floor surface following asbestos remediation works.

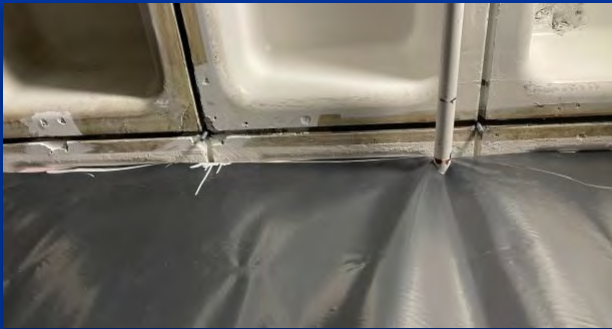
Photo 1

Level 5 - Zone F - Ceiling following drilling works for the installation of bracing.

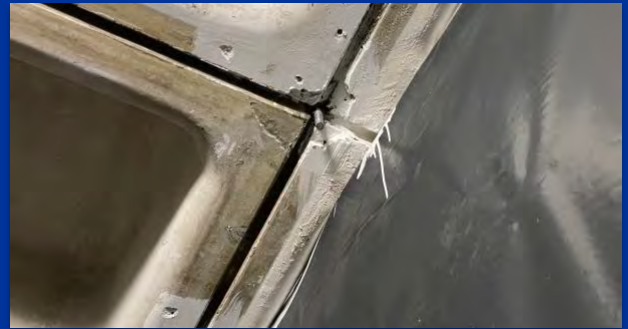
Photo 2

Level 5 - Zone F - Ceiling following drilling works for the installation of bracing. .

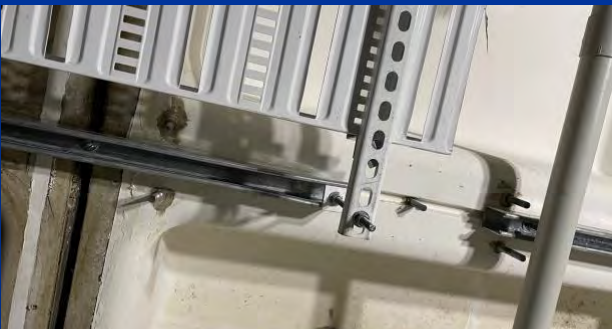
Photo 3

Level 2 - Zone K - Ceiling following drilling works for the installation of bracing.

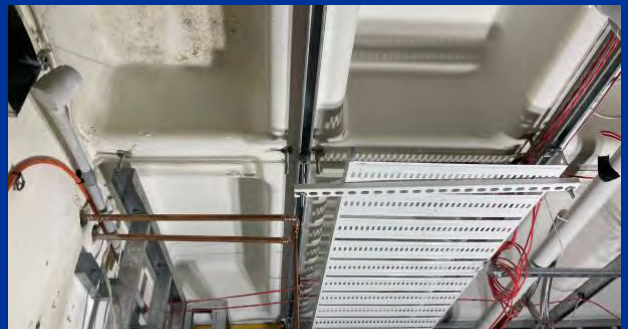
Photo 4

Level 2 - Zone K - Ceiling following drilling works for the installation of bracing. .

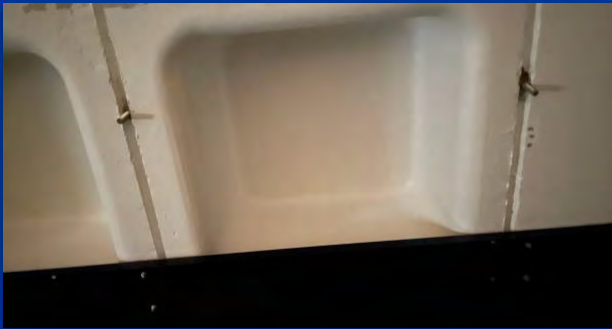
Photo 1

Surface of work area following deilling works.

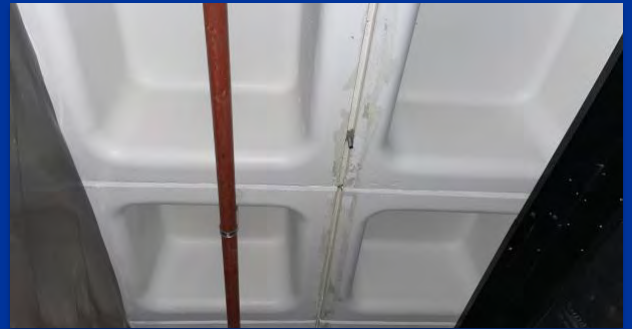
Photo 2

Surface of work area following deilling works.

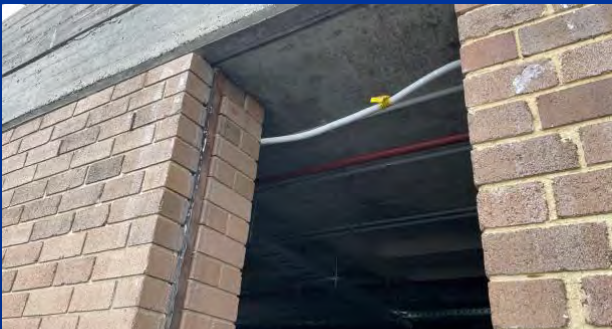
Photo 3

Level 6 - Roof 10 accessway following removal of mastic.

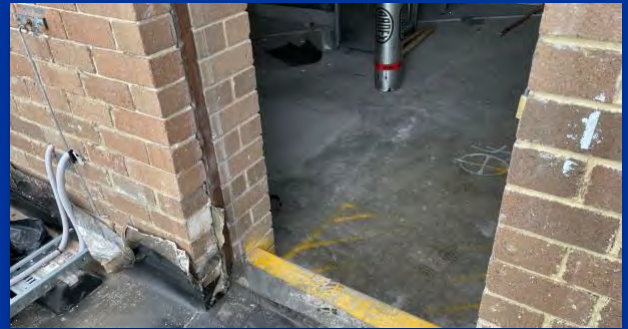
Photo 4

Level 6 - Roof 10 accessway following removal of mastic.

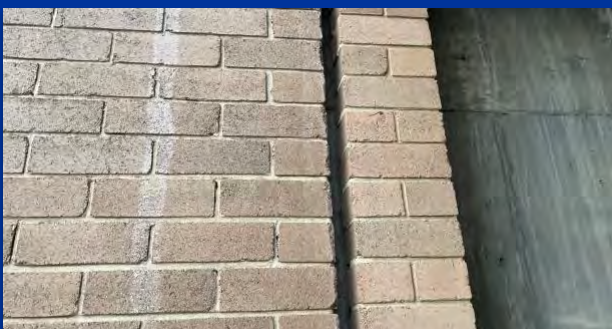
Photo 5

Level 6 - Roof 10 accessway following removal of mastic.

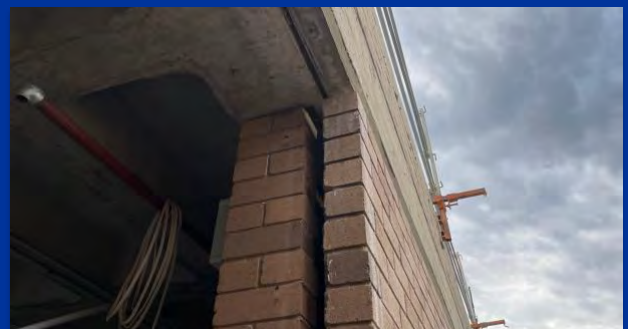
Photo 6

Level 6 - Roof 10 accessway following removal of mastic.

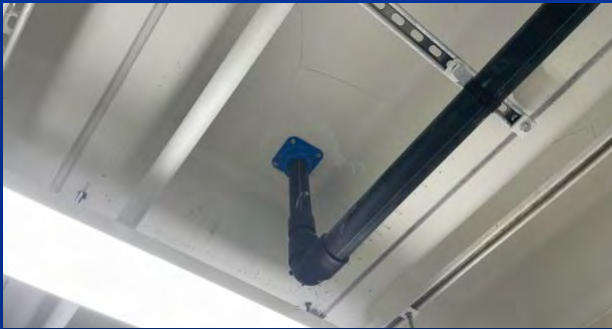
Photo 1

Penetration Level 3 - Zone J.

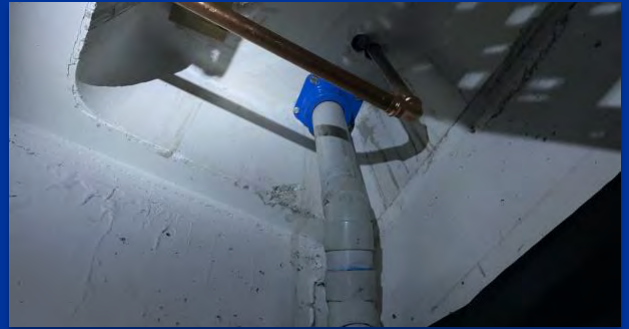
Photo 2

Penetration Level 3 - Parking area.

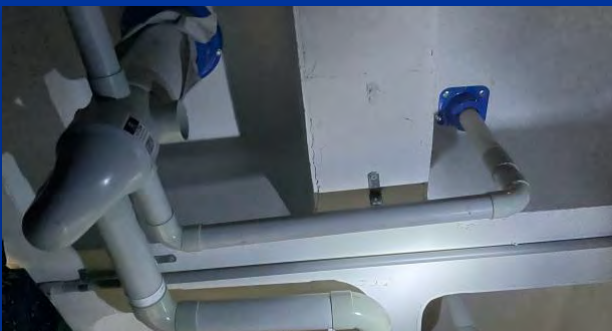
Photo 3

Penetration Level 3 - Zone K.

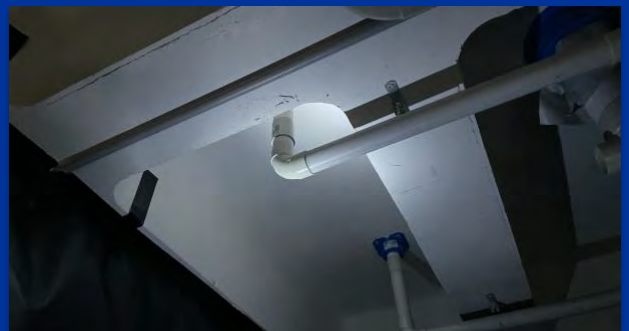
Photo 4

Penetration Level 3 - Zone K.

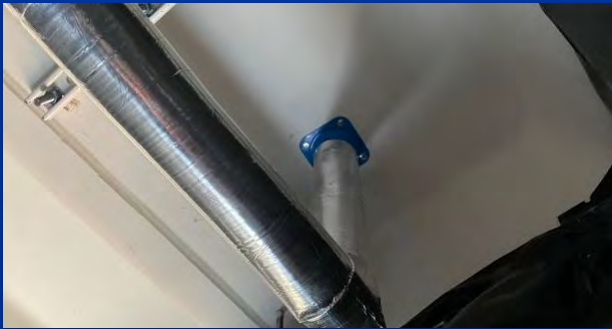
**Photo 1**

Level 3 - Zone J - Ceiling following installation of fire collar around pipe.

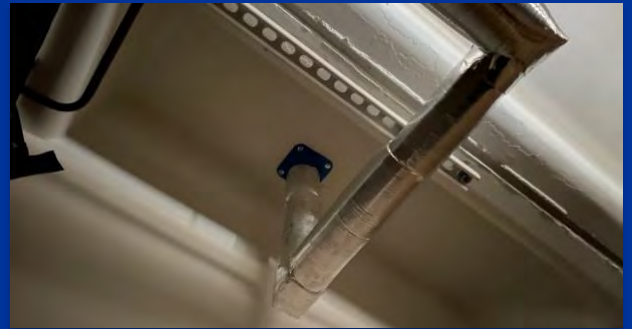
**Photo 2**

Level 3 - Zone J - Ceiling following installation of fire collar around pipe.

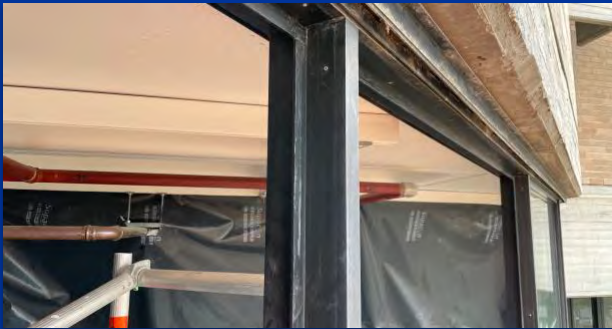
Photo 1

Window frame following the removal of asbestos containing mastic.

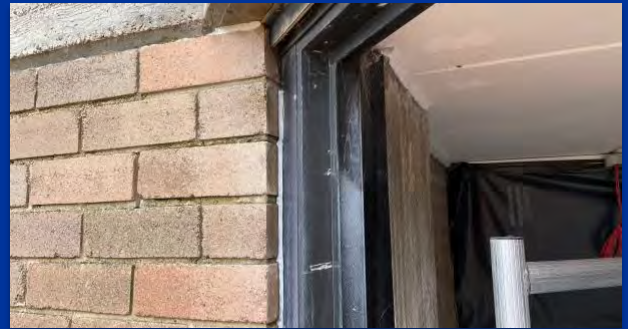
Photo 2

Window frame following the removal of asbestos containing mastic.

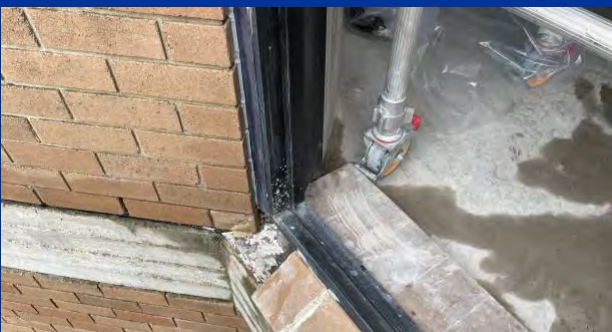
Photo 3

AreWindow frame following the removal of asbestos containing mastic.

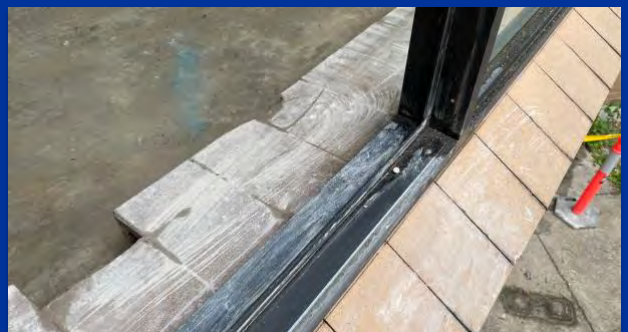
Photo 4

Window frame following the removal of asbestos containing mastic.

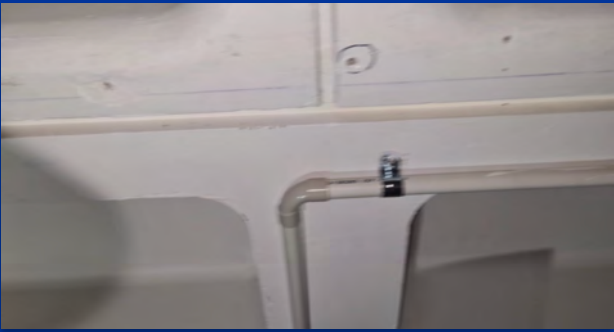
Photo 1

Drill holes following removal works

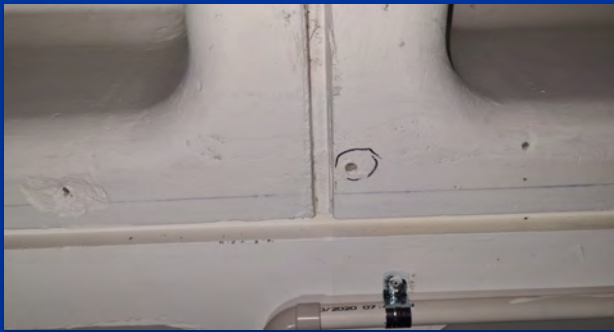
Photo 2

Drill holes following removal works

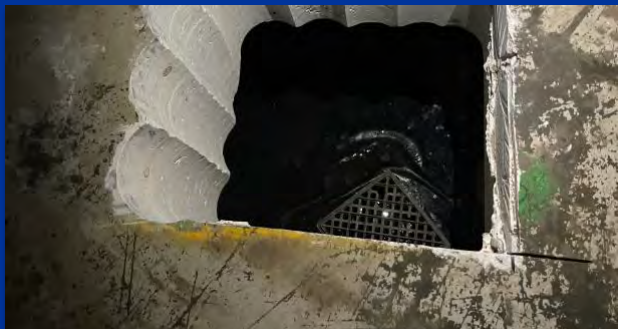
Photo 1

Penetration following removal works

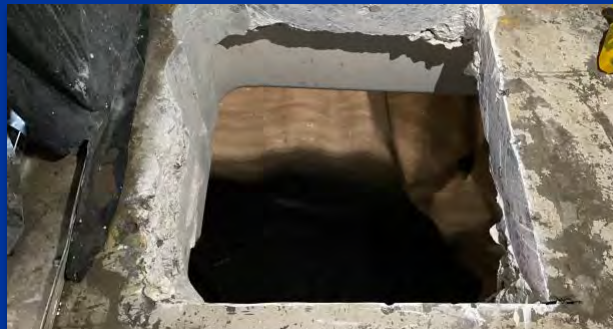
Photo 2

Penetration following removal works

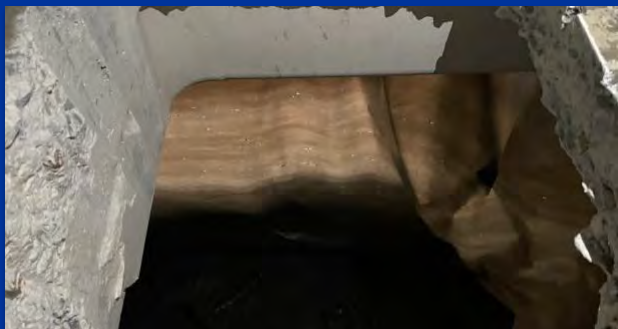
Photo 3

Penetration following removal works

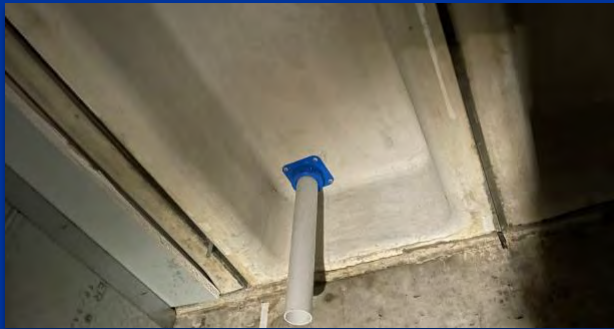
Photo 1

Ceiling following installation of fire collar around pipe.

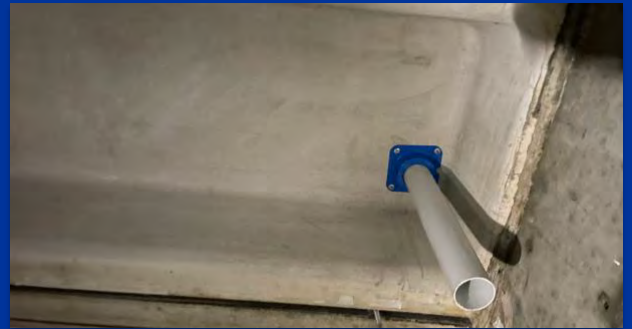
Photo 2

Ceiling following installation of fire collar around pipe.

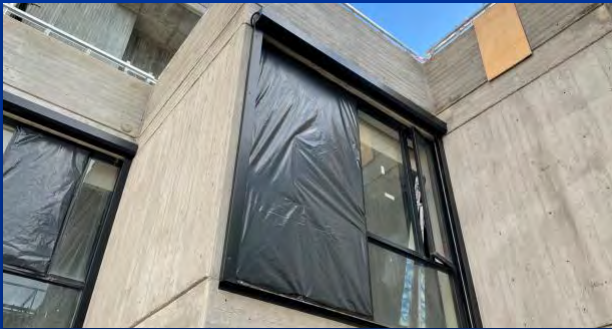
Photo 1

Window frame following the removal of asbestos containing mastic.

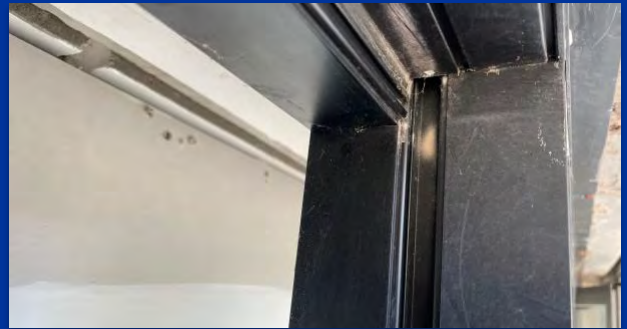
Photo 2

Window frame following the removal of asbestos containing mastic.

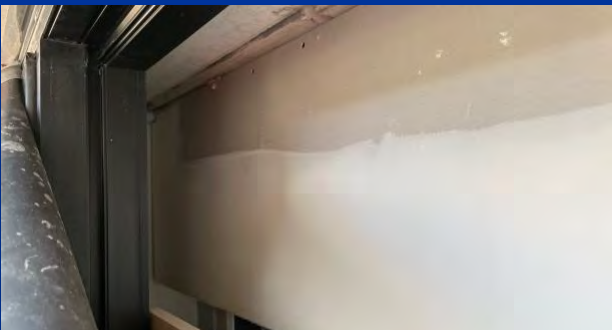
Photo 3

Window frame following the removal of asbestos containing mastic.

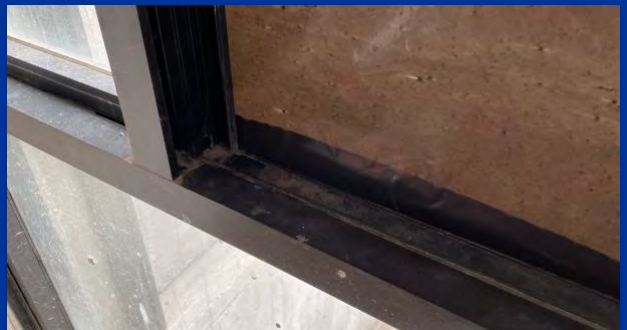
Photo 4

Window frame following the removal of asbestos containing mastic.

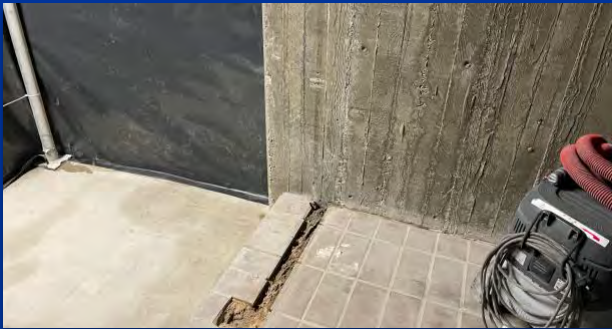
Photo 1

Location of window frames section containing asbestos mastic following removal works.

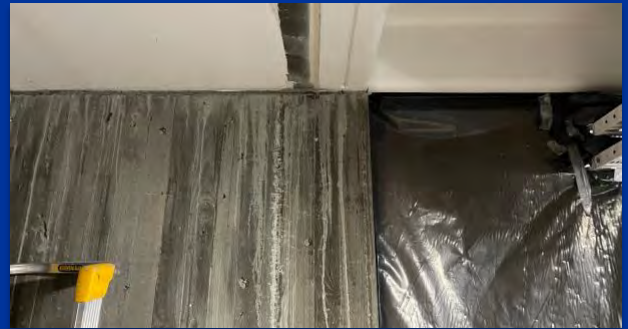
Photo 2

Location of window frames section containing asbestos mastic following removal works.

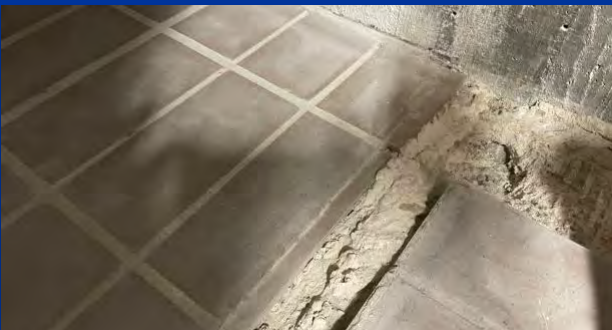
Photo 3

Location of window frames section containing asbestos mastic following removal works.

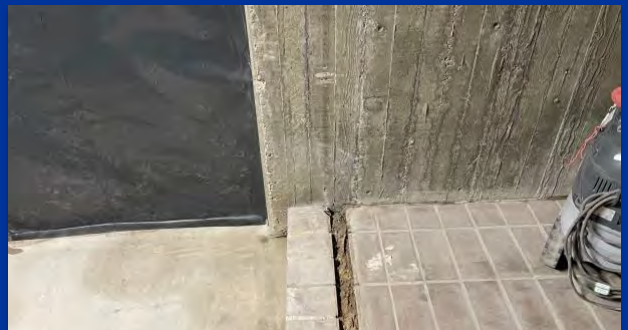
Photo 4

Location of window frames section containing asbestos mastic following removal works.

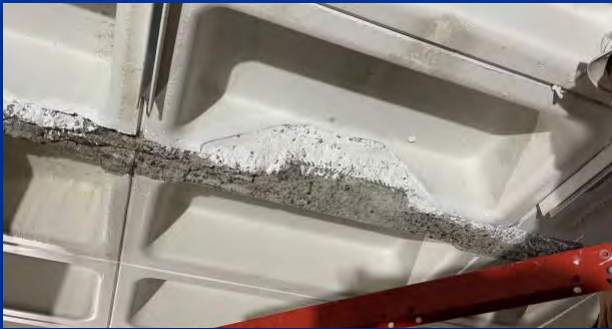
**Photo 1**

Waffle ceiling following the removal of damaged section of waffle ceiling and encapsulation of exposed edges.

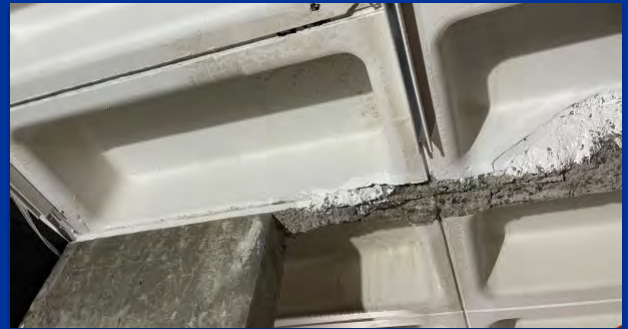
**Photo 2**

Waffle ceiling following the removal of damaged section of waffle ceiling and encapsulation of exposed edges.

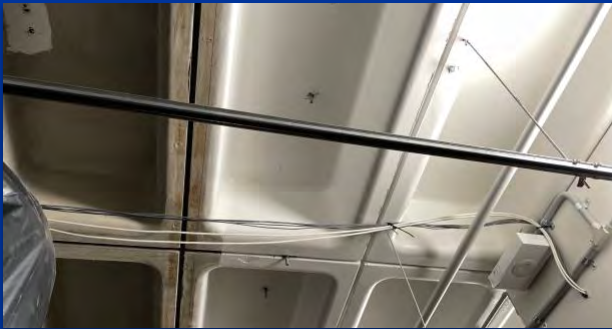
Photo 1

Ceiling following drilling works for brace installation.

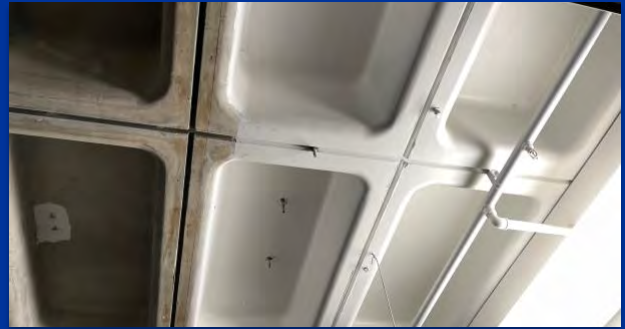
Photo 2

Ceiling following drilling works for brace installation.

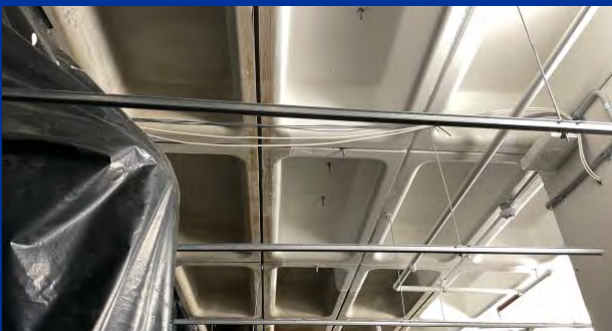
Photo 3

Ceiling following drilling works for brace installation.

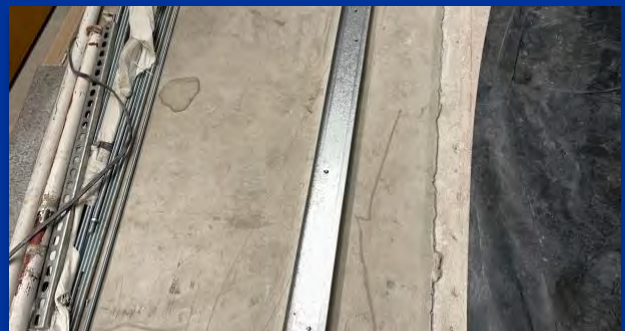
Photo 4

Work area following works.

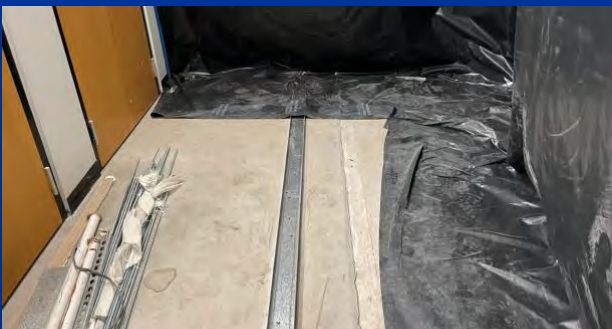
Photo 5

Work area following works.

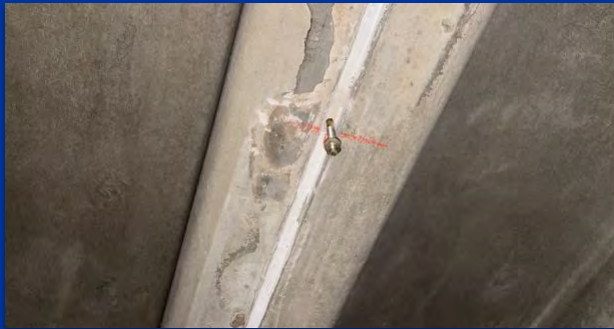
Photo 1

Ceiling following drilling and installation of bracing.

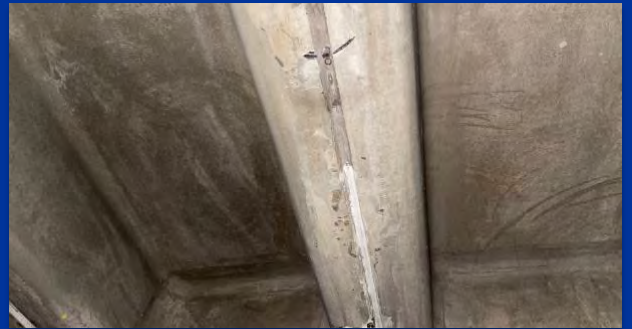
Photo 2

Ceiling following drilling and installation of bracing.
