INSPECTION REPORT

Your Reference: Lindfield Learning Village – 100 Eton Road, Lindfield
Job Number: 53140

In accordance with your instructions, Airsafe carried out an inspection of an asbestos work area prior to the resumption of normal work in the area by unprotected personnel to confirm that the asbestos removal work has been completed.

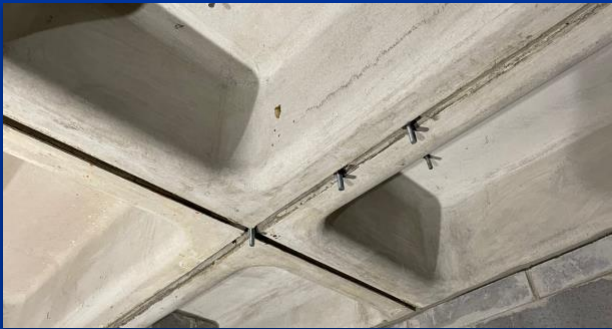
Photo 1

Ceiling following drilling works and installation of ceiling bracing.

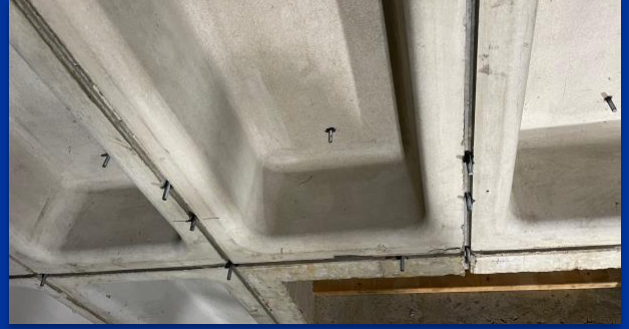
Photo 2

Ceiling following drilling works and installation of ceiling bracing.

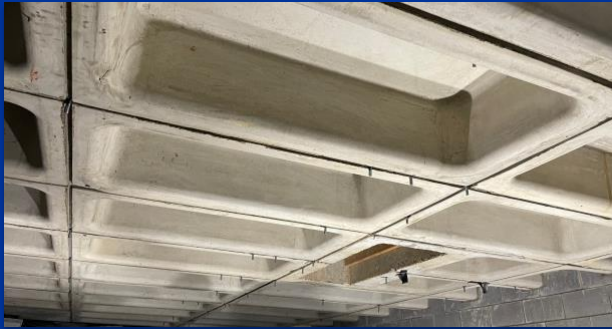
Photo 3

Ceiling following drilling works and installation of ceiling bracing.

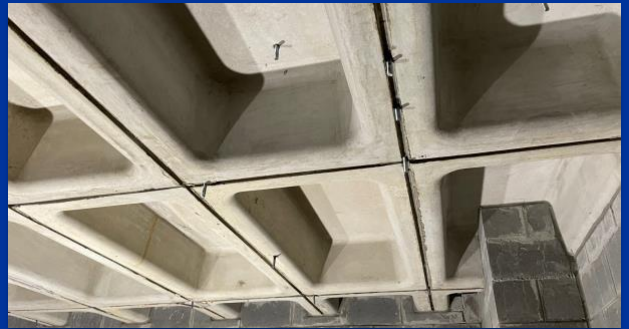
Photo 4

Ceiling following drilling works and installation of ceiling bracing.
