ASSESSMENT OF TREE NOS. 248 & 251

Platanus x hybrida
London Plane Tree

NEWCASTLE EDUCATION CAMPUS
PARKWAY AVENUE
HAMILTON SOUTH

07th JUNE 2024

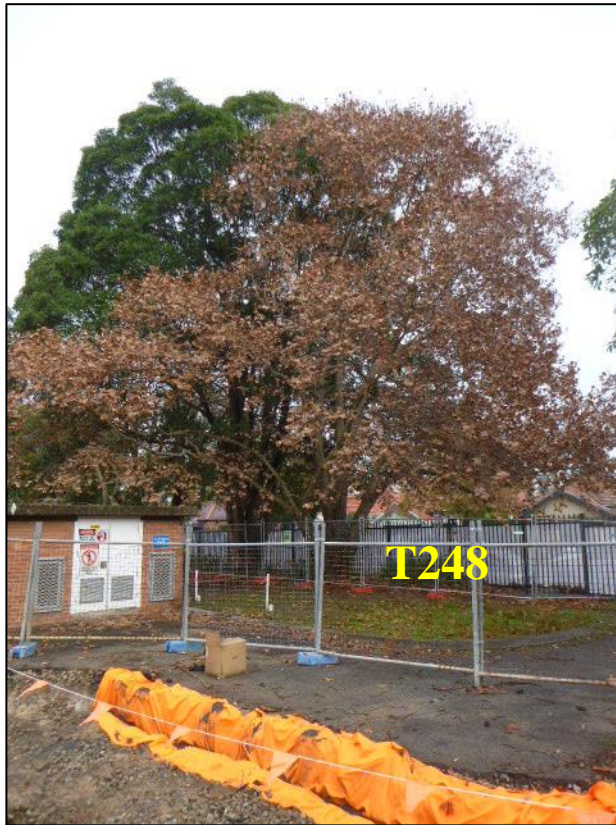
- Approximately 15 holes around 1cm in diameter have been drilled around the entire base of the trunk of Tree No. 248 and browned-off leaves still attached to branches (Photo's 1, 2, 3).
- Approximately 21 holes around 1cm in diameter have been drilled around the entire base of the trunk of Tree No. 251 and browned-off leaves still attached to branches (Photo's 4, 5, 6).

The drill holes observed around the base of the trunk at their root crowns and browned-off leaves still attached to branches would indicate that the trees have been poisoned.

However whilst the trees are deciduous and leaf colour at this time of year (at / or towards the end of the deciduous stage) is typical and not unusual, browned-off leaves are still attached to branches rather than have fallen as would be more typical for this species at this time of year. This is particularly noticeable when compared to other *Platanus x hybrida* within the site that have not been affected.

Photo 1 – Leaves retained on branches

1. Retain trees for now and undertake remedial action as outlined
2. Undertake remedial action again in the spring when the trees are no longer dormant and new growth would be expected to form.
3. Monitor health & vigour closely for signs of new growth & improvement
4. Remove trees if remedial action is not affective and trees are dead
5. If litigation action is to be pursued either tissue / leave / soil analysis should be undertaken, and the services of a consulting arborist experienced in preparing documentation and representation in lawsuits sought.

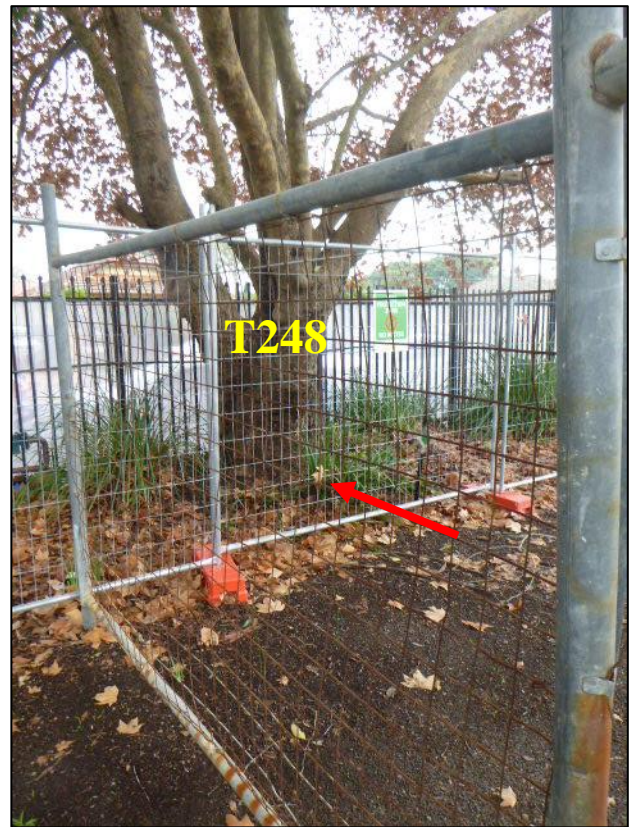
Photo 2 – Holes drilled around the entire base of the trunk

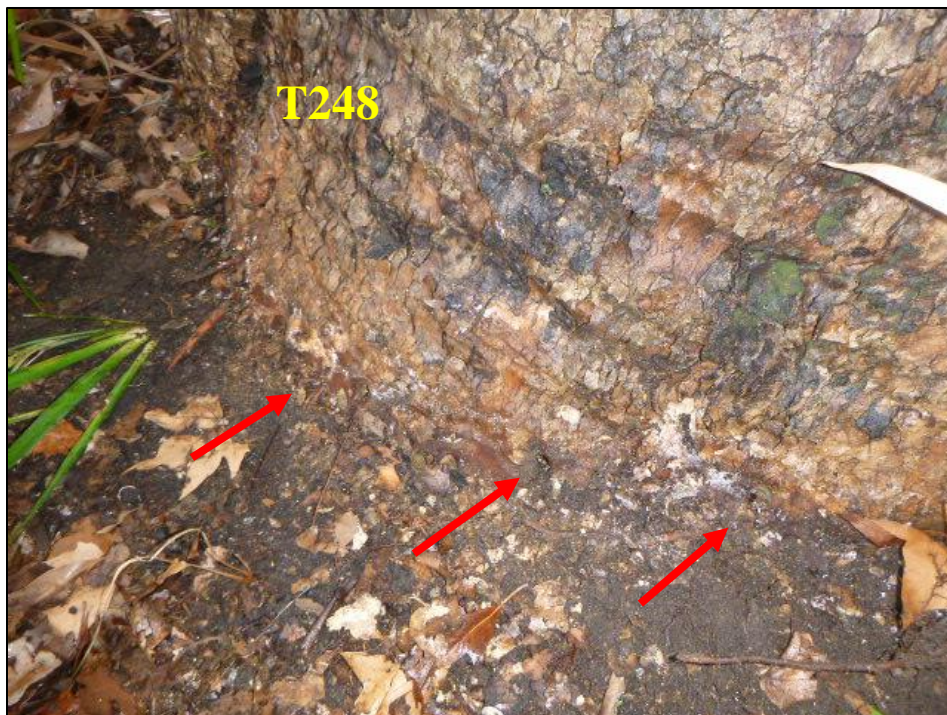
Photo 3 – Holes drilled around the entire base of the trunk

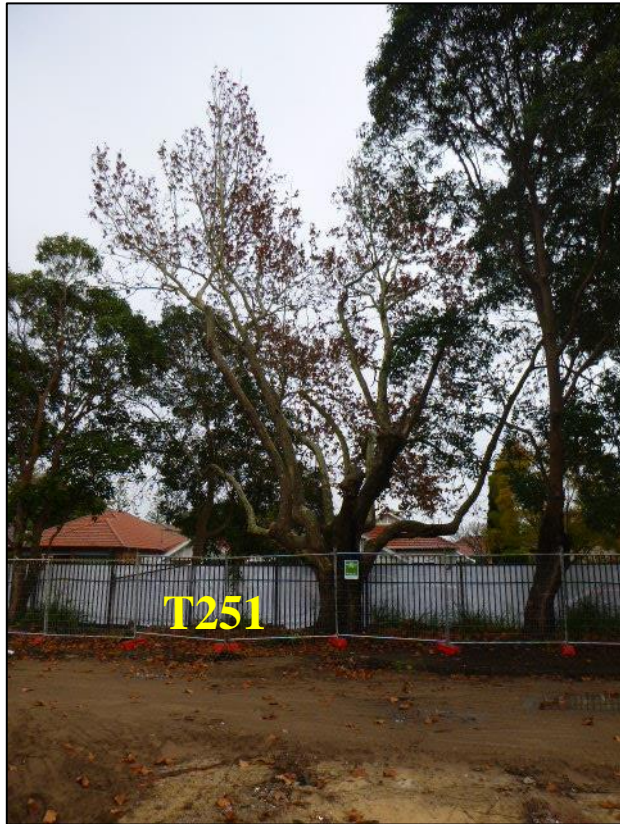
Photo 4 – Leaves retained on branches

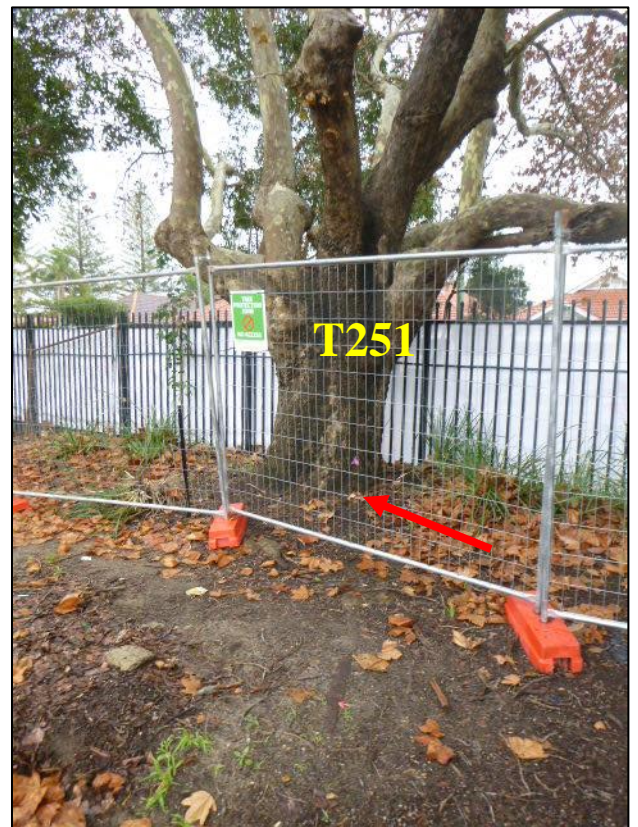
Photo 5 – Holes drilled around the entire base of the trunk

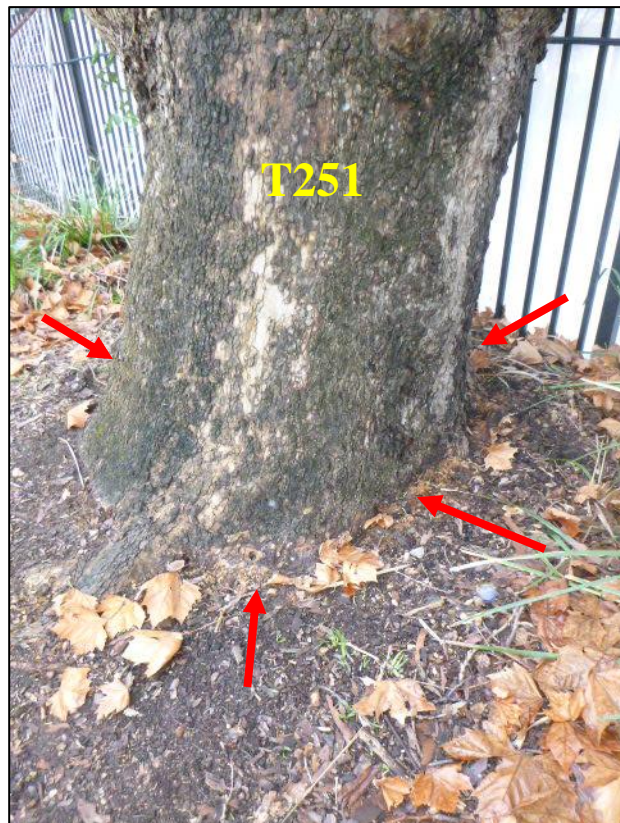
Photo 6 – Holes drilled around the entire base of the trunk
