POST - CONSTRUCTION DILAPIDATION REPORT

**External Areas Surrounding Proposed North Kellyville
Public School**

Hezlett Road, North Kellyville NSW 2155

Job Number: 17827 – S02
Date: 4th January 2019

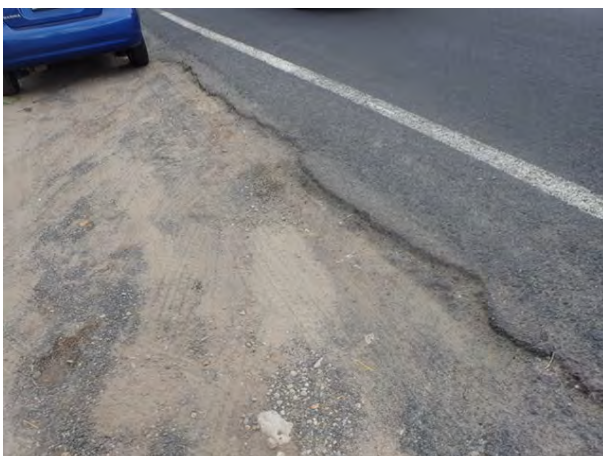
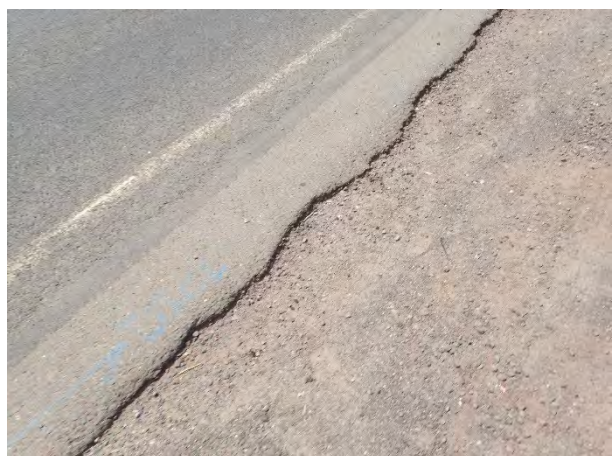
- Typical cracking and damage were noted to the asphalt roadway during our initial investigation on 1/2/18. The condition of the asphalt roadway appeared to not have worsened during our recent inspection on 2/1/19 as seen comparatively in Photo 1 and Photo 2.
- The damage signage noted in our initial investigation was observed on 2/1/19 to have been repaired. Photographic evidence of this can be seen comparatively in Photo 3 and Photo 4.

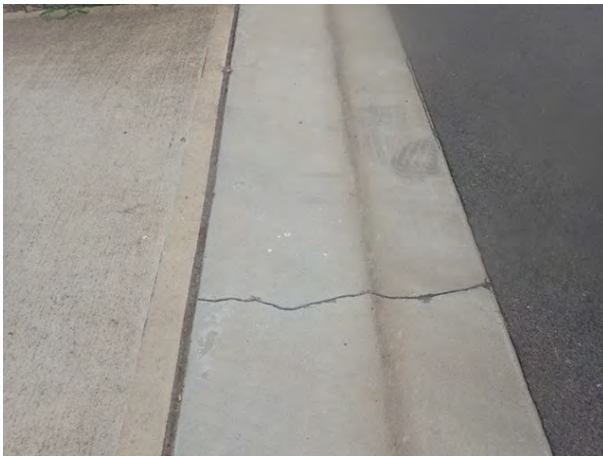
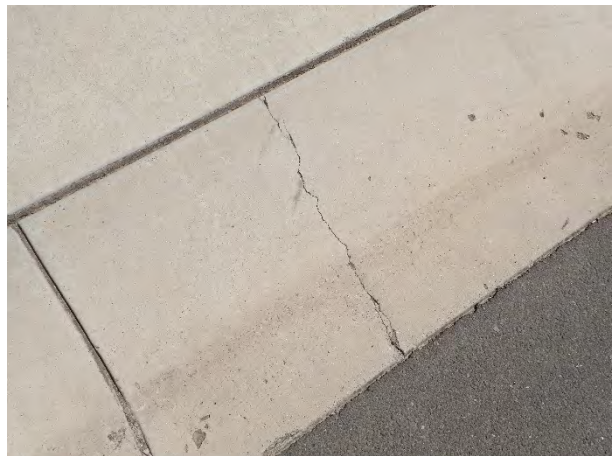
- Typical cracking was noted to concrete driveways and roadways on 1/2/18. Our recent inspection on 2/1/19 has verified that the condition of the concrete driveways and the roadway have not worsened. An example of our observations of the concrete driveways and the roadway can be seen comparatively in Photos 5 to 6 and Photos 7 to 8 respectively.

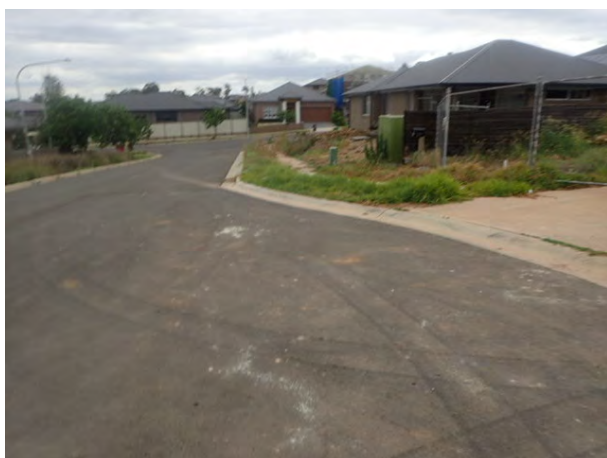
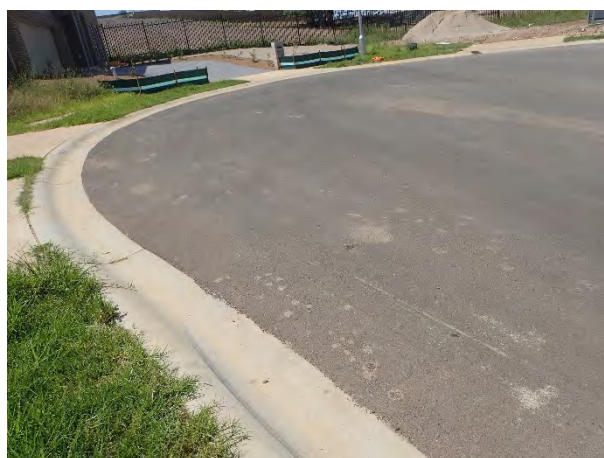
- Tyre marks to the roadway were observed from our initial investigation on 1/2/18. The condition of the roadway has not worsened as seen comparatively in Photos 9 to 10.

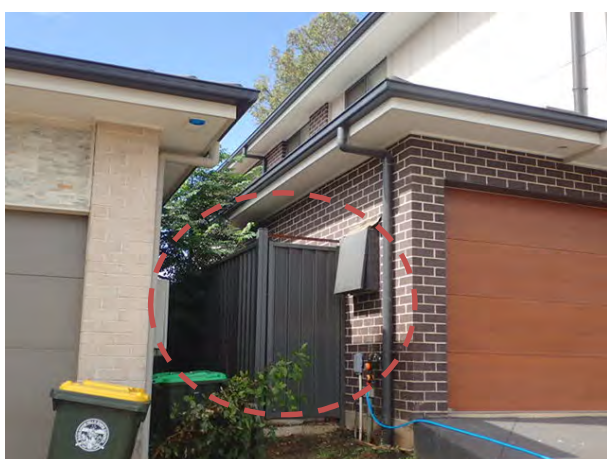
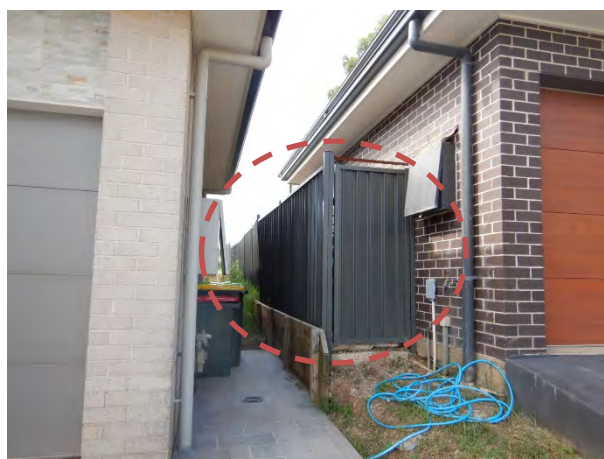
At the time of our inspection, we noted rotation to the boundary colorbond fencing which was not observed during our initial investigation. It is of our opinion that this has not resulted from the construction works. Photographic evidence of the condition of the boundary fence is shown in Photo 11 & Photo 12.

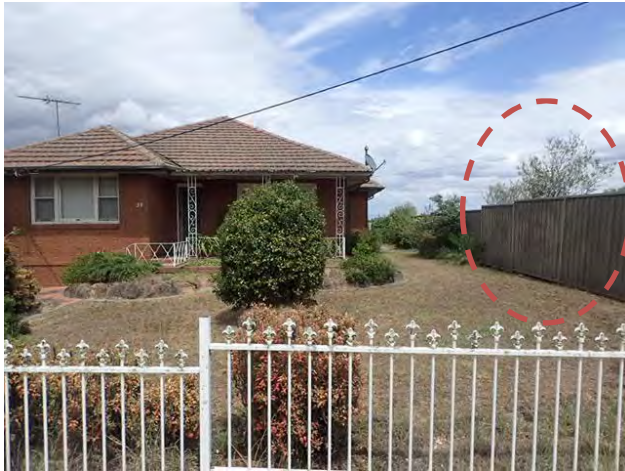
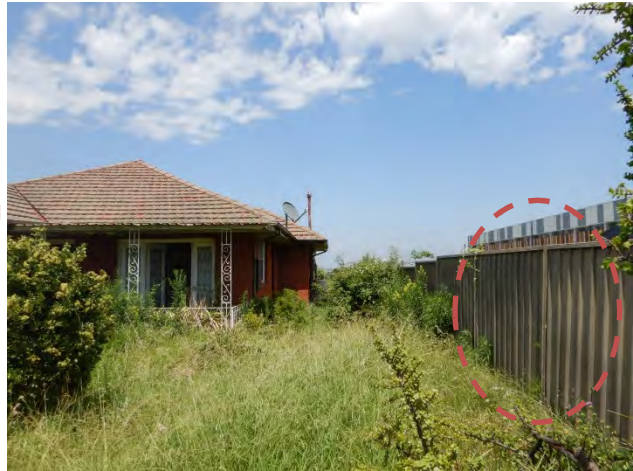
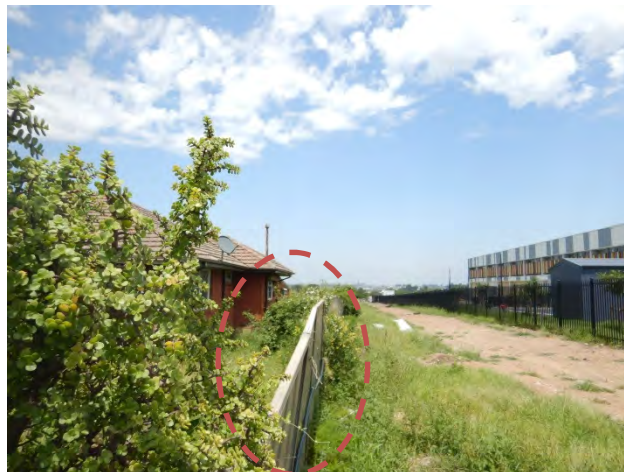
At the time of our inspection, we noted rotation to the boundary colorbond fencing which was not observed during our initial investigation. It is of our opinion that this has not resulted from the construction works. Photographic evidence of the condition of the boundary fence is shown in Photo 13 to Photo 15.

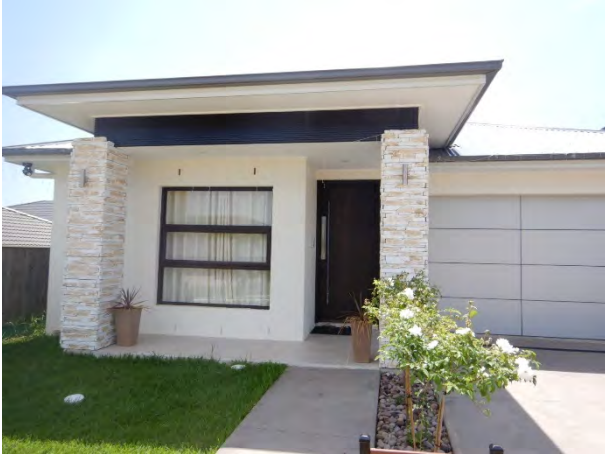
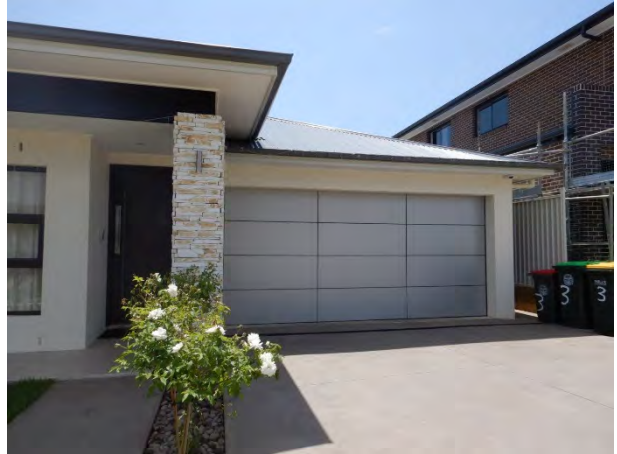
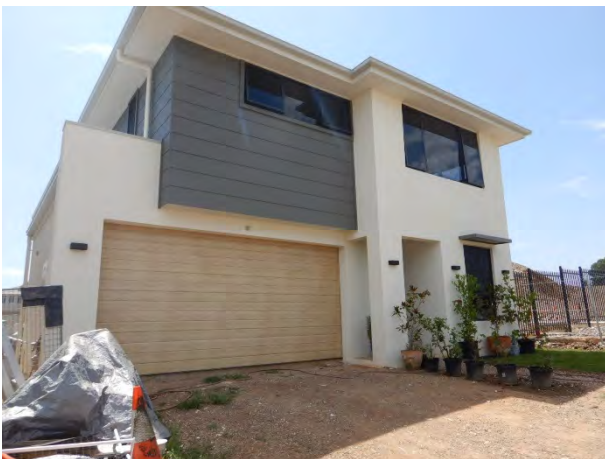
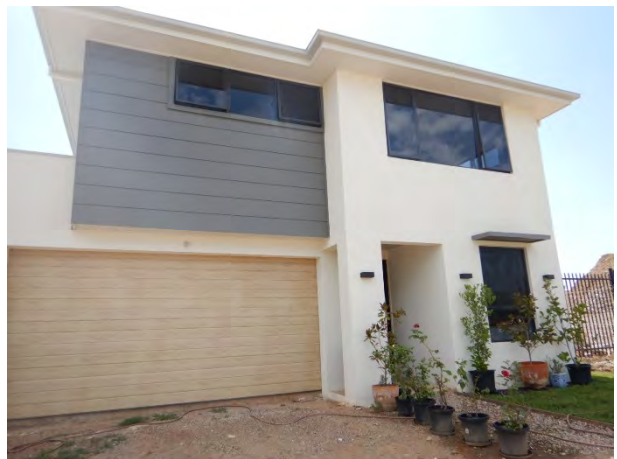
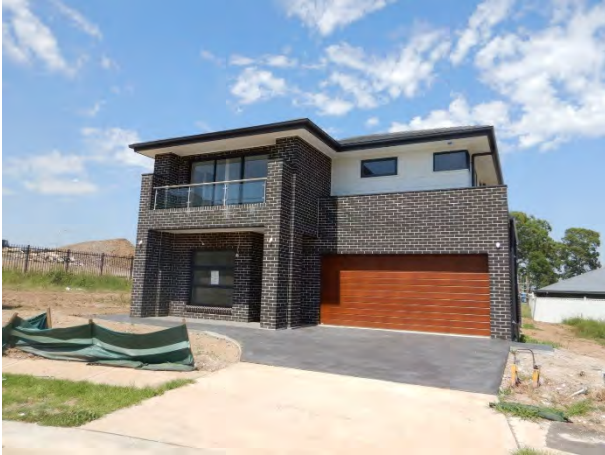
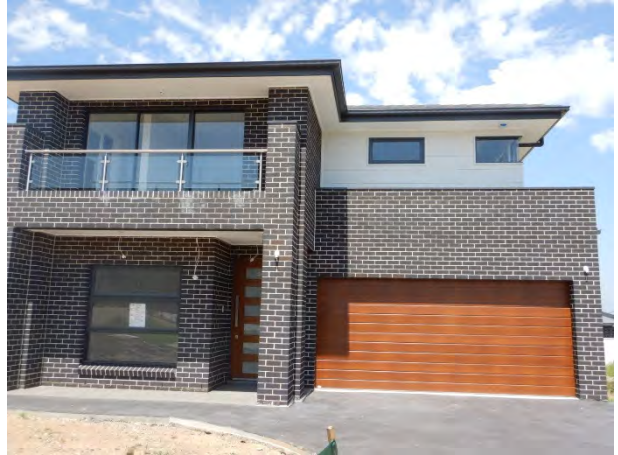
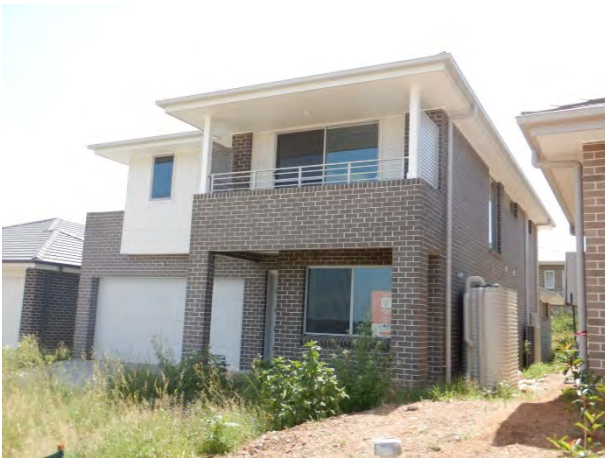
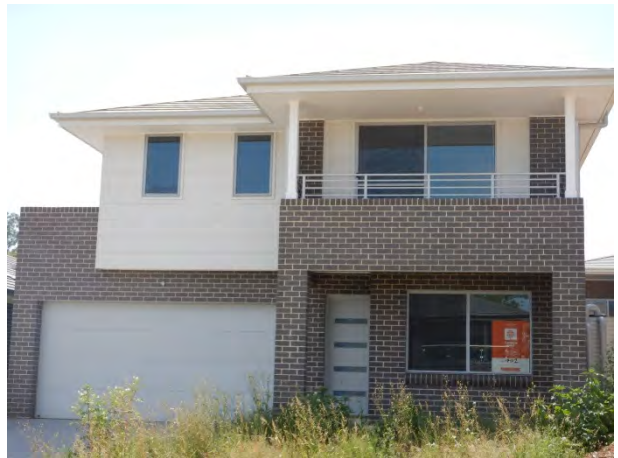
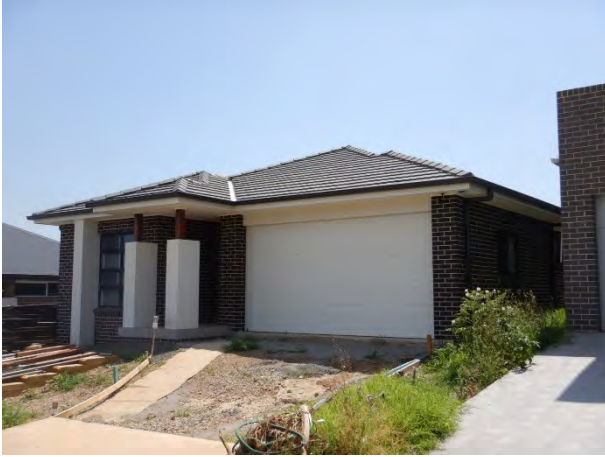
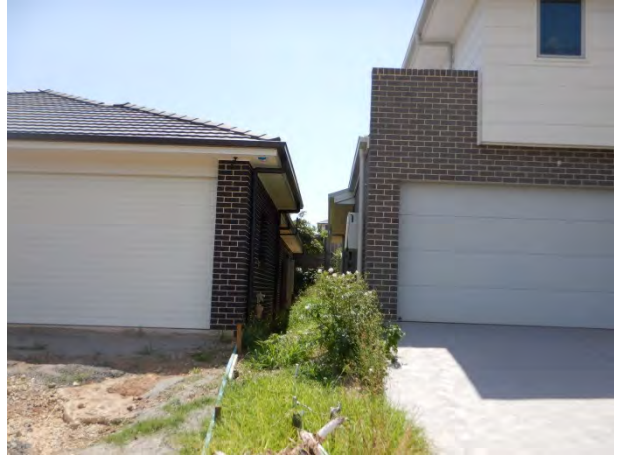
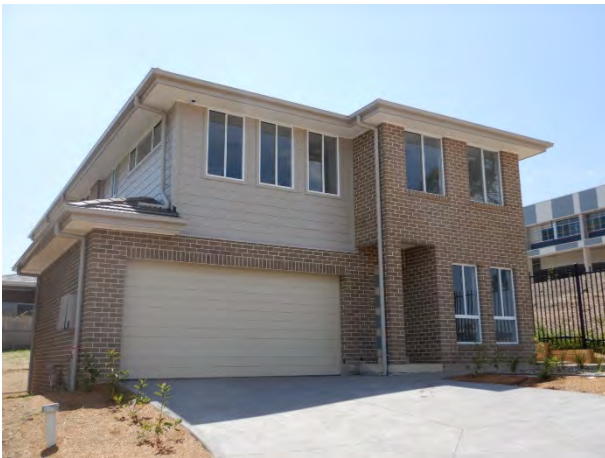
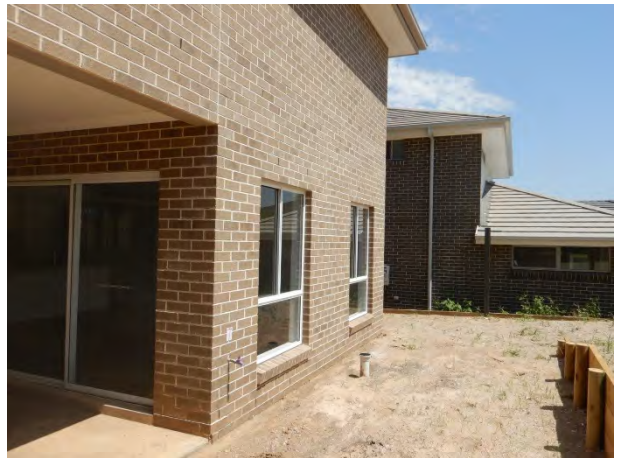
Additional recently constructed properties were noted along Hipwell Avenue and Wickham Boulevard during the time of our inspection which were not observed during our pre-construction dilapidation inspection. No observable defects were evident to these properties. General overviews of the additional properties are shown in Photo 16 to Photo 27:
