**BIRZULIS ASSOCIATES Pty Ltd**  
Consulting Structural + Civil Engineers

**RE: SAMUEL GILBERT PUBLIC SCHOOL  
RIDGECROP DRIVE, CASTLE HILL NSW  
(OUR REF: 7738)  
DILAPIDATION REPORT FOR PUBLIC INFRASTRUCTURE**

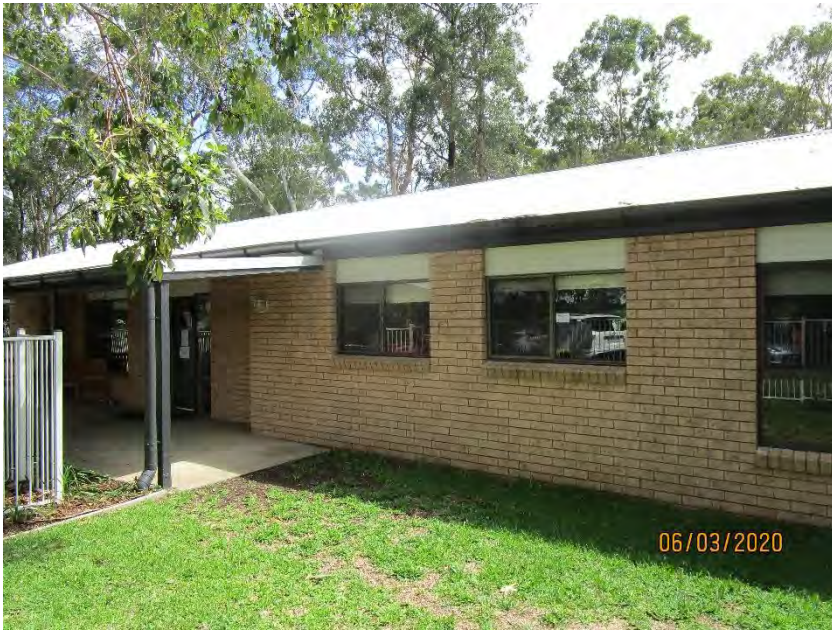
Photo 1

<b><u>Photo</u></b>	<b><u>Comments</u></b>
1-5	Front façade of childcare centre. Structure appears to be in reasonable condition.
6-9	Western wall of childcare centre. Structure is generally in good condition.
10-11	Masonry pavement in reasonable condition. Some areas with minor vertical displacement.
12	Roof framing on western side of building. No signs of structural distress and generally in good condition.
13-24	Western wall of childcare centre. Structure is generally in good condition.
25-30	South-western corner of building. Generally in good condition with no signs of structural defects.
32-42	Rear wall of the building. Generally in good condition with no signs of structural defects.
43-52	Masonry pavement in reasonable condition. Some areas with minor vertical displacement.
54-55	Concrete pavement generally in reasonable condition. Some areas with vertical displacement.
56-60	Cracking on concrete pavement.

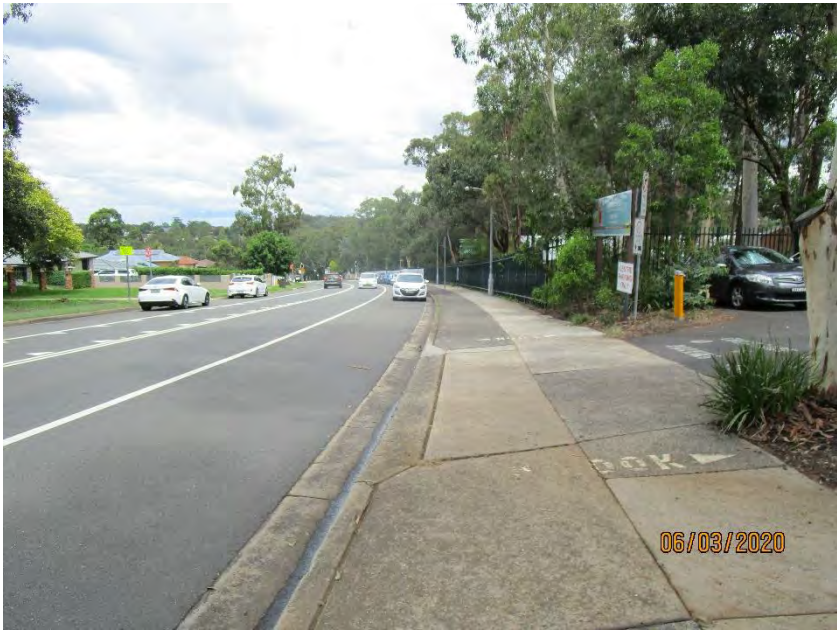
Photo 120

118	Eastern side of front façade generally in good condition.
119	Road condition on Gilbert Road generally in good condition.
120	Damage to stormwater outlet pipe on Gilbert Road.
121	Kerb and gutter on Gilbert Road generally in good condition.
122-124	Cracking in concrete kerb and gutter on Gilbert Road.
125	Concrete pavement on Gilbert Road generally in good condition.
126	Castle Glen signage generally in good condition.
127	Concrete pavement on Gilbert Road generally in good condition.
128-129	Damage to stormwater outlet pipe on Gilbert Road.

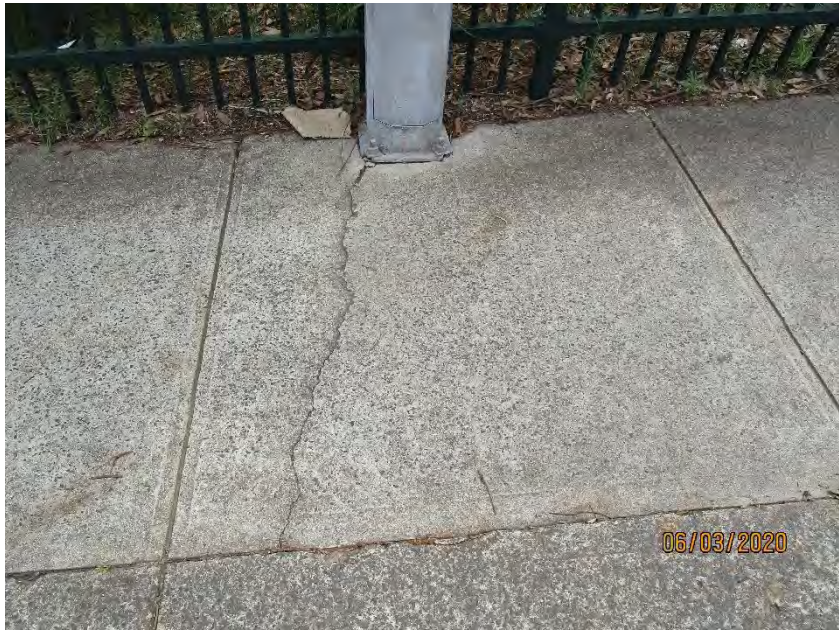
Photo 133

130	Concrete pavement on Gilbert Road generally in good condition.
131	Lighting post generally in good condition.
132	Road sign generally in good condition.
133-134	Cracking in concrete pavement at base of street light.
135	Road condition on Gilbert Road generally in good condition.
136	Concrete pavement on Gilbert Road generally in good condition.
137-138	Concrete cracking on kerb and gutter on Gilbert Road.
139-140	Schools signage and fencing generally in good condition.
141	Concrete pavement on Gilbert Road generally in good condition.
142	Cracking in concrete pavement on Gilbert Road.
143-144	Cracking on concrete kerb on Gilbert Road.
145-146	Concrete pavement on Gilbert Road generally in good condition.
147	Concrete cracking on kerb and gutter on Gilbert Road.
148-149	Cracking in concrete pavement adjacent to services lid.
150	Concrete pavement on Gilbert Road generally in good condition.
151	Concrete cracking on kerb and gutter on Gilbert Road.

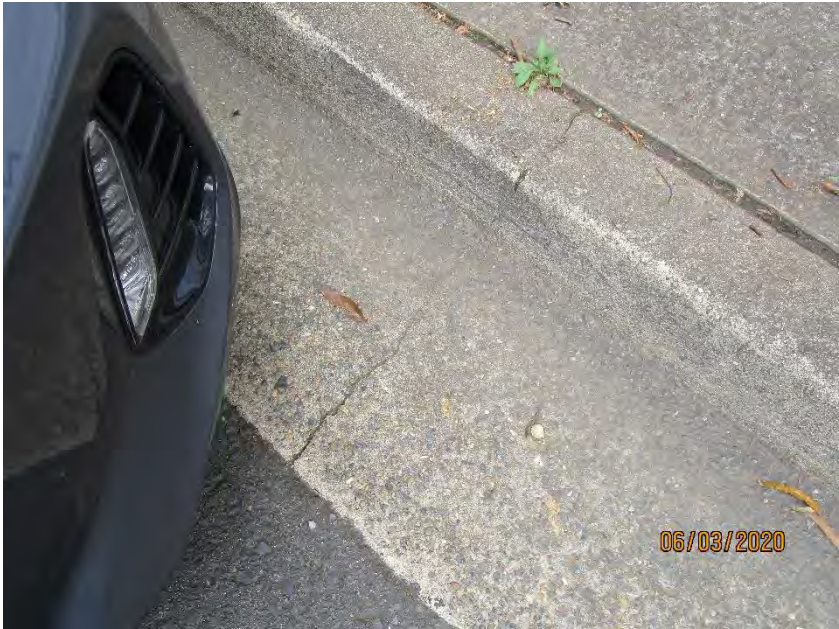
Photo 154

152	Concrete pavement on Gilbert Road generally in good condition.
153	Kerb and gutter on Gilbert Road generally in good condition.
154	Concrete cracking on kerb and gutter on Gilbert Road.
155	Concrete pavement on Gilbert Road generally in good condition.
156	Kerb inlet pit on Gilbert Road generally in good condition.
157-159	Concrete pavement on Gilbert Road generally in good condition.
160	Road condition on Gilbert Road generally in good condition.
161	Damage to 'Keep Left' sign on Gilbert Road.
162-163,165	Concrete pavement on Gilbert Road generally in good condition.
164	Street sign on Gilbert Road generally in good condition.
166	Street lights on Gilbert Road generally in good condition.
167-168	Cracking in concrete pavement at light crossing.
169	Street lights on Gilbert Road generally in good condition.
170	Concrete pavement at intersection of Gilbert Road and Ridgescrop Drive generally in good condition.

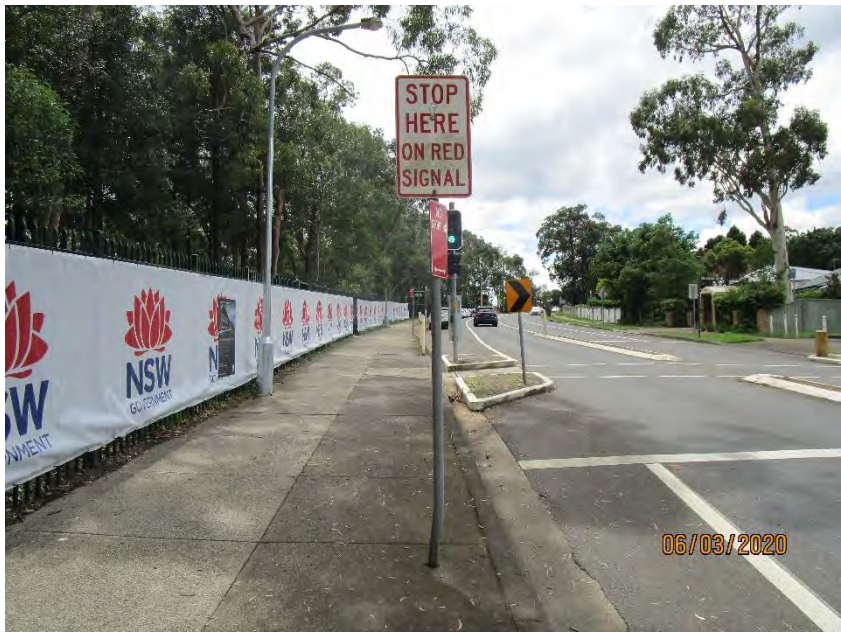
Photo 173

171-173	Damage to street sign at intersection of Gilbert Road and Ridgescrop Drive
174	Concrete pavement at intersection of Gilbert Road and Ridgescrop Drive generally in good condition.
175	Damage to street post at intersection of Gilbert Road and Ridgescrop Drive
176-177	Concrete pavement generally in reasonable condition. Some areas with vertical displacement.
178-183	Street signs on Ridgescrop Drive generally in good condition.
184	Spray paint on street sign on Ridgescrop Drive.
185	Concrete pavement generally in reasonable condition. Some areas with vertical displacement.
186-187	Cracking in concrete pavement on Ridgescrop Drive.
188	Concrete pavement generally in reasonable condition. Some areas with vertical displacement.
189-190	Displacement in balustrade on Ridgescrop Drive.
191	Minor cracking in kerb and gutter, asphaltic pavement.
192	Seating bench on Ridgescrop Drive generally in good condition.

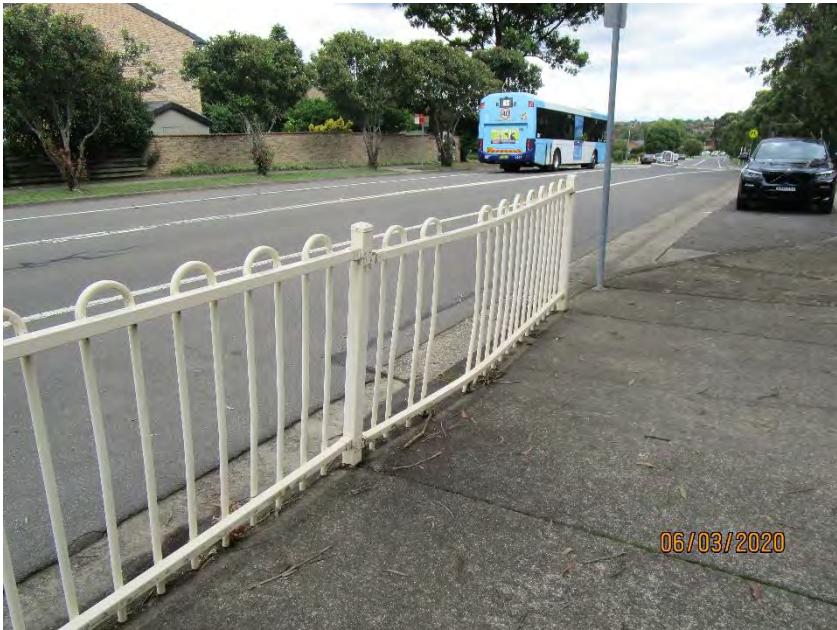
Photo 198

195-196	Cracking on concrete pavement on Ridgecrop Drive.
197	Seating bench on Ridgecrop Drive generally in good condition.
198-199	Damage to balustrade on Ridgecrop Drive.
200	Cracking in concrete pavement on Ridgecrop Drive.
201-204	Concrete pavement and asphaltic road on Ridgecrop Drive generally in good condition.
205-206	Road crossing on Ridgecrop drive generally in good condition.
207	Cracking in kerb on Ridgecrop Drive.
208	Damage to signage posts at crossing on Ridgecrop Drive
209-210	Cracking in concrete pavement on Ridgecrop Drive.
211-212	Damage to signage posts on Ridgecrop Drive
213	Damage to signage posts on Ridgecrop Drive
214	Cracking on concrete kerb and gutter on Ridgecrop Drive.
215	Concrete pavement and asphaltic road on Ridgecrop Drive generally in good condition.
216	Cracking on concrete kerb and gutter on Ridgecrop Drive.
