**Site Location:** 3A & 3B Smalls Road, Ryde, NSW  
**Prepared for:** Richard Crookes  
**Date prepared:** 5 December 2018  
**Our Ref:** 18/12/05/3BSRR  
**Report Type:** Certificate

This document has been prepared by Urban Arbor Pty Ltd in relation to tree protection at the development site.

Urban Arbor inspected the tree protection on 5 December 2018. All demolition works have been completed and tree protection has been installed as per the following points.

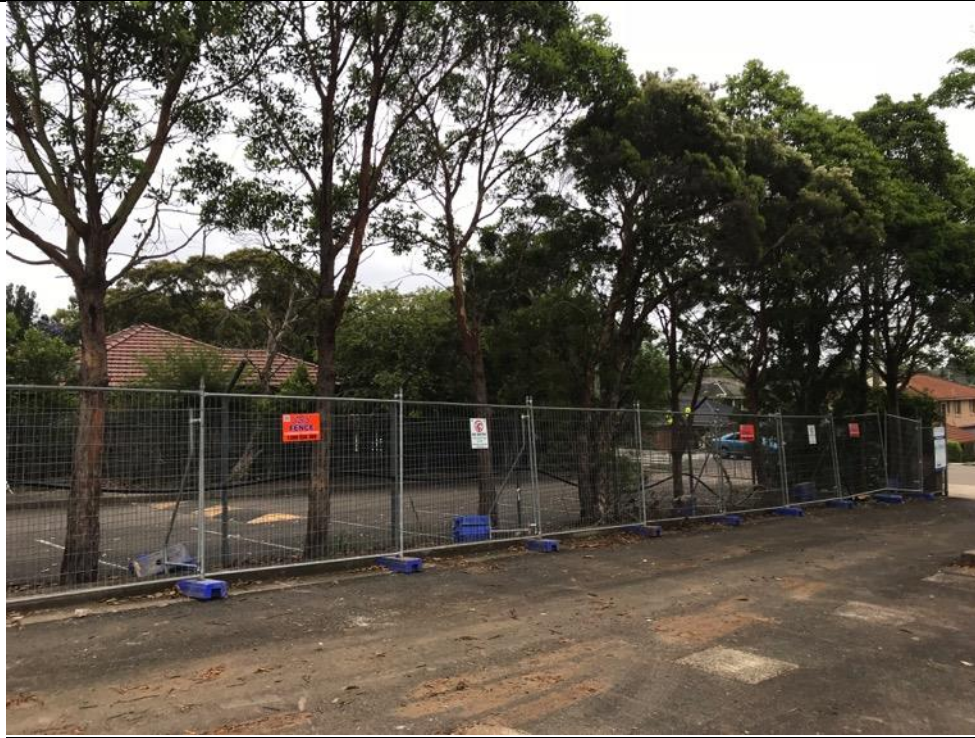
Image A: Tree protection fencing installed adjacent to tree 145 - 153.

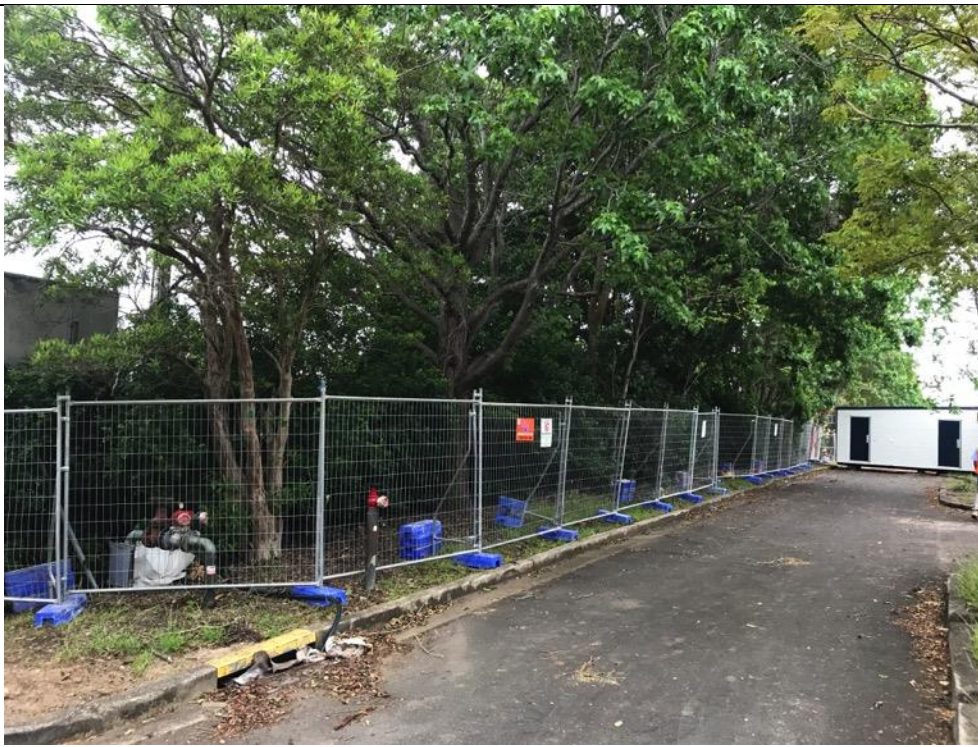
Image B: Tree protection fencing installed adjacent to tree 158, 159, 160, 161, 162, 169, 170, 171 and 172.

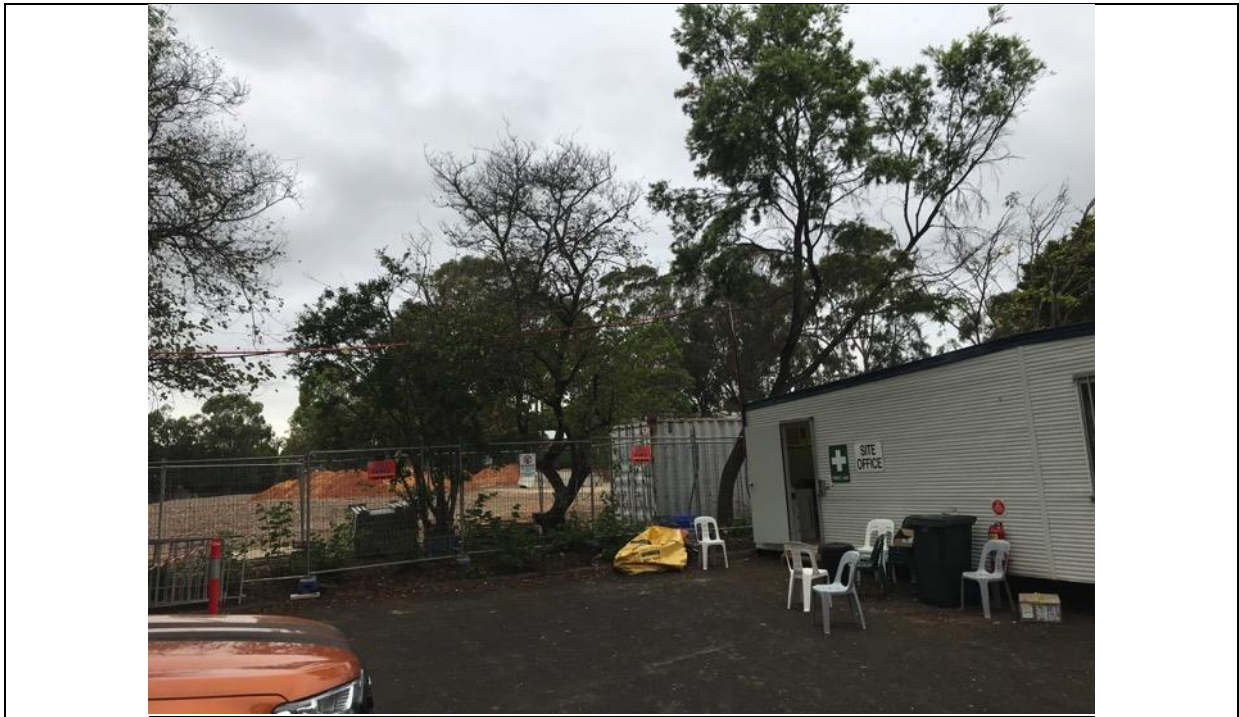
Image C: Tree protection fencing installed adjacent to tree 163, 164 and 165.

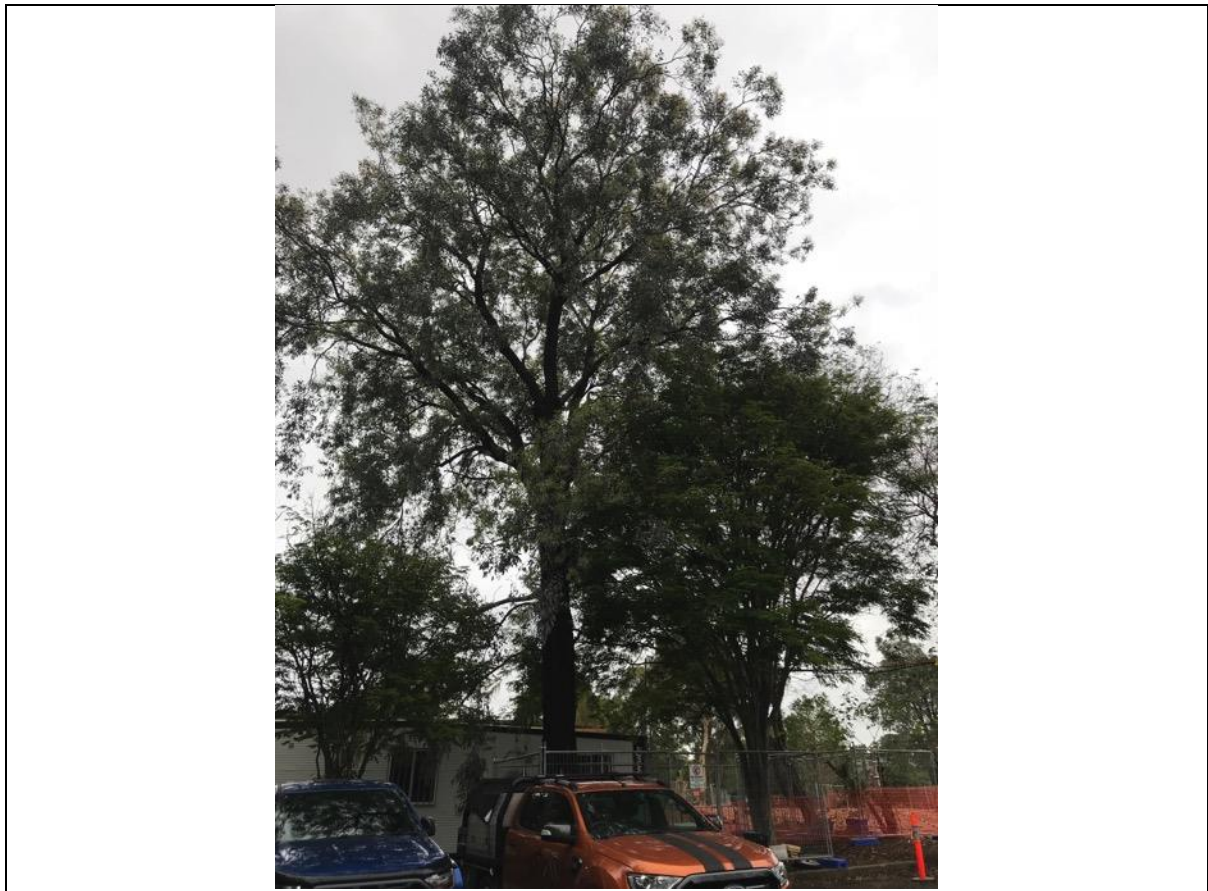
Image D: Tree protection fencing installed adjacent to tree 154, 155 and 173.

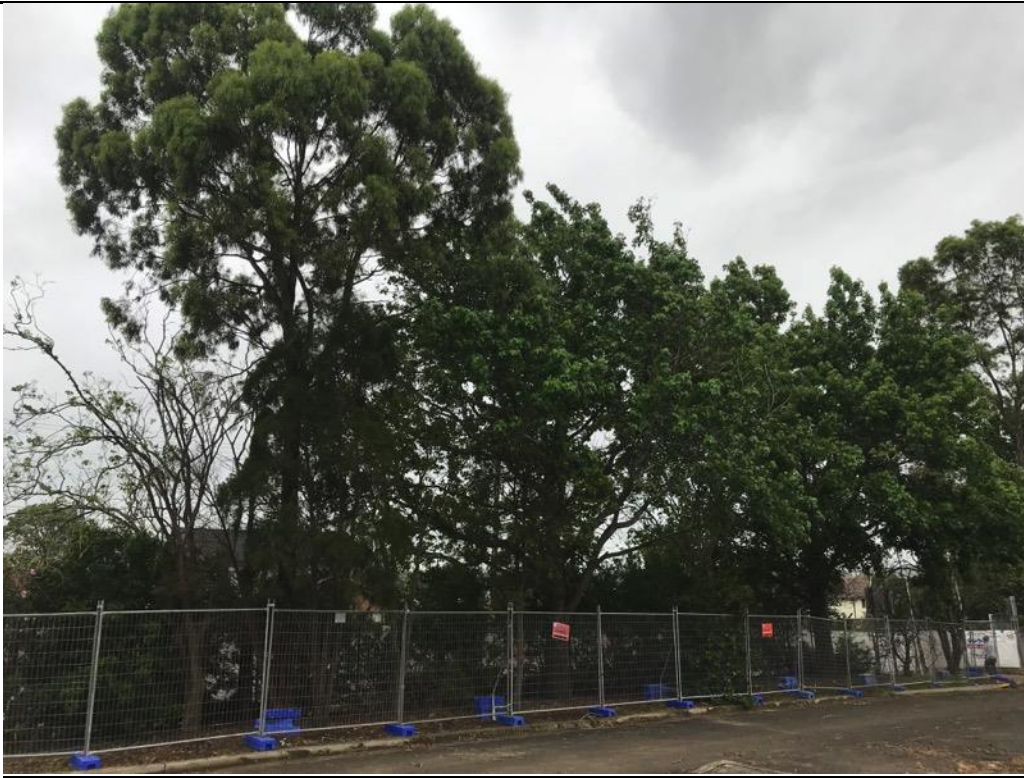
Image E: Tree protection fencing installed adjacent to tree 101, 102, 133, 134 and 134A.

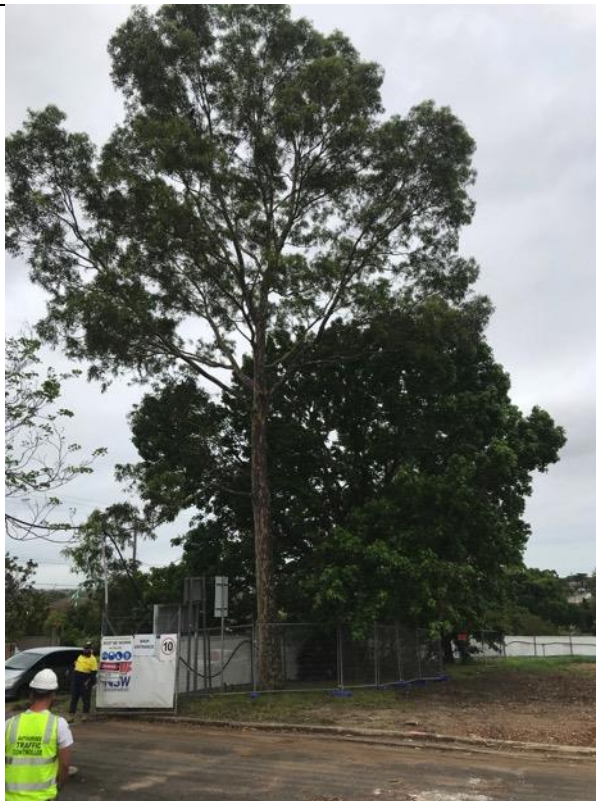
Image F: Tree protection fencing installed adjacent to tree 97, 98, 99 and 100.

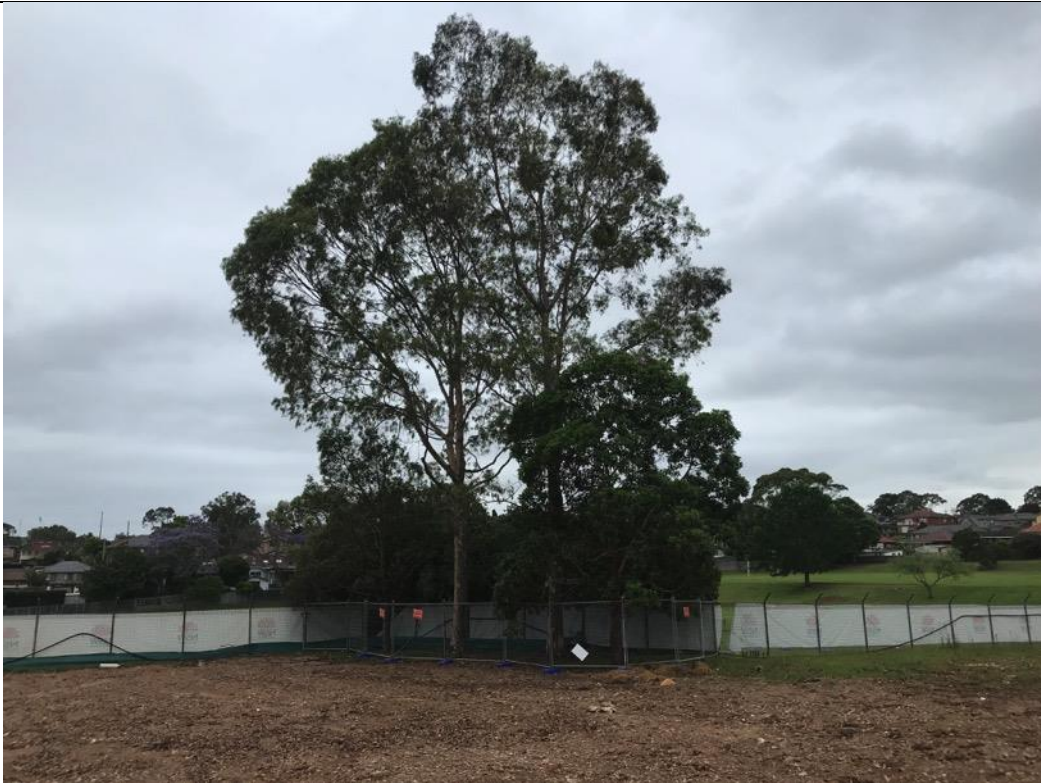
Image G: Tree protection fencing installed adjacent to tree 94, 95, 96 and 121A.

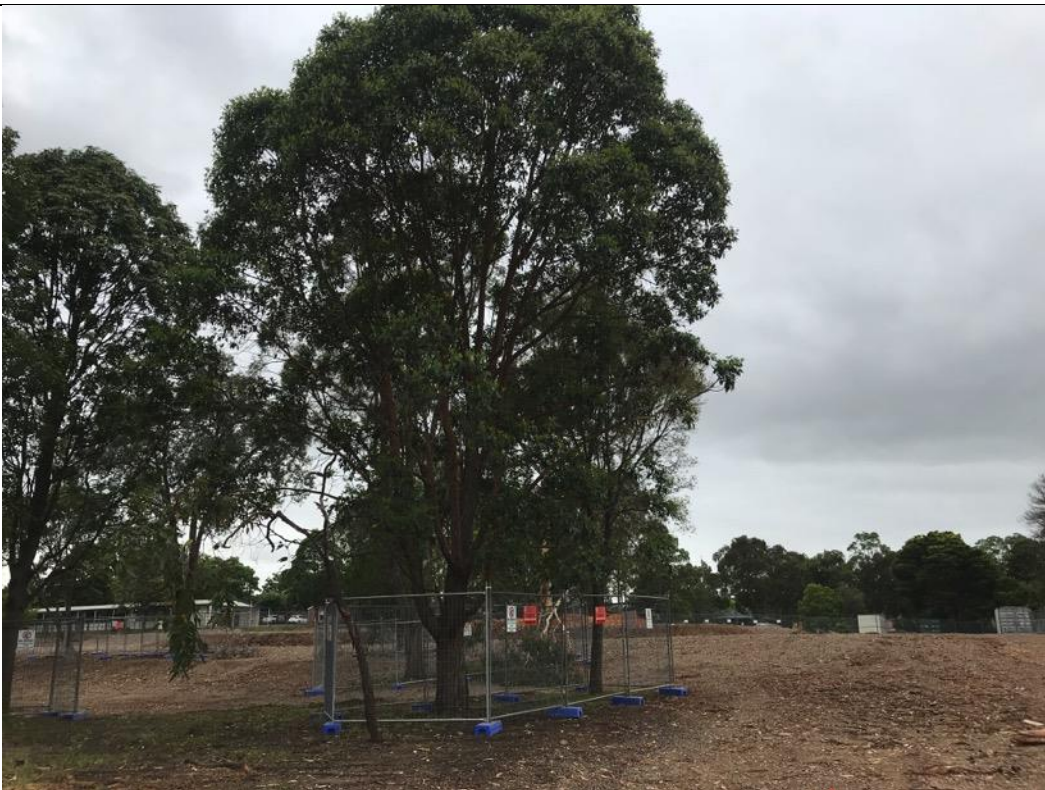
Image H: Tree protection fencing installed adjacent to tree 115 and 116.

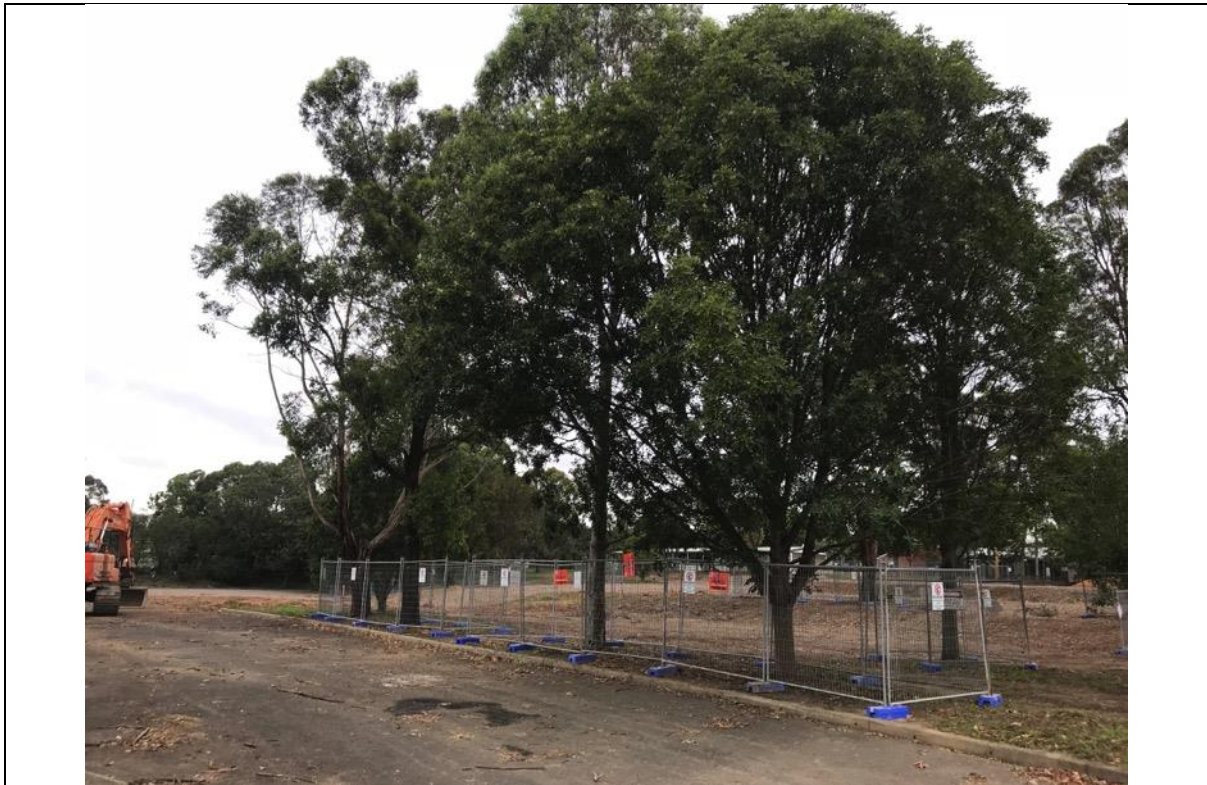
Image I: Tree protection fencing installed adjacent to tree 108, 109, 110, 111, 111A and 119.

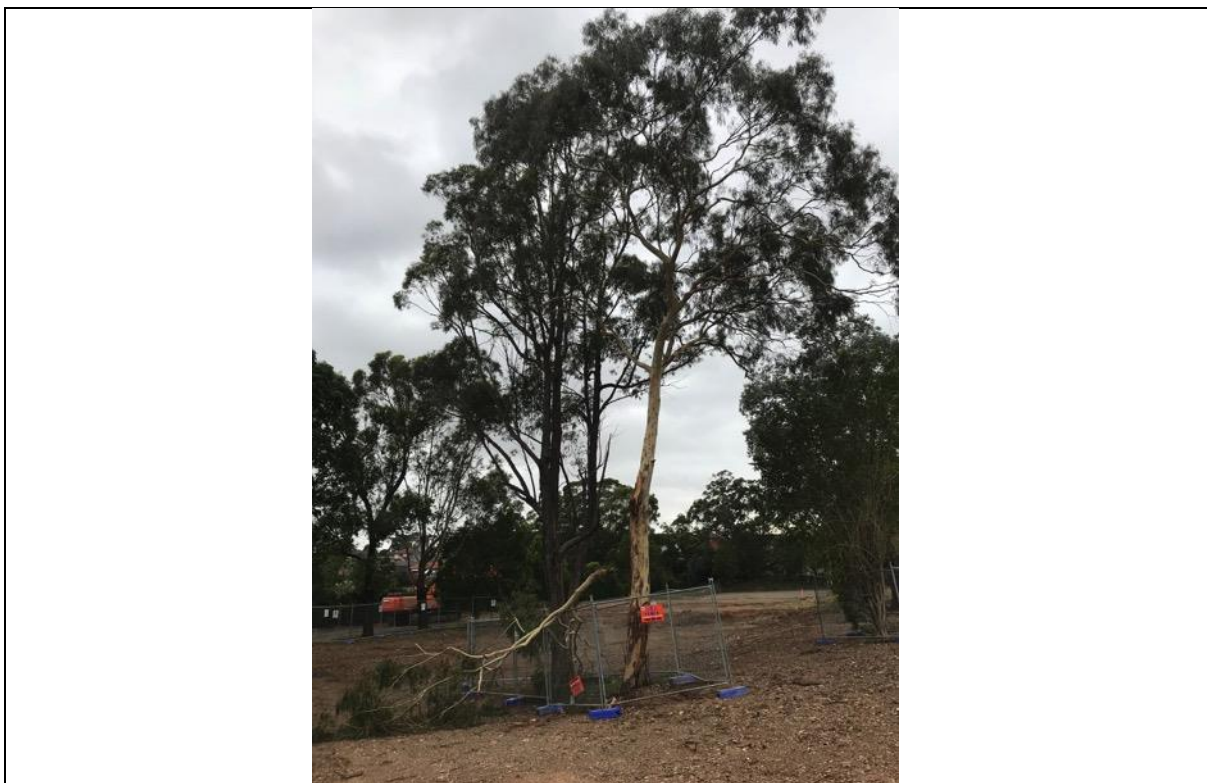
Image J: Tree protection fencing installed adjacent to tree 117 and 118, showing failure of lowest primary branch on tree 117.

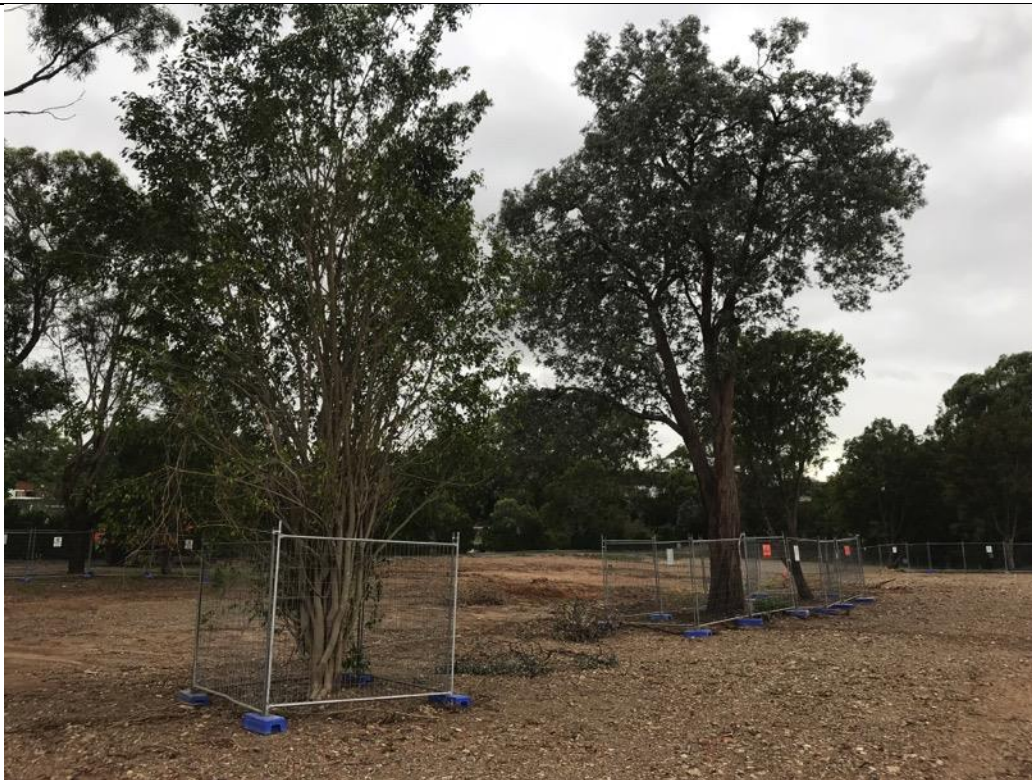
Image K: Tree protection fencing installed adjacent to tree 120, 141 and 142.

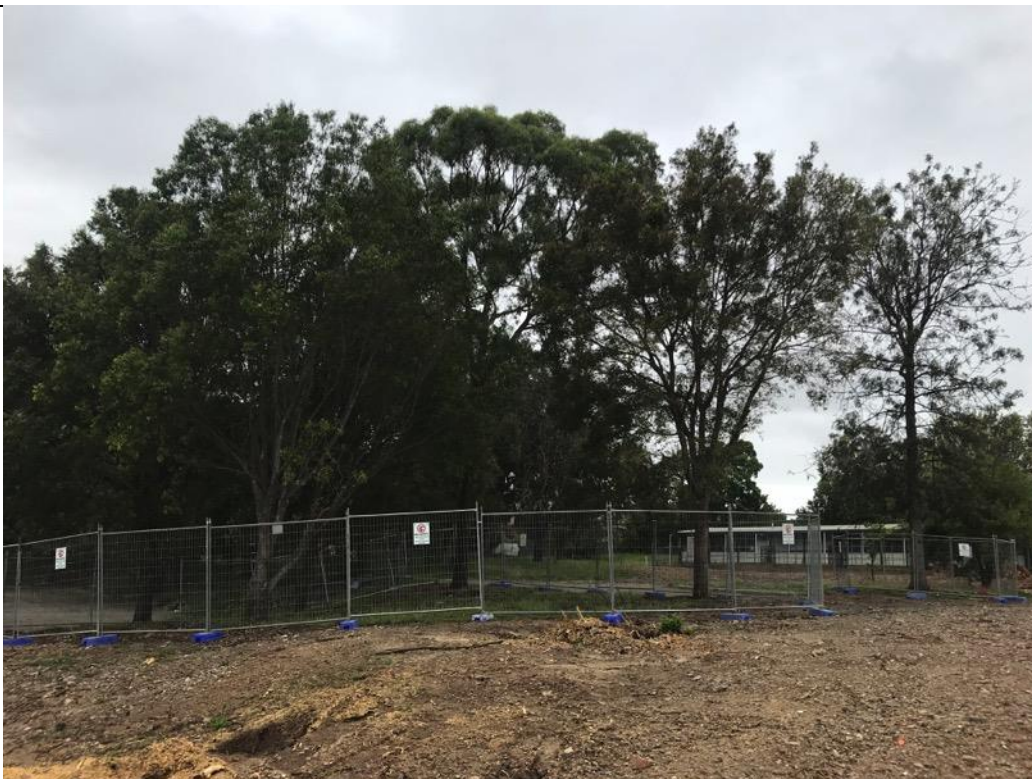
Image L: Tree protection fencing installed adjacent to tree 70, 70A, 71, 72, 73, 75 and 198.

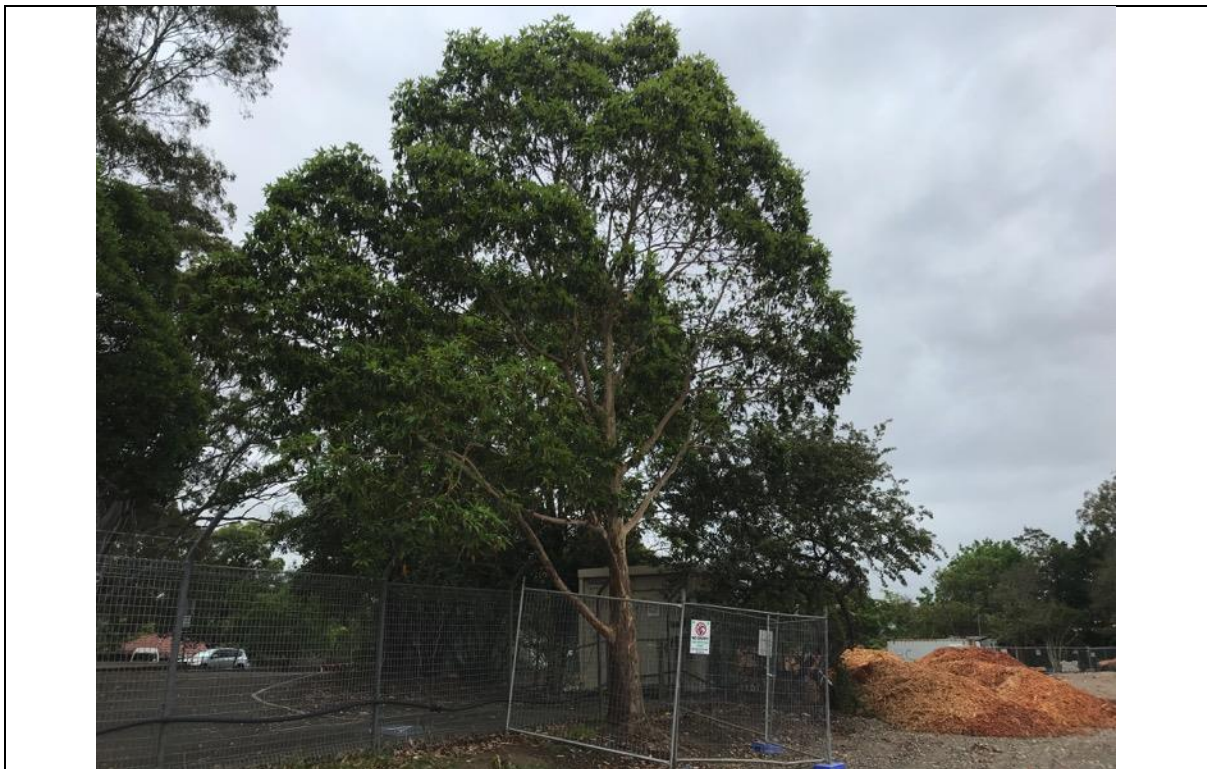
Image M: Tree protection fencing installed adjacent to tree 182.

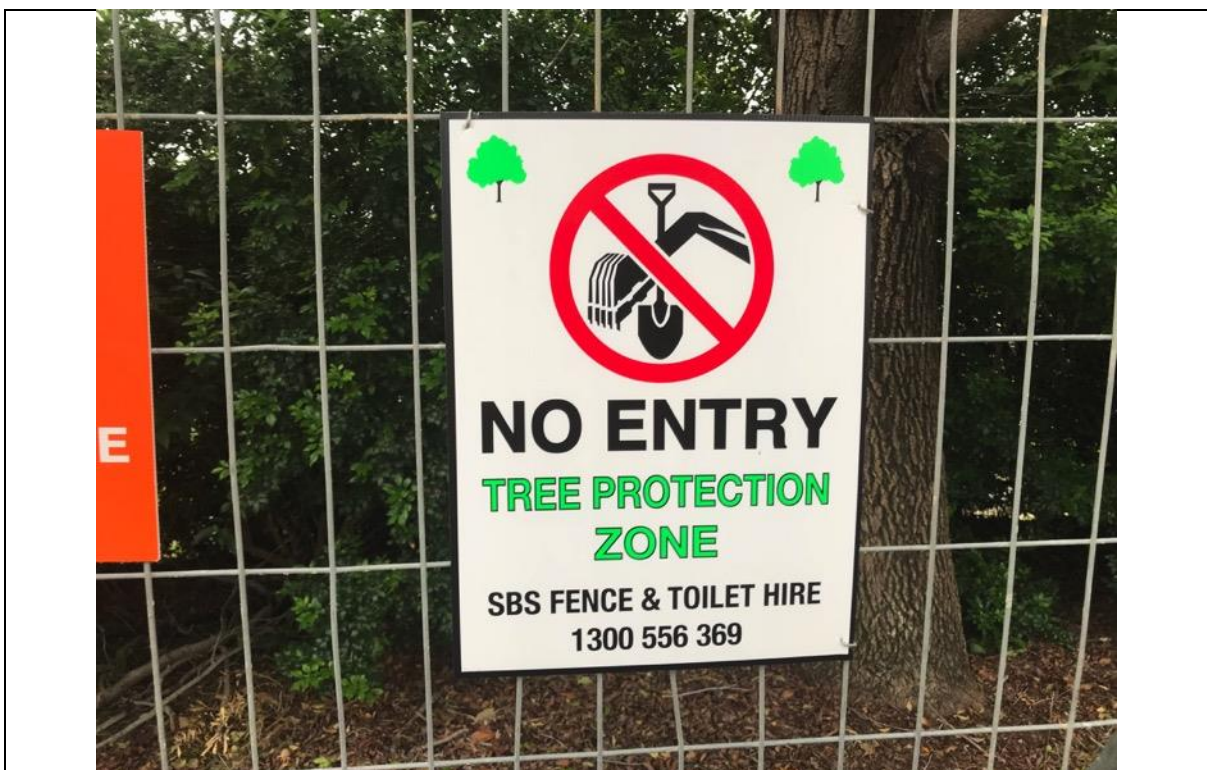
Image N: TPZ signage used on site.
