# Public Infrastructure Condition Survey

(PRE-CONSTRUCTION REPORT)

## The Forest High School Education Precinct

**PUBLIC INFRASTRUCTURE TO  
ALLAMBIE ROAD, ALLAMBIE HEIGHTS AND  
AQUATIC DRIVE, FRENCHS FOREST**

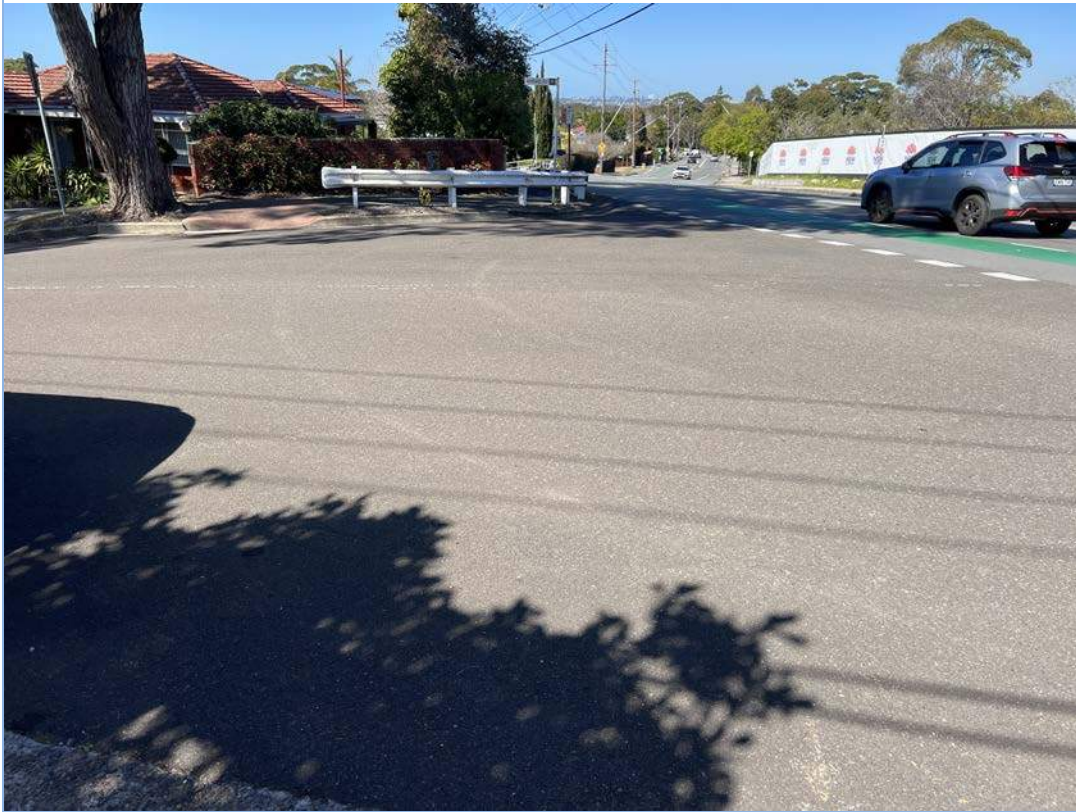
Crack damage throughout the kerb and gutter to the north side of Arnhem Road, Allambie Heights.

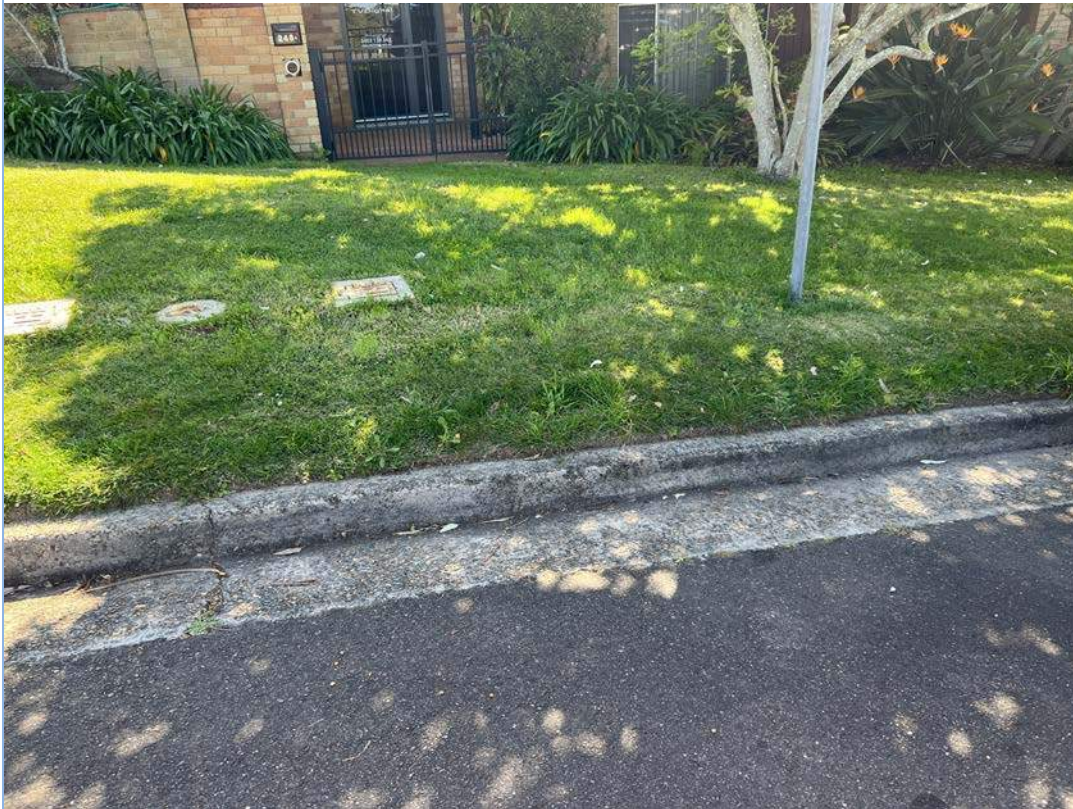
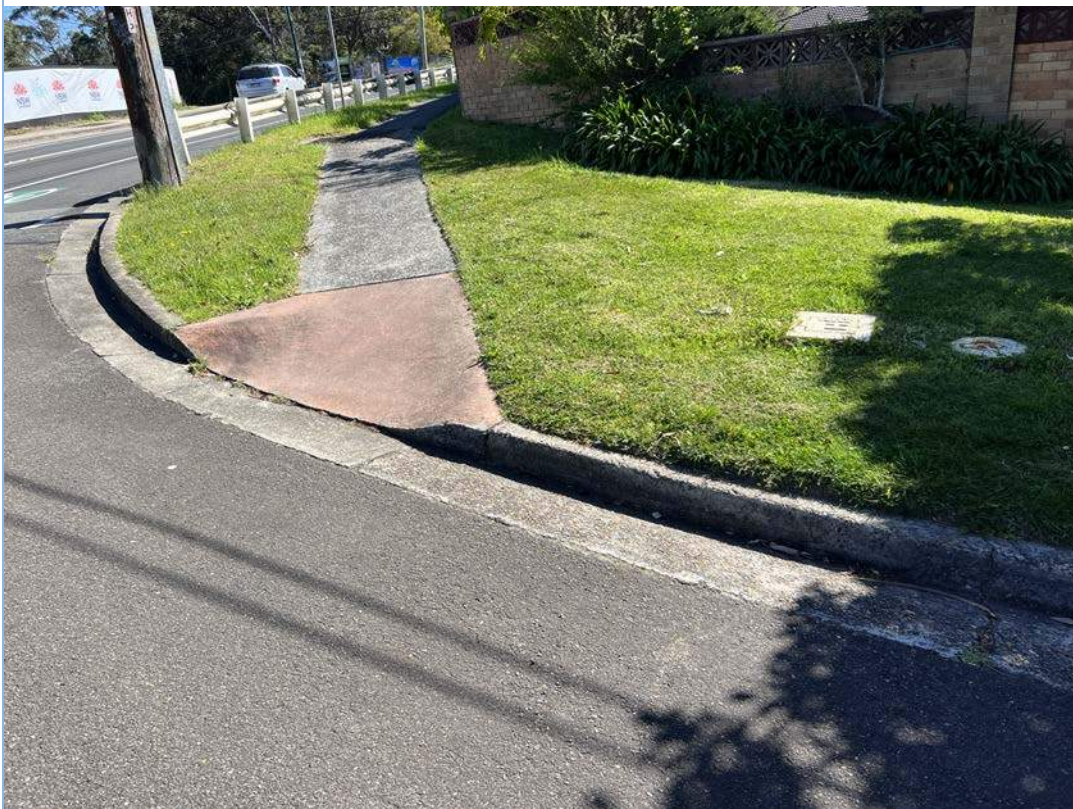
Crack damage throughout the kerb and gutter to the north side of Arnhem Road, Allambie Heights.

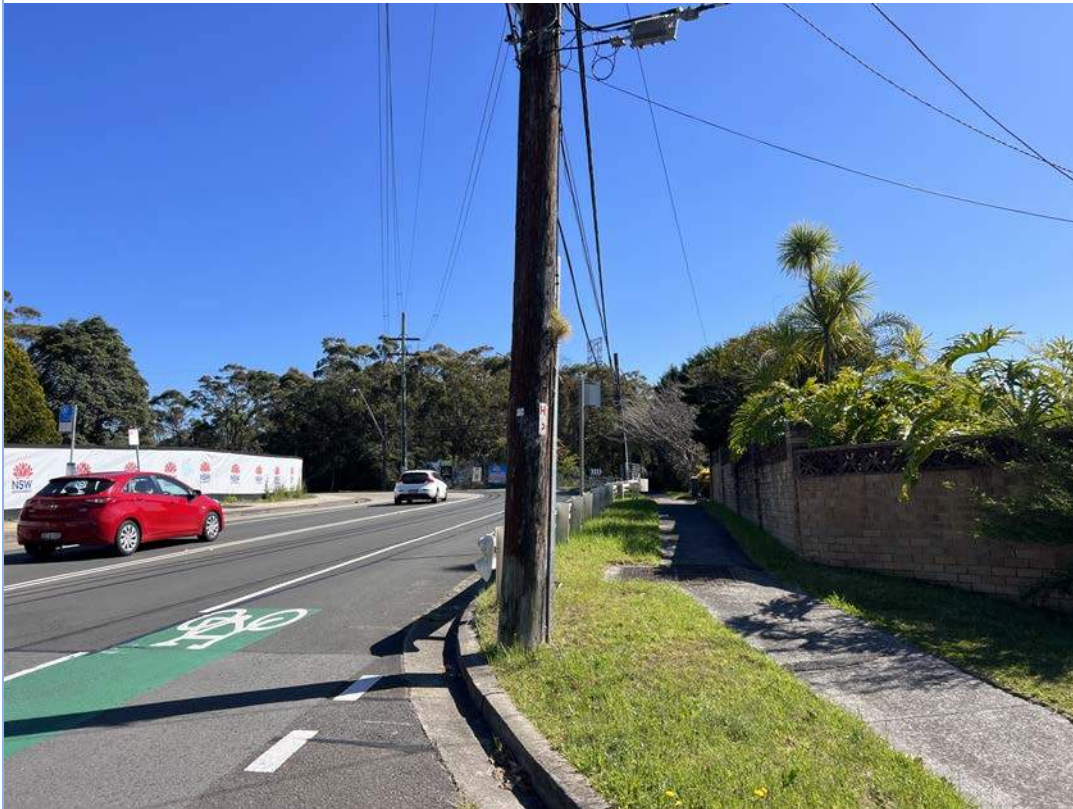
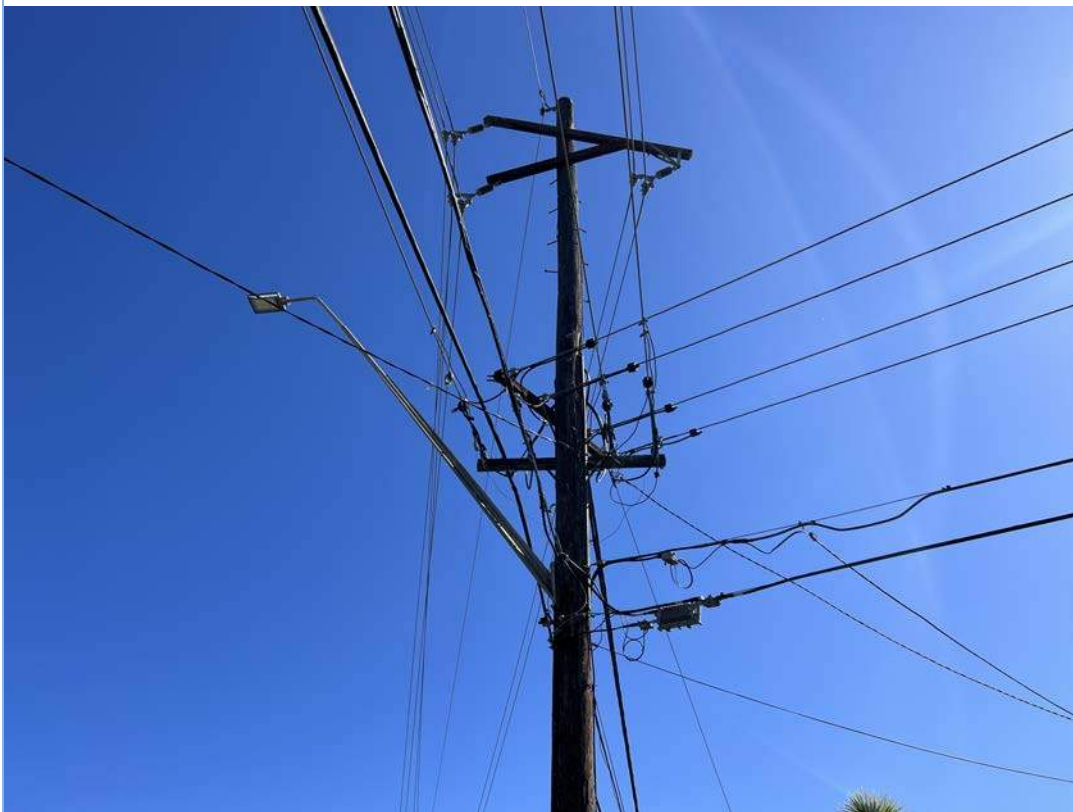
Kerb and gutter showing crack damage and lifting of the expansion joints of Arnhem Road, south side.

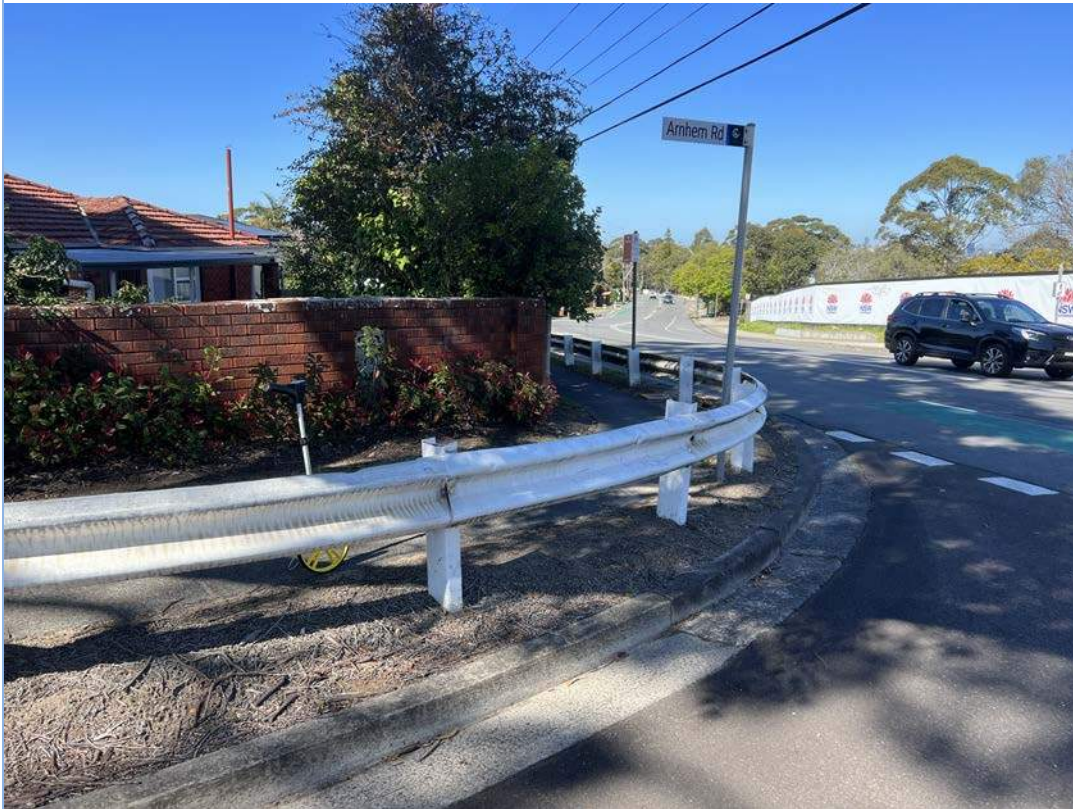
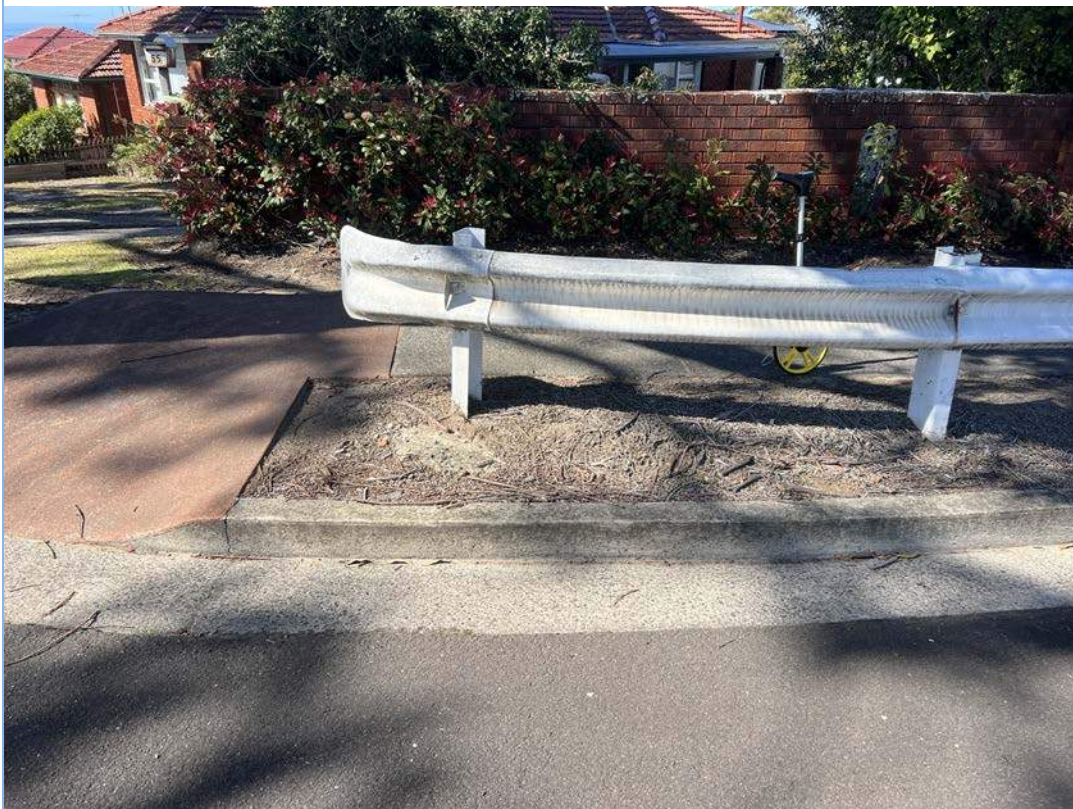
Kerb and gutter showing crack damage and lifting of the expansion joints of Arnhem Road, south side.

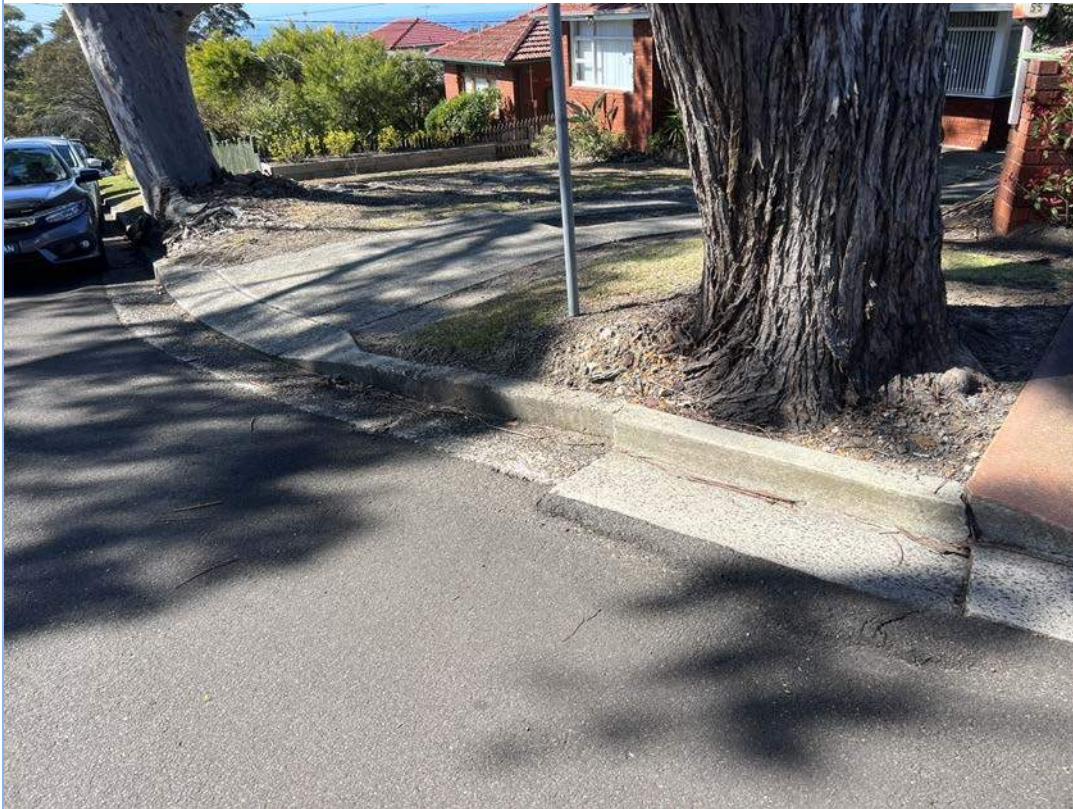
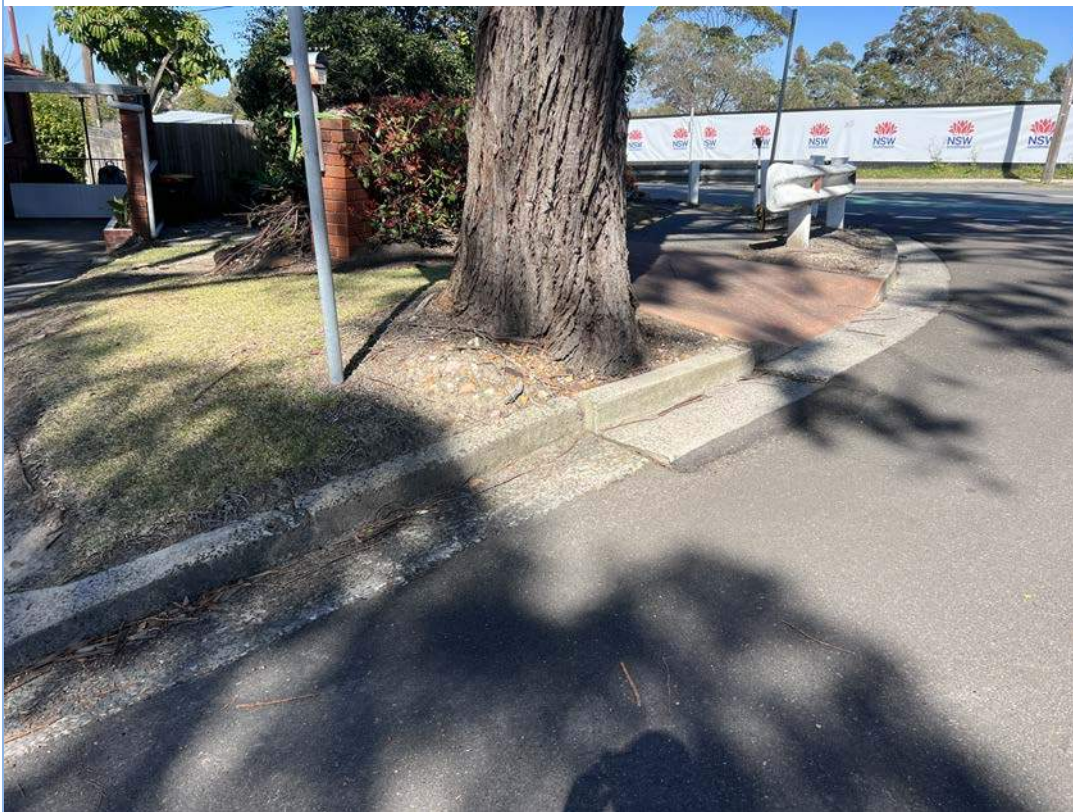
Road surface showing crack damage and lifting at the south side of Arnhem Road, Allambie Heights.

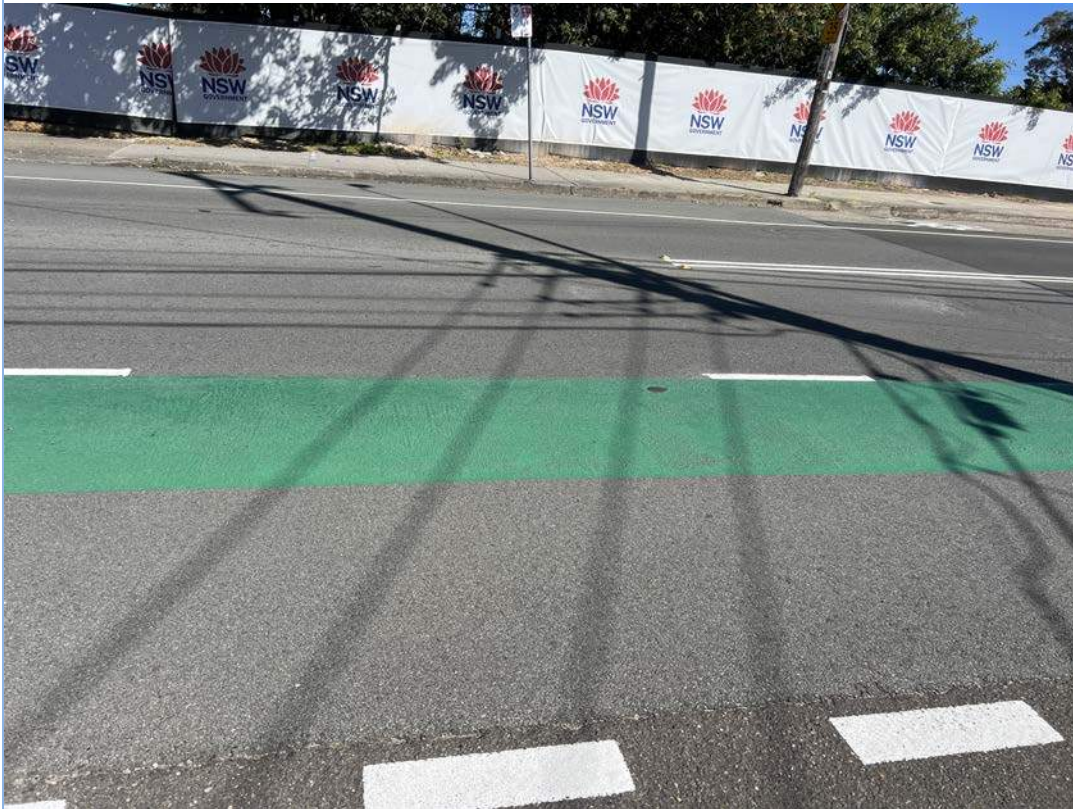
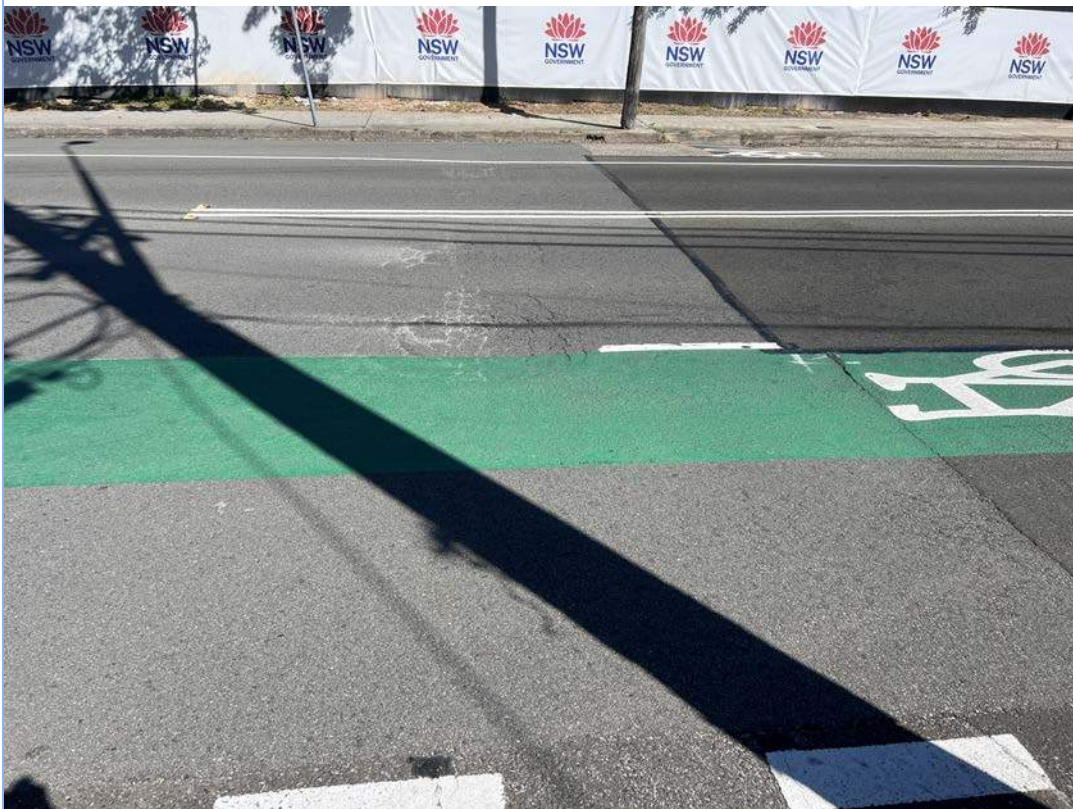
Crocodile cracking and subsidence to the road surface at the intersection of Arnhem Road and Allambie Road, Allambie Heights.

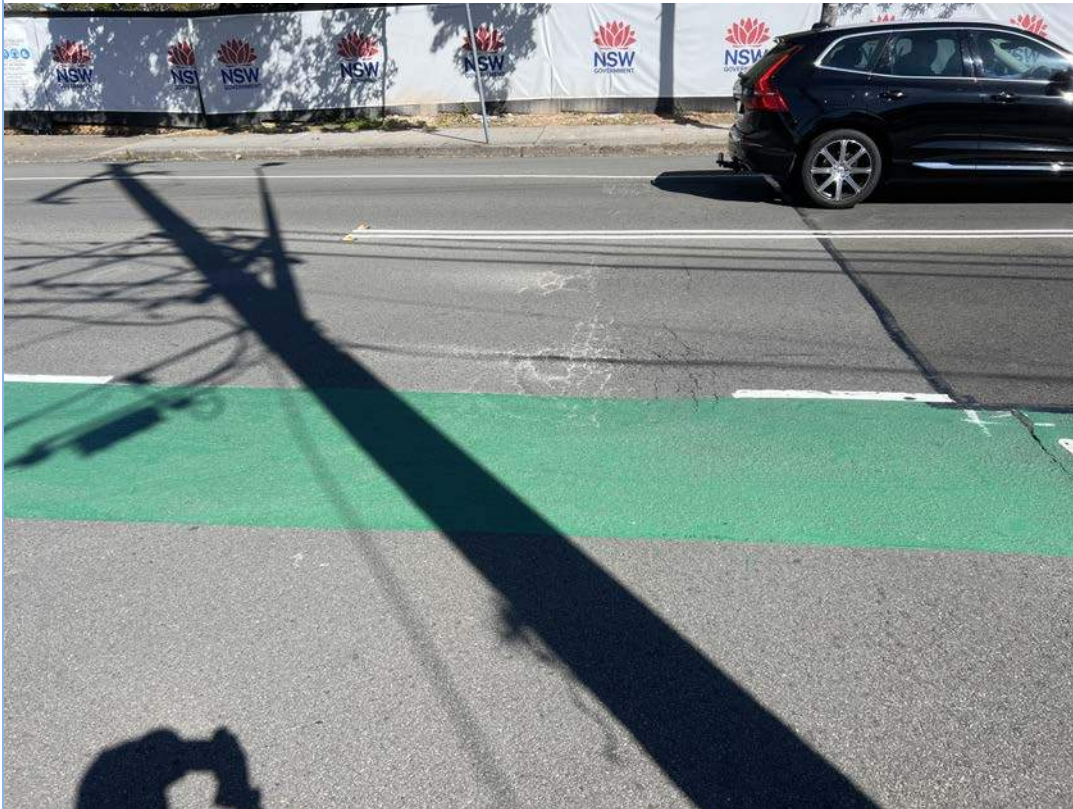
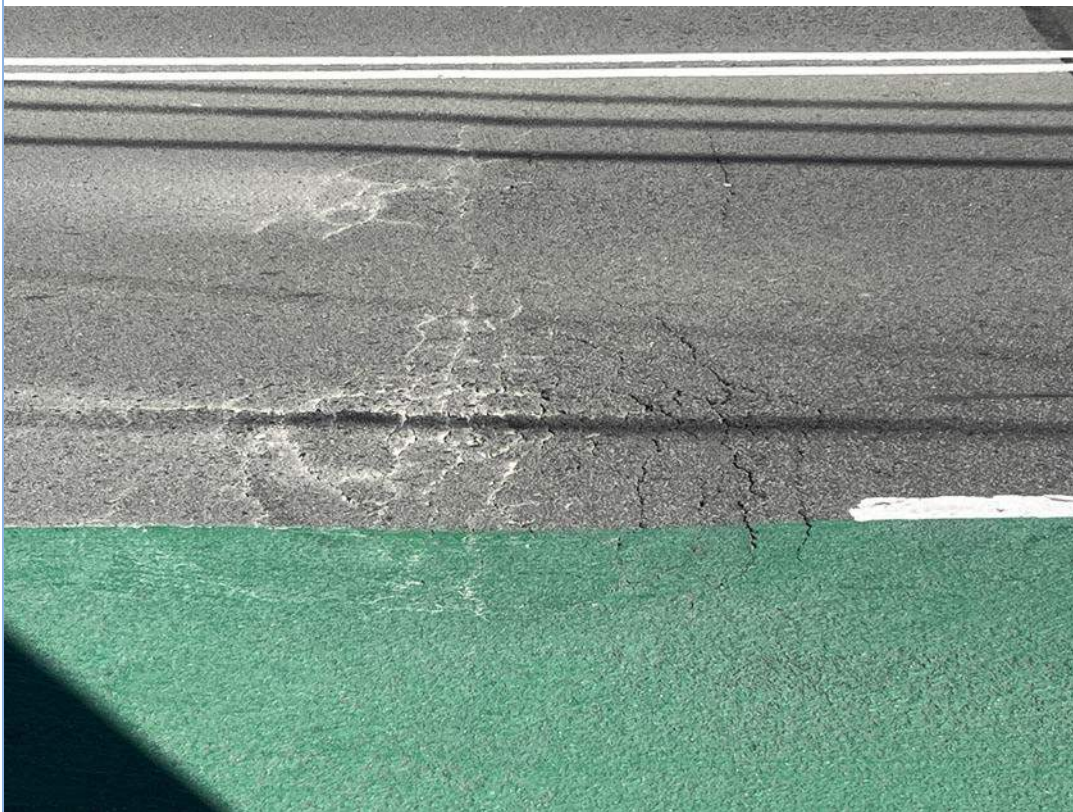
Crocodile cracking and subsidence to the road surface at the intersection of Arnhem Road and Allambie Road, Allambie Heights.

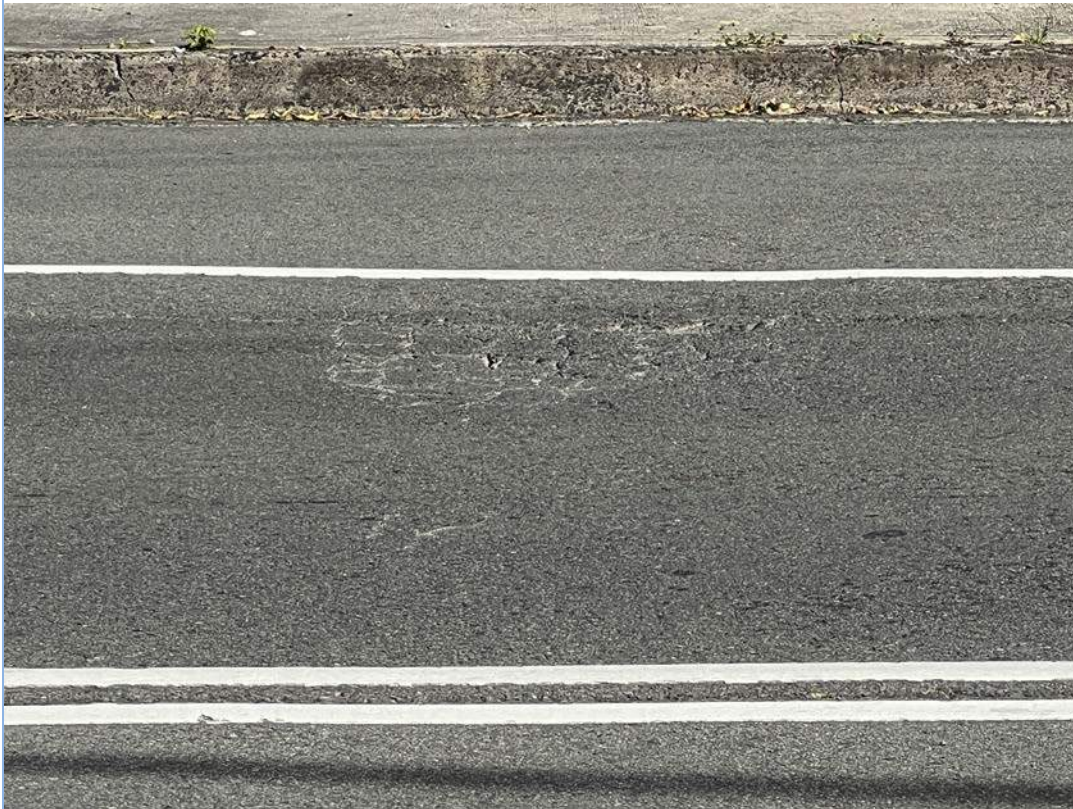
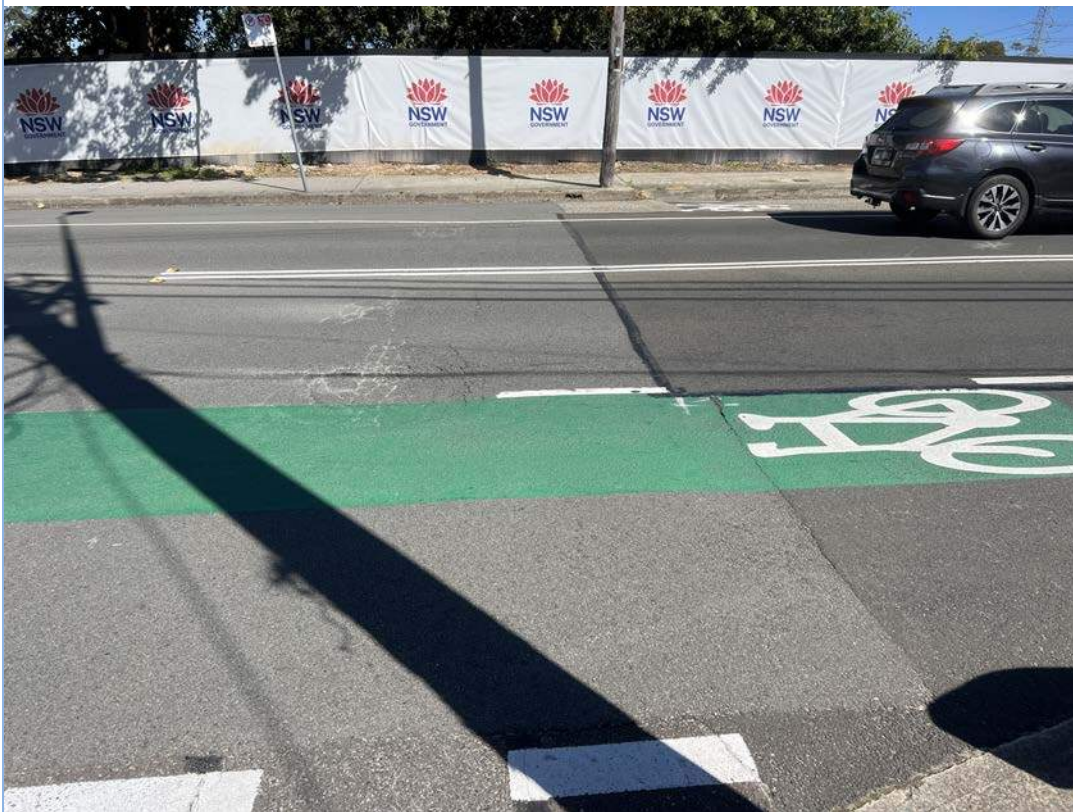
Crocodile cracking and subsidence to the road surface at the intersection of Arnhem Road and Allambie Road, Allambie Heights.

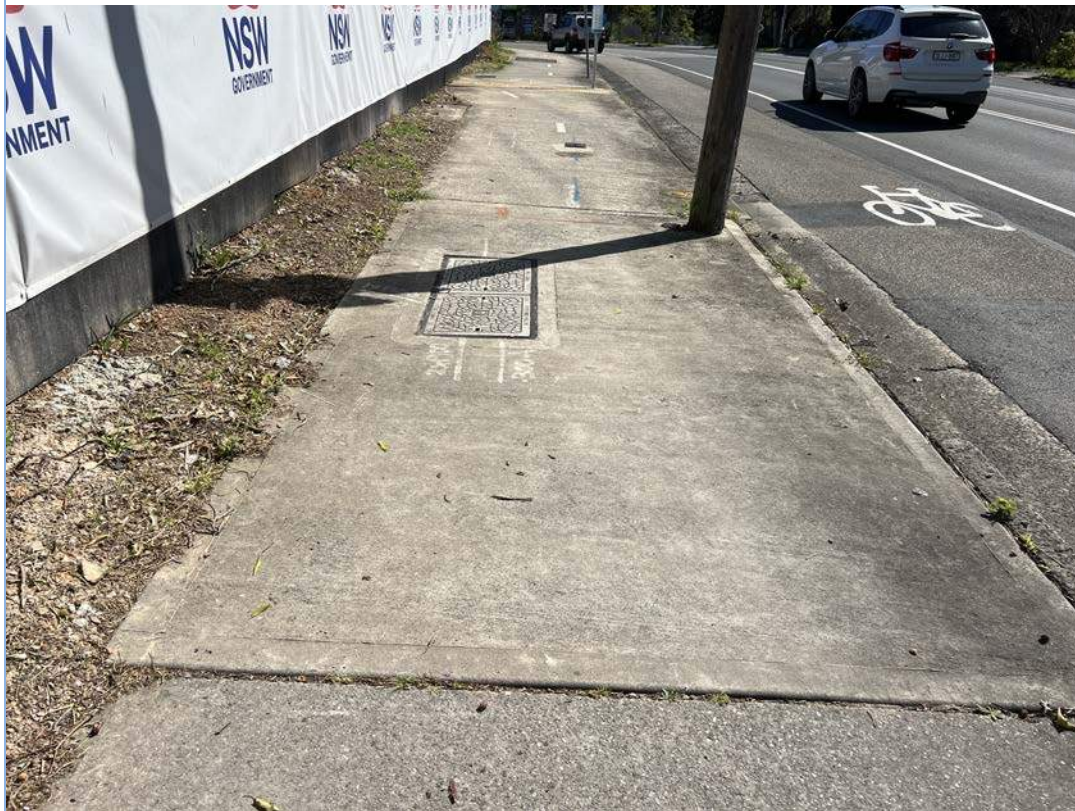
Kerb, gutter, driveway and layback showing multiple cracks on the west side of the intersection of Arnhem Road and Allambie Road, Allambie Heights.

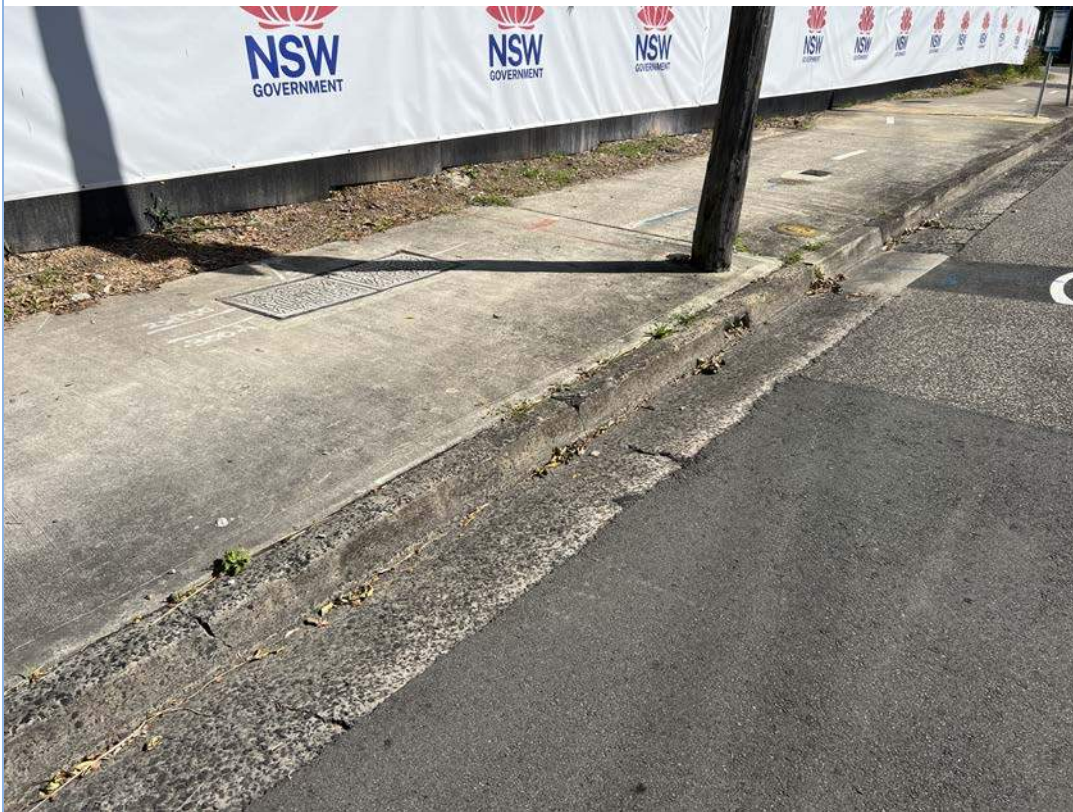
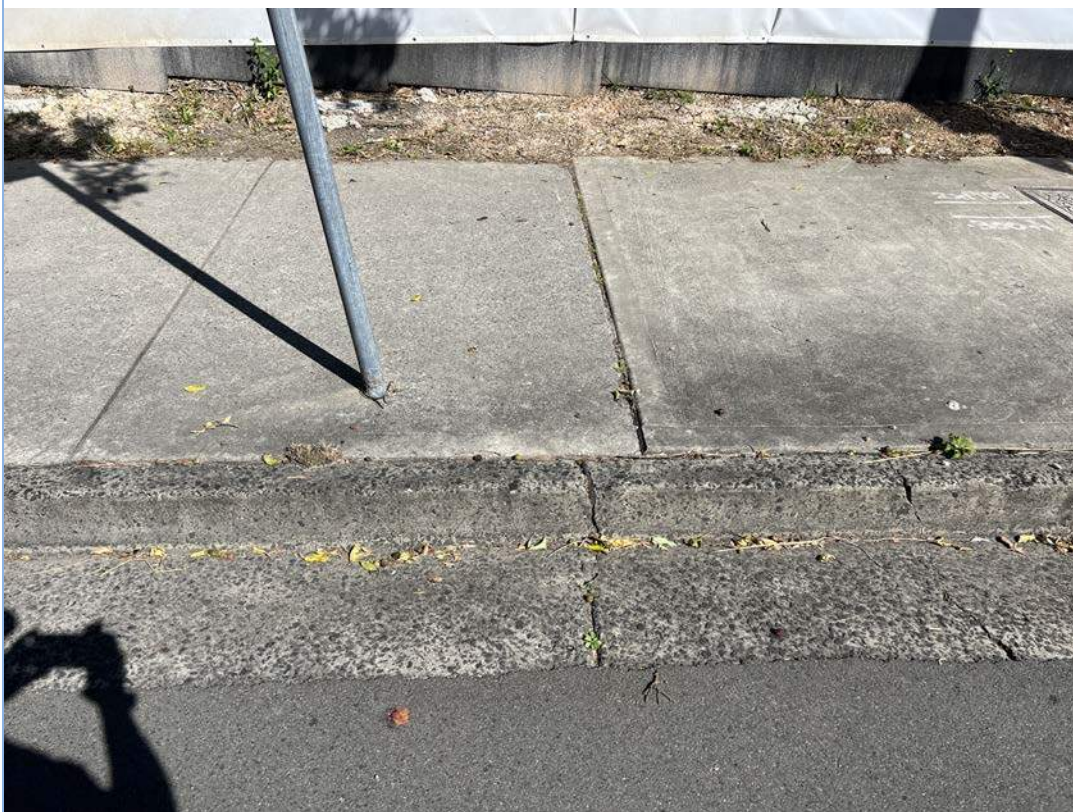
Kerb, gutter, driveway and layback showing multiple cracks on the west side of the intersection of Arnhem Road and Allambie Road, Allambie Heights.

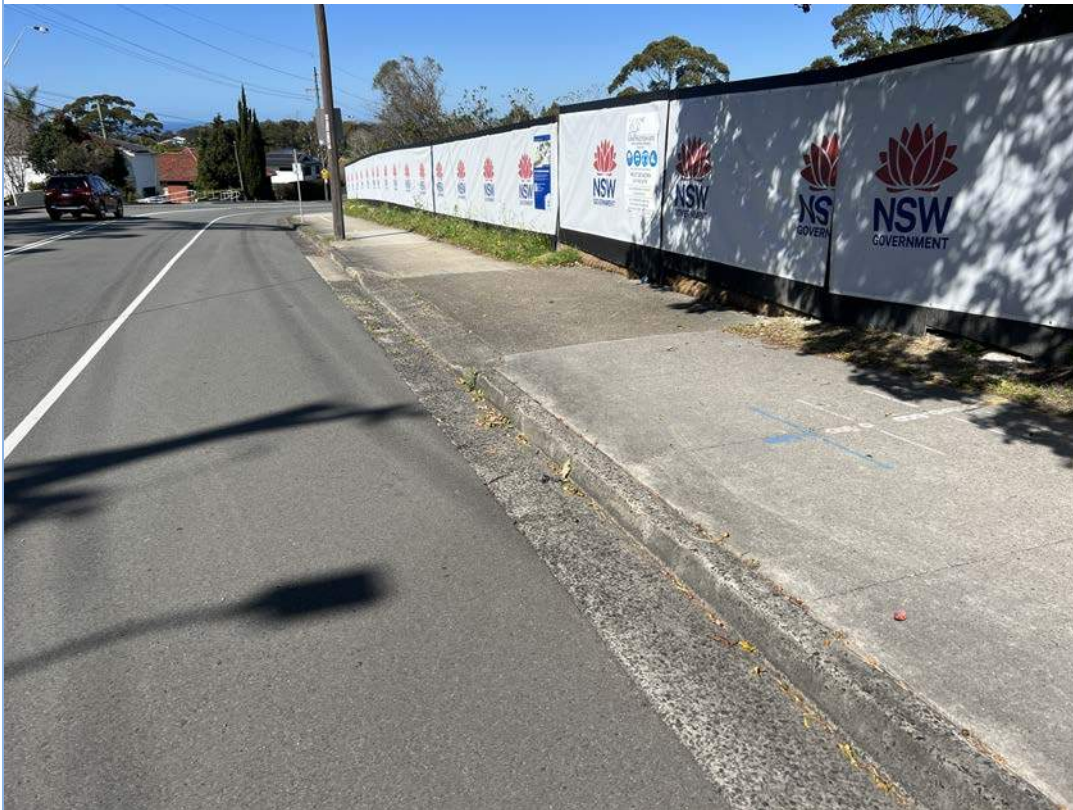
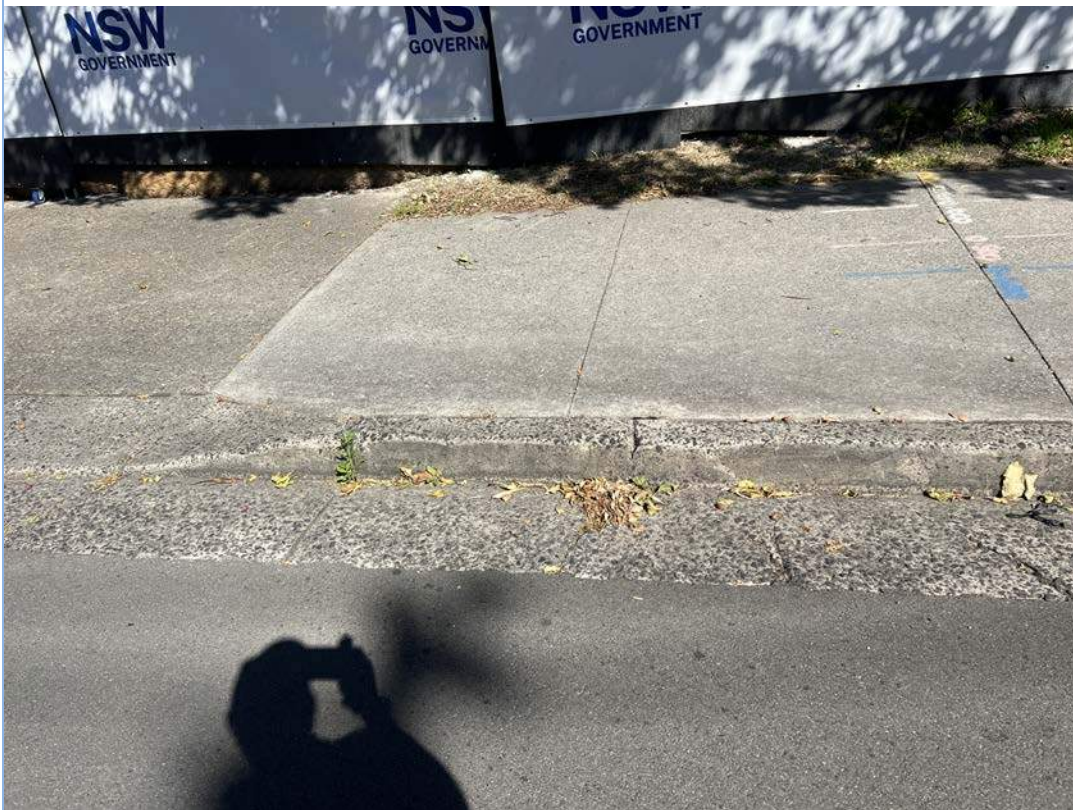
Kerb, gutter, driveway and layback showing multiple cracks on the west side of the intersection of Arnhem Road and Allambie Road, Allambie Heights.

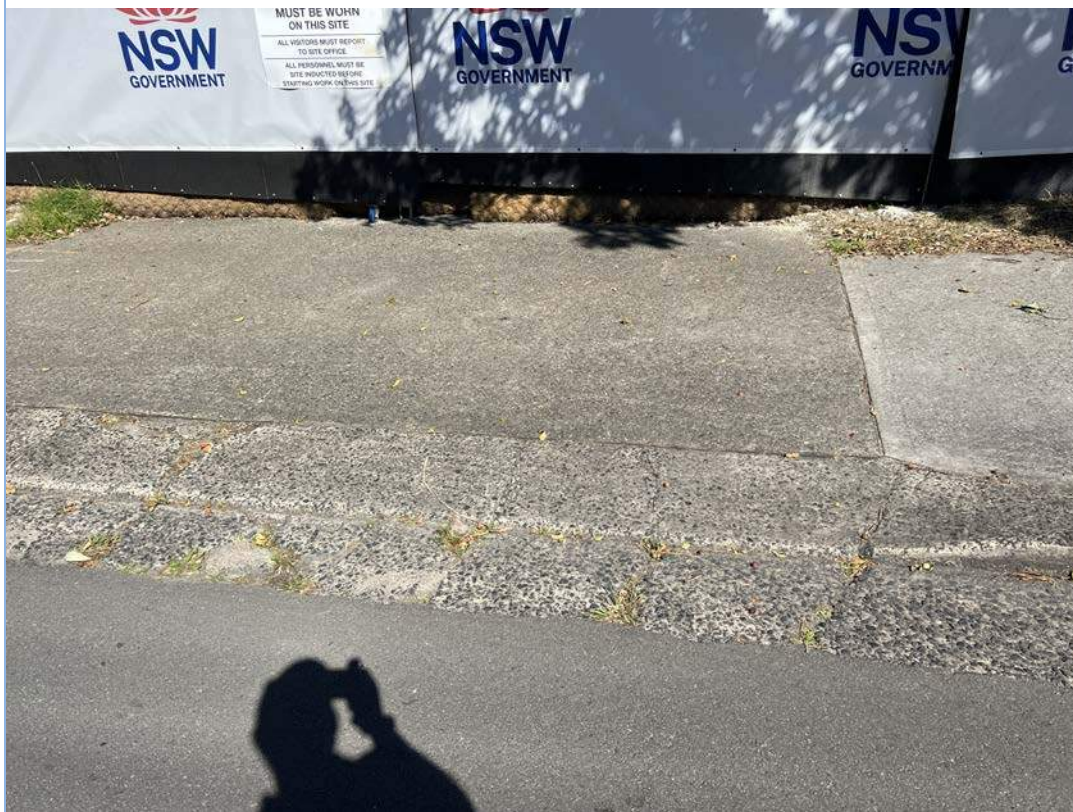
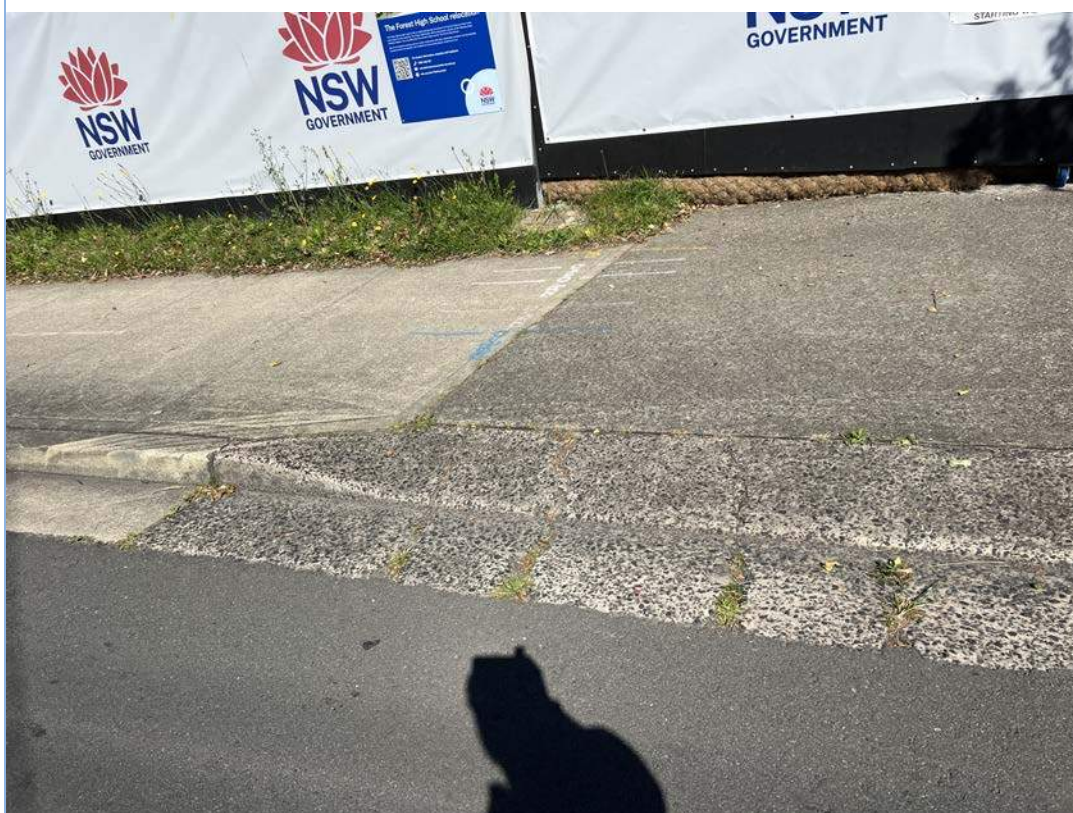
Kerb, gutter, driveway and layback showing multiple cracks on the west side of the intersection of Arnhem Road and Allambie Road, Allambie Heights.

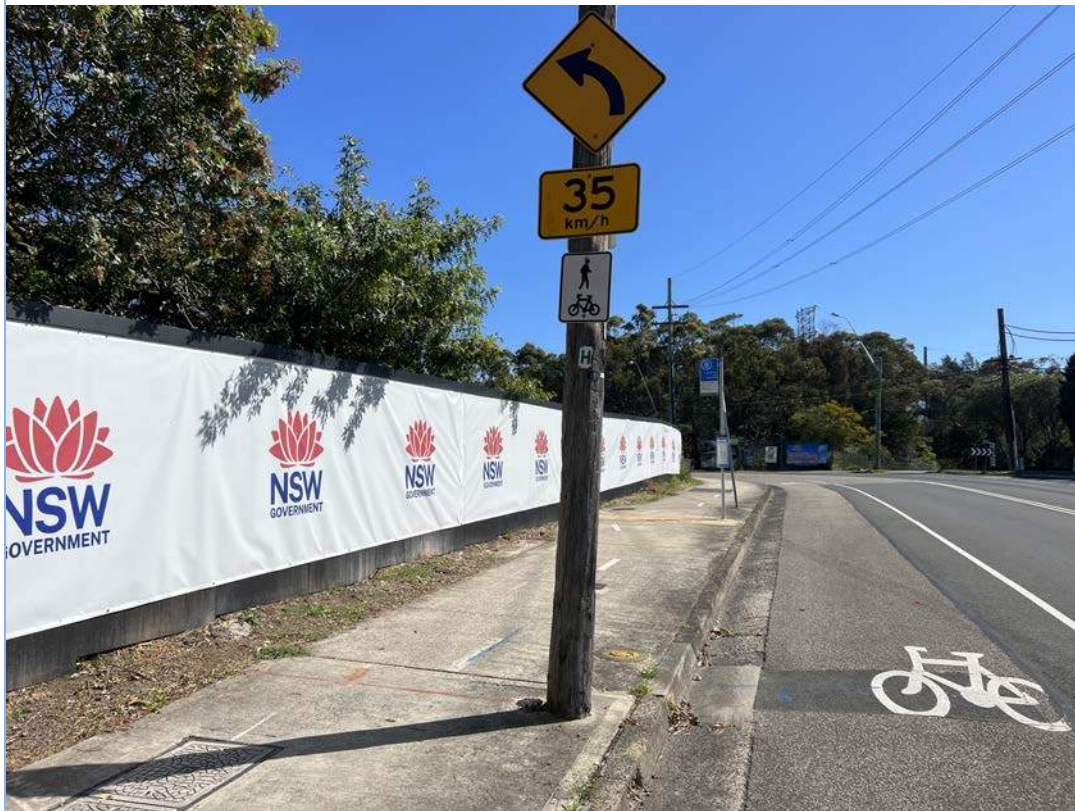
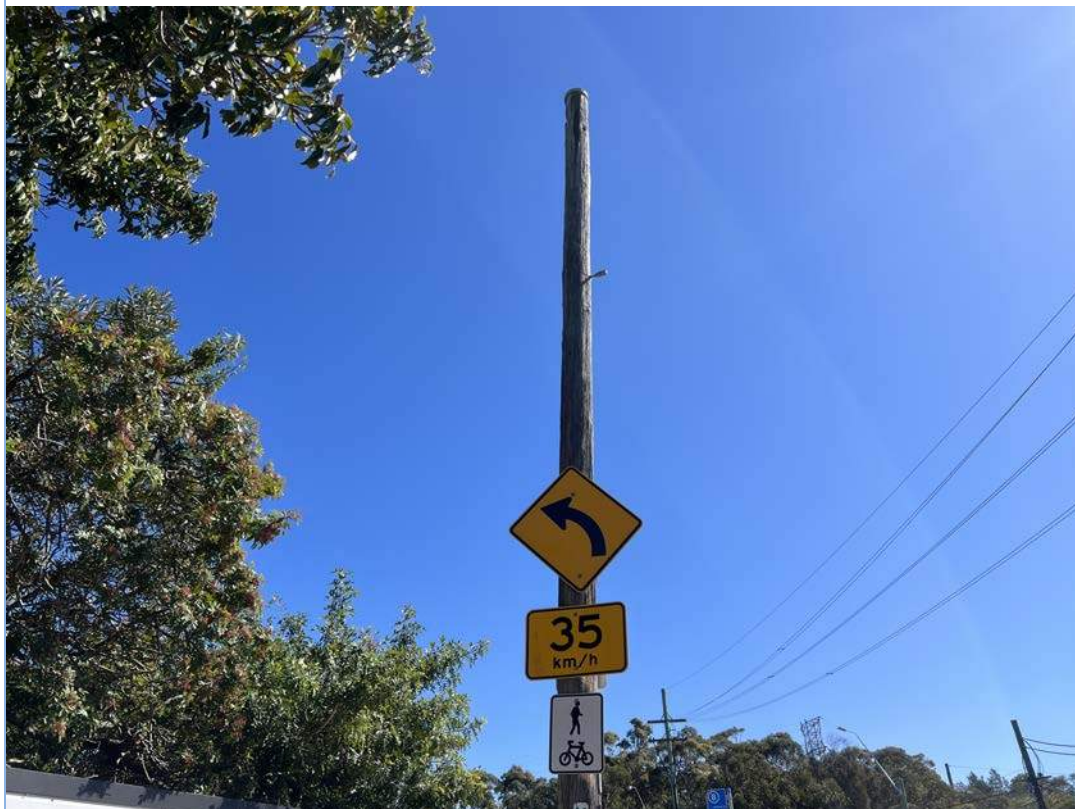
Street sign is leaning southward.
