The following inspection is of the road surface, kerb and gutter to the eastern side of Allambie Road starting from the intersection of Sunlea Place and heading towards the intersection of Arnhem Road.

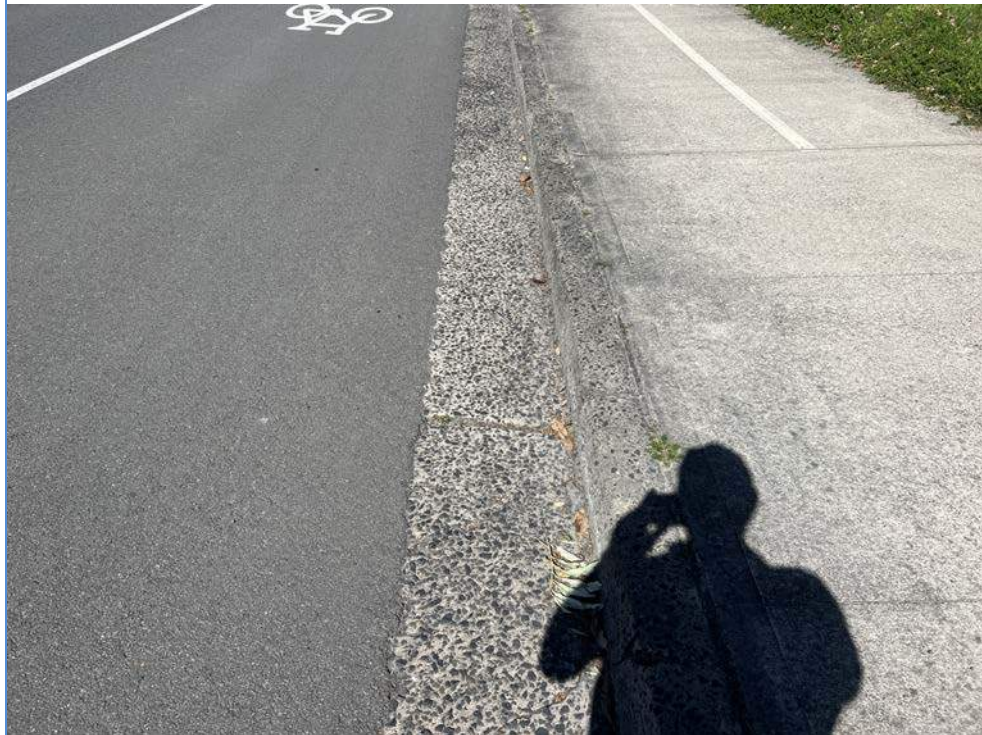
40m

Crack damage to the kerb and gutter.

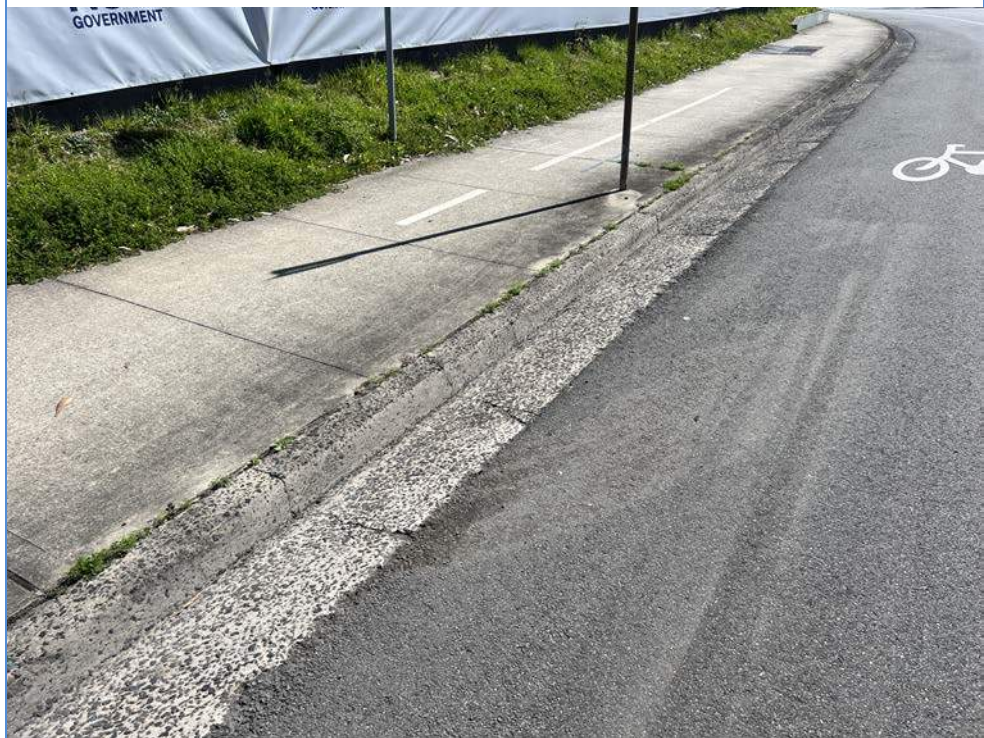
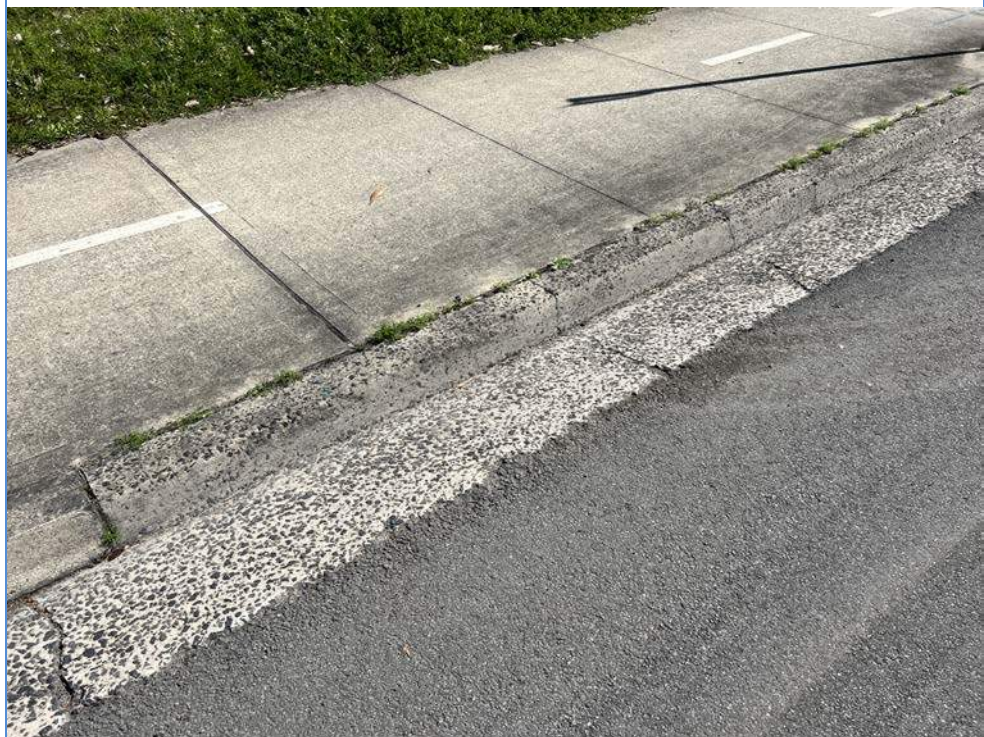
60m

Crack damage to the kerb and gutter.

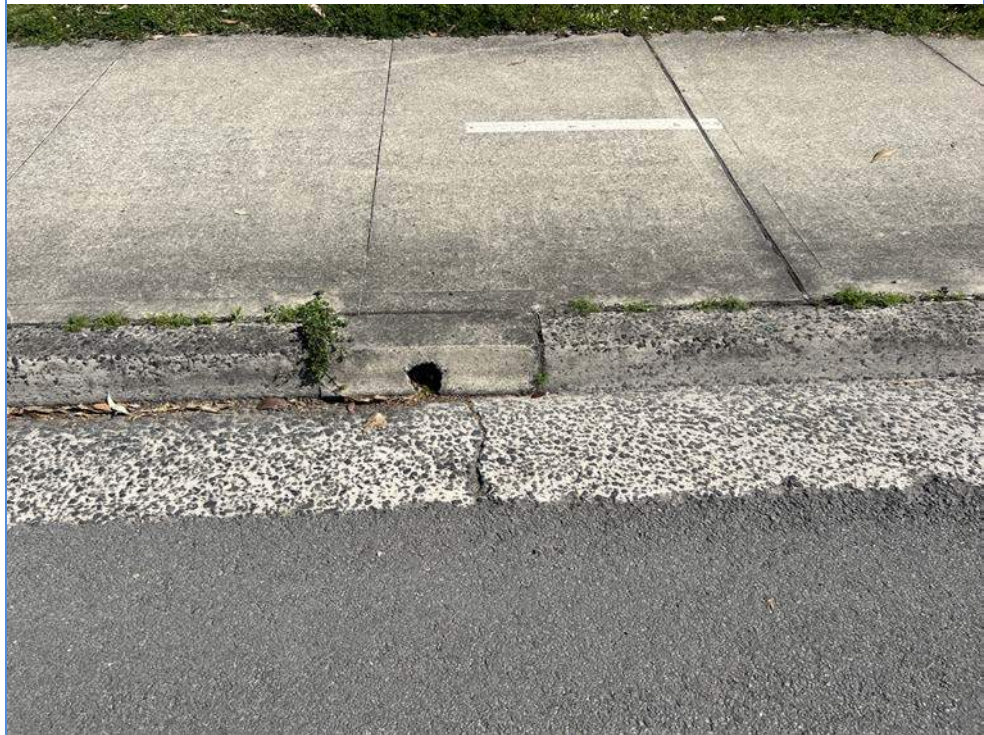
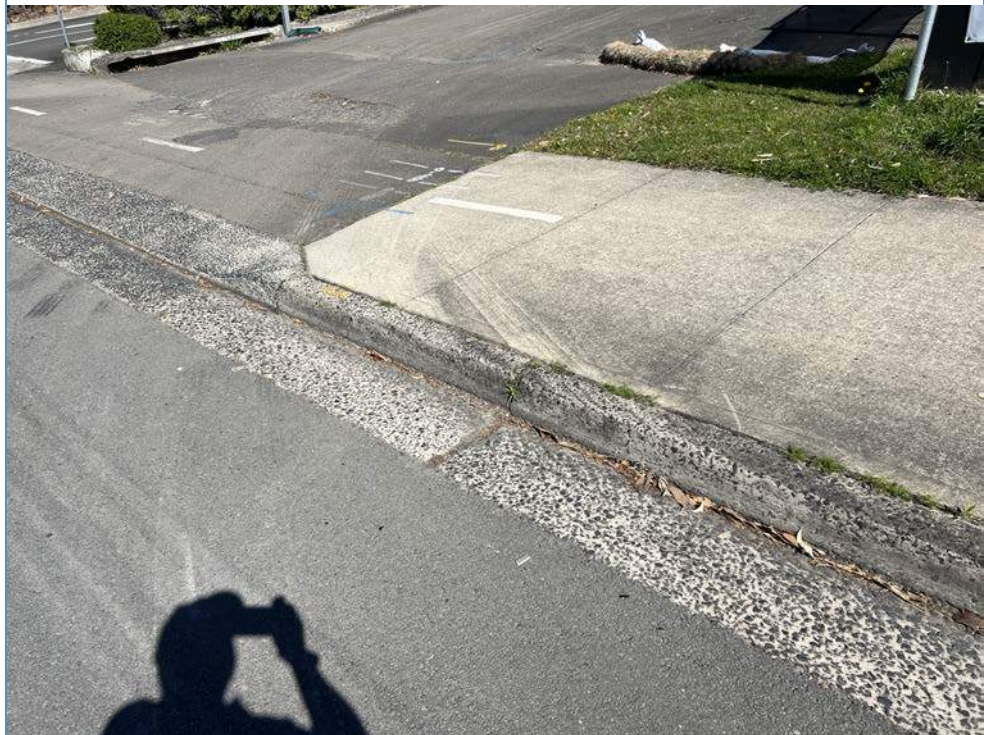
60m

Crack damage to the kerb and gutter.

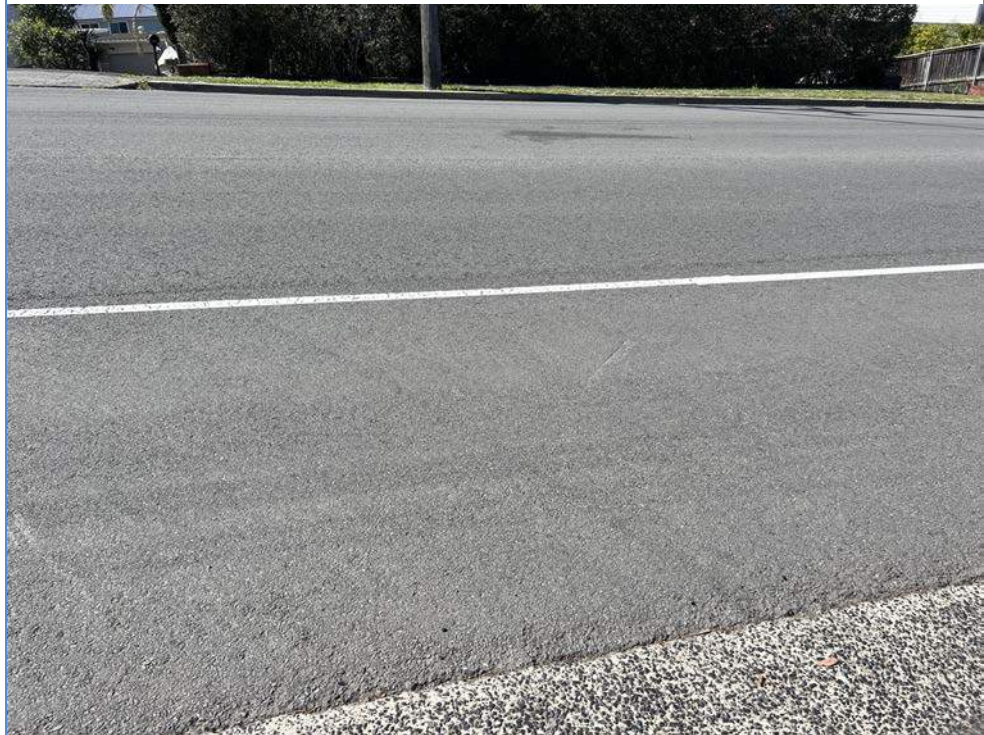
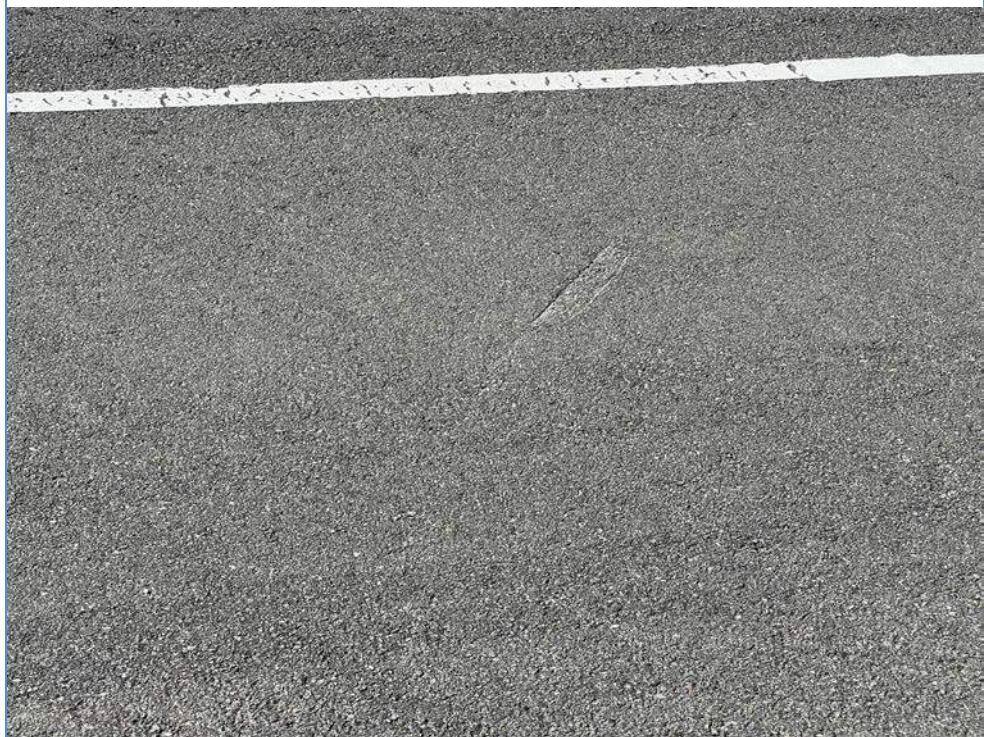
70m

Gouging to the road surface.

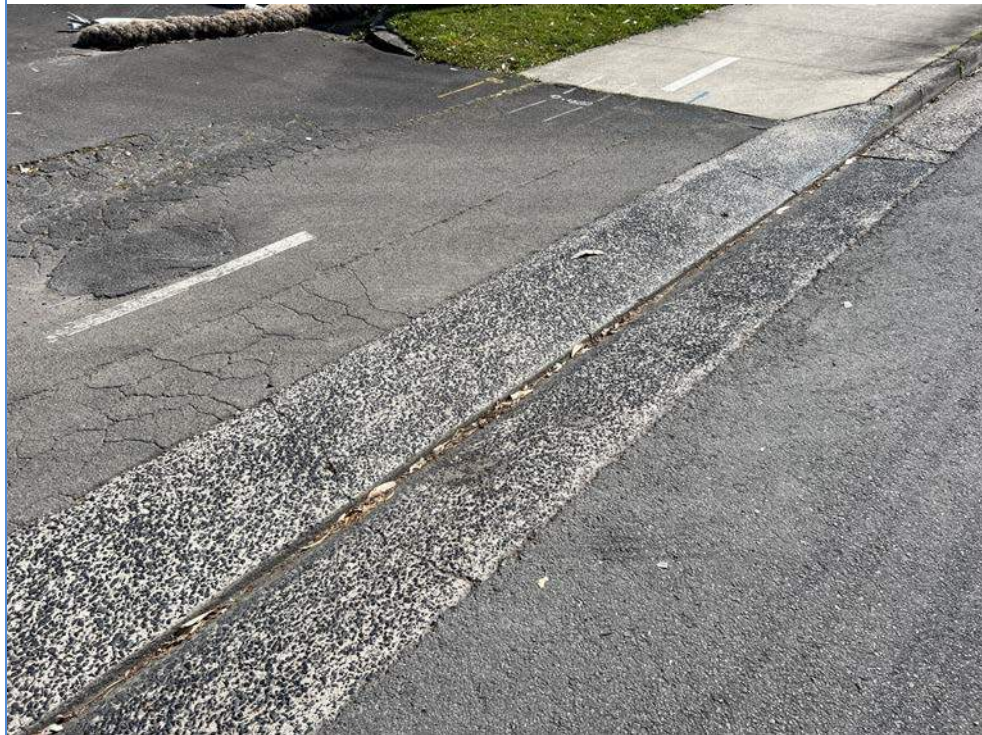
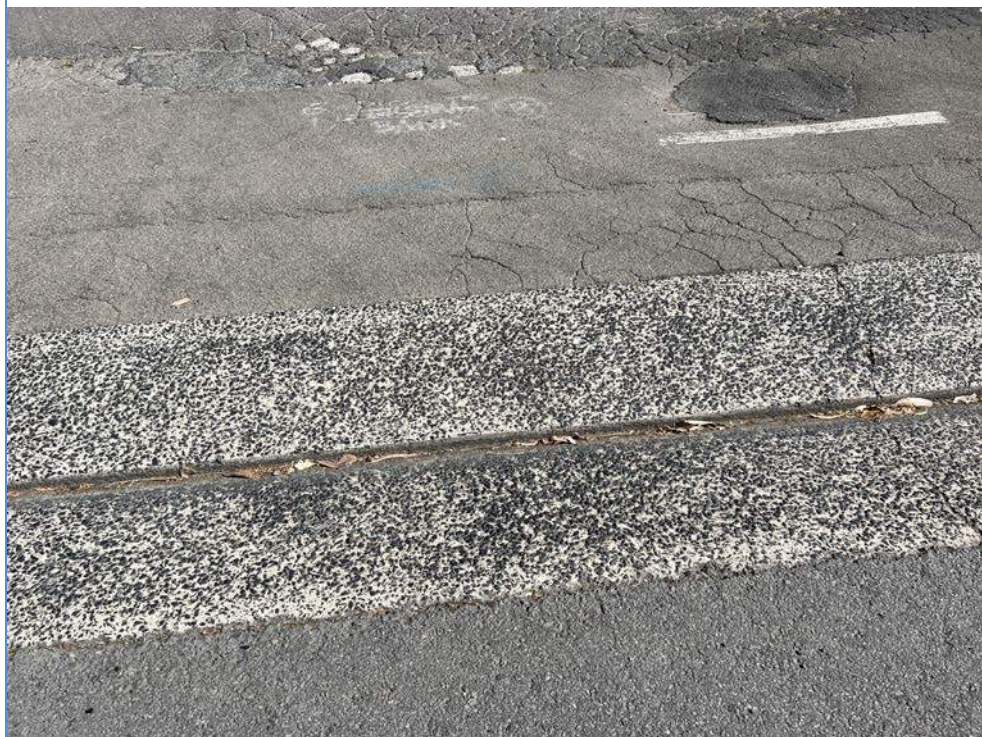
70m

Views of the layback and gutter showing multiple cracks.

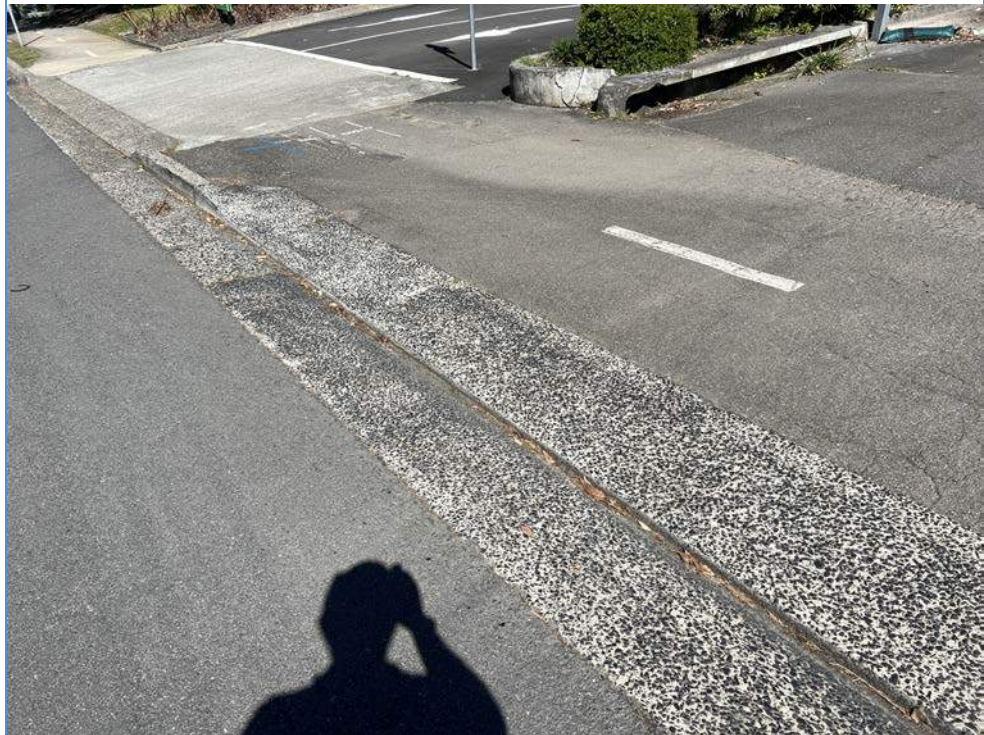
70m

Views of the layback and gutter showing multiple cracks.

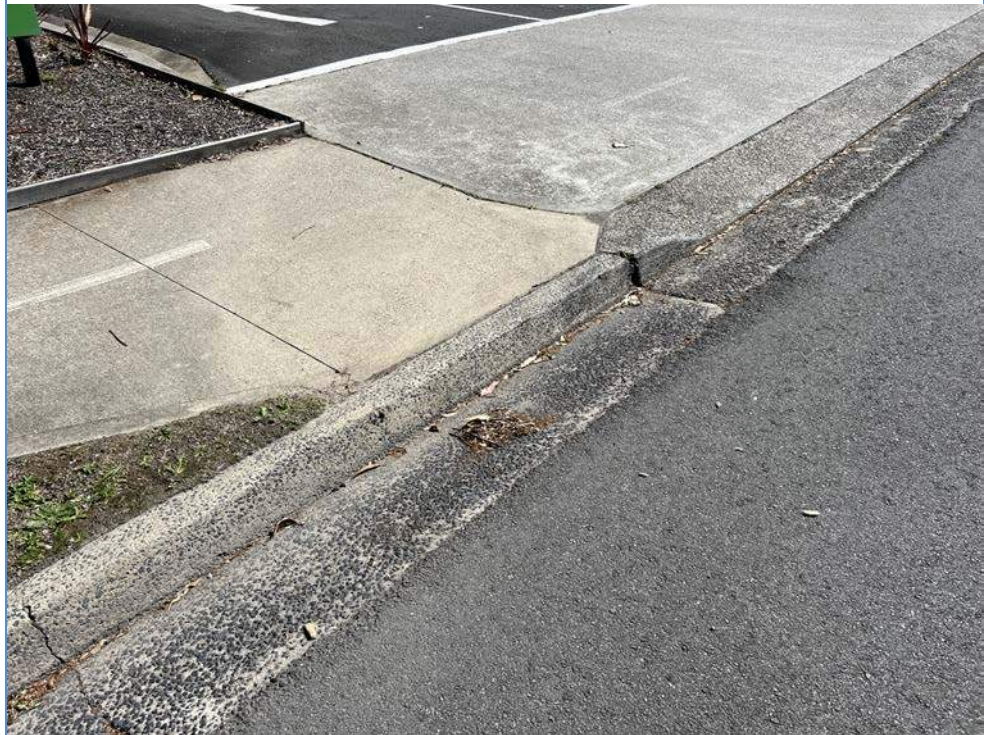
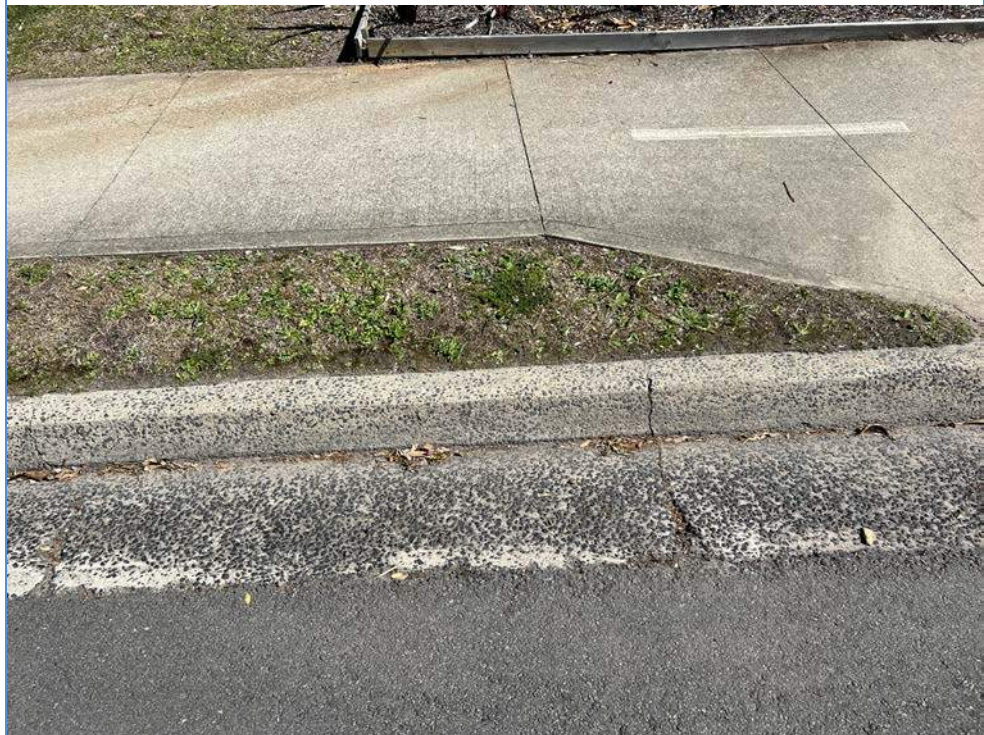
90m

Crack damage to the kerb and gutter.

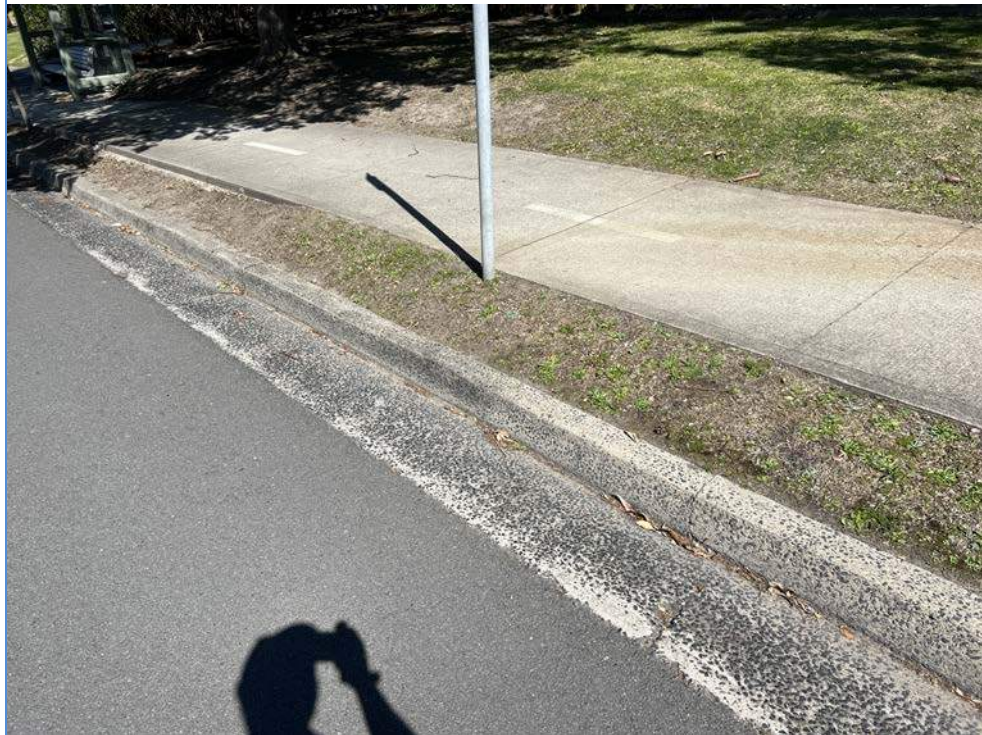
90m

Crack damage to the kerb and gutter.

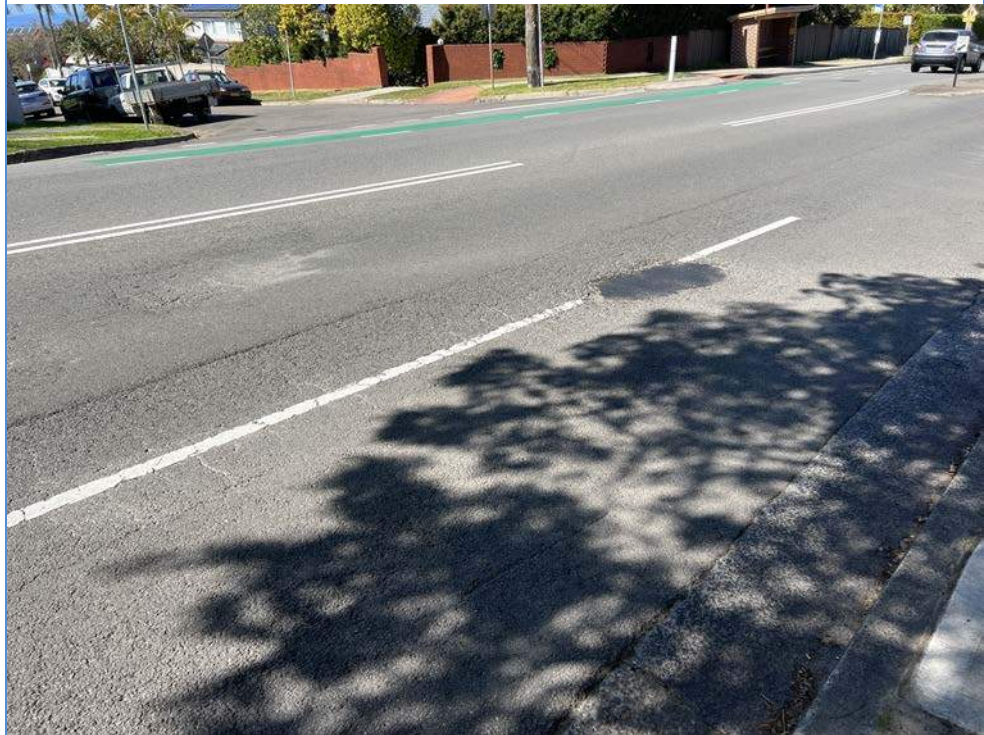
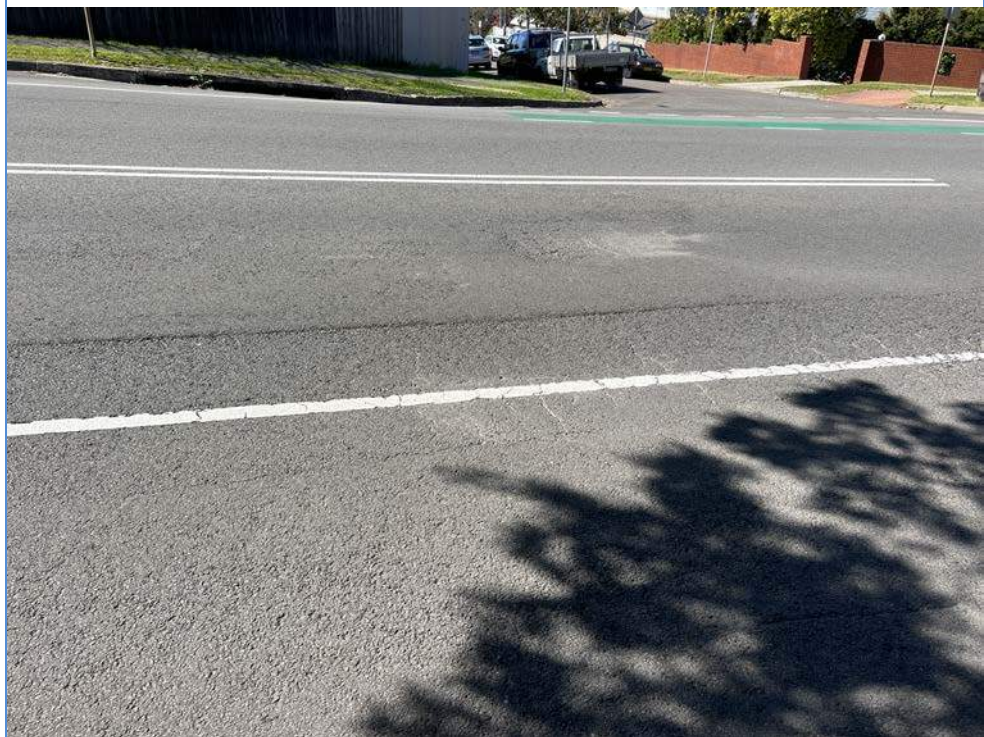
100m

Various cracks and potholes to the road surface.

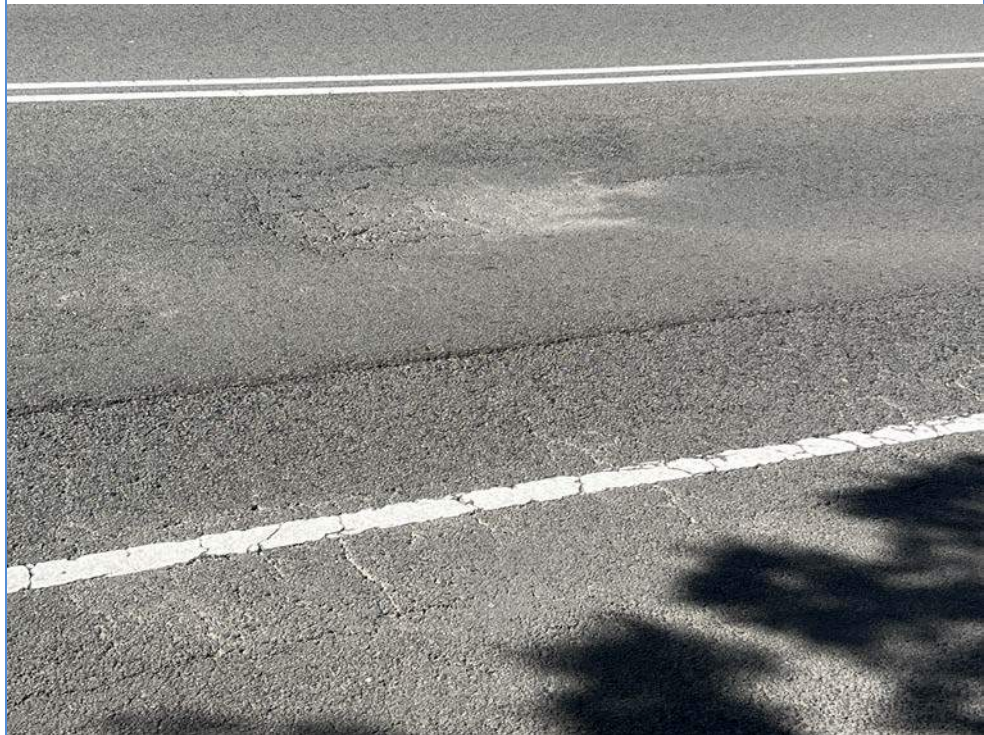
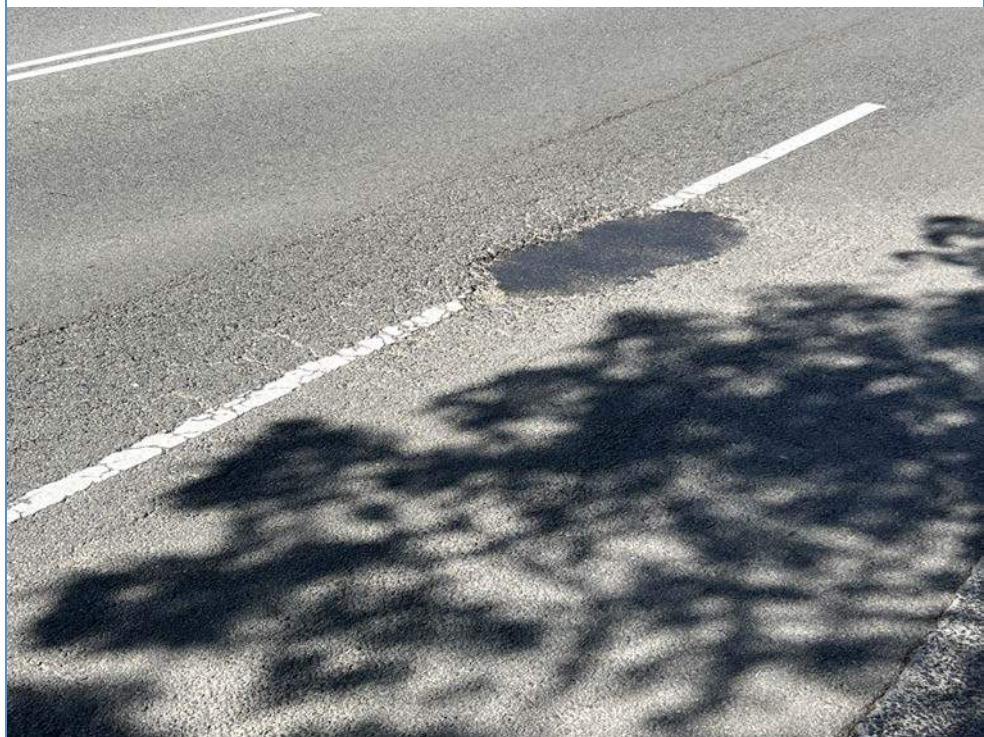
100m

Various cracks and potholes to the road surface.

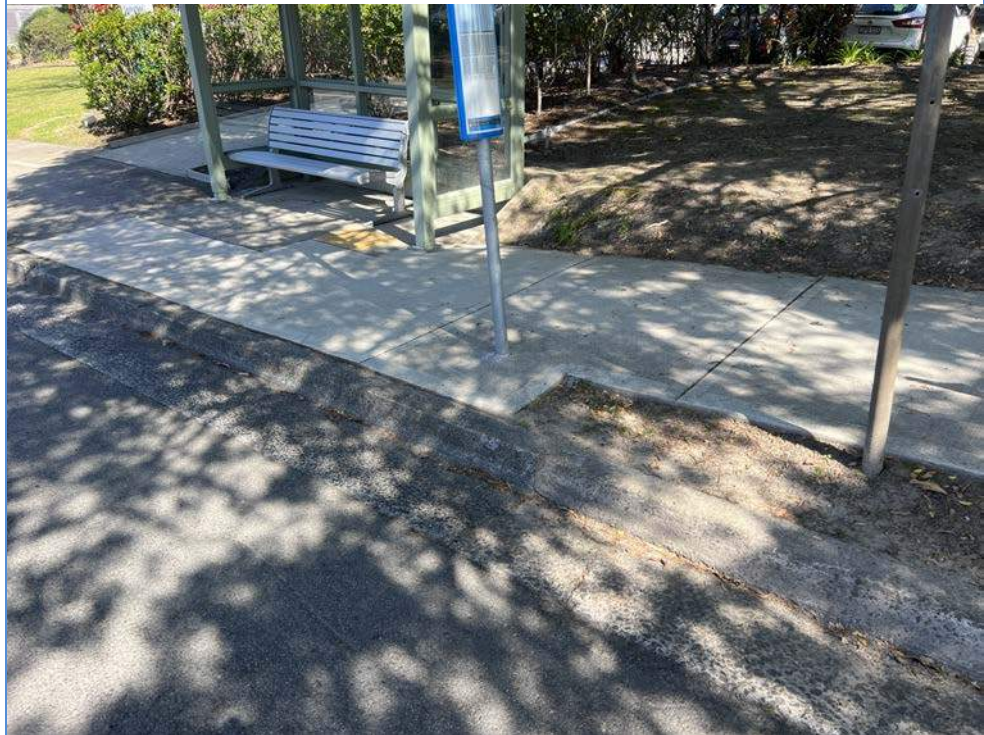
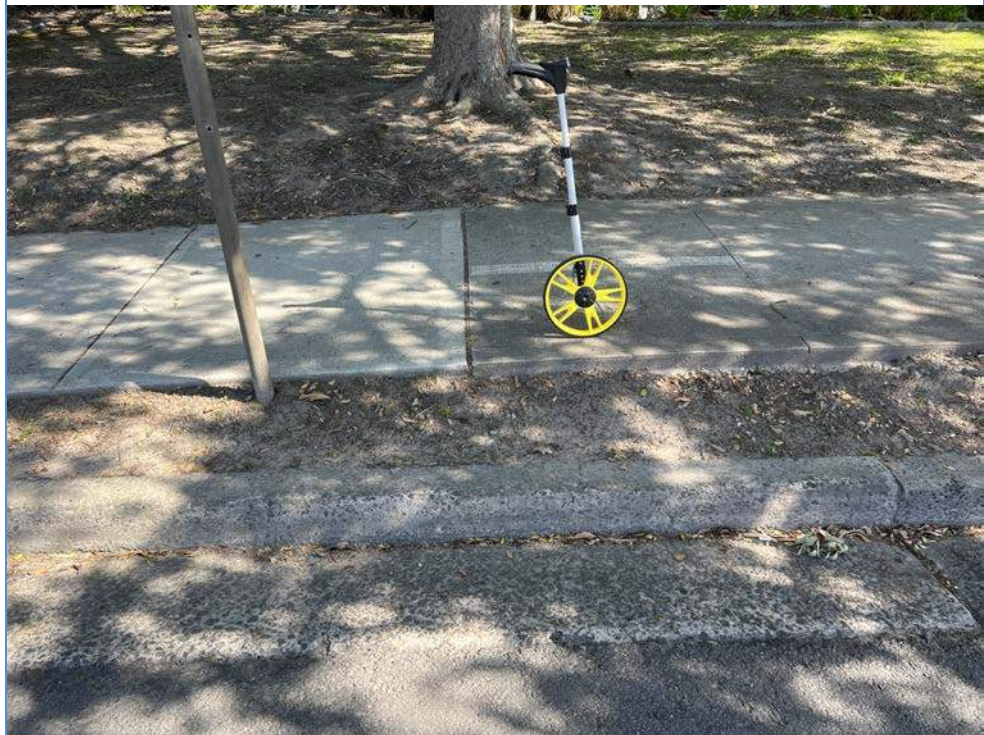
100m

Crack damage to the kerb and gutter.

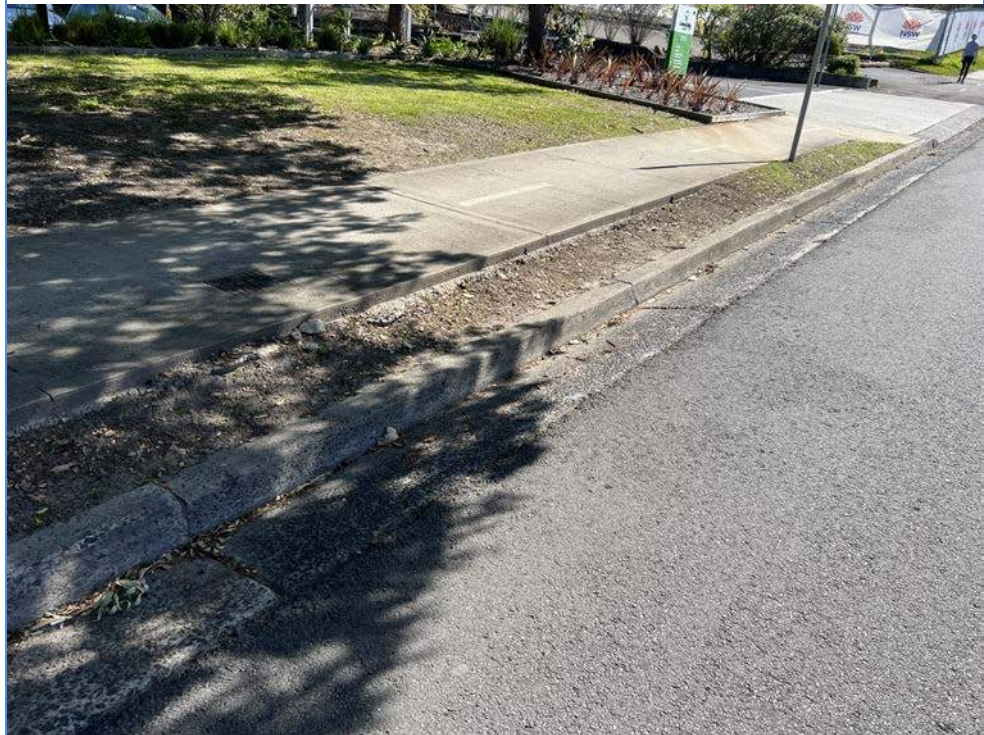
100m

Crack damage to the kerb and gutter.

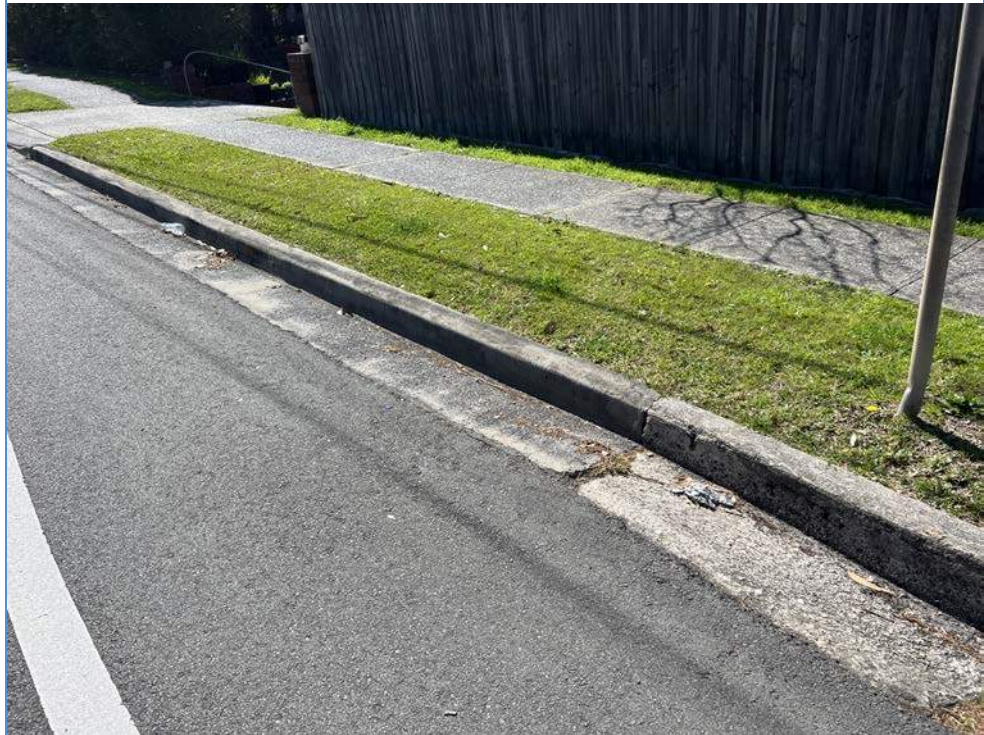
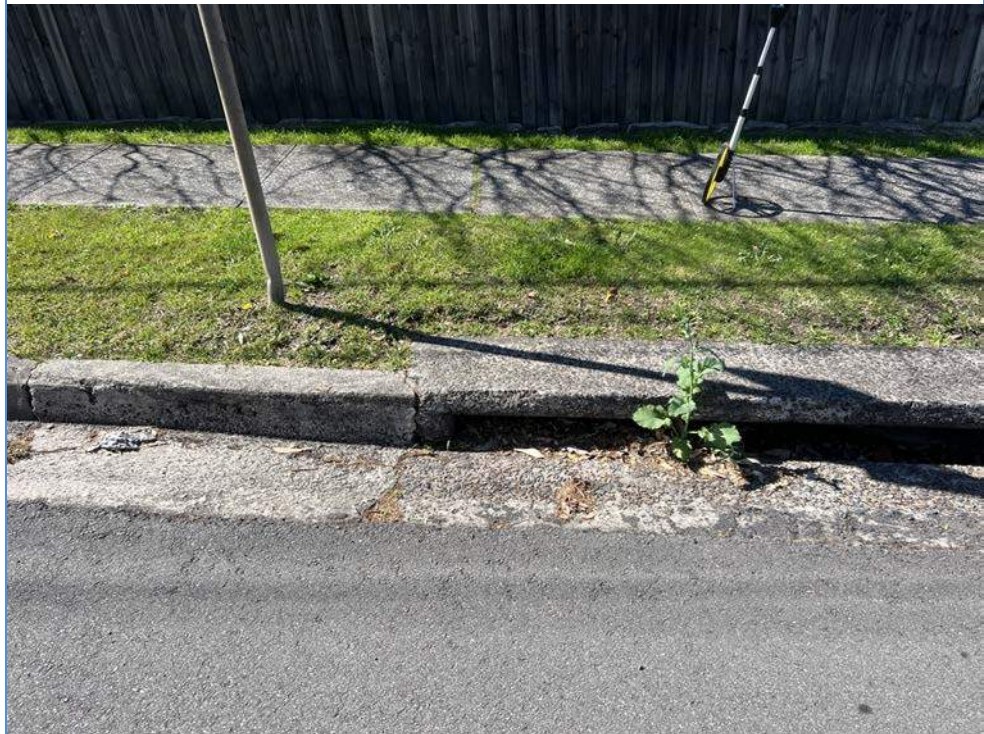
0m

Crack damage noted to the kerb, gutter and stormwater drain.

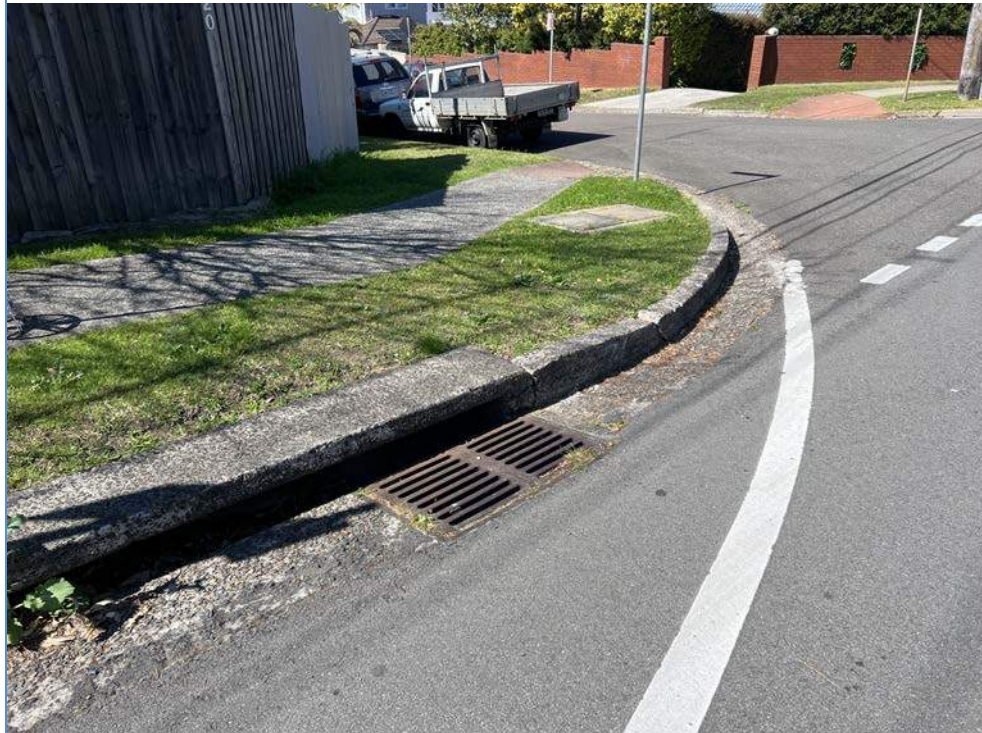
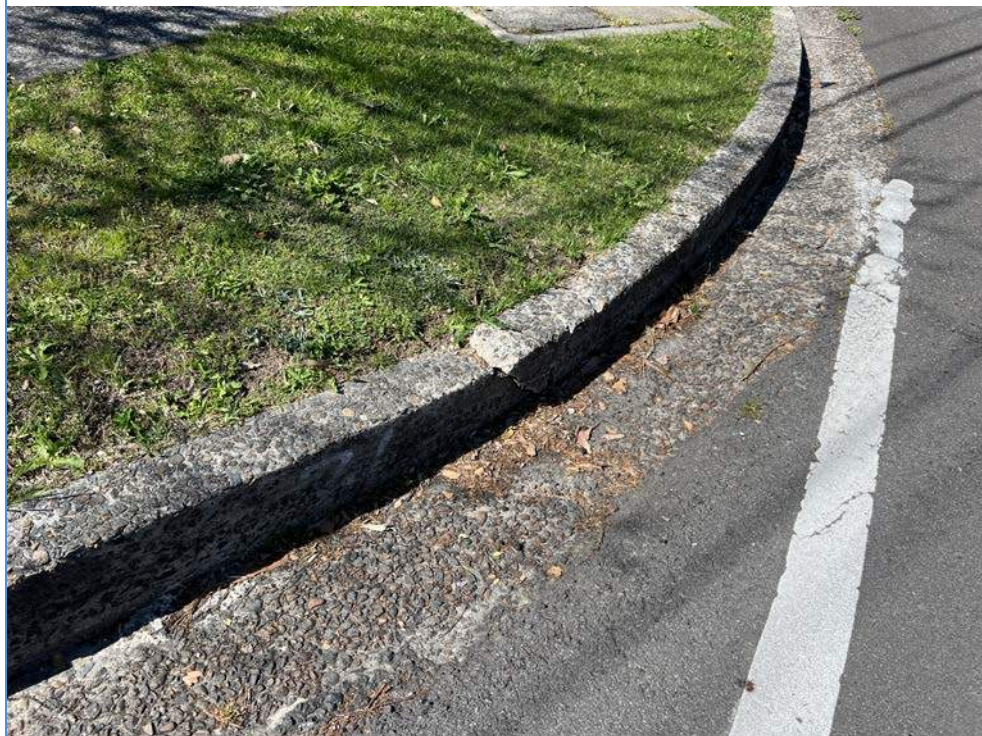
0m

Crack damage noted to the kerb, gutter and stormwater drain.

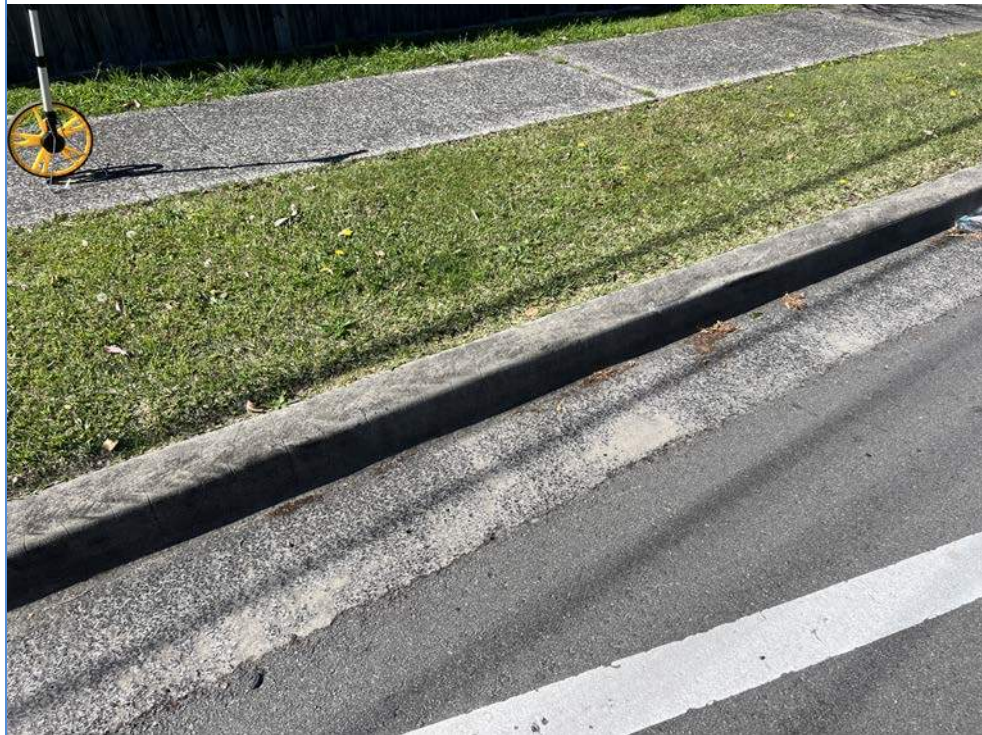
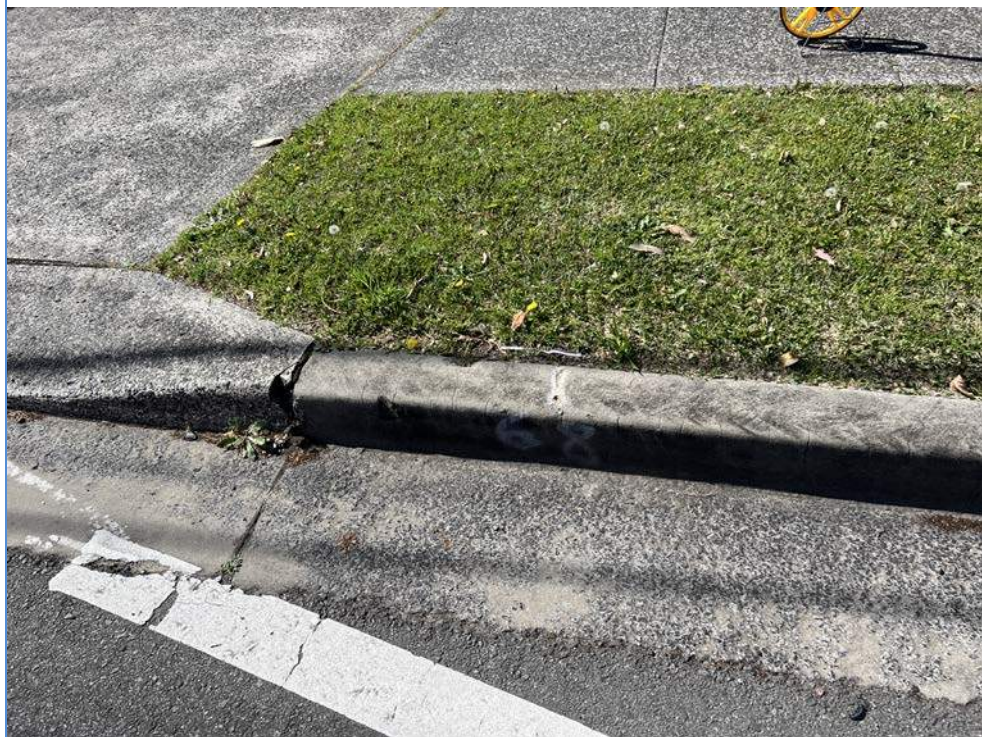
10m

Crack damage noted to the kerb, gutter and layback.

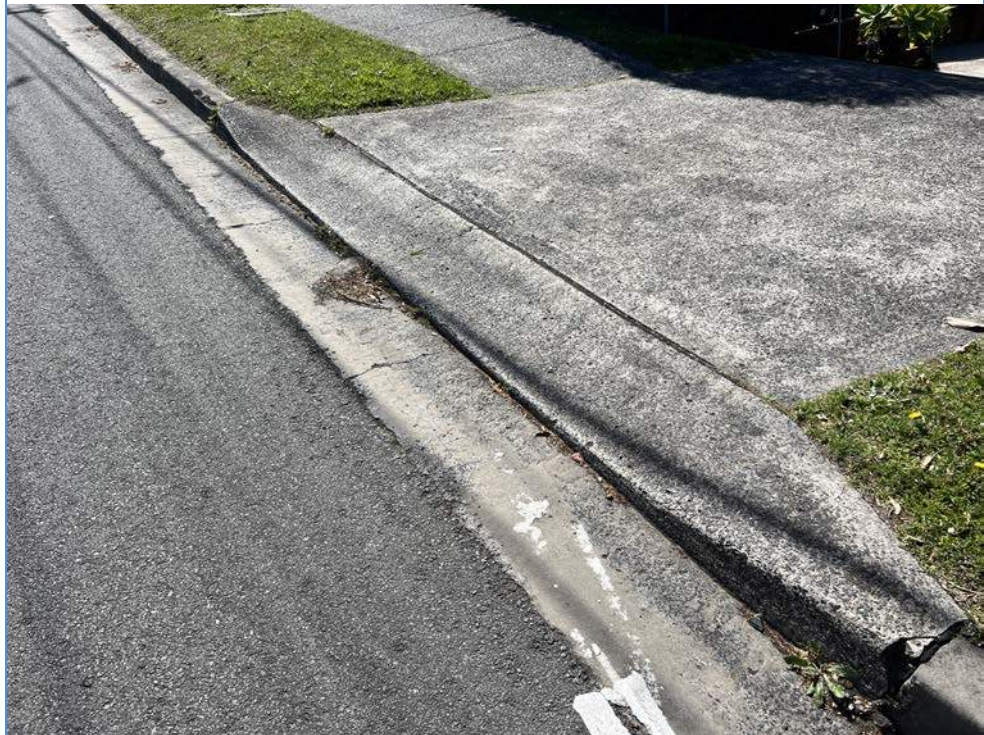
10m

Crack damage noted to the kerb, gutter and layback.

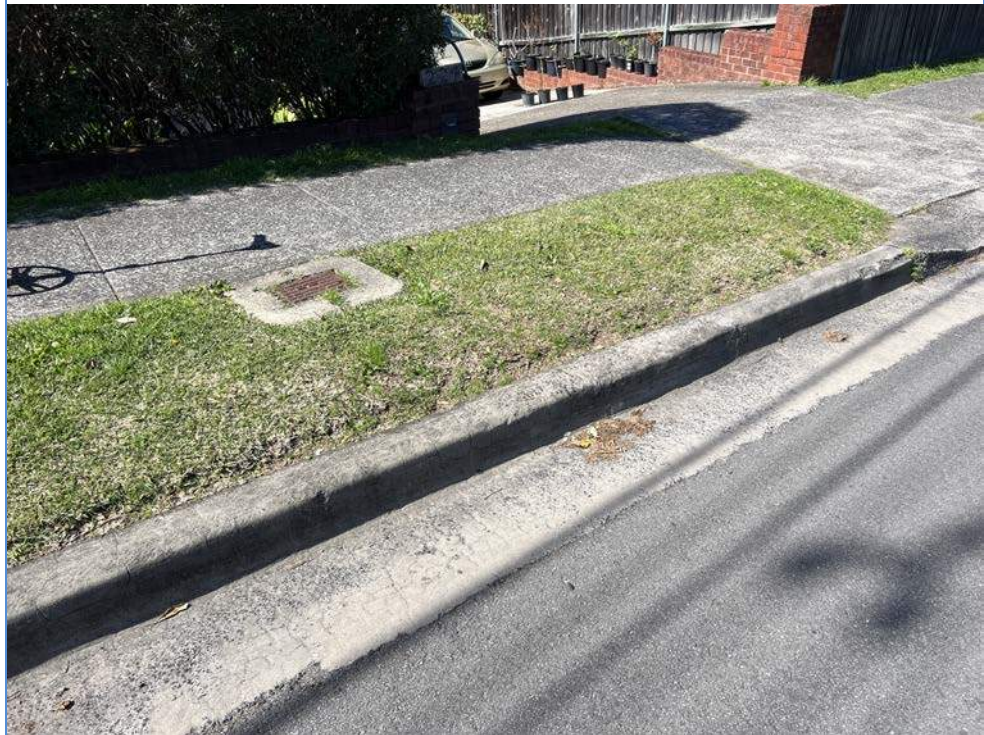
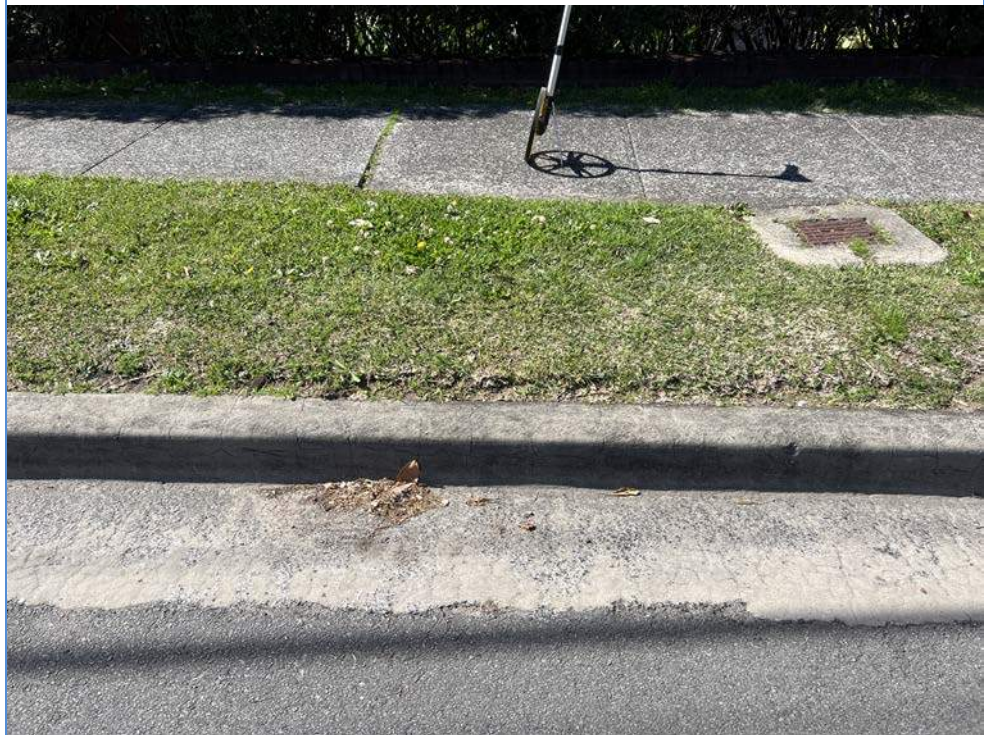
20m

Crack damage to the kerb and gutter.

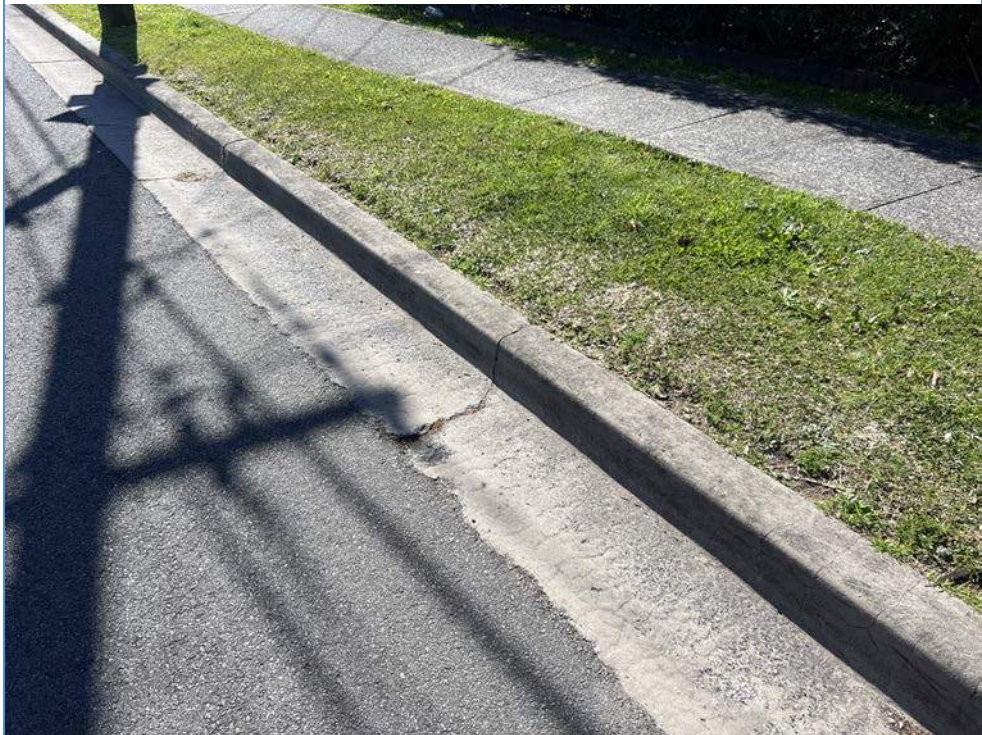
20m

Crack damage to the kerb and gutter.

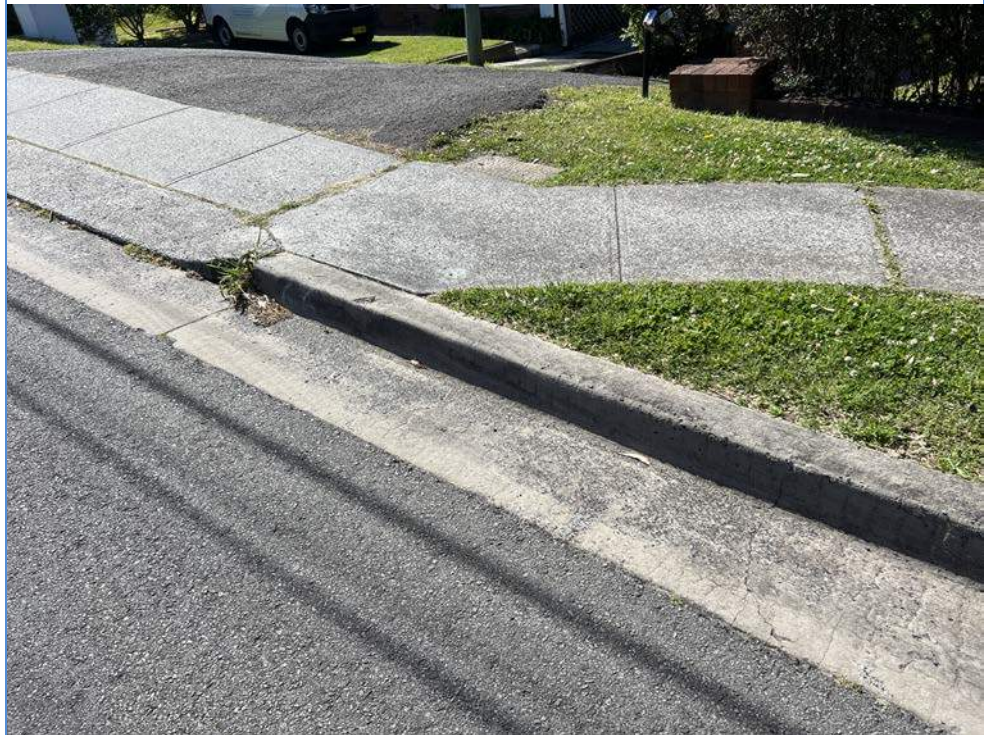
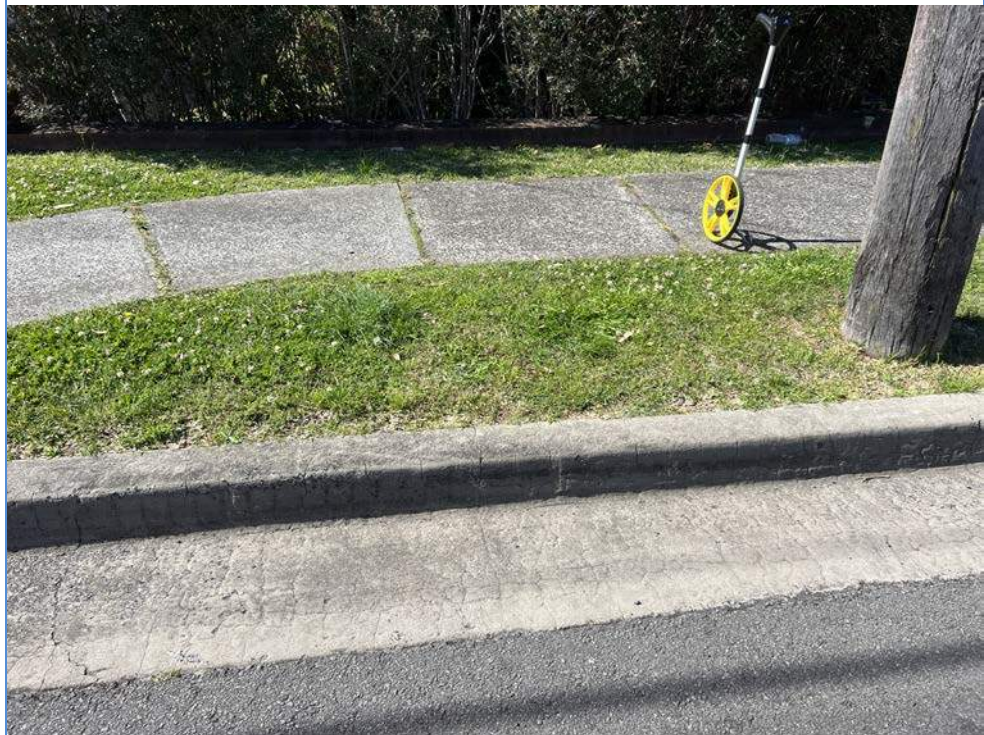
30m

Crack damage to the kerb and gutter.
