The following inspection is of the footpath, kerb and gutter along the south side of Aquatic Drive starting at the entrance driveway of Arranounbai School and heading in an easterly direction towards the roundabout.

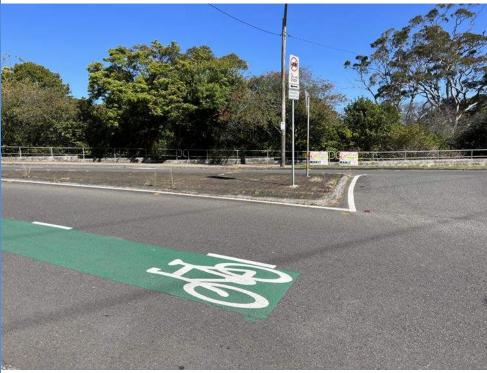
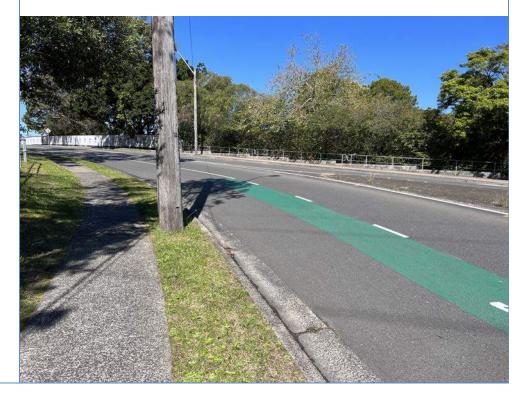
190m General views of the road surface, kerb and gutter.

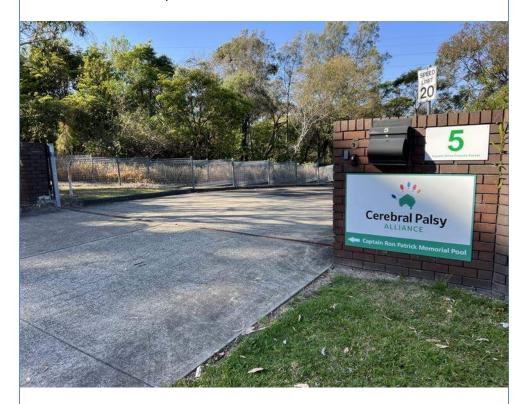
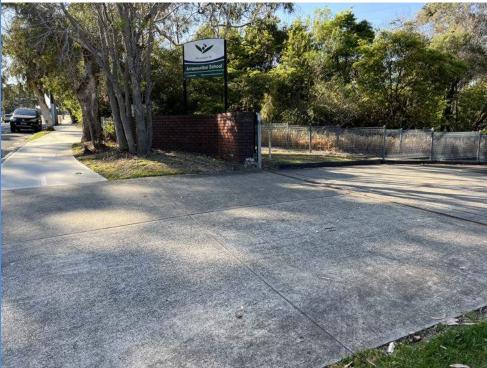
Om General views of the driveway crossover to Arranounbai School at the start point.

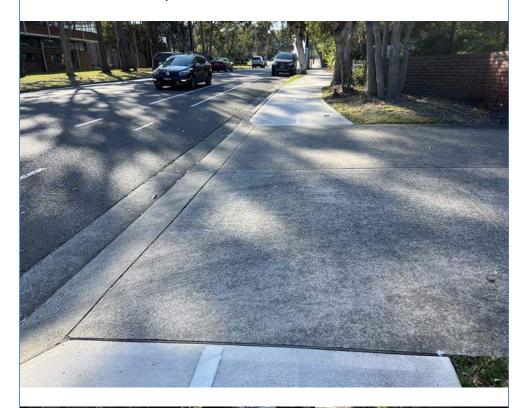
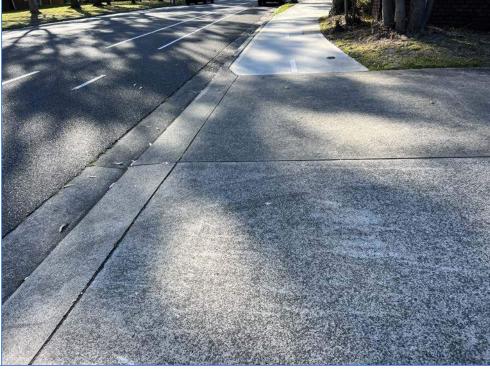
Om General views of the driveway crossover to Arranounbai School at the start point.

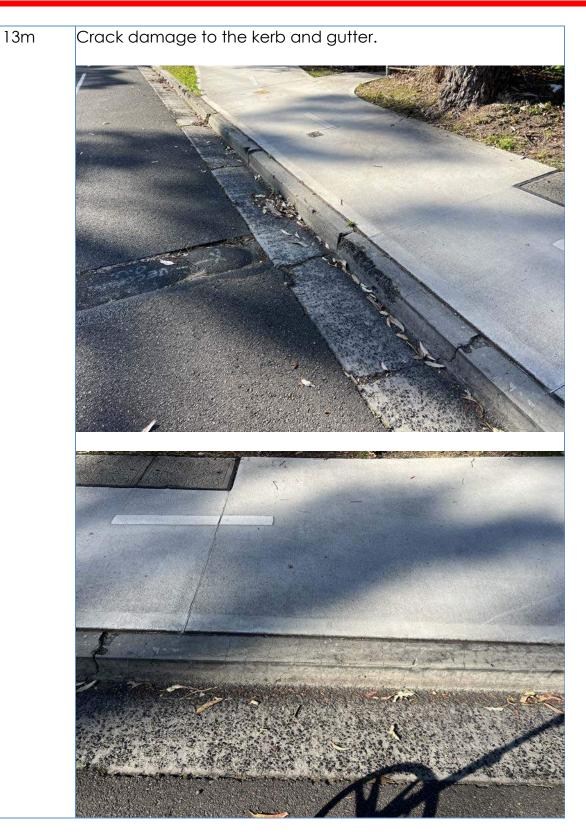
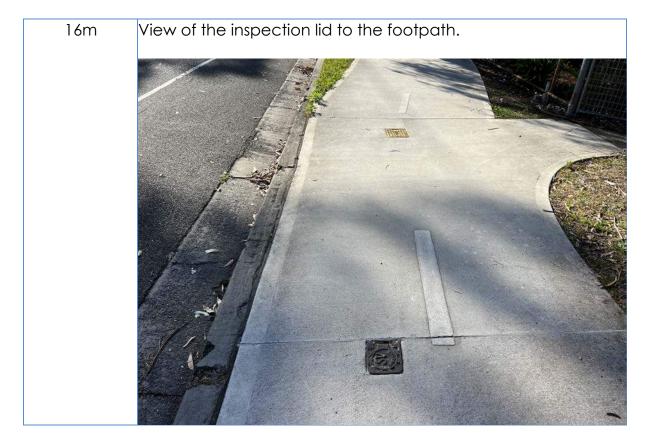
10m Crack damage to the kerb and gutter. 12m View of the inspection lids.

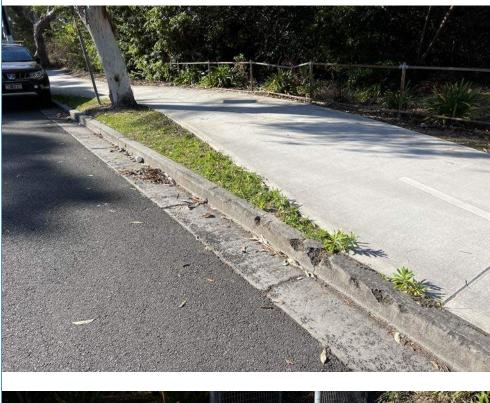
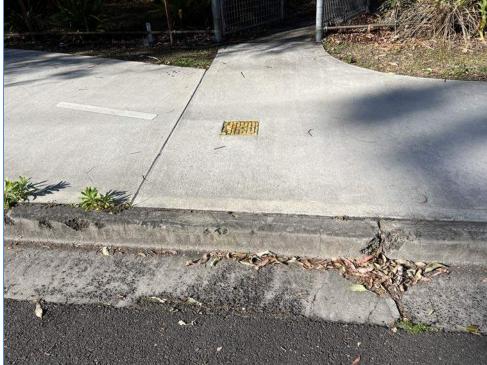
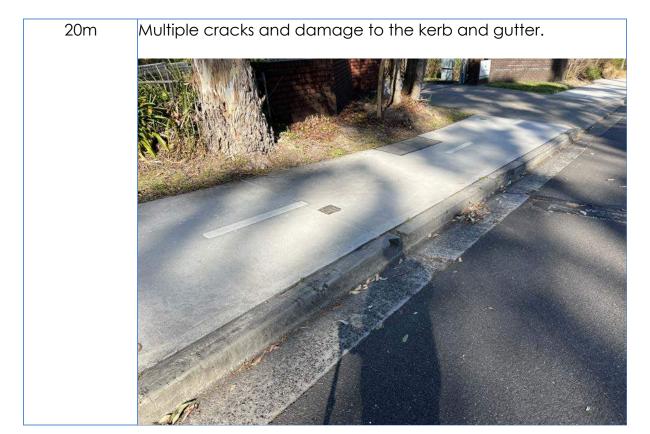
20m Multiple cracks and damage to the kerb and gutter.

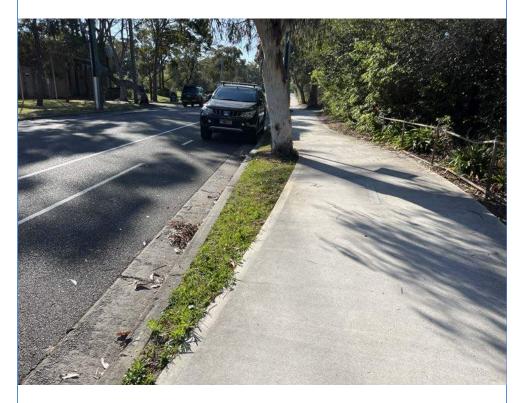
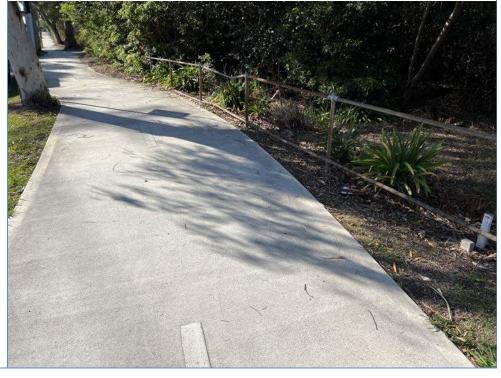
20m General views of the footpath, kerb and gutter.

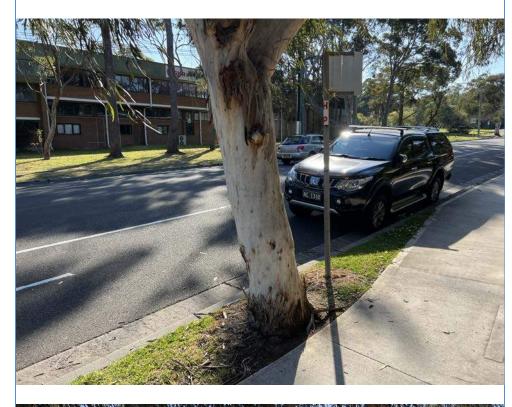
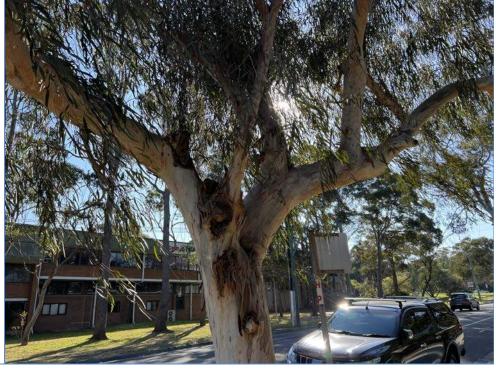
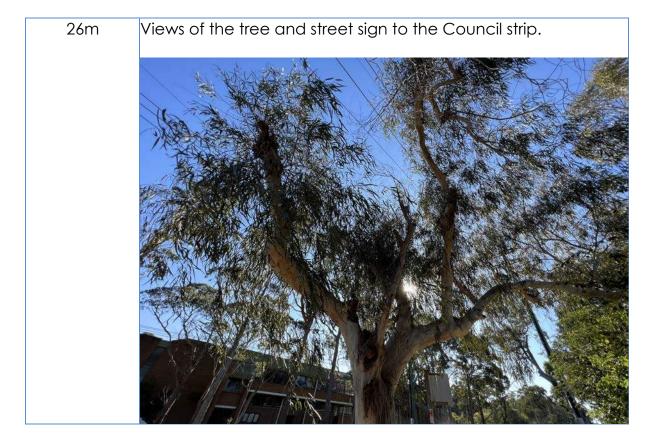
26m Views of the tree and street sign to the Council strip.

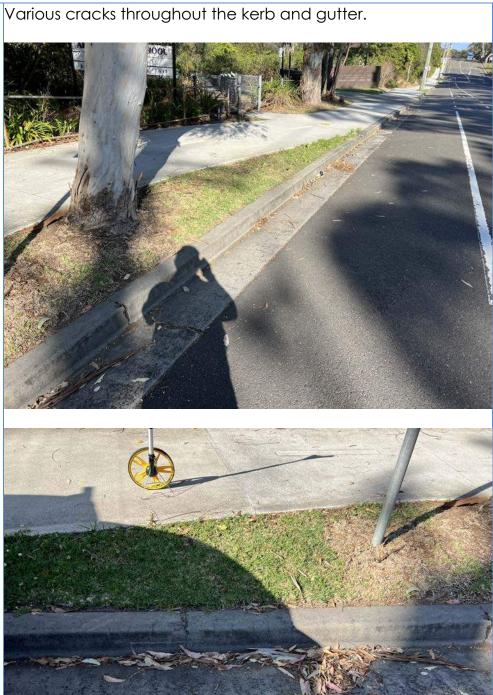
30m Various cracks throughout the kerb and gutter.

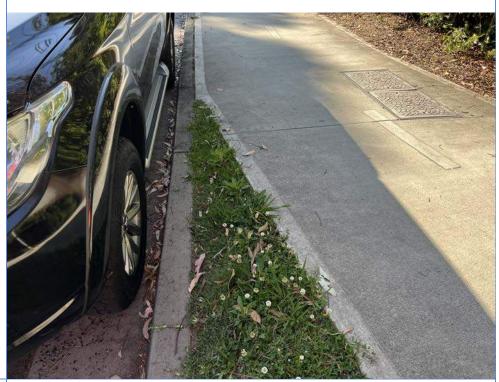
33m View of the inspection lid to the footpath.

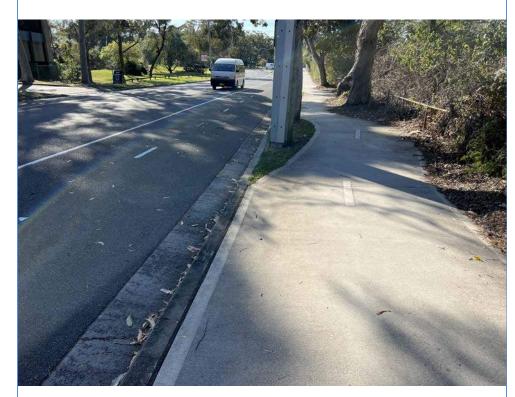
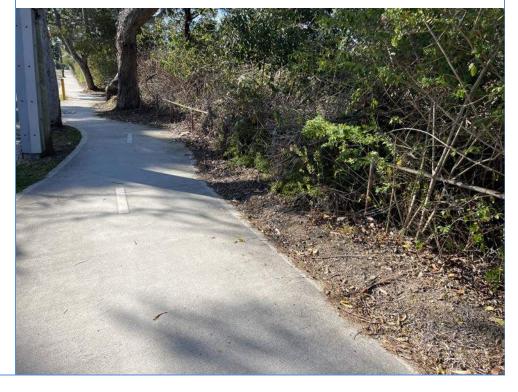
Various cracks throughout the kerb and gutter.

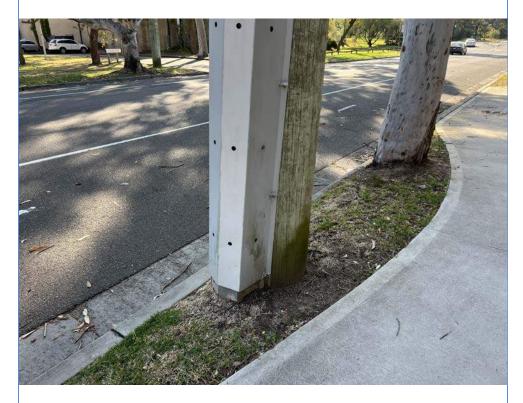
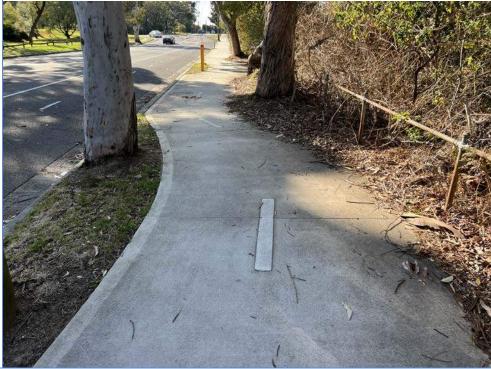
50m General views of the footpath, kerb and gutter.
