The following inspection is of the kerb, gutter and road surface to the north side of Aquatic Drive starting at number 4 – 6 Aquatic Drive, heading east and finishing at the roundabout at the intersection of Aquatic Drive and Allambie Road.

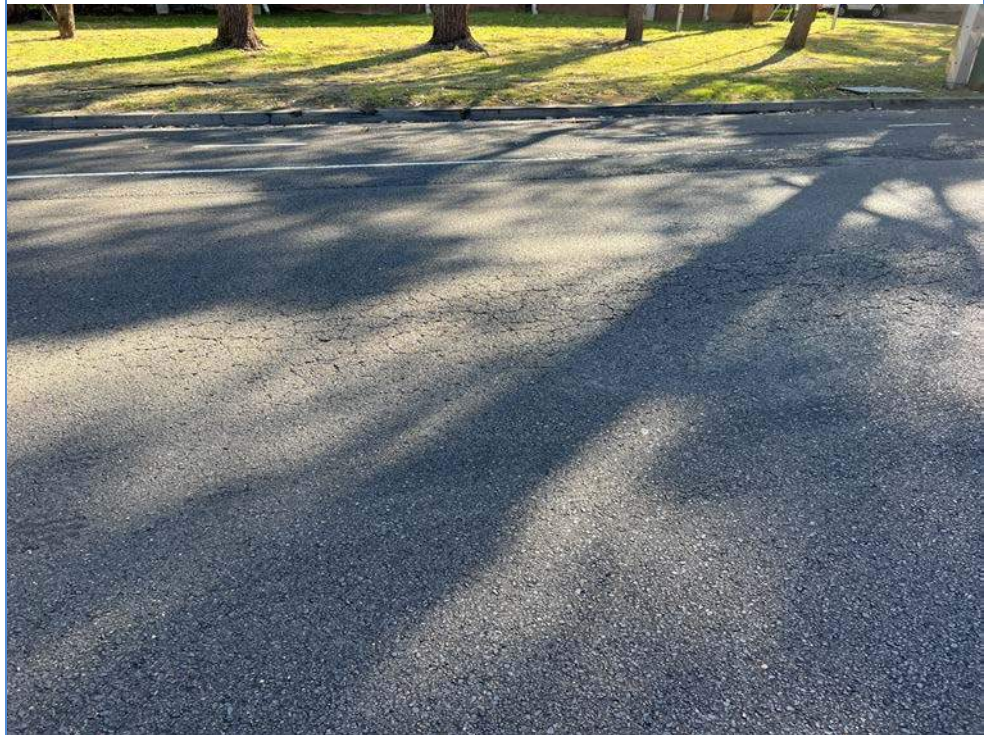
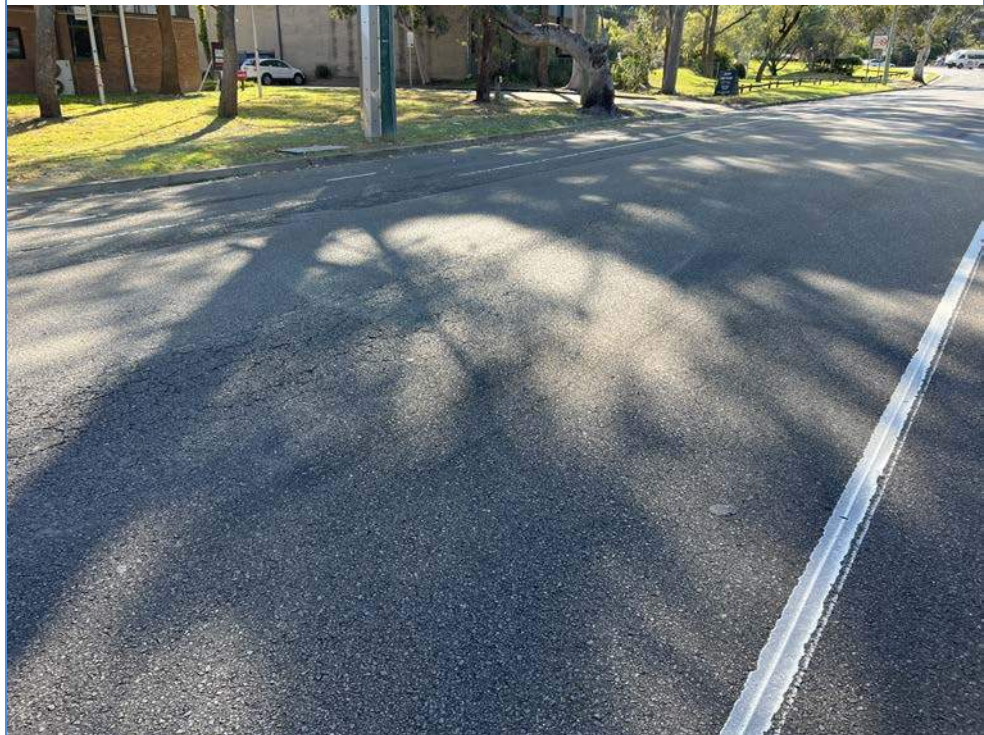
130m

Crocodile cracking to the road surface.

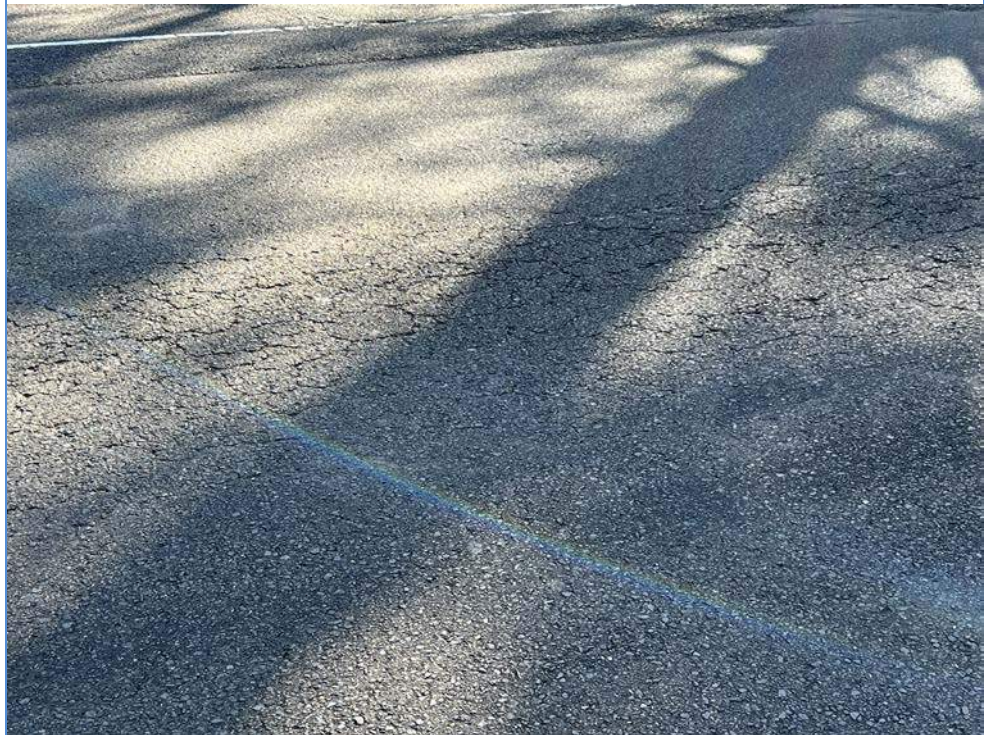
130m

Crocodile cracking to the road surface.

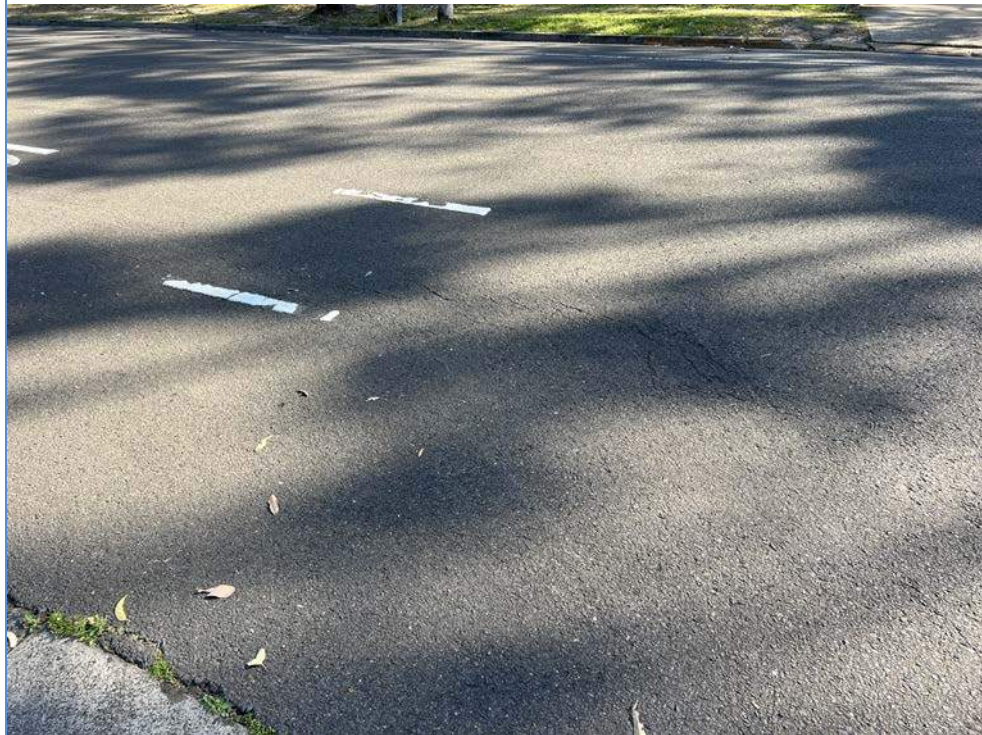
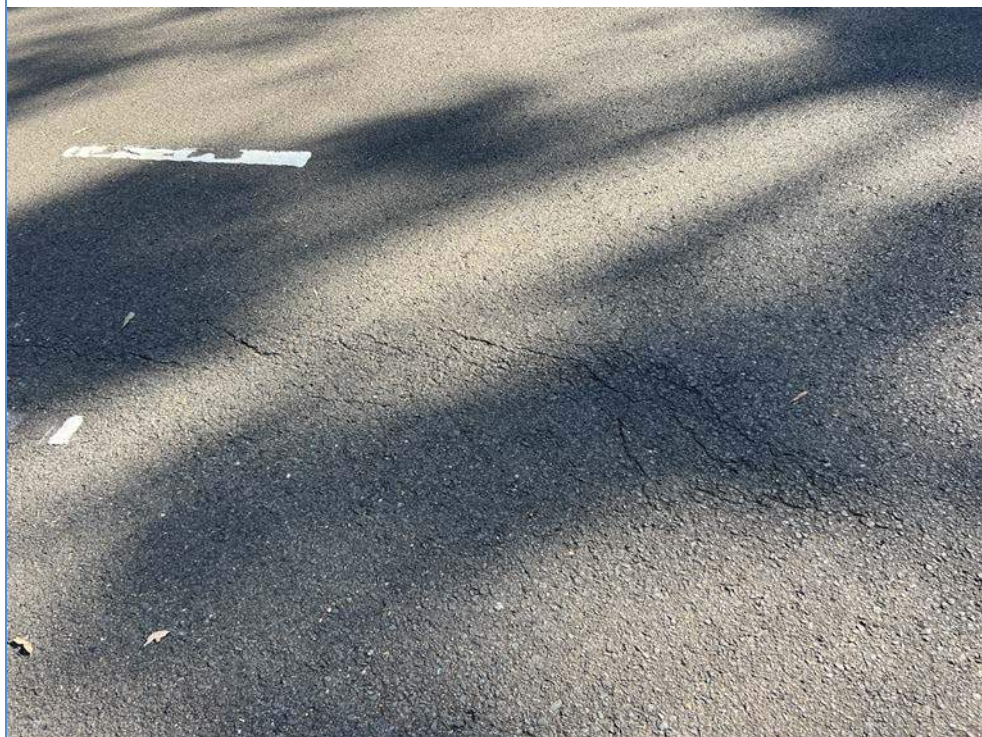
160m

Crack damage throughout the road surface.

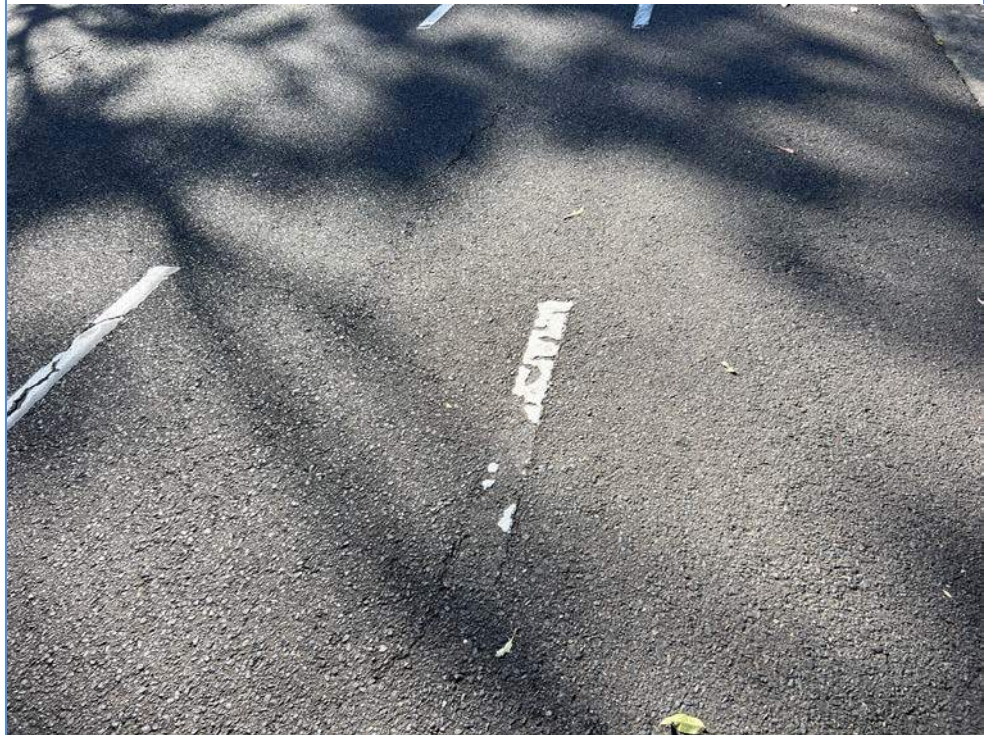
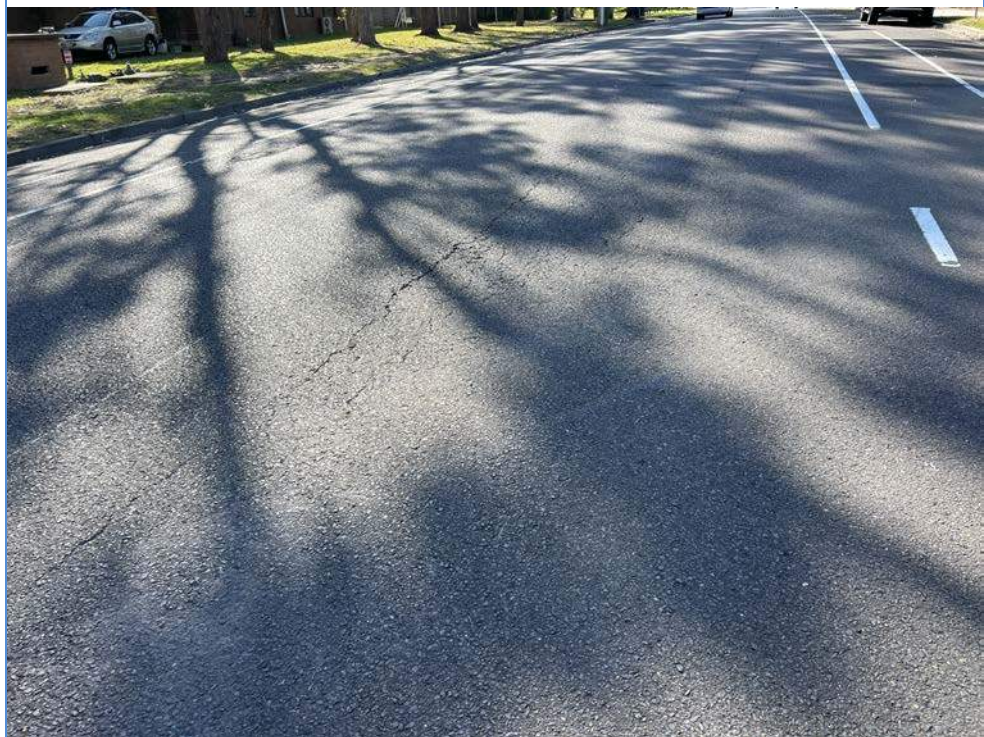
160m

Crack damage throughout the road surface.

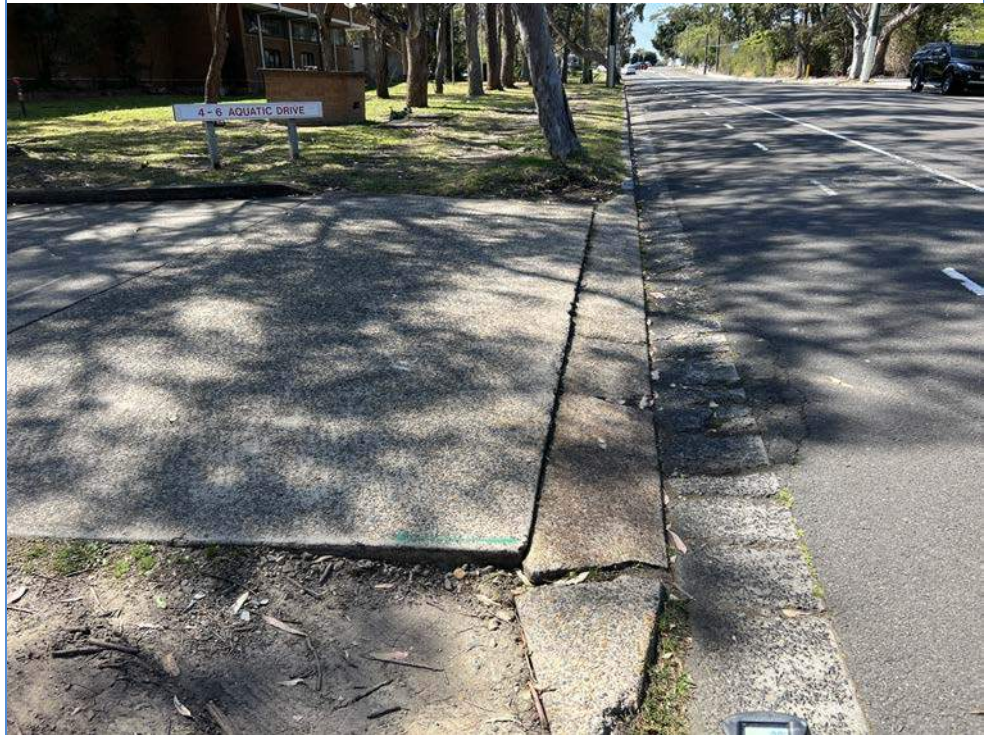
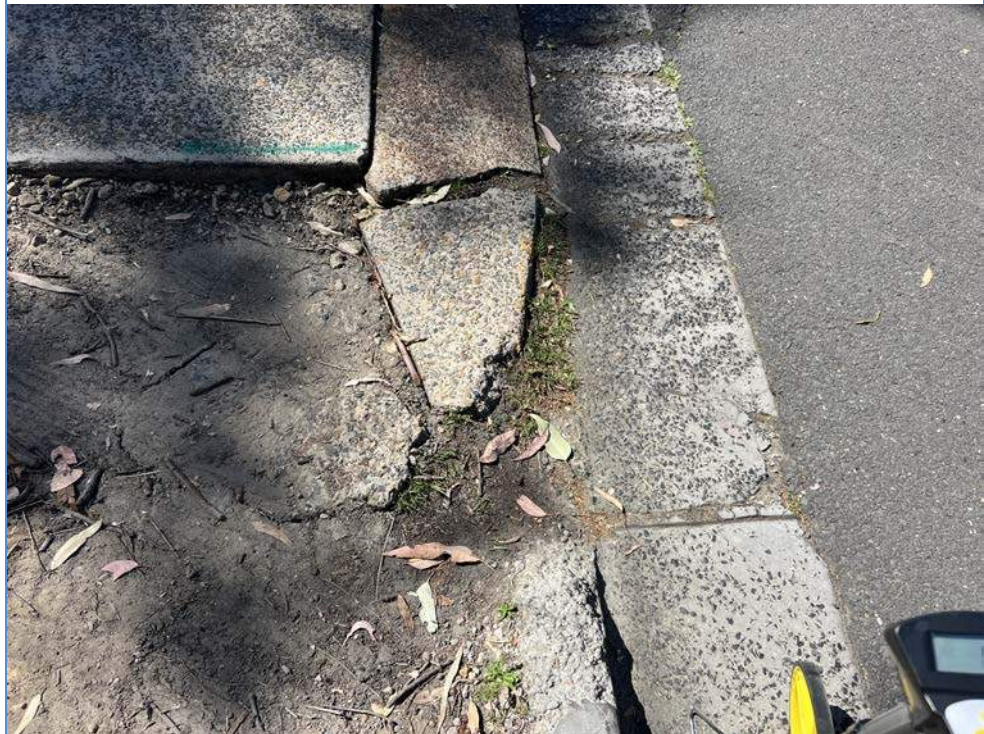
Crack damage throughout the driveway, layback and gutter servicing number 4 – 6 Aquatic Drive.

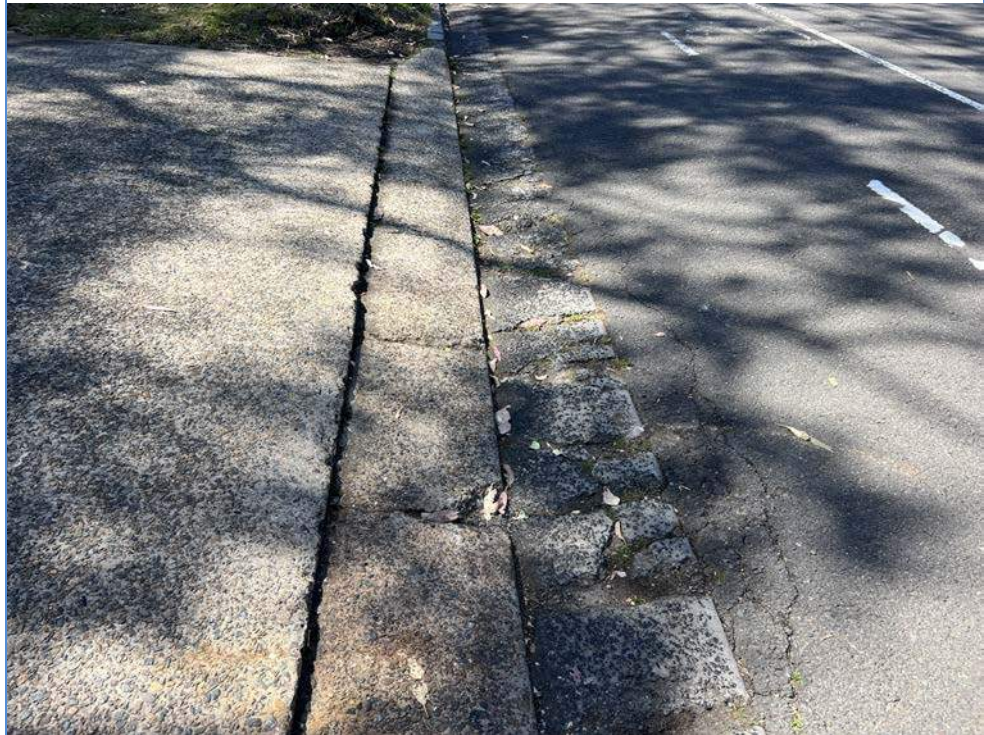
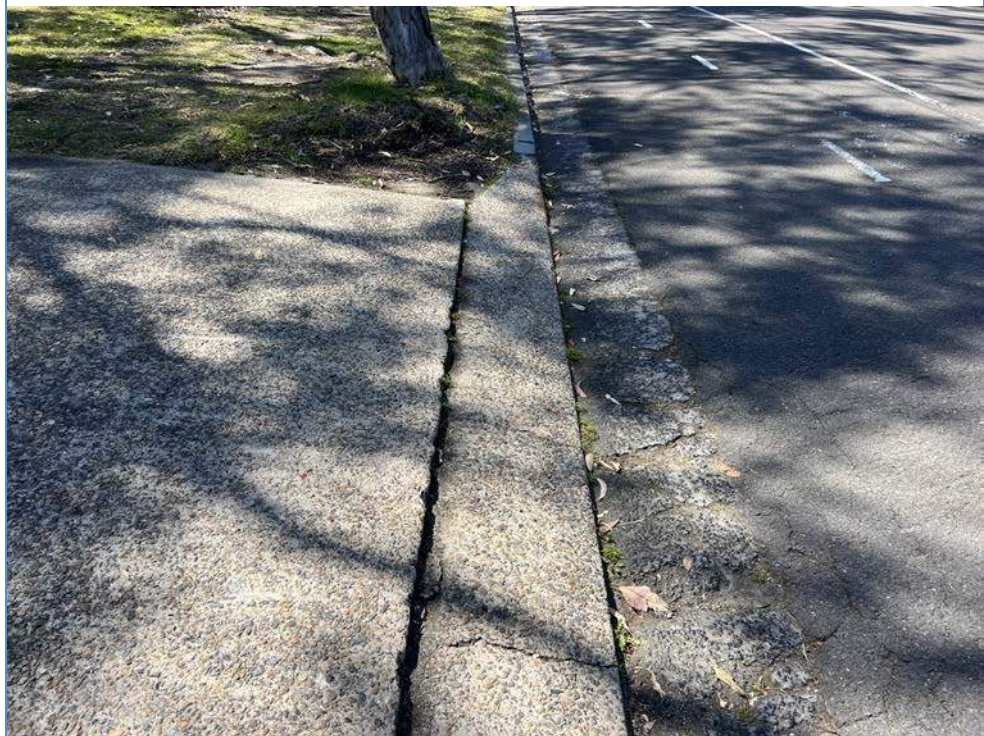
Crack damage throughout the driveway, layback and gutter servicing number 4 – 6 Aquatic Drive.

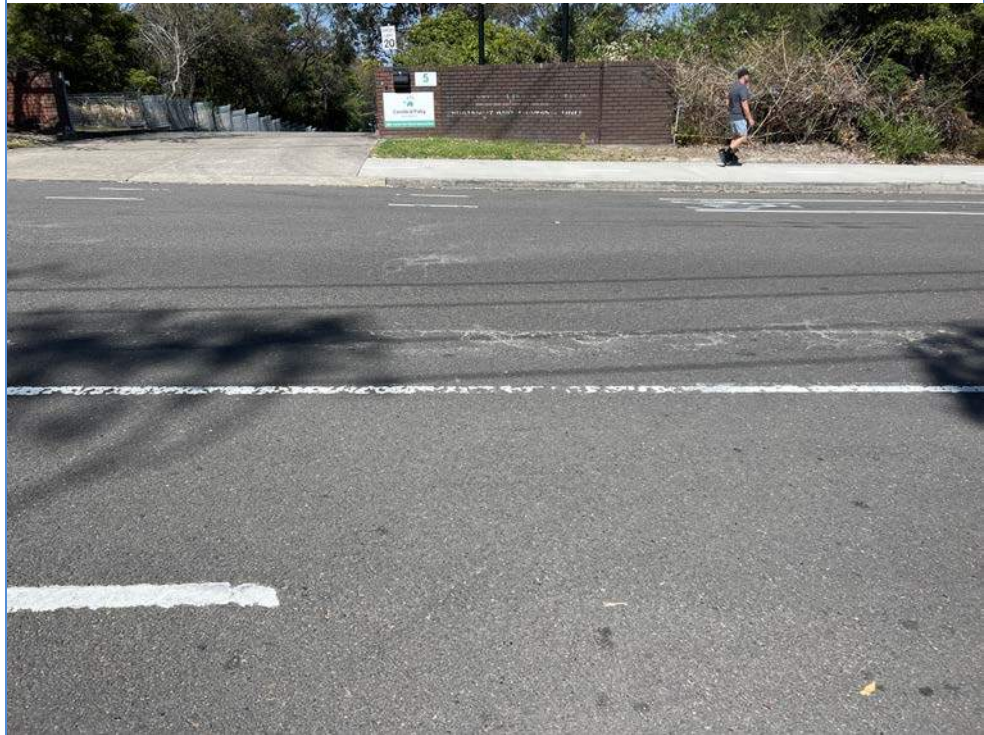
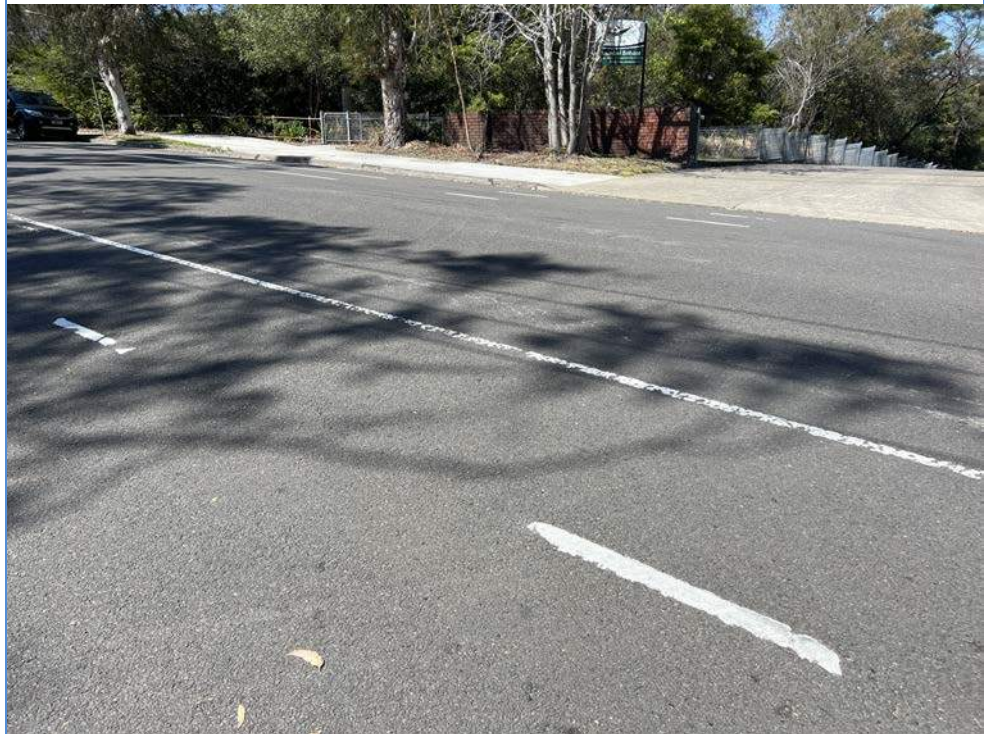
Crack damage throughout the road surface fronting number 4 – 6 Aquatic Drive.

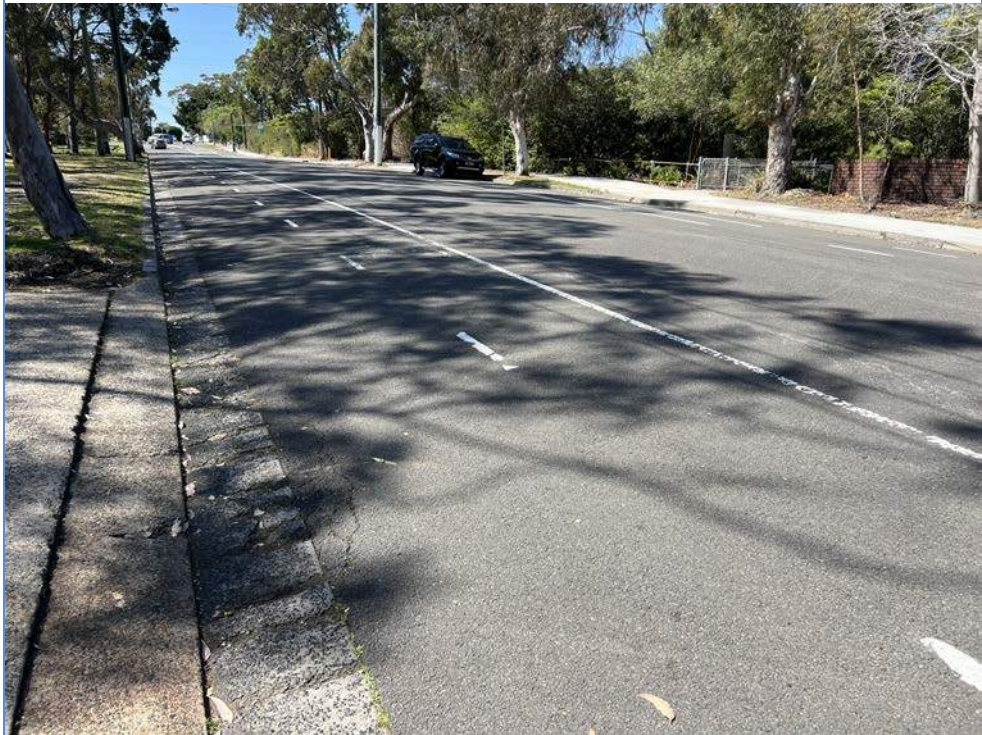
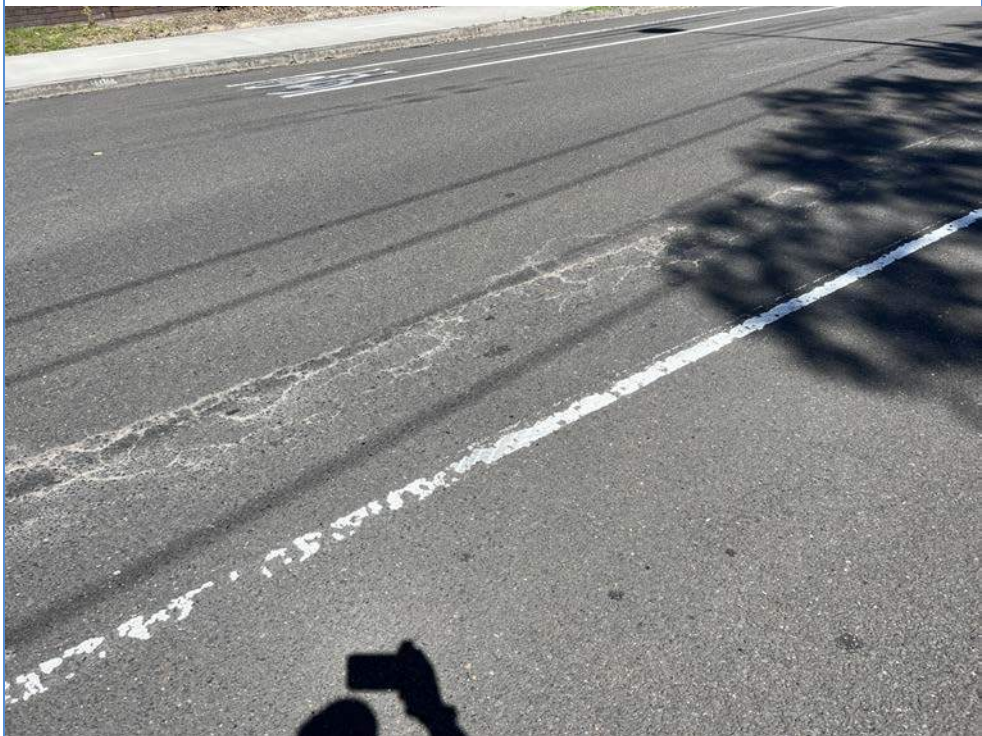
Crack damage throughout the road surface fronting number 4 – 6 Aquatic Drive.

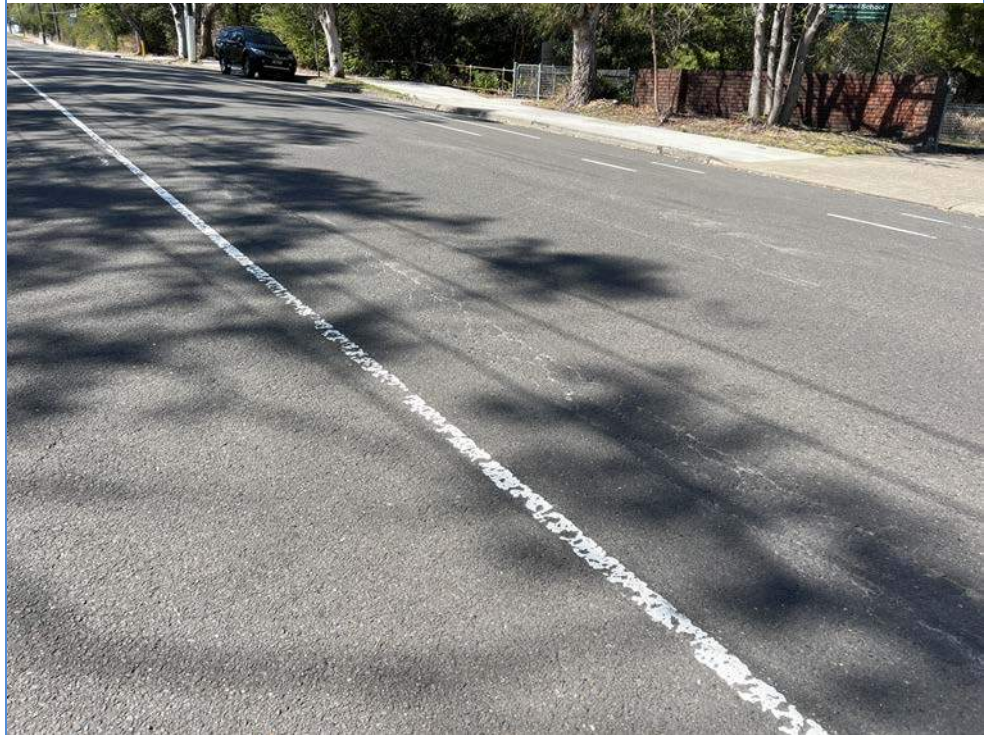
Crack damage throughout the road surface fronting number 4 – 6 Aquatic Drive.

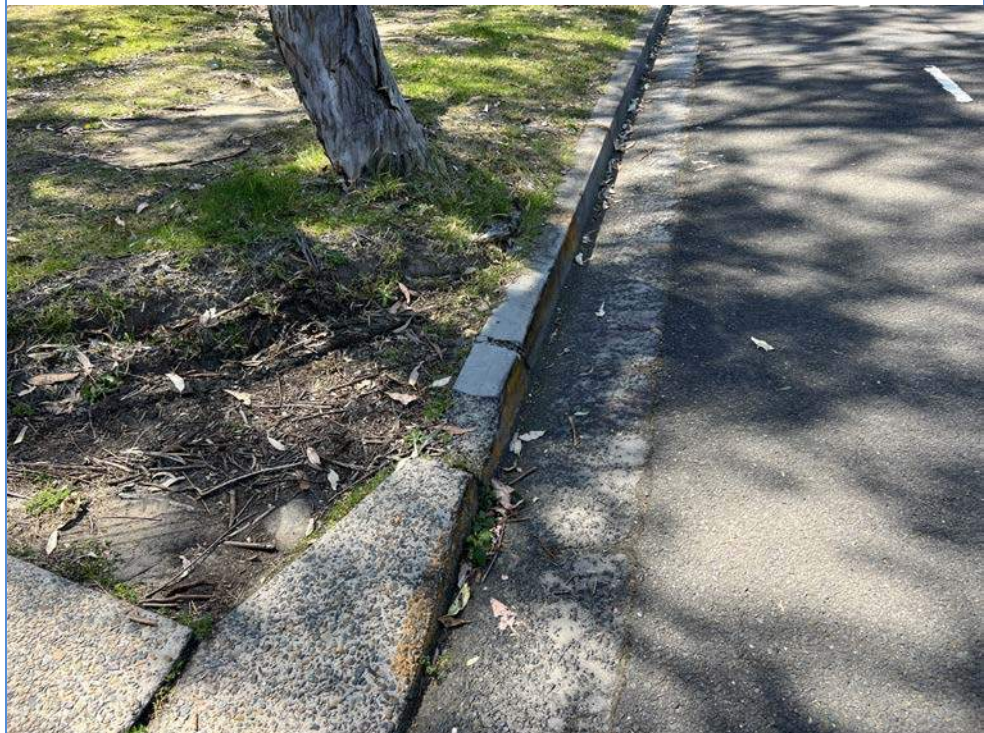
7m

Crack damage to the kerb and gutter.

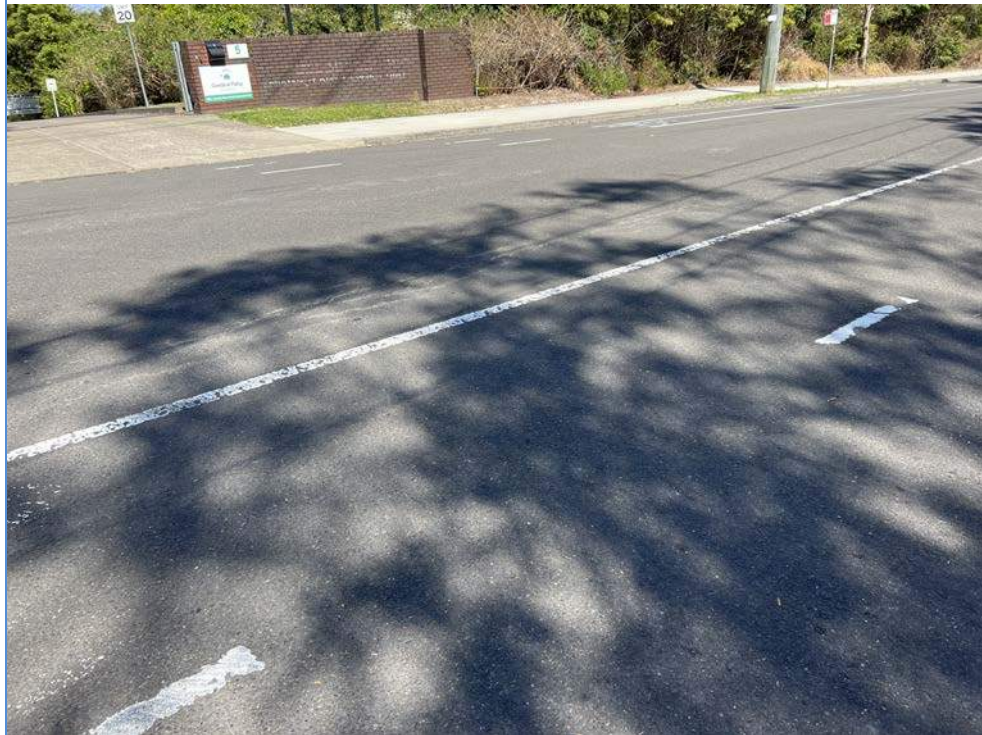
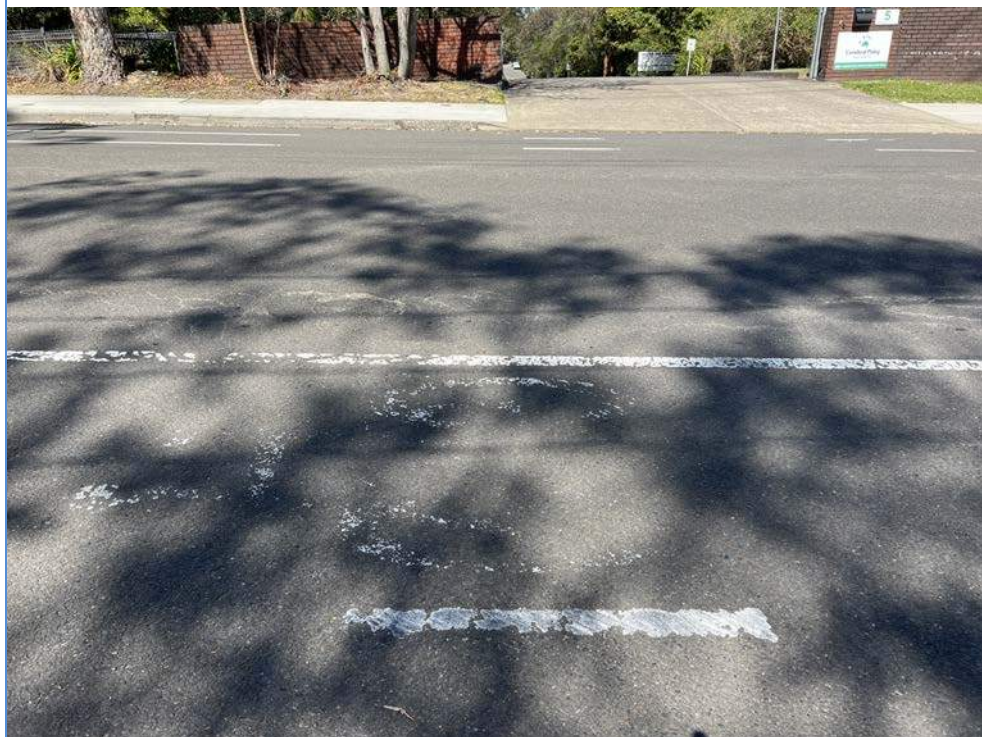
10m

Crack damage throughout the road surface.

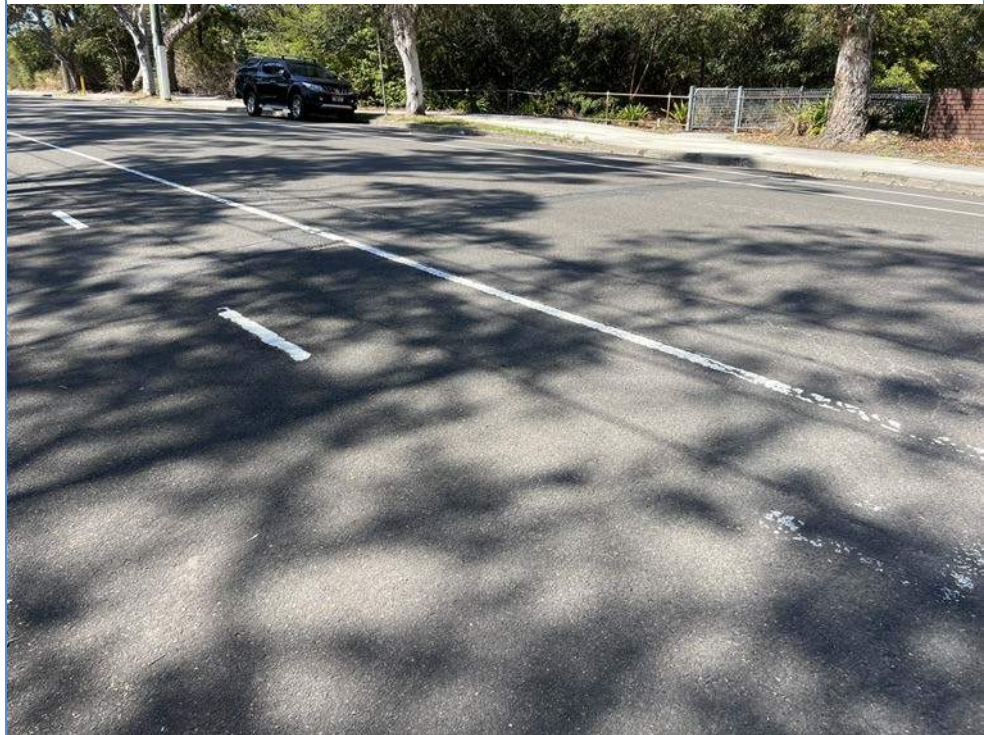
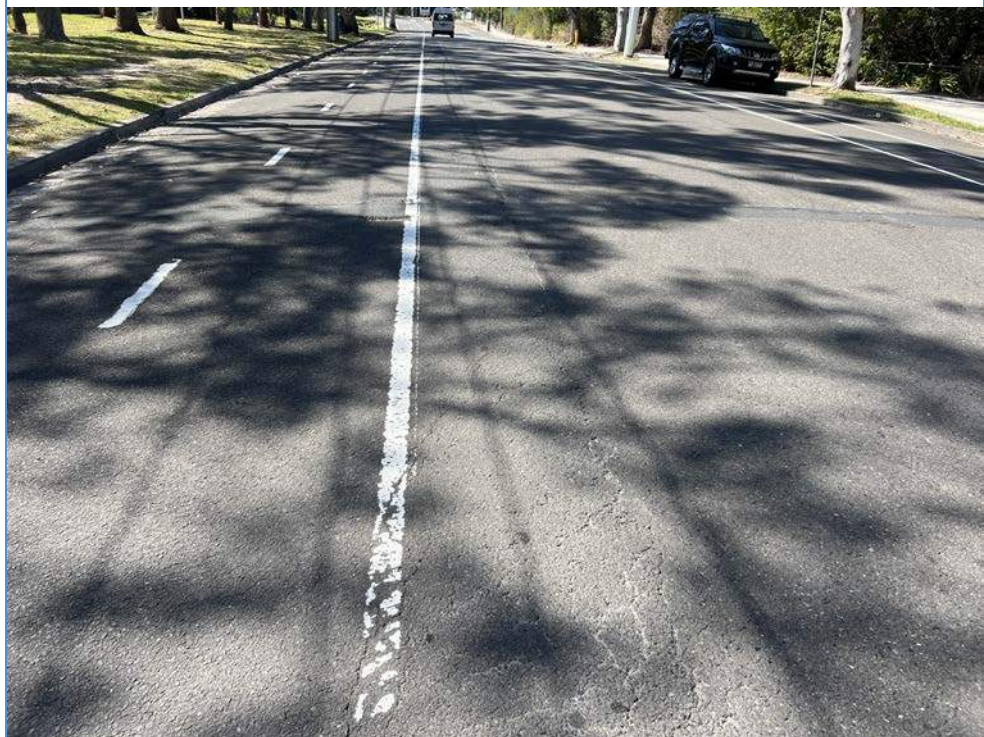
10m

Crack damage throughout the road surface.

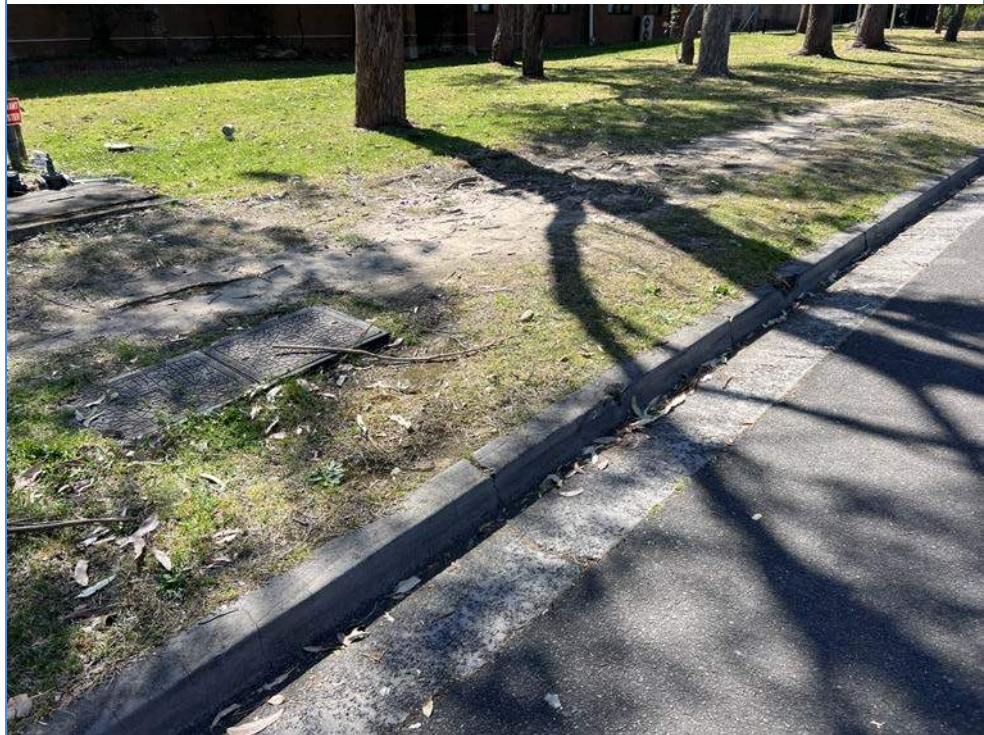
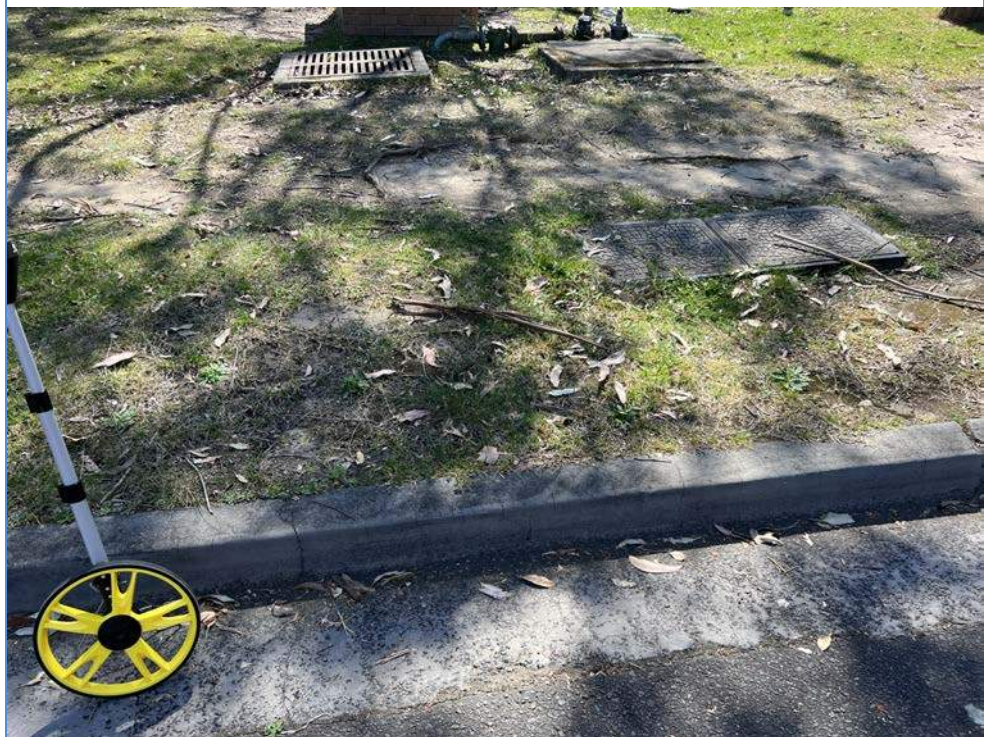
15m

Crack damage to the kerb and gutter.

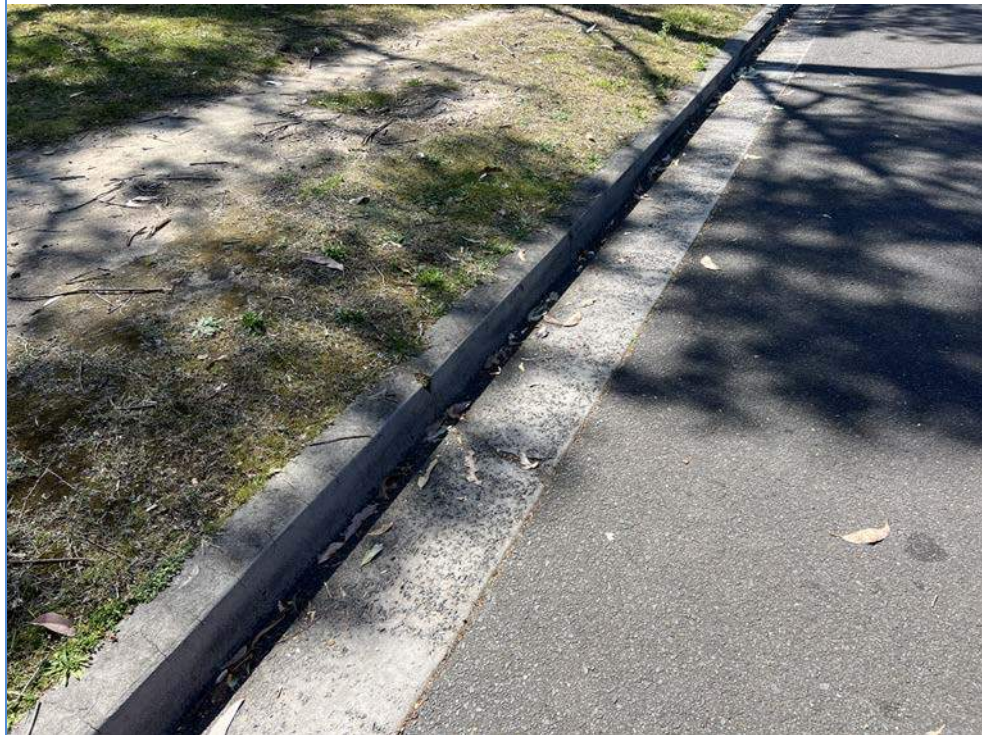
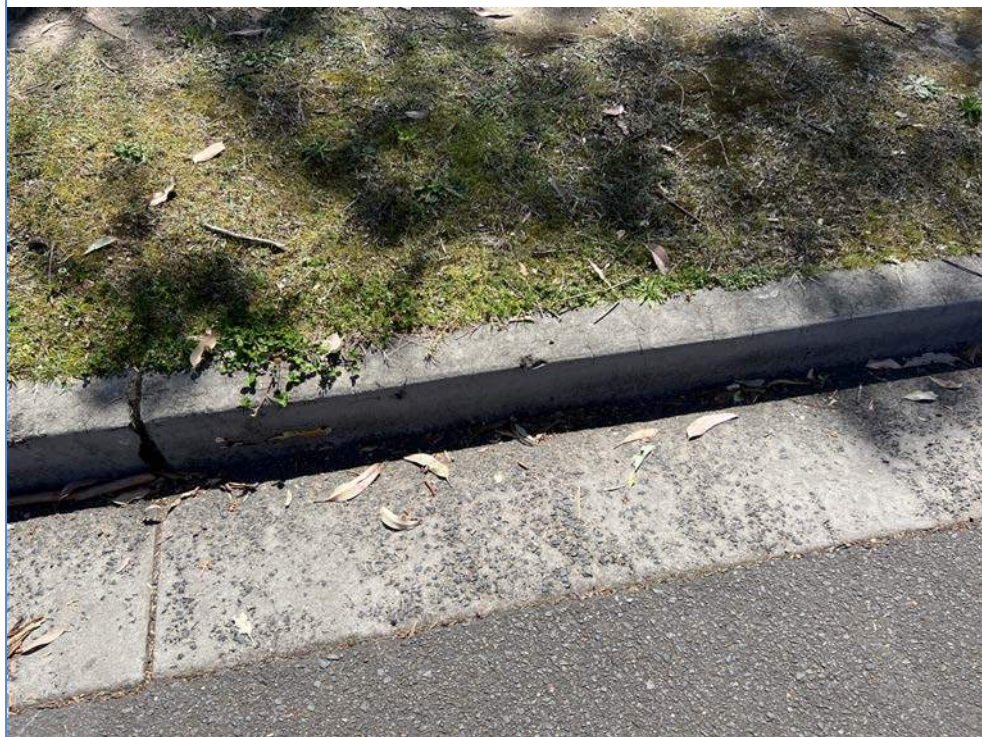
20m

Crack damage throughout the kerb and gutter.

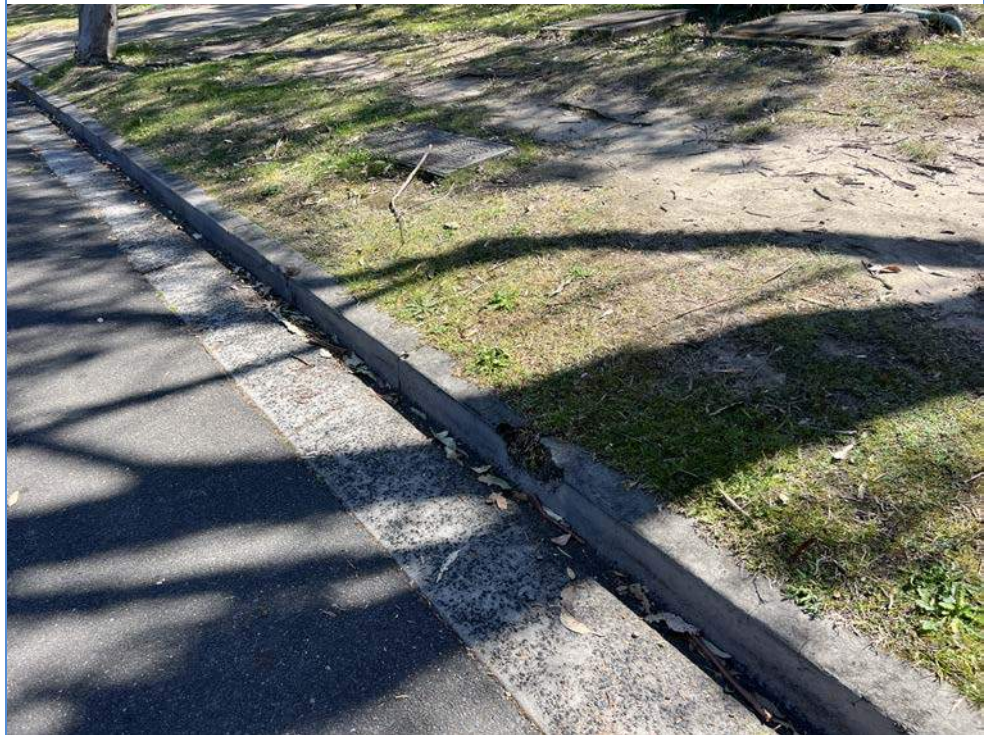
20m

Crack damage throughout the kerb and gutter.

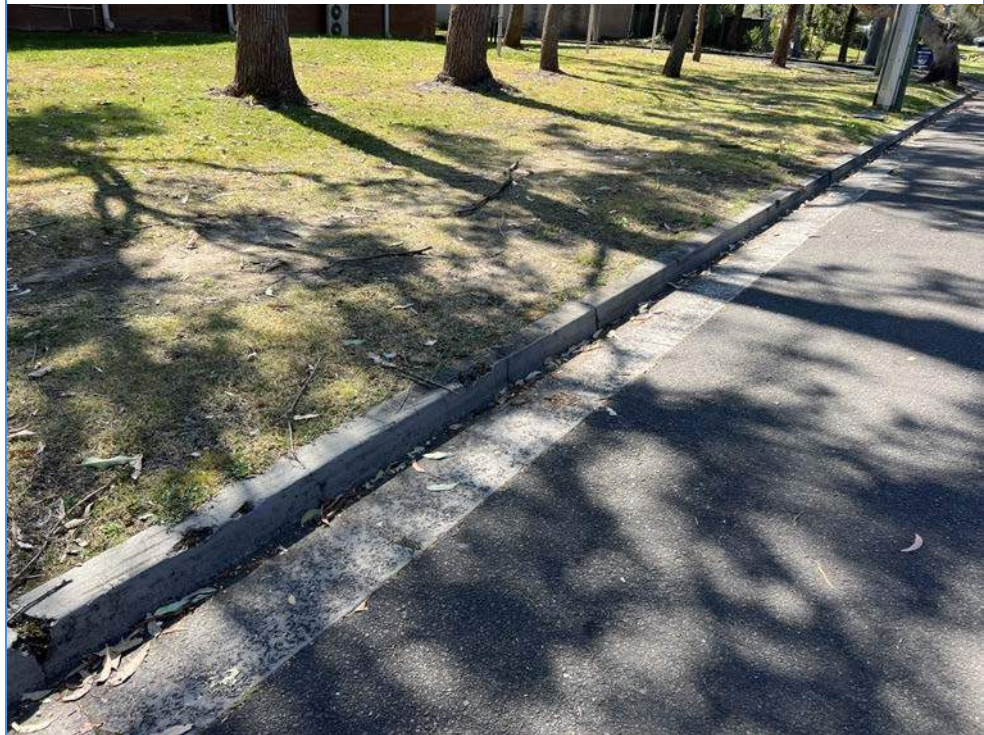
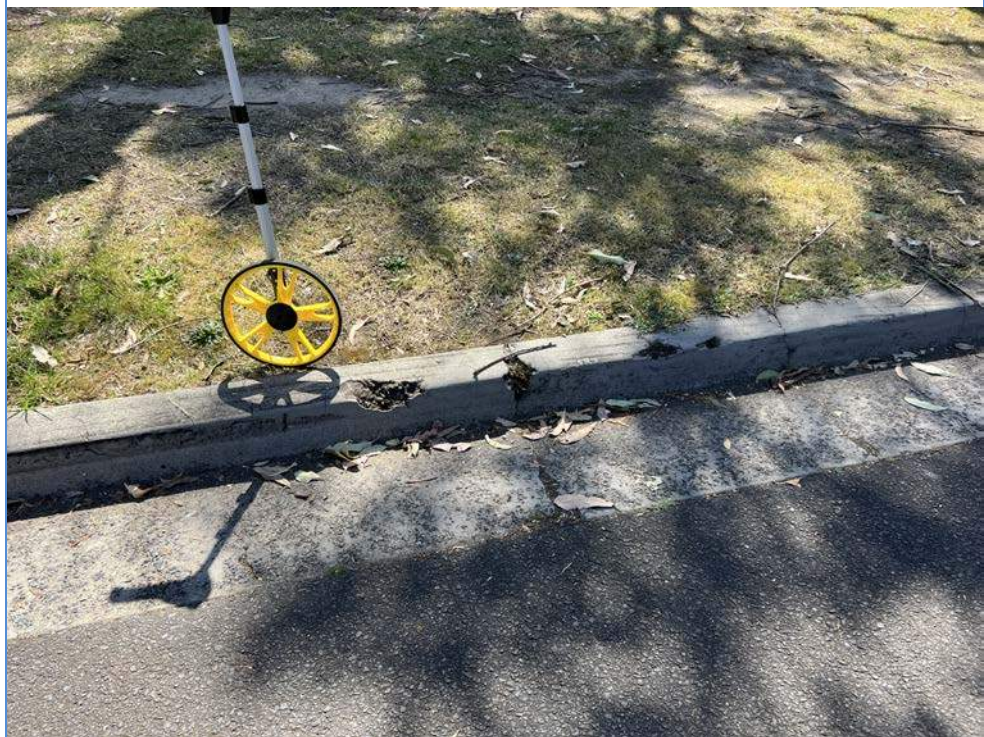
30m

Crack damage throughout the kerb and gutter.

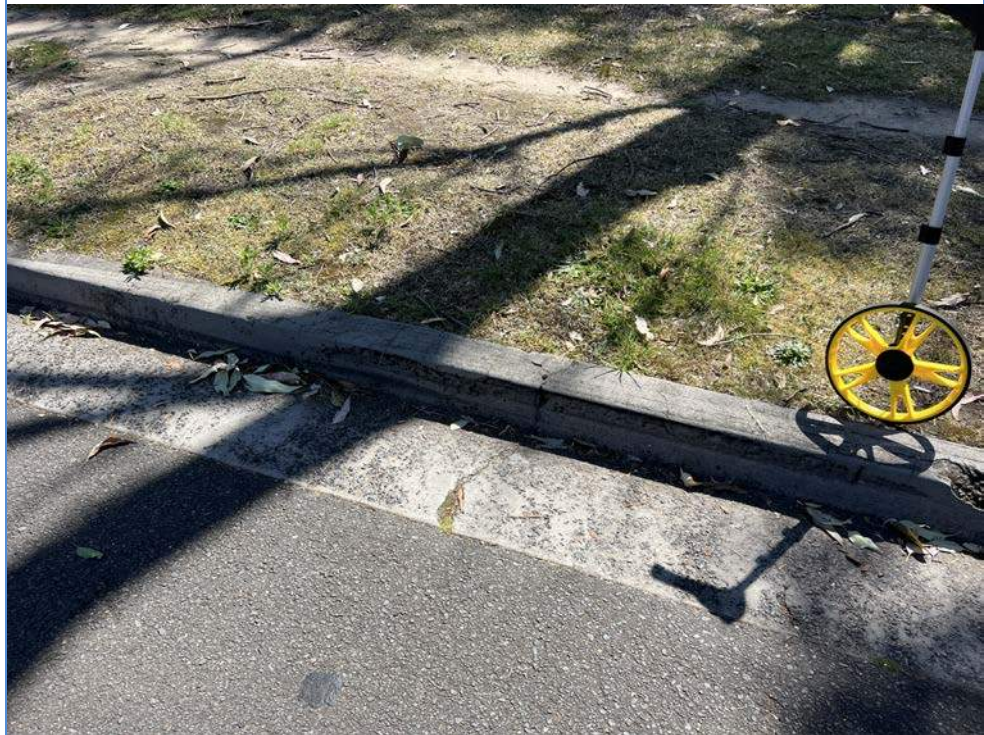
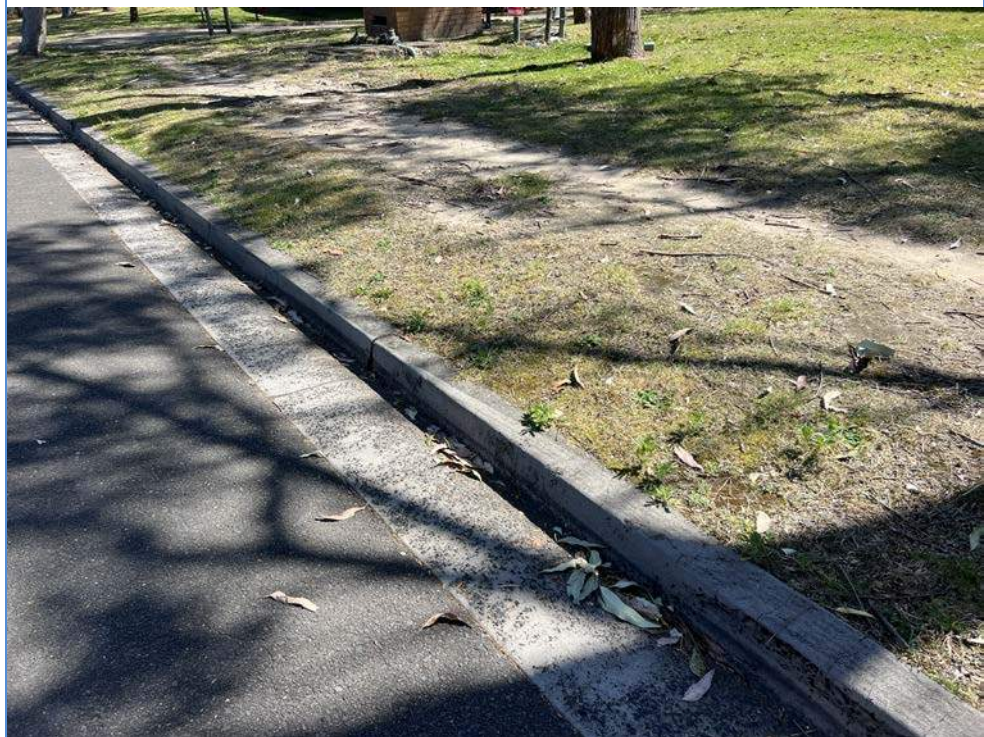
30m

Crack damage throughout the kerb and gutter.
