The following inspection is of the driveway, kerb and gutter starting at the black fence at Arranounbai School and heading in a northerly direction towards Aquatic Drive.

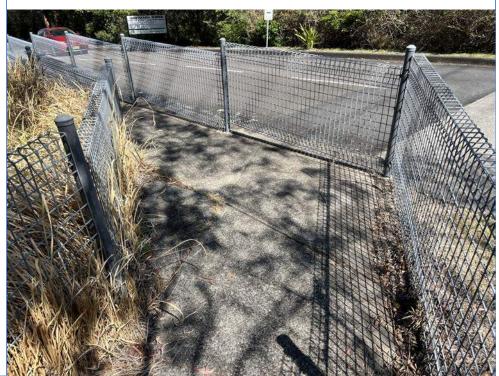
13m General view of the fencing and footpath.

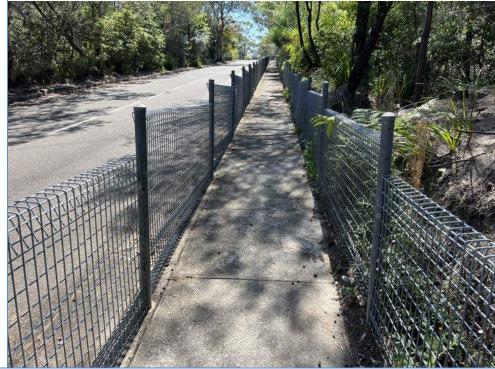
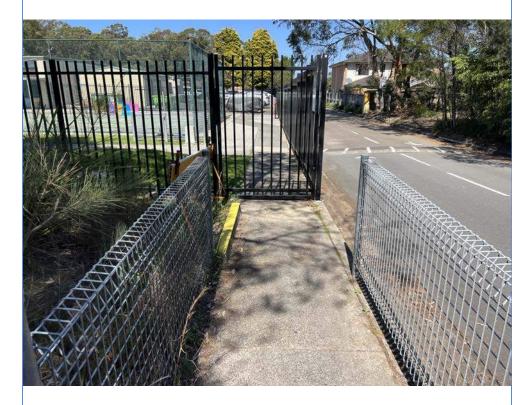
General views of the fencing and footpath at the end point..

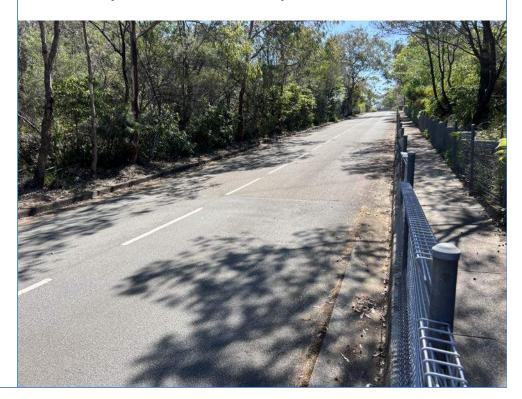
0m General views of the road surface at the start point.

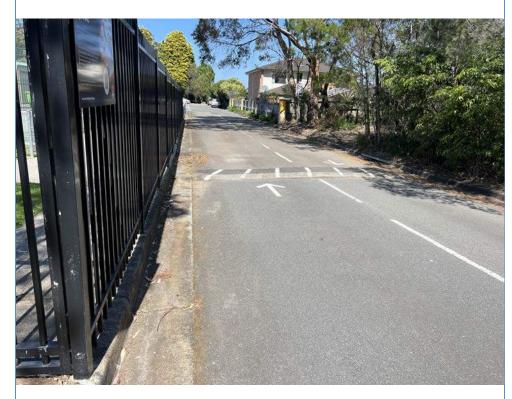
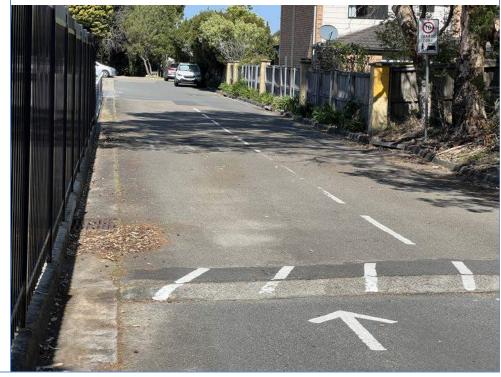
General views of the road surface at the start point. 0m

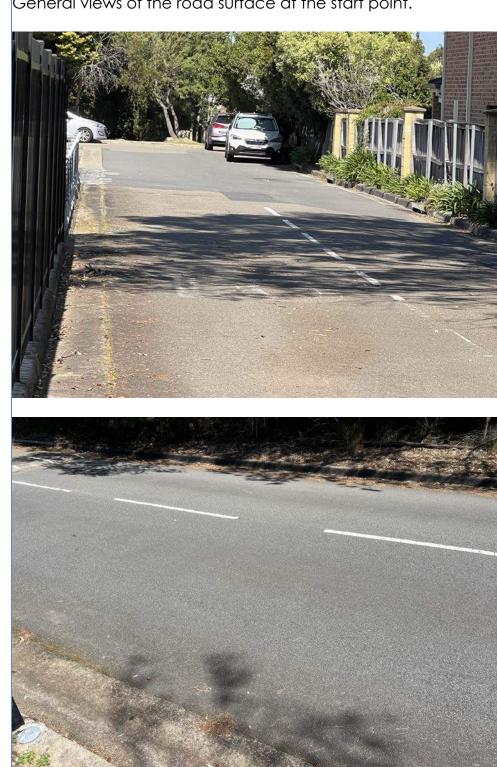
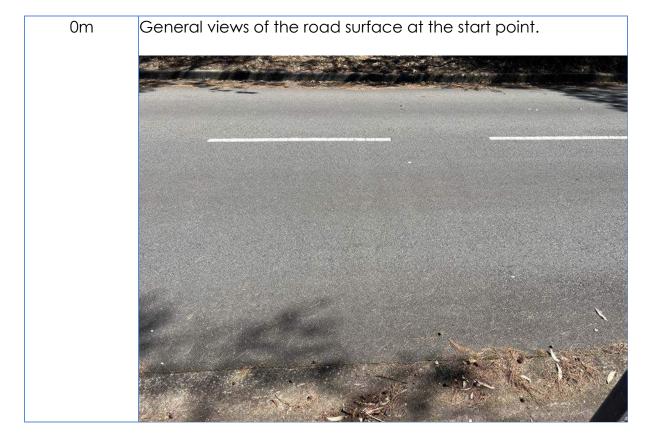
General views of the road surface, kerb and gutter looking towards Aquatic Drive from the start point.

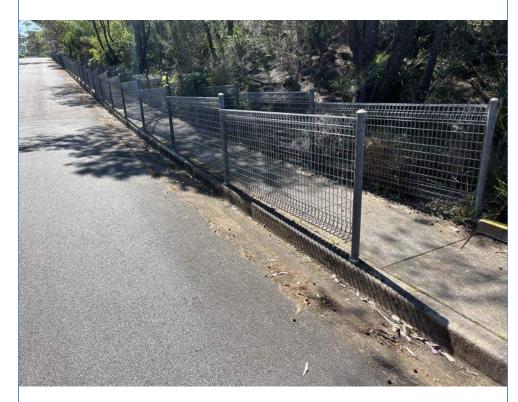
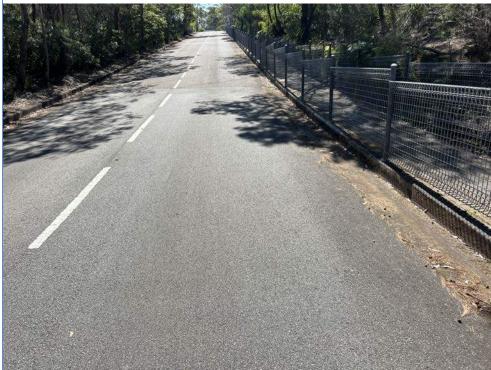
Om General views of the road surface, kerb and gutter looking towards Aquatic Drive from the start point.

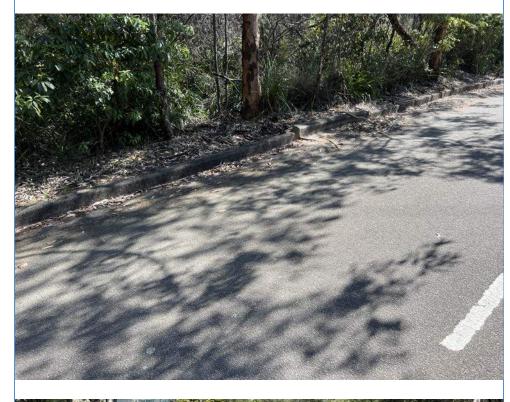
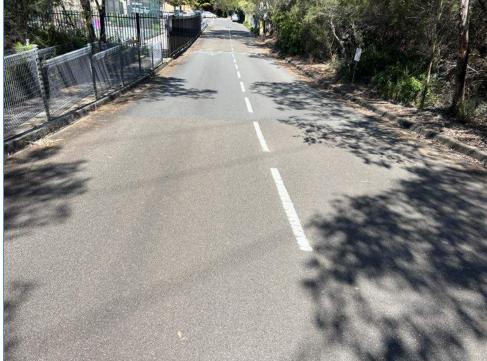
Crack damage to the kerb, gutter and road surface to the western side of the driveway.

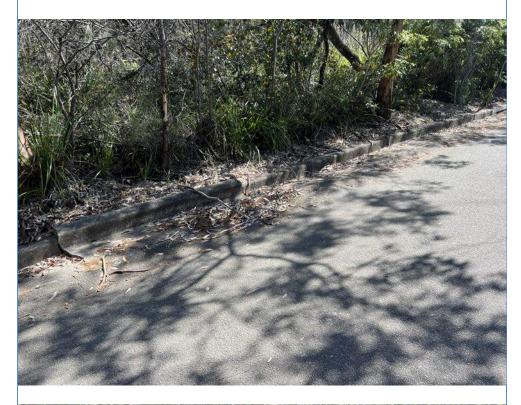
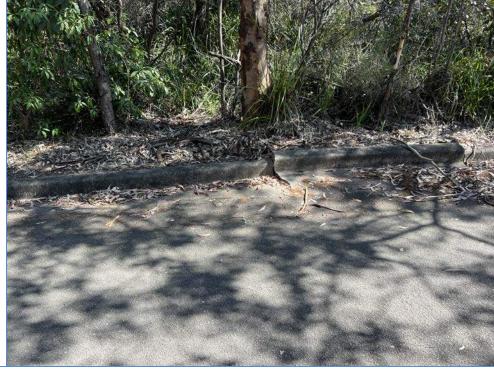
Crack damage to the kerb, gutter and road surface to the western side of the driveway.

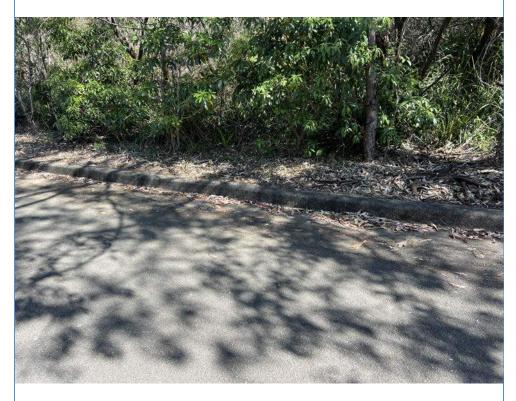
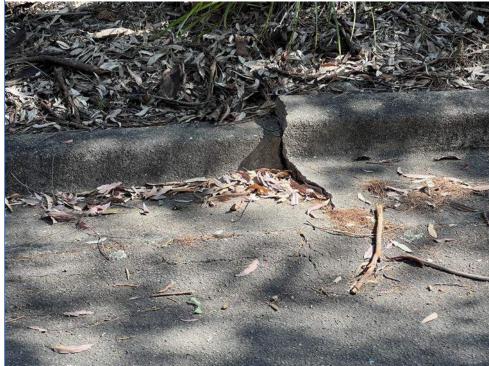
Crack damage to the kerb, gutter and road surface to the western side of the driveway.

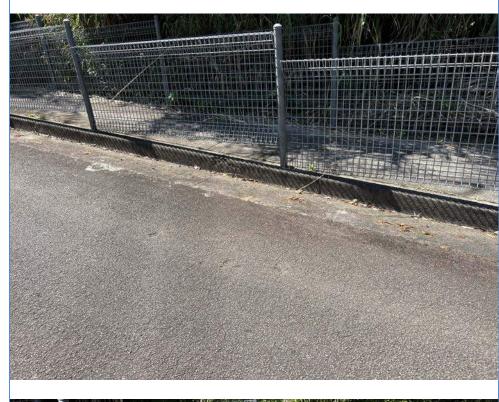
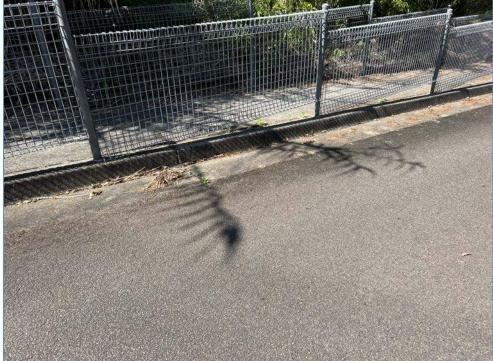
Crack damage to the kerb, gutter and road surface.

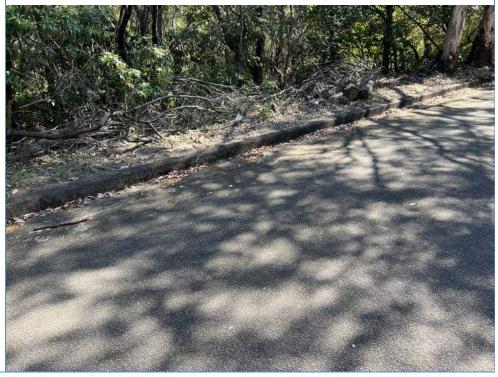
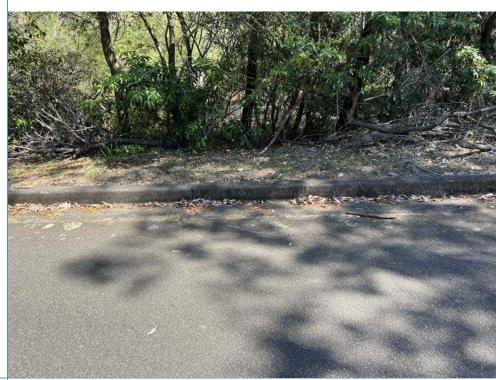
70m Crack damage to the road surface.
