# Arborist Assessment Report

PROJECT: SSD-21854025 Wee Waa High School

Site Address: 105-107 Mitchel Wee Waa NSW

Date of Inspection: 16<sup>th</sup> February 2022

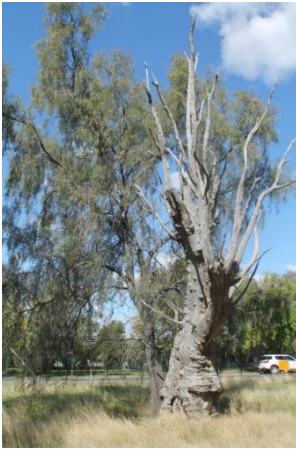
TREE 1 & 1A

- Two (2) significant in sized dead trees (Tree 1 and 46) of indigenous species both contain hollows.  
*(Ecologist required for further information)*

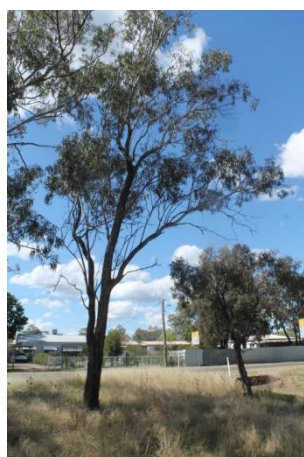
TREE 6E

6E	On Council Lands	Eucalyptus <i>microtheca</i> Coolibah	12	40	6	Mature moderate condition, structure good, damage at base, healthy tissue development at wound site	60	2.0	4.8	A2 HIGH	RETAIN
7	On Council Lands	Eucalyptus <i>microtheca</i> Coolibah	10	60/15	10	Mature good condition, structure good	70	2.8	7.4	A2 HIGH	RETAIN
7A	On Council Lands	Eucalyptus <i>microtheca</i> Coolibah	8	15	2	Immature good condition, structure good	25	1.8	2.0	A2 HIGH	RETAIN
7B	On Council Lands	Eucalyptus <i>microtheca</i> Coolibah	8	15	2	Immature good condition, structure good	25	1.8	2.0	A2 HIGH	RETAIN

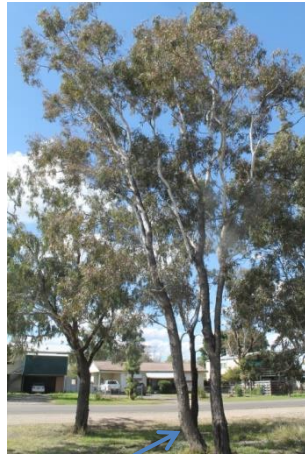
TREE 10 & 10A small tree

10A	Not affected	<i>Eucalyptus microtheca</i> Coolibah	7	20	3	Mature good condition but poor form	28	N/A	N/A	A2  HIGH	Impacted by construction  REMOVE TREE
11	Not affected	<i>Eucalyptus microtheca</i> Coolibah	12	50/30	10	Mature good condition, structure good	80	N/A	N/A	A2  HIGH	Impacted by construction  REMOVE TREE

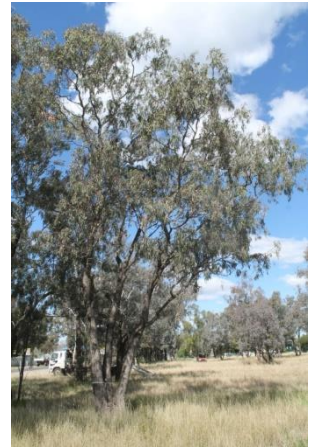
TREE 12

12	Not affected	<i>Eucalyptus microtheca</i> Coolibah	10	30x3	7	Mature good condition but poor form inclusion @ base	80	N/A	N/A	A2 HIGH	Impacted by construction REMOVE TREE
13	In Build Zone	<i>Eucalyptus microtheca</i> Coolibah	10	40/30	7	Mature good condition but poor form Lowest branch section failed	70	N/A	N/A	D2 Medium	Impacted by construction REMOVE TREE
14	In Build Zone	<i>Eucalyptus microtheca</i> Coolibah	10	50/30/ 15	8	Mature good condition, structure good	80	N/A	N/A	A2 HIGH	Impacted by construction REMOVE TREE
14A-	In Build Zone	<i>Eucalyptus microtheca</i> Coolibah	10	30	5	Mature good condition, structure good	45	N/A	N/A	A2 HIGH	Impacted by construction REMOVE TREE
14B-F	X5 In Build Zone	<i>Eucalyptus microtheca</i> Coolibah	10	30	5	Mature good condition structure good	40	N/A	N/A	A2 HIGH	Impacted by construction REMOVE TREE
15	Not affected	<i>Eucalyptus microtheca</i> Coolibah	12	35	5	Mature good condition, structure good	40	2.2	4.2	A2 HIGH	RETAIN

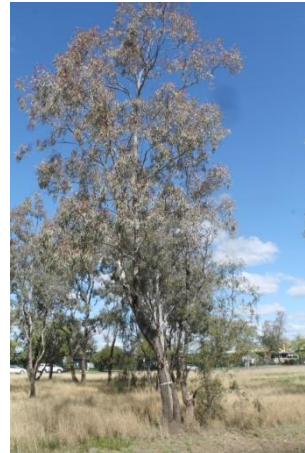
TREE 19

19	Not affected	<i>Eucalyptus microtheca</i> Coolibah	10	40/15	5	Mature good condition damage @ base good tissue response	55	2.5	5.1	A2 HIGH	RETAIN
20	Not affected	<i>Eucalyptus microtheca</i> Coolibah	11	40/15	6	Mature moderate condition, inclusion @ base	50	2.4	5.1	A2 HIGH	RETAIN
21	Not affected	<i>Eucalyptus microtheca</i> Coolibah	9	15x4	4	Mature moderate condition, possible white ant nest @ base	50	2.4	3.6	D2 HIGH	RETAIN
22	Not affected	<i>Eucalyptus microtheca</i> Coolibah	9	30/30/ 20	6	Mature moderate condition poor form, decay in union @ base.	60	2.6	5.6	D2	RETAIN
22A	Not affected	<i>Eucalyptus microtheca</i> Coolibah	11	28	3	Semi mature good condition structure good	35	2.1	5.0	A2 HIGH	RETAIN
23	Not affected	<i>Eucalyptus microtheca</i> Coolibah	10	30/30	7	Mature good condition, structure good	50	2.4	4.2	A2 HIGH	RETAIN
24	Not affected	<i>Eucalyptus microtheca</i> Coolibah	7	15x3	6	Semi mature good condition, poor form damage @ base good tissue response	45	2.3	3.1	D2 HIGH	RETAIN

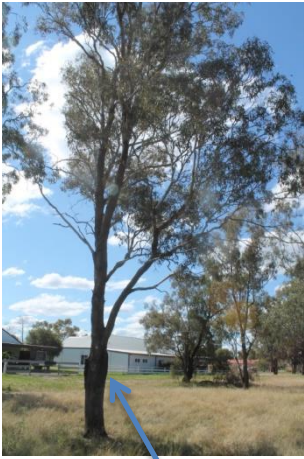
32A	Not affected	<i>Eucalyptus microtheca</i> Coolibah	12	55	8	Mature good condition, inclusion @ 2 m , swelling at site of union	70	N/A	N/A	D3 HIGH	RETAIN
32B	Not affected	<i>Eucalyptus microtheca</i> Coolibah	12	45	6	Mature moderate condition, damage@ 3m	70	N/A	N/A	D3 HIGH	RETAIN
33	In Build Zone	<i>Eucalyptus microtheca</i> Coolibah	10	30/15/ 15	5	Semi mature good condition poor form	50	N/A	N/A	A2 HIGH	Impacted by construction REMOVE TREE
34	In Build Zone	<i>Eucalyptus microtheca</i> Coolibah	12	60	8	Mature good condition, structure good minor dead wood	75	N/A	N/A	A2 HIGH	Impacted by construction REMOVE TREE
35	In Build Zone	<i>Eucalyptus microtheca</i>	12	60	9	Mature good condition, structure good minor dead wood	80	N/A	N/A	A2	Impacted by construction

TREE 32A swelling at union

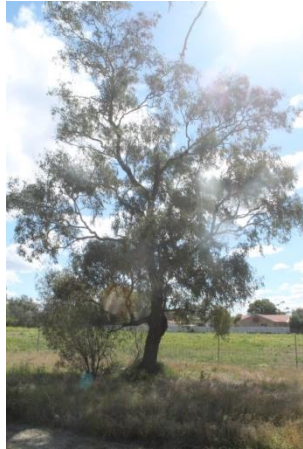
Coolibah								HIGH	REMOVE TREE
35A	In Build Zone	Eucalyptus <i>microtheca</i> Coolibah	10	50	8	Mature good condition, structure fair 3 x branch failures	65	N/A	N/A	D2 HIGH	Impacted by construction REMOVE TREE
36	Not affected	Eucalyptus <i>microtheca</i> Coolibah	8	30/30	6	Mature good condition, structure good tree suppressed by adjacent tree	50	2.4	5.0	A2 HIGH	RETAIN
37	Not affected	Eucalyptus <i>microtheca</i> Coolibah	12	60/30	10	Mature good condition, structure good	80	3.0	8.0	A2 HIGH	RETAIN
37A	Not affected	Eucalyptus <i>microtheca</i> Coolibah	10	30	5	Mature good condition, structure good	40	2.2	3.6	A2 HIGH	RETAIN
37B	Not affected	Eucalyptus <i>microtheca</i> Coolibah	12	60	8	Mature good condition, structure good	75	2.9	7.2	A2 HIGH	RETAIN
37C	REF' works	Eucalyptus <i>microtheca</i> Coolibah	10	40	6	Mature good condition, structure good	55	2.6	4.8	A2 HIGH	Tree to be removed under separate approval (if not removed retain)

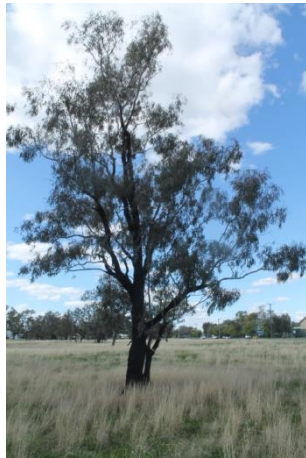
TREE 45

45	REF' works	Eucalyptus <i>microtheca</i> Coolibah	10	30/30	7	Mature moderate condition, inclusion @ base OK	60	2.7	4.2	D3 HIGH	Tree to be removed under separate approval (if not removed retain)
46	REF' works	Eucalyptus <i>microtheca</i> Coolibah	10	70	8	DEAD several small hollows observed. HABITAT TREE	N/A	6.0	N/A	C4 HIGH	Tree to be removed under separate approval (if not removed retain)
47x4	Not affected	Eucalyptus <i>microtheca</i> Coolibah	10	30	6	Semi mature good condition, some damage at base and union	40	2.2	3.6	D3 HIGH	RETAIN
48	Not affected	Geijera <i>parviflora</i> Wilga	12	40/40	8	Mature moderate condition borer attack decay in trunk. Leans to south tree appears to be declining in health & vigour review in 6 months	60	2.6	6.8	D3 Medium	RETAIN <i>review tree status in 6 months'</i>  <i>May have implications on construction of security fence panels.</i>

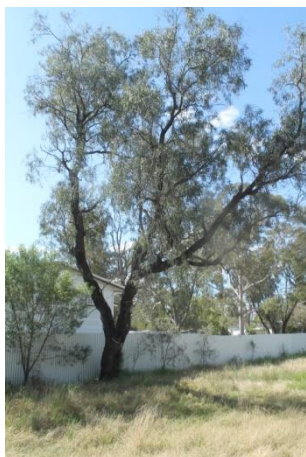
TREE 49

49	REF' works	<i>Eucalyptus microtheca</i> Coolibah	12	40	5	Mature poor condition borer attack, failed section	50	2.4	4.8	D3 HIGH	Tree to be removed under separate approval (if not removed retain)
49A	REF' works	<i>Geijera parviflora</i> Wilga	9	30	7	Mature good condition, structure good	40	2.2	3.6	D3 HIGH	Tree to be removed under separate approval (if not removed retain)
50	REF' works	<i>Eucalyptus microtheca</i> Coolibah	12	30	6	Mature good condition, structure good	50	2.4	3.6	A2 HIGH	Tree to be removed under separate approval (if not removed retain)
51	REF' works	<i>Eucalyptus microtheca</i> Coolibah	12	30	6	Mature good condition, structure good	50	2.4	6.0	A2 HIGH	Tree to be removed under separate approval (if not removed retain)
51A	REF' works	<i>Eucalyptus microtheca</i> Coolibah	12	30	6	Mature good condition, structure good	50	2.4	6.0	A2 HIGH	Tree to be removed under separate approval (if not removed retain)

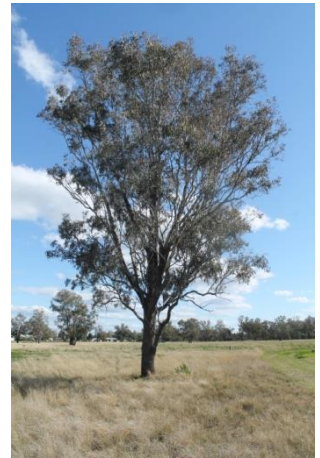
TREE 55

55	Not affected	<i>Eucalyptus microtheca</i> Coolibah	10	60	8	Mature good condition, structure poor, fracture in union West side	80	3.0	7.2	D3 Medium	RETAIN
56	REF' works	<i>Eucalyptus microtheca</i> Coolibah	10	35	7	Mature good condition, structure good	50	N/A	N/A	A2 HIGH	Tree to be removed under separate approval (if not removed retain)
57	Not affected	<i>Eucalyptus microtheca</i> Coolibah	10	40	7	Mature moderate condition	48	2.4	4.2	A2 HIGH	RETAIN
58	REF' works	<i>Eucalyptus microtheca</i> Coolibah	10	20x4	6	Mature good condition, poor form structure good.	80	3.0	4.8	A2 HIGH	Tree to be removed under separate approval (if not removed retain)
59	REF' works	<i>Eucalyptus microtheca</i> Coolibah	10	40	6	Mature good condition, structure good	50	2.4	4.2	A2 HIGH	Tree to be removed under separate approval (if not removed retain)
60	REF' works	<i>Eucalyptus microtheca</i> Coolibah	12	40	6	Mature moderate condition, structure ok	50	2.4	4.2	D3 HIGH	Tree to be removed under separate approval (if not removed retain)
