Microbial Testing - Willyama High School

Radium Street, Broken Hill, NSW 2880

School Infrastructure NSW Regional Office - North Western NSW

Report No.: 30158-R04

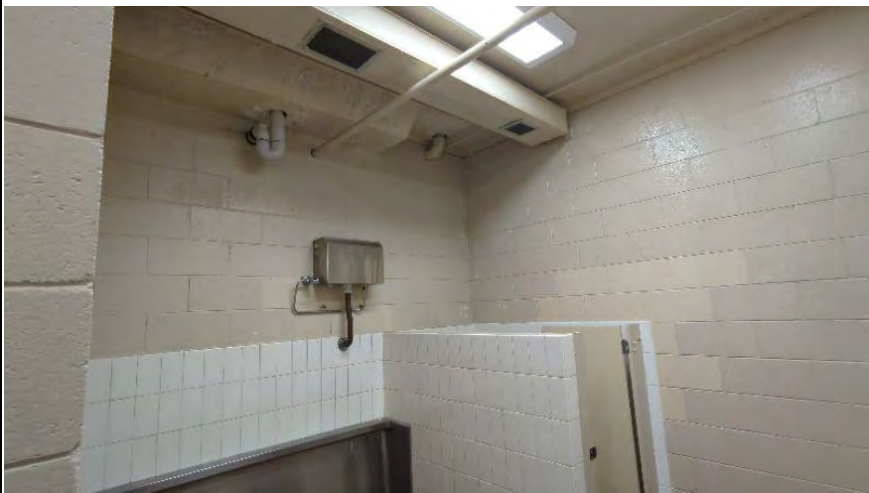
<p data-bbox="354 993 646 1024">B00A-ROE20 - Boys Toilet</p>	<p data-bbox="943 499 1250 562">Masonry wall, ceramic wall tiles, ceramic floor tiles.</p>	<p data-bbox="1273 499 1555 716">Suspected visual mould growth was noted to upper section of masonry wall. Evaporative water stains noted to ceramic floor tiles.</p> <p data-bbox="1273 730 1555 800">IICRC-520:2015 Condition 3 guidelines</p>

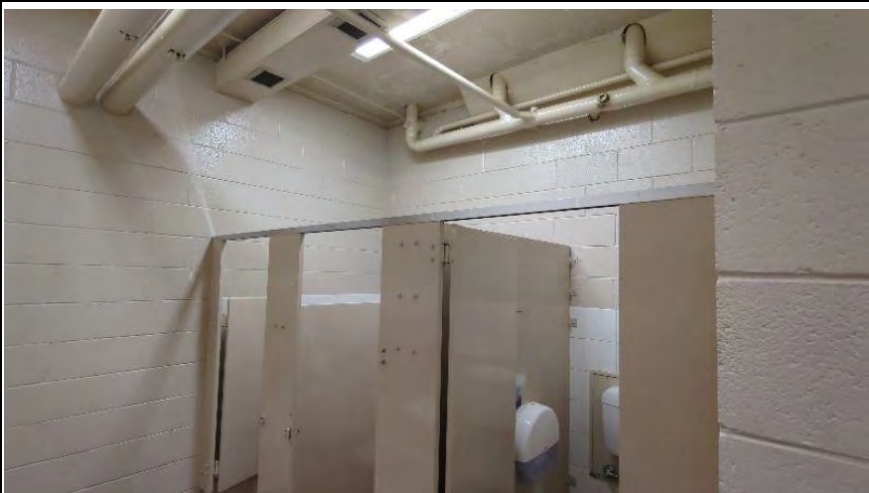
<p data-bbox="354 1539 646 1570">B00A-ROE21 - Girls Toilet</p>	<p data-bbox="943 1045 1250 1108">Masonry wall, ceramic wall tiles, ceramic floor tiles.</p>	<p data-bbox="1273 1045 1555 1224">No signs of visual mould growth were noted. Evaporative water stains noted to ceramic floor tiles.</p> <p data-bbox="1273 1239 1555 1308">IICRC-520:2015 Condition 3 guidelines</p>

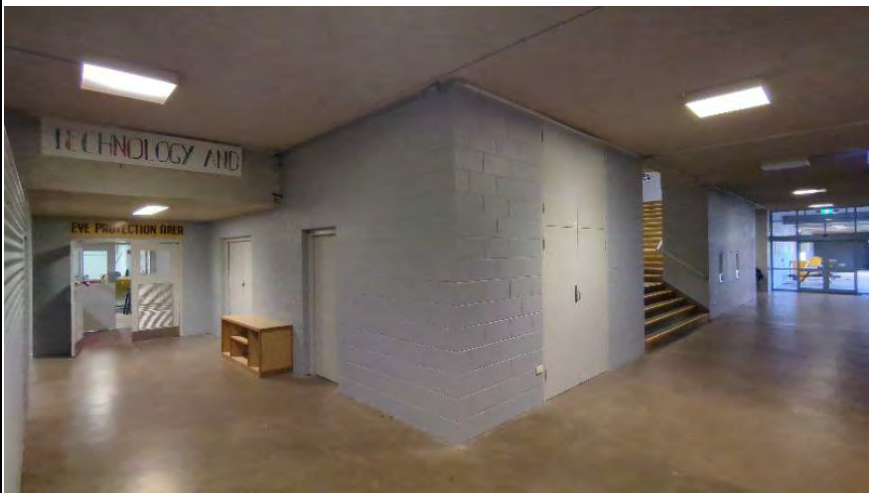
<p data-bbox="354 993 646 1020">B00A-R0E24 - Movement</p>	<p data-bbox="951 499 1243 604">Masonry walls, concrete floor and sprayed coating (vermiculite) ceiling.</p>	<p data-bbox="1268 499 1552 720">Traces of suspected visual mould were noted to concrete floor and lower section of masonry wall. IICRC-520:2015 Condition 3 guidelines</p>

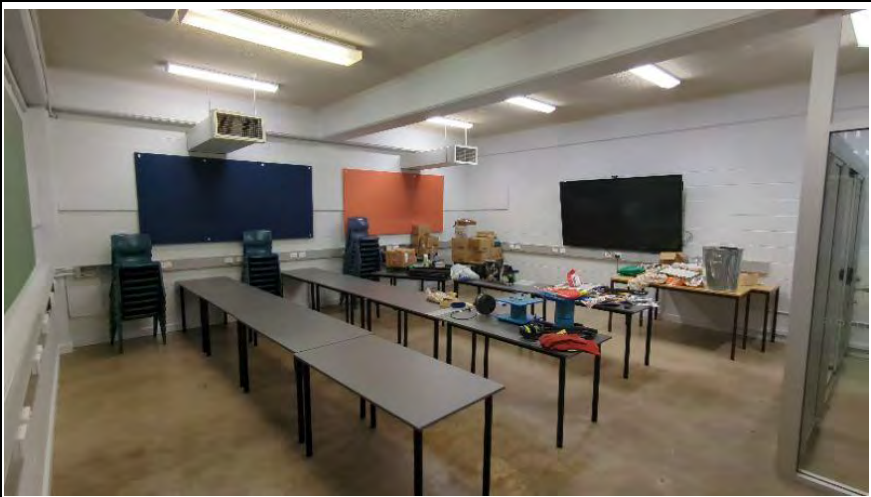
<p data-bbox="362 1539 638 1566">B00A-R0E06 - Design LS</p>	<p data-bbox="951 1052 1243 1157">Masonry walls, concrete floor and sprayed coating (vermiculite) ceiling.</p>	<p data-bbox="1268 1052 1552 1234">No signs of visual mould growth or water damage were noted. IICRC-520:2015 Condition 3 guidelines</p>

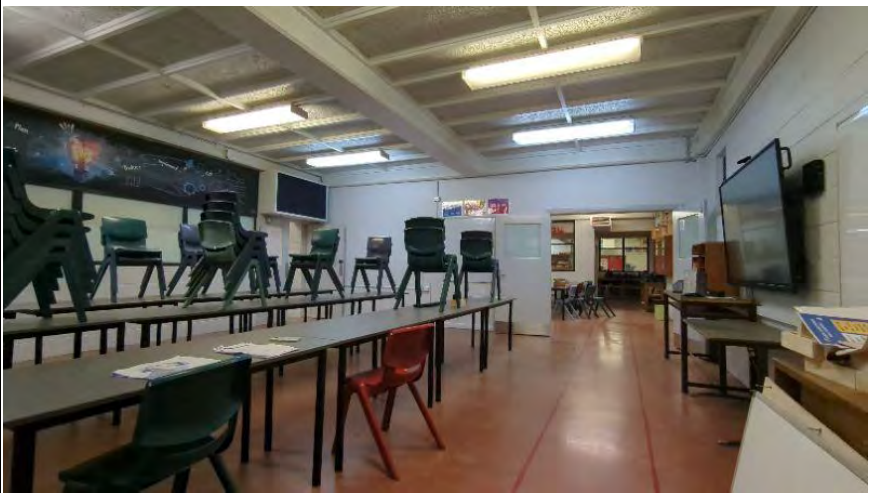
<p data-bbox="358 993 651 1024">B00A-R0E26 - General LS</p>	<p data-bbox="954 499 1252 611">Masonry walls, vinyl floor sheeting, composite ceiling panels.</p>	<p data-bbox="1279 499 1560 751">Suspected visual mould growth was noted to leather boots on shoe rack. Traces of suspected visual mould growth noted inside bench cupboard.</p> <p data-bbox="1279 768 1560 879">Refer to index photo 18. IICRC-520:2015 Condition 3 guidelines</p>

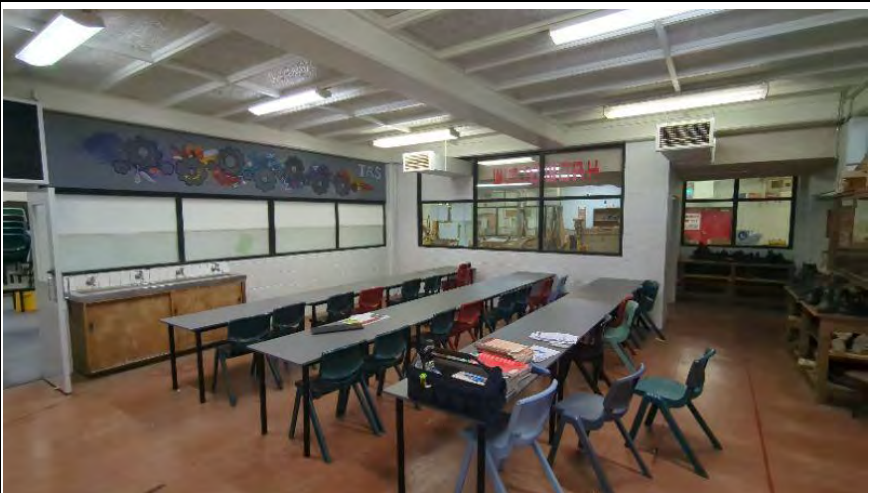
<p data-bbox="358 1539 651 1570">B00A-R0E25 - General LS</p>	<p data-bbox="954 1052 1252 1163">Masonry walls, vinyl floor sheeting, composite ceiling panels.</p>	<p data-bbox="1279 1052 1560 1304">Suspected visual mould growth was noted to leather boots on shoe rack. Traces of suspected visual mould growth noted to inside sink top cupboard.</p> <p data-bbox="1279 1320 1560 1388">IICRC-520:2015 Condition 3 guidelines</p>

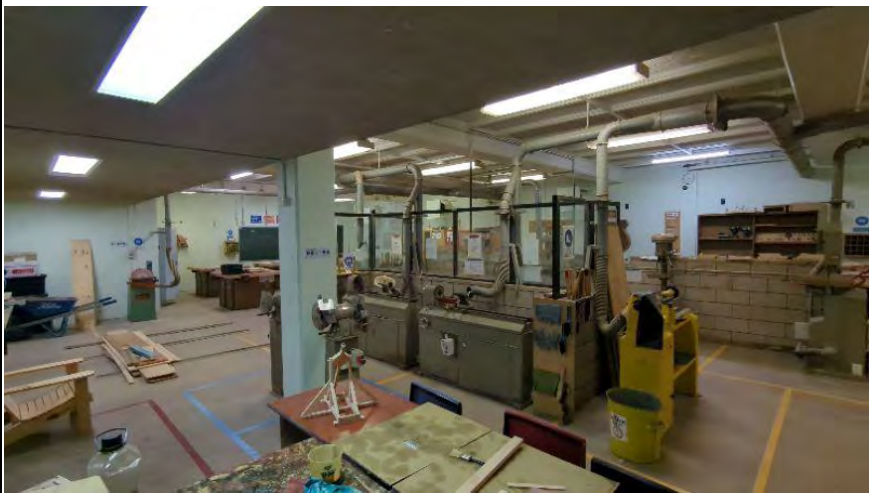
<p data-bbox="347 993 651 1020">B00A-R0E09 - Materials LS</p>	<p data-bbox="954 499 1243 604">Masonry walls, concrete floor and sprayed coating (vermiculite) ceiling</p>	<p data-bbox="1276 499 1547 730">Suspected visual mould growth was noted to chipboard cabinetry. Refer to Index photo 28. IICRC-520:2015 Condition 3 guidelines</p>

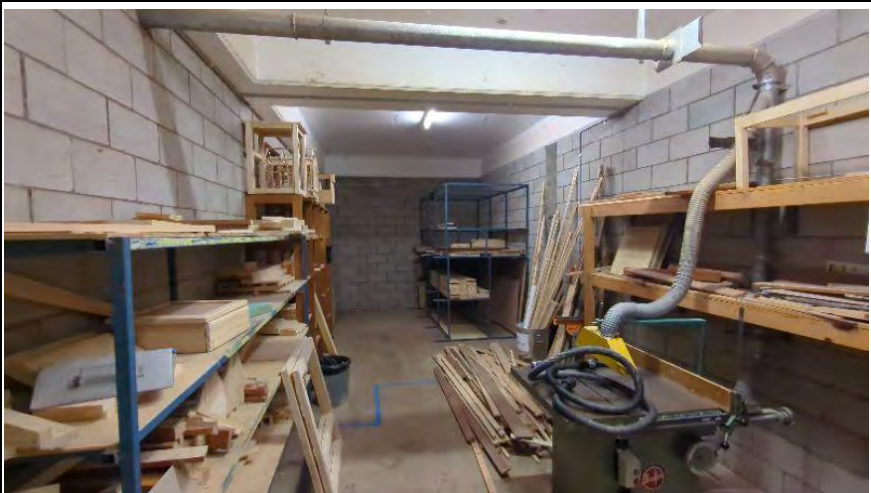
<p data-bbox="354 1539 644 1566">B00A-R0E12 - Store room</p>	<p data-bbox="954 1052 1243 1157">Masonry walls, concrete floor and sprayed coating (vermiculite) ceiling</p>	<p data-bbox="1276 1052 1547 1392">No signs of visual mould growth were noted. Water ingress (leaching) was noted to the upper section of masonry wall. Refer to index photo 26 - 27. IICRC-520:2015 Condition 3 guidelines</p>

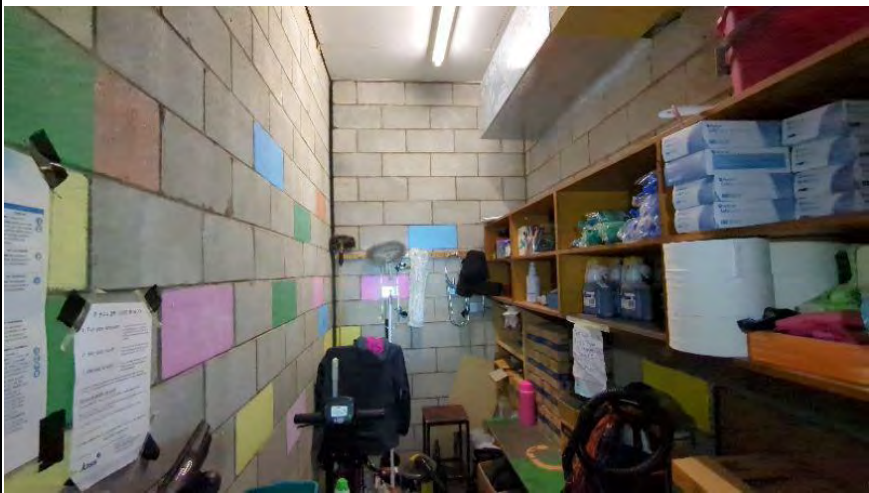
<p data-bbox="354 999 646 1031">B00A-R0E18 - Store room</p>	<p data-bbox="938 499 1252 604">Masonry walls, carpet over concrete and sprayed coating (vermiculite) ceiling.</p>	<p data-bbox="1268 499 1554 678">Suspected visual mould were noted to chipboard shelves, chipboard benchtop and porous contents.</p> <p data-bbox="1268 695 1554 758">Refer to index photo 29 - 31.</p> <p data-bbox="1268 779 1554 842">IICRC-520:2015 Condition 3 guidelines</p>

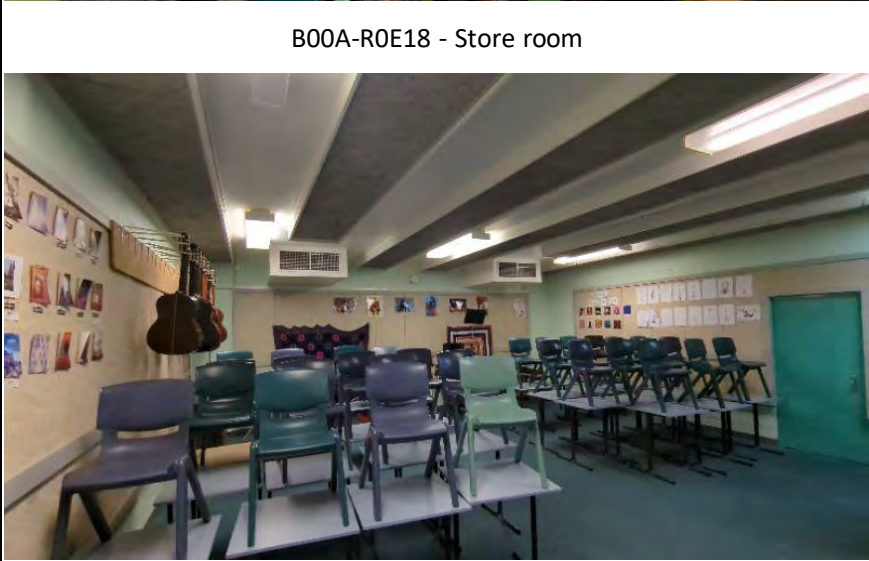
<p data-bbox="367 1556 633 1587">B00A-R0N12 - Music LS</p>	<p data-bbox="938 1052 1252 1157">Masonry walls, plasterboard walls, carpet over concrete and acoustic ceiling tiles.</p>	<p data-bbox="1268 1052 1554 1230">Suspected visual mould growth was noted to carpet, plasterboard wall, all furniture and all contents.</p> <p data-bbox="1268 1251 1554 1314">Refer to index photo 32 - 40.</p> <p data-bbox="1268 1335 1554 1398">IICRC-520:2015 Condition 3 guidelines</p>

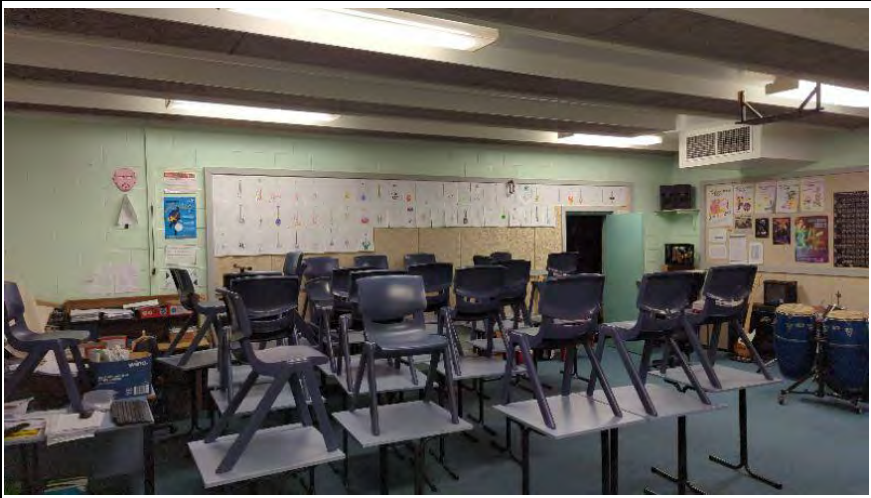
<p data-bbox="293 1010 703 1037">B00A-R0N11 - Music Practice Room</p>	<p data-bbox="938 506 1253 617">Masonry walls, plasterboard walls, carpet over concrete and acoustic ceiling tiles.</p>	<p data-bbox="1268 506 1555 684">Suspected visual mould growth was noted to carpet, plasterboard wall, all furniture and all contents.</p> <p data-bbox="1268 701 1555 764">Refer to index photos 41 - 48.</p> <p data-bbox="1268 831 1555 894">IICRC-520:2015 Condition 3 guidelines</p>

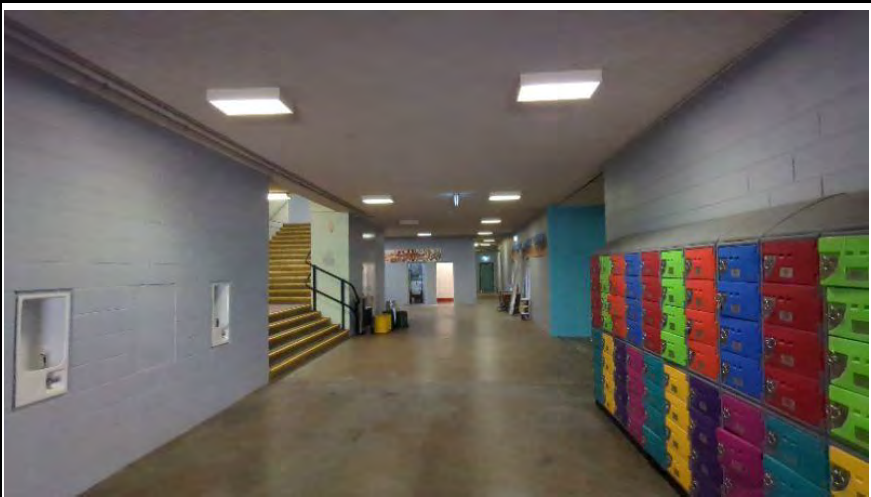
<p data-bbox="347 951 651 978">B00A-R0W32 - Movement</p>	<p data-bbox="938 457 1253 562">Masonry walls, carpet over concrete and sprayed coating (vermiculite) ceiling.</p>	<p data-bbox="1266 457 1554 674">Traces of suspected visual mould growth were noted to the concrete floor, lower sections of masonry walls, hardwood furniture and artworks.</p> <p data-bbox="1266 688 1554 758">IICRC-520:2015 Condition 3 guidelines</p>

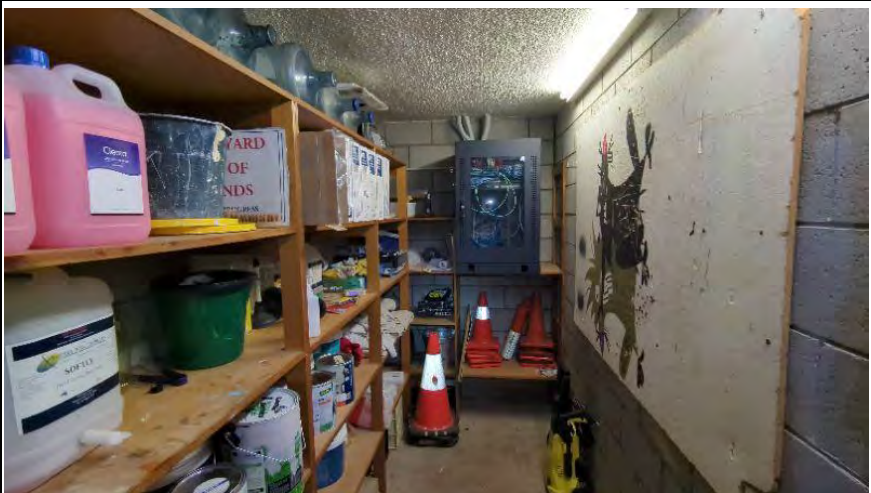
<p data-bbox="331 1499 667 1526">B00A-R0N21 - Cleaning Store</p>	<p data-bbox="954 1010 1243 1115">Masonry walls, concrete floor and sprayed coating (vermiculite) ceiling</p>	<p data-bbox="1266 1010 1554 1150">Traces of suspected visual mould growth were noted to chipboard shelving unit.</p> <p data-bbox="1266 1165 1554 1234">Refer to Index photos 63 - 66.</p> <p data-bbox="1266 1249 1554 1318">IICRC-520:2015 Condition 3 guidelines</p>

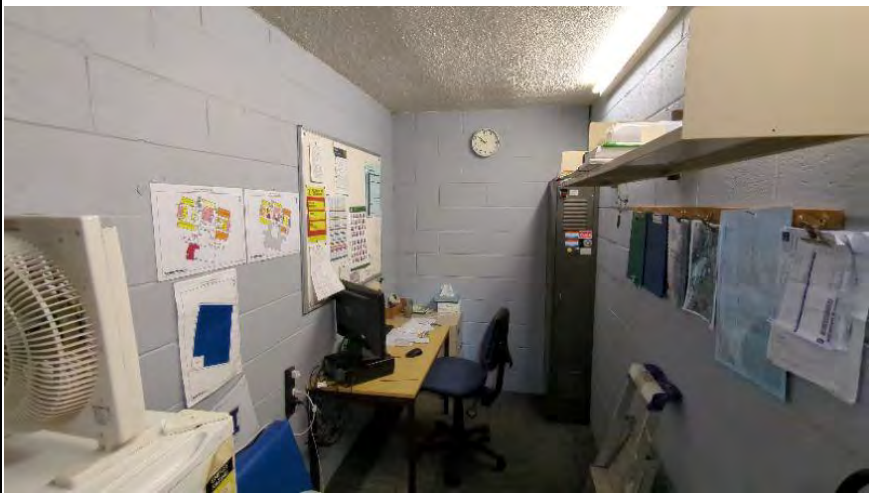
<p data-bbox="363 999 636 1031">B00A-R0N22 - GA office</p>	<p data-bbox="938 499 1252 604">Masonry walls, carpet over concrete and sprayed coating (vermiculite) ceiling.</p>	<p data-bbox="1268 499 1555 604">No signs of visual mould growth or water damage were noted.</p> <p data-bbox="1268 621 1563 684">Refer to index photos 67 - 68.</p> <p data-bbox="1268 701 1563 764">IICRC-520:2015 Condition 3 guidelines</p>

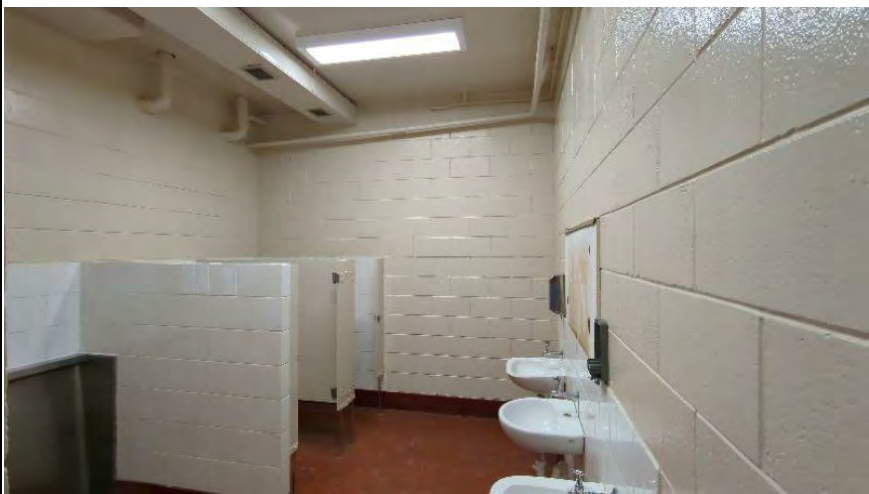
<p data-bbox="350 1556 649 1587">B00A-R0W05 - Boys Toilet</p>	<p data-bbox="938 1056 1252 1161">Concrete ceiling, ceramic, masonry walls, ceramic wall tiles and ceramic floor tiles.</p>	<p data-bbox="1268 1056 1555 1276">Suspected visual mould growth was noted to ceramic floor tiles, masonry walls, ceramic wall tiles and concrete ceiling.</p> <p data-bbox="1268 1293 1563 1356">Refer to index photos 70 - 77.</p> <p data-bbox="1268 1373 1563 1436">IICRC-520:2015 Condition 3 guidelines</p>

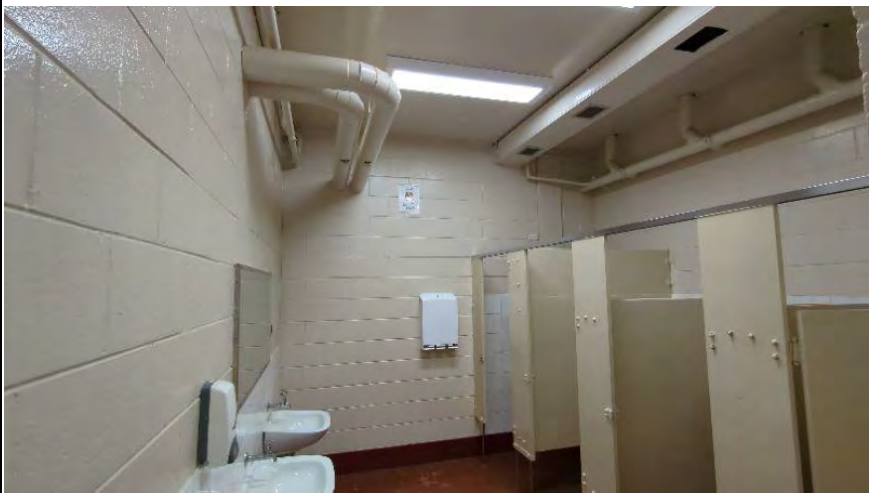
<p data-bbox="349 989 651 1020">B00A-R0W06 - Girl's toilet</p>	<p data-bbox="938 499 1252 600">Concrete ceiling, ceramic, masonry walls, ceramic wall tiles and ceramic floor tiles.</p>	<p data-bbox="1276 499 1547 716">Suspected visual mould growth was noted to ceramic floor tiles, masonry walls, ceramic wall tiles and concrete ceiling.</p> <p data-bbox="1276 730 1539 762">Refer to index photos.</p> <p data-bbox="1370 777 1451 808">78 - 81</p> <p data-bbox="1263 823 1560 890">IICRC-520:2015 Condition 3 guidelines</p>

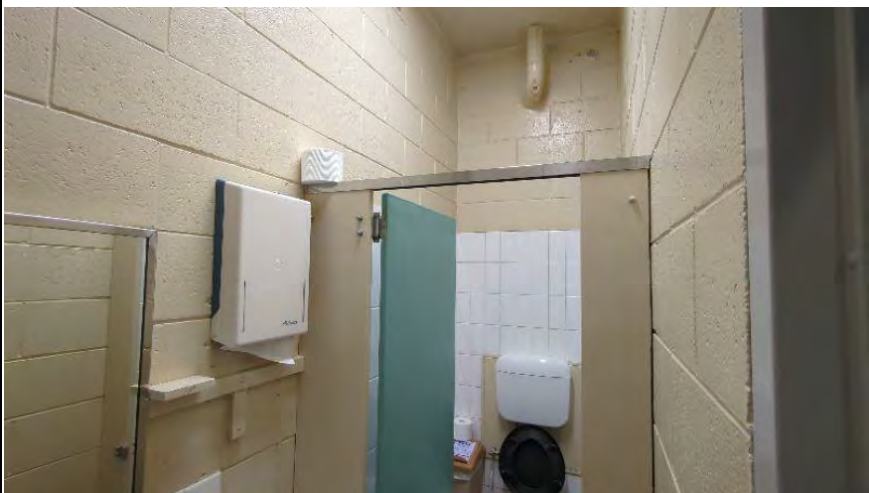
<p data-bbox="349 1537 651 1568">B00A-R0W04 - Staff Toilet</p>	<p data-bbox="938 1050 1252 1110">Concrete ceiling, masonry walls and ceramic floor tiles.</p>	<p data-bbox="1276 1050 1547 1117">No signs of visual mould growth were noted.</p> <p data-bbox="1276 1125 1547 1226">Evaporative water stains were noted to ceramic floor tiles.</p> <p data-bbox="1263 1241 1560 1308">Refer to index photos 82 - 83.</p> <p data-bbox="1263 1323 1560 1390">IICRC-520:2015 Condition 3 guidelines</p>

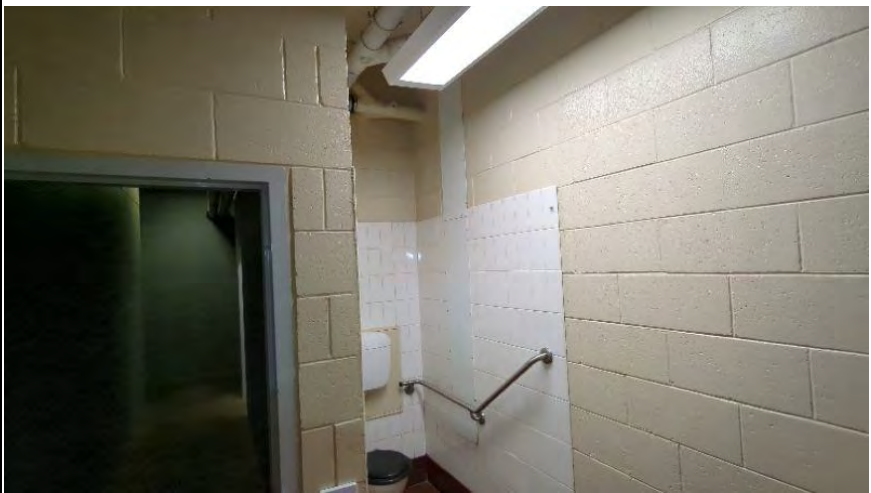
<p data-bbox="350 993 651 1020">B00A-R0W03 - Staff Toilet</p>	<p data-bbox="938 499 1253 600">Concrete ceiling, ceramic, masonry walls, ceramic wall tiles and ceramic floor tiles.</p>	<p data-bbox="1268 499 1552 762">No signs of visual mould growth were noted. Evaporative water stains were noted to ceramic floor tiles. IICRC-520:2015 Condition 3 guidelines</p>

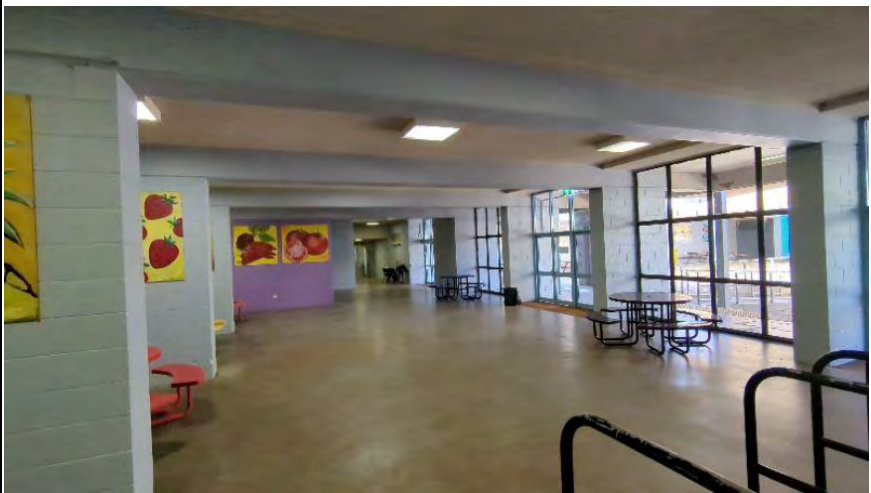
<p data-bbox="354 993 646 1020">B00A-R0N19 - Movement</p>	<p data-bbox="954 499 1243 604">Concrete floor, masonry walls and sprayed coating (vermiculite) ceiling.</p>	<p data-bbox="1268 499 1555 678">Traces of suspected visual mould noted to floor, lower sections of masonry wall and art works.</p> <p data-bbox="1268 695 1555 762">IICRC-520:2015 Condition 3 guidelines</p>

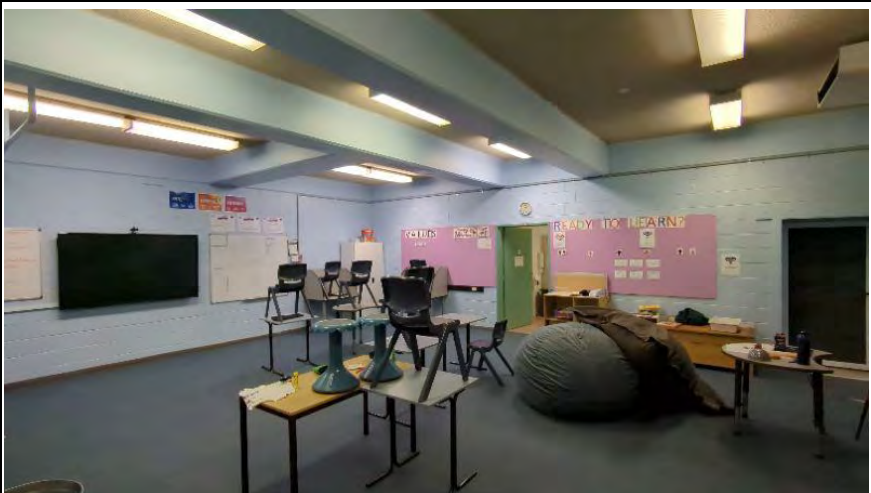
<p data-bbox="282 1539 716 1566">B00A-R0W26 - Special Learning Space</p>	<p data-bbox="943 1052 1252 1157">Masonry walls, carpet over concrete and sprayed coating (vermiculite) ceiling.</p>	<p data-bbox="1268 1052 1555 1157">No signs of visual mould growth or water damage were noted.</p> <p data-bbox="1268 1173 1555 1241">Refer to index photos 88 - 92.</p> <p data-bbox="1268 1257 1555 1325">IICRC-520:2015 Condition 3 guidelines</p>

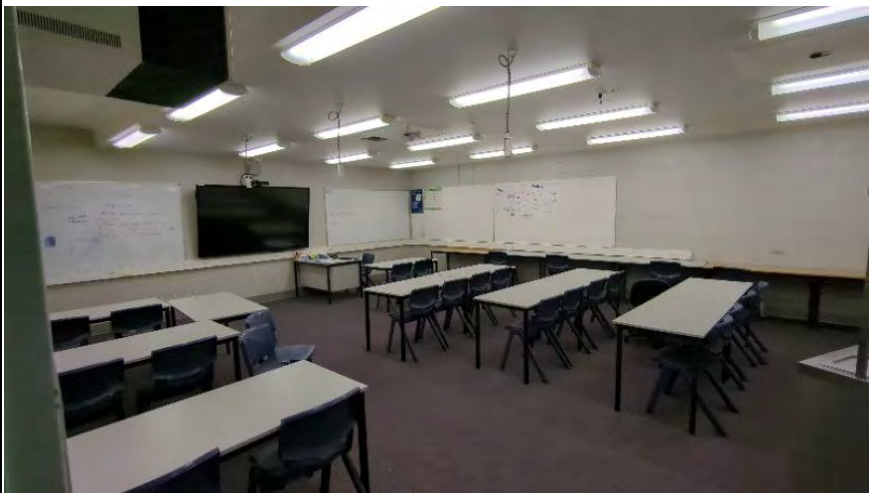
<p data-bbox="266 993 735 1024">B00A-R0W23 - Materials Technology L. S</p>	<p data-bbox="956 499 1235 604">Masonry walls, concrete ceiling and carpet over concrete.</p>	<p data-bbox="1273 499 1552 678">Suspected visual mould growth was noted to carpet, porous furniture and within benchtop cupboard.</p> <p data-bbox="1260 695 1562 758">Refer to index photos 92 - 97.</p> <p data-bbox="1260 774 1562 842">IICRC-520:2015 Condition 3 guidelines</p>

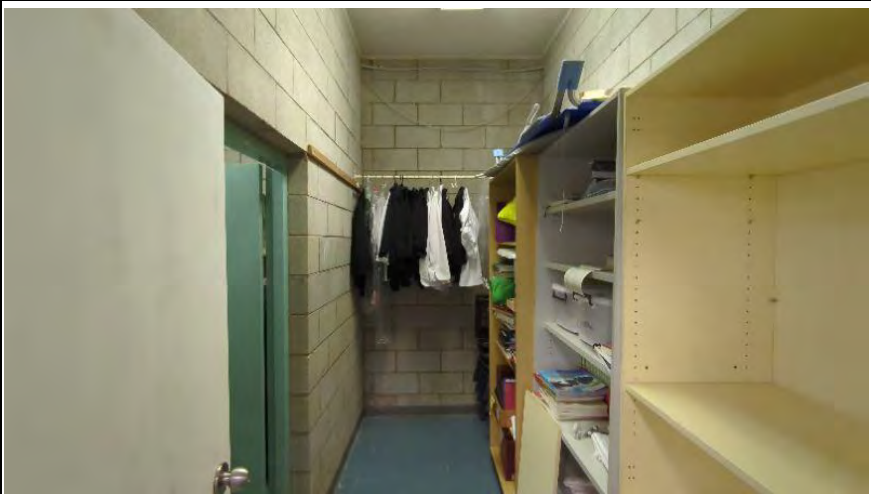
<p data-bbox="350 1570 647 1602">B00A-R0W22 - Storeroom</p>	<p data-bbox="956 1077 1235 1182">Masonry walls, concrete ceiling and carpet over concrete.</p>	<p data-bbox="1273 1077 1552 1182">No signs of visual mould or water damage were noted.</p> <p data-bbox="1260 1199 1562 1266">IICRC-520:2015 Condition 3 guidelines</p>

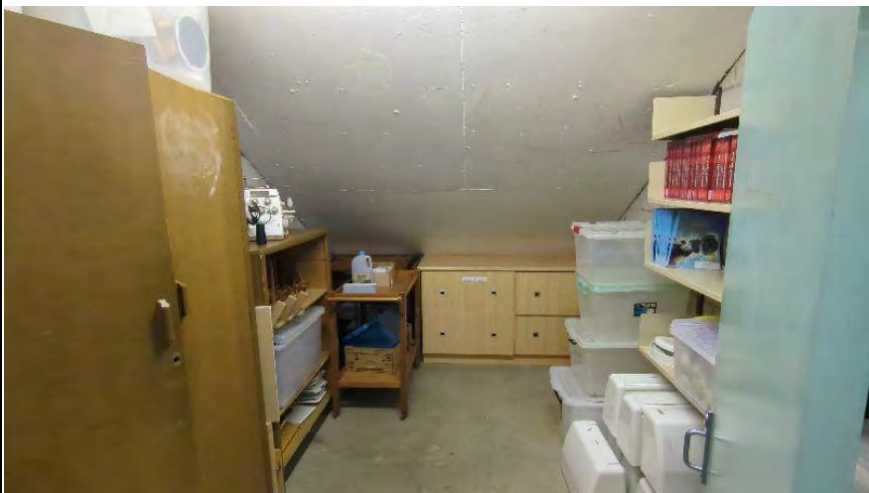
<p data-bbox="342 993 654 1020">B00A-R0W21 - Store Room</p>	<p data-bbox="951 499 1247 569">Masonry walls, concrete ceiling and concrete floor.</p>	<p data-bbox="1271 499 1550 600">No signs of visual mould or water damage were noted.</p> <p data-bbox="1271 621 1555 684">Refer to index photos 98-101.</p> <p data-bbox="1271 705 1555 768">IICRC-520:2015 Condition 3 guidelines</p>

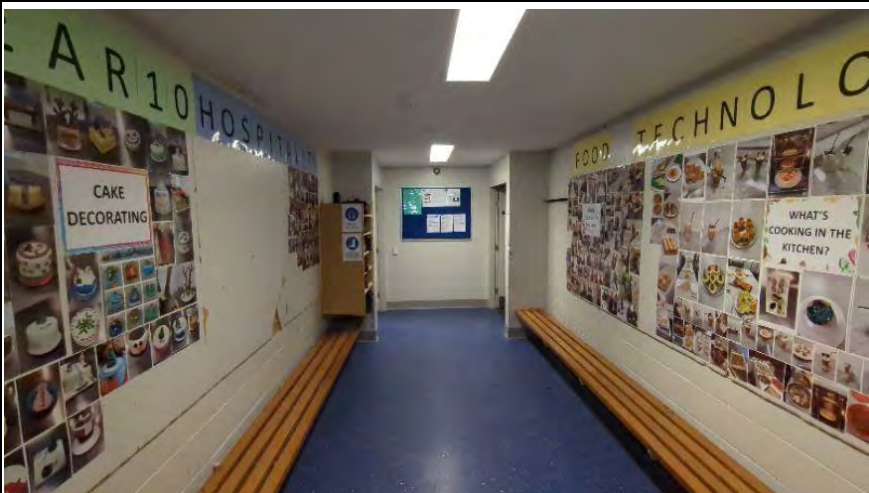
<p data-bbox="350 1545 654 1572">B00A-R0W40 - Movement</p>	<p data-bbox="951 1052 1255 1157">Masonry walls, vinyl floor sheeting and sprayed coating (vermiculite) ceiling.</p>	<p data-bbox="1271 1052 1550 1157">Suspected visual mould was noted to leather boots within shoe rack.</p> <p data-bbox="1271 1167 1550 1241">Refer to index photos. 102-104</p> <p data-bbox="1271 1262 1555 1325">IICRC-520:2015 Condition 3 guidelines</p>

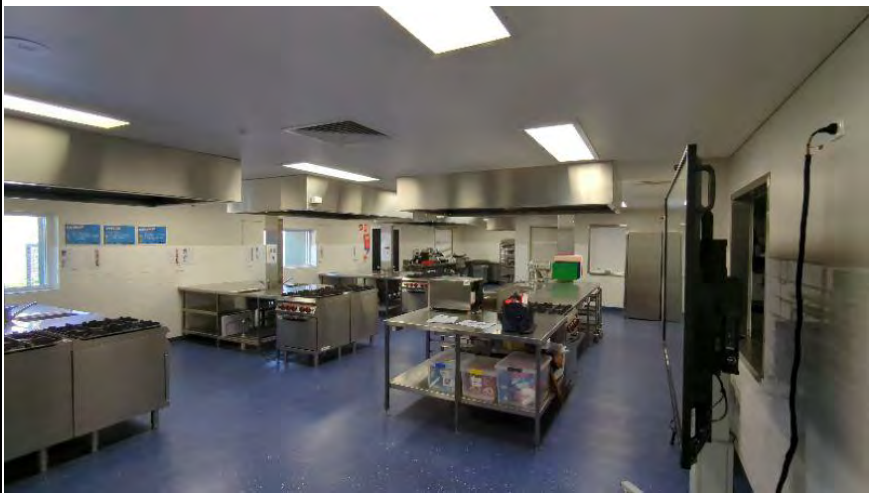
<p data-bbox="337 999 667 1031">B00A-R0W34 - Food Tech LS</p>	<p data-bbox="930 489 1260 604">Masonry walls, plasterboard walls and plasterboard ceiling.</p>	<p data-bbox="1260 489 1560 688">Traces of suspected visual mould growth noted to vinyl floor sheeting. Refer to index photos 105 - 113.</p> <p data-bbox="1260 699 1560 772">IICRC-520:2015 Condition 3 guidelines</p>

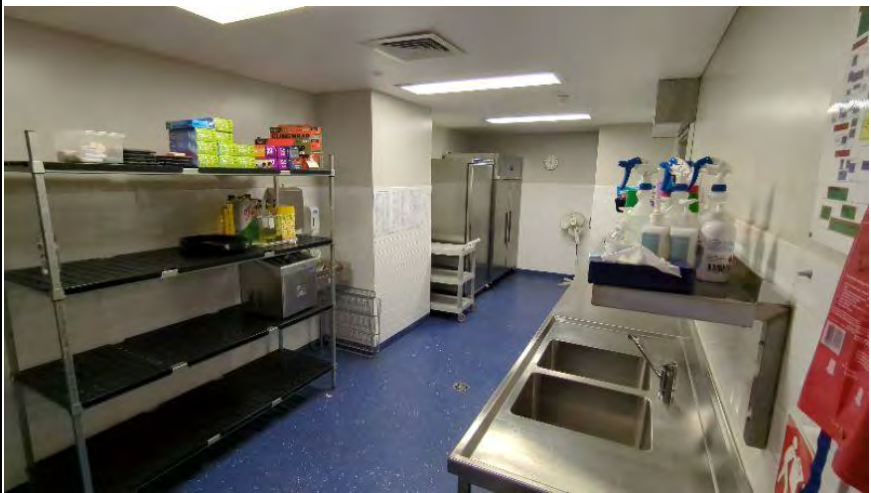
<p data-bbox="370 999 626 1026">B00A-R037 - Research</p>	<p data-bbox="943 499 1250 638">Building materials comprised of plasterboard ceiling, plasterboard walls and vinyl floor sheeting.</p>	<p data-bbox="1271 499 1552 600">No signs of visual mould growth or water damage were noted.</p> <p data-bbox="1271 617 1552 684">Refer to index photos 132 - 137.</p> <p data-bbox="1271 701 1552 768">IICRC-520:2015 Condition 3 guidelines</p>

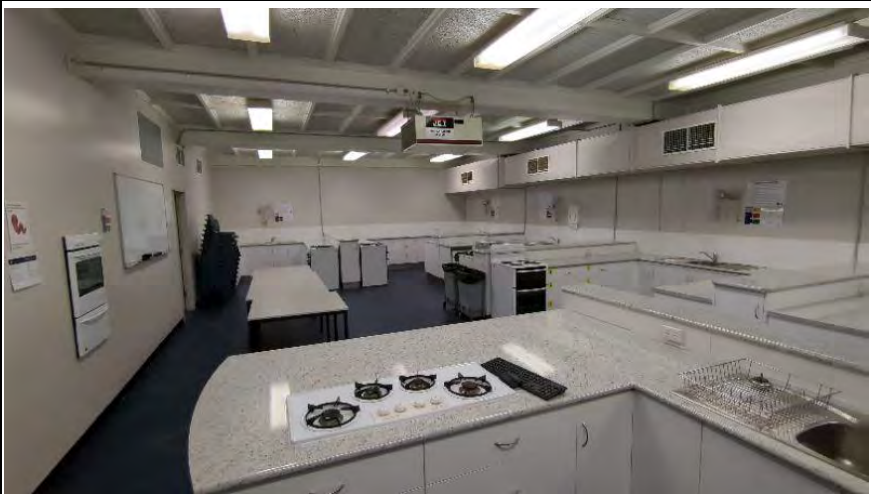
<p data-bbox="354 1556 643 1583">B00A-R0W39 - Food Tech</p>	<p data-bbox="951 1056 1243 1167">Plasterboard walls, carpet over concrete and acoustic ceiling tiles.</p>	<p data-bbox="1271 1056 1552 1157">Traces of suspected visual mould growth was noted to carpet floor.</p> <p data-bbox="1271 1173 1552 1241">Refer to index photos 138 - 143.</p> <p data-bbox="1271 1257 1552 1325">IICRC-520:2015 Condition 3 guidelines</p>

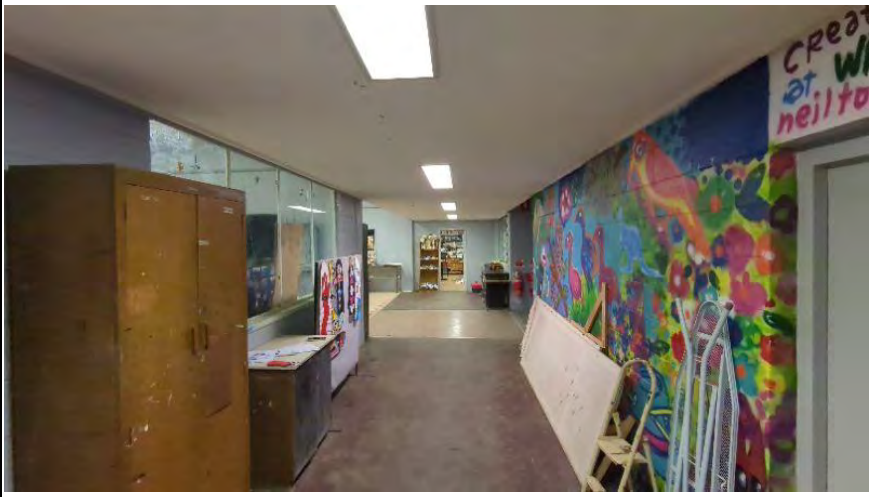
<p data-bbox="349 1003 649 1031">B00A-R0W17 - Movement</p>	<p data-bbox="959 499 1235 604">Masonry walls, concrete floor and plasterboard ceiling.</p>	<p data-bbox="1268 499 1554 678">Suspected visual mould growth was noted to masonry walls, concrete floor, plasterboard ceiling and all contents.</p> <p data-bbox="1268 695 1554 758">Refer to index photos 147 - 156.</p> <p data-bbox="1268 779 1554 842">IICRC-520:2015 Condition 3 guidelines</p>

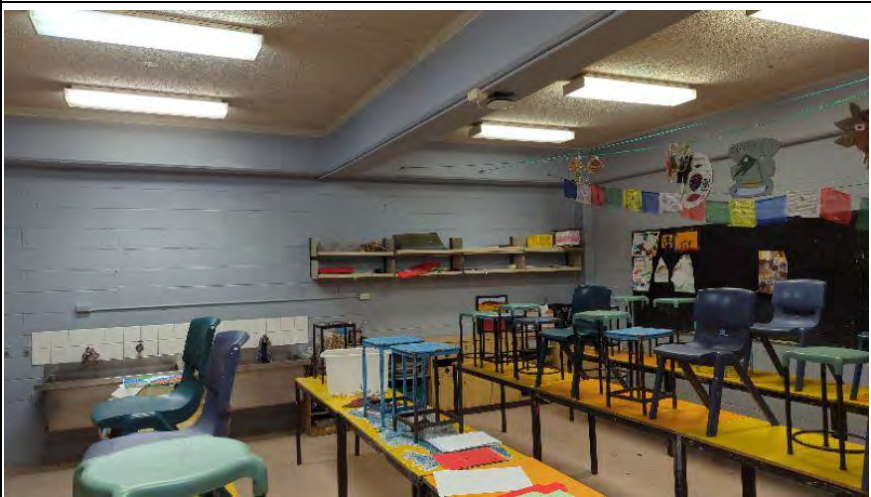
<p data-bbox="375 999 621 1024">B00A-R0W18 - Art LS</p>	<p data-bbox="951 495 1243 600">Masonry walls, concrete floor and sprayed coating (vermiculite) ceiling</p>	<p data-bbox="1268 495 1550 674">Suspected visual mould growth was noted to masonry walls, concrete floor, plasterboard ceiling and all contents.</p> <p data-bbox="1268 688 1550 758">Refer to index photos 157 - 163.</p> <p data-bbox="1268 772 1550 842">IICRC-520:2015 Condition 3 guidelines</p>

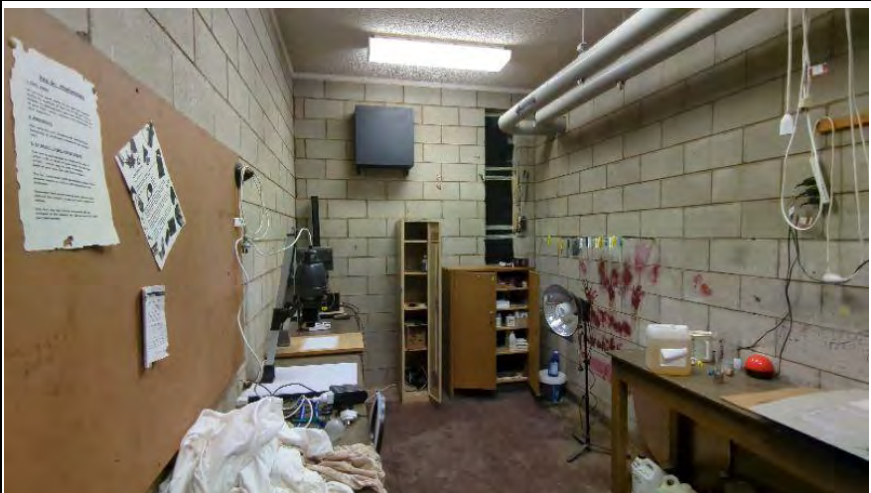
<p data-bbox="347 1593 651 1619">B00A-R0W08 - Dark Room</p>	<p data-bbox="951 1094 1243 1199">Masonry walls, concrete floor and sprayed coating (vermiculite) ceiling.</p>	<p data-bbox="1268 1094 1550 1241">Suspected visual mould growth was noted chipboard entrance archway.</p> <p data-bbox="1268 1255 1550 1325">Refer to index photos 167 - 170.</p> <p data-bbox="1268 1339 1550 1409">IICRC-520:2015 Condition 3 guidelines</p>

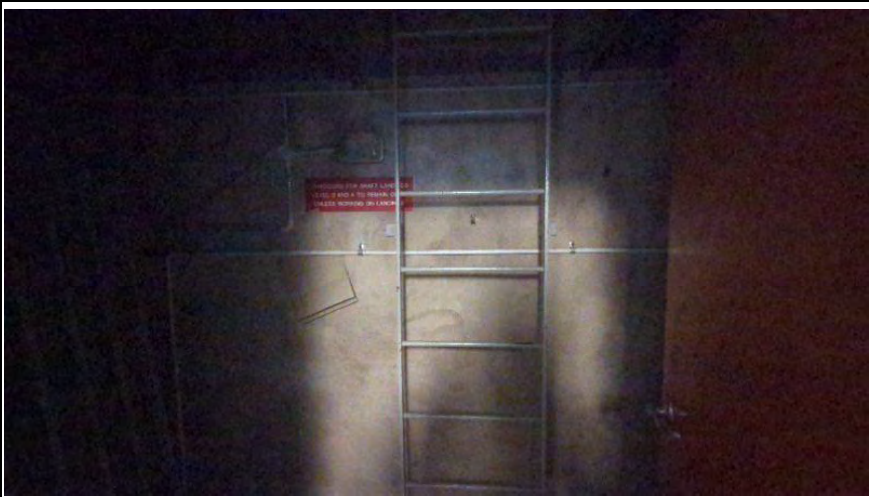
<p data-bbox="396 1541 604 1568">B00A-R1E13 Plant</p>	<p data-bbox="946 1050 1243 1115">Concrete walls, concrete floor and concrete ceiling.</p>	<p data-bbox="1268 1050 1555 1318">Suspected visual mould growth noted to hardwood door and architraves. Refer to index photo 196. IICRC-520:2015 Condition 3 guidelines</p>

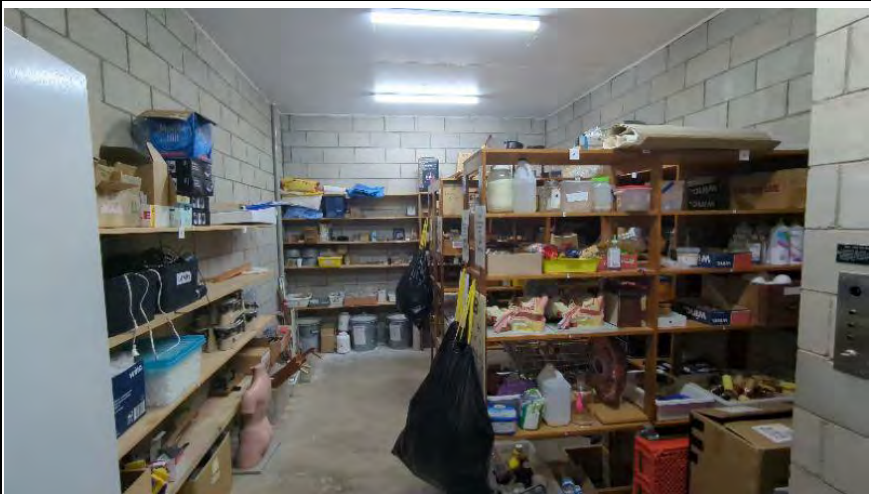
<p data-bbox="363 1629 634 1661">B00A-R1E09 - App Store</p>	<p data-bbox="959 1140 1235 1245">Masonry walls, concrete floor and plasterboard ceiling.</p>	<p data-bbox="1276 1140 1552 1245">No signs of visible mould or water damage were noted.</p> <p data-bbox="1276 1262 1552 1325">IICRC-520:2015 Condition 3 guidelines</p>

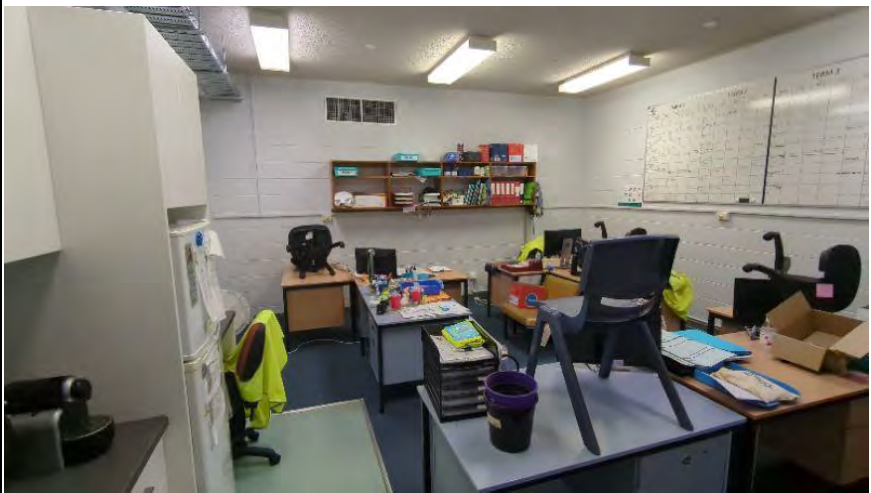
<p data-bbox="363 989 634 1020">B00A-R1E10 Staff study</p>	<p data-bbox="935 495 1256 600">Masonry walls, vinyl floor sheeting and sprayed coating (vermiculite) ceiling.</p>	<p data-bbox="1263 495 1555 768">Suspected visual mould growth was noted to vinyl floor sheeting and fridge. Refer to index photos 202 - 204. IICRC-520:2015 Condition 3 guidelines</p>

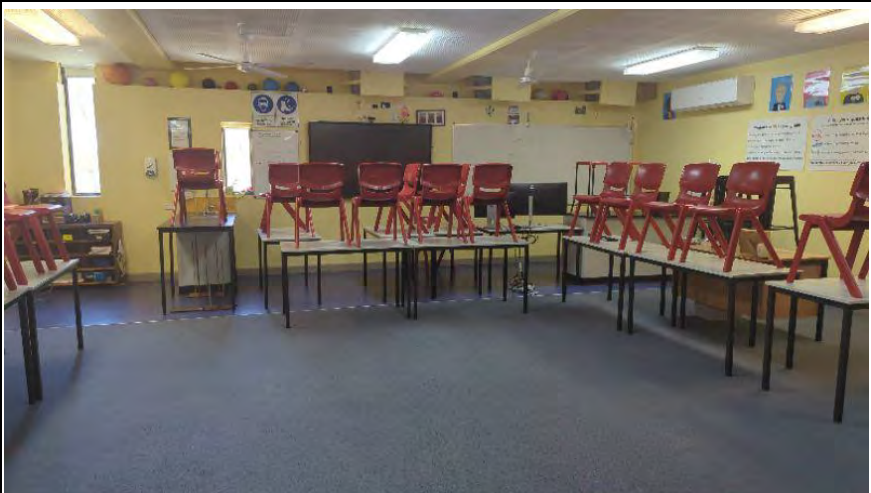
<p data-bbox="331 1535 672 1566">B00A-R1E01 - Laboratory L. S</p>	<p data-bbox="943 1041 1252 1146">Masonry walls, perforated plasterboard ceiling and carpet over concrete.</p>	<p data-bbox="1263 1041 1555 1230">No signs of visual mould growth or water damage were noted. IICRC-520:2015 Condition 3 guidelines</p>

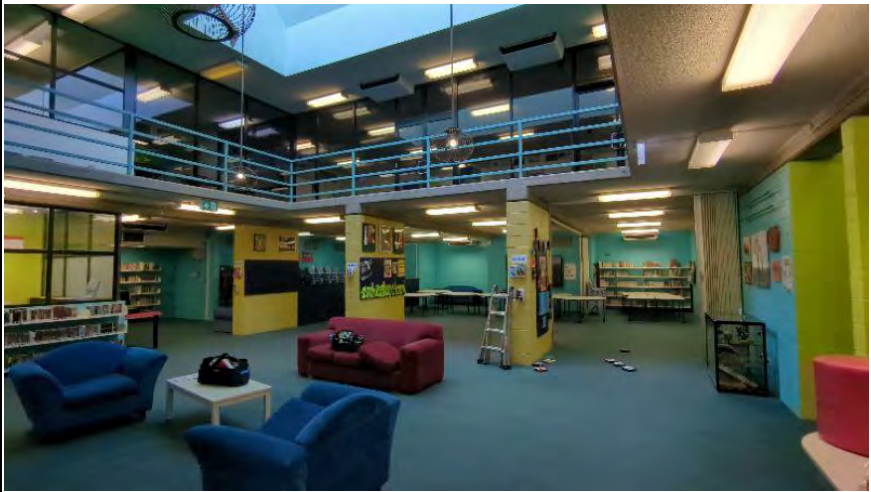
<p data-bbox="375 940 623 974">B00A-R1N05 - Library</p>	<p data-bbox="938 453 1253 558">Masonry walls, carpet over concrete and sprayed coating (vermiculite) ceiling.</p>	<p data-bbox="1273 453 1550 758">Suspected visual mould growth was noted to carpet floor and porous couches. Refer to index photos 218 - 225. IICRC-520:2015 Condition 3 guidelines</p>

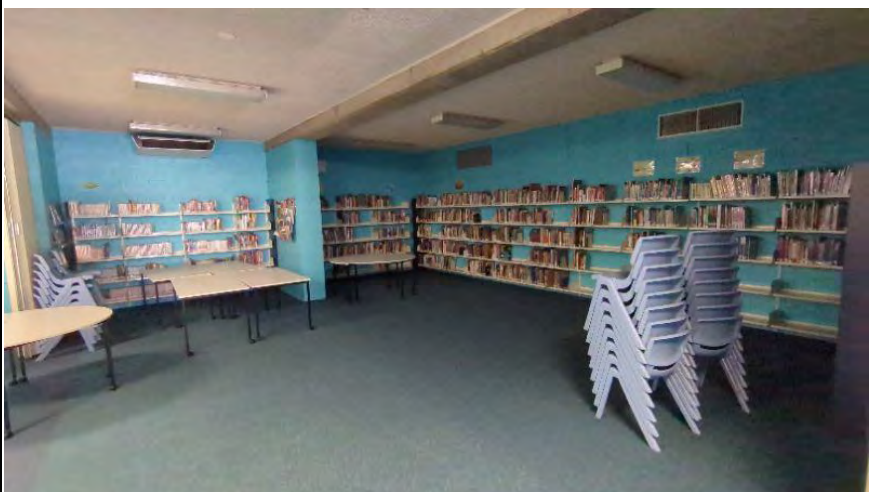
<p data-bbox="350 1493 647 1526">B00A-R1N03 - Work room</p>	<p data-bbox="938 999 1253 1104">Masonry walls, carpet over concrete and sprayed coating (vermiculite) ceiling.</p>	<p data-bbox="1273 999 1550 1188">No signs of visual mould growth or water damage were noted. IICRC-520:2015 Condition 3 guidelines</p>

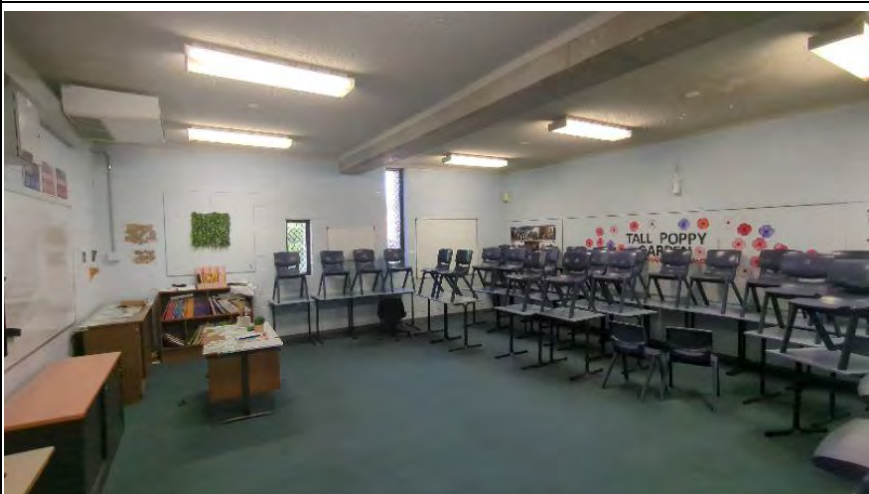
<p data-bbox="342 1497 654 1528">B00A-R1W21 - General L. S</p>	<p data-bbox="938 1005 1252 1110">Masonry walls, carpet over concrete and sprayed coating (vermiculite) ceiling.</p>	<p data-bbox="1268 1005 1555 1152">Suspected visual mould growth was noted to carpet floor and all contents.</p> <p data-bbox="1268 1167 1555 1234">Refer to index photos 261 - 267.</p> <p data-bbox="1268 1249 1555 1316">IICRC-520:2015 Condition 3 guidelines</p>

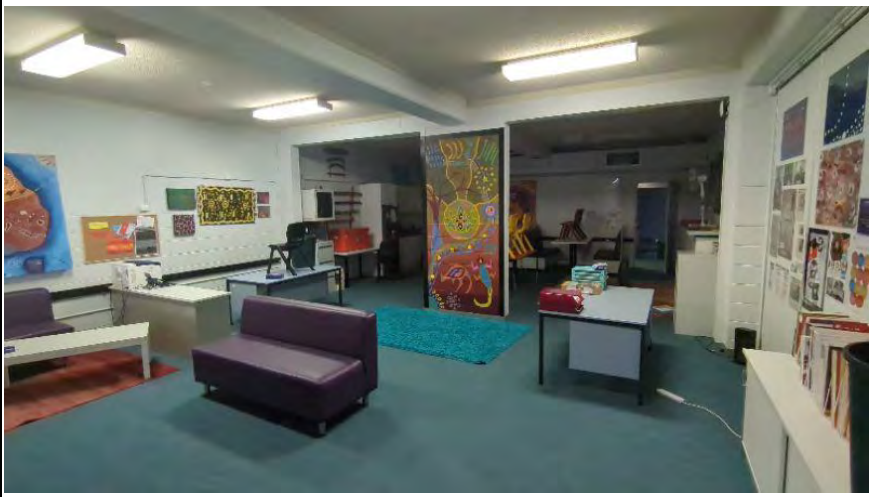
<p data-bbox="331 1003 669 1031">B00A-R1W15 - Computer L. S</p>	<p data-bbox="938 499 1255 604">Masonry walls, carpet over concrete and sprayed coating (vermiculite) ceiling.</p>	<p data-bbox="1279 499 1547 678">Sporadic patches of suspected visible mould growth were noted to carpet and porous contents.</p> <p data-bbox="1263 695 1562 762">Refer to index photos 276 - 278.</p> <p data-bbox="1263 779 1562 846">IICRC-520:2015 Condition 3 guidelines</p>

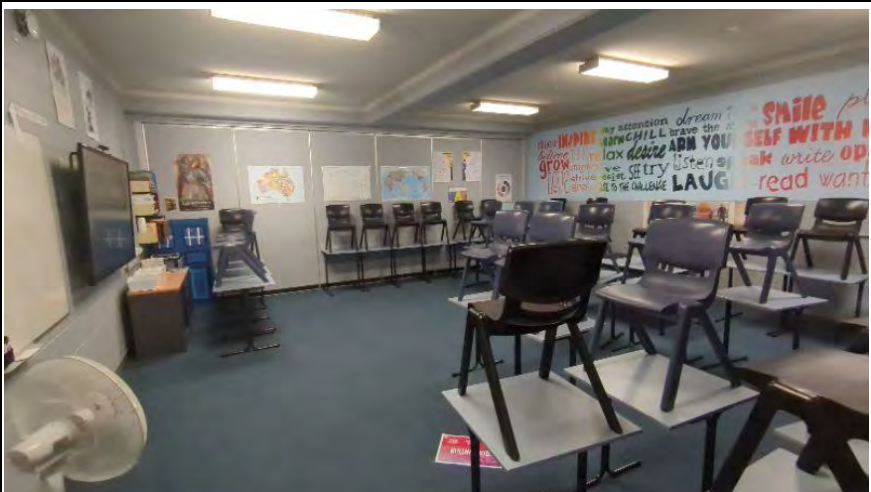
<p data-bbox="342 1688 656 1715">B00A-R1W16 - General L. S</p>	<p data-bbox="938 1188 1255 1293">Plasterboard walls, carpet over concrete and sprayed coating (vermiculite) ceiling.</p>	<p data-bbox="1279 1188 1544 1293">Suspected visual mould growth was noted to carpet floor and chairs.</p> <p data-bbox="1284 1312 1539 1375">Refer to index photos 288 - 293.</p> <p data-bbox="1263 1394 1555 1457">IICRC-520:2015 Condition 3 guidelines</p>

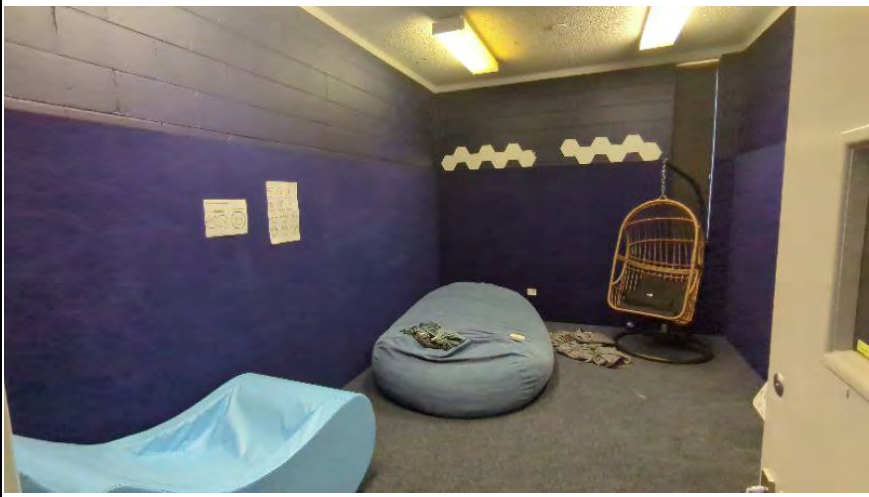
<p data-bbox="347 993 651 1024">B00A-R109 - Sensory Zone</p>	<p data-bbox="938 499 1252 604">Masonry walls, carpet over concrete and sprayed coating (vermiculite) ceiling.</p>	<p data-bbox="1276 499 1547 640">Suspected visual mould growth was noted to carpet floor and porous contents.</p> <p data-bbox="1276 657 1555 720">Refer to index photos 308 - 309.</p> <p data-bbox="1276 737 1555 800">IICRC-520:2015 Condition 3 guidelines</p>

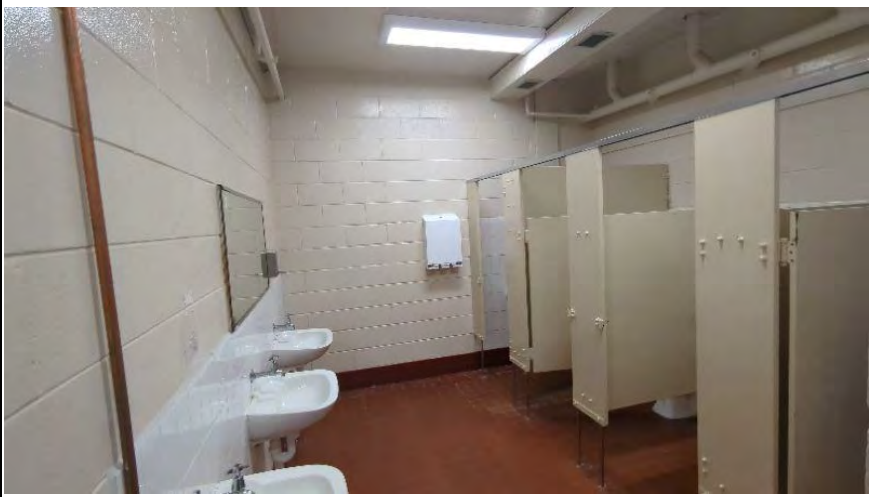
<p data-bbox="347 1541 651 1572">B00A-R1W07 - Girl's Toilet</p>	<p data-bbox="938 1050 1252 1113">Concrete ceiling, masonry walls and ceramic floor tiles.</p>	<p data-bbox="1276 1050 1547 1113">No signs of visible mould growth were noted.</p> <p data-bbox="1276 1129 1547 1224">Evaporative water stains were noted to ceramic floor.</p> <p data-bbox="1276 1241 1555 1304">IICRC-520:2015 Condition 3 guidelines</p>
