Microbial Testing - Willyama High School

Radium Street, Broken Hill, NSW 2880

School Infrastructure NSW Regional Office - North Western NSW

Report No.: 30158-R04

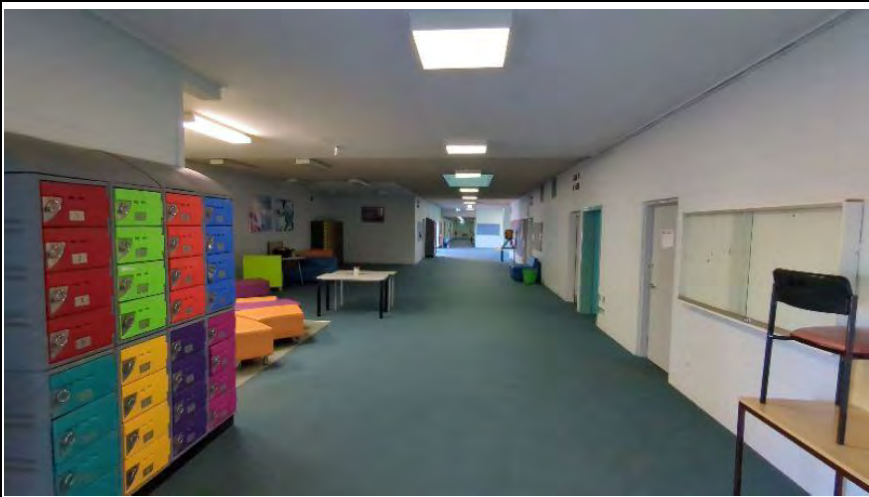
<p data-bbox="354 1543 651 1575">B00A-R2N17 - Movement</p>	<p data-bbox="943 1052 1250 1157">Masonry walls, carpet over concrete and plasterboard ceiling.</p>	<p data-bbox="1273 1052 1555 1157">No signs of visual mould growth or water damage were noted.</p> <p data-bbox="1273 1173 1555 1241">Refer to index photos 317 - 318.</p> <p data-bbox="1273 1257 1555 1325">IICRC-520:2015 Condition 3 guidelines</p>

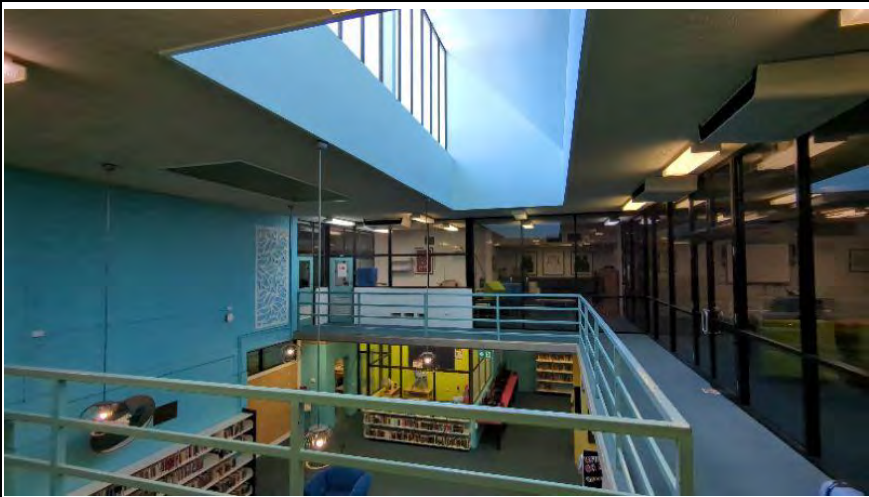
<p data-bbox="310 1539 688 1575">B00A-R2N05 - Library Mezzanine</p>	<p data-bbox="967 1050 1227 1121">Plasterboard walls and carpet over concrete.</p>	<p data-bbox="1268 1050 1554 1155">No signs of visual mould growth. Liquid stains noted to carpet.</p> <p data-bbox="1284 1167 1537 1236">Refer to index photos 319.</p> <p data-bbox="1268 1249 1562 1320">IICRC-520:2015 Condition 3 guidelines</p>

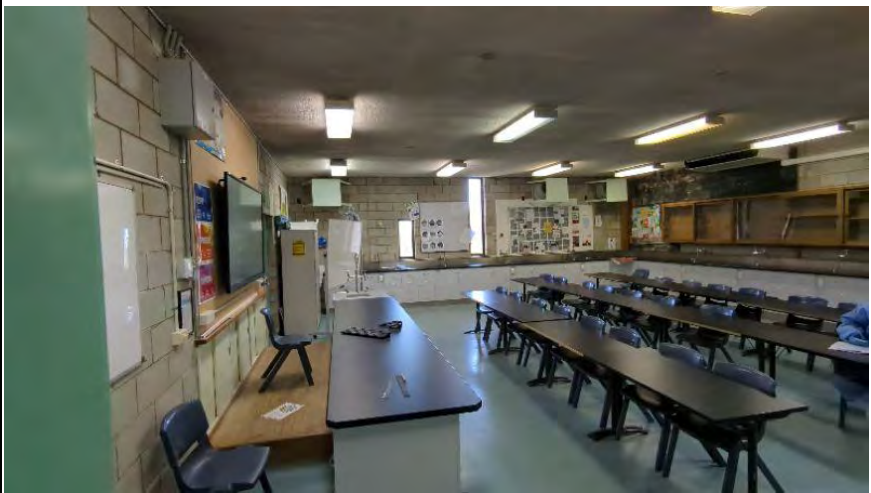
<p data-bbox="375 993 623 1020">B00A-R2E01 - Lab L. S</p>	<p data-bbox="935 499 1256 604">Masonry walls, vinyl floor sheeting and sprayed coating (vermiculite) ceiling.</p>	<p data-bbox="1268 499 1552 789">No signs of visual mould growth were noted to building materials or contents. However, suspected visual mould growth was noted to paper towel in water trough.</p> <p data-bbox="1268 806 1552 911">Refer to index photo 326. IICRC-520:2015 Condition 3 guidelines</p>

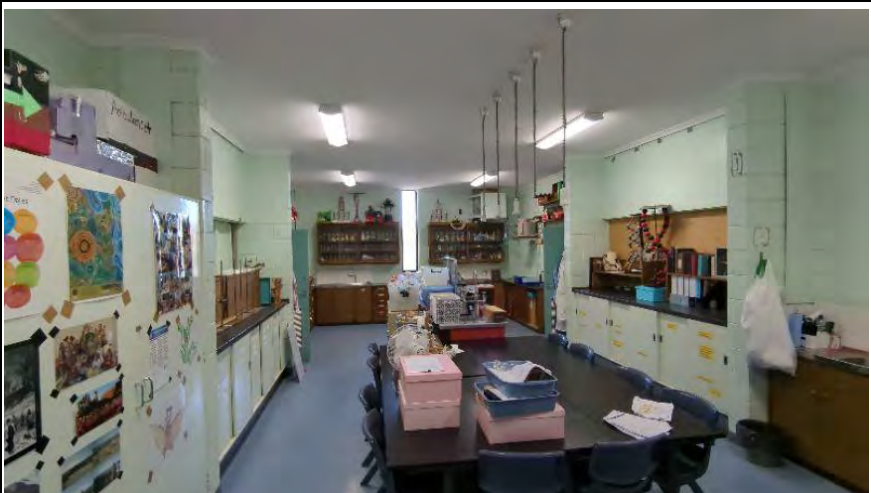
<p data-bbox="350 1541 647 1568">B00A-R2E02 - Preparation</p>	<p data-bbox="951 1052 1243 1150">Masonry walls, vinyl floor sheeting, plasterboard ceiling.</p>	<p data-bbox="1268 1052 1552 1262">No signs of visual mould growth were noted. Signs of water damage (in the form of swelling) were noted to the hardwood cupboards.</p> <p data-bbox="1268 1283 1552 1346">IICRC-520:2015 Condition 3 guidelines</p>

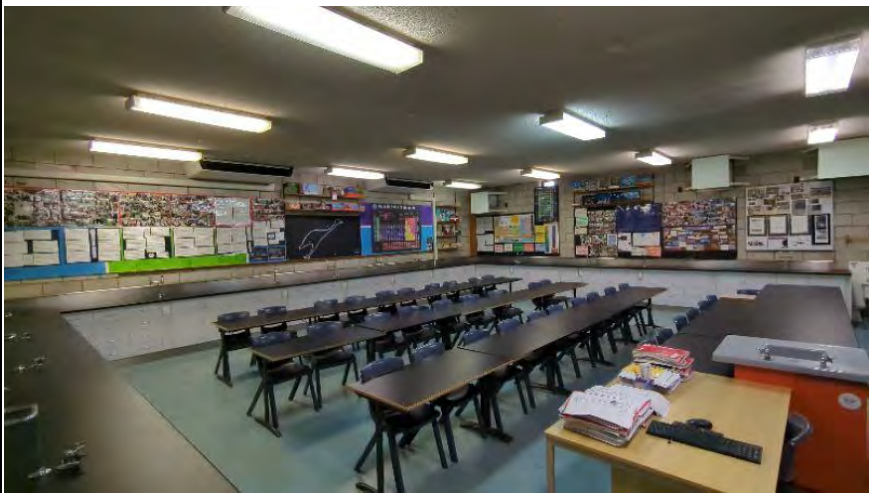
<p data-bbox="396 989 602 1020">B00A-R2E03 - Lab</p>	<p data-bbox="935 499 1256 604">Masonry walls, vinyl floor sheeting and sprayed coating (vermiculite) ceiling.</p>	<p data-bbox="1268 499 1550 751">Suspected visual mould growth was noted to the push in corner tap. No signs of visual mould growth or water damage were noted to building materials.</p> <p data-bbox="1268 768 1550 835">Refer to index photos 327 - 328.</p> <p data-bbox="1268 852 1550 919">IICRC-520:2015 Condition 3 guidelines</p>

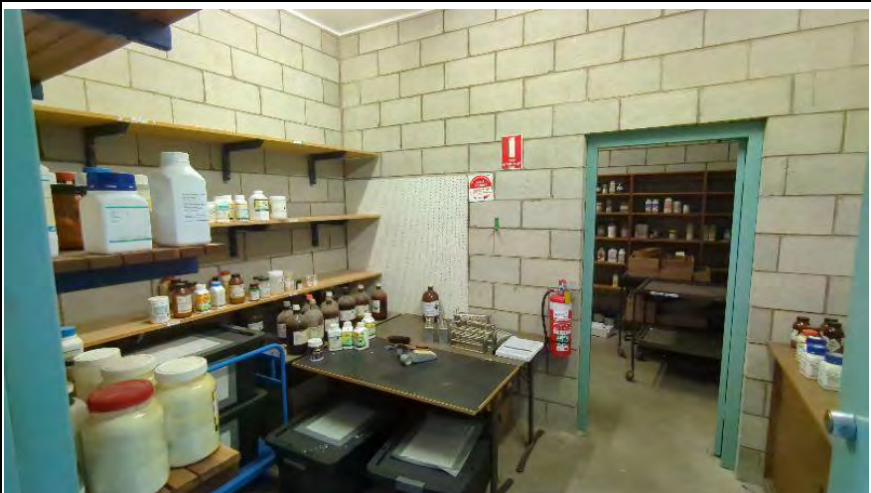
<p data-bbox="355 1539 641 1570">B00A-R2E15 - Storeroom</p>	<p data-bbox="959 1052 1235 1157">Masonry walls, concrete floor and fibre cement ceiling.</p>	<p data-bbox="1268 1052 1550 1157">No signs of visual mould growth or water damage were noted.</p> <p data-bbox="1268 1173 1550 1241">IICRC-520:2015 Condition 3 guidelines</p>
