REPORT: Arboricultural Impact Assessment Our Ref: 20153 V8Jm

Pendle Hill High School Cornock Avenue Toongabbie NSW 2146

> 5th of May, 2021 Version 9.1

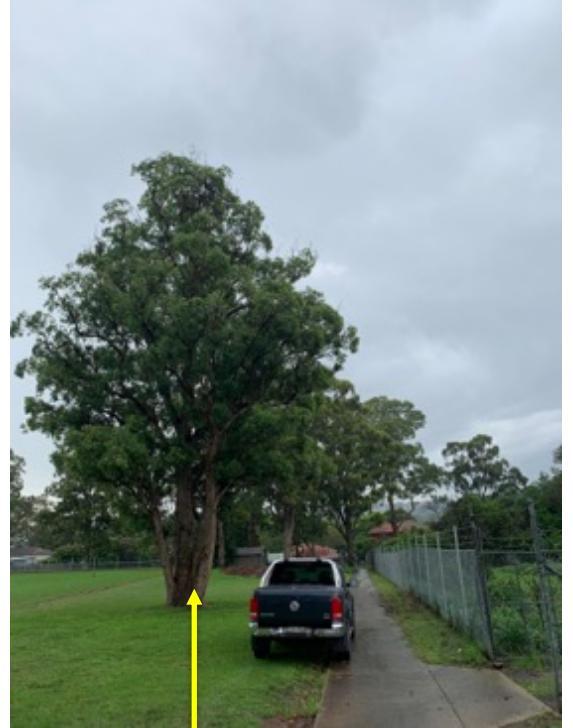
Plate 1: Tree 90 (yellow arrow), a <u>Eucalyptus resinifera</u> of HIGH retention value. This tree requires **retention** and **protection**.

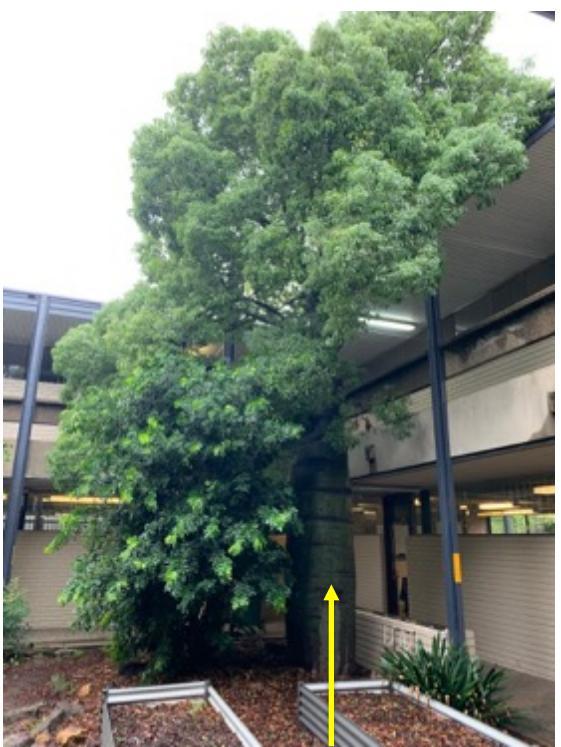
Plate 2: Tree 172 (yellow arrow), a <u>Brachychiton</u> <u>acerifolius</u> (Firewheel Tree) of MODERATE-HIGH retention value. This tree requires retention and protection.

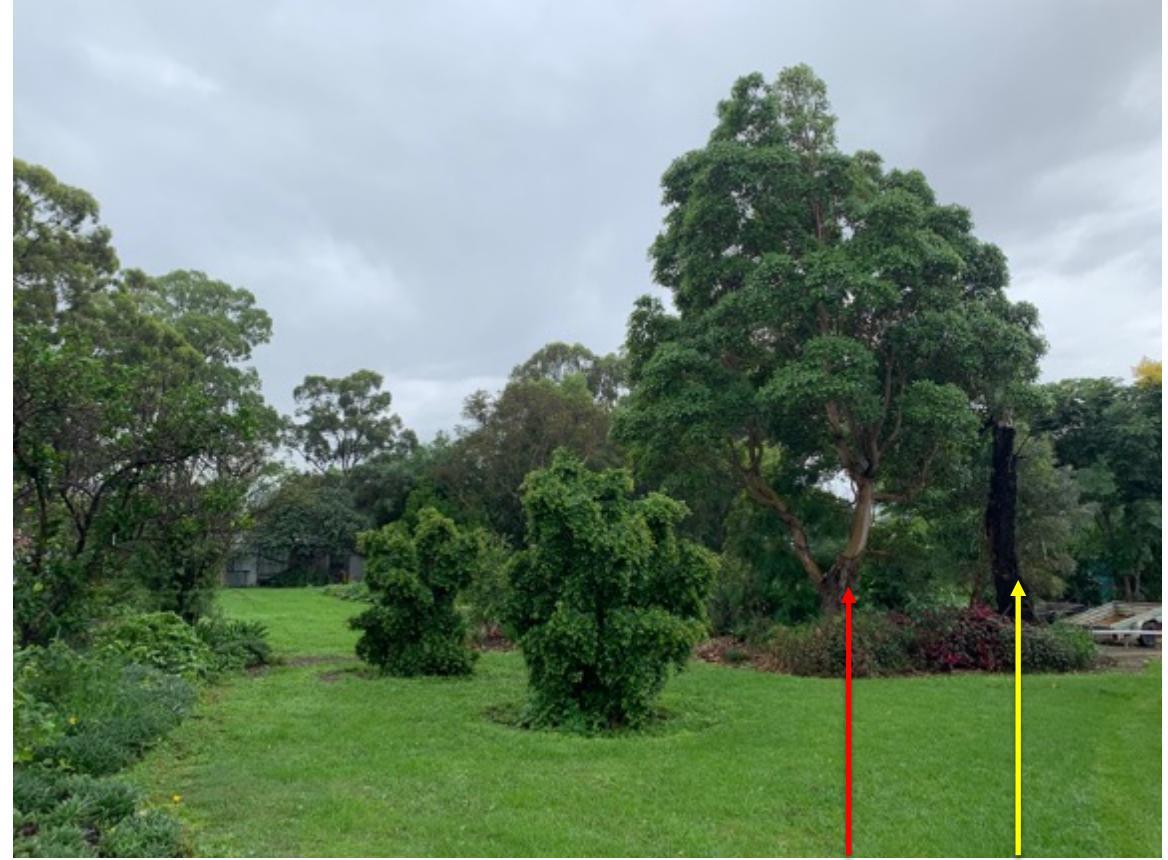
Plate 3: Trees at the northern end of the school that require **retention**. Tree 99 (red arrow), Tree 100, dead (yellow arrow).

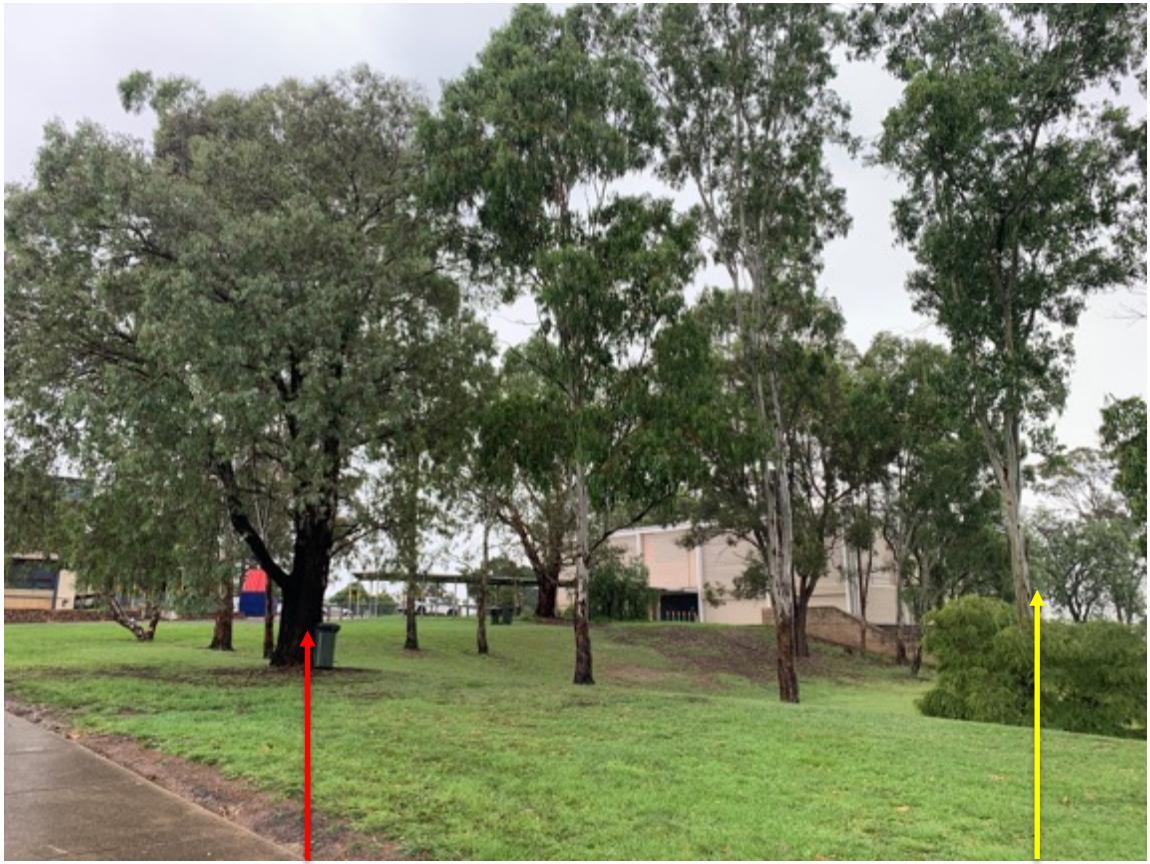
Plate 4: Trees 73 to 88. Tree 88 (yellow arrow) and Tree Group 85 (red arrow).

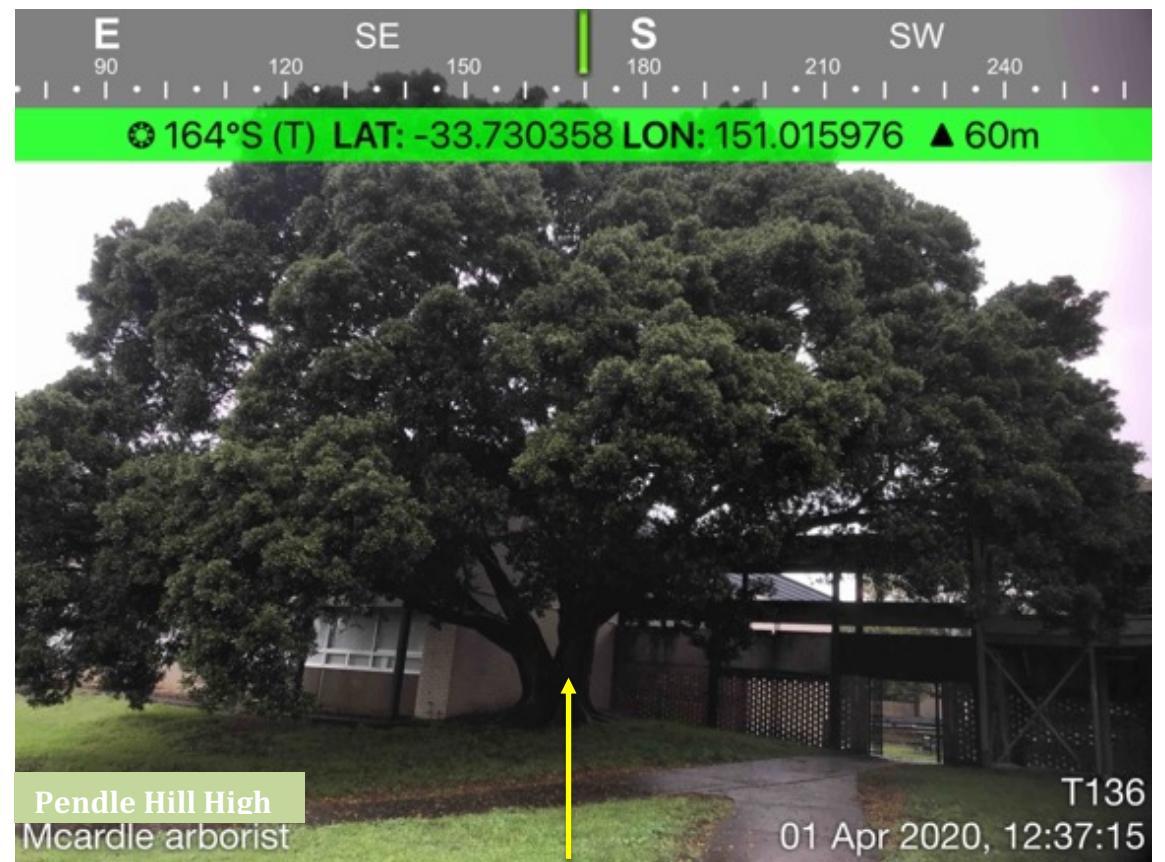
Plate 5: Tree 136 (yellow arrow), a *Ficus rubiginosa* (Port Jackson Fig) of **MODERATE-HIGH** retention value. This tree requires **retention** and **protection**.
