Remediation Action Plan

Carlingford West Public School  
and Cumberland High School Upgrades

59-73 Felton Road  
and 183 Pennant Hills Road,  
Carlingford

Project 86976.03  
March 2024

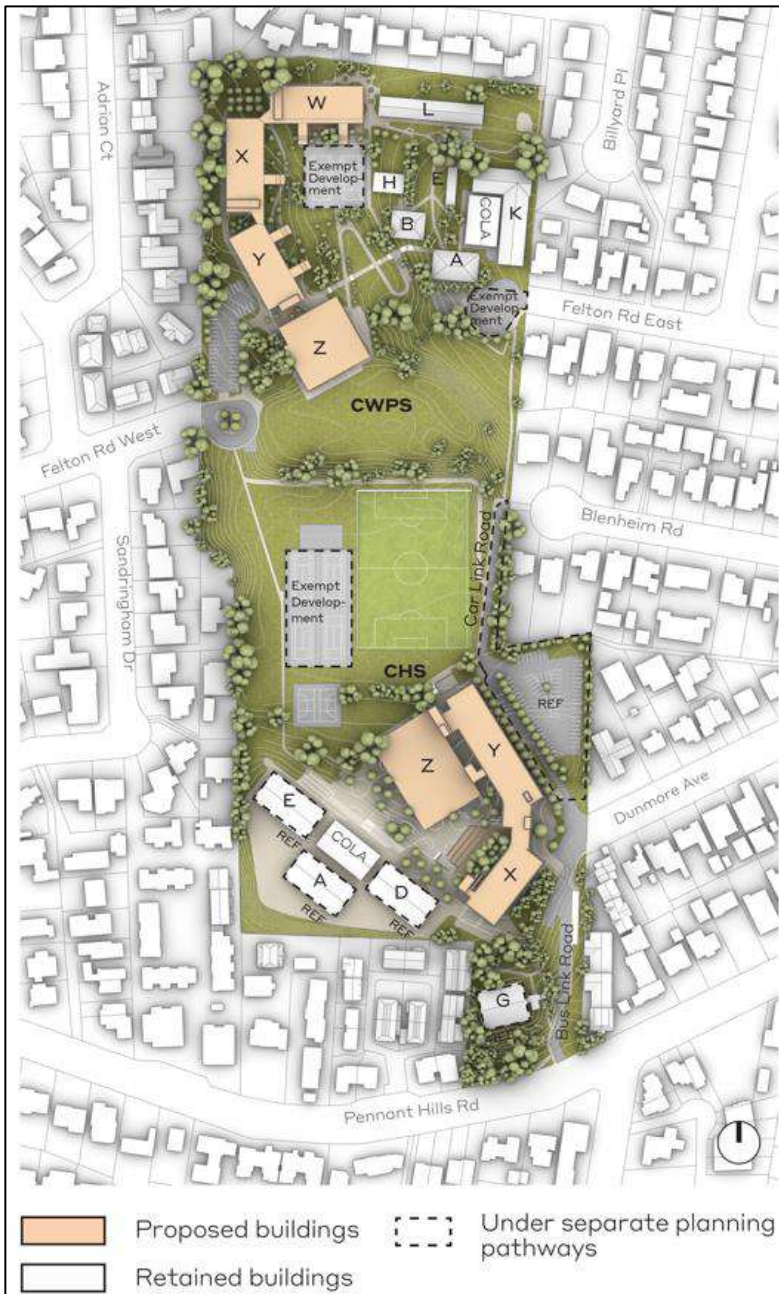
**Figure 1. Works Outside of SSDA Approval (Source: Woods Bagot)**

The proposed development for the site also includes the associated civil works and landscape works including tree removal, tree planting, new play areas and public domain upgrades. Selected architectural plans showing the proposed developments at CWPS and CHS are included in Appendix B. DP notes that ancillary works are also proposed to be undertaken across the site, however, these works are not included in the SSDA. The ancillary works include the demolition of existing buildings, refurbishment of some existing buildings, relocation/decommission of temporary demountable buildings, construction of new game courts, set up of the temporary school and construction of a new staff carpark and kiss and ride driveway at CHS with a one-way bus link connecting Dunmore Avenue and Blenheim Road, see **Figure 1** showing the relevant development areas.

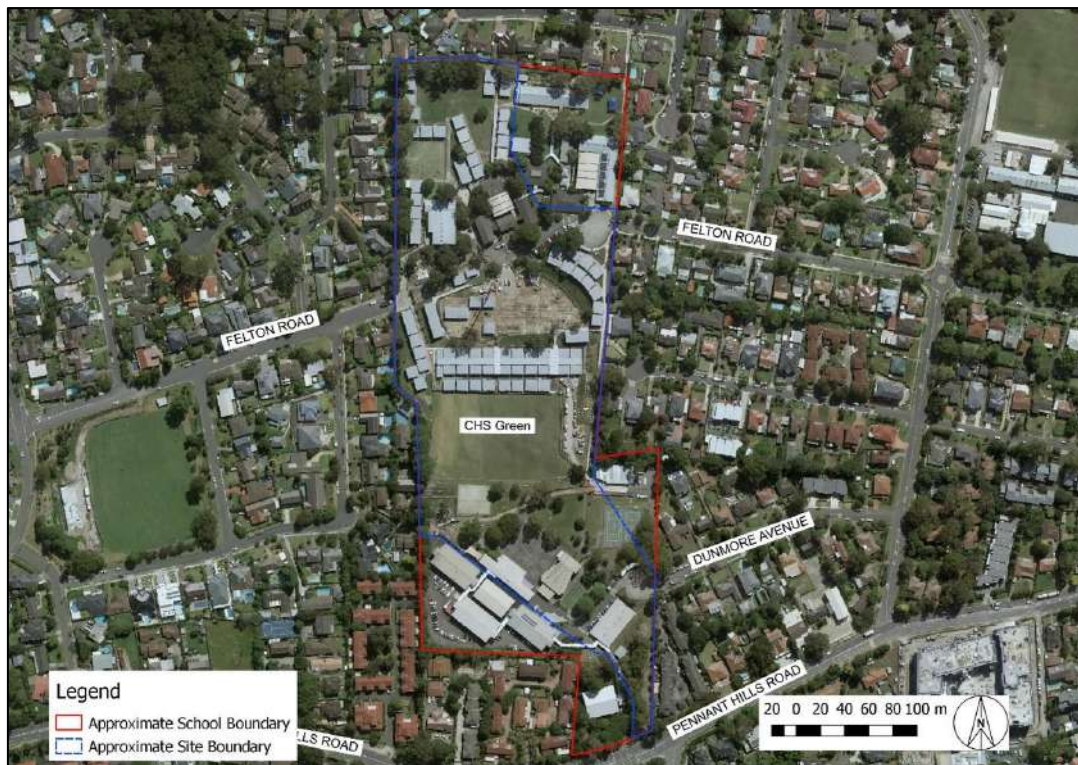
**Figure 2: School Site and Site Boundaries**

The school site (red) and site (blue) boundaries are shown on Figure 2.

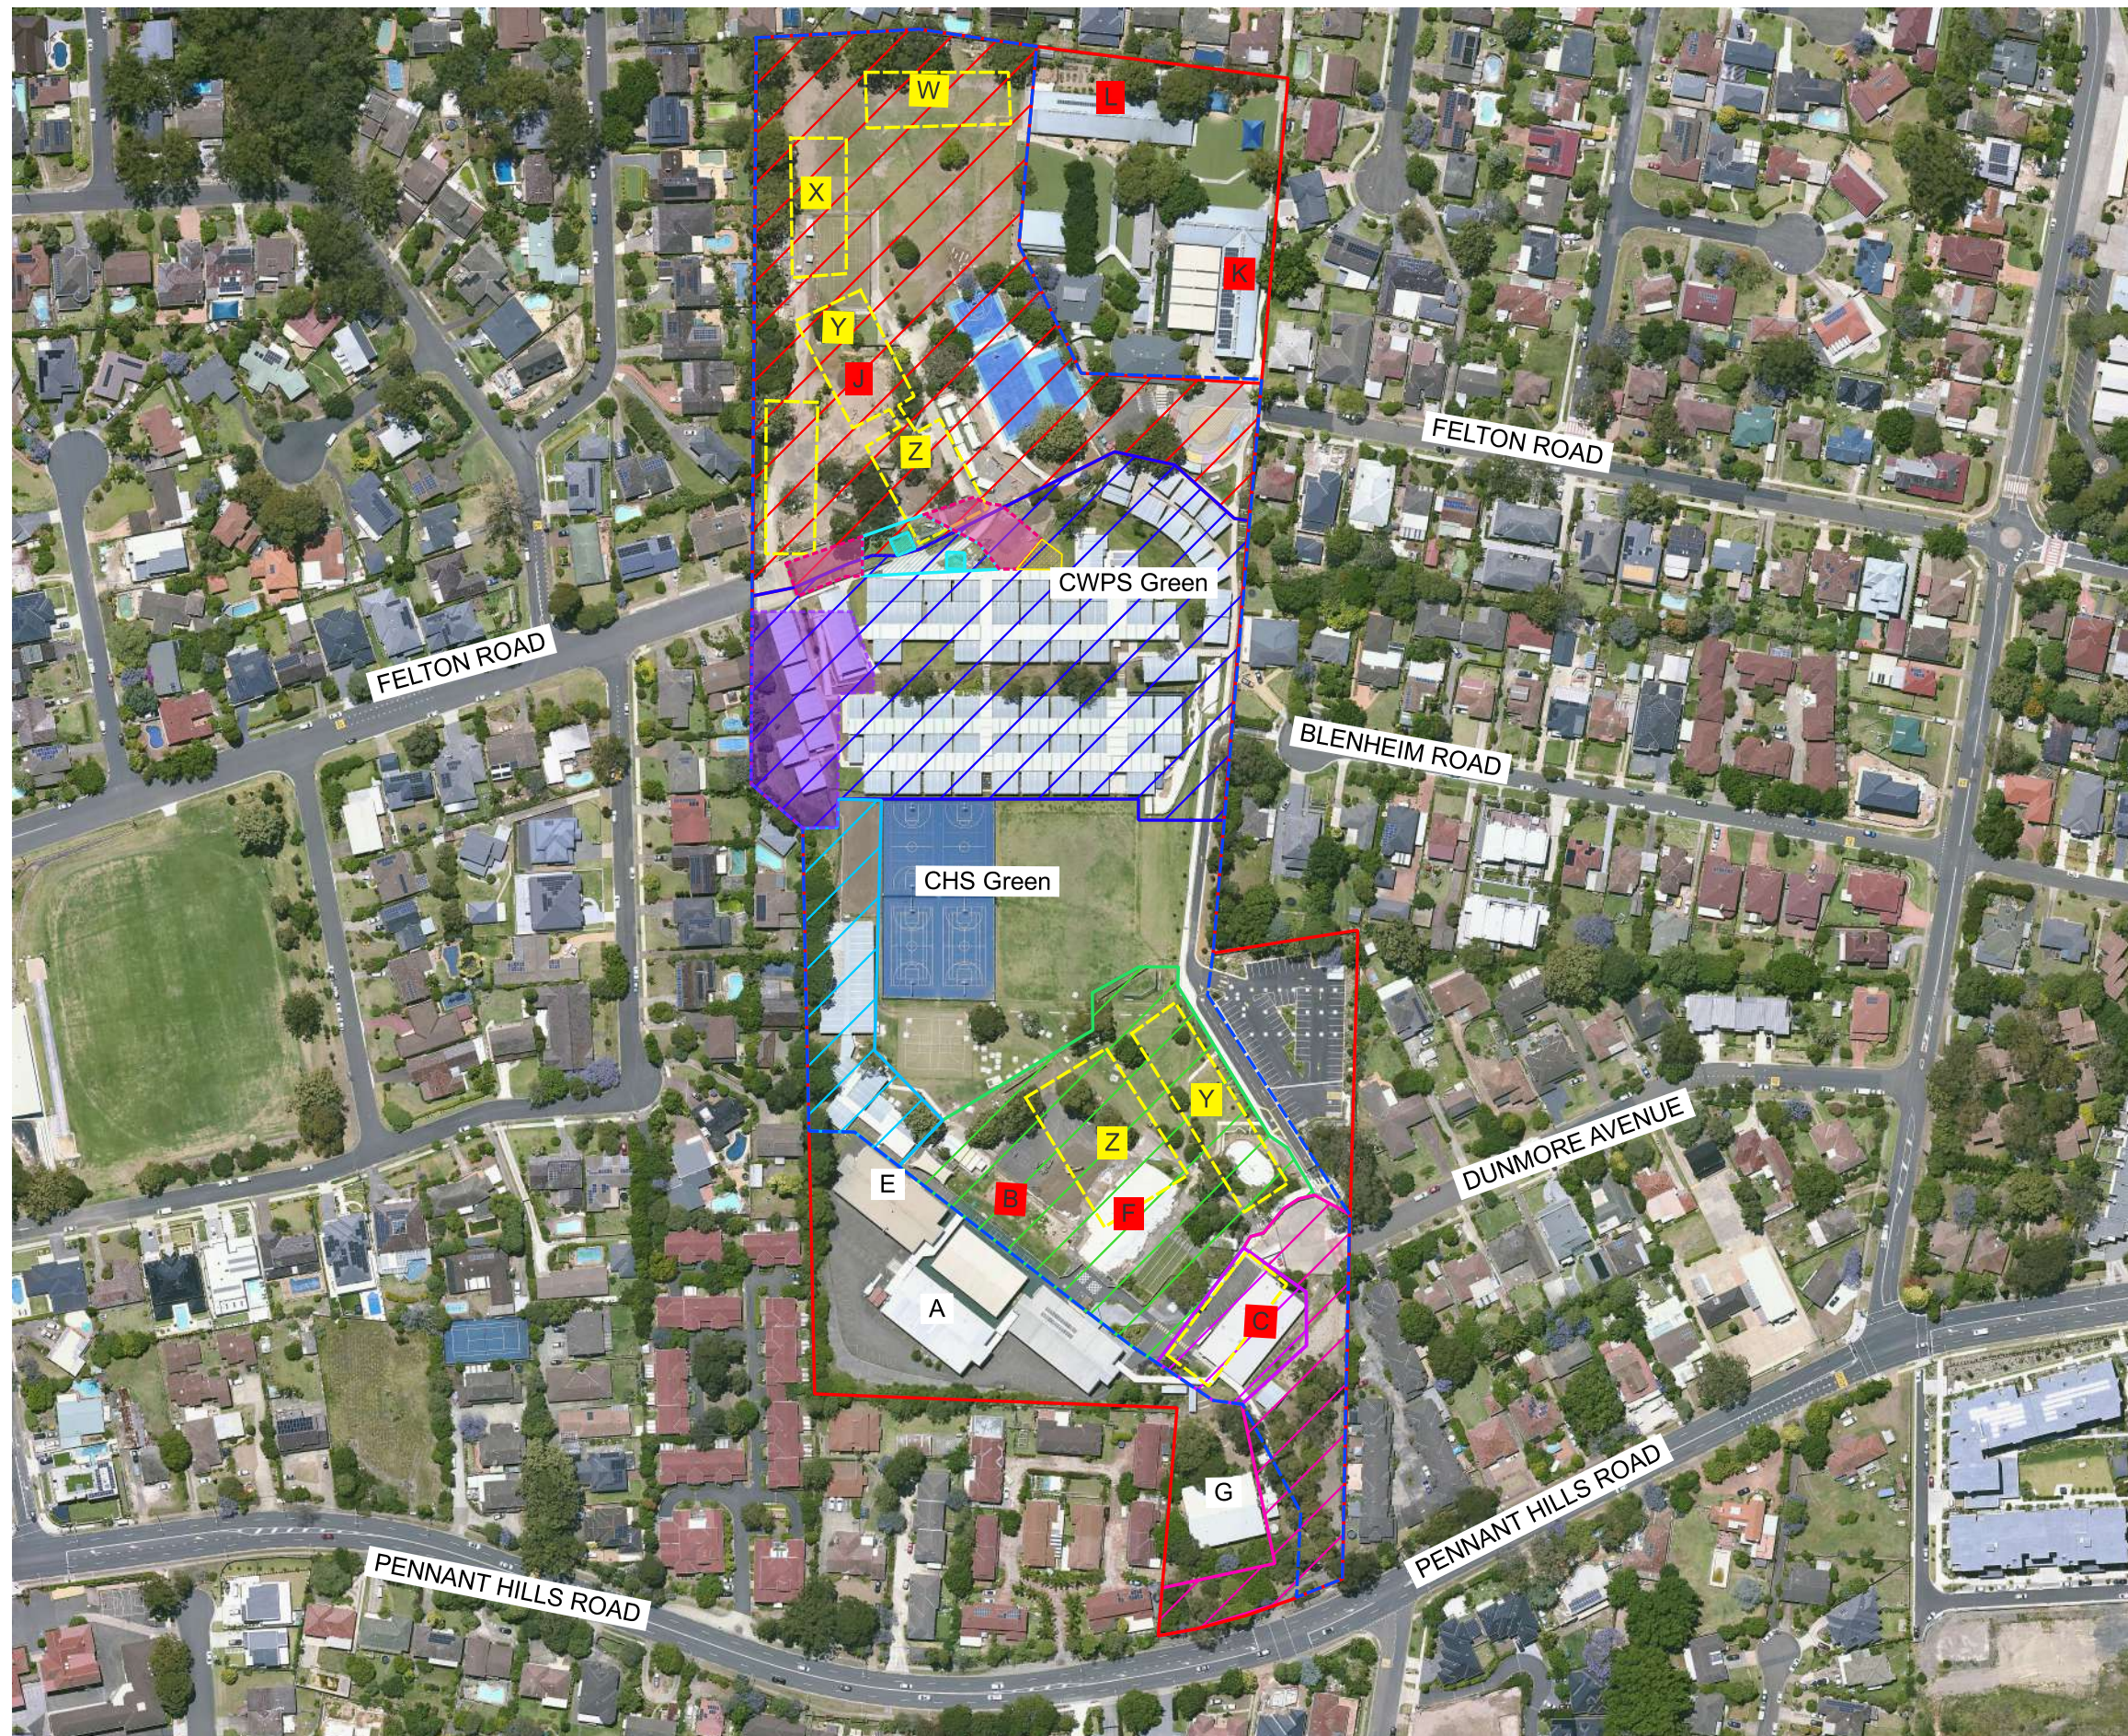
The currently identified remediation area is labelled as 'Remediation Area 1' which is impacted by asbestos (bonded) impacted fill and is shown shaded pink in Drawings R.002.D.02 and R.002.D.03, Appendix B. The drawings indicate the current estimated extent of possible asbestos contamination, which includes all test locations highlighted red where asbestos / likely asbestos impacted fill was identified. The area was nominated either up to the site boundary or to the next closest test location where PACM fragments were not observed. The depth of fill requiring remediation ranges from estimated depths of between 0.1 m to 1.5 m to depths of between 0.6 m and 2.0 m. The remediation extent may vary depending on the data gap investigation results.

The DGA recommended that the remaining data gap investigation areas which were inaccessible at the time of conducting the DGA still need to be investigated. This includes Remediation Area 1, and the areas which at the time of the DGA were not accessible. The proposed data gap test locations that still need to be completed are shown on the Drawings R.002.D.02 and R.002.D.03 by light blue square icons.
