# **Upgrades to Chatswood Public School and Chatswood High School**

## **Appendix 11 - Arborist Report - Public School**

SSD 9483

# Upgrades to Chatswood Public School - Arboricultural Impact Assessment

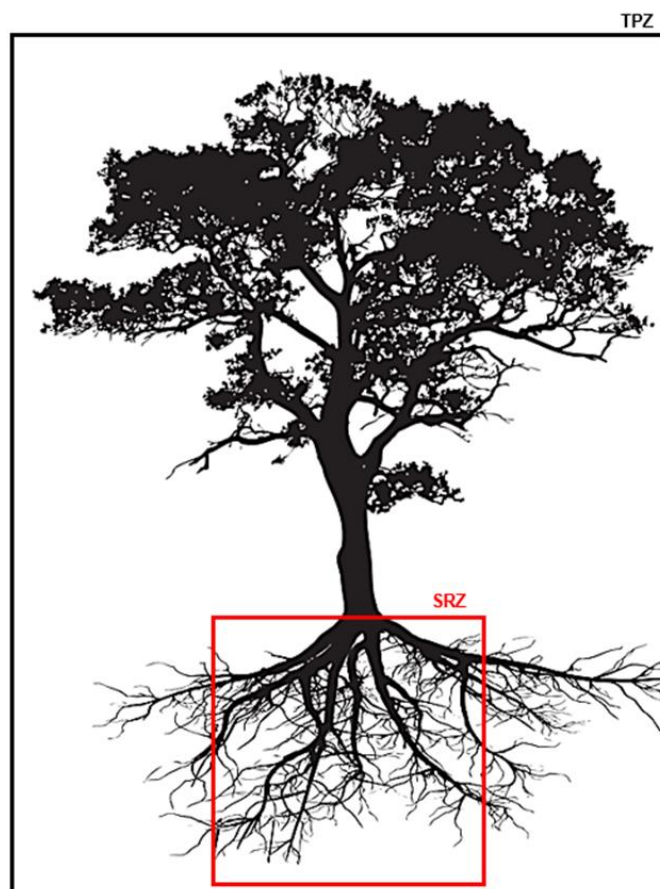
Figure 2: Indicative TPZ and SRZ

The TPZ is the combination of crown and root area (as defined by AS 4970-2009) that requires restriction of access during the construction process. Tree sensitive construction measures must be implemented if works are to proceed within the Tree Protection Zone.

The SRZ is the area of the root system (as defined by AS 4970-2009) used for stability, mechanical support and anchorage of the tree. It is critical for the support and stability of trees. Severance of roots within the SRZ is not recommended as it may lead to the destabilisation and/or decline of the tree.

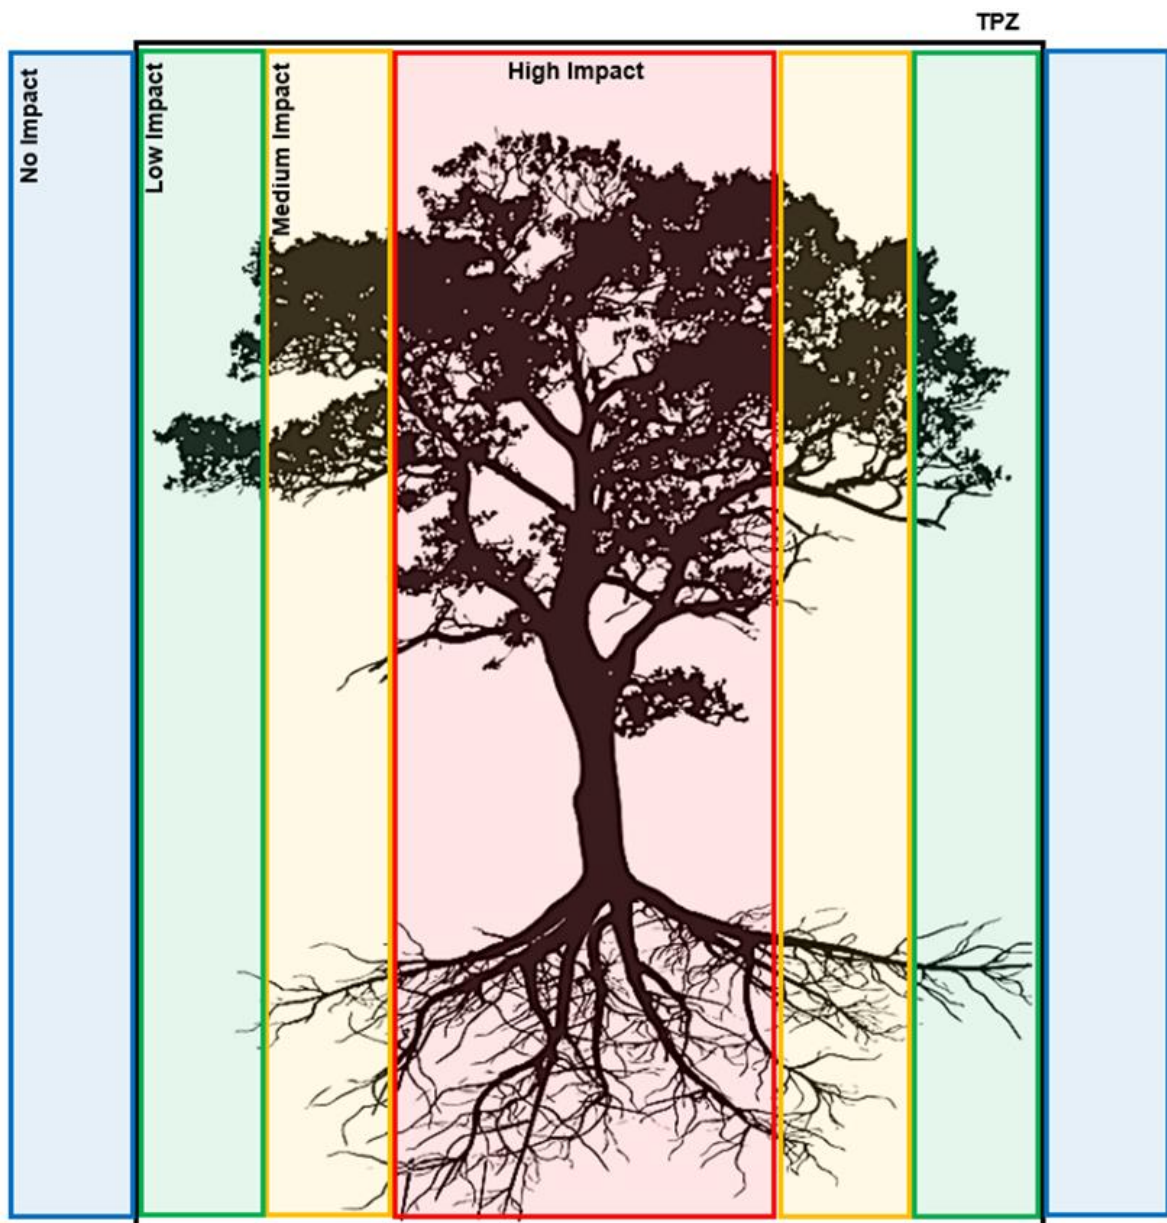
Figure 3: Indicative zones of impact

Trees may be impacted by cutting or damaging roots or branches. Impacts to the tree protection zones are determined by the percentage of the area that the development incurs into the tree protection zone. The following are the definition of these impacts:

- **High impact:** The SRZ may be impacted if the proposed encroachment is greater than 20 % of the TPZ. Trees may not remain viable if they are subject to high impact.
- **Medium impact:** If the proposed encroachment is greater than 10% of the TPZ and outside of the SRZ, the project arborist may require detailed root investigation to demonstrate that the tree(s) would remain viable.
- **Low impact:** If the proposed encroachment is less than 10% (total area) of the TPZ, and outside of the SRZ, detailed root investigations should not be required.
- **No impact:** No likely or foreseeable encroachment within the TPZ.

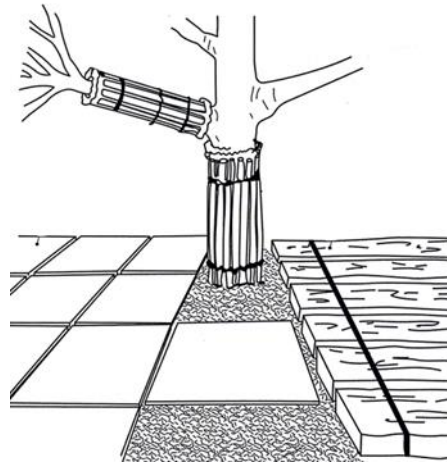
Trunk protection fencing

Trunk protection shall consist of a layer of either carpet underfelt, geotextile fabric or similar wrapped around the trunk, followed by 1.8 m lengths of softwood timbers aligned vertically and spaced evenly around the trunk (with an approx. 50 mm gap between the timbers).

The timbers must be secured using galvanised hoop strap (aluminium strapping). The timbers shall be wrapped around the trunk but not fixed to the tree, as this will cause injury/damage to the tree.
