RE: INTERIM AUDIT ADVICE LETTER NO. 1 - REVIEW OF REMEDIAL ACTION PLAN, CHATSWOOD PUBLIC SCHOOL, 5 CENTENNIAL AVENUE, CHATSWOOD NSW

Ref 318001008

Attachments: 1 Site Locality Plan
2 Soil Sampling Location Plan
3 Proposed Development Plan

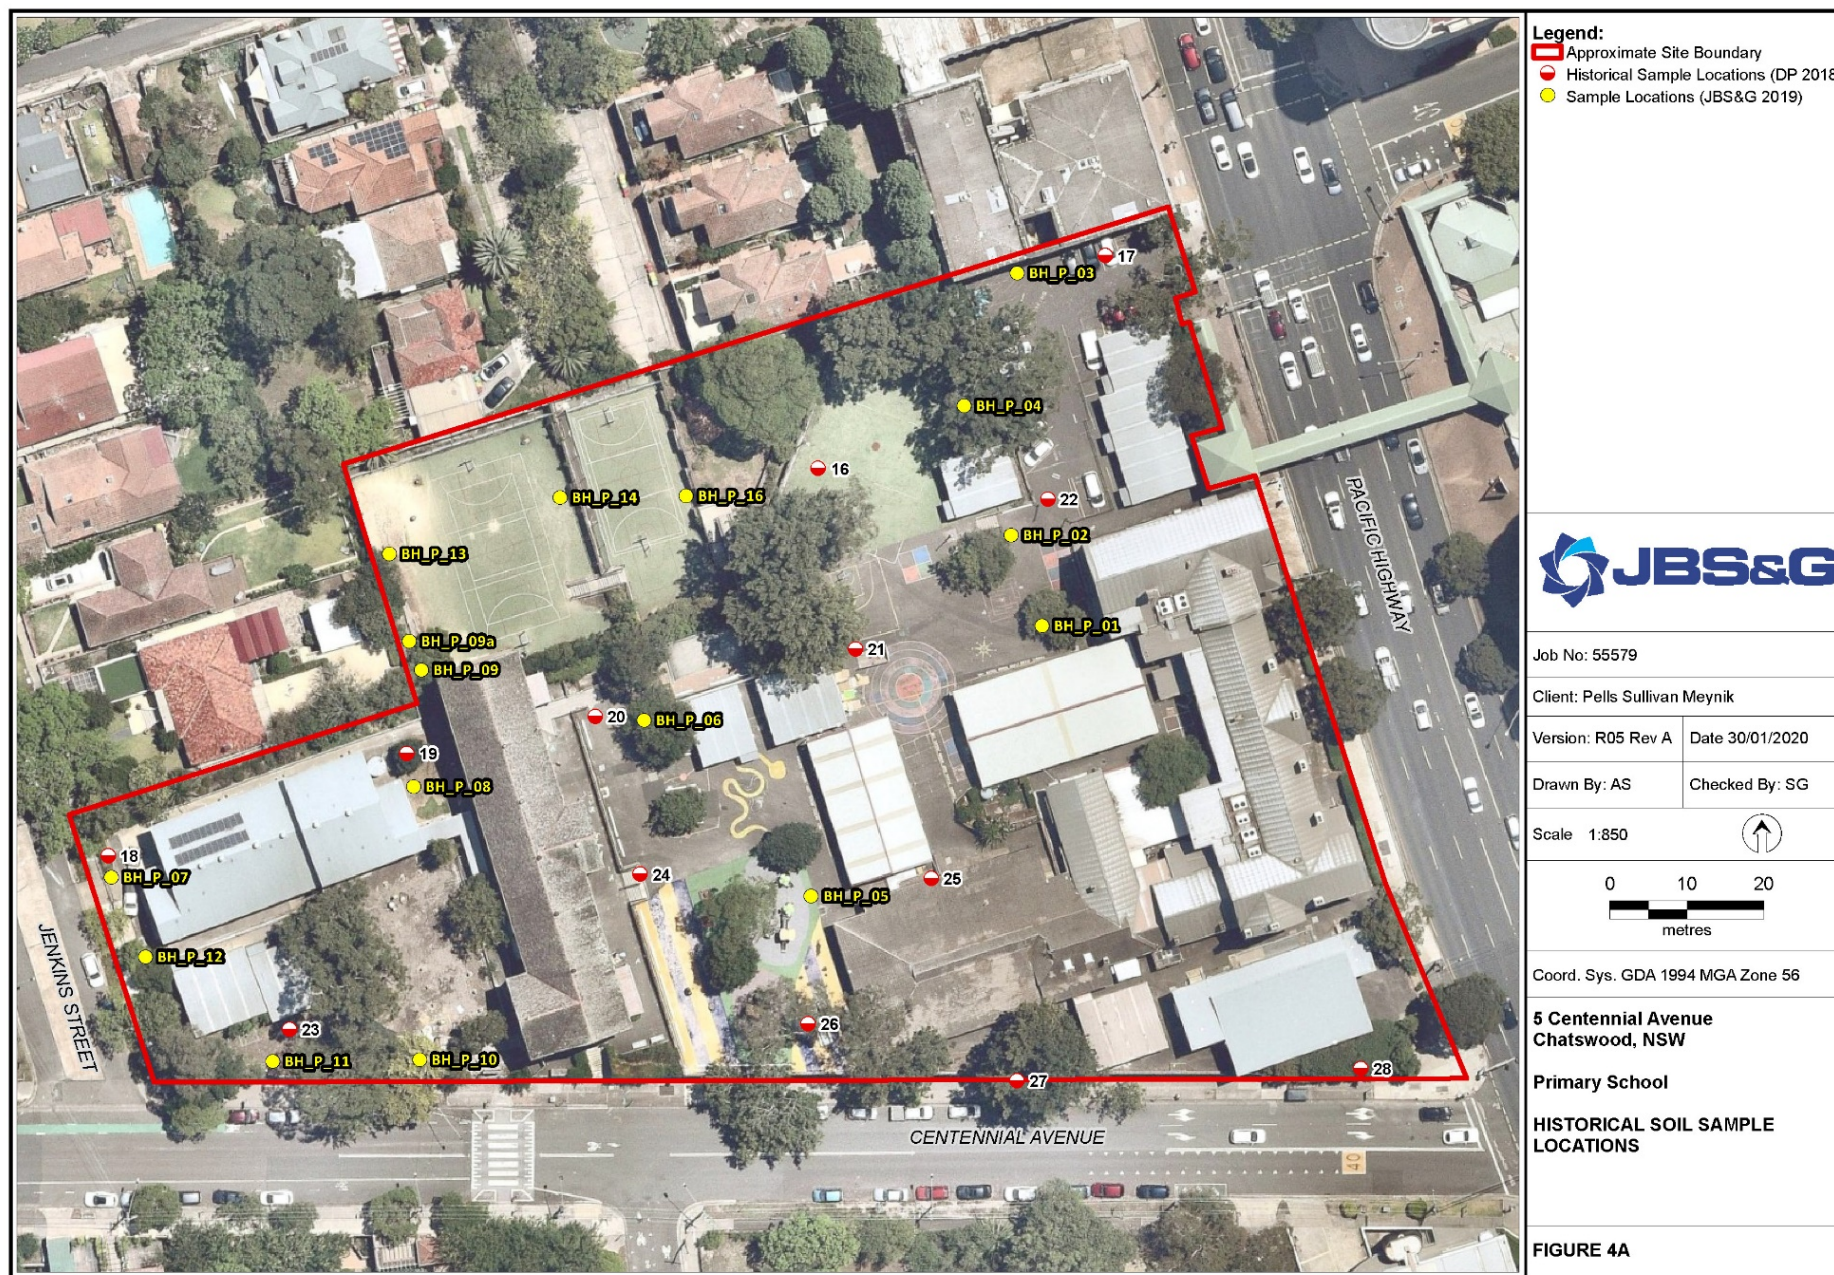
Douglas undertook 13 boreholes and JBS&G undertook 16 boreholes at the site as shown in Attachment 2. The sub-surface profile encountered is summarised by the Auditor in Table 5.1.

As outlined in Table 6.1, Douglas undertook a PSI including the drilling of 13 boreholes in accessible areas of the site. JBS&G undertook a DSI at the site which included the drilling of 16 boreholes in accessible areas of the site to increase the site coverage. Douglas and JBS&G soil sampling locations are shown as Attachment 2. The following sections outline the soil field and analytical results for the PSI and DSI investigations.

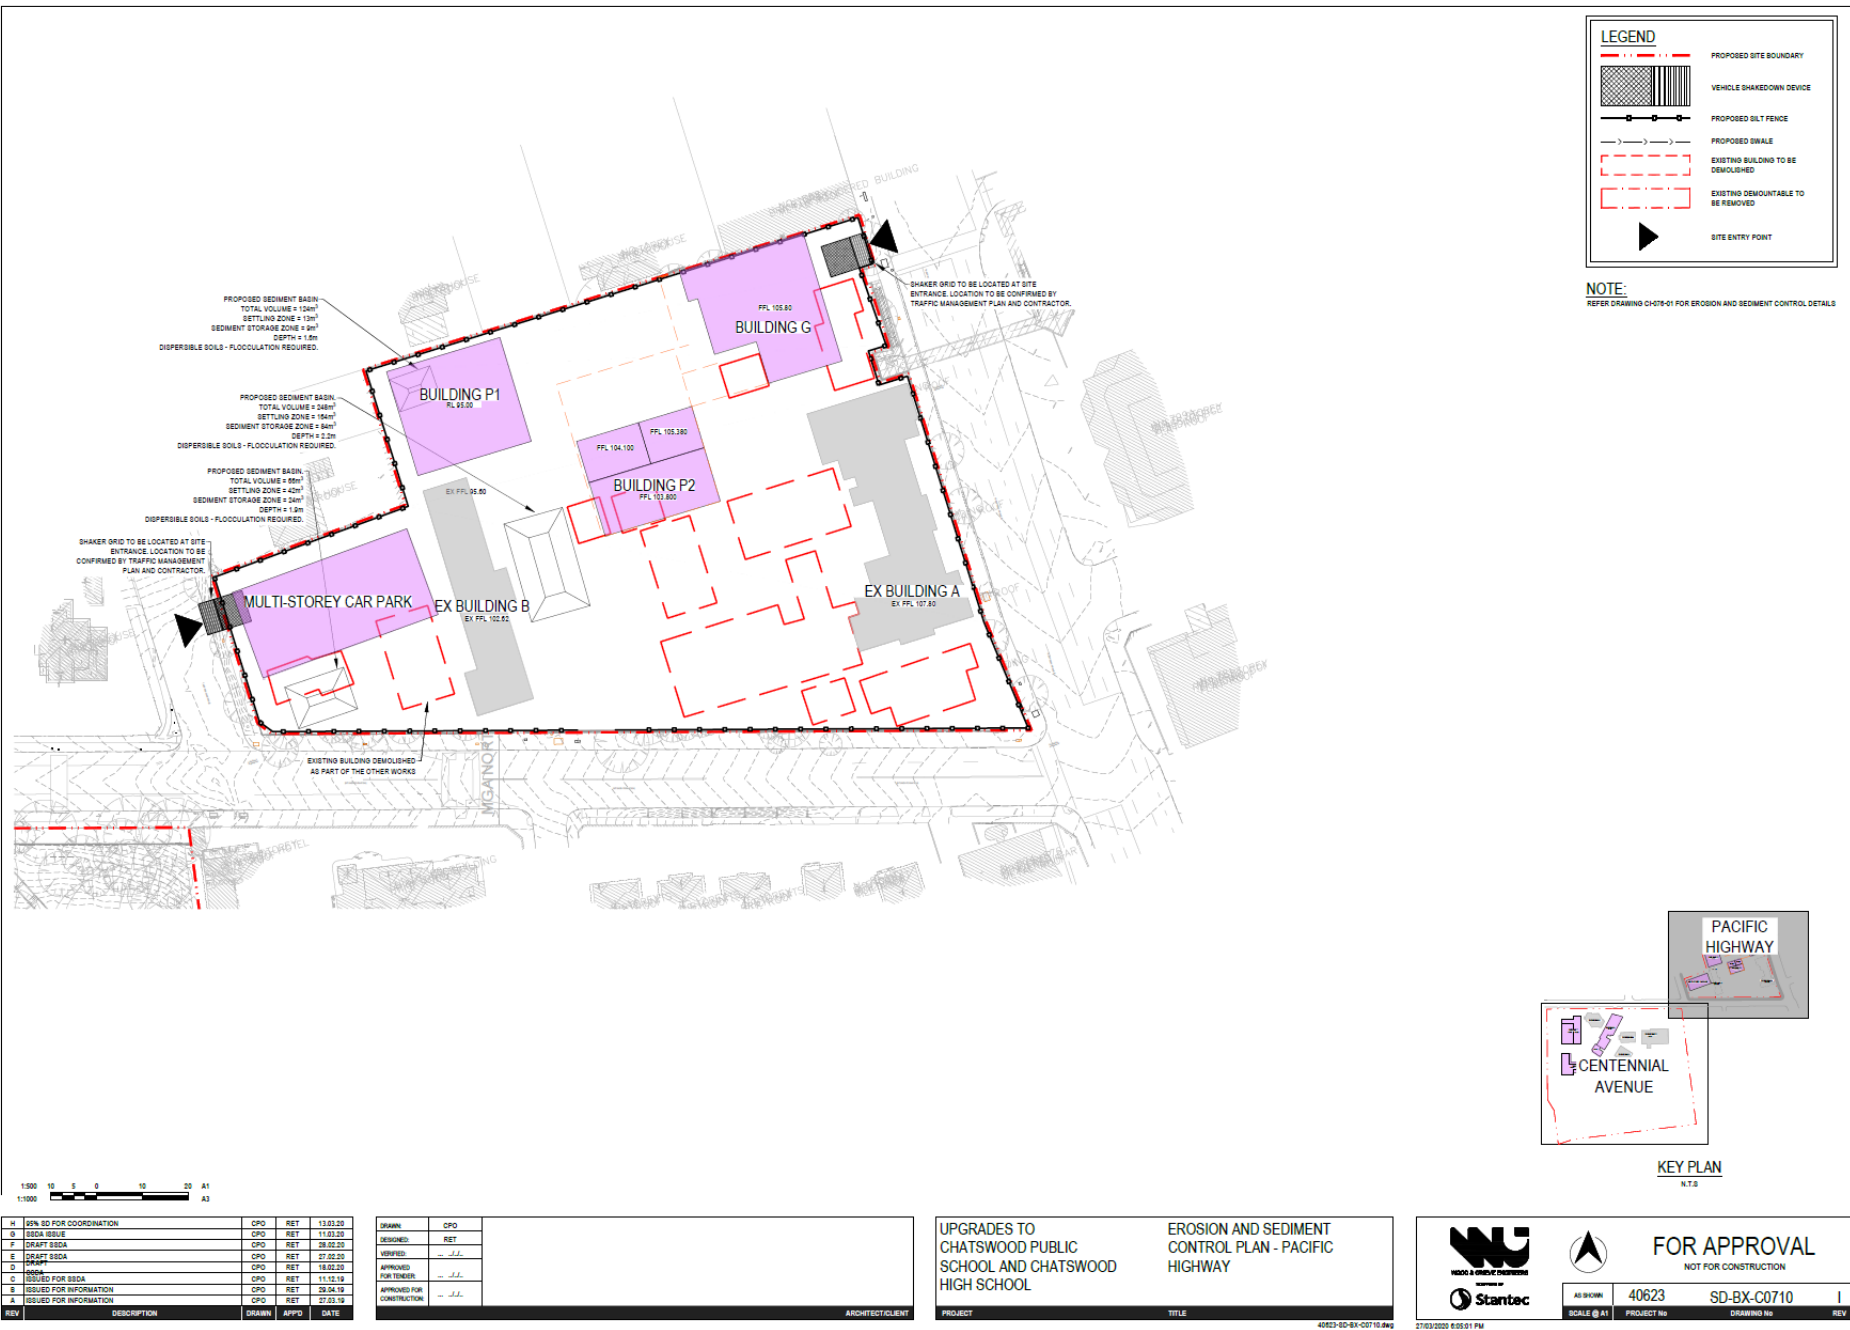
Attachment 3: Proposed Development Plan

The site is to be redeveloped by SINSW for ongoing use as a primary school. As shown on Attachment 3, this will involve retention of the historical school buildings to the east and the west of the site and historical brick retaining walls, demolition of several buildings including the hall in the northeast, the building in the south and the building in the western-most portion of the site with construction of three new multi-level buildings in the north and new carpark and play area in the west. Most of the remaining hardstand and play areas will be resurfaced. The majority of trees will be removed, and new landscaped areas will be installed.
