SINSW C/- Fulton Trotter Architects

# Supplementary Geotechnical Investigation: Cronulla High School, Captain Cook Drive, Cronulla, NSW

P2108205JR03V01  
August 2022

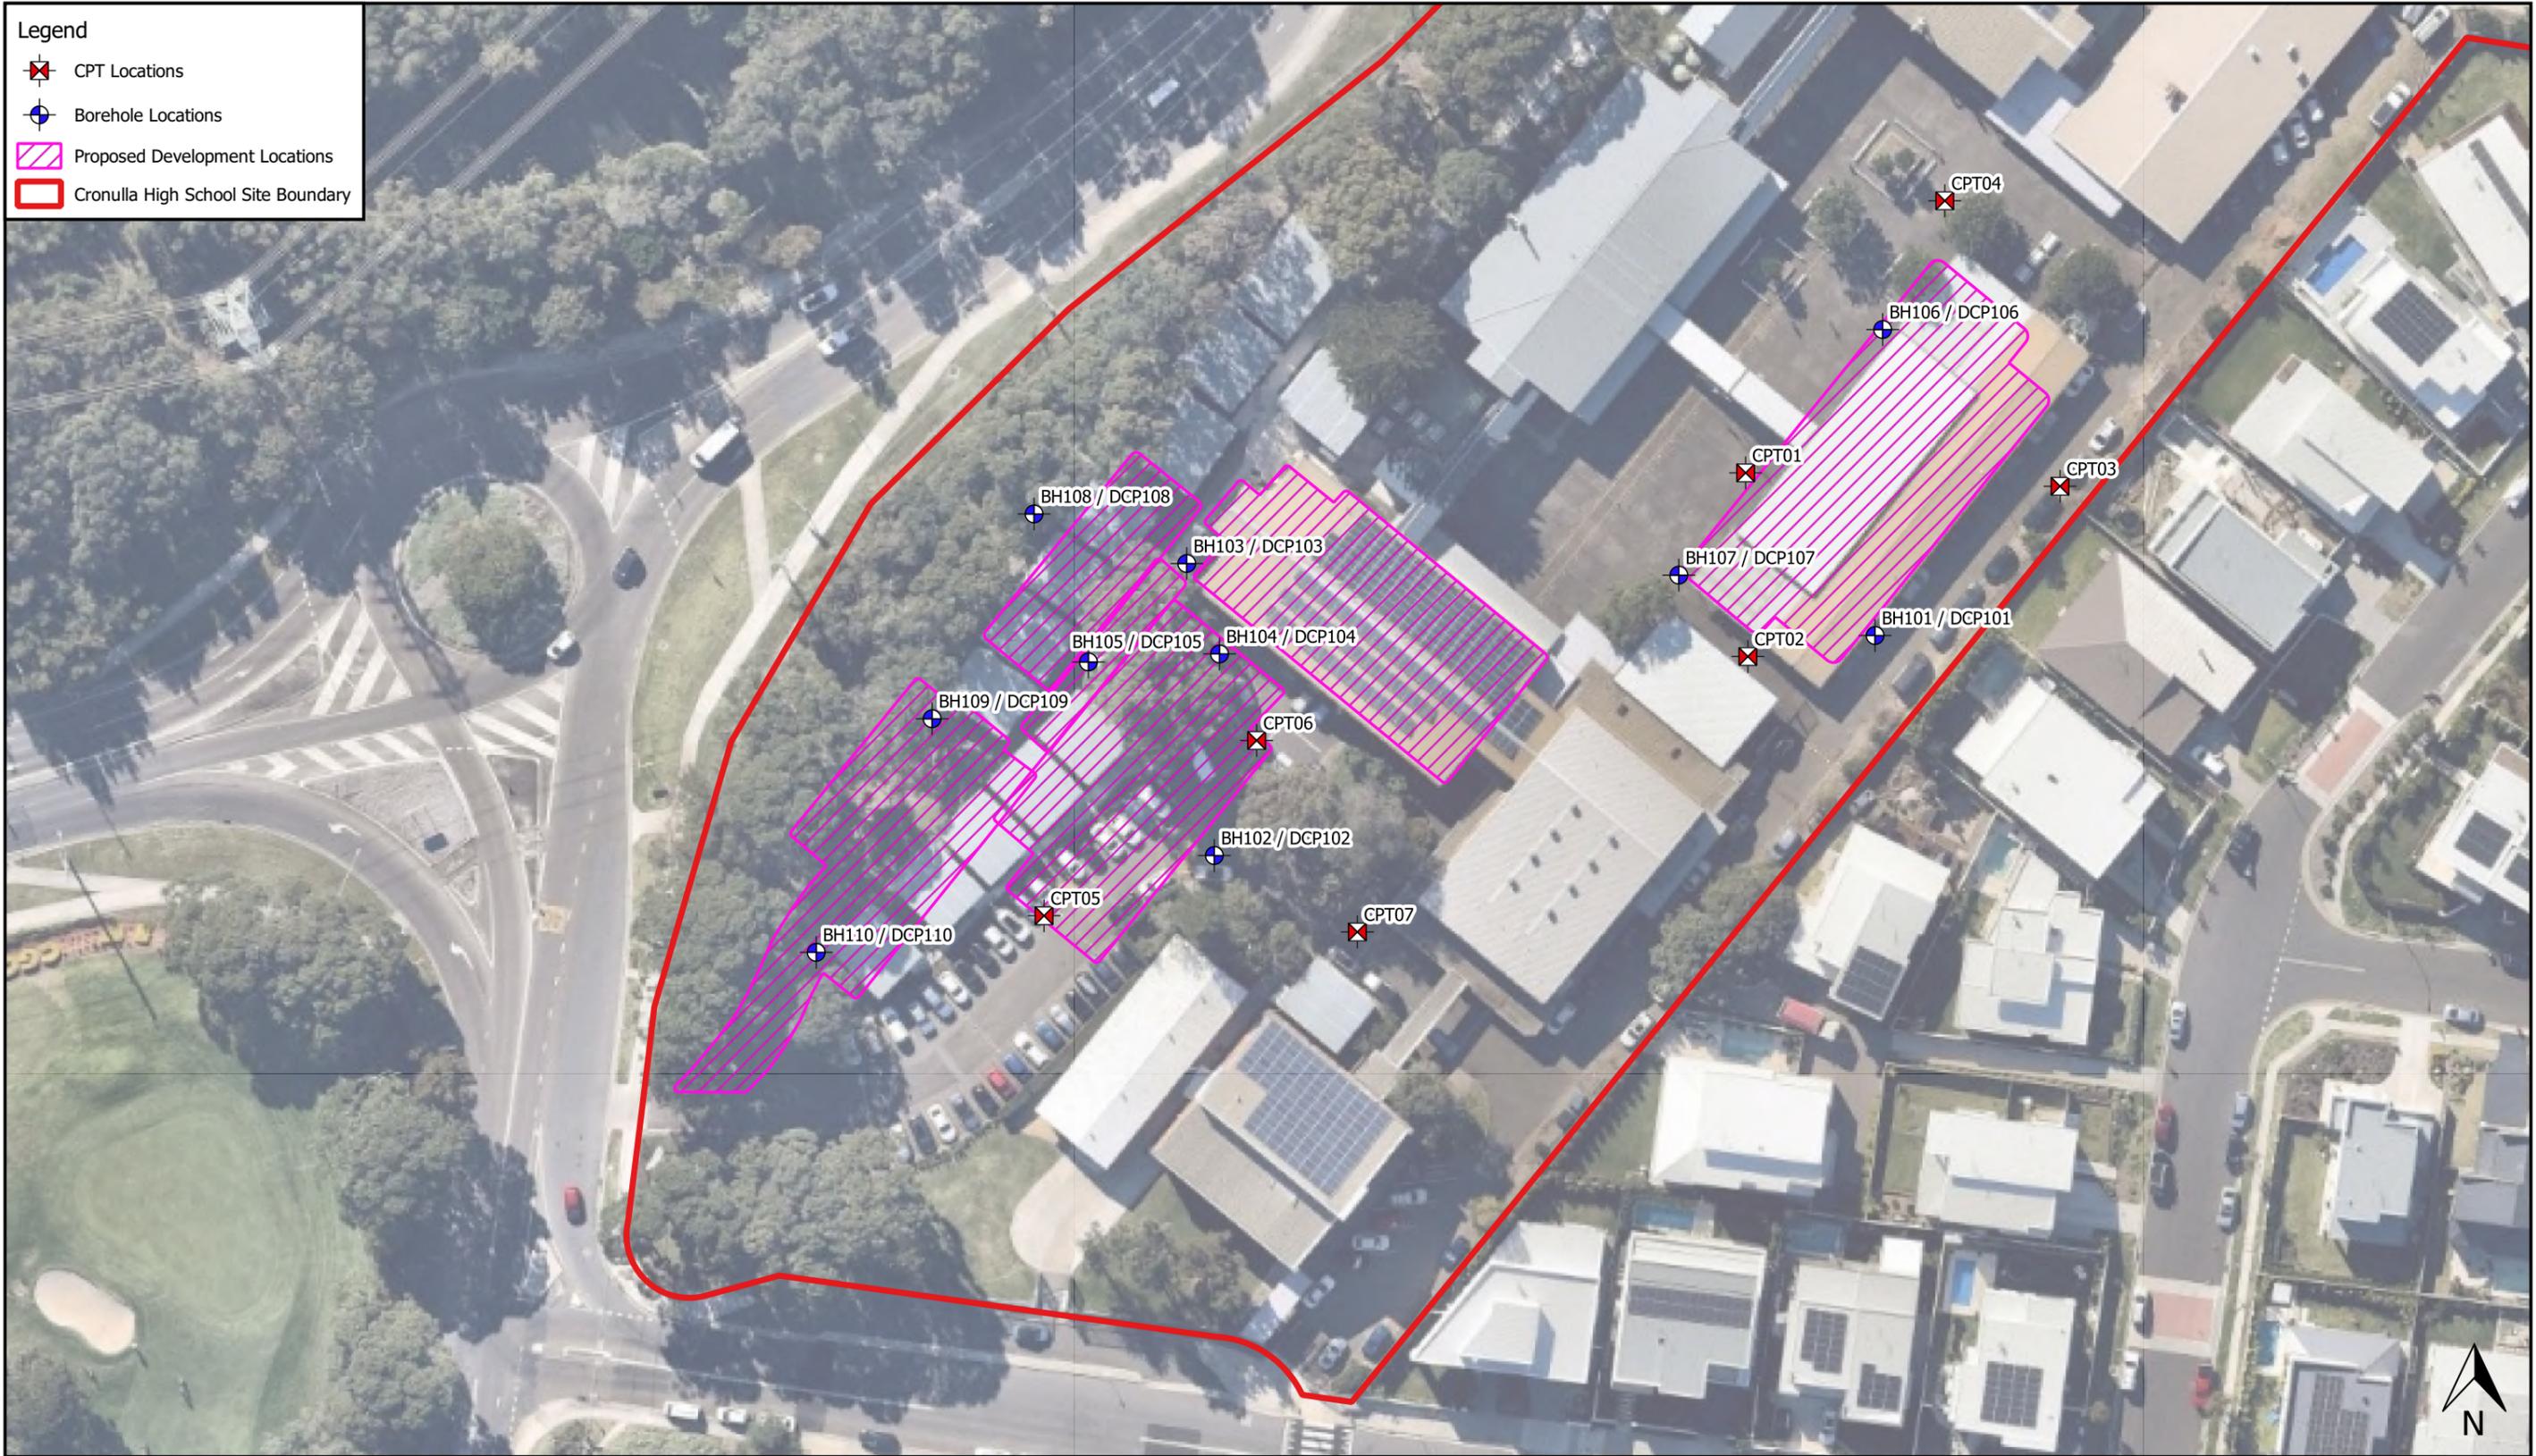
Map Title / Figure:  
**Borehole & CPT Locations**

Cronulla High School Site Boundary

1:750 @ A3  
 Viewport A  
 Aerial: Nearmap (May 2021)
