# Remedial Action Plan

Cronulla High School, Captain Cook Drive, Cronulla, NSW

**Final Report**

P2108205JR04V01.docx

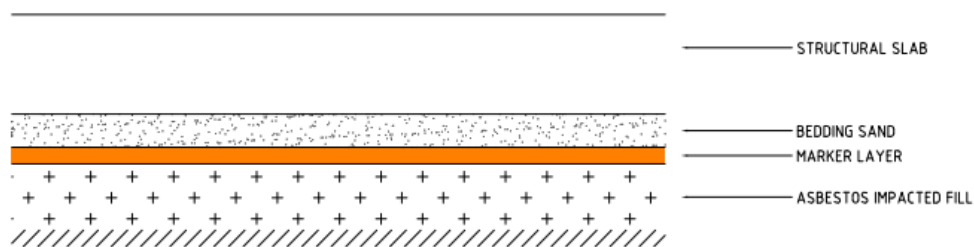
STRUCTURAL SLABS

The capping solution for concrete slabs (whether below a building or pedestrian walkways / driveway) is to comprise, as a minimum:

1. A marker layer (geotextile layer) over ACM impacted fill;
2. Bedding sand with thickness to design specifications; and
3. Structural concrete slab to design engineer's specification with minimum slab thickness of 100 mm.

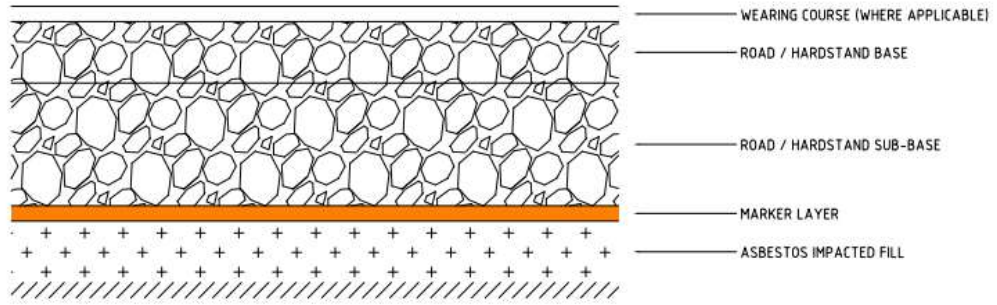
FLEXIBLE ROAD AREAS / HARDSTANDS

The capping solution for flexible road pavements is to comprise:

1. A mandatory marker layer (geotextile layer) over ACM impacted fill;
2. A pavement subbase / base layer with thickness to design specifications as required;
3. and
4. Where required, a wearing course (e.g. chip seal / asphalt) with thickness to design specifications.

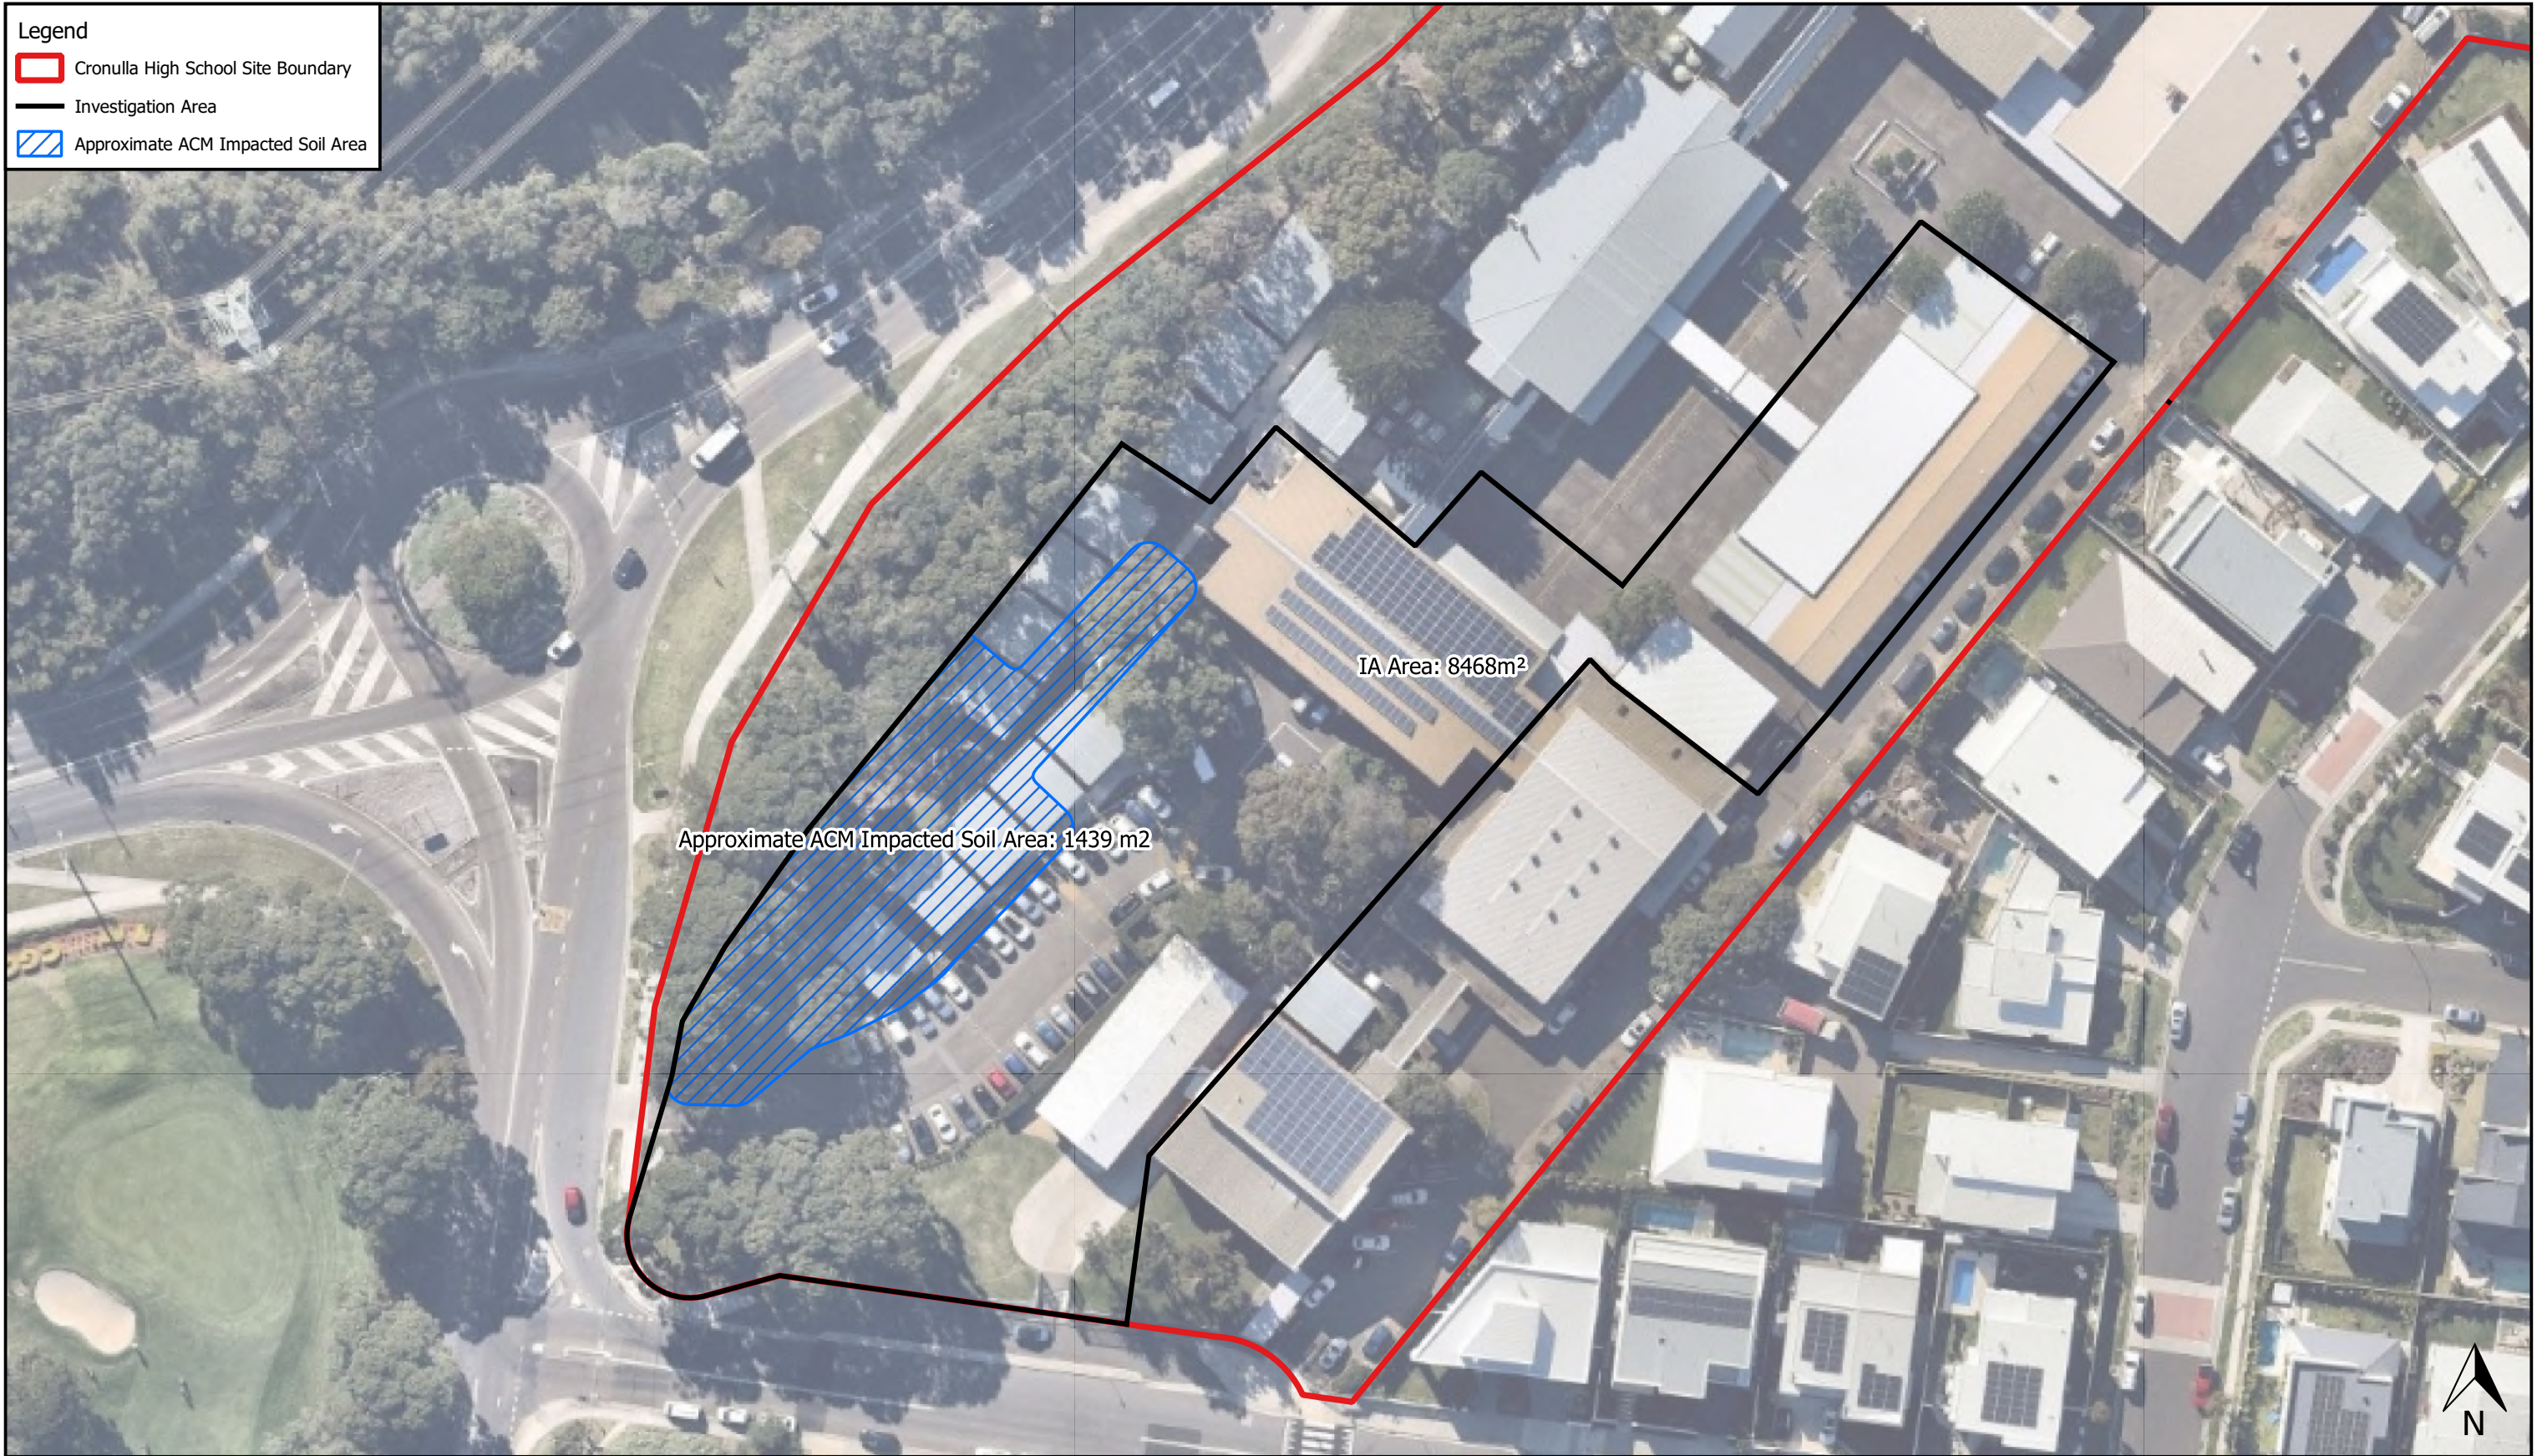
1:750 @ A3  
 Viewport A  
 Aerial: Nearmap (2021)

- ▭ Cronulla High School Site Boundary
- Investigation Area
- Approximate ACM Impacted Soil Area
