INTERIM LONG-TERM ENVIRONMENTAL MANAGEMENT PLAN

April 2022
J169905

Stage 1 Area - Darlington
Public School

Interim Long-Term Environmental Management Plan (EMP)

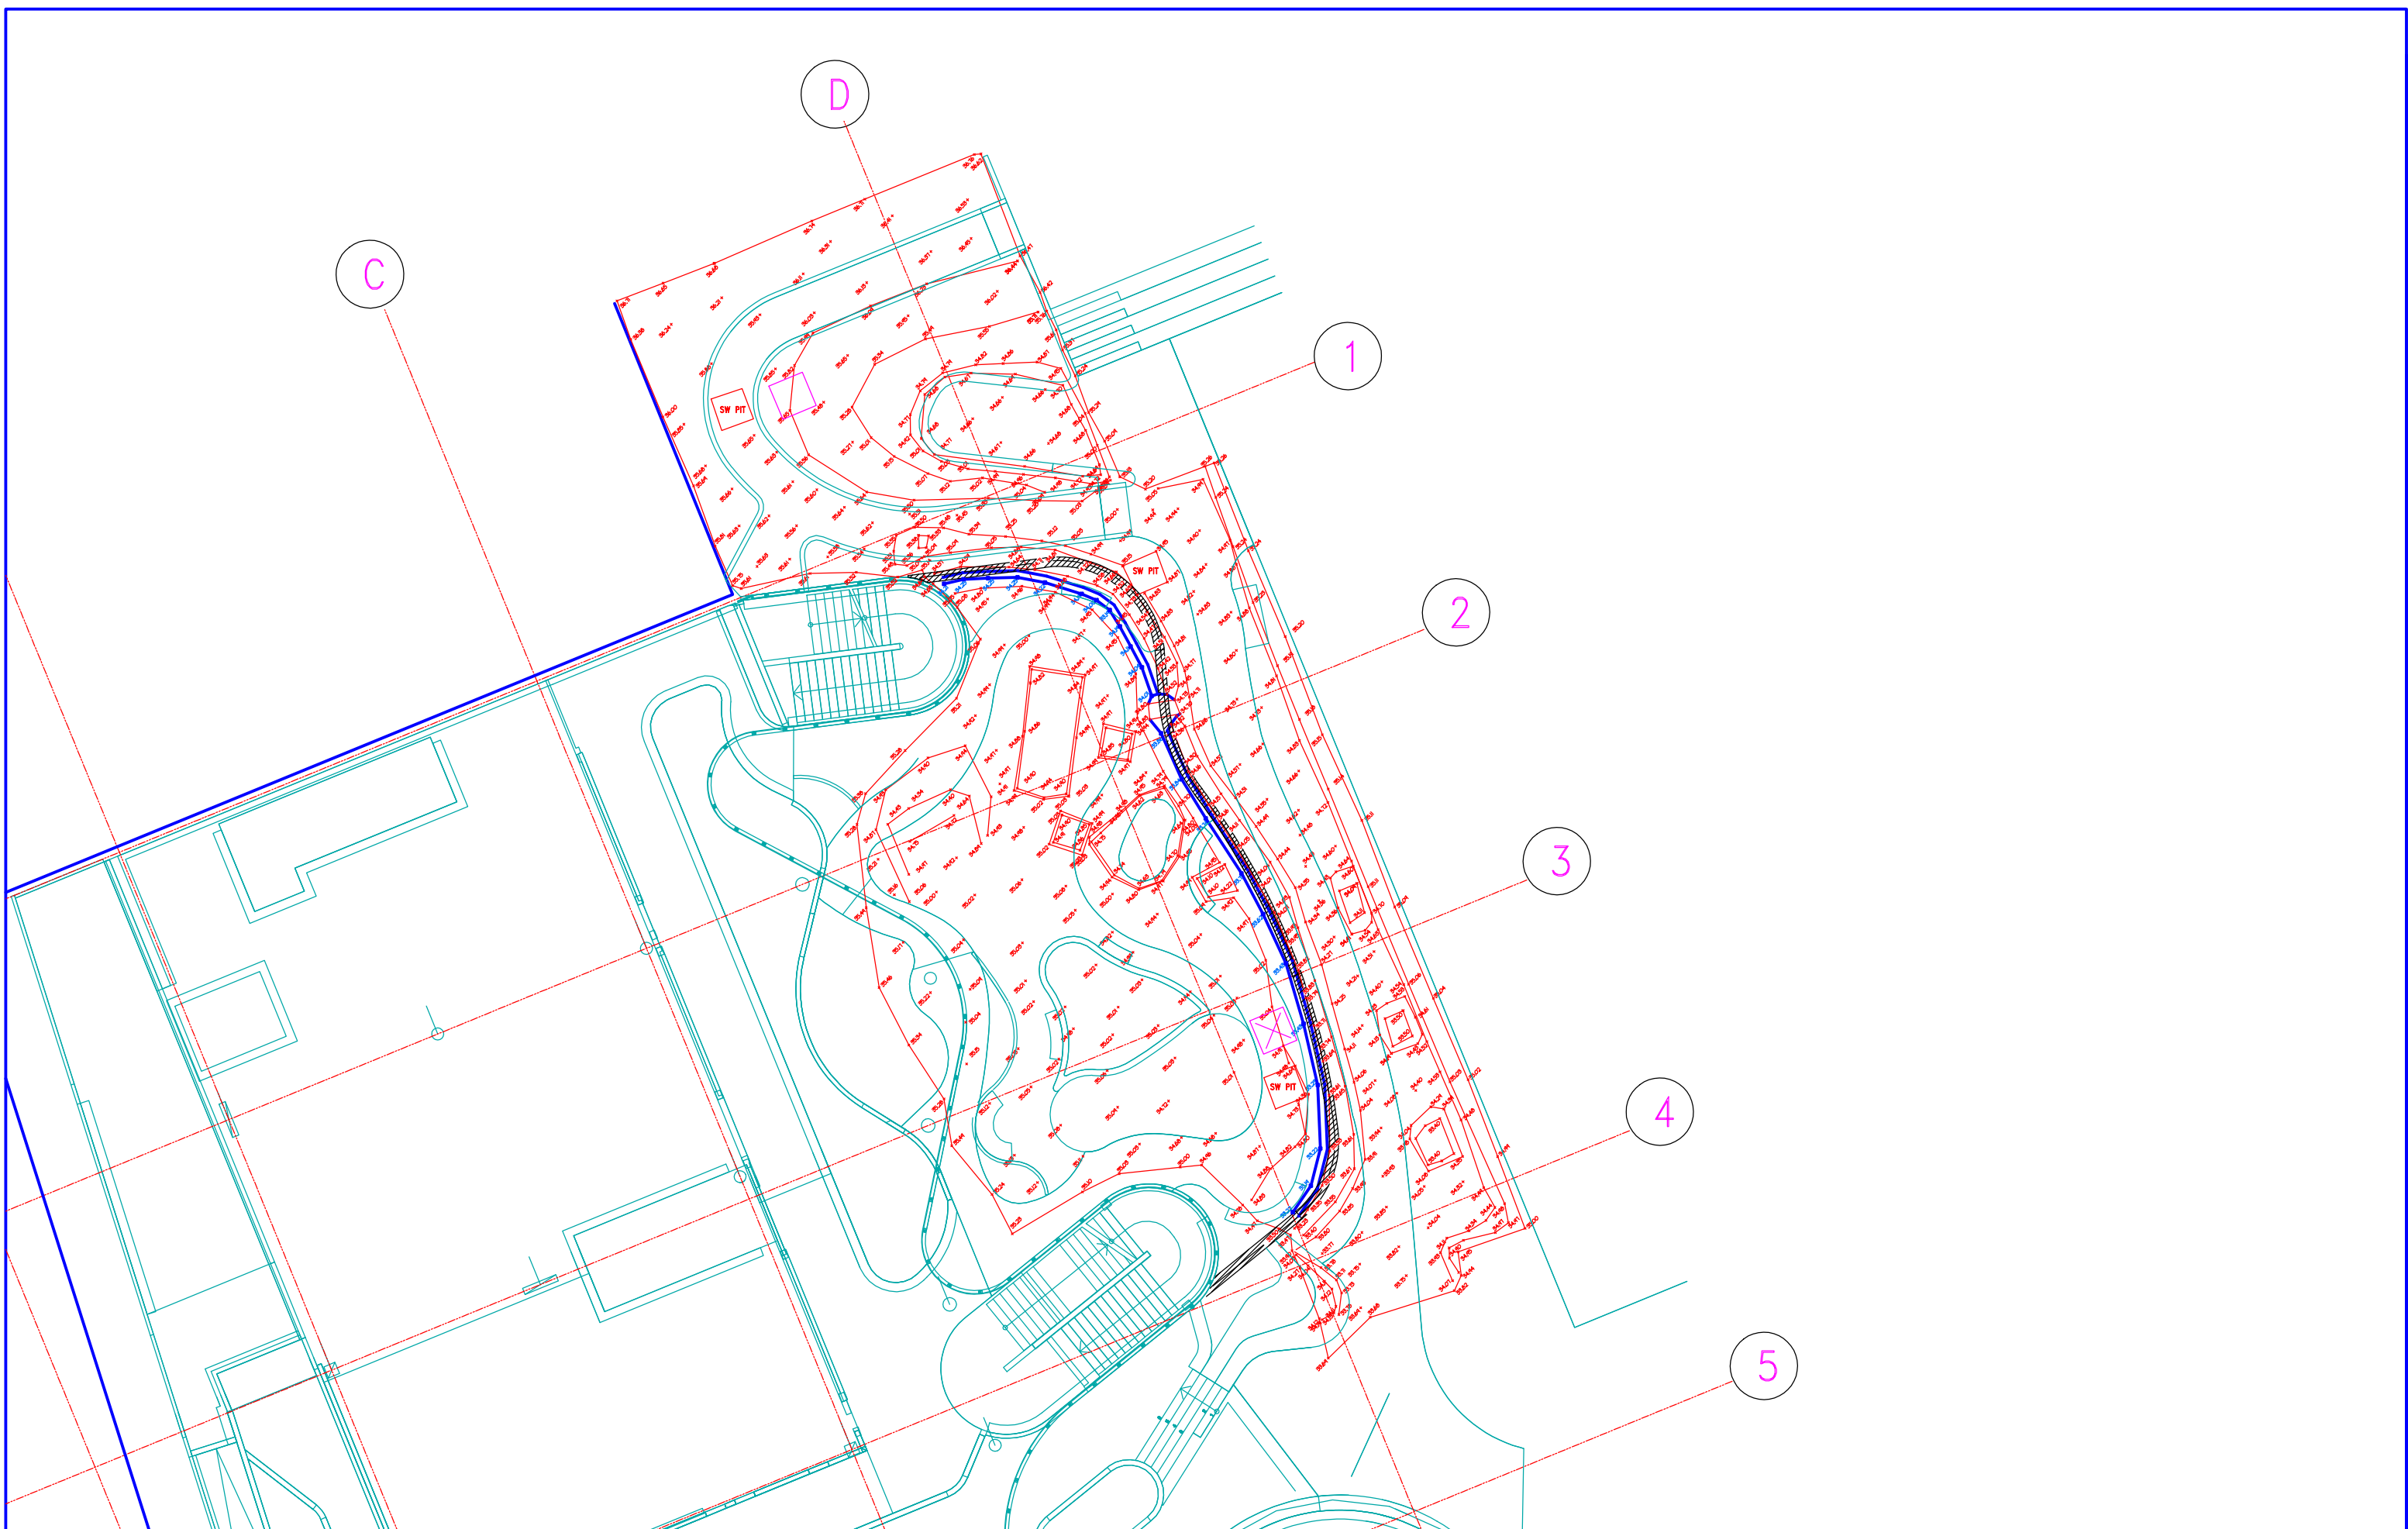
PLAN:
 PLAY AREA MARKER LAYER
 LEVEL SURVEY
SHEET 1 OF 3

SCALE	1:100 (A1)
DATE	10/07/2021 DATUM A.H.D
GADD FILE REF	AWE/DARLINGTON
DWG No:	SP1208-044.PRO
