Site Audit Statement

Site audit statement no. SAS188

Address 417-445 Abercrombie Street Darlington NSW

Appendix B – Final Site Survey Plans

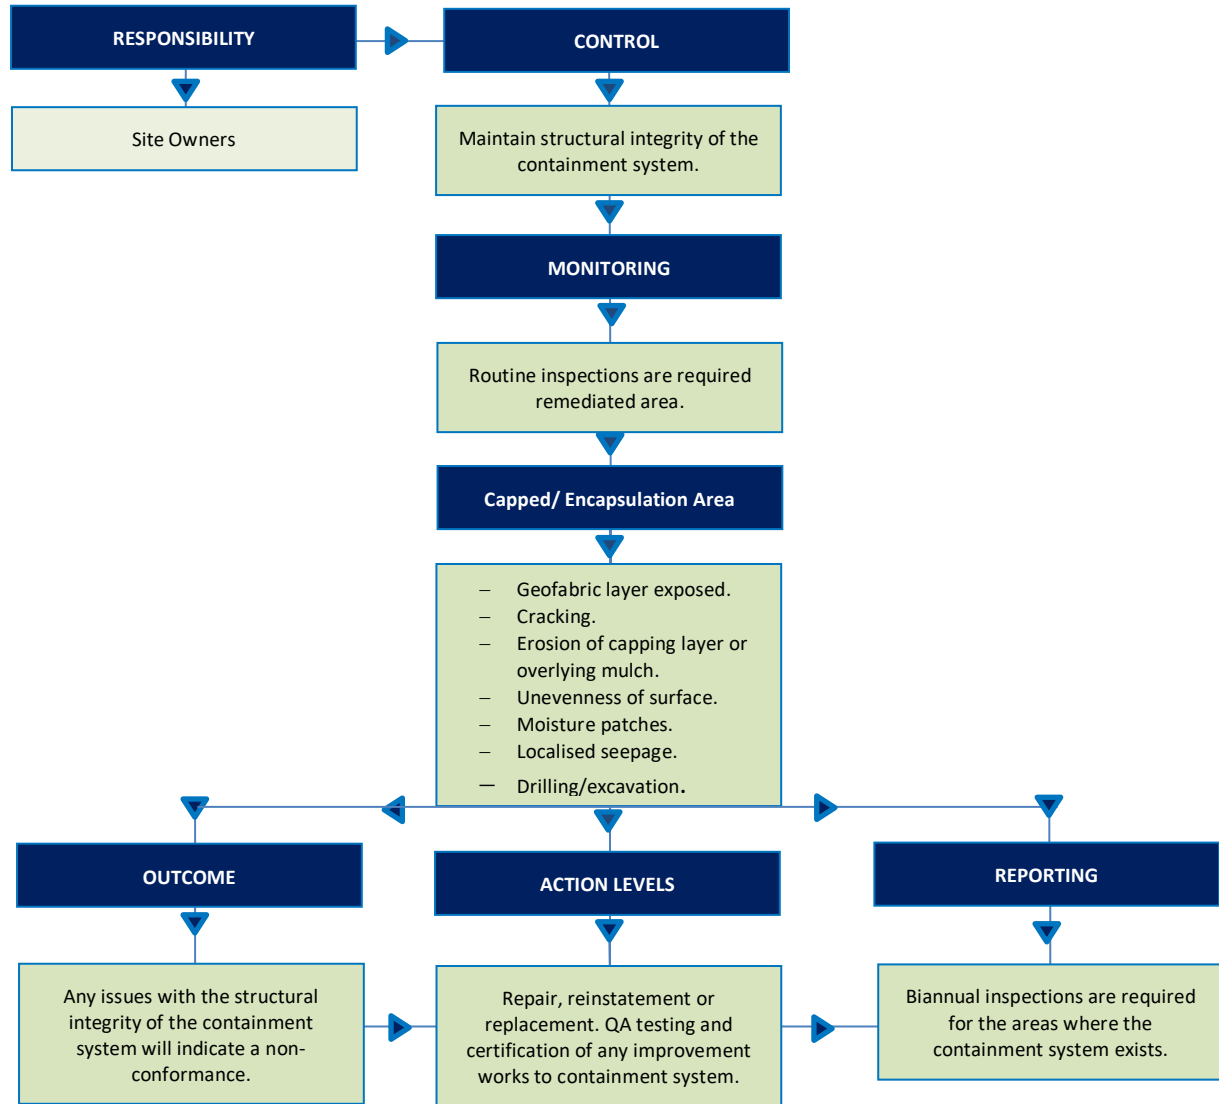
Chart 1: Schematic Summary

As a minimum requirement, bi-annual visual inspections of the area of capping should be conducted and are the responsibility of the site owner (DoE). Inspections are to focus on the assessment of potential issues that may hinder the structural integrity of the cap with examples provided in *Chart 1: Schematic Summary*.

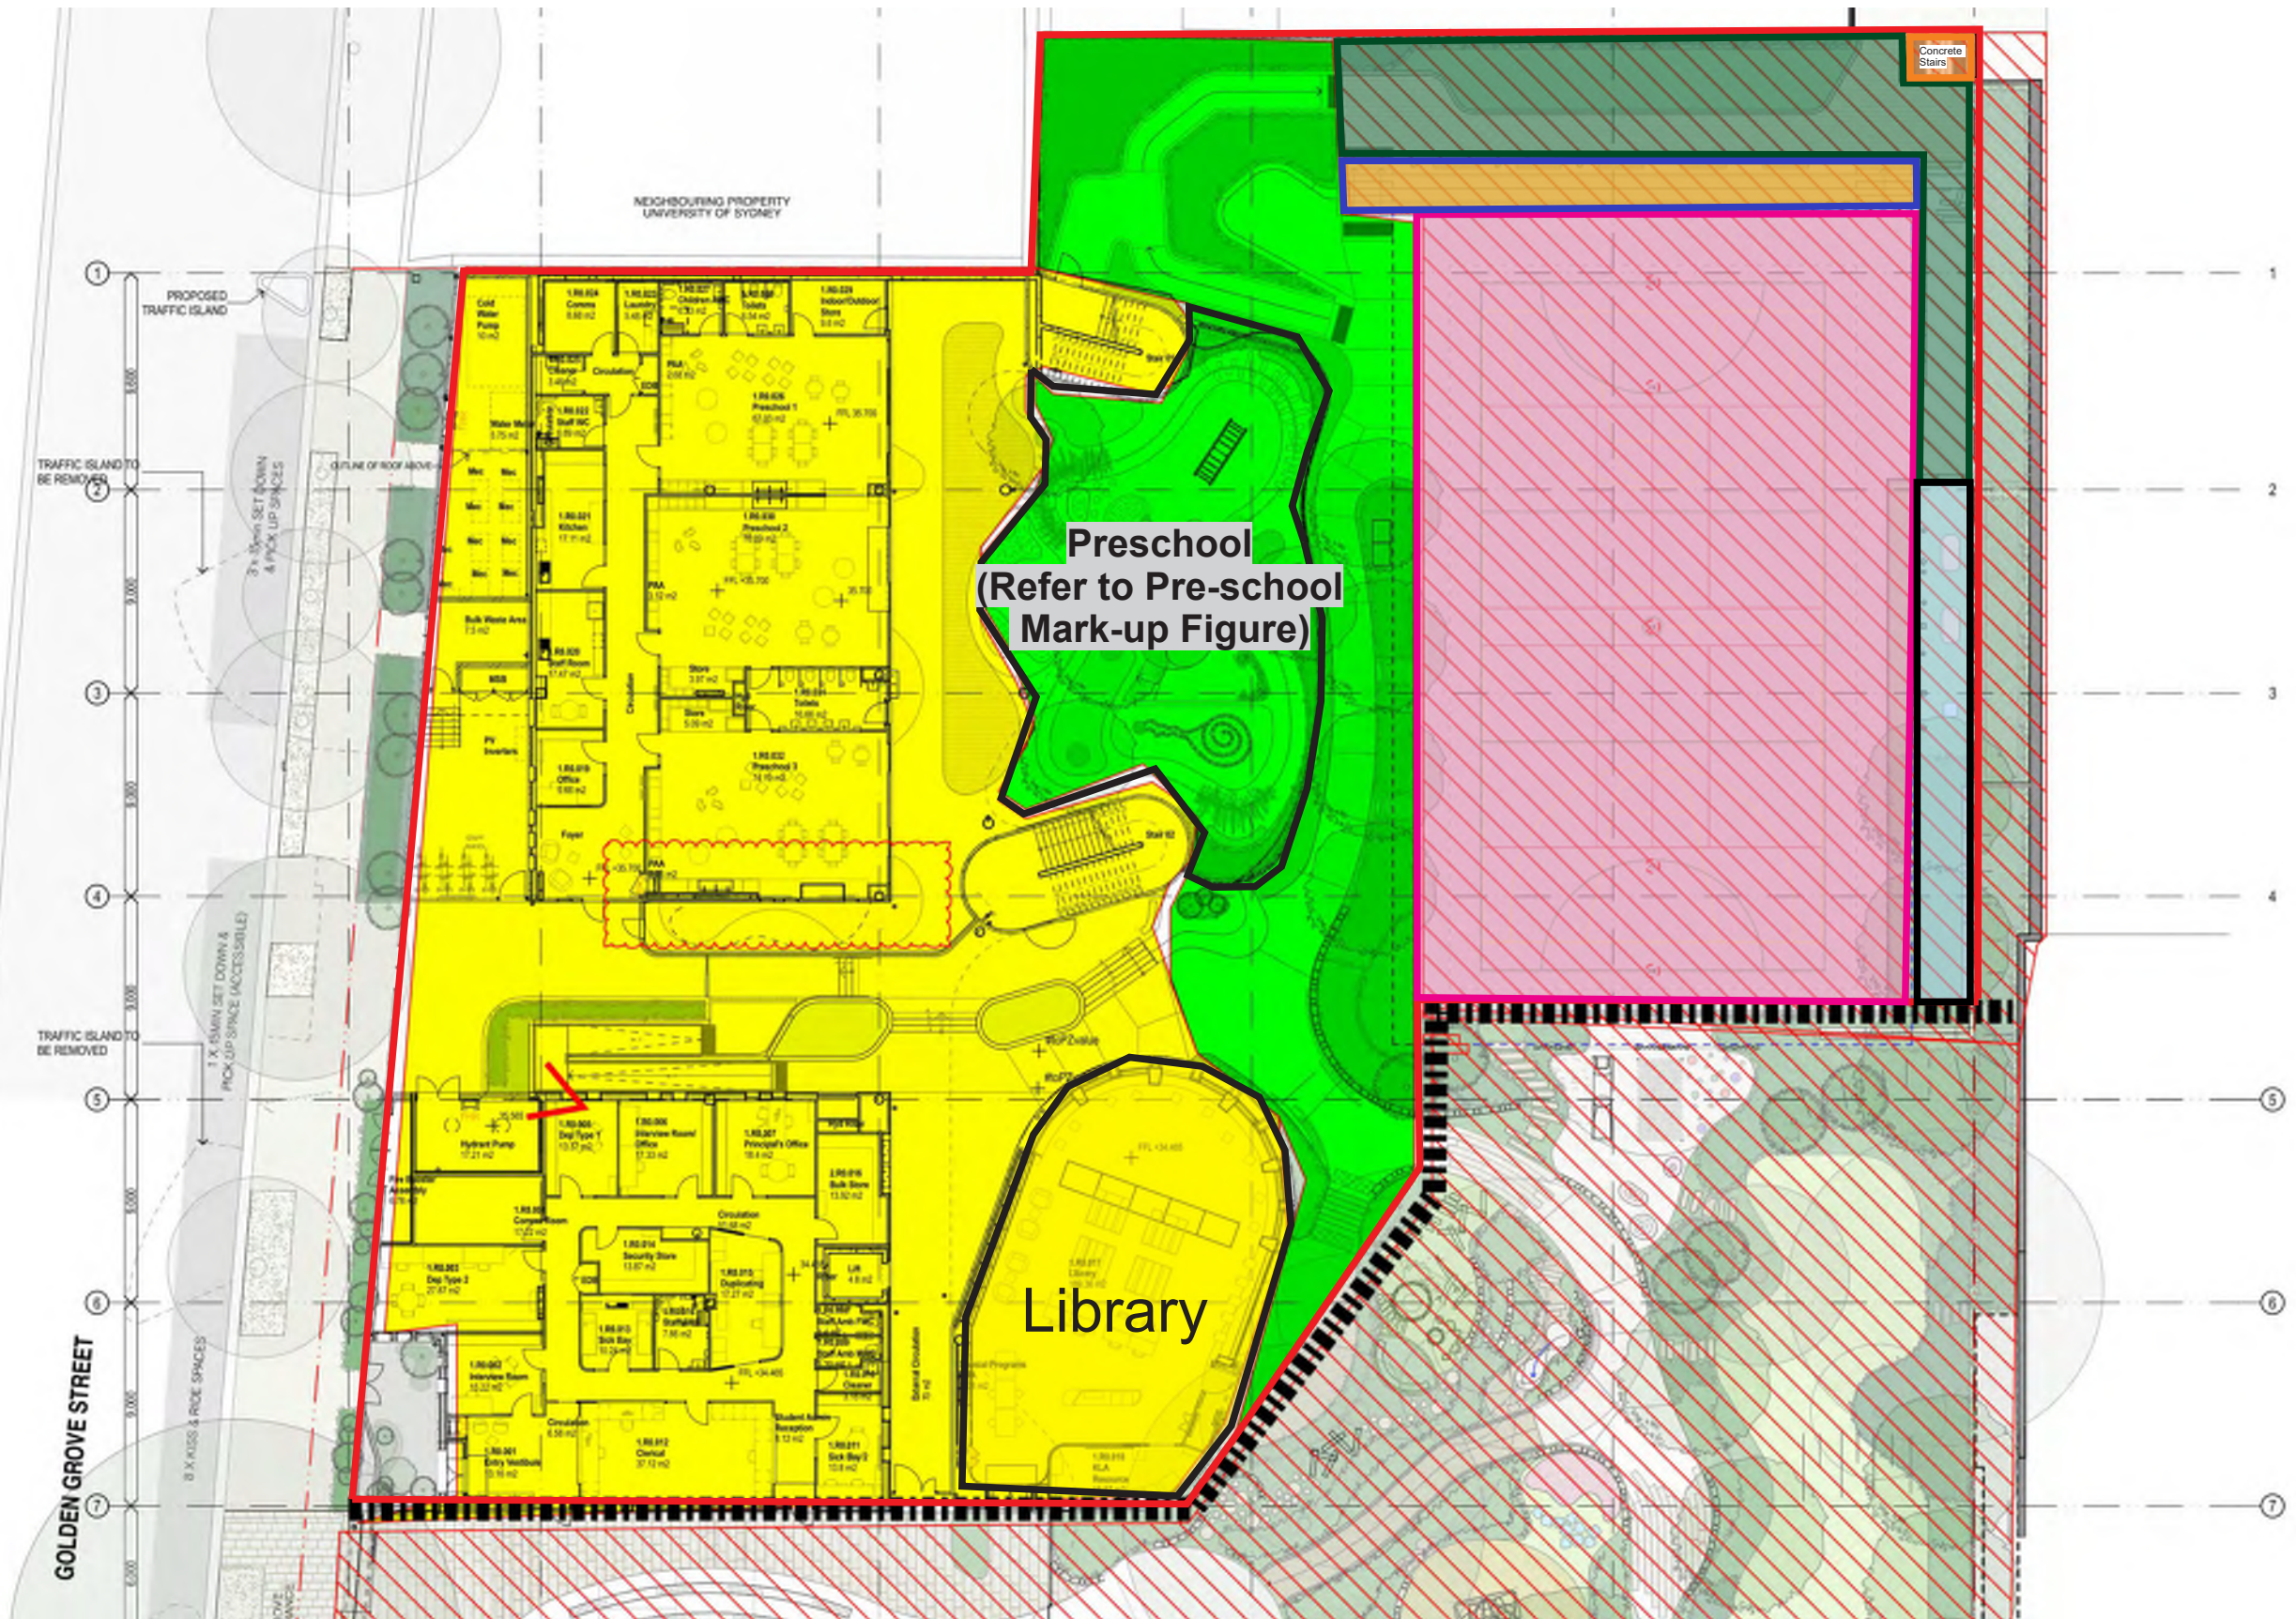
Client Name:		AW Edwards Pty Ltd		
Client Number:		C1207251	Project Number: J169905	
Project Description:		Darlington PS LT-EMP		
Address:		417 Abercrombie St, Darlington NSW 2008		
Prepared:	TM	Reviewed:	AG	Date: 28/06/23
Figure 3	Stage 1 Capping Layer Variations

- Stage 1 Site Validation Boundary
- Asphalt Pavement Capping
- Outdoor Landscaping Capping
- Building Floor Slab Capping (Concrete)

In addition to the requirements of this EMP, all works with potential to disturb all the capping area (refer to Figure 2 to 7) should comply with requirements of the DoE Asbestos Management Plan (currently October 2020 edition). This includes engagement of a Class A licensed contractor, and Licensed Asbestos Assessor, Safework NSW permit, restricted work hours if excavations disturb asbestos and could possibly cause dust emission.

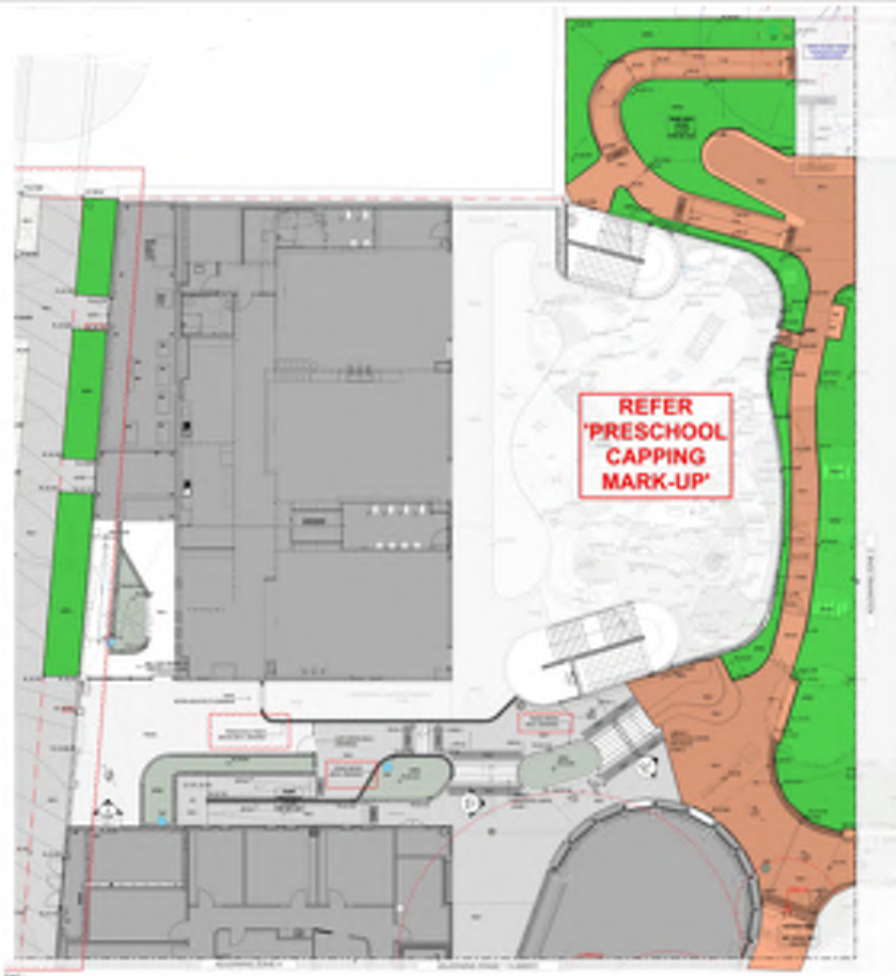
Client Name:		AW Edwards Pty Ltd	
Client Number:		C1207251	Project Number: 1169905
Project Description: Darlington PS LTEMP			
Address:		417 Abercrombie St, Darlington NSW 2008	
Prepared:	DF	Reviewed:	AG
Version Date:		18/06/2023	
Figure 4A Stage 1 Capping layers

PRESCHOOL CAPPING MARK-UP - STAGE 1

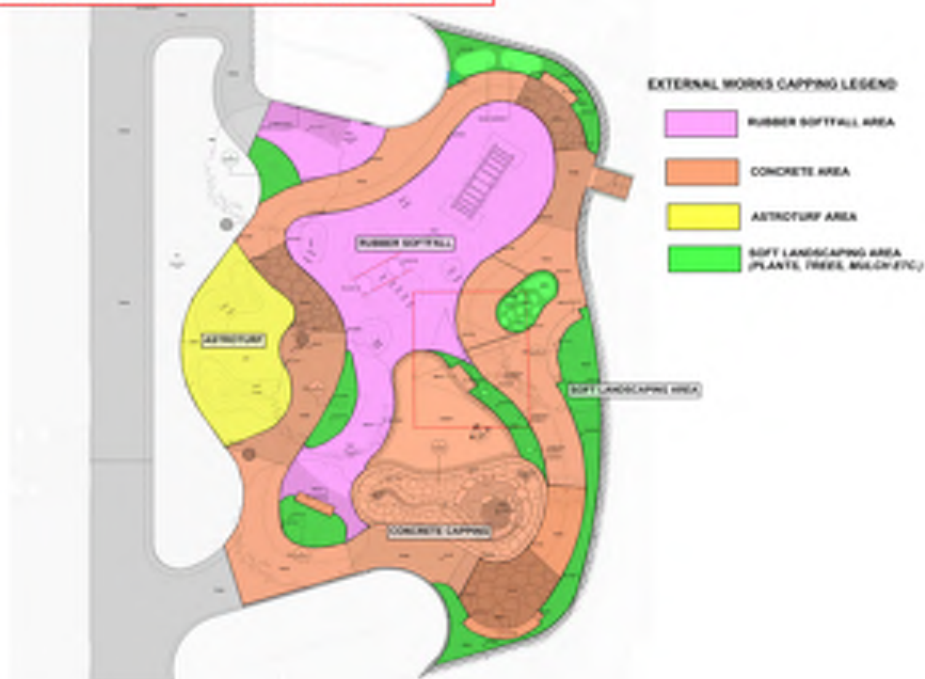
Client Name:	JW Edwards Pty Ltd		
Client Number:	C1207253	Project Number:	J359905
Project Description:	Darlington PS LTEMP		
Address:	417 Abercrombie St, Darlington NSW 2008		
Prepared:	TM	Reviewed:	AG
Version Date:	21/06/2023		
Figure 48 Stage 1 Capping layers

- Rubber Sofffall Area
- Concrete Area
- AstroTurf Area
- Soft Landscaping area
(Plants, Trees, Mulch etc)

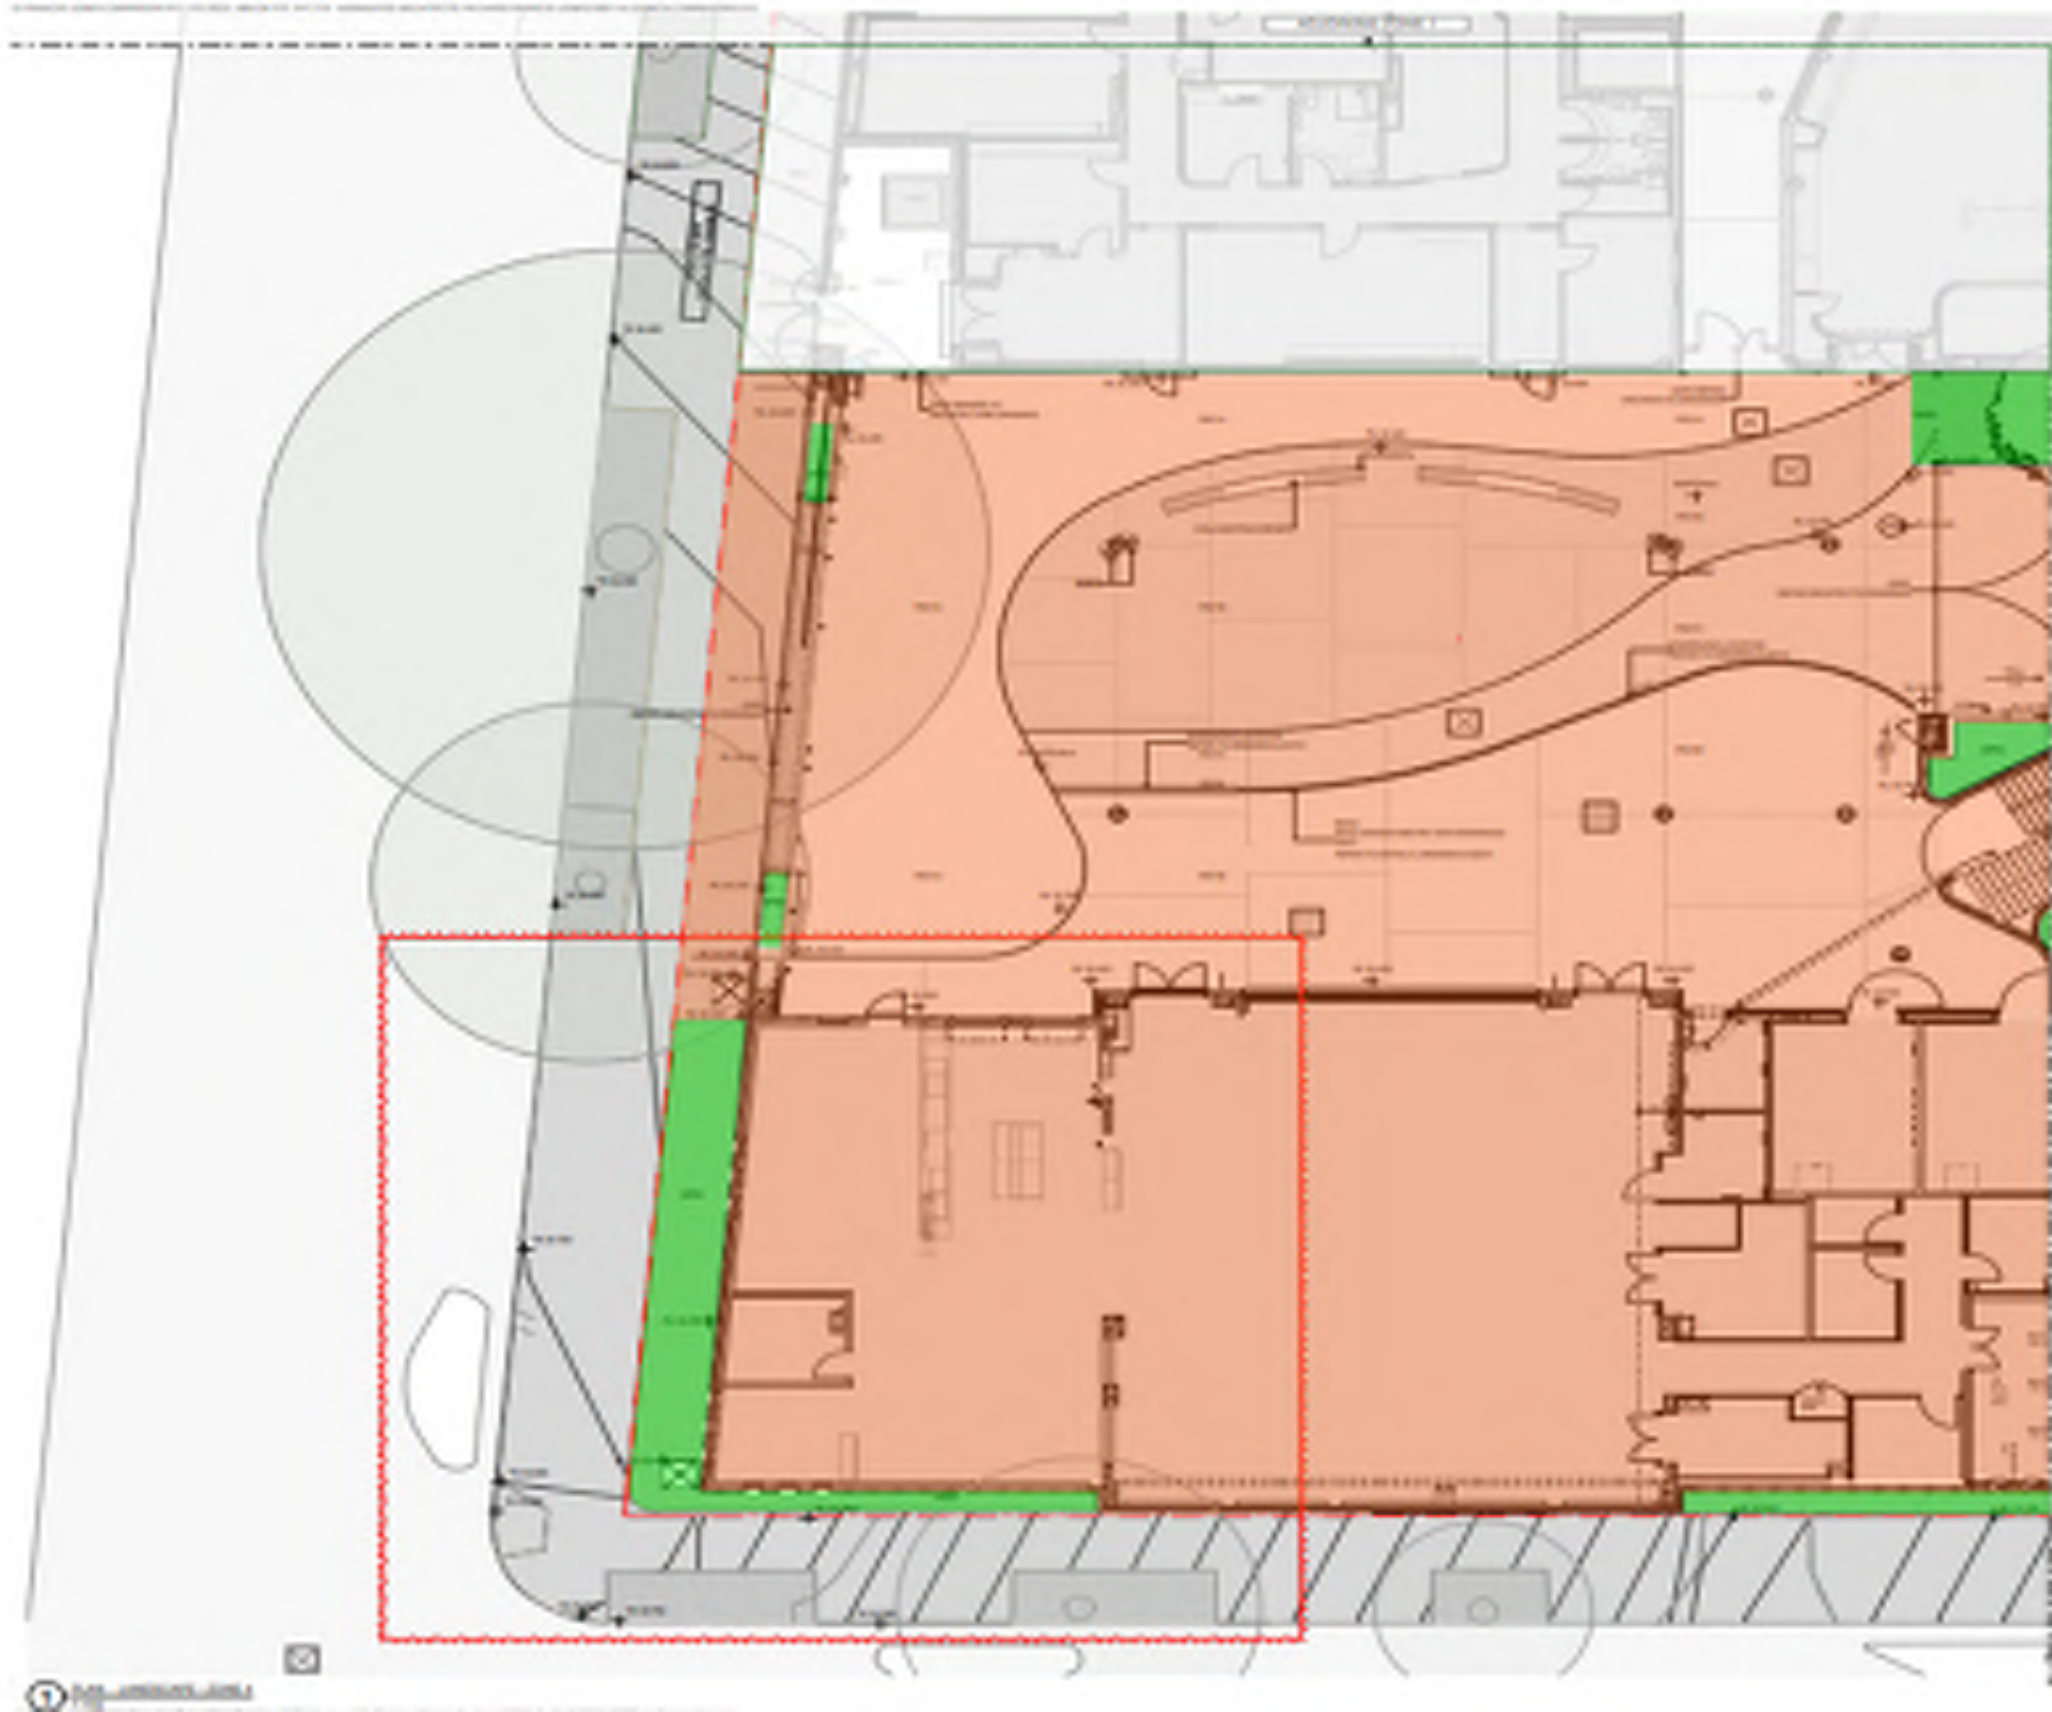
Client Name:		AW Edwards Pty Ltd	
Client Number:		C1207251	Project Number: J169905
Project Description: Darlington PS LT-EMP			
Address:		417 Abercrombie St, Darlington NSW 2008	
Prepared:	DF	Reviewed:	AG
Version Date:		28/06/2023	
Figure 5	Stage 2 Capping Layers (Western portion of the site)

- Building /Undercover Concrete Area
- Soft Landscaping Area (Plants, Trees, Mulch etc)

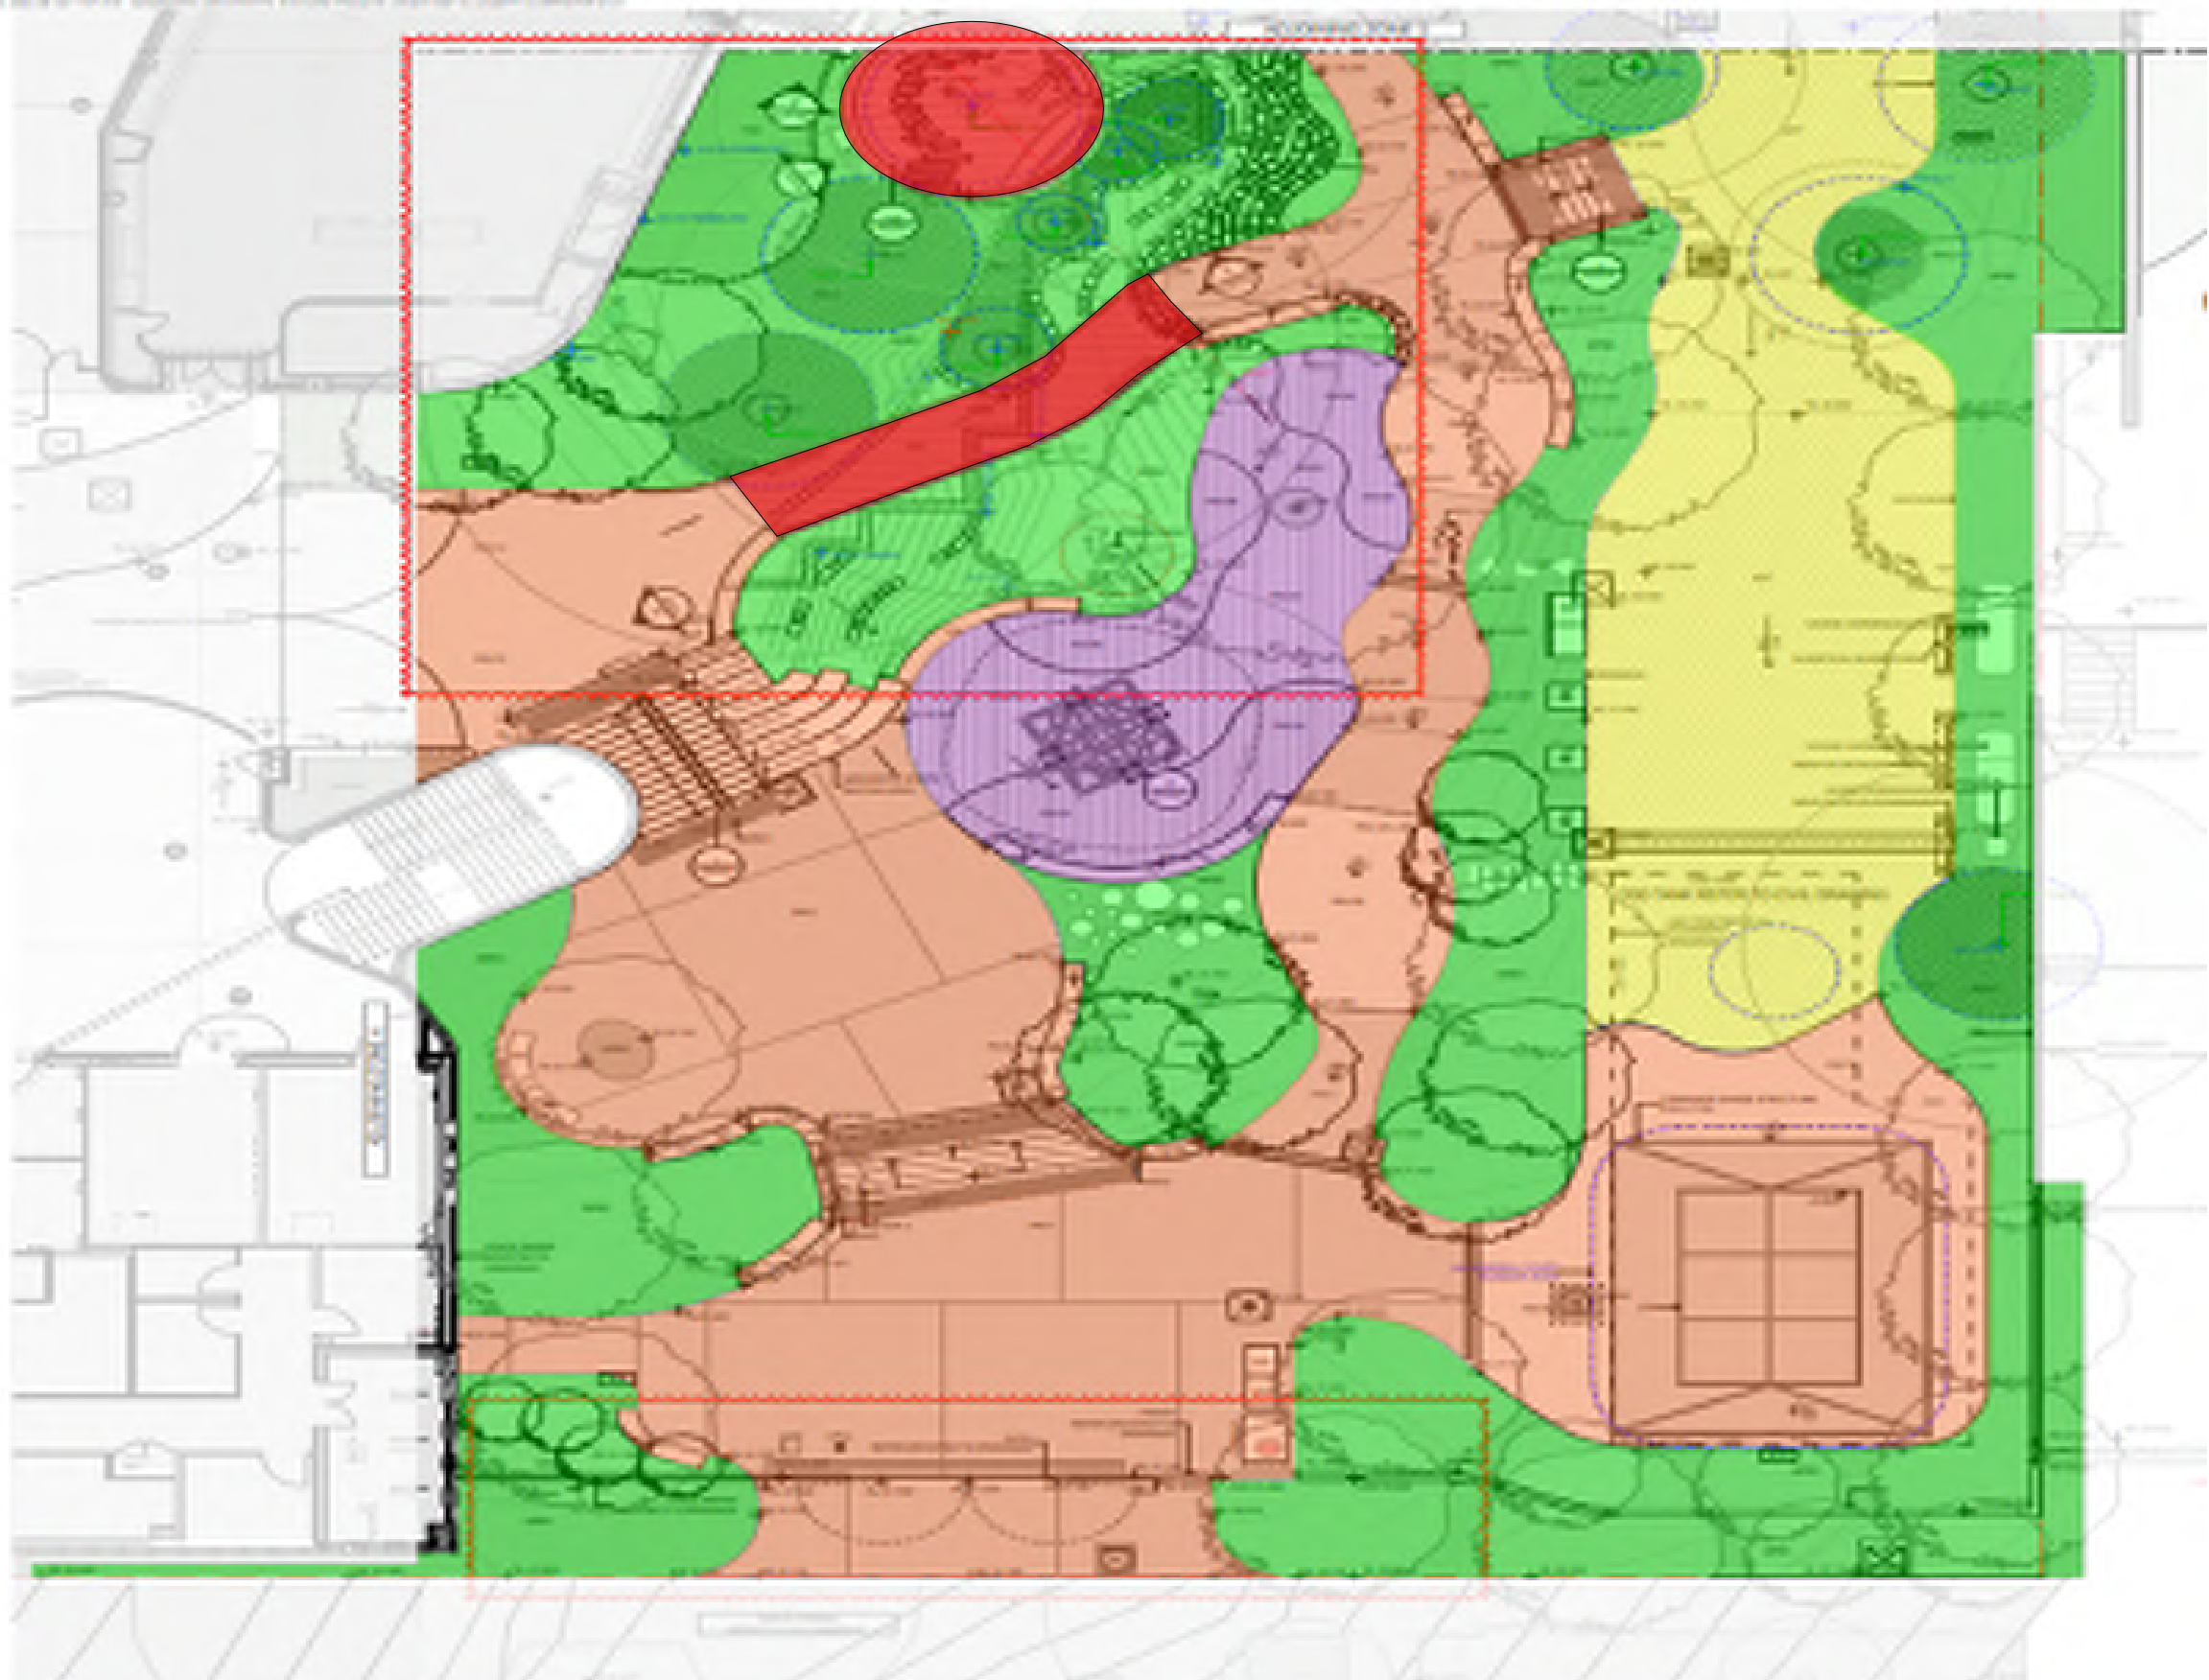
Client Name:		AW Edwards Pty Ltd	
Client Number:		C1207251	Project Number: J169905
Project Description: Darlington PS LT-EMP			
Address:		417 Abercrombie St, Darlington NSW 2008	
Prepared:	DF	Reviewed:	AG
Version Date:		28/06/2023	
Figure 6	Stage 2 Capping layers (Eastern portion of the site)

- Rubber Softfall Area
- Concrete Area
- Astroturf Area
- Soft Landscaping area
(Plants, Trees, Mulch etc)
- Timber Composite Deck

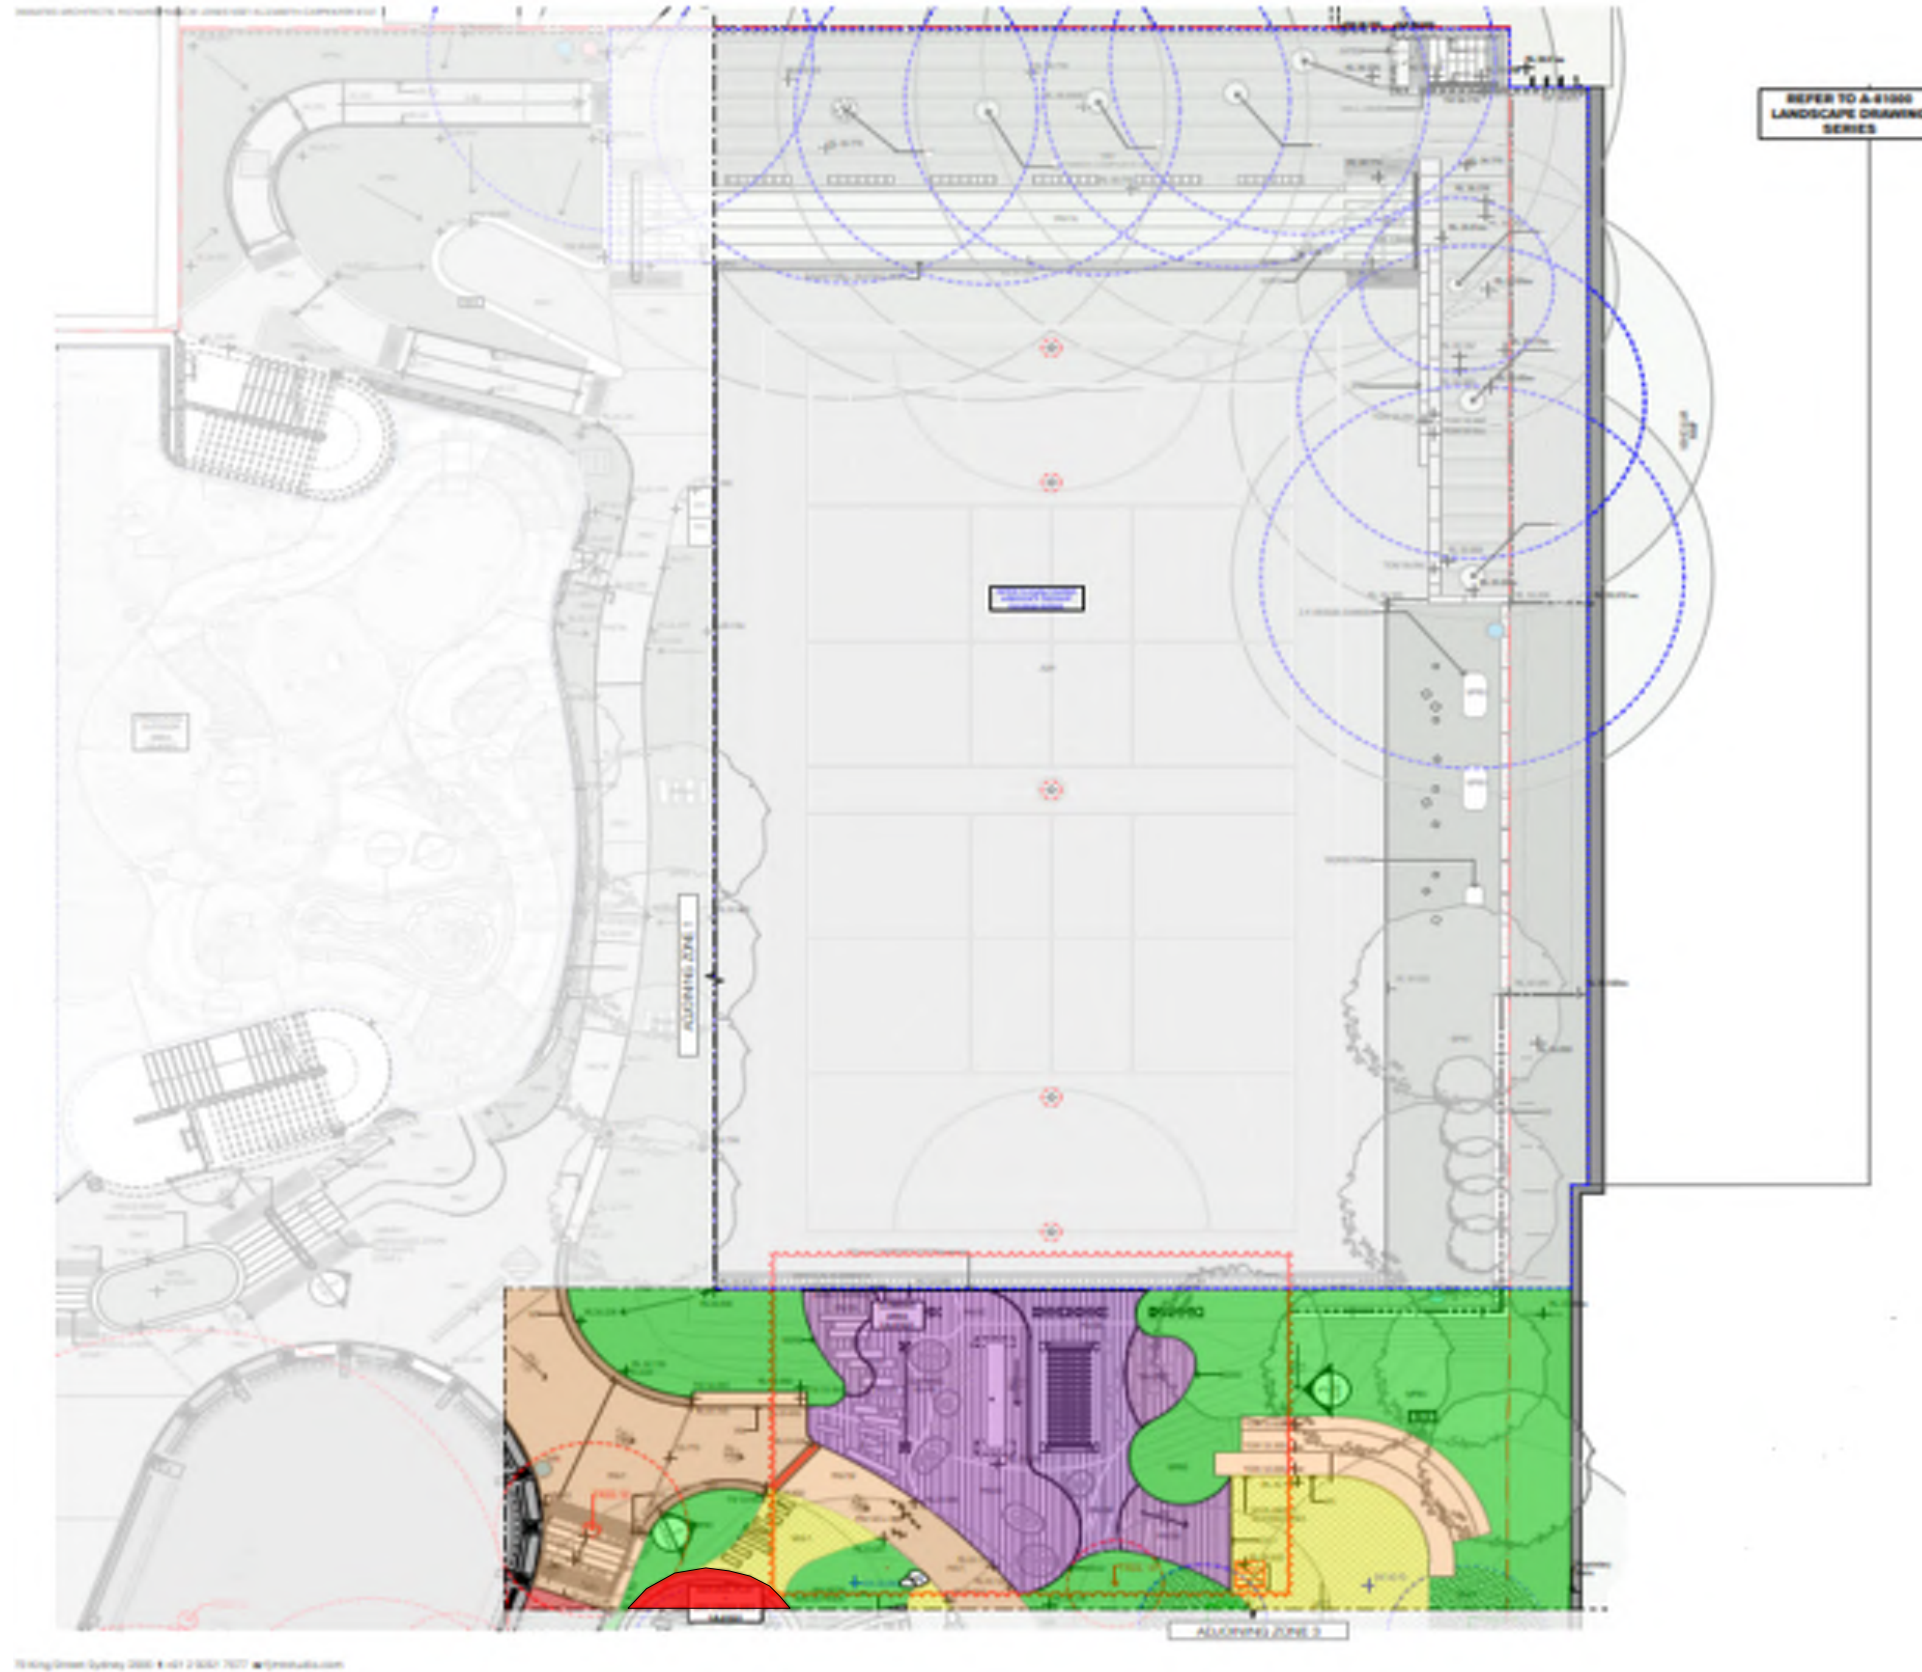
Client Name:		AW Edwards Pty Ltd	
Client Number:		C1207251	Project Number: J169905
Project Description: Darlington PS LT-EMP			
Address:		417 Abercrombie St, Darlington NSW 2008	
Prepared:	DF	Reviewed:	AG
Version Date:		28/06/2023	
Figure 7		tage 2 Capping layers (Eastern portion of the site)

- Rubber Softfall Area
- Concrete Area
- Astroturf Area
- Soft Landscaping area (Plants, Trees, Mulch etc)
- Timber Composite Deck

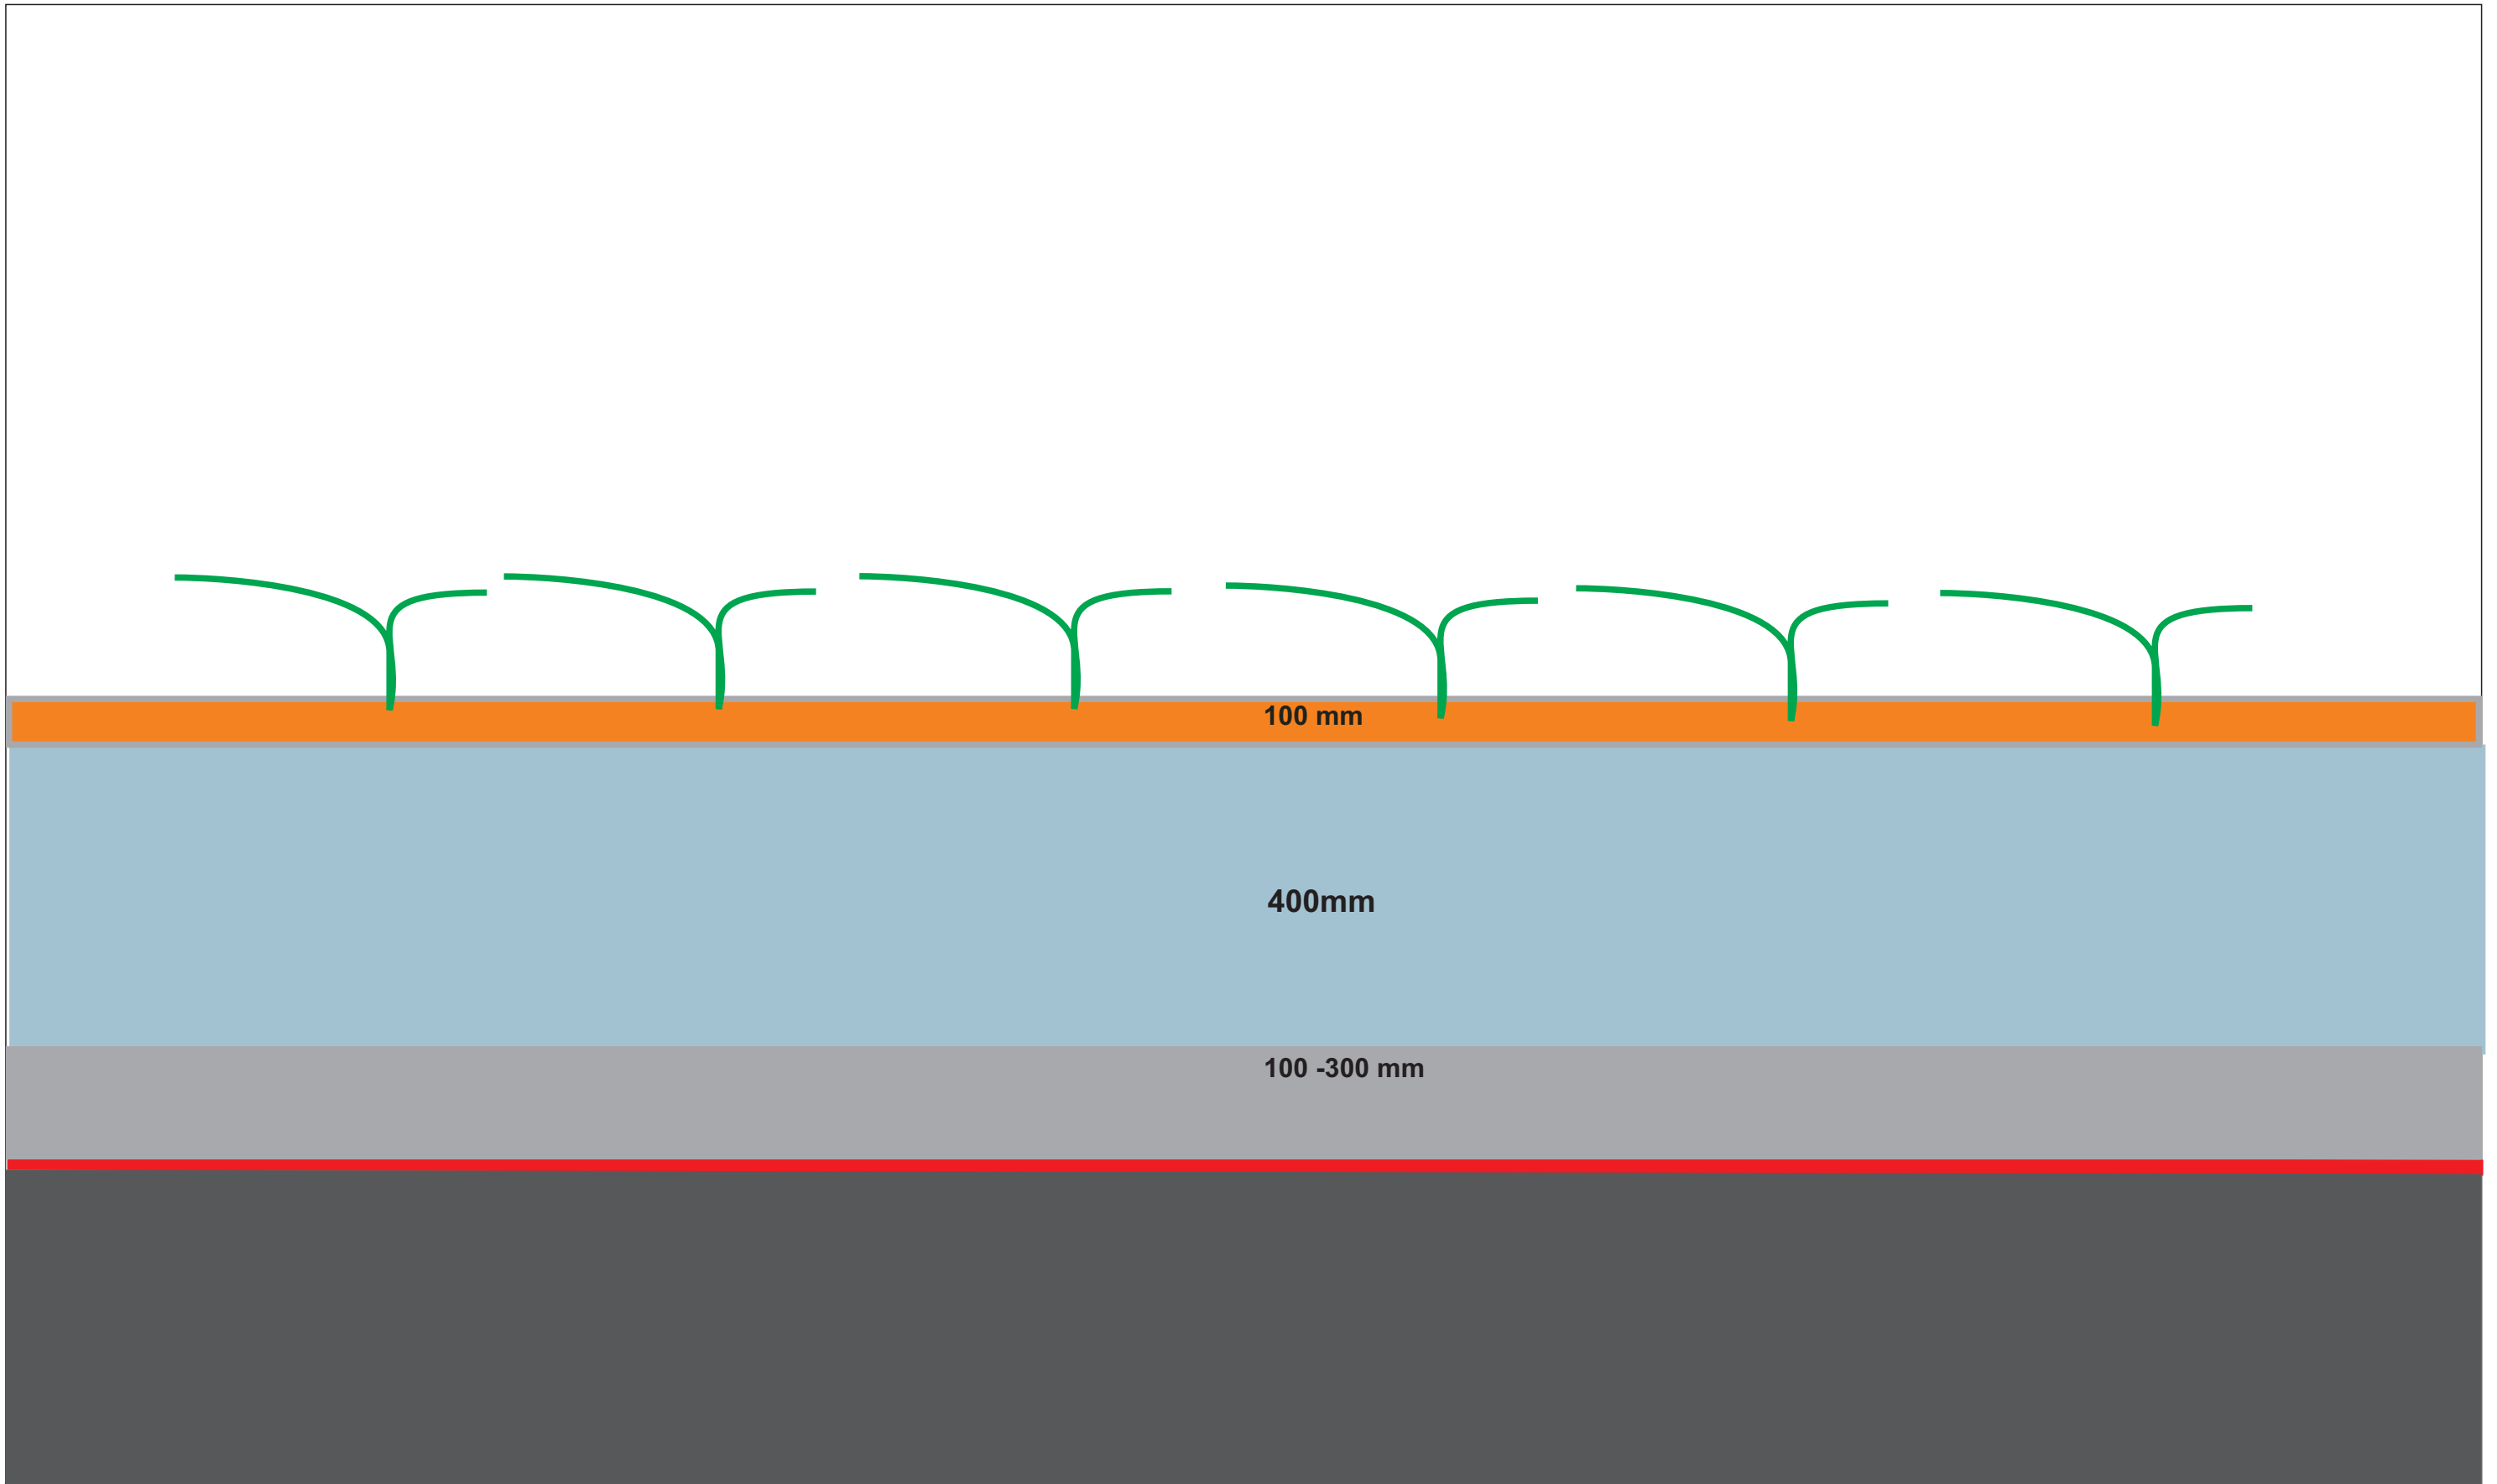
Legend: Road Base/Aggregates VENM Non-Woven Geofabric Marker Layer Contaminated Fill Mulch Plants			Client Name:		A.W. Edwards Pty Ltd	
			Client Number:		C107251	
	GF, North Building, 22 Giffnock Av Mcquarie Park, NSW 2113 Ph: 02-9889-1800 Fx: 02-9889-1811		Project Description:		Darlington PS LT-EMP	
	Address:		Darlington Public School - 417 Abercrombie Street, Darlington NSW 2000			
	Prepared:	TM	Reviewed:	AG	Date:	28/06/2023
Figure 9		Remediation Area - Garden Bed Area on the east side BB Court
