Site Audit Statement

Site audit statement no. SAS188

Address 417-445 Abercrombie Street Darlington NSW

Appendix B – Final Site Survey Plans

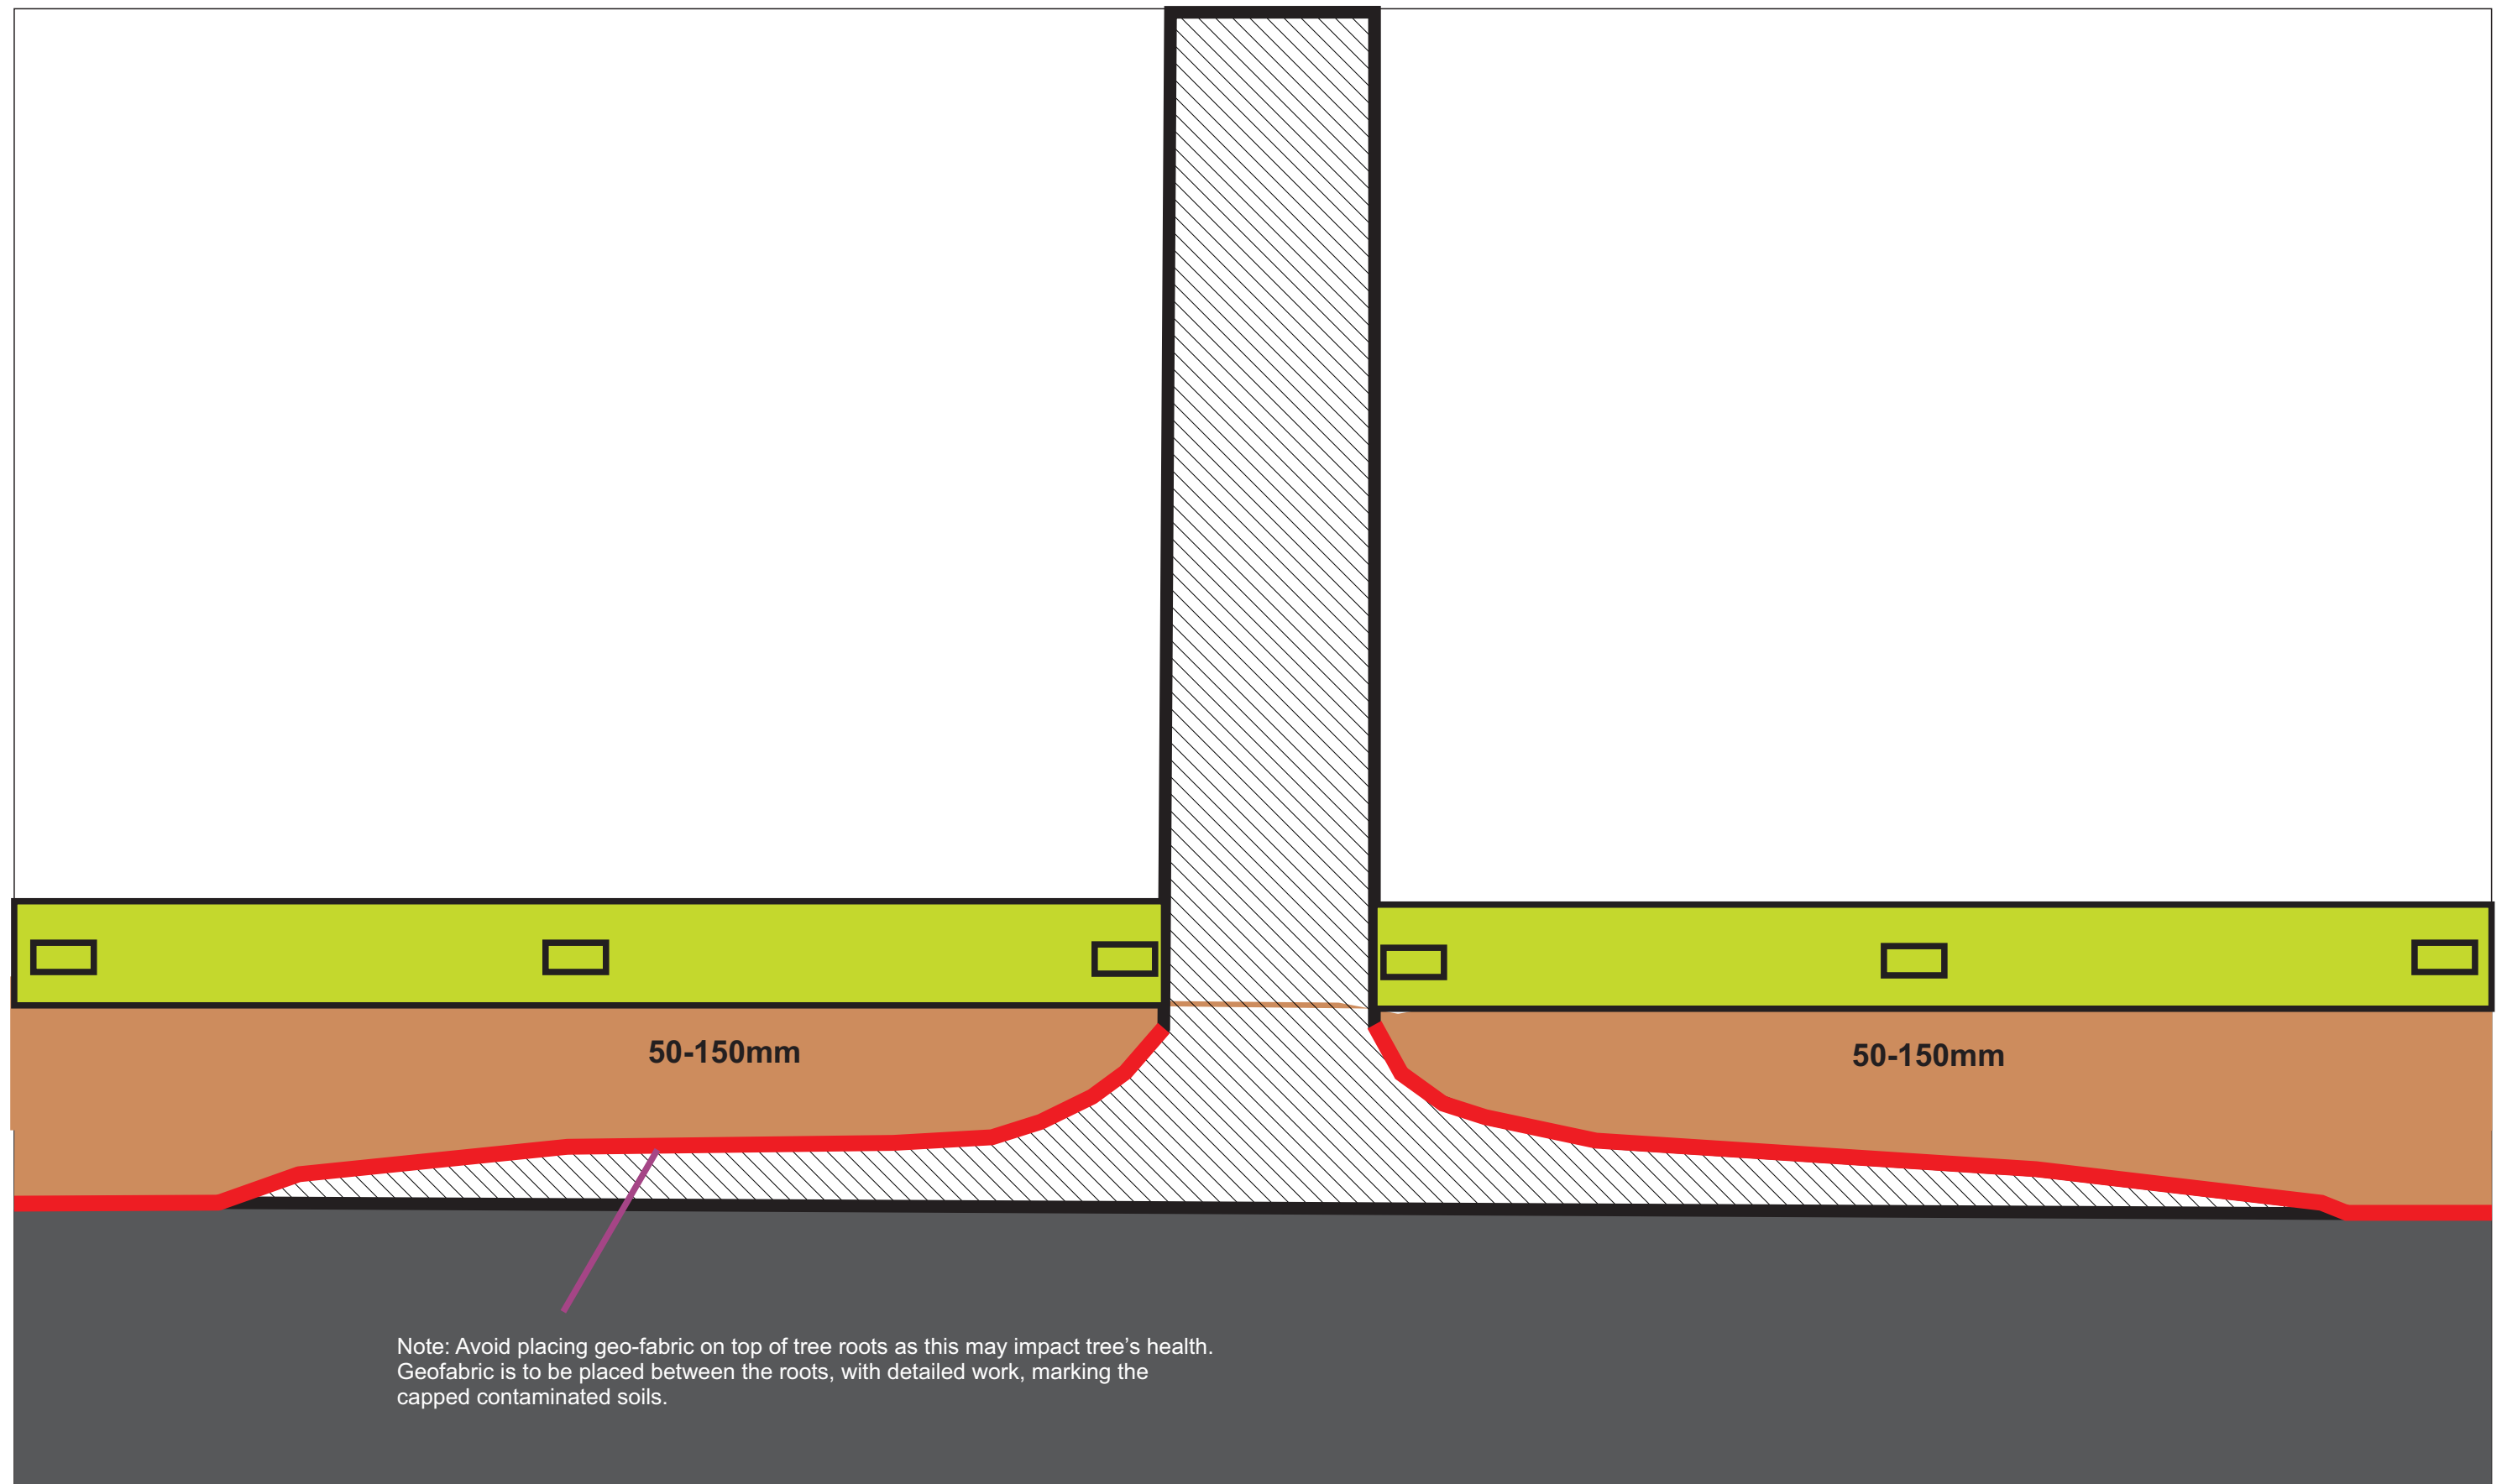
Note: Avoid placing geo-fabric on top of tree roots as this may impact tree's health. Geofabric is to be placed between the roots, with detailed work, marking the capped contaminated soils.

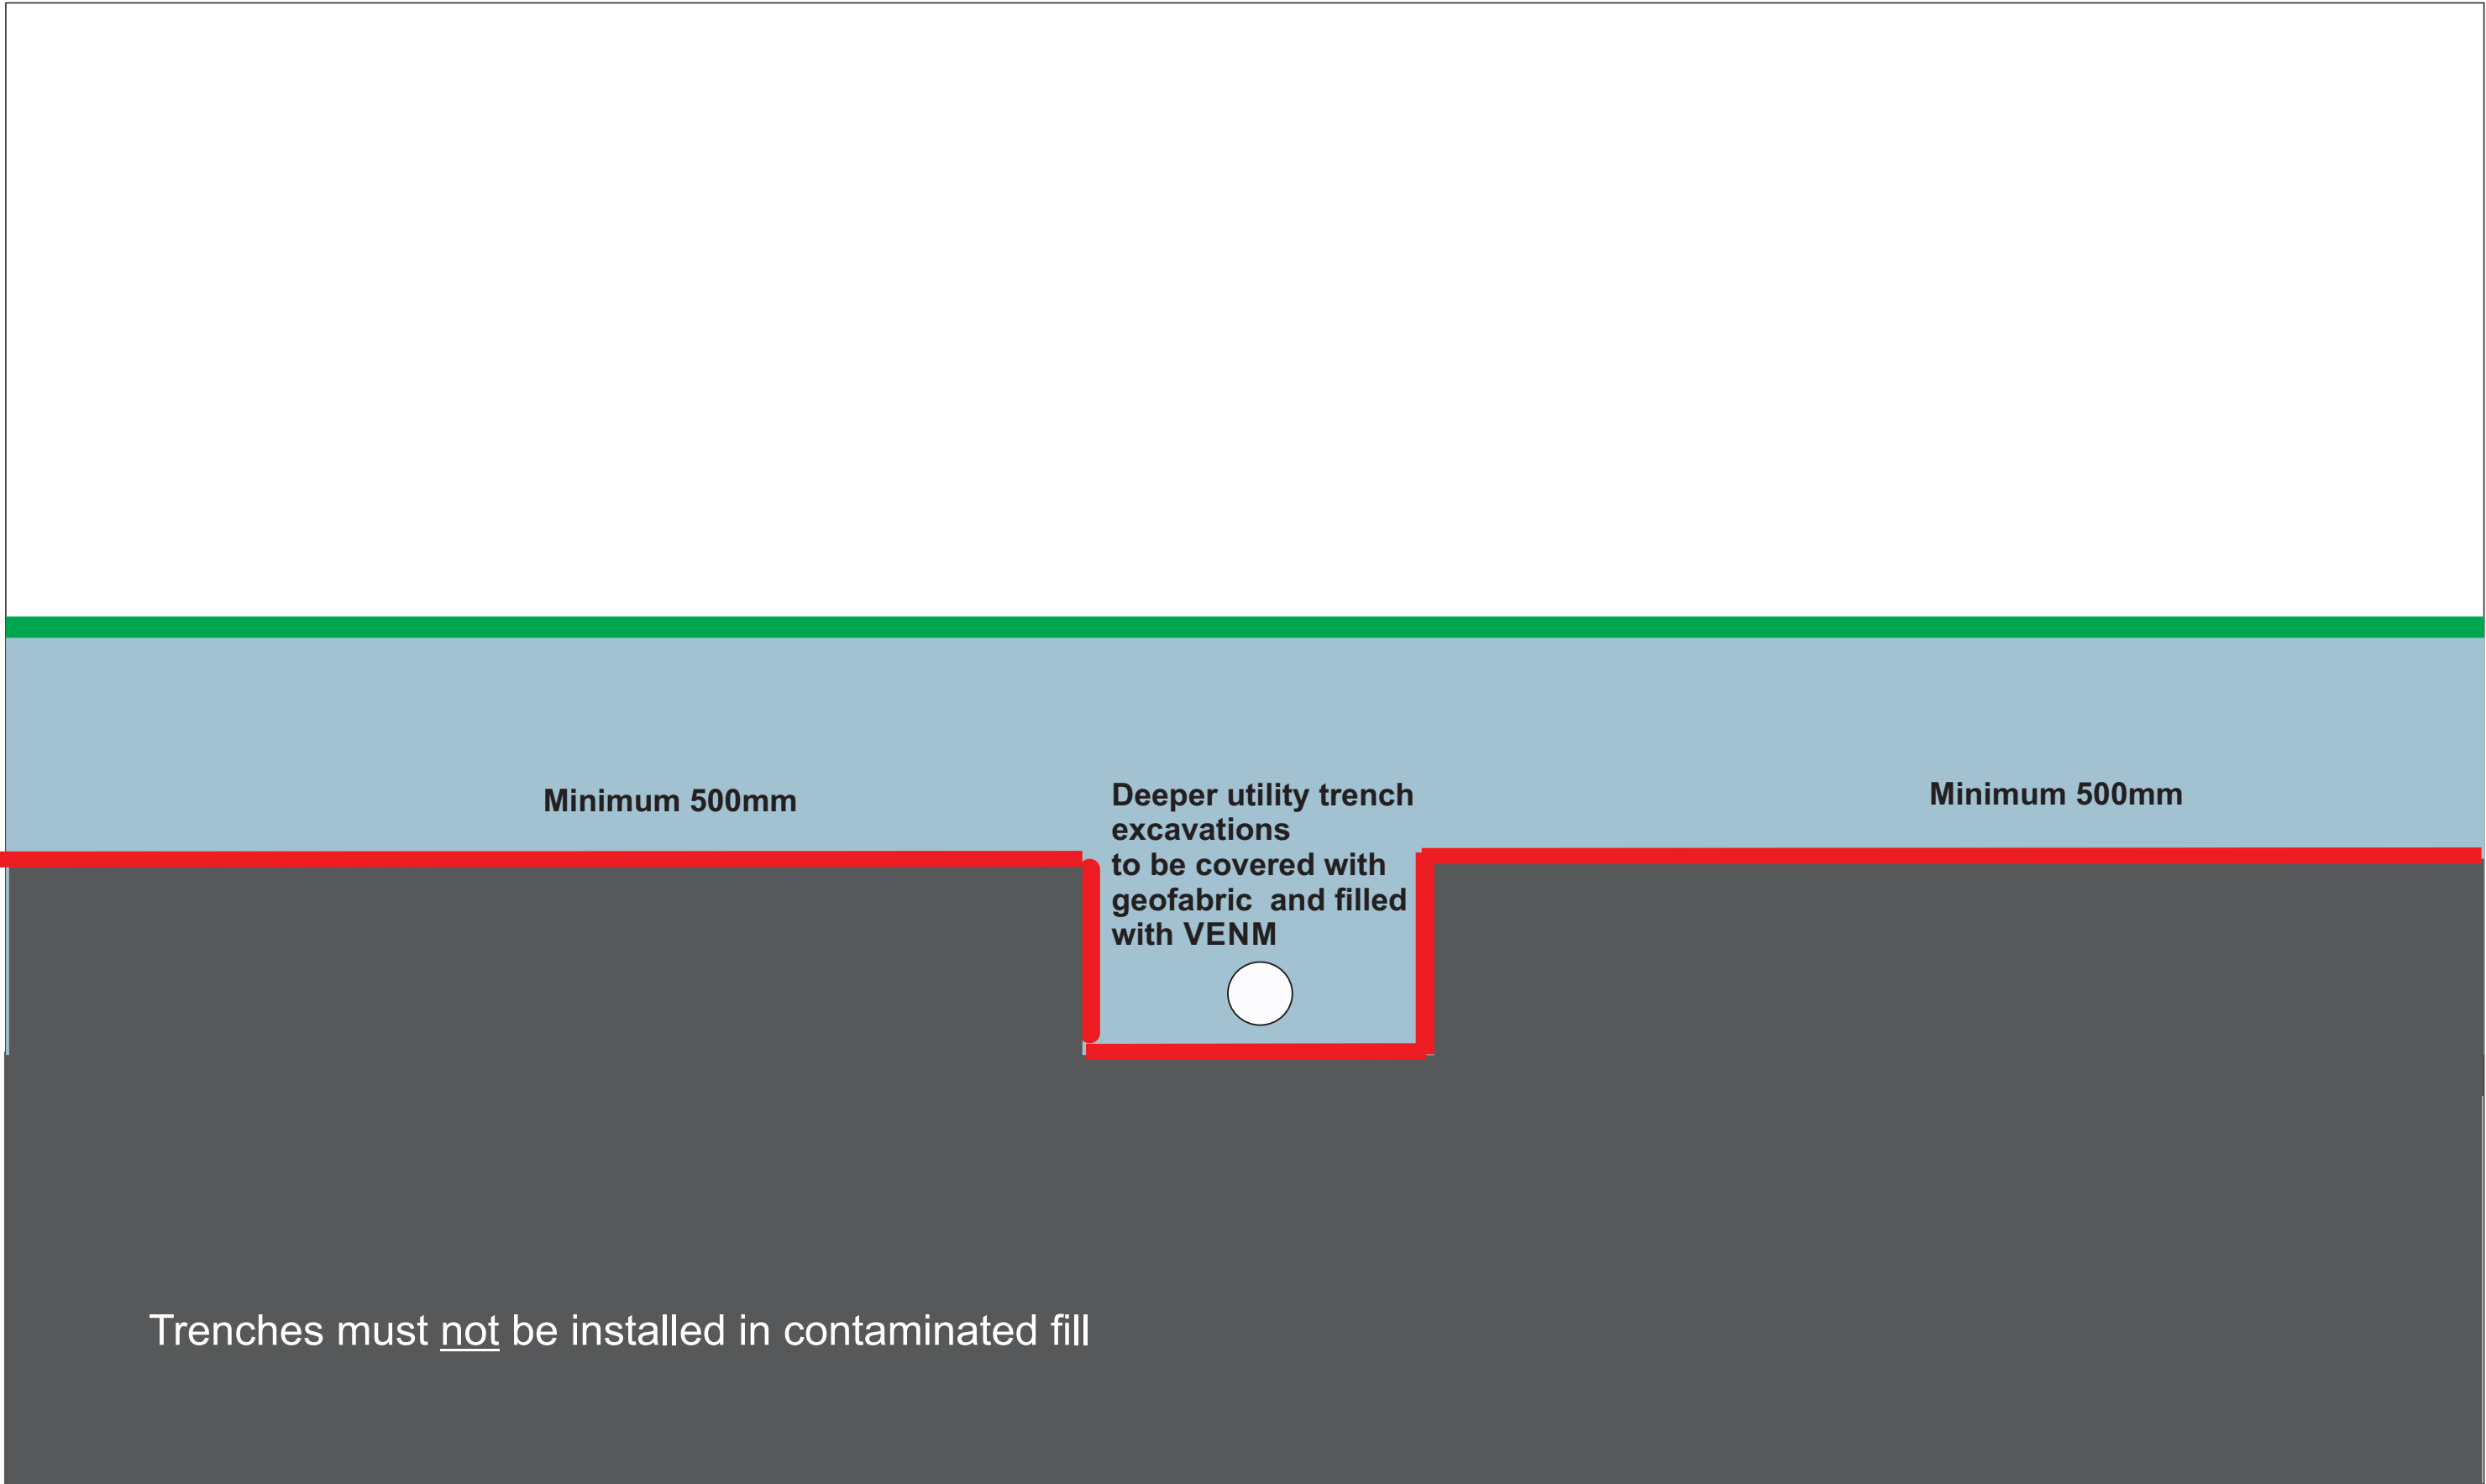
Minimum 500mm

Deeper utility trench excavations to be covered with geofabric and filled with VENM

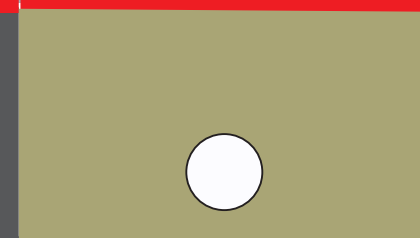
Minimum 300mm

Deeper utility trench excavations to be backfilled with onsite fill from cleaner areas

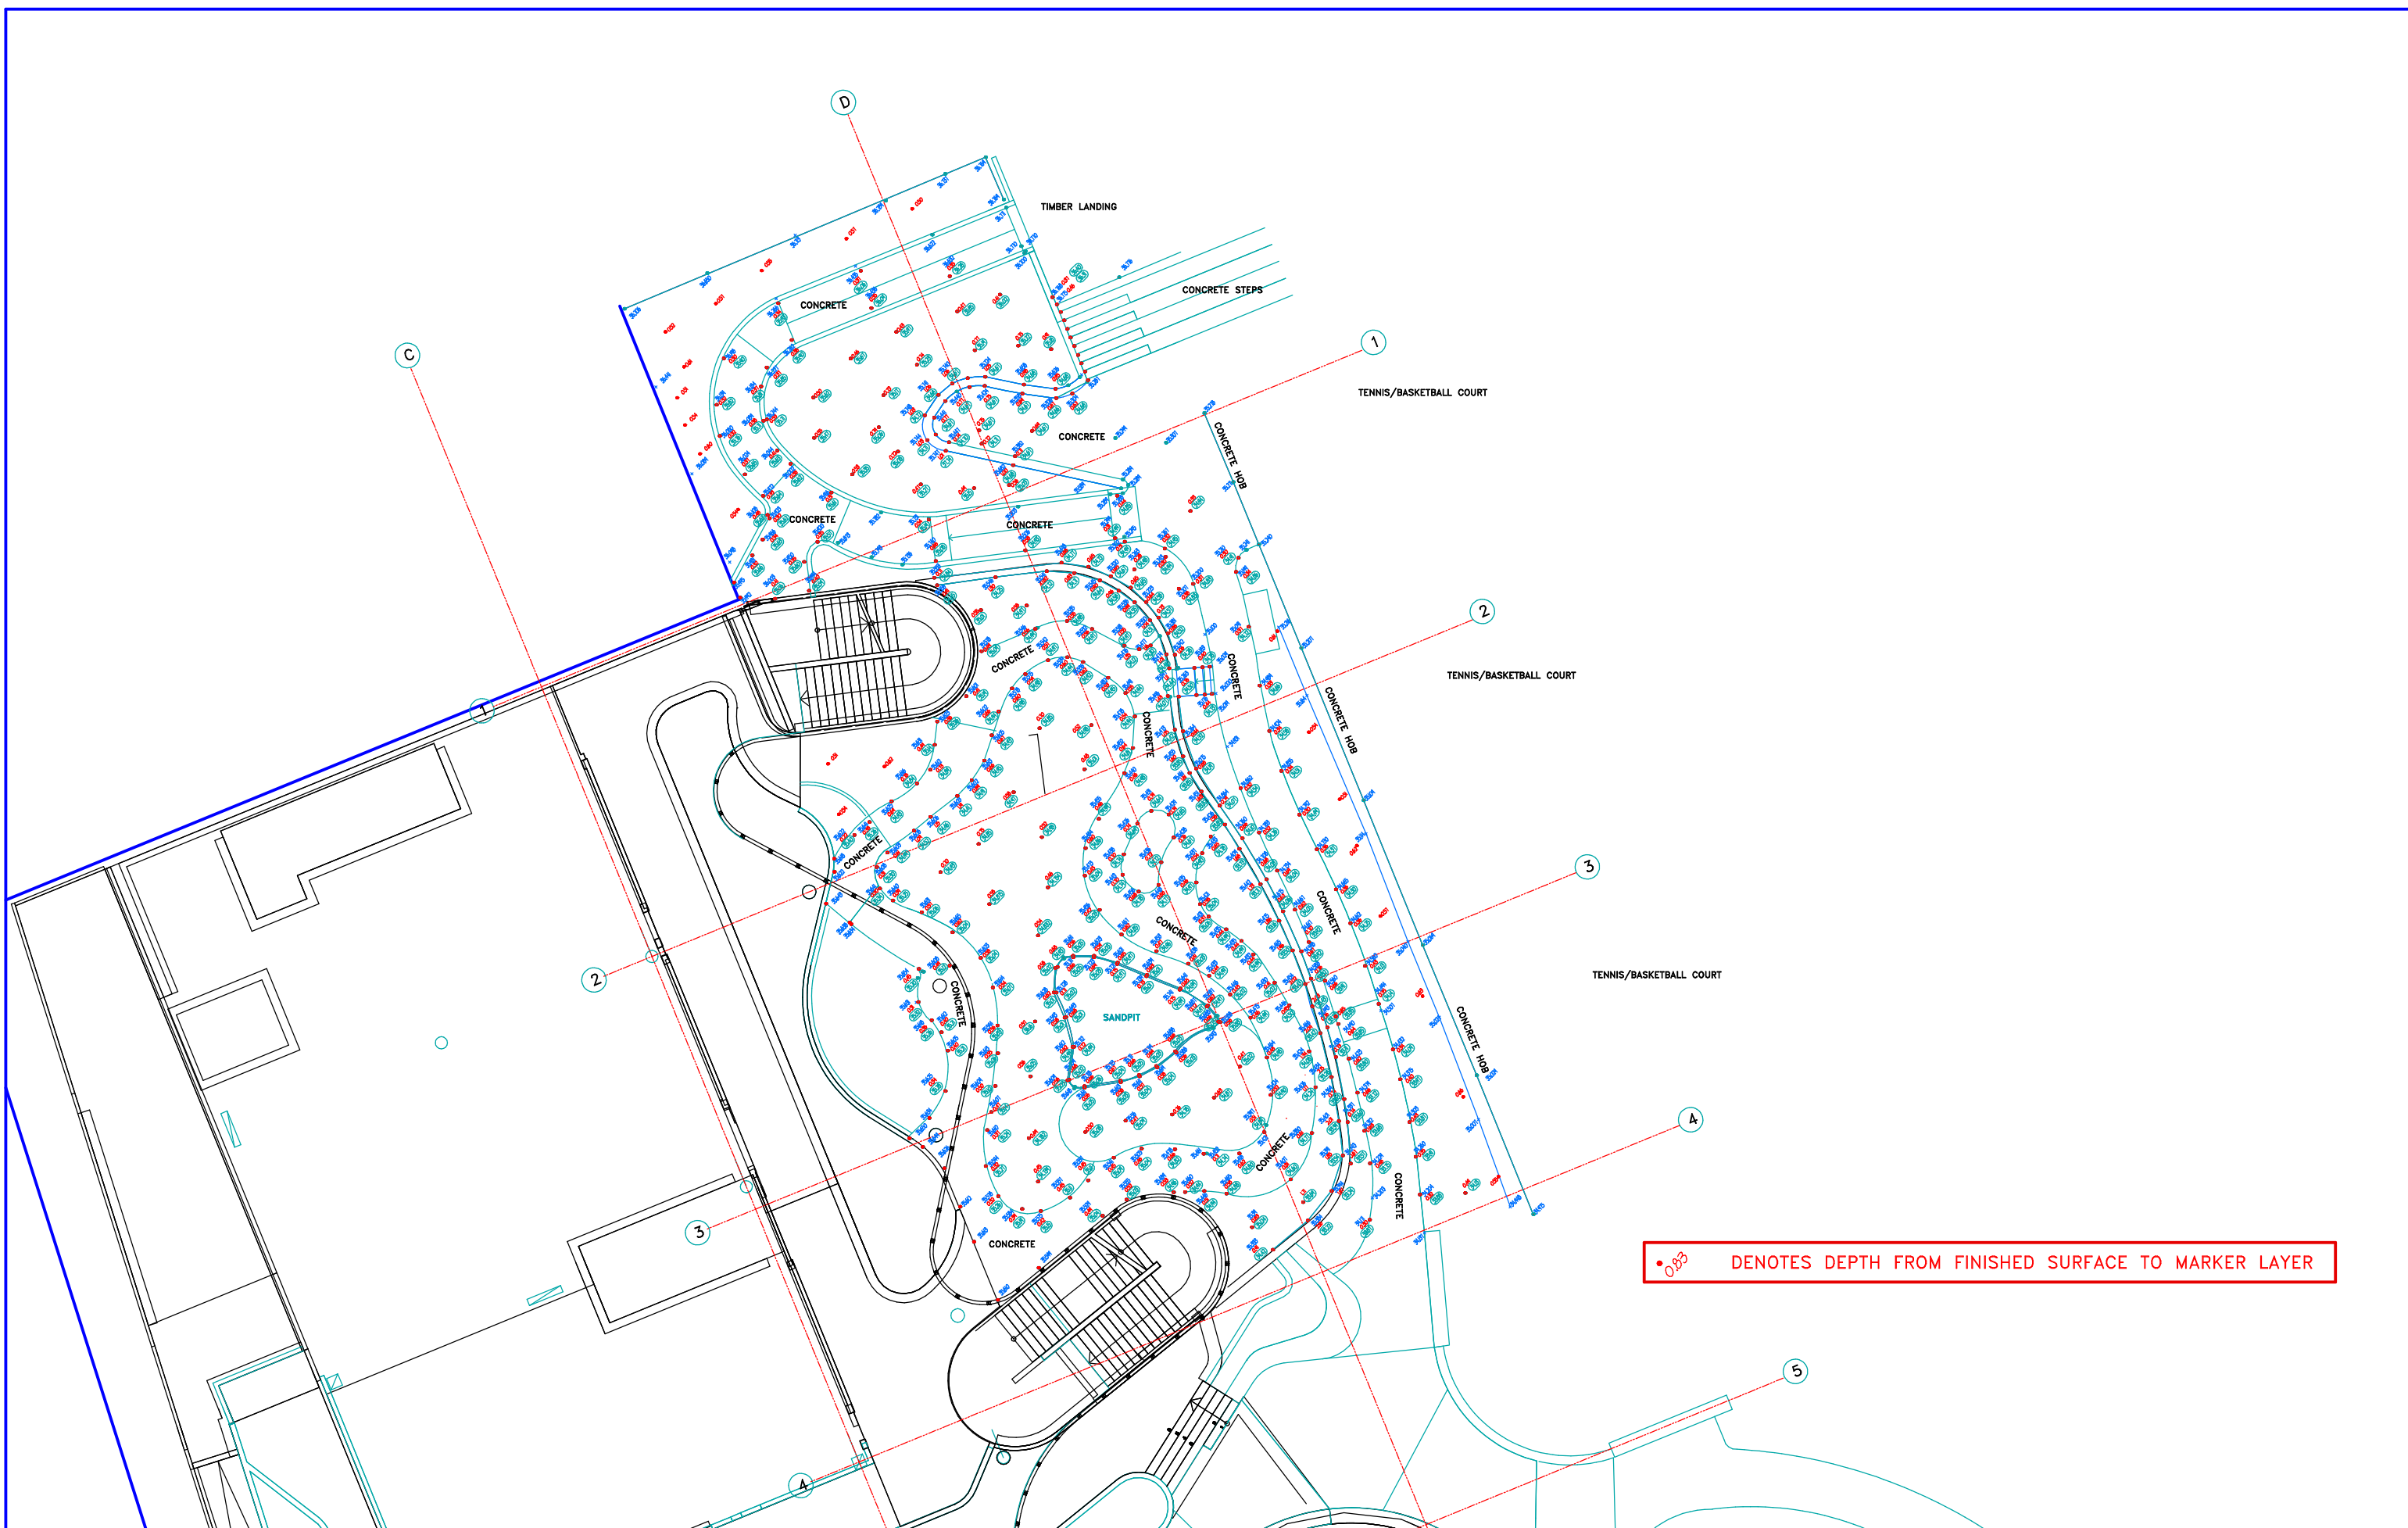
PLAN:
 PLAY AREA
 MARKER LAYER
 DEPTH FROM FINISHED SURFACE
SHEET 1 OF 3

• 0.03 DENOTES DEPTH FROM FINISHED SURFACE TO MARKER LAYER

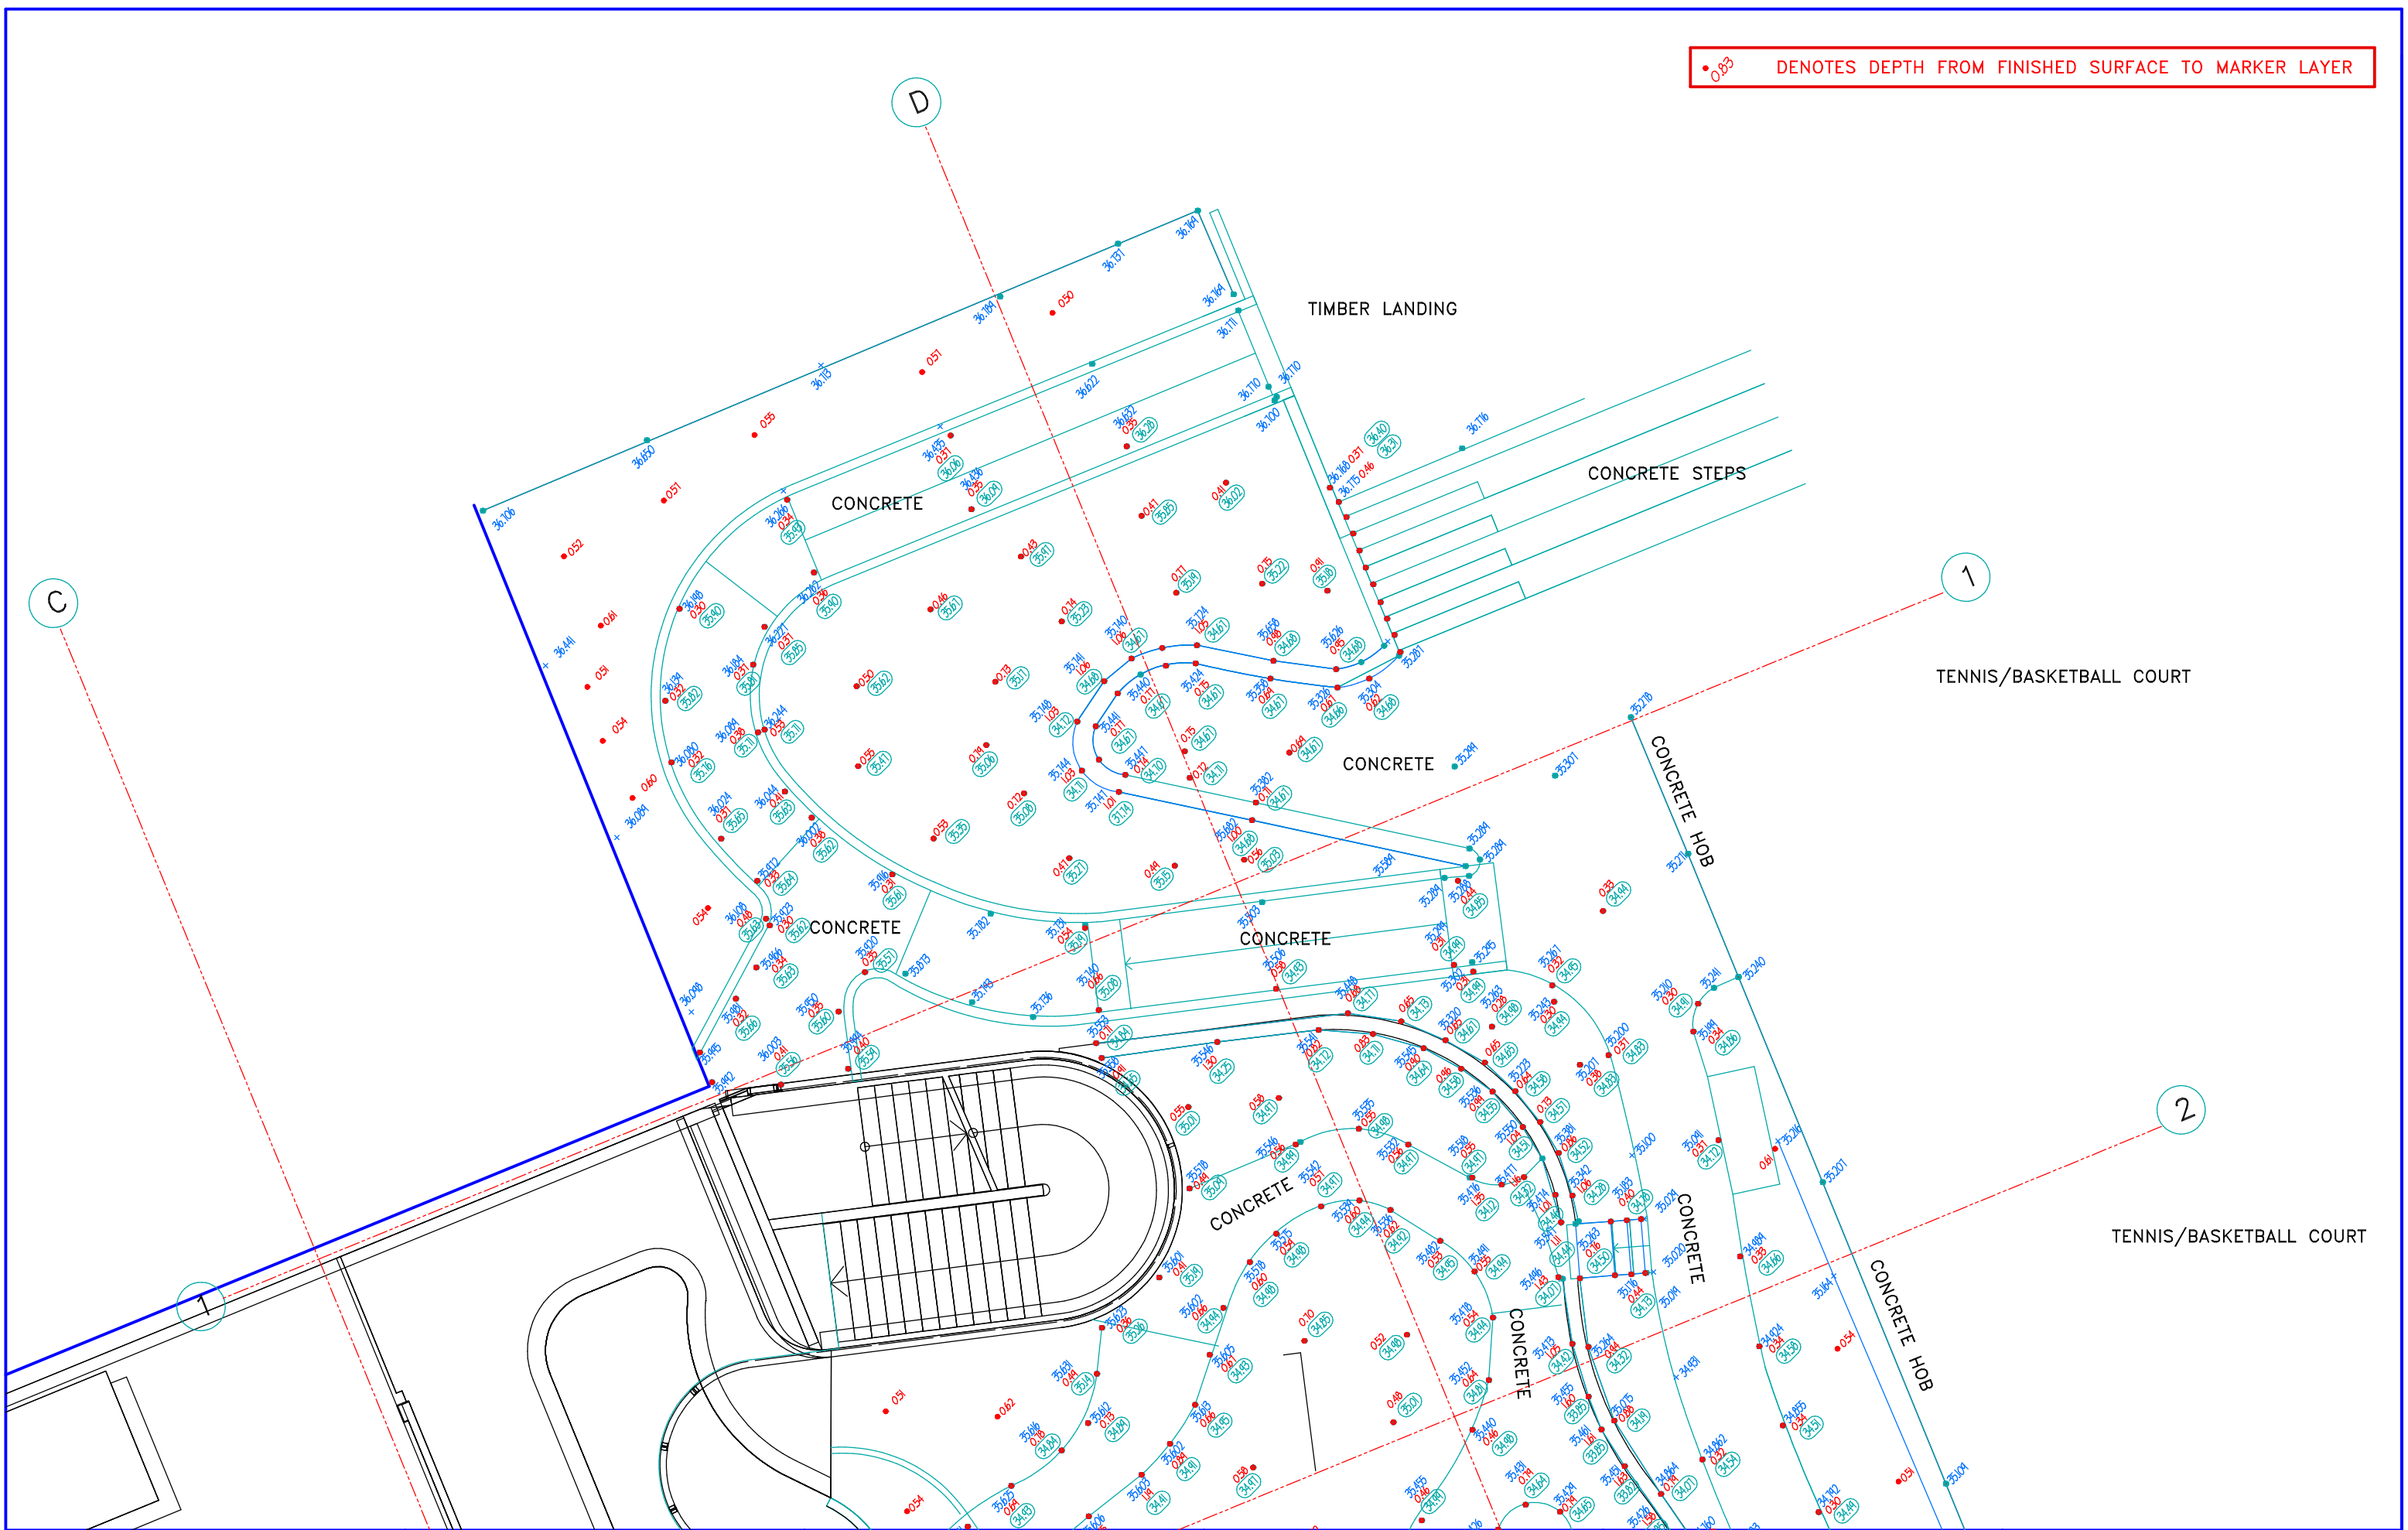
• 0.00 DENOTES DEPTH FROM FINISHED SURFACE TO MARKER LAYER

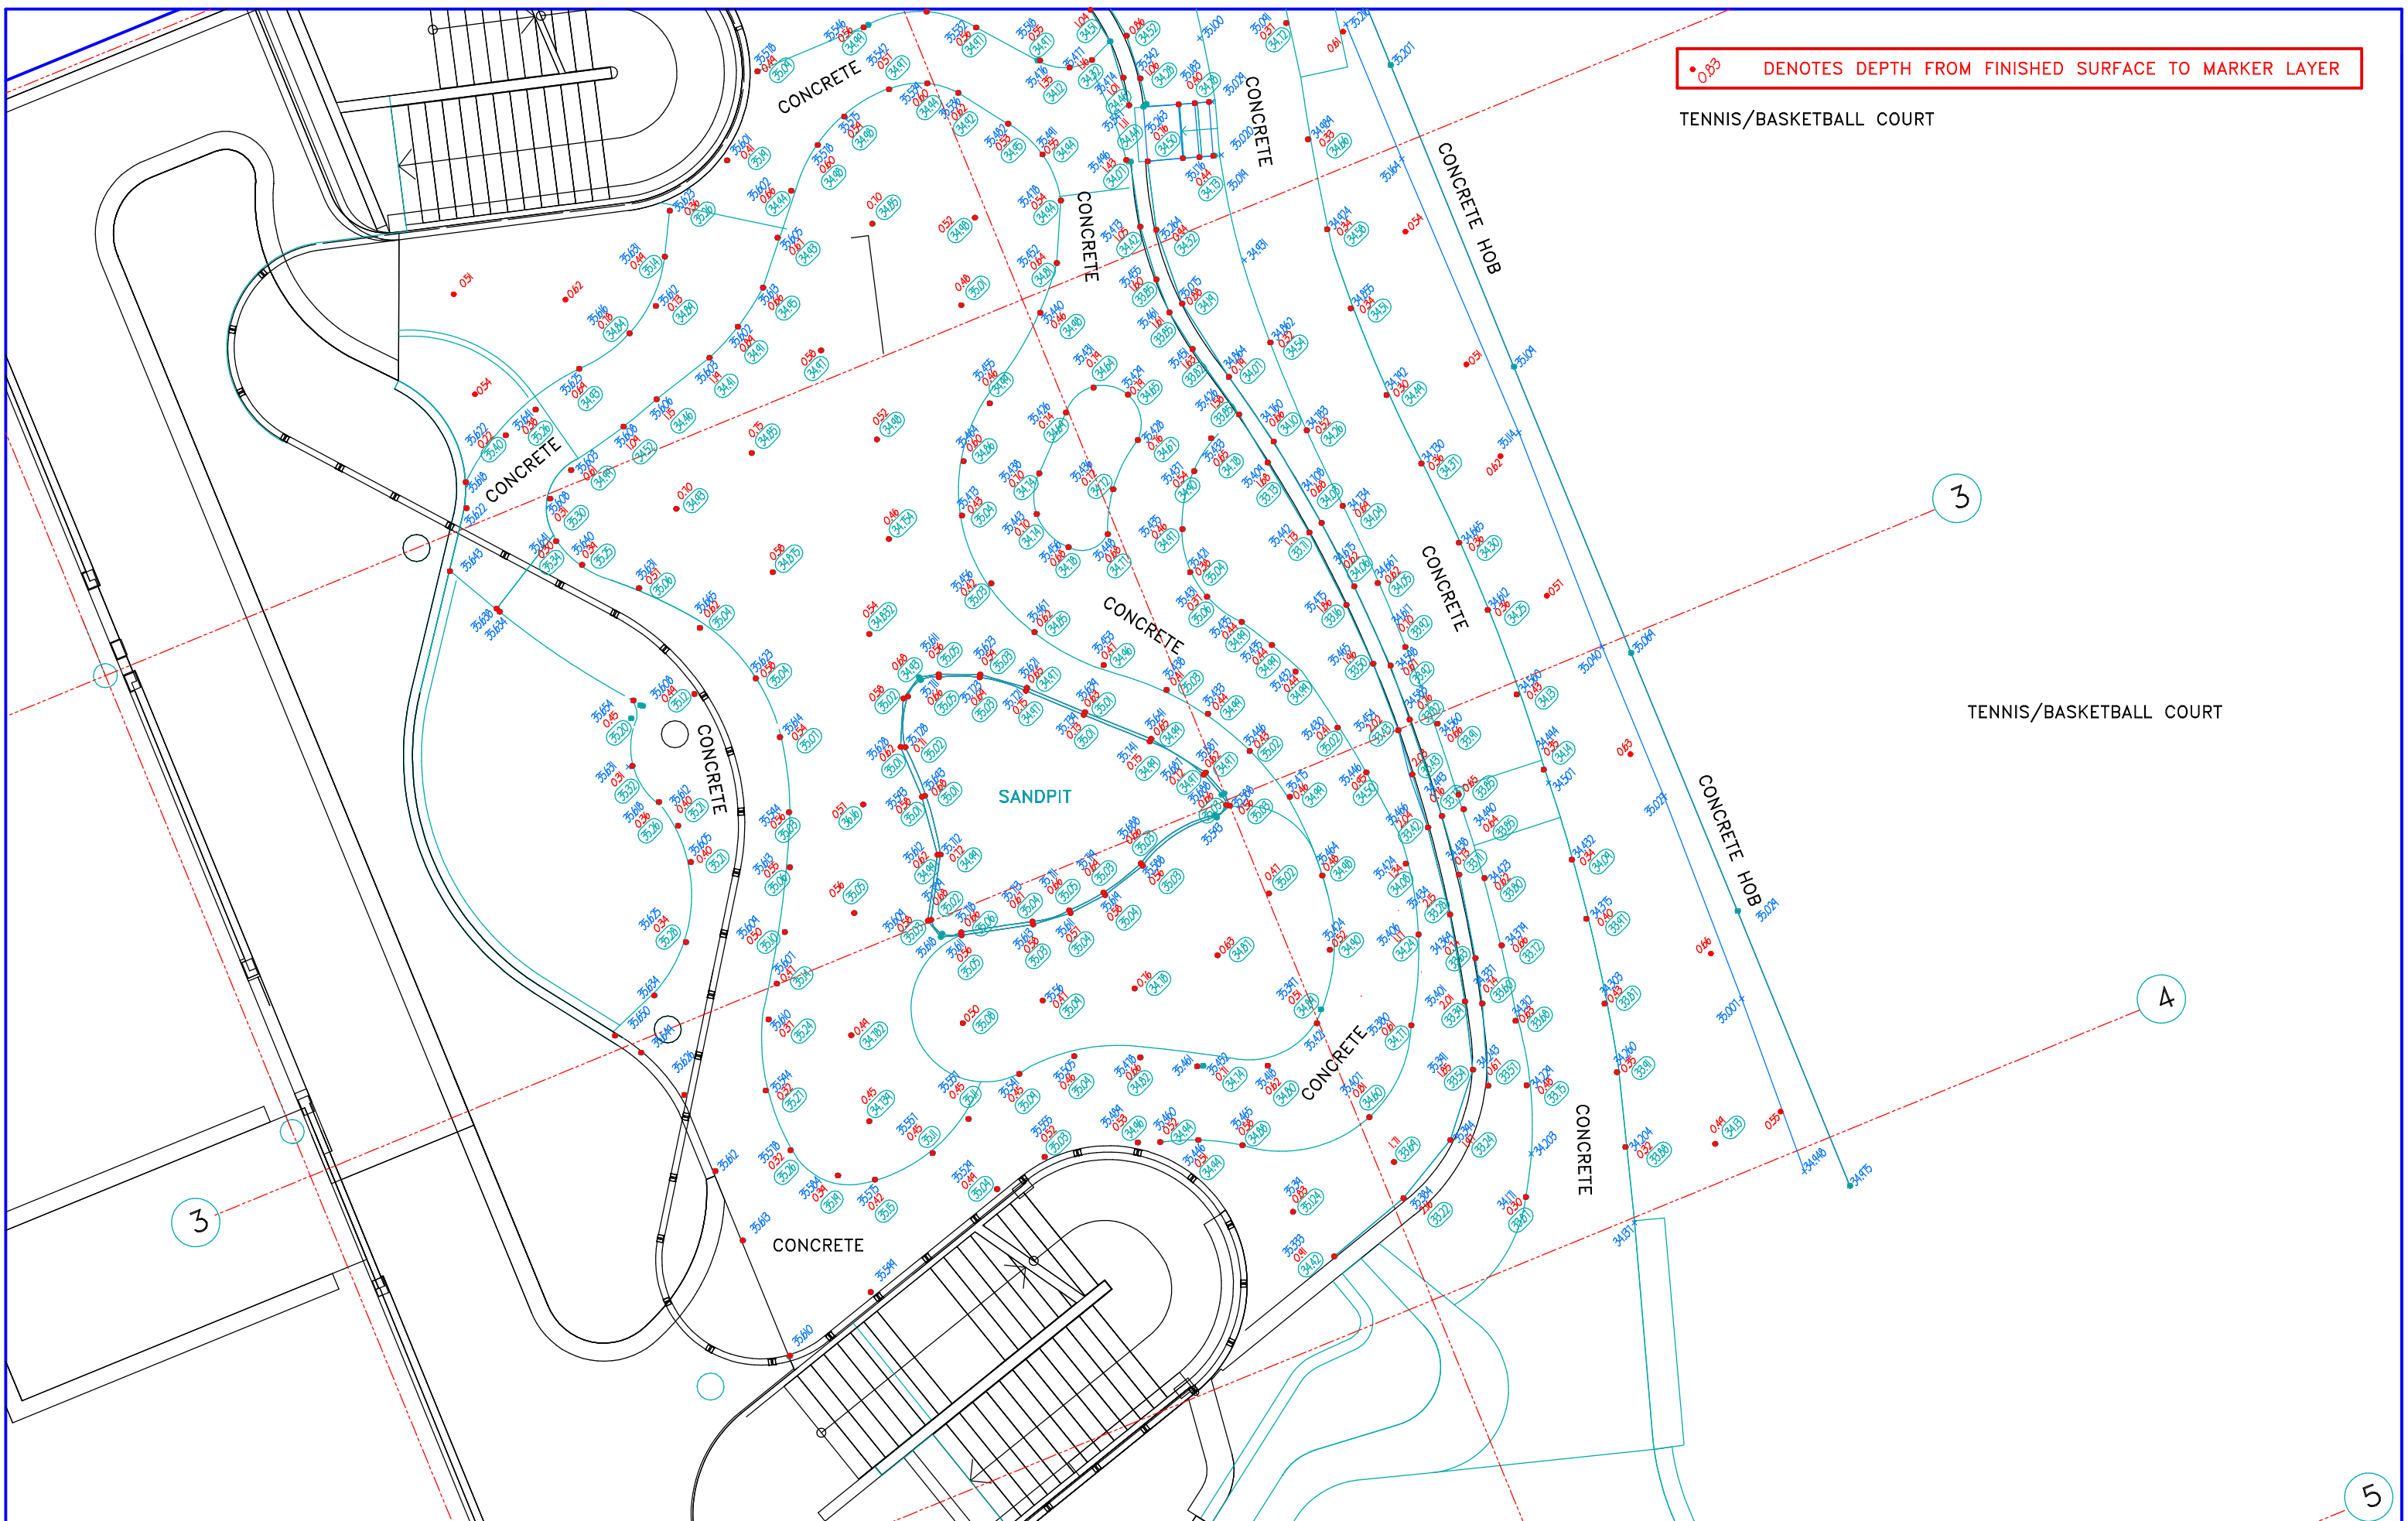
PLAN:
 PLAY AREA
 MARKER LAYER
 DEPTH FROM FINISHED SURFACE
SHEET 3 OF 3

• 0.00 DENOTES DEPTH FROM FINISHED SURFACE TO MARKER LAYER

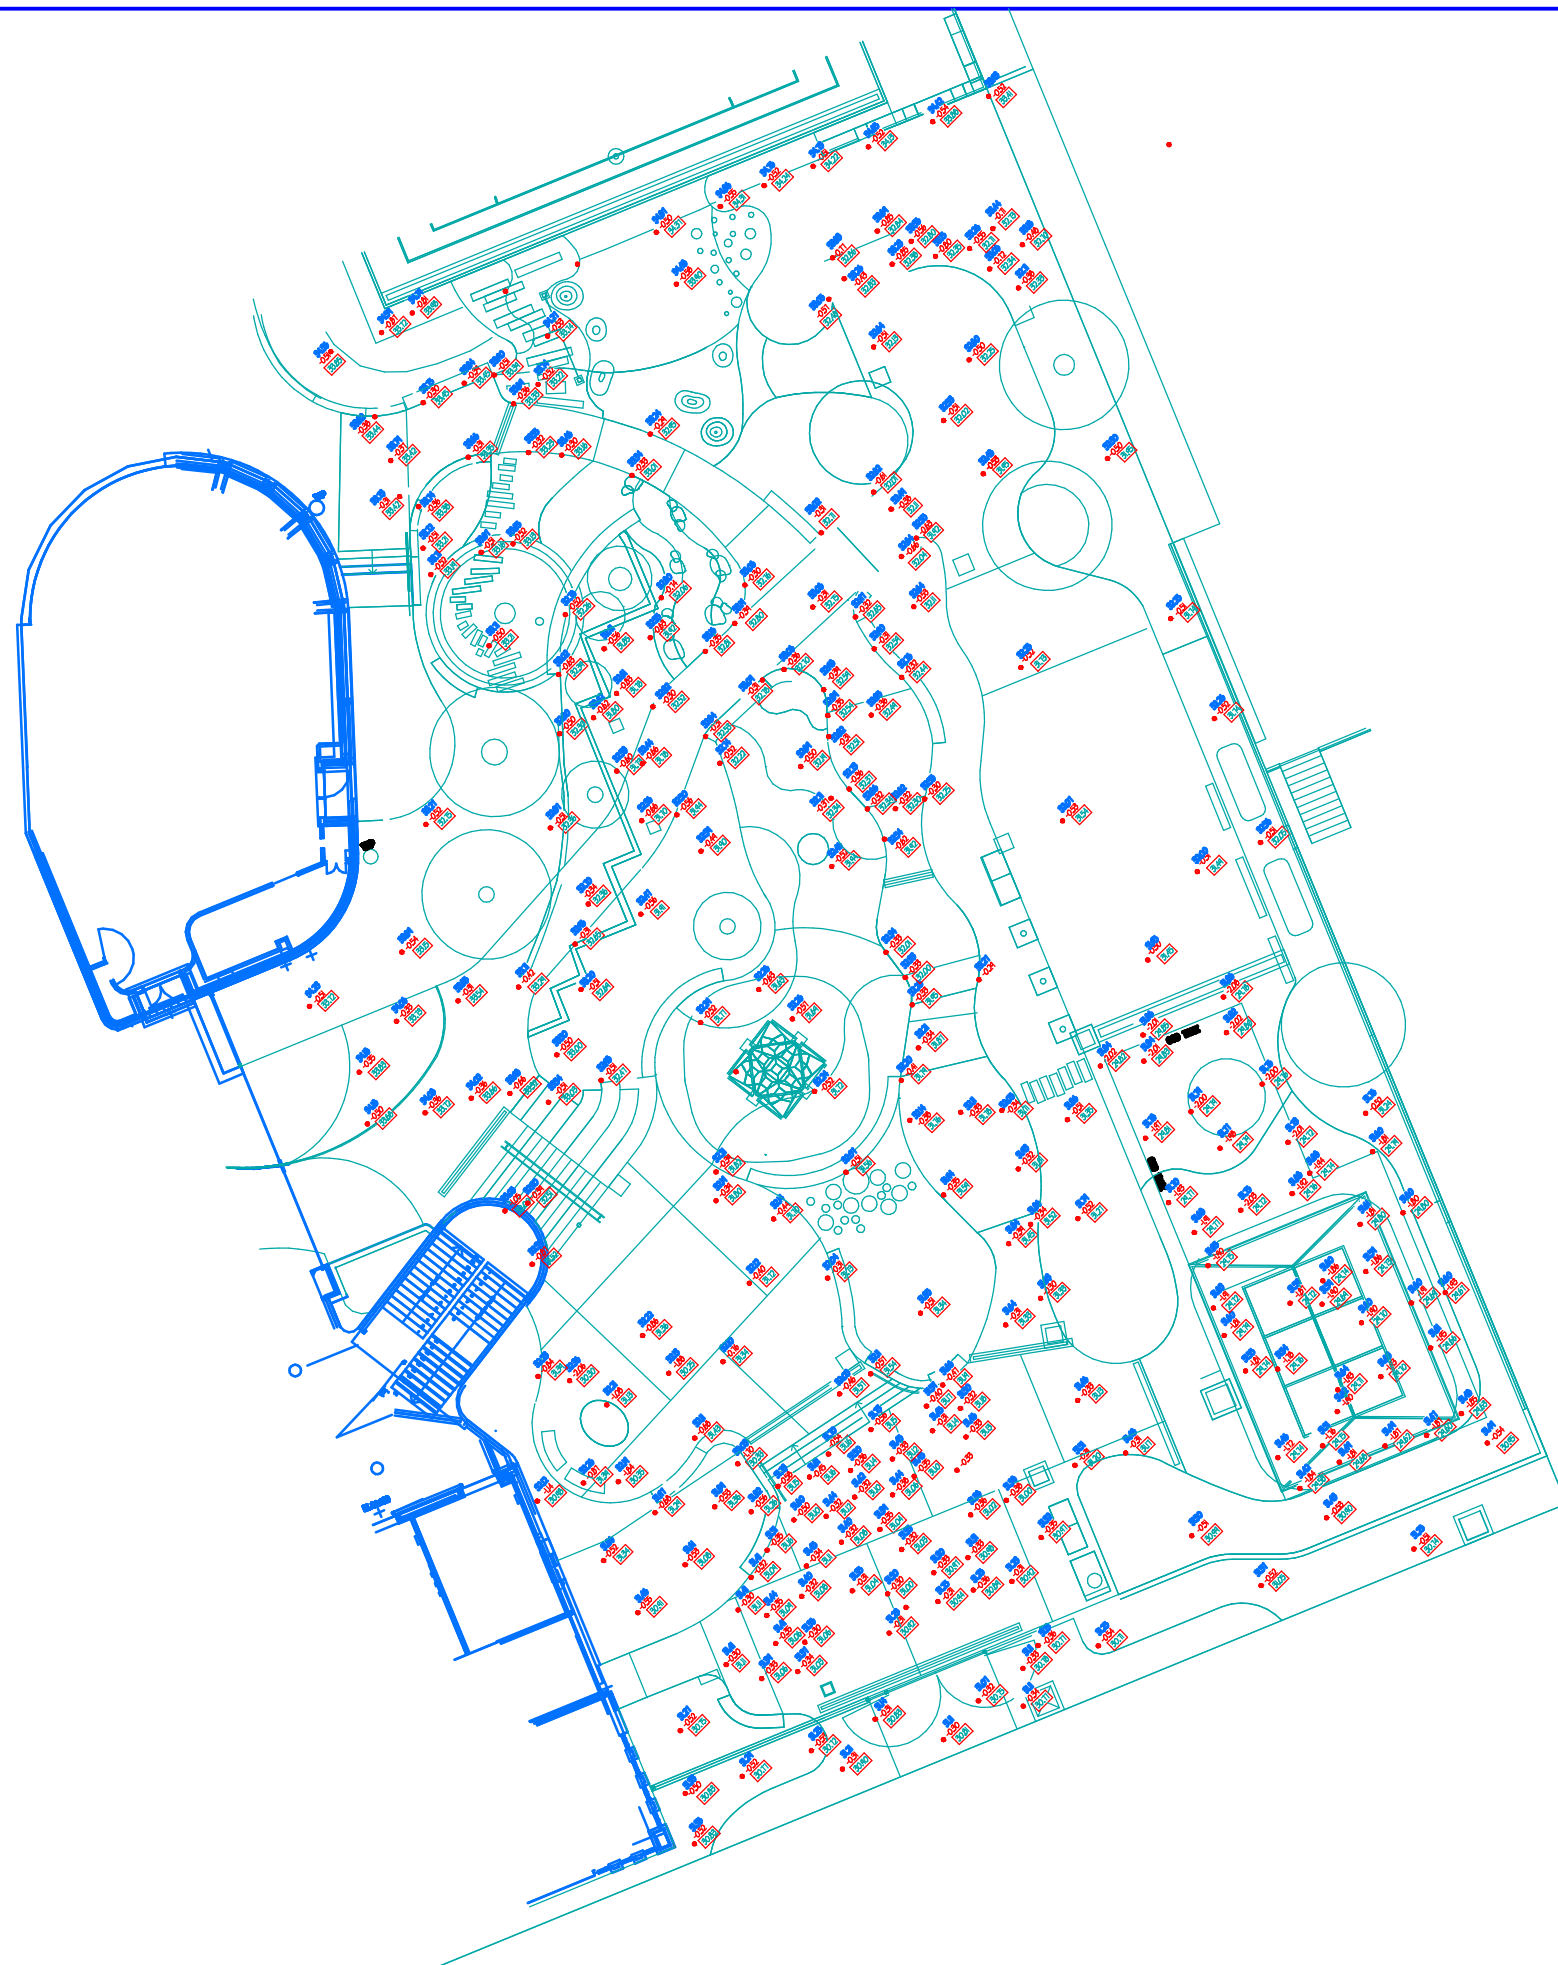
PLAN:
 MARKER LAYER DEPTH TO
 FINAL FINISHED SURFACE
 OVER LANDSCAPE AREAS
SHEET 1 OF 4

LEGEND
 33.93 : FINISHED SURFACE LEVEL
 -0.52 : DEPTH TO MARKER LAYER
 33.41 : RL MARKER LAYER
