Site Audit Statement

Site audit statement no. SAS188

Address 417-445 Abercrombie Street Darlington NSW

Appendix B – Final Site Survey Plans

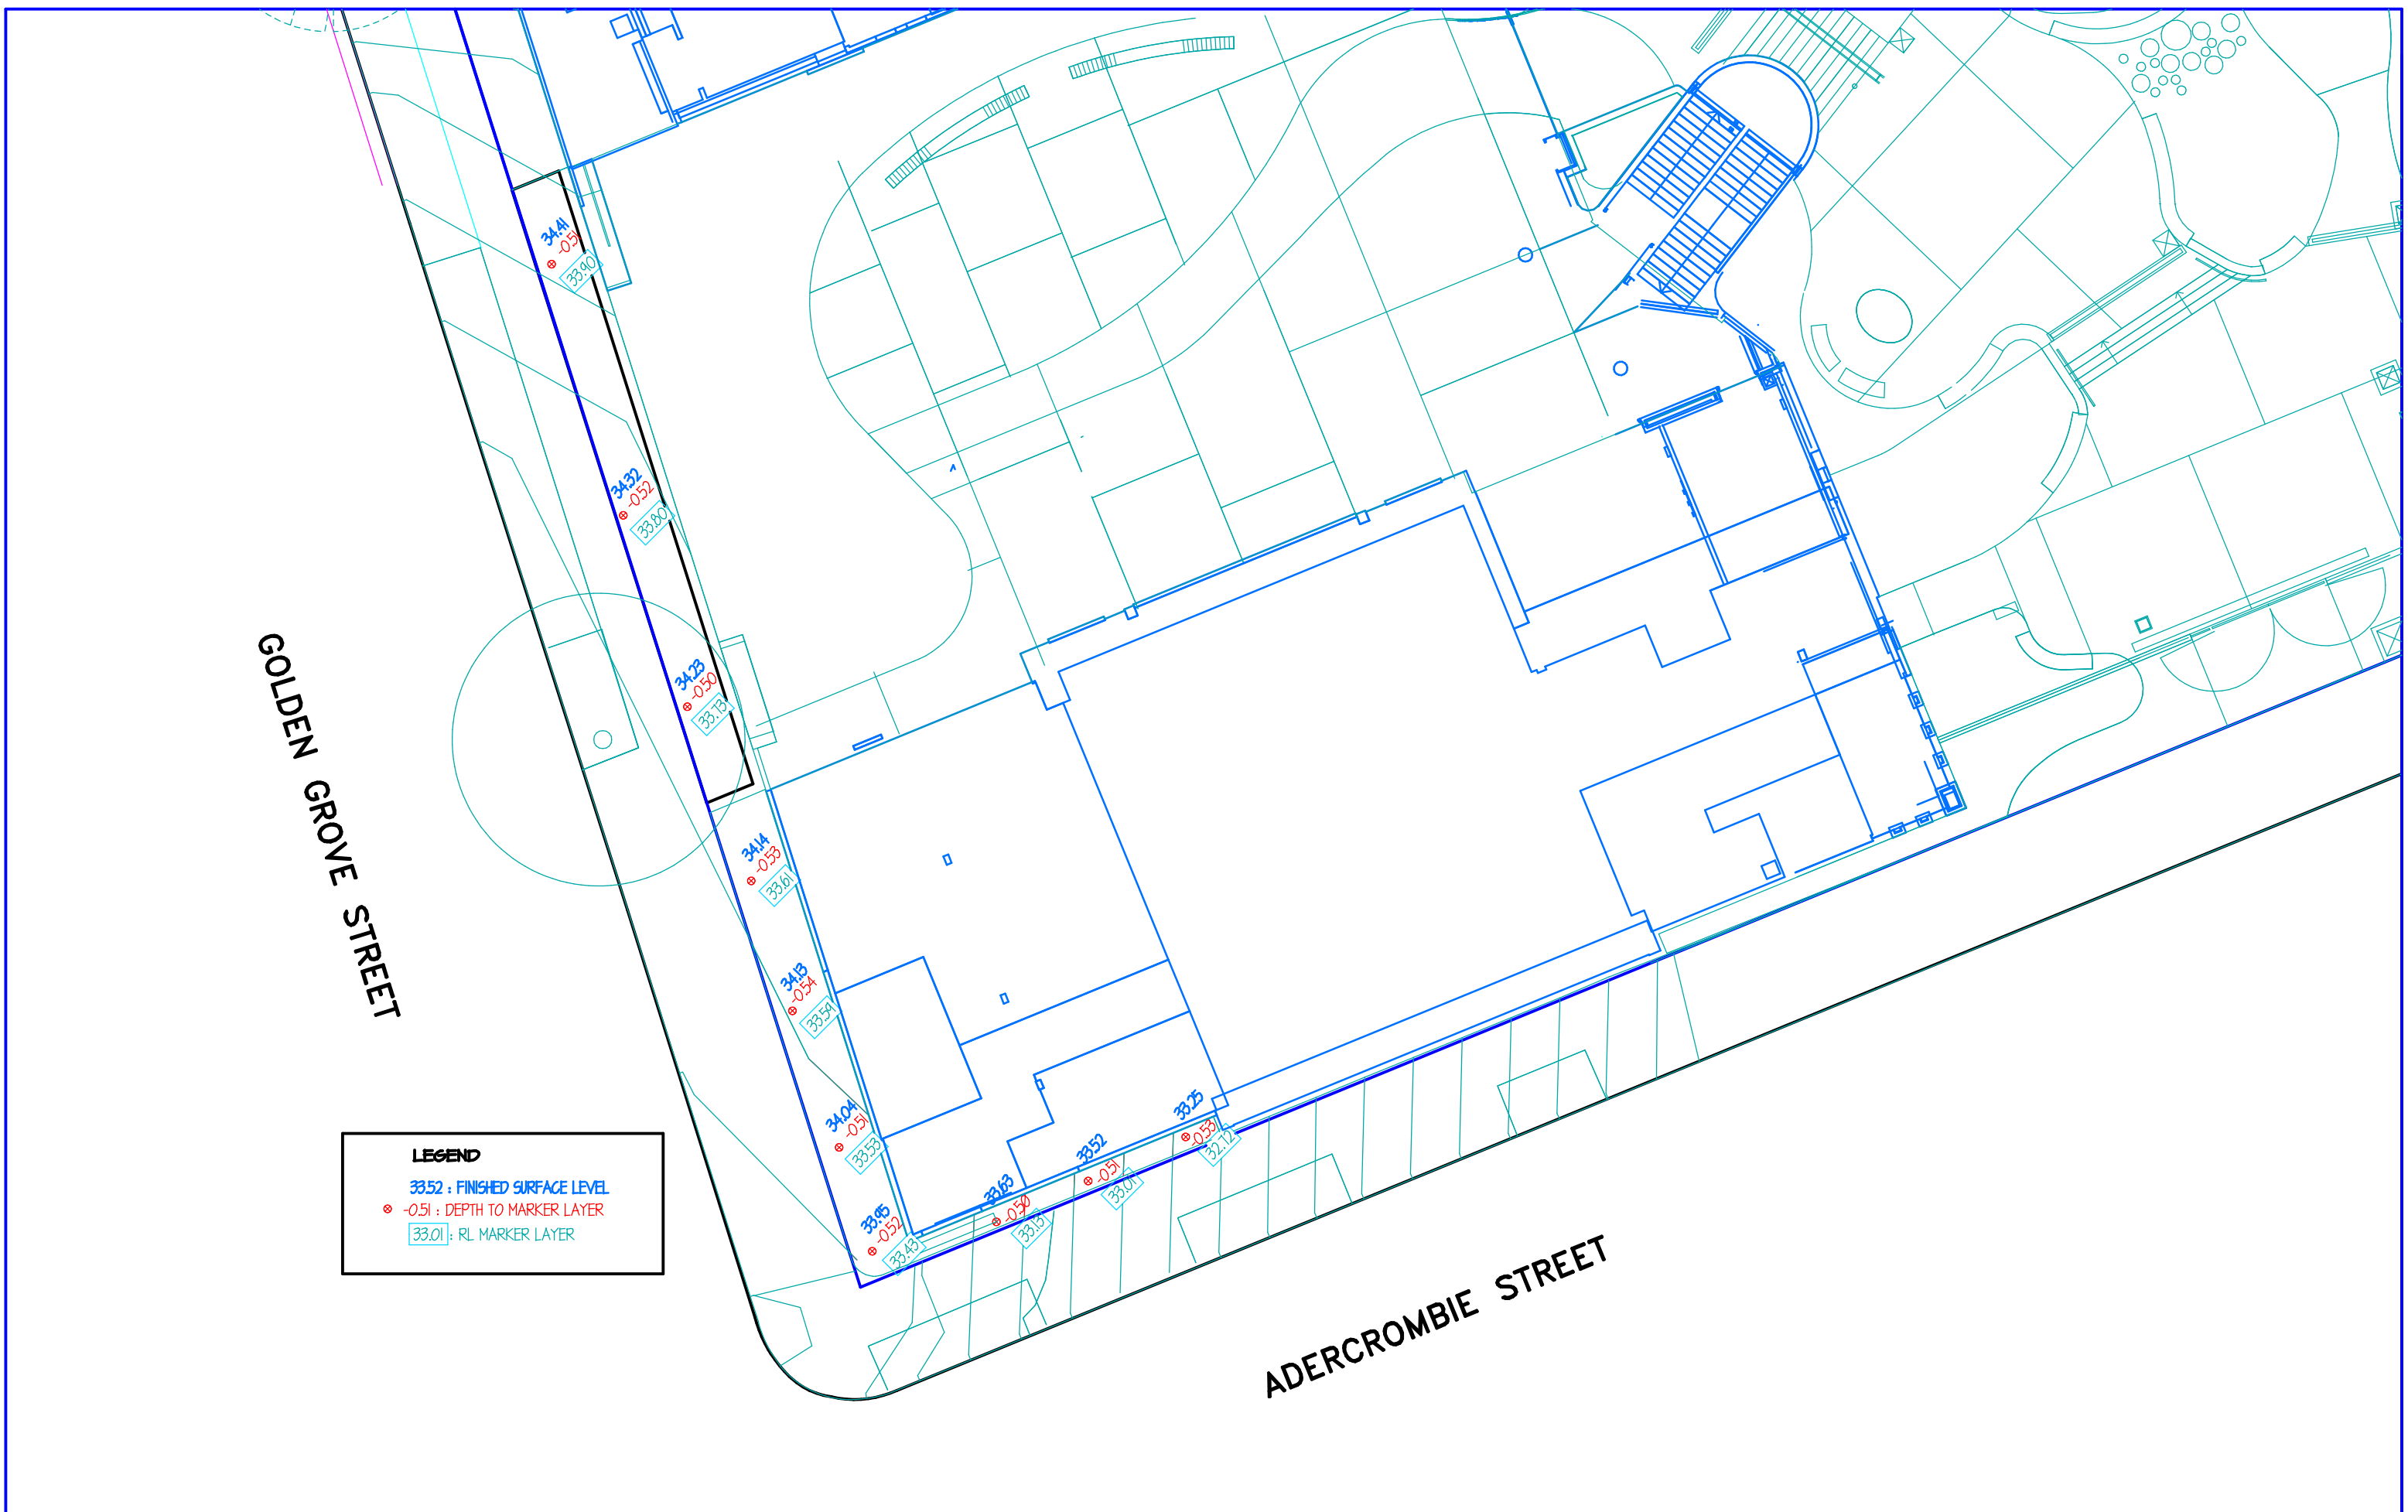
PLAN:
 MARKER LAYER DEPTH TO
 FINAL FINISHED SURFACE
 OVER LANDSCAPE AREAS

LEGEND
 33.52 : FINISHED SURFACE LEVEL
 -0.51 : DEPTH TO MARKER LAYER
 33.01 : RL MARKER LAYER

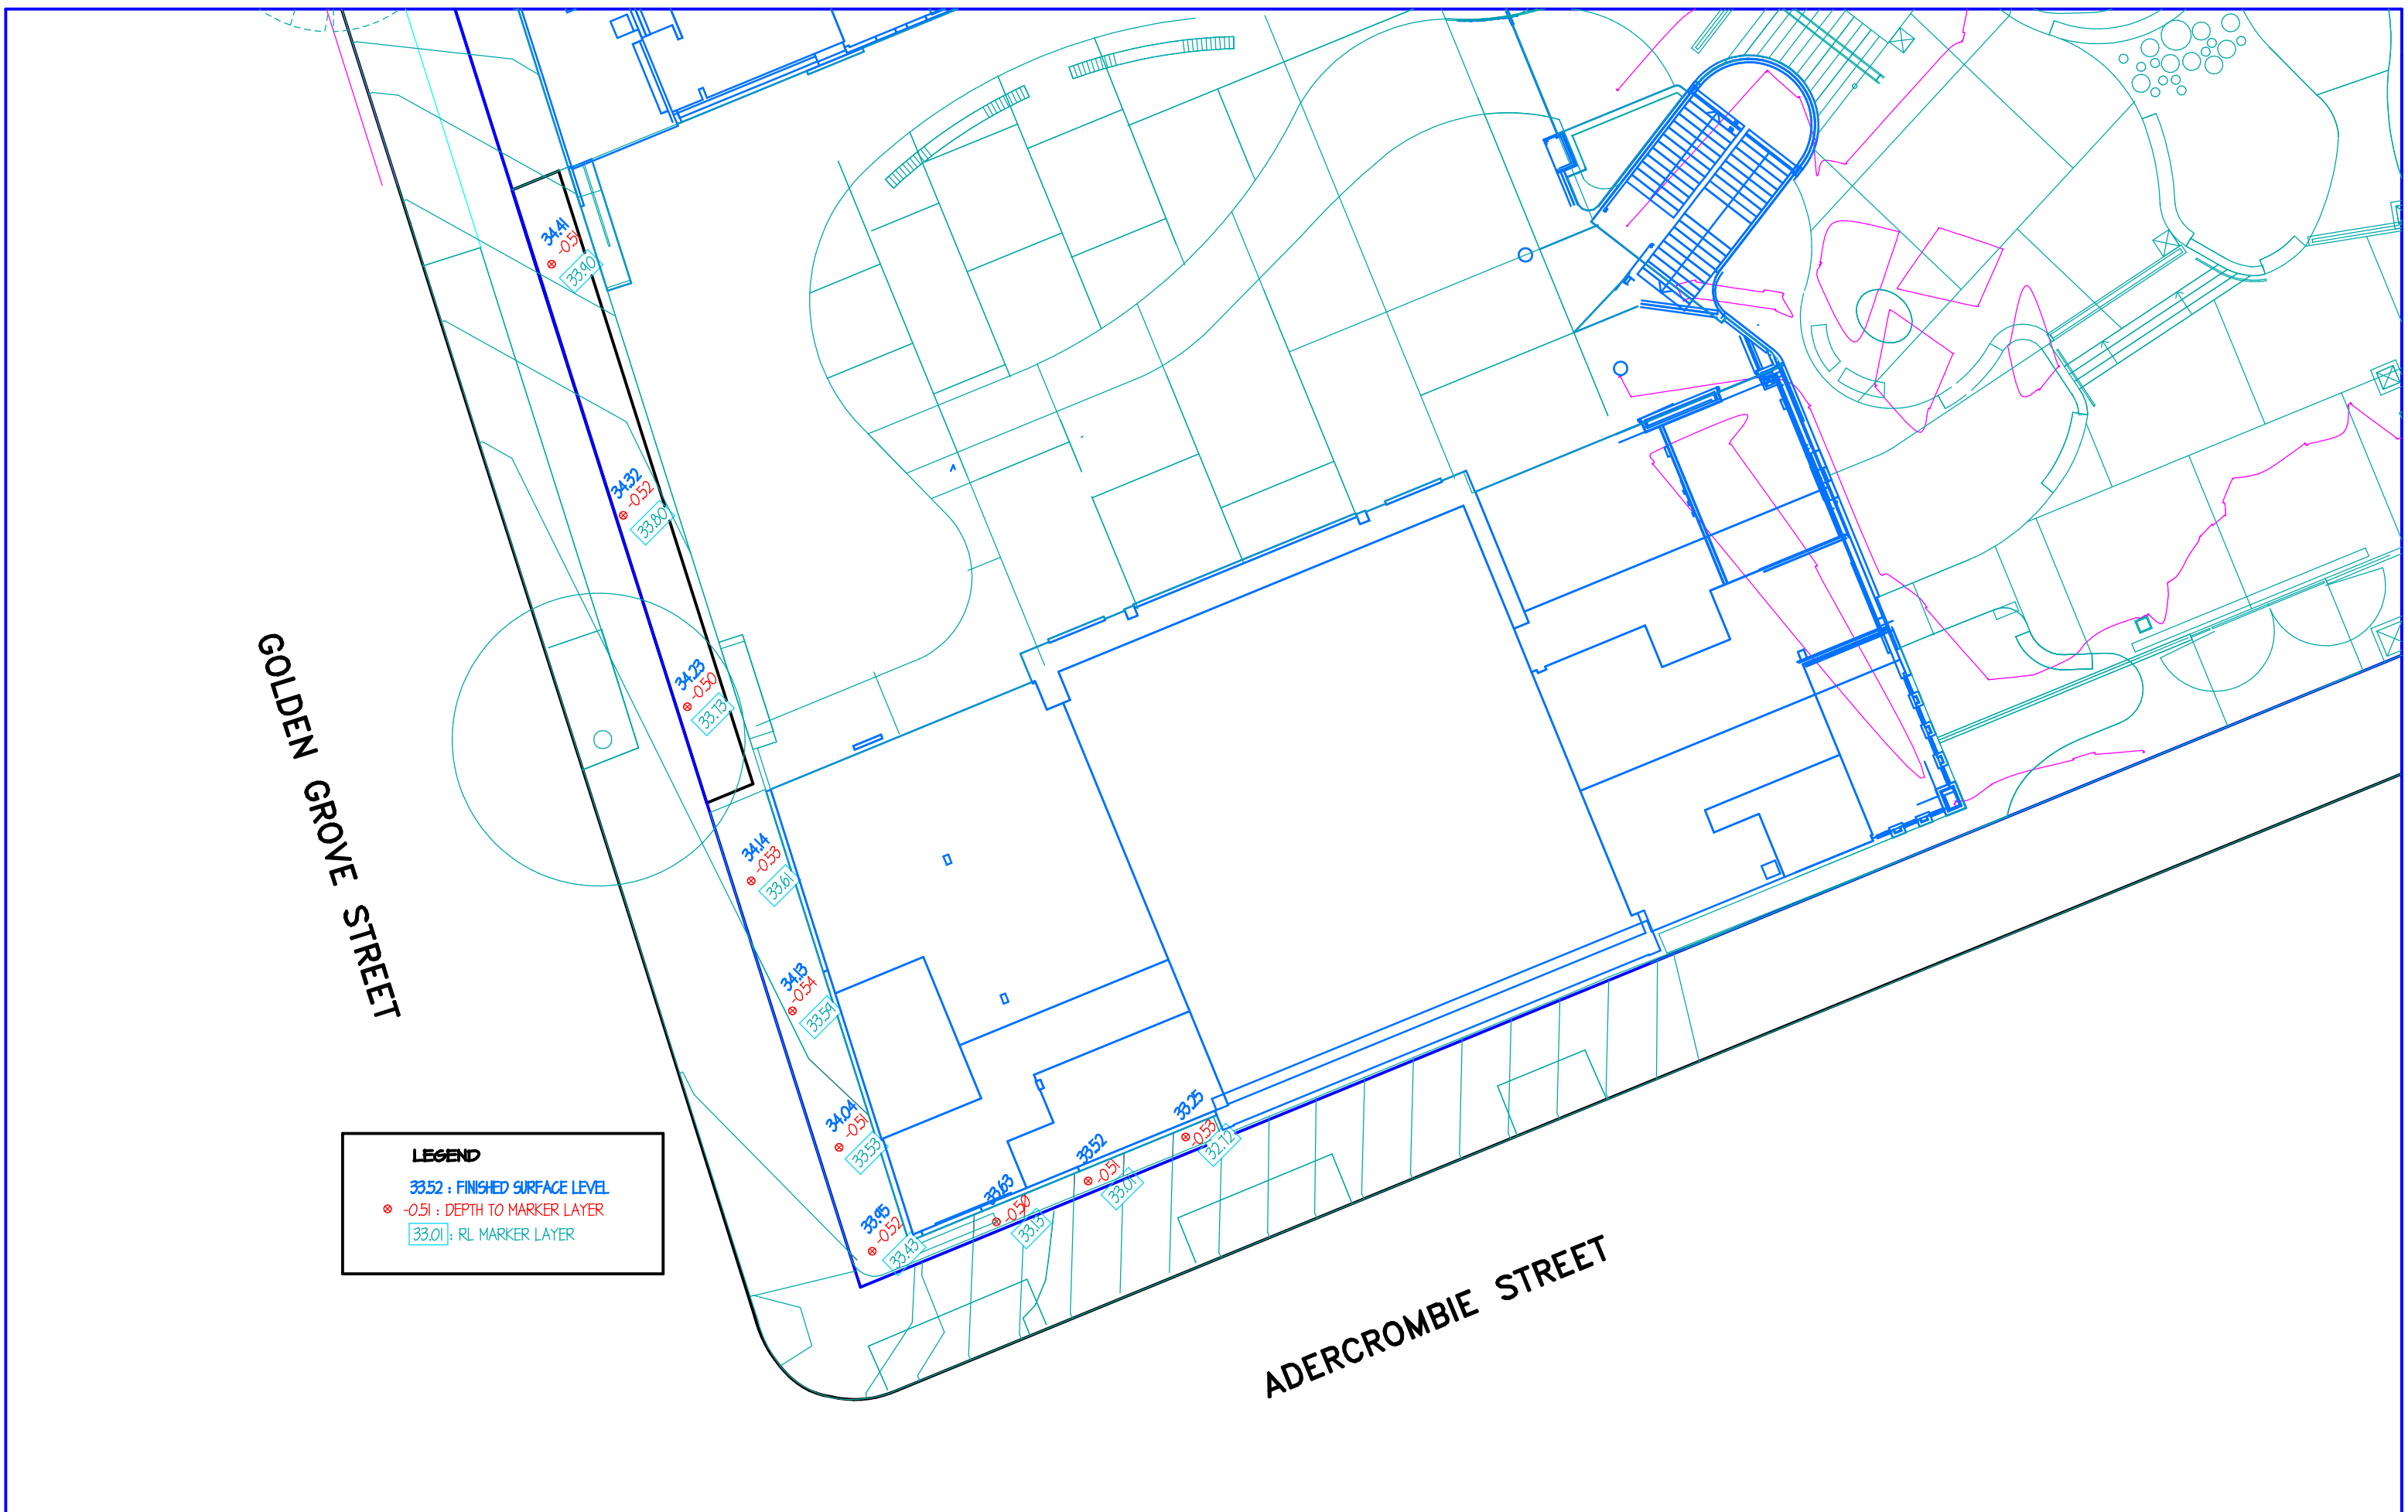
PLAN:
 MARKER LAYER DEPTH TO
 FINAL FINISHED SURFACE
 OVER LANDSCAPE AREAS

- 33.52 : FINISHED SURFACE LEVEL
- ⊙ -0.51 : DEPTH TO MARKER LAYER
- 33.01 : RL MARKER LAYER

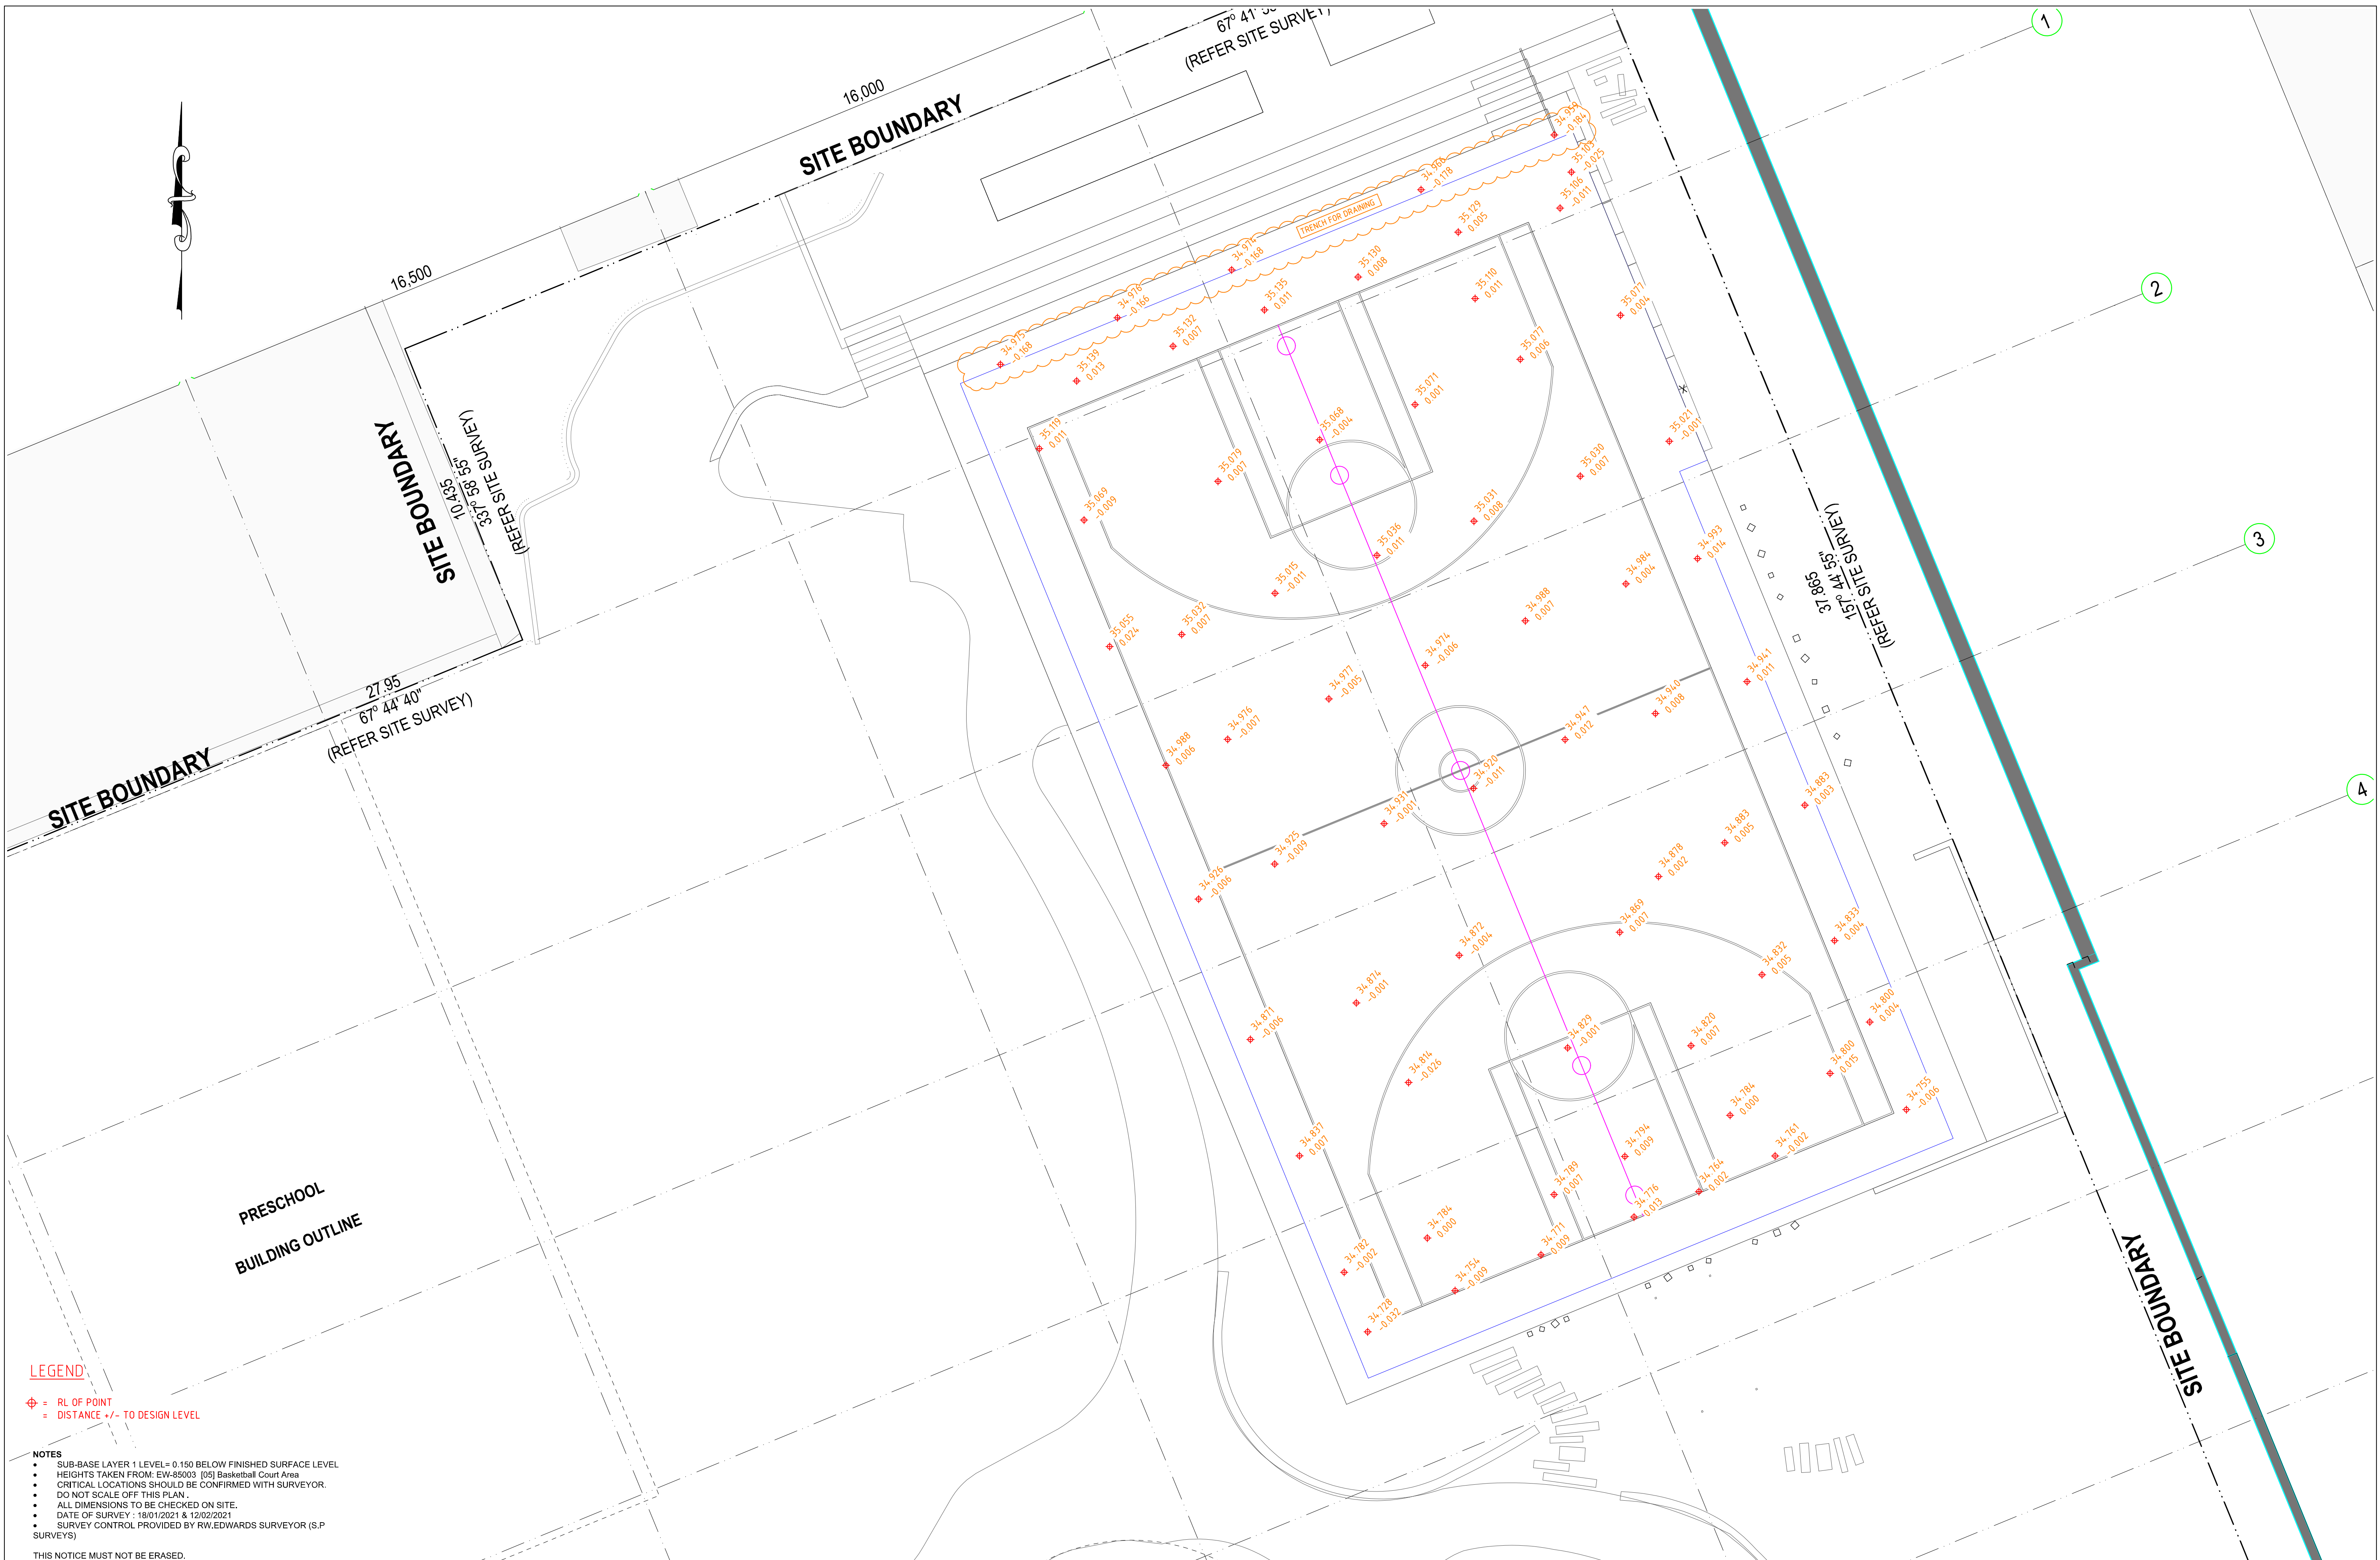
BASKETBALL COURT SURFACE WAE

LEGEND
 ◆ = RL OF POINT
 = DISTANCE +/- TO DESIGN LEVEL

- NOTES**
- SUB-BASE LAYER 1 LEVEL= 0.150 BELOW FINISHED SURFACE LEVEL
 - HEIGHTS TAKEN FROM: EW-85003 [05] Basketball Court Area
 - CRITICAL LOCATIONS SHOULD BE CONFIRMED WITH SURVEYOR.
 - DO NOT SCALE OFF THIS PLAN.
 - ALL DIMENSIONS TO BE CHECKED ON SITE.
 - DATE OF SURVEY: 18/01/2021 & 12/02/2021
 - SURVEY CONTROL PROVIDED BY RW.EDWARDS SURVEYOR (S.P SURVEYS)

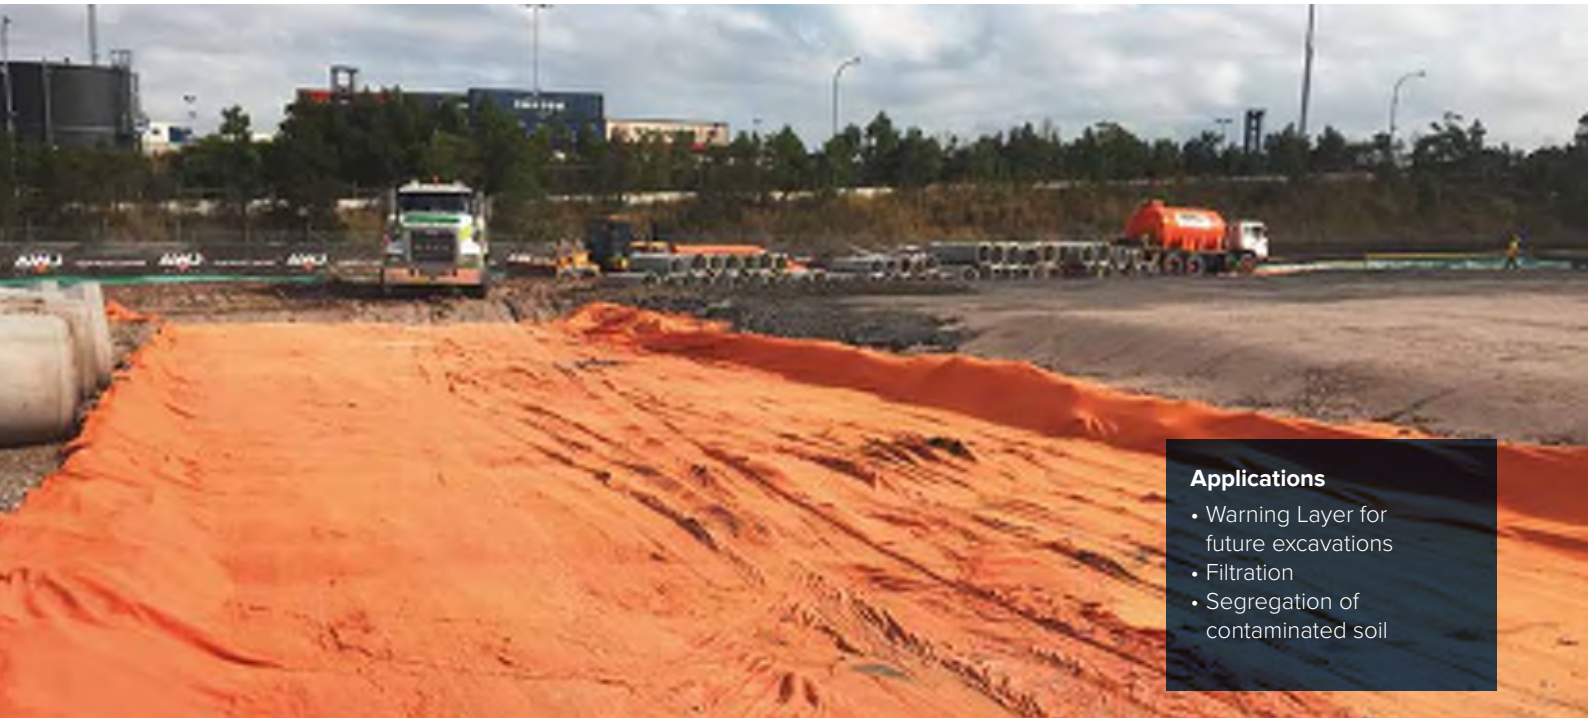
Applications

- Warning Layer for future excavations
- Filtration
- Segregation of contaminated soil
