project
Darlington Public School
 Golden Grove Street
 Darlington NSW 2008

title
Landscape Plans
Indicative Planting Palette

DARLINGTON PUBLIC SCHOOL REDEVELOPMENT

DARLINGTON PUBLIC SCHOOL
SSD - 9914 LANDSCAPE REPORT

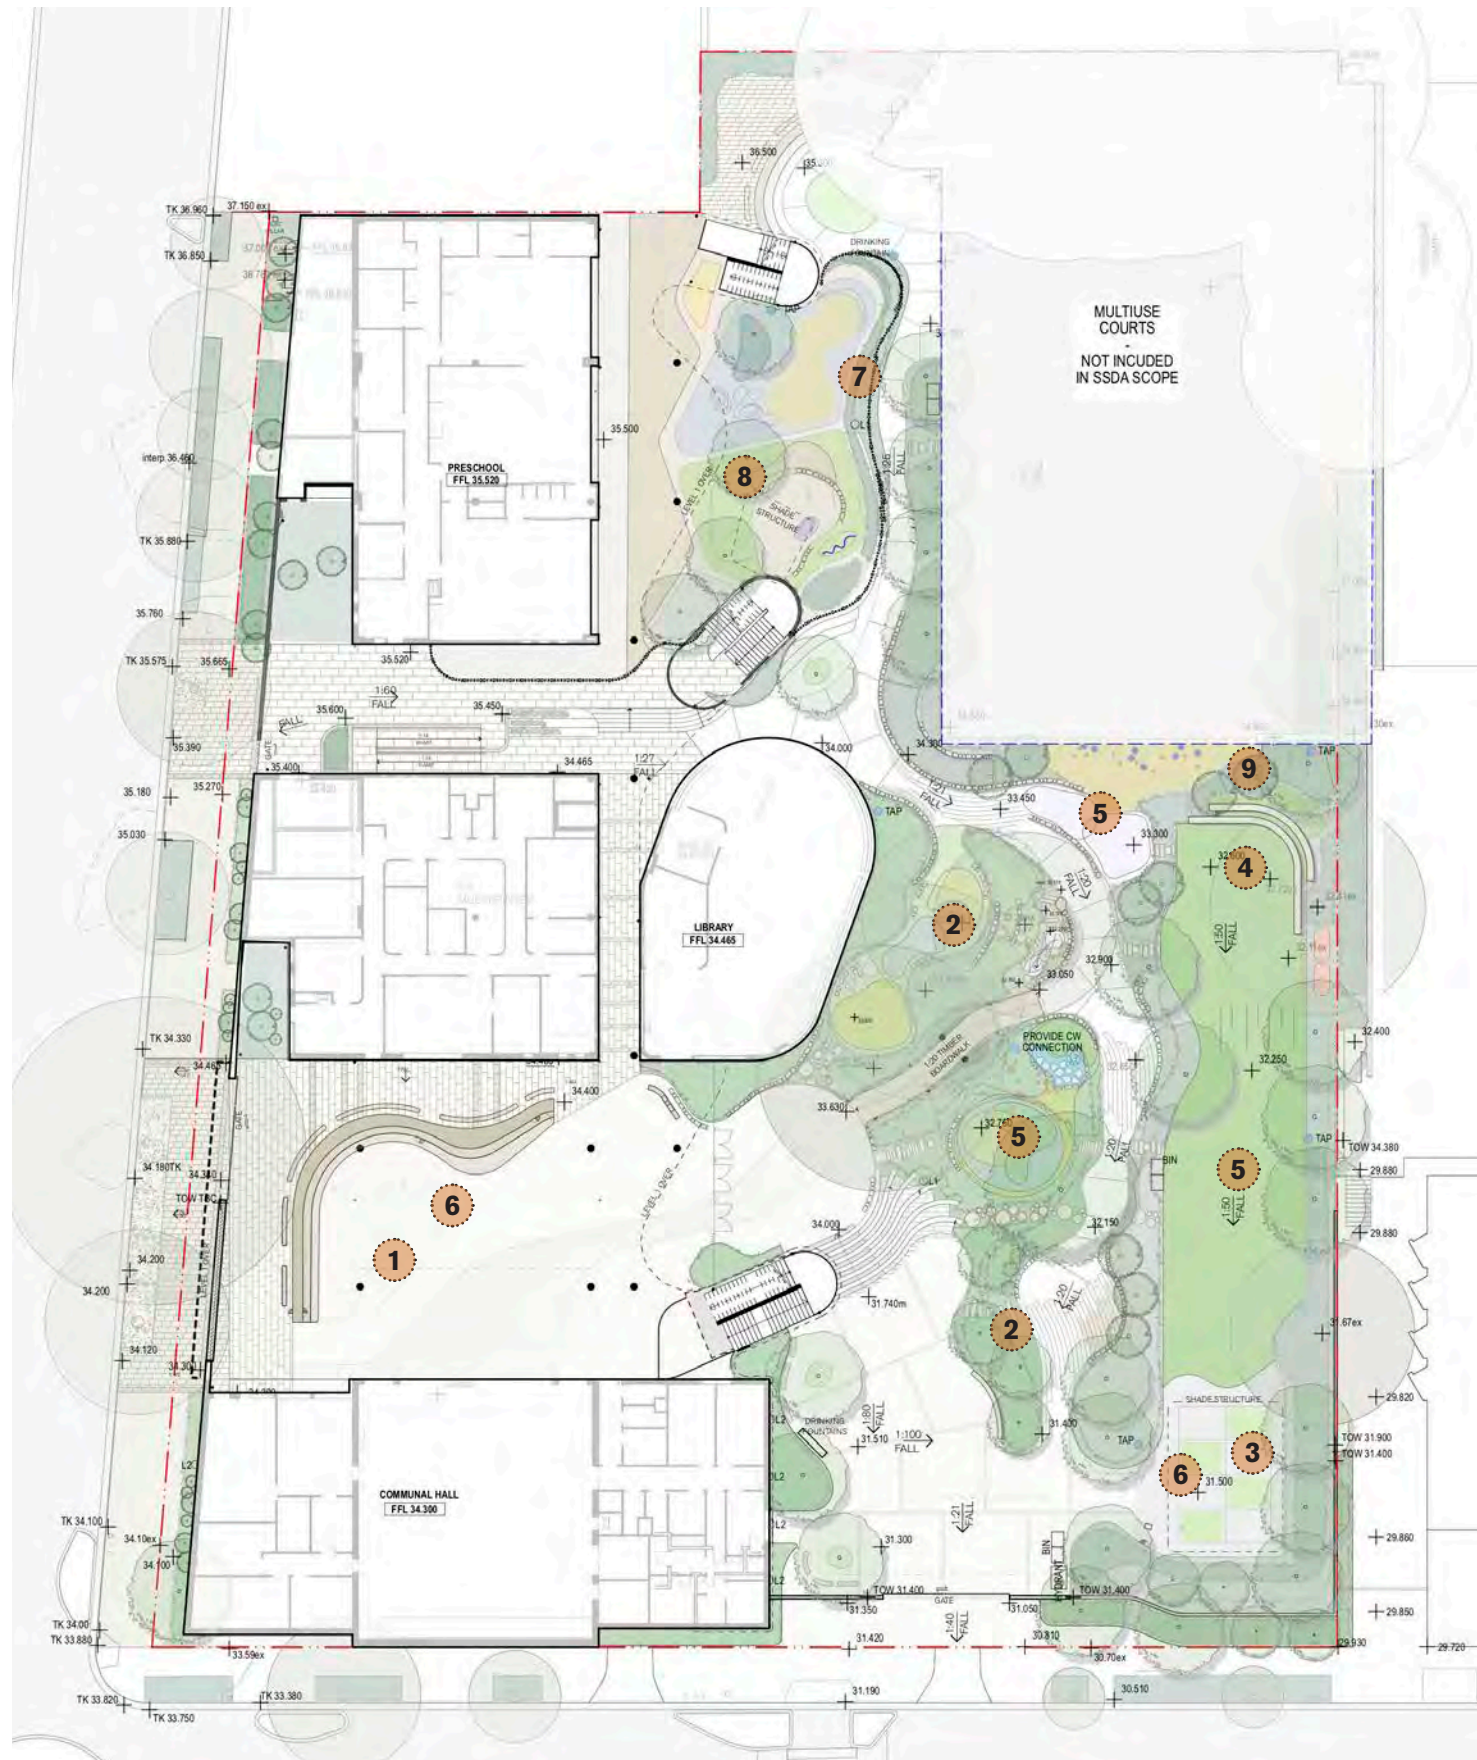
COMPLETED SCHEME

- 1. COLA / Assembly Area
- 2. Nature Play / Indigenous gardens
- 3. Hardcourt / Multipurpose play
- 4. The Amphitheatre
- 5. Active Play
- 6. Active Play - Ball games
- 7. Linear Garden & Sculptural Fence
- 8. Preschool playground & garden
- 9. Climbing wall

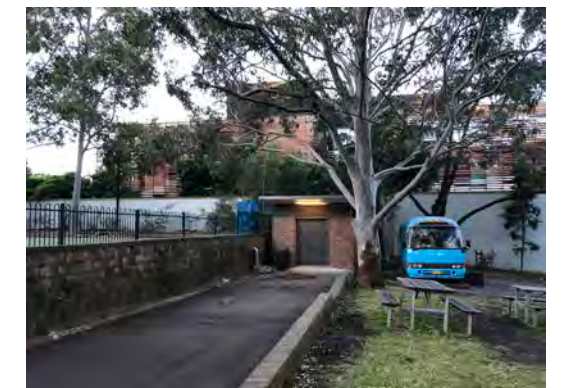
View to Eastern Boundary - wall to be retained

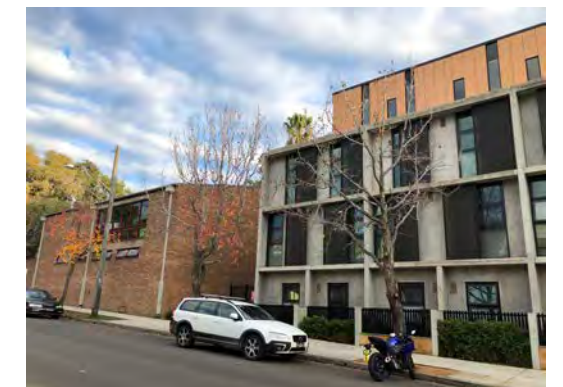
View to Sydney University Student Accommodation - from Abercrombie Street

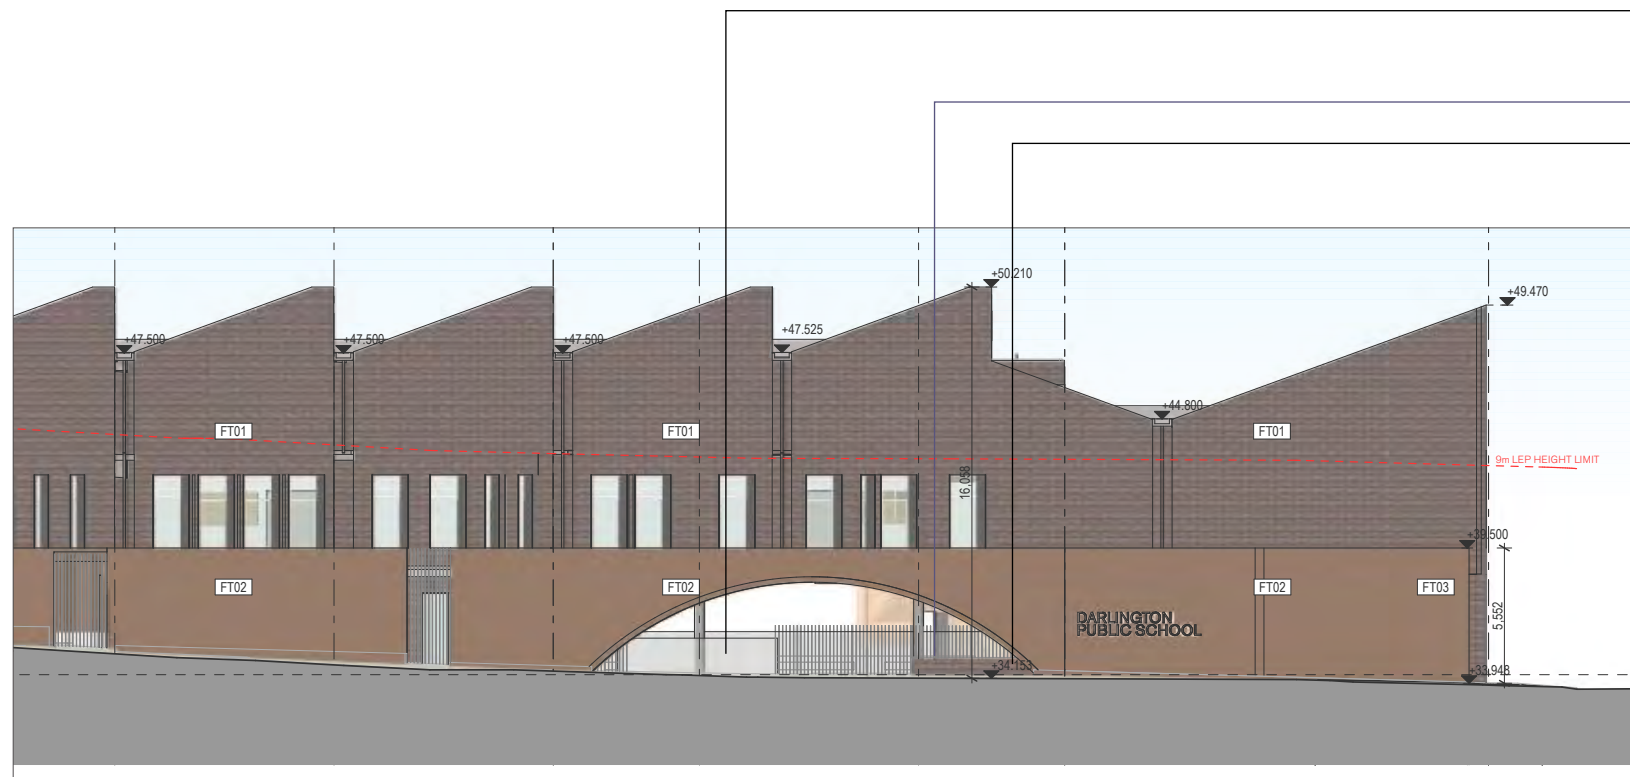
Golden Grove Street - Main Entry - Elevation

Sliding Gates
 Vertical blades - powdercoat bronze to match Architectural
 Entry fencing (atop brick wall)
 Vertical blades - powdercoat dark grey to match Architectural

Brick wall provides protection from flood events - brick selection to match the Architectural finishes

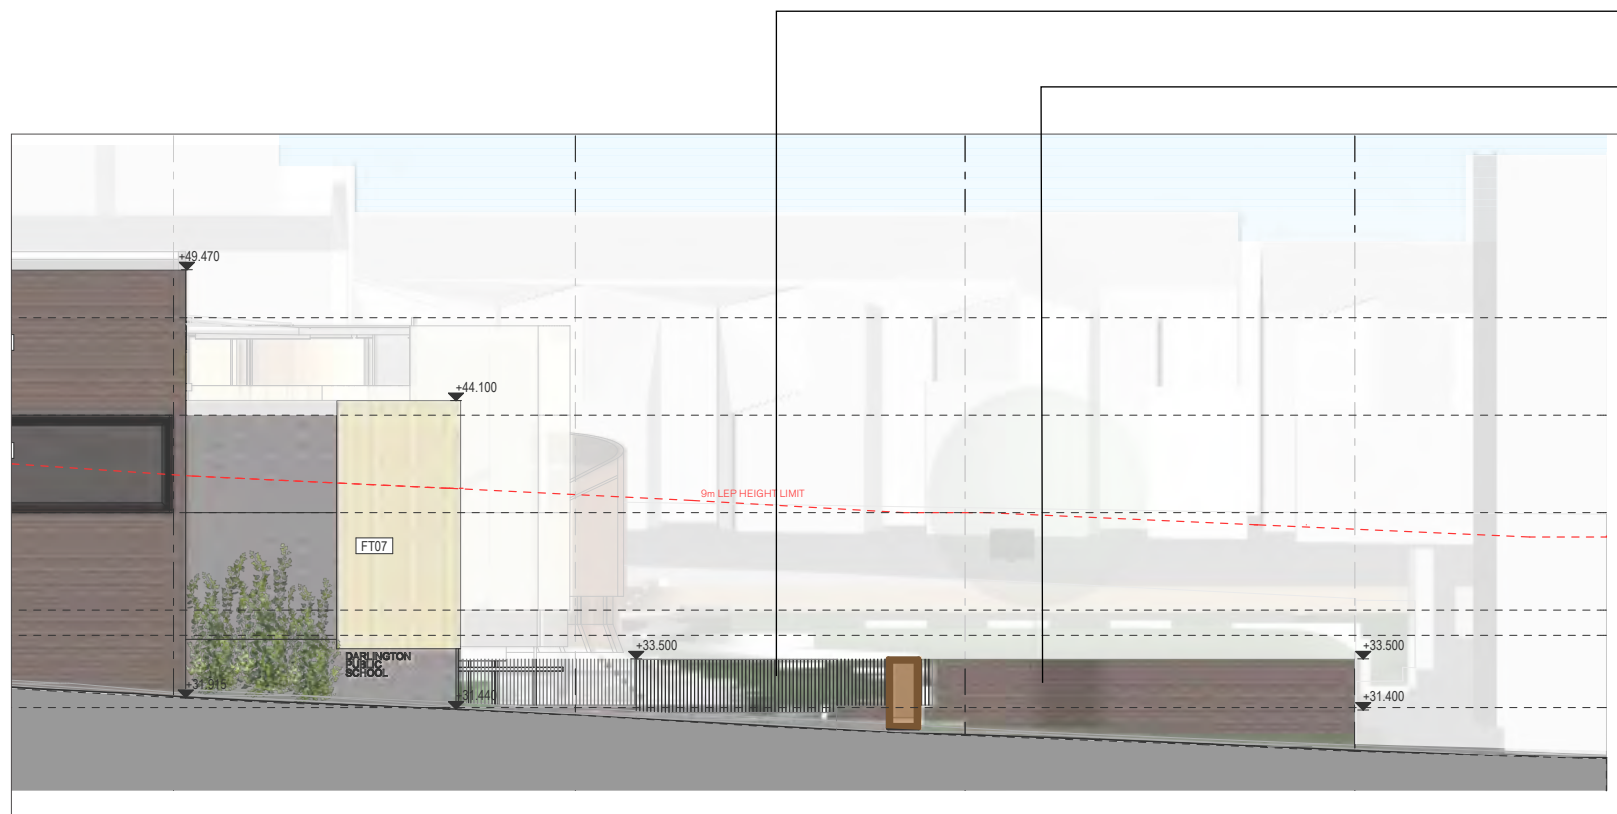
Abercrombie Street - Secondary Entry

Entry fencing - Vertical blades - powdercoat dark grey to match Architectural finishes

Brick wall provides secure school boundary (min 2.1 high)-
 brick selection to match the Architectural finishes

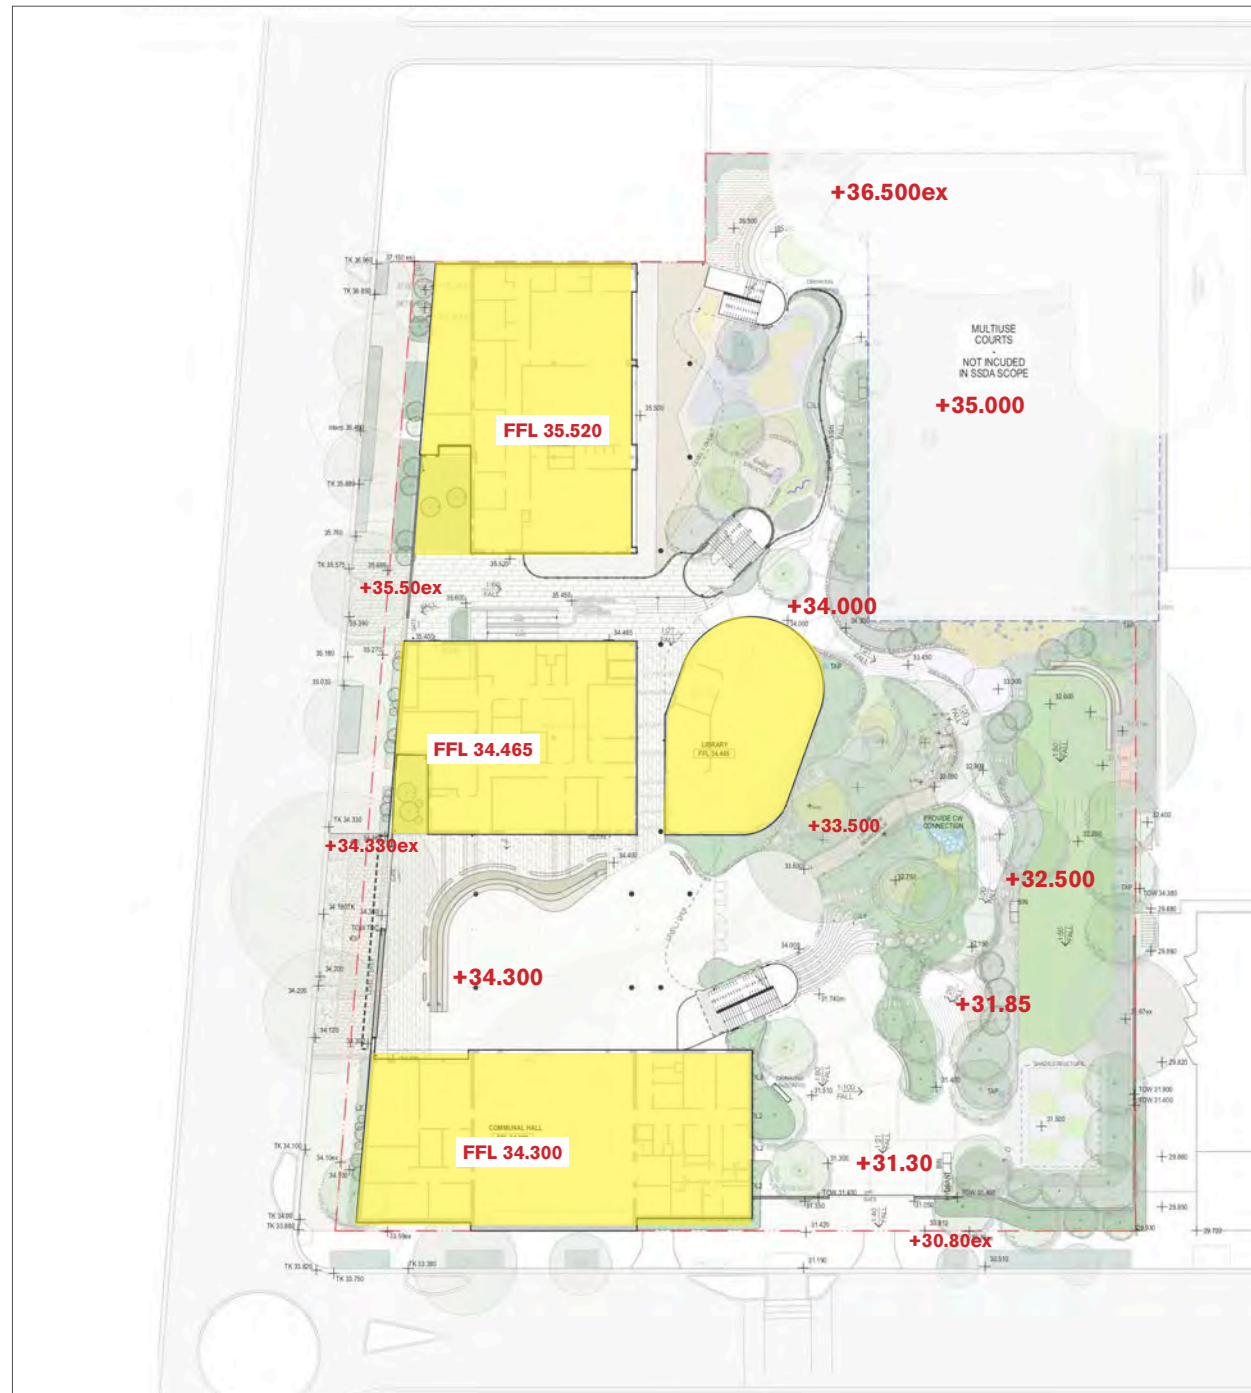
Levels

- +30.80ex** EXISTING LEVEL
- FFL33.650** BUILDING FINISH FLOOR LEVEL
- +30.80** DESIGN RL

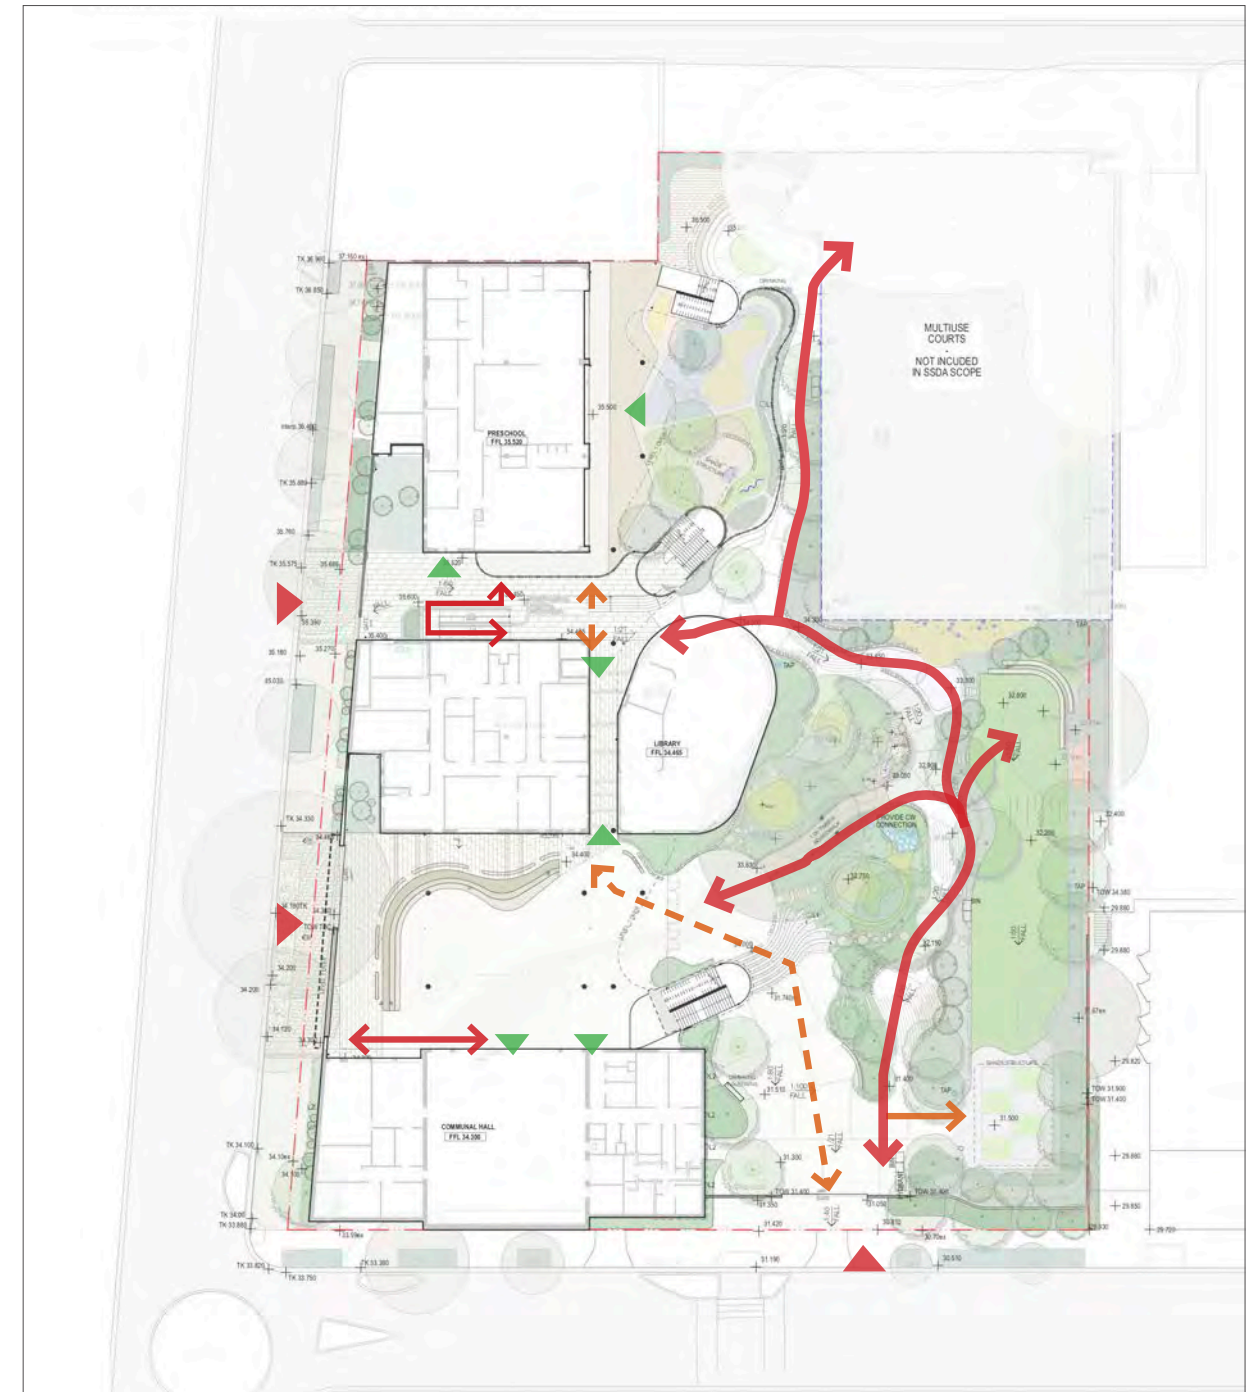
Accessible circulations

- WHEELCHAIR CONNECTIONS
- STEPPED/ STAIRWAY CONNECTIONS
- SCHOOL ENTRANCE
- BUILDING ENTRANCE

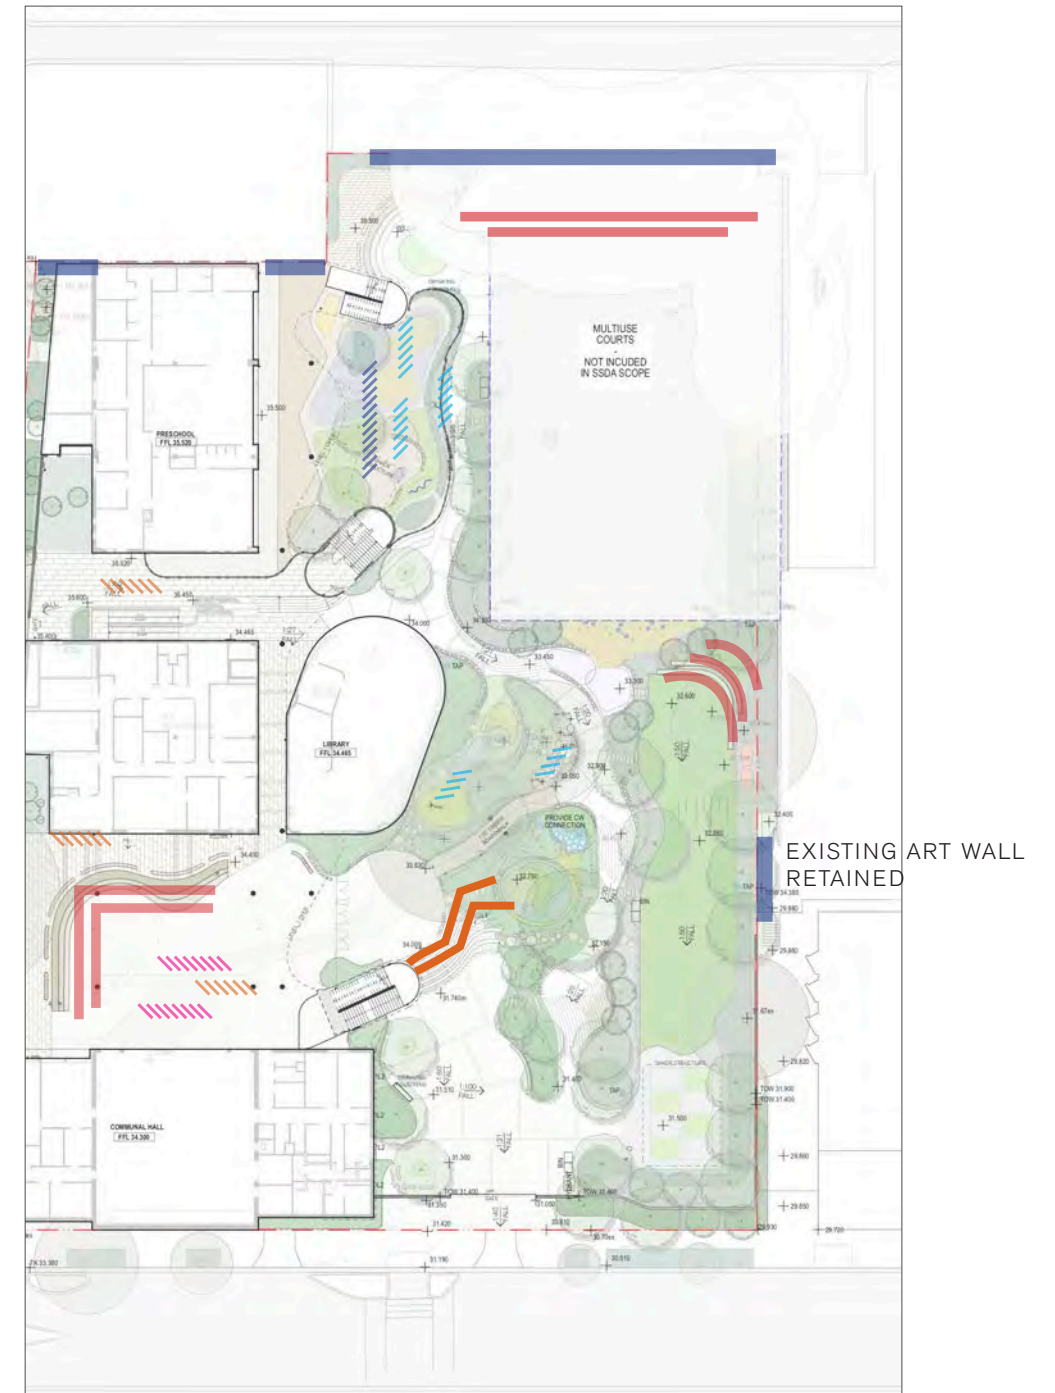
Indigenous Overlay and Artwork

- ARTWORK MOUNTED TO EXISTING WALLS
- ARTWORK MOUNTED TO / OR INTEGRATED WITH NEW WALLS
- WALL ART RELAID INTO THE FACE OF NEW TERRACE SEATS
- ART & / OR INDIGENOUS INTERPRETATION:
 - SET INTO THE UNDERCROFT OF THE ROOF ABOVE
 - INLAID INTO THE NEW PAVED COLA AREA
 - LOCATED IN THE NATURE LEARNING PLAYGROUND OR SCULPTURE GARDEN
 - INTEGRATED WITH THE SCULPTURAL FENCE

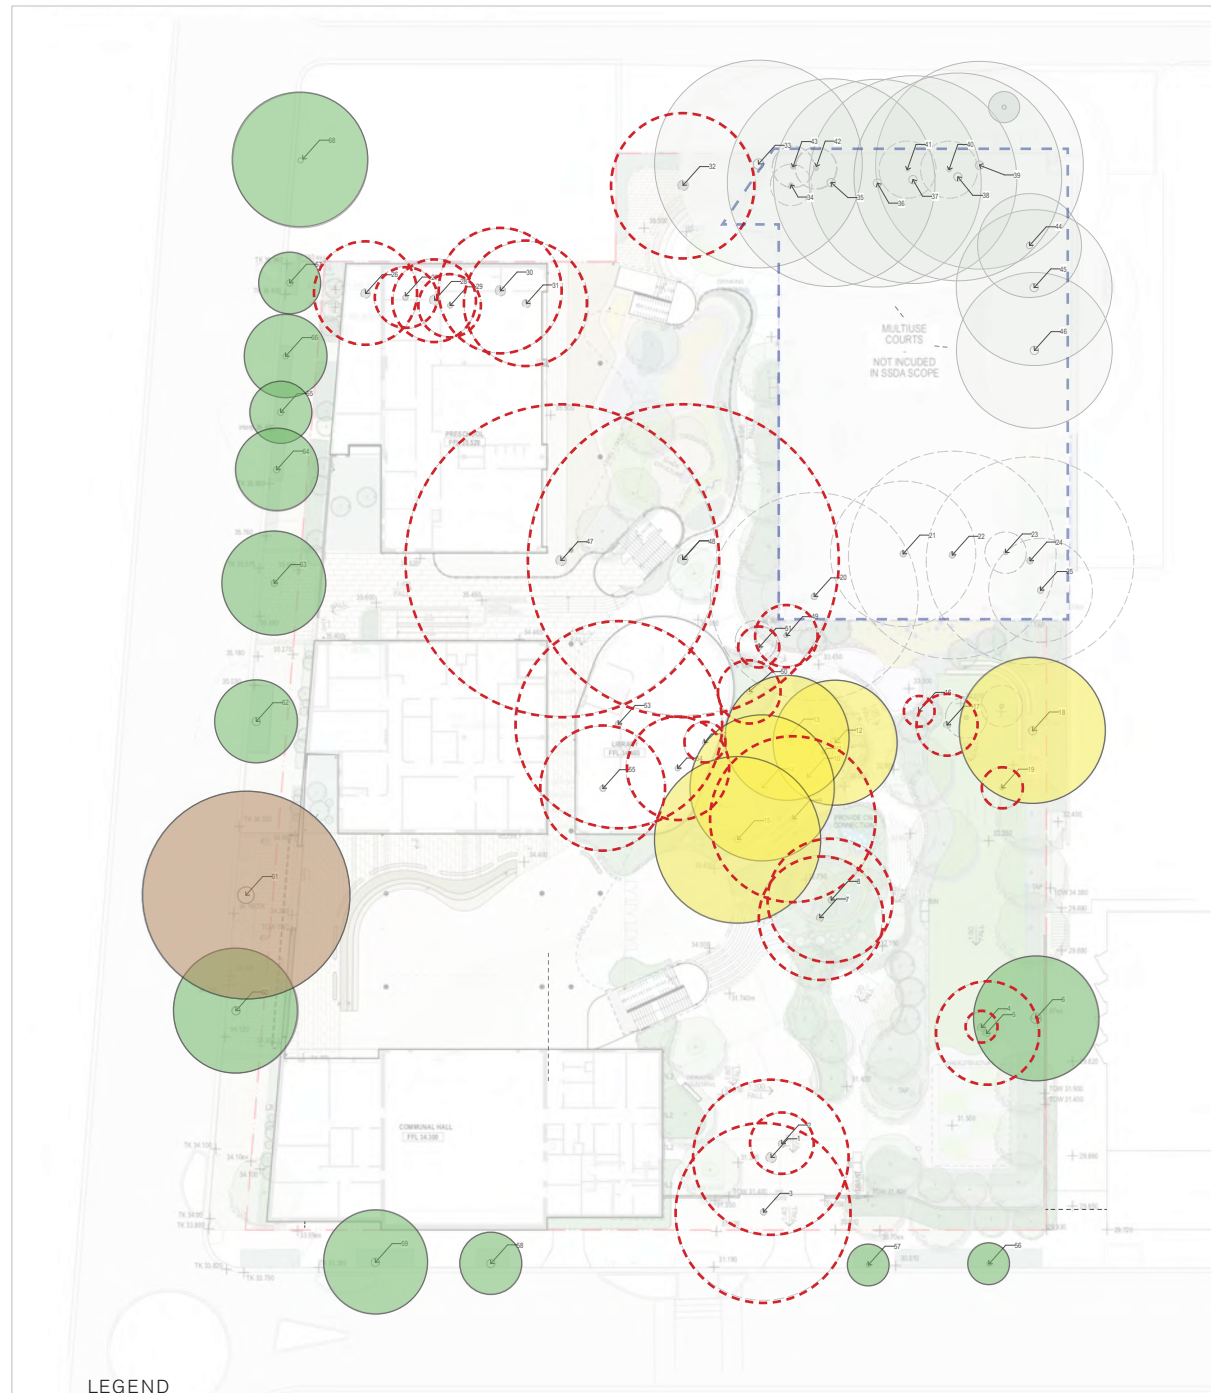
Tree management plan

- EXISTING TREE TO BE RETAINED
- EXISTING TREE TO BE RETAINED SUBJECT TO FINAL LEVEL CONFIRMATION
- EXISTING STREET TREE TO BE RETAINED SUBJECT TO FOOT-PATH LEVELS / ARBORIST ADVICE
- EXISTING TREE TO BE REMOVED

TOTAL TREE TO BE RETAINED: 19 TREES

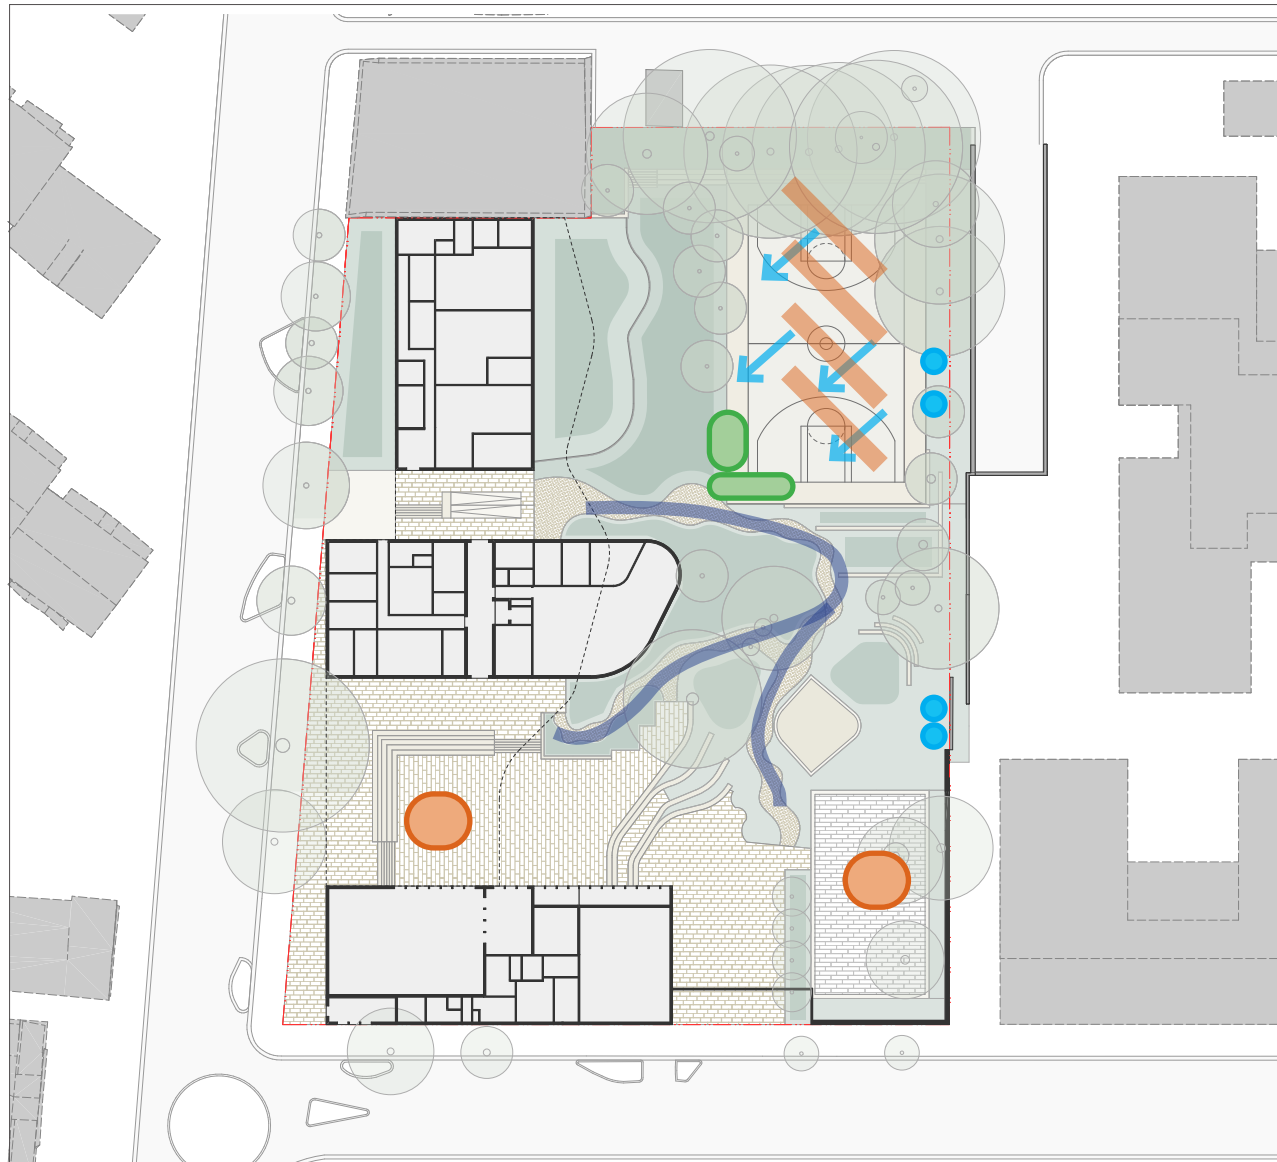
Ecological Sustainable Development & Water Sensitive Urban Design

The primary landscape ESD initiatives include:
 Fall paving to facilitate surface water recharge to mass planting beds to reduce potable water usage
 Provide an appropriate area of planting to improve air quality and reduce the urban heat island effect;
 and select hardy, low water use, indigenous plant species where possible suited to the harsh urban environment.

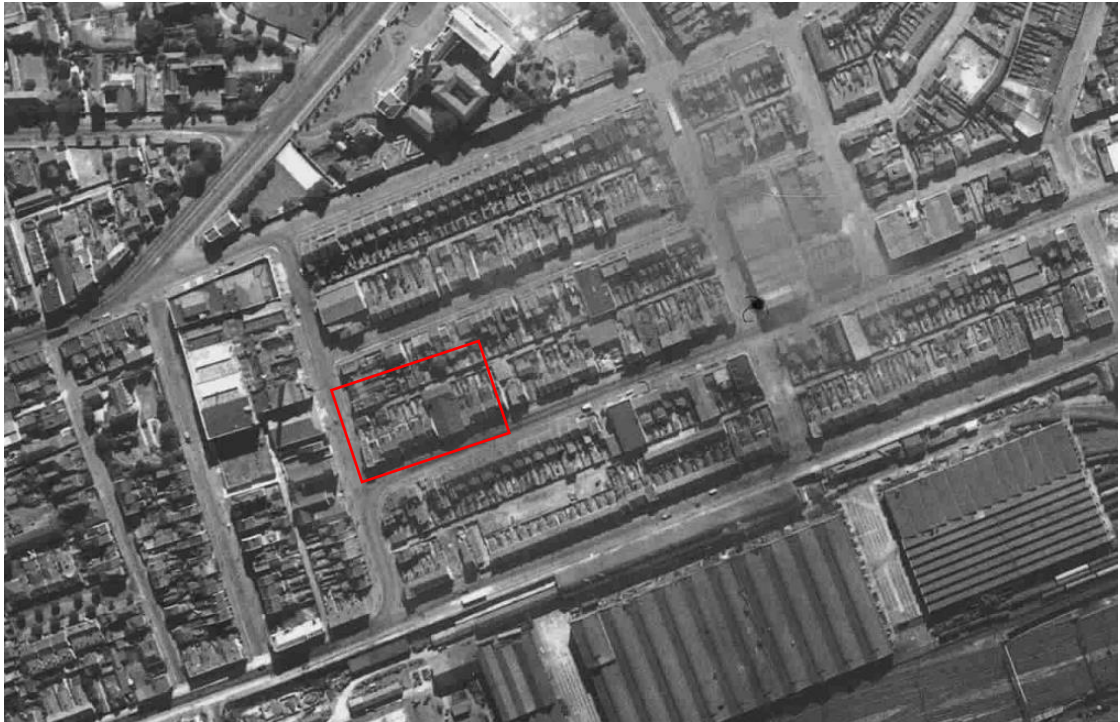
Diagram 2: The site as seen in 1943, devoid of trees (RTA From the skies, 2007).

3.1 Darlington Public School is located in Chippendale in Sydney. Darlington Public School is an inner city school servicing the suburbs of Chippendale, Darlington, Redfern and Waterloo. The school was built in the 1970s (Diagram 2) however the school's trees are well established, with some being almost twenty (20) metres in height and spread.

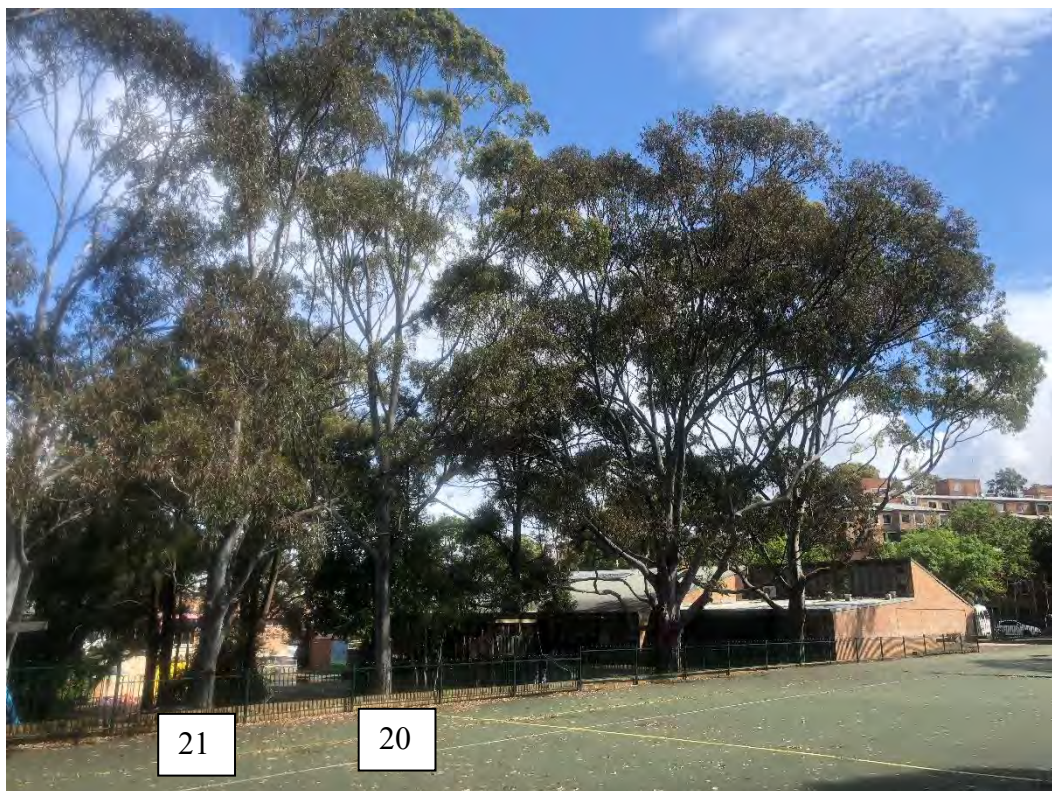
Plate 1: Image showing Trees 21, 20. P. Vezgoff

- 3.6** Trees 20 and 21 are some of the larger trees on site being some twenty (20) metres in height (Plate 1). The majority of the root zone of these trees is covered with hard surface. These trees have some previous failures which is to be expected from trees of this size and age. These trees were assessed as being in good health and condition. The main trunks, first and second order branches are free of any cracks, splits or fruiting bodies. New extension growth was noted. The basal area and woody root zones were free of any ground heaving, or lifting. Ideally an aerial inspection should occur to fully determine the condition of the main branch unions if they were to be retained.

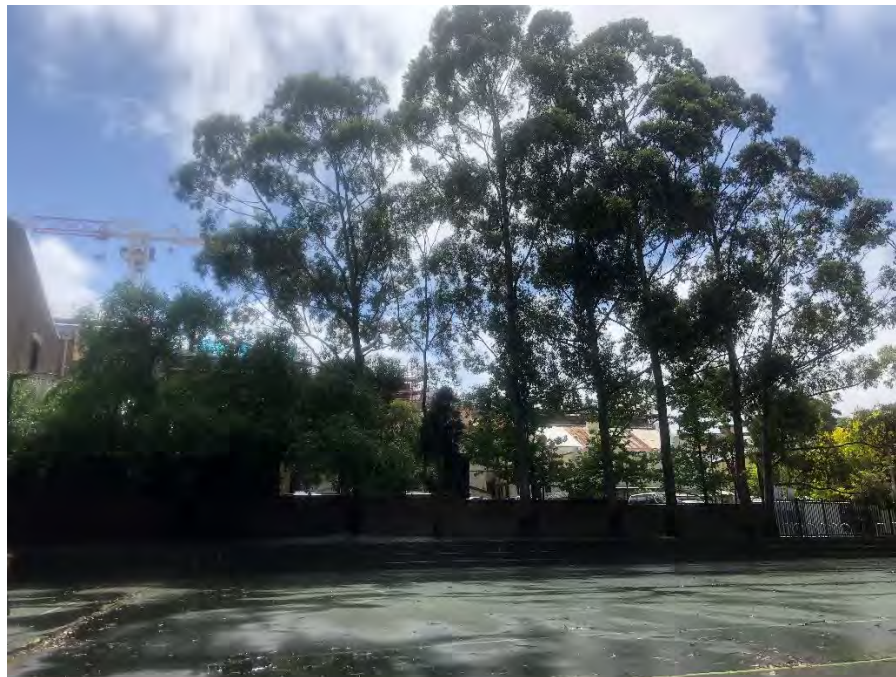
Plate 2: Image showing Trees 32-43. P. Vezgoff

- 3.7** Trees 32-43 are growing along the northern boundary fence (Plate 2). These are a mixed group of large mature *Eucalyptus* specimens but competing with some exotic specimens that have been planted between and under the large *Eucalyptus* specimens. These trees are also tightly grouped specimens that have a restricted root space and are covered with asphalt and playground rubberised matting up to the trunks. Varied levels are present as these trees have been planted on a stepped area (Plate 3).
- 3.8** Under these larger more dominant specimens are Trees 40-43 that are Liquidambar (*Liquidambar styraciflua*) and a single *Cupresses* specimen. These trees can be seen in Plate 3. Now suppressed, these trees will not reach maturity and as such are not long term viable specimens.

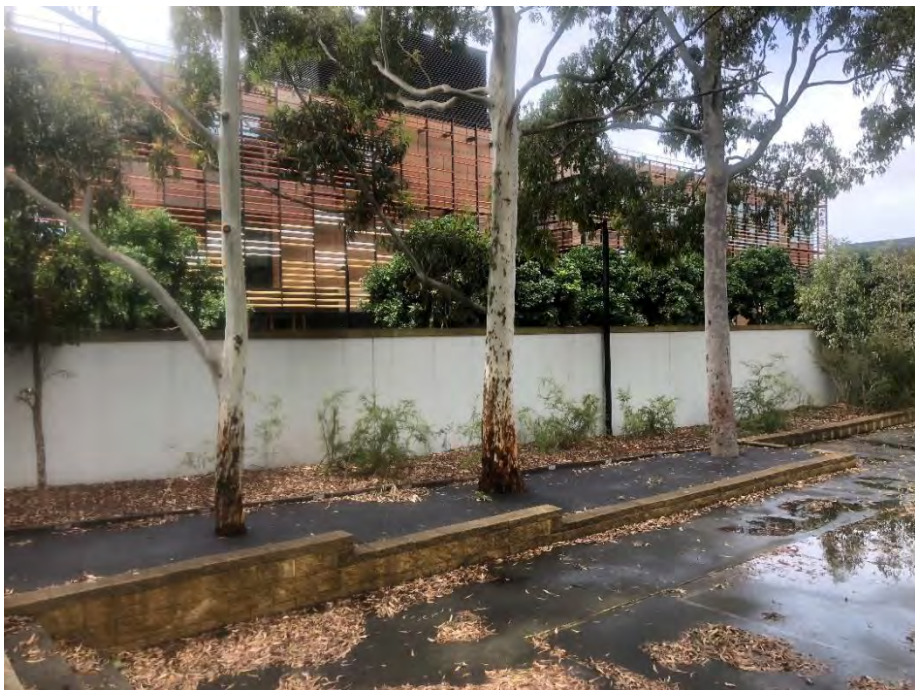
Plate 4: Image showing Trees 44-46. P. Vezgoff

3.9 Trees 44-46 (Plate 4) are growing along the eastern boundary fence. These trees are younger specimens in excellent health and condition and provide a good screen between two properties. The majority of the root zones of these trees is covered with hard surface.

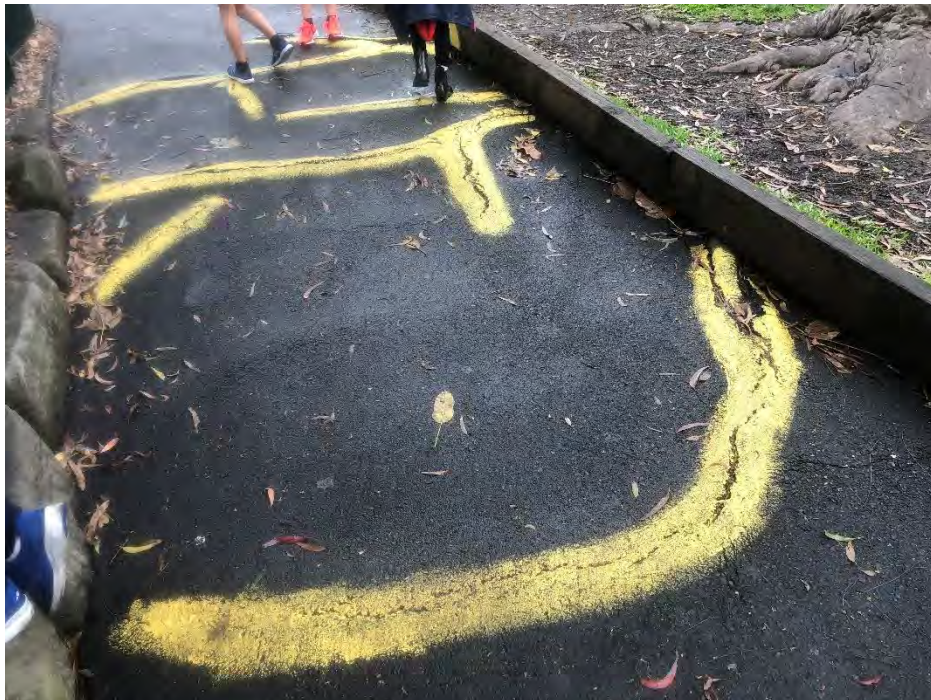
Plate 5: Image showing surface roots from Tree 20. P. Vezgoff

3.10 Although this part of Sydney may be high in sand content that would normally encourage deeper root systems, the site has an uncertain history. Based on Diagram 2, it appears that prior to the school being built, there were rows of terrace houses and warehouse structures, so subsoil conditions will be far from natural and would be highly disturbed. This will mean that old footings or foundations that may be subsurface will deflect woody roots keeping them close to the surface such as near Tree 20 (Plate 5).

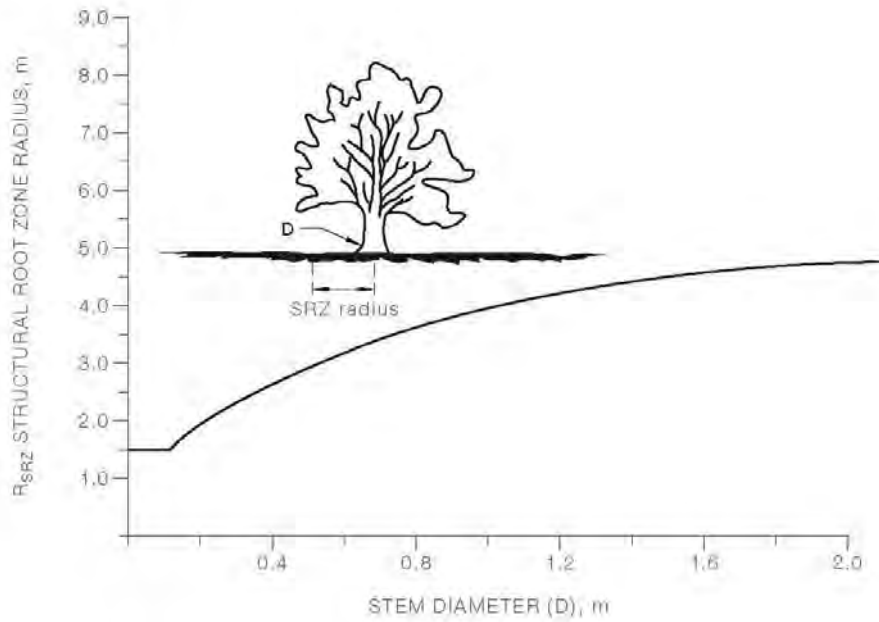
FIGURE 1 - STRUCTURAL ROOT ZONE

D = trunk diameter, in m, measured above the root buttress

NOTE: The SRZ for trees with trunk diameters less than 0.15m will be 1.5m (see Figure 1).

The curve can be expressed by the following formula:
 $R_{SRZ} = (D \times 50)^{0.42} \times 0.64$

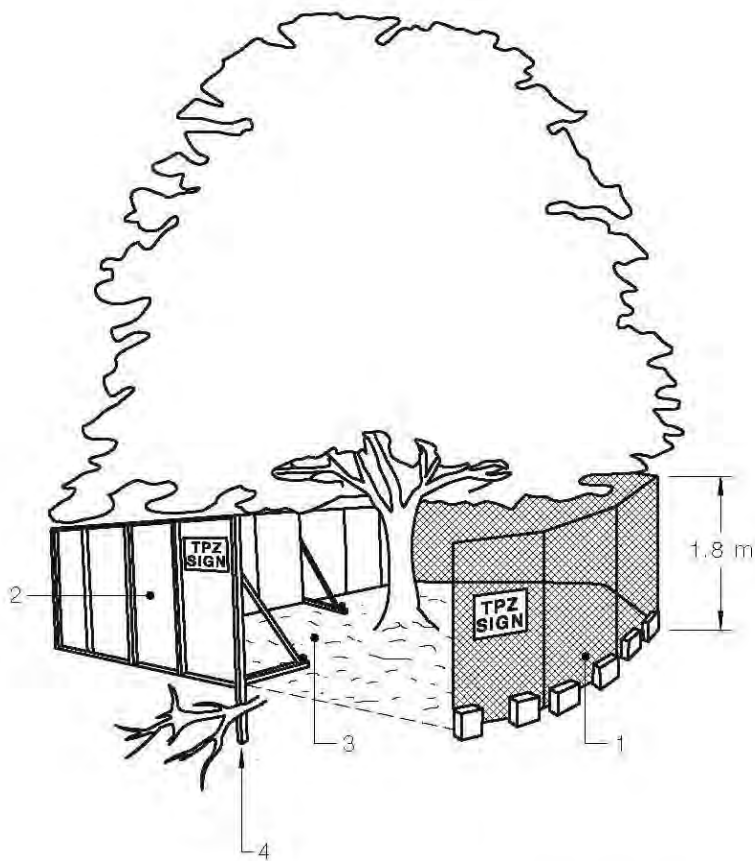
Tree protection fencing
specifications

- 1 Chain wire mesh panels with shade cloth (if required) attached, held in place with concrete feet.
- 2 Alternative plywood or wooden paling fence panels. This fencing material also prevents building materials or soil entering the TPZ.
- 3 Mulch installation across surface of TPZ (at the discretion of the project arborist). No excavation, construction activity, grade changes, surface treatment or storage of materials of any kind is permitted within the TPZ.
- 4 Bracing is permissible within the TPZ. Installation of supports should avoid damaging roots.

5.2 Implementation of Tree Protection Zone: All tree protection works should be carried out before the start of demolition or building work. It is recommended that chain mesh fencing with a minimum height of 1.8 metres be erected as shown in the Tree Protection Plan (Appendix 1). Specifications for this fencing are shown in Tree Protection Fencing Specifications (Appendix 6). Typically the fencing is set at the TPZ measurement (Table 1) however for this project the top area of the steps in front of trees 33, 35-39 and the wall along Trees 44-46 shall have to be used to locate the fences to allow the works to proceed.
