project
Darlington Public School
 Golden Grove Street
 Darlington NSW 2008

title
Landscape Plans
Indicative Planting Palette

DARLINGTON PUBLIC SCHOOL REDEVELOPMENT

DARLINGTON PUBLIC SCHOOL
SSD - 9914 LANDSCAPE REPORT

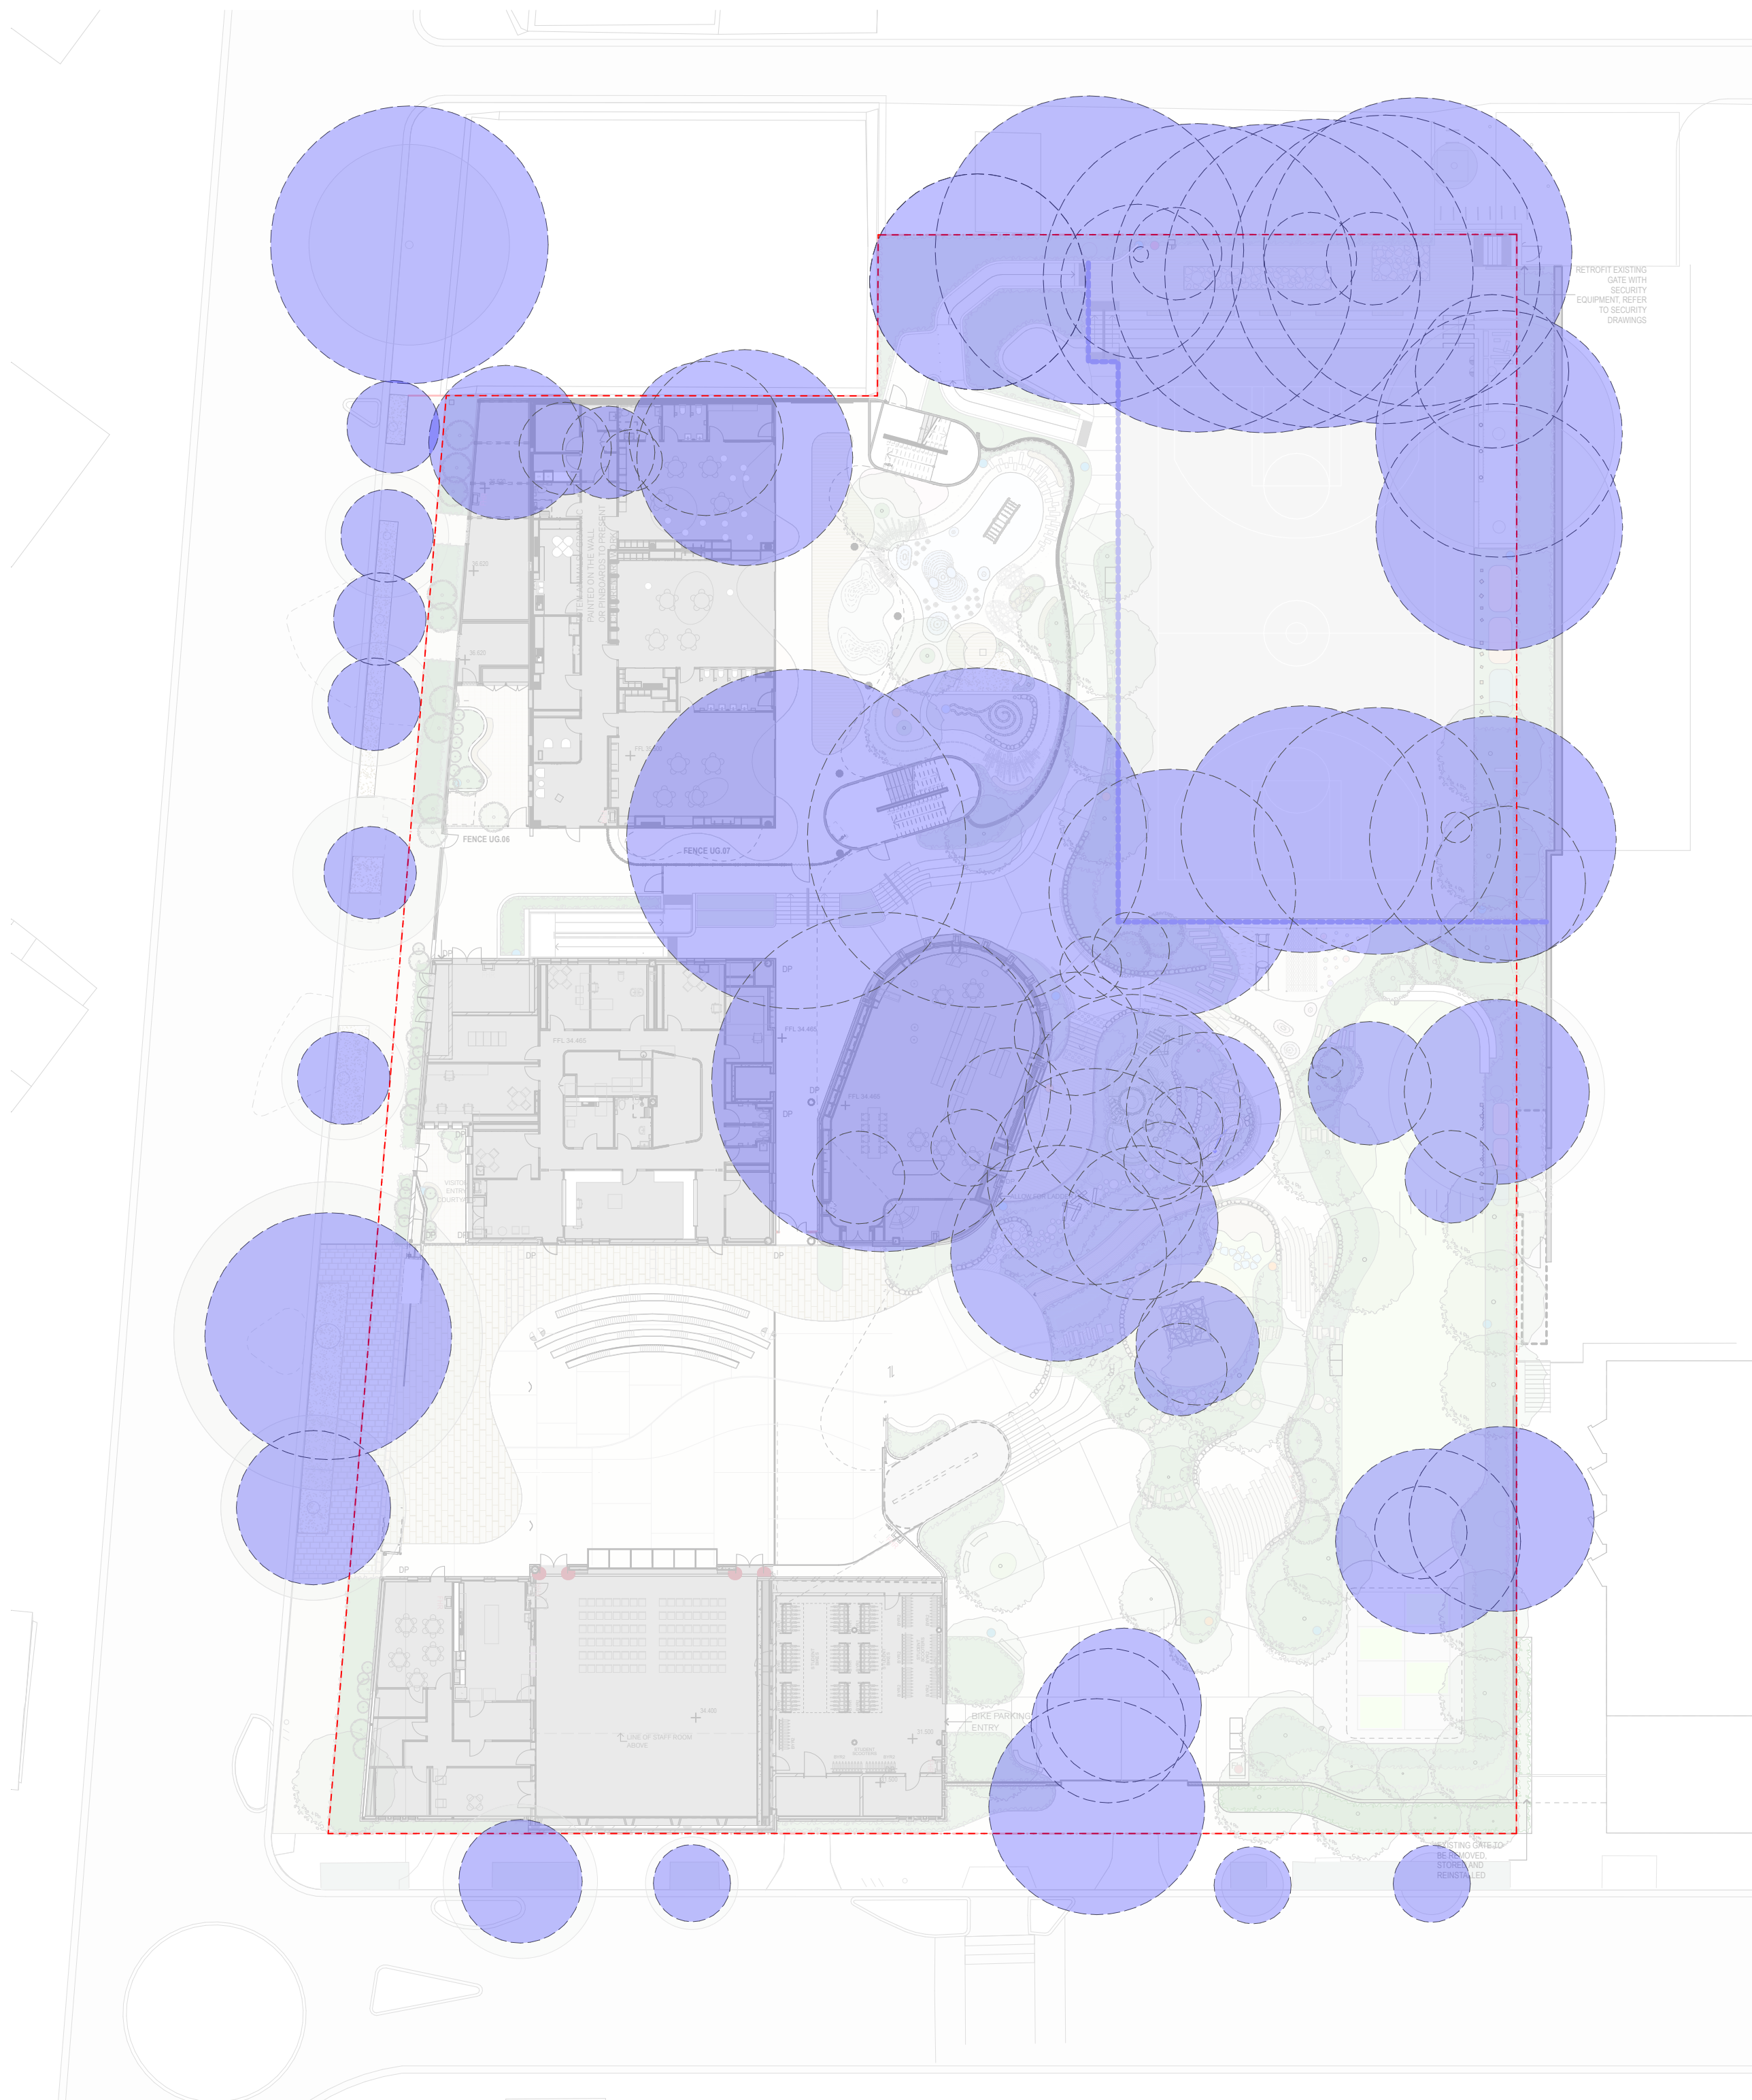
1 PLAN TREES PRE-DEVELOPMENT

AREA OF TREE CANOPY PRE-DEVELOPMENT : 4440m²

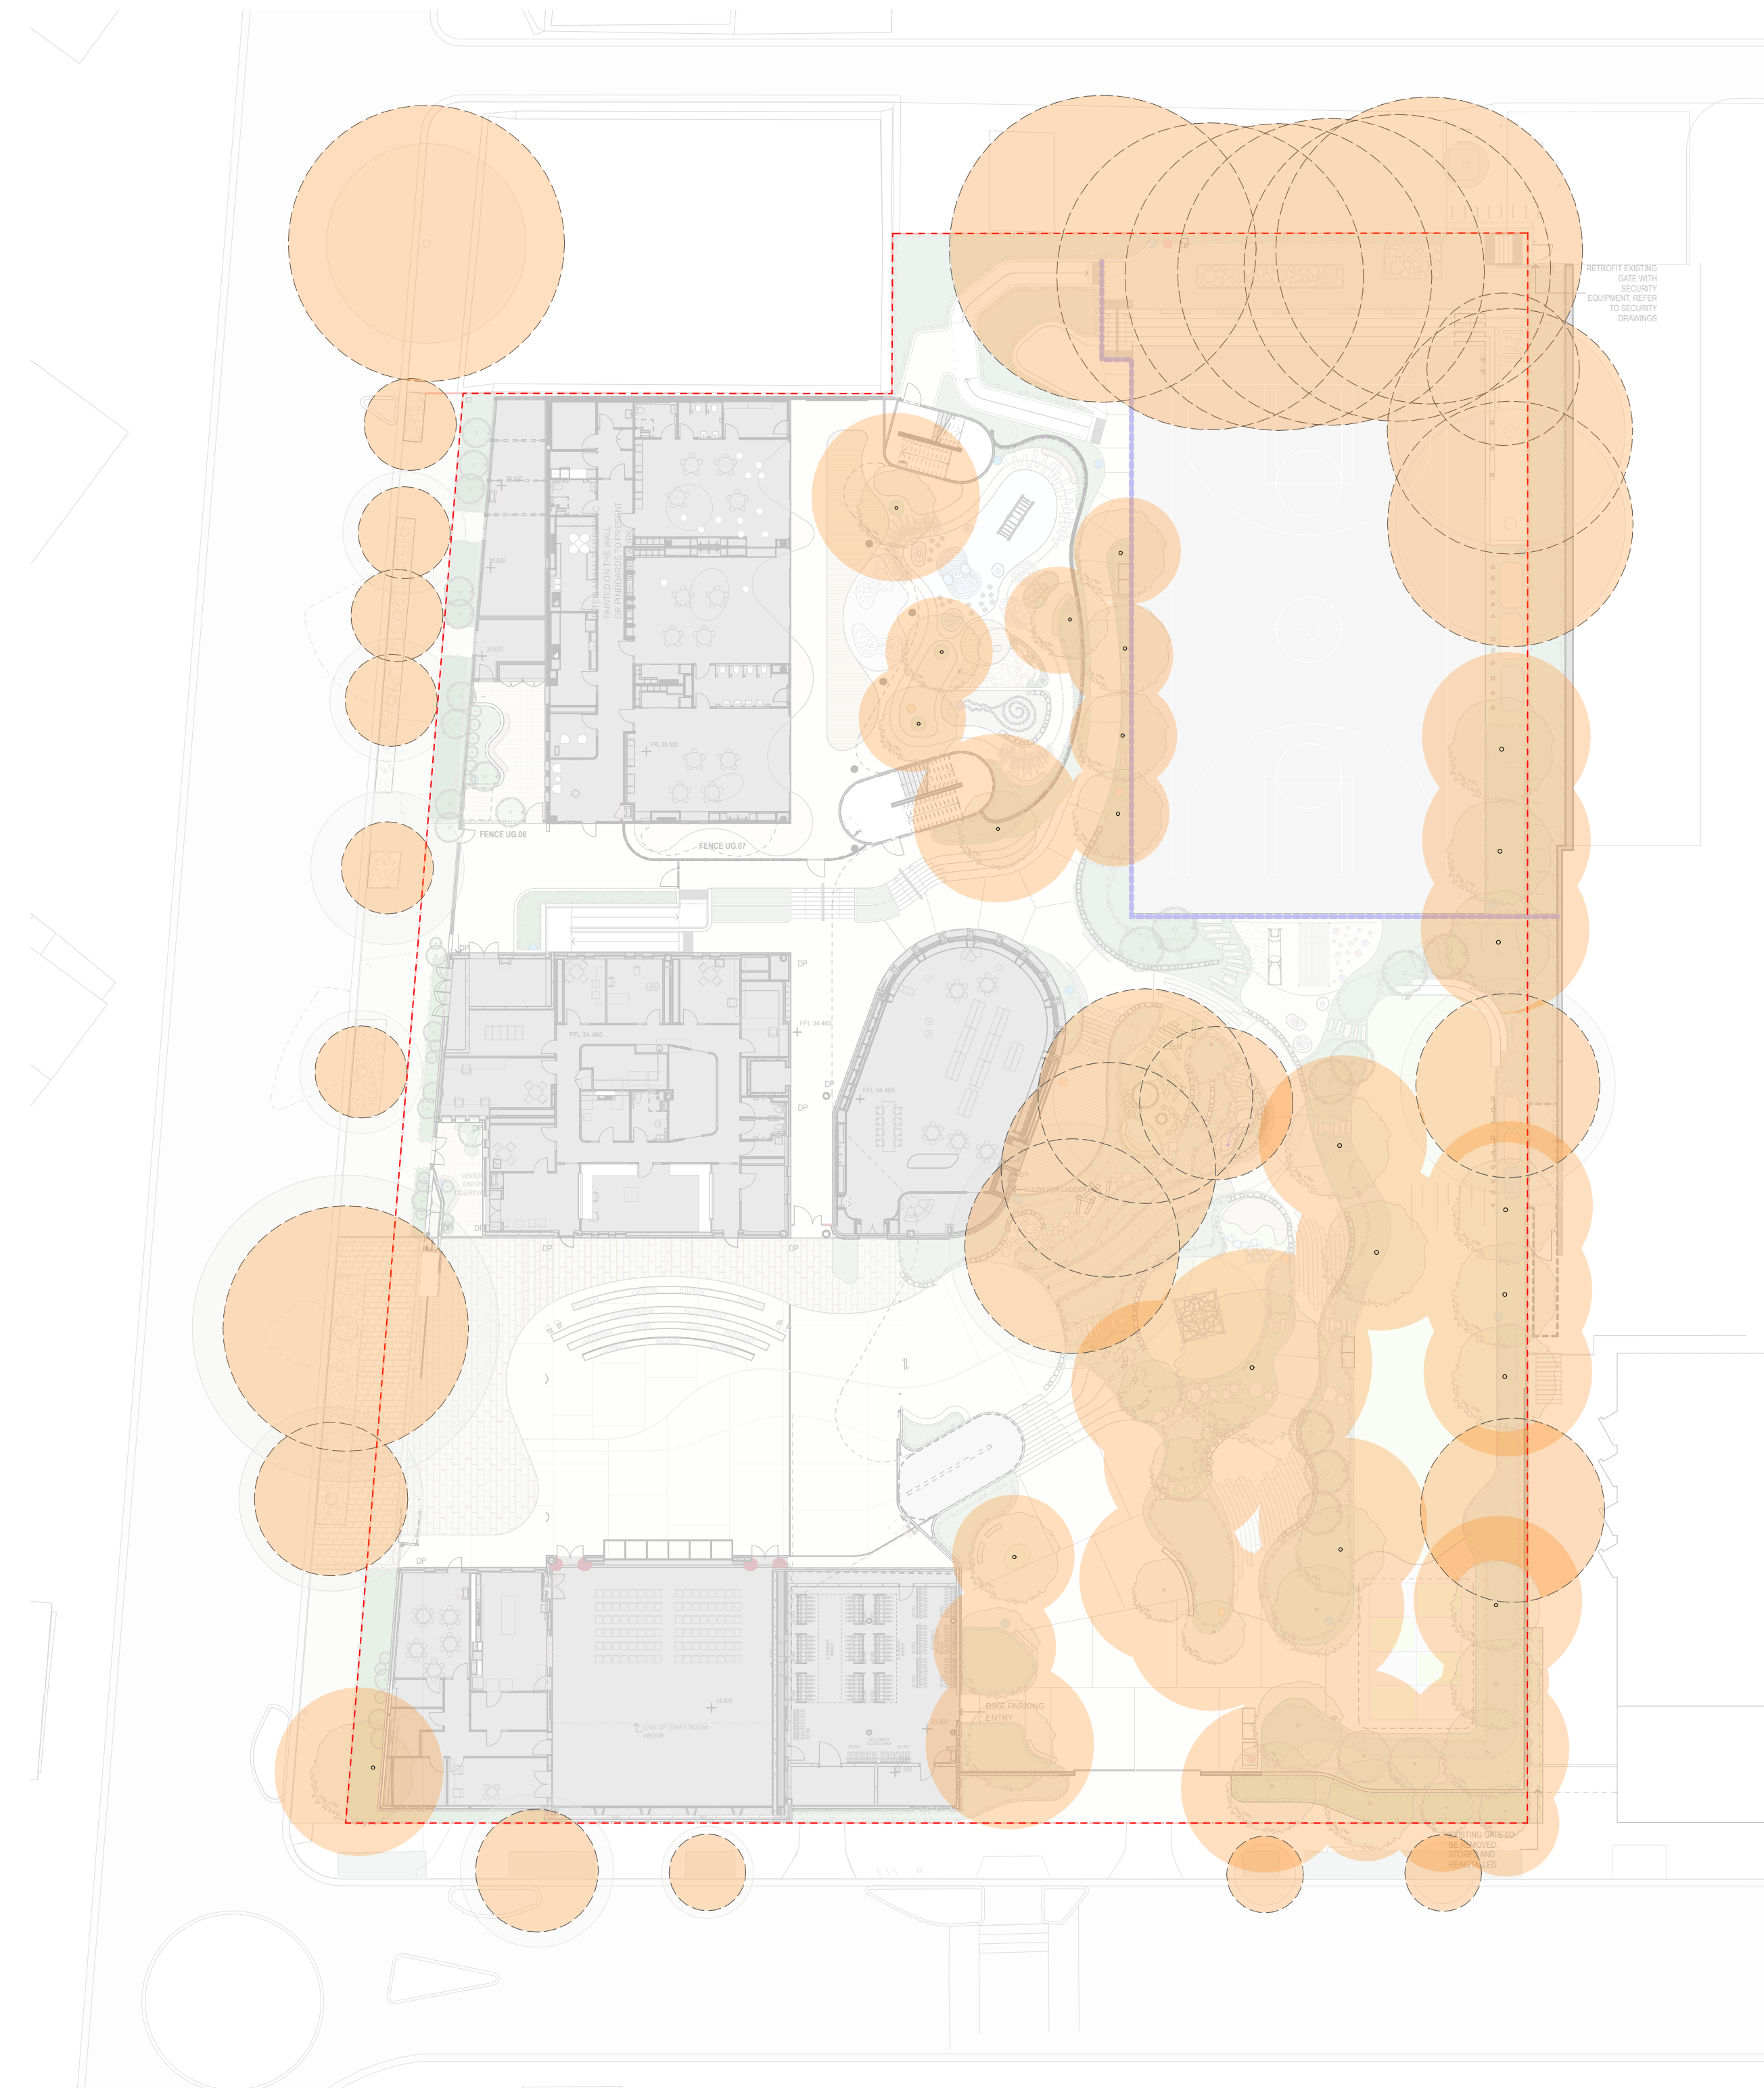
2 PLAN TREES POST-DEVELOPMENT

AREA OF TREE CANOPY POST-DEVELOPMENT : 4500m²
